DEKRA's commission No. : PKOL(W)/LODZ/54386/26/06/12
 commission/ damage No. : 23/033170
 Date of commission: 12-06-2026

Vehicle data

Measurement of thickness of the vehicle lacquer coating

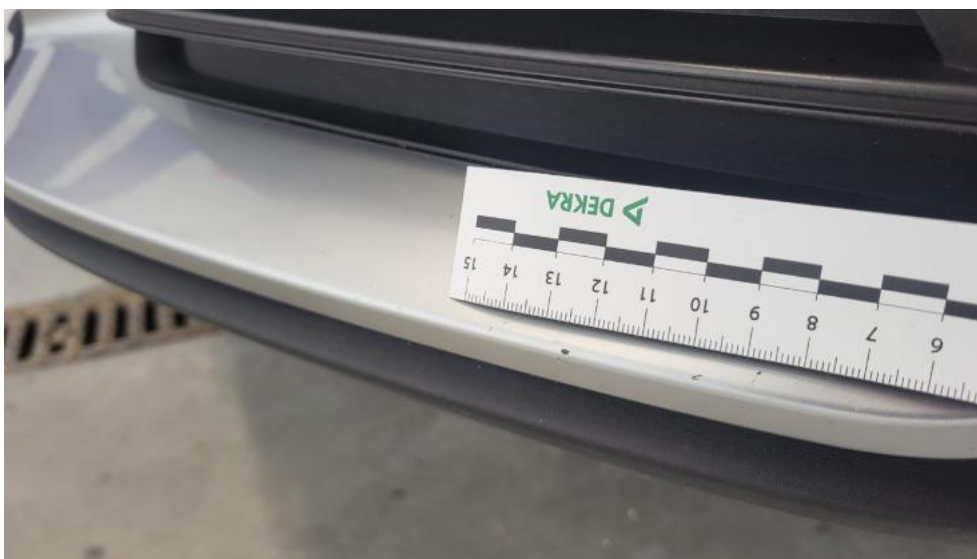
Photo 39.
Kratka/zaślepka halogenu L - Rysa/odprysk 1

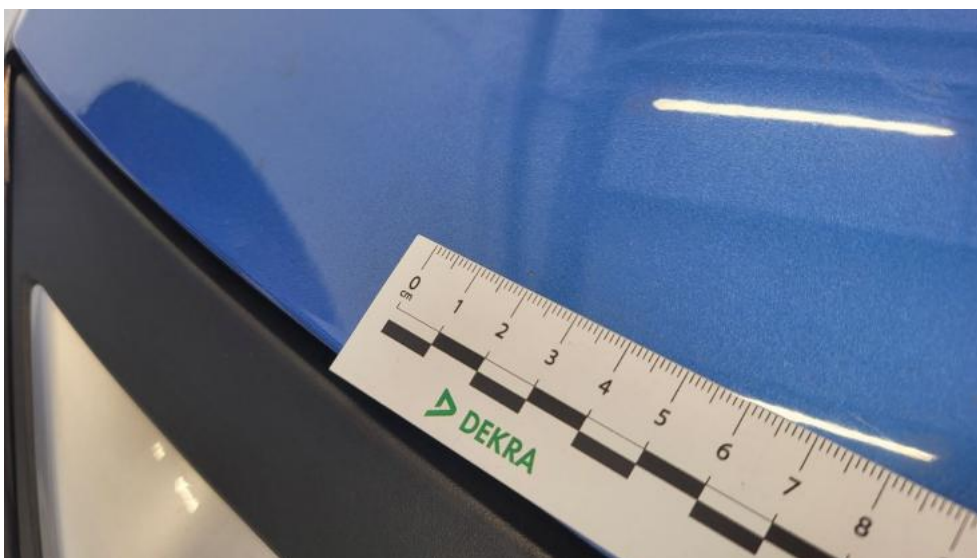
Photo 40.
Pokrywa komory silnika - Rysa/odprysk 1

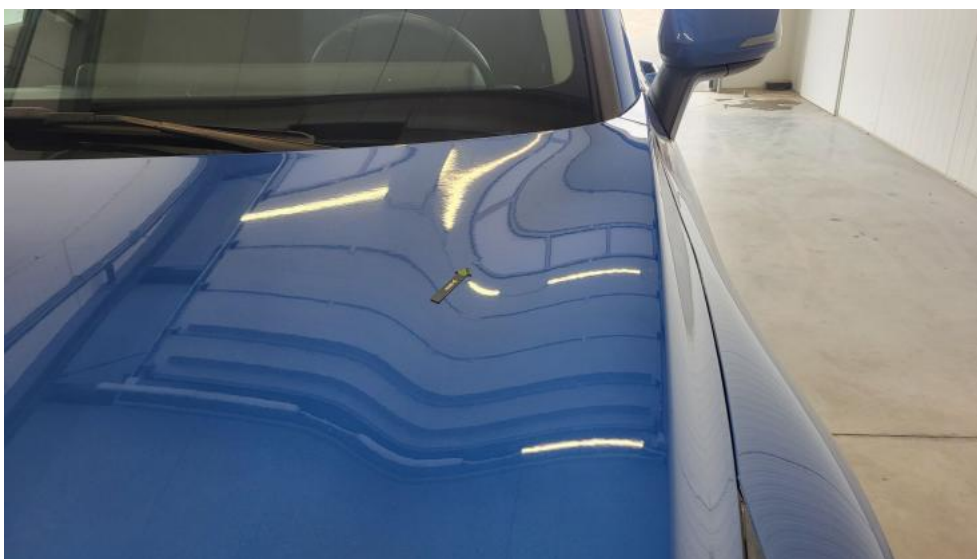
Photo 41.
Pokrywa komory silnika - Wgniecenie/odkształcenie 1

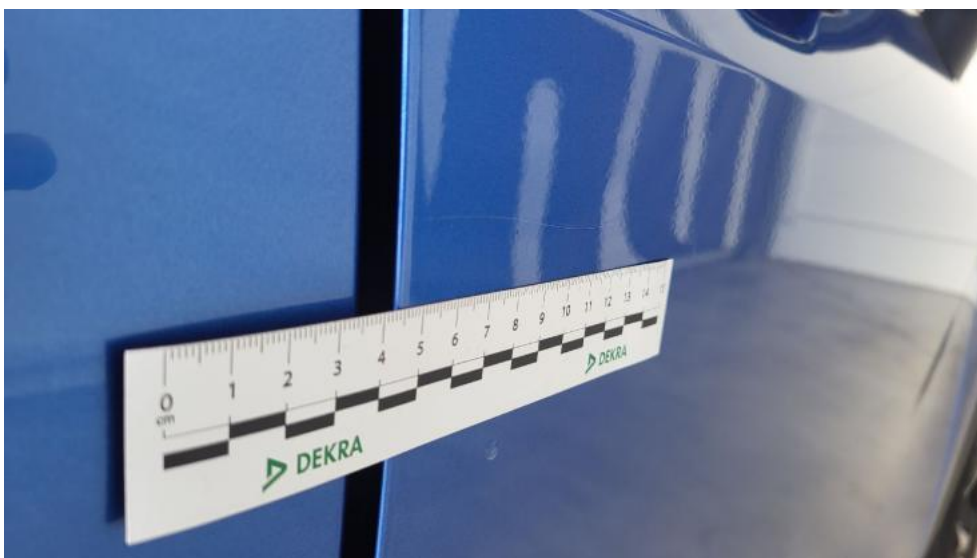
Photo 42.
Drzwi przednie P - Rysa/odprysk 1

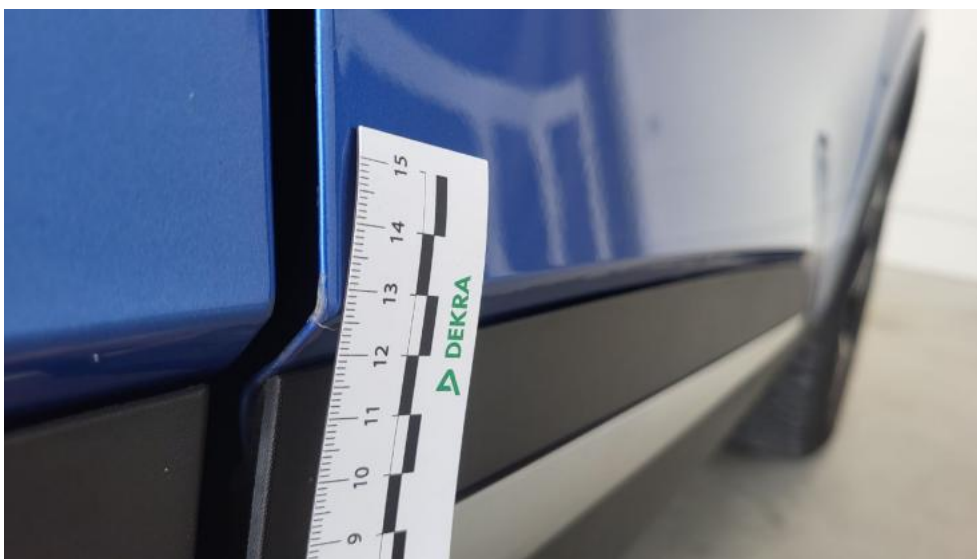
Photo 43.

Drzwi przednie P - Rysa/odprysk 2

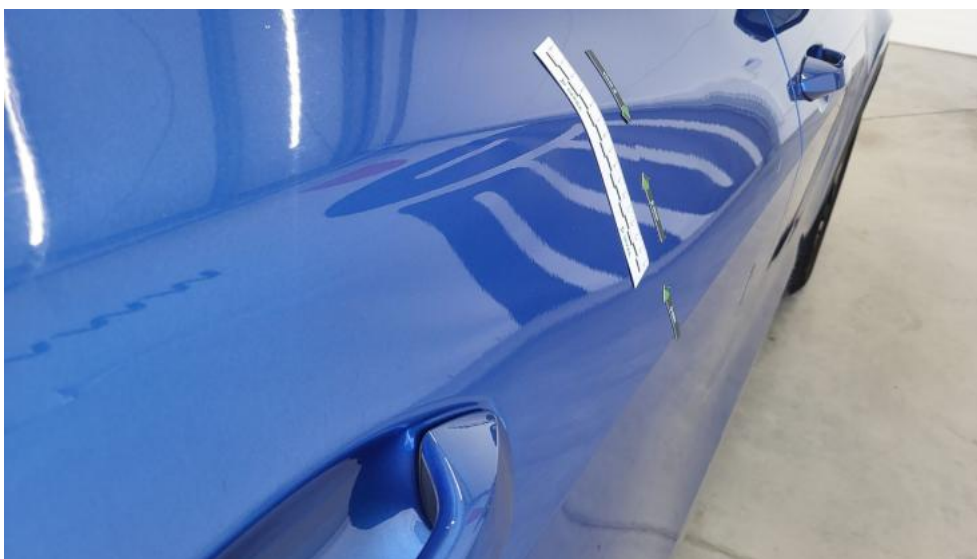
Photo 45.
Drzwi tylne P - Wgniecenie/odkształcenie 1

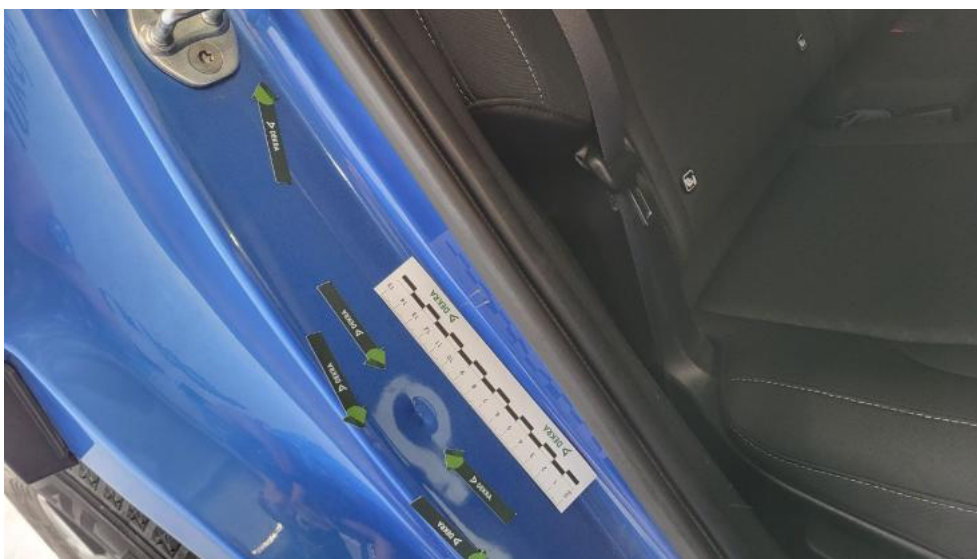
Photo 47.
Błotnik tylny P / Ściana boczna P - Wgniecenie/odkształcenie 1

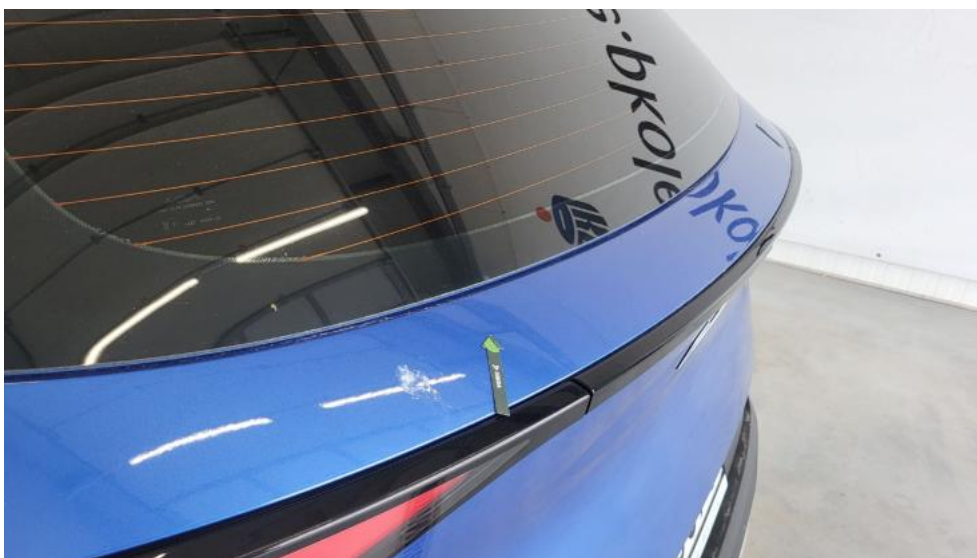
Photo 48.
Pokrywy bagażnika - Wgniecenie/odkształcenie 1

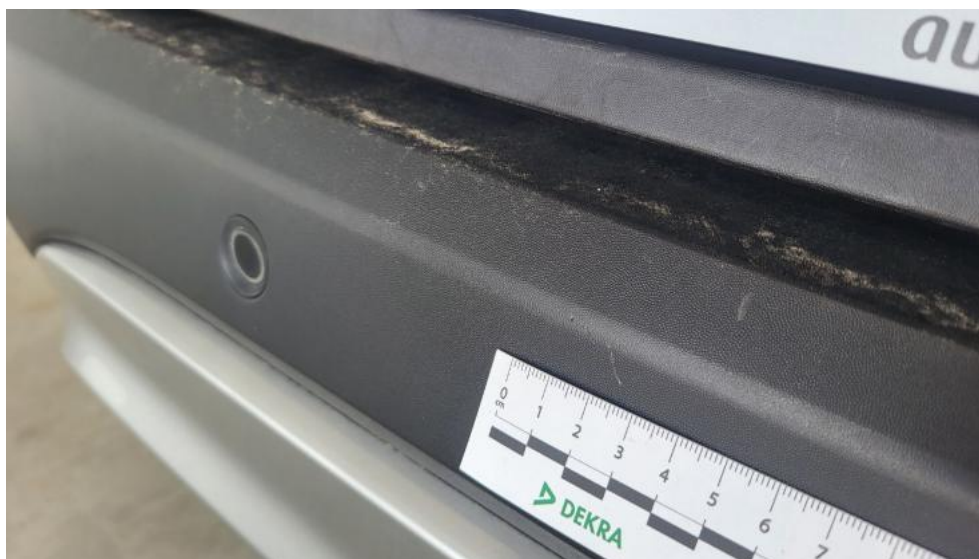
Photo 49.
Zderzak tylny - Rysa/odprysk 1

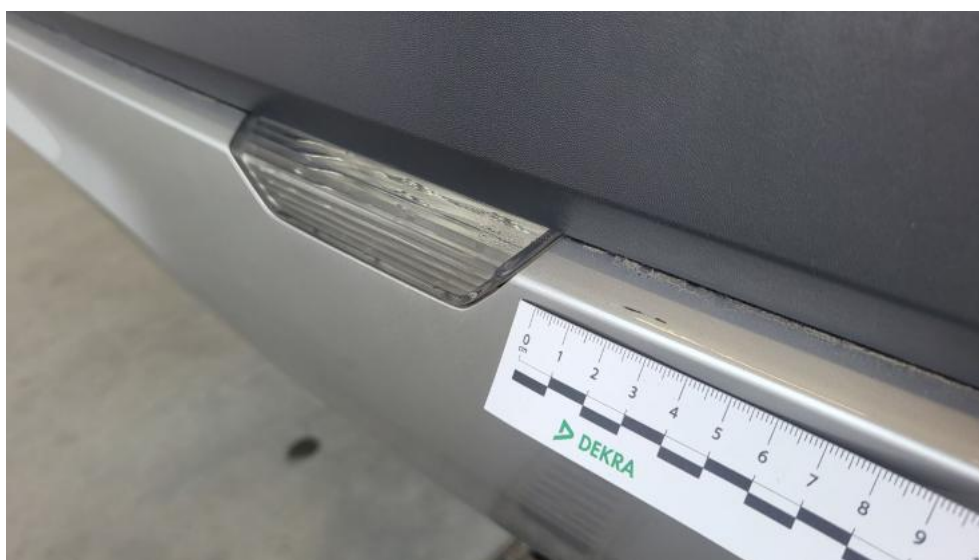
Photo 50.
Zderzak tylny cz dolna - Rysa/odprysk 1

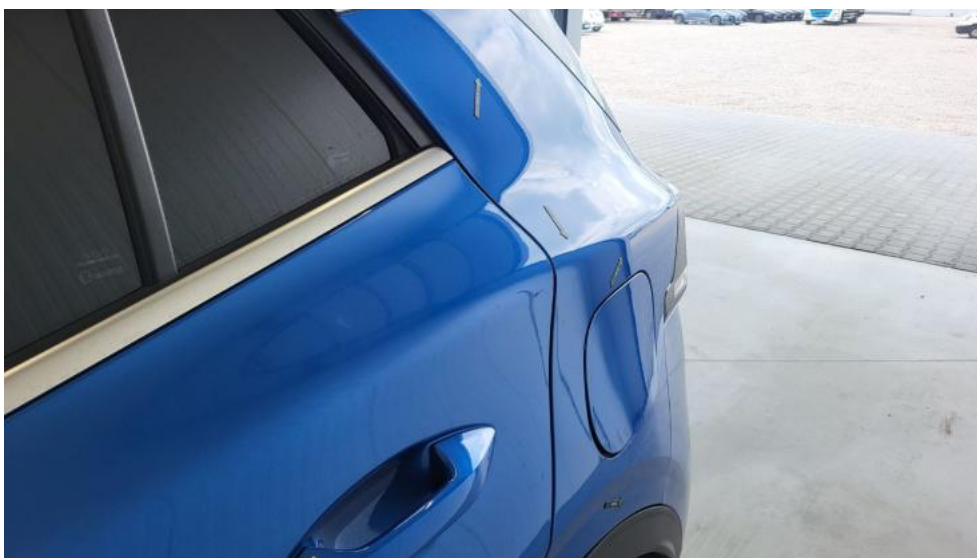
Photo 52.
Błotnik tylny L / Ściana boczna L - Wgniecenie/odkształcenie 1

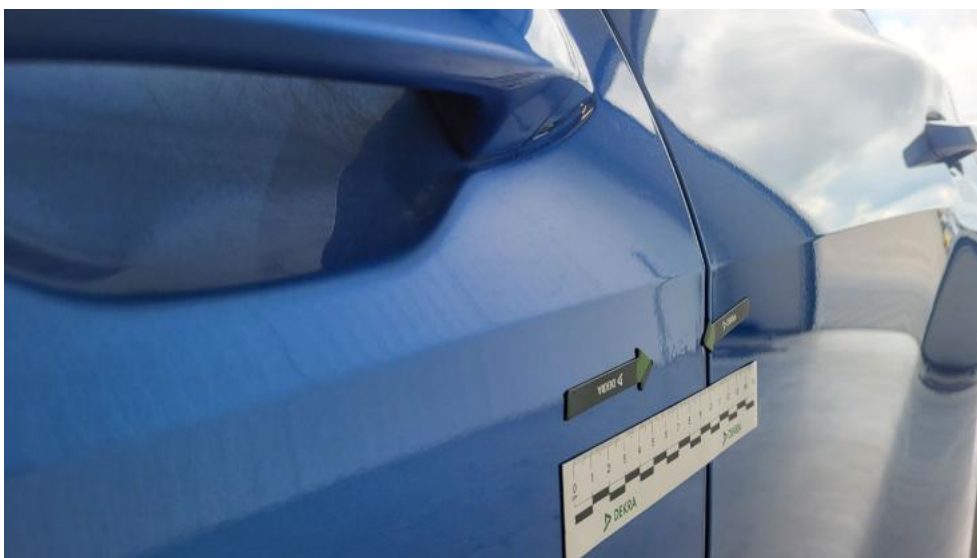
Photo 54.

Drzwi przed L - Wgniecenie/odkształcenie 1

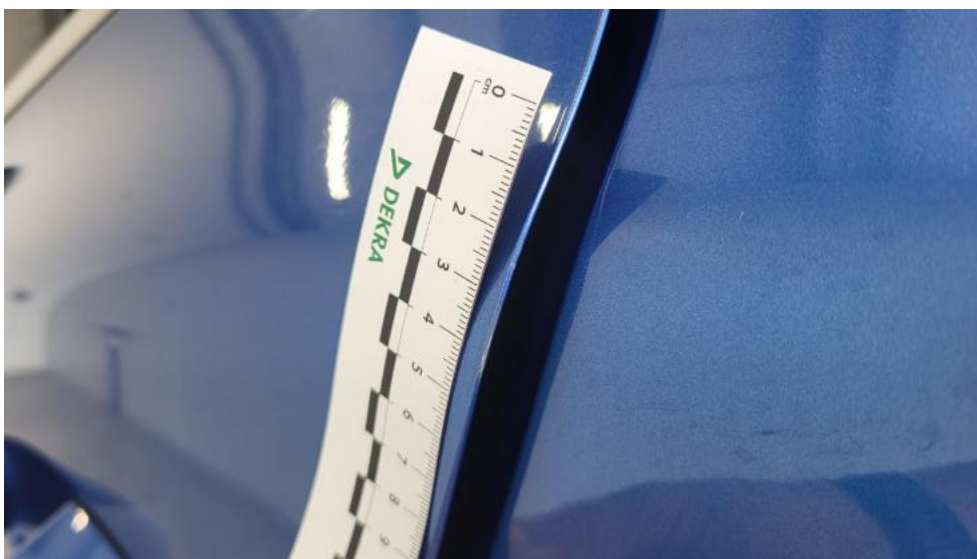
Photo 55.
Drzwi tylne L - Rysa/odprysk 1

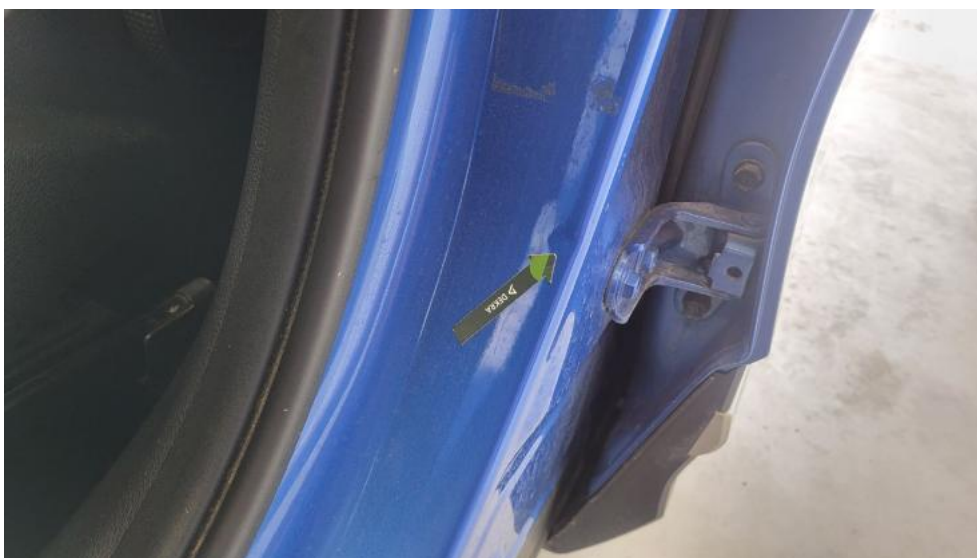
Photo 56.
Próg L - Wgniecenie/odkształcenie 1

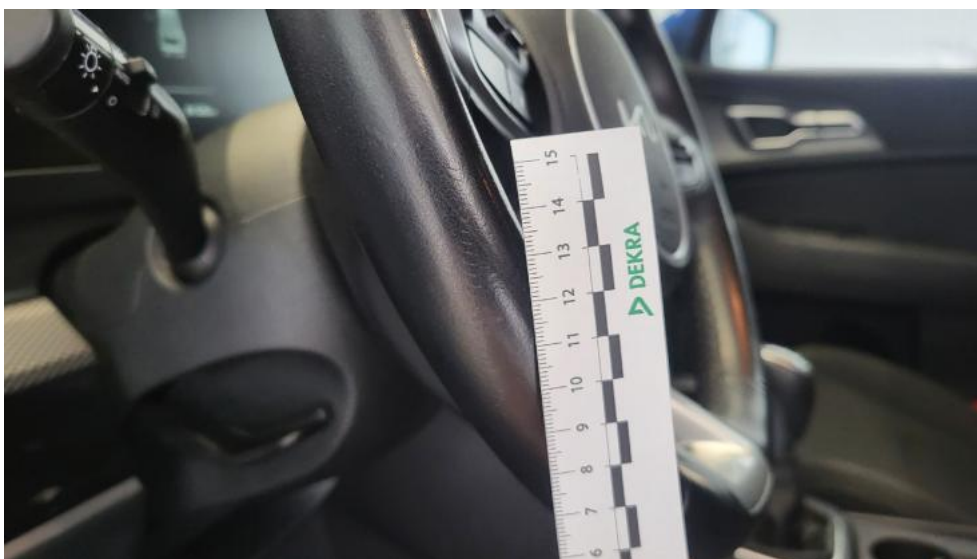
Photo 57.
Koło kierownicy - Rysa/odprysk 1

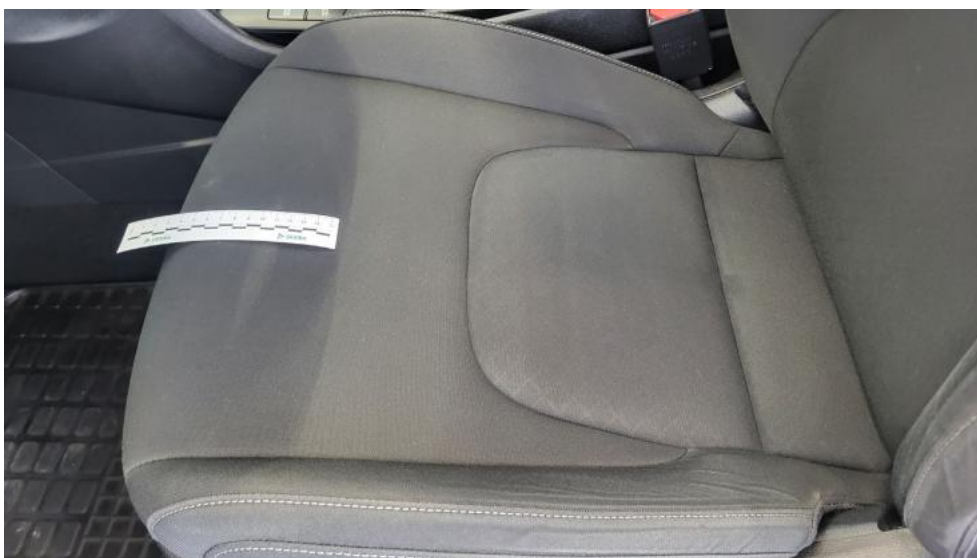
Photo 58.
Fotel prz. lew. - Inne 1

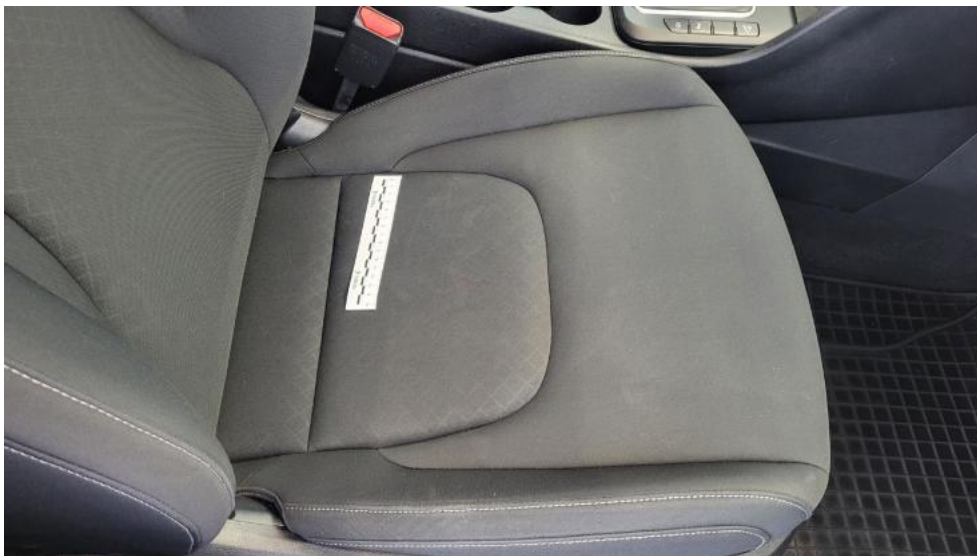
Photo 59.
Fotel prz. praw. - Inne 1

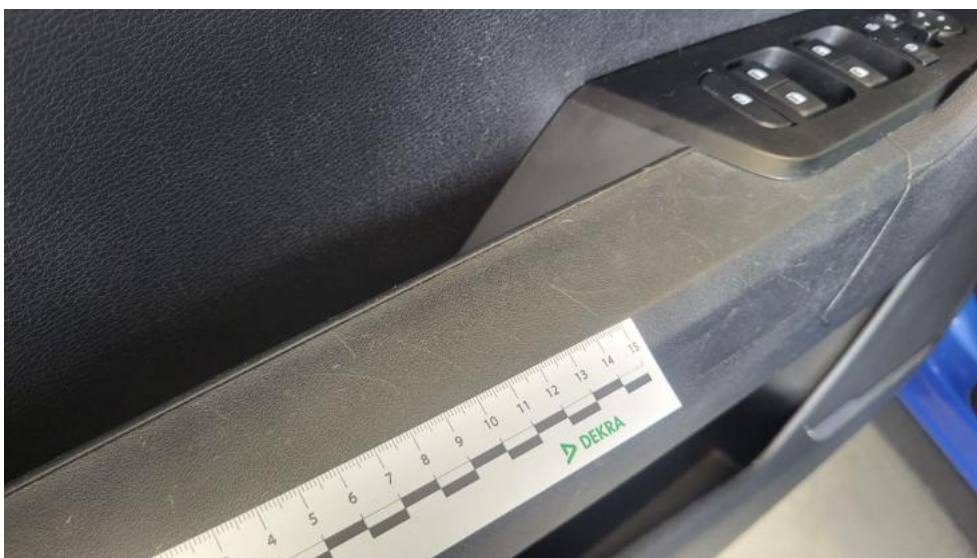
Photo 60.
Tapicerka drzwi przednich L - Rysa/odprysk 1

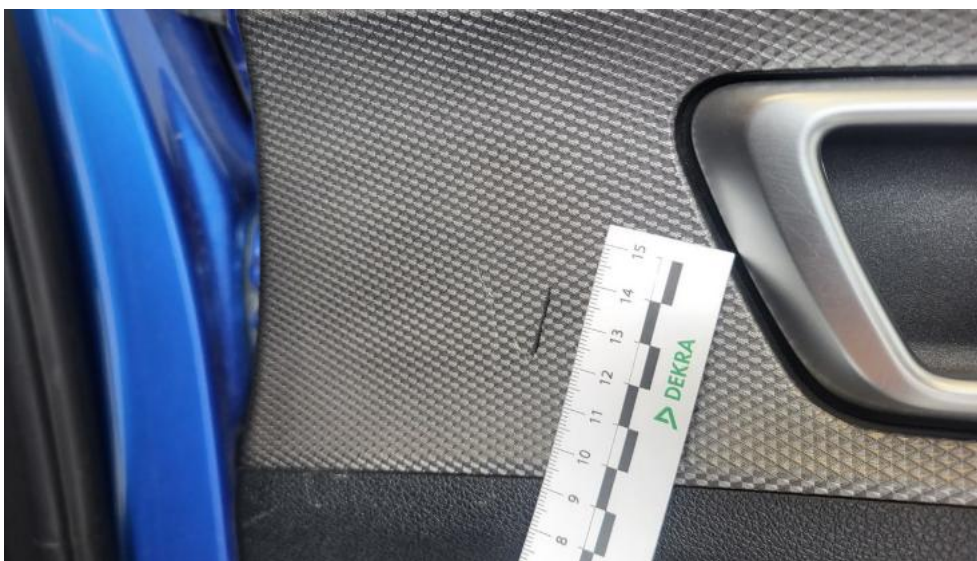
Photo 61.
Tapicerka drzwi tylnych P - Rysa/odprysk 1

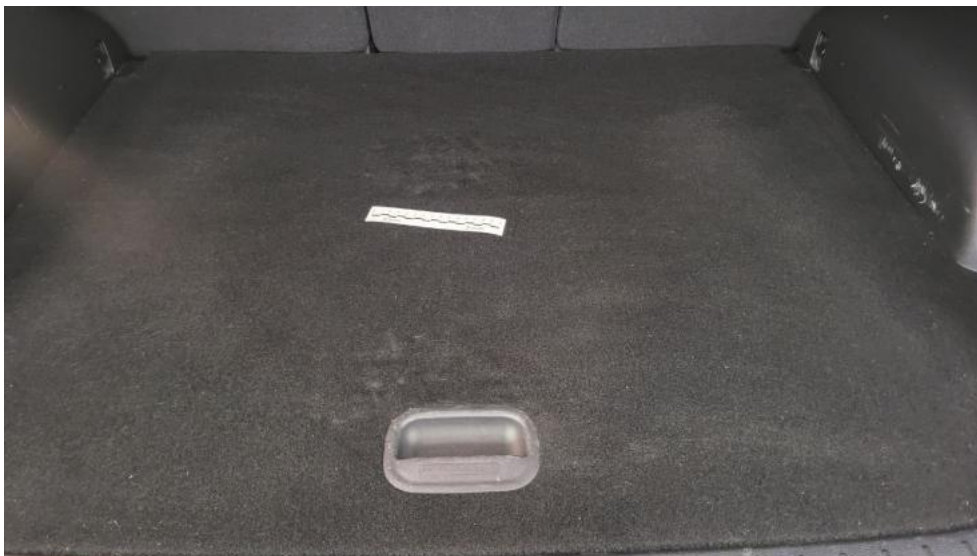
Photo 63.
Wykładzina podłogi bagażnika - Inne 1

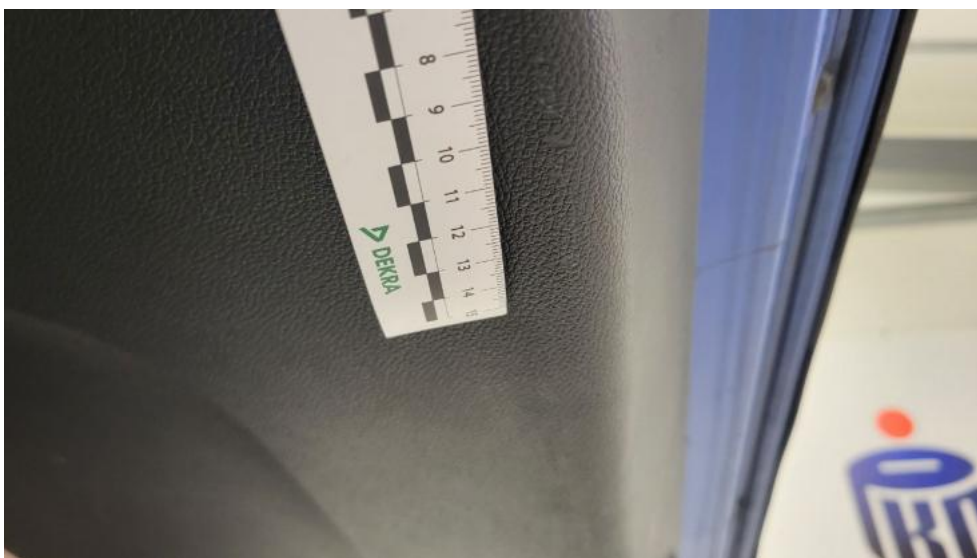
Photo 64.
Wykładzina pokrywy tylnej - Rysa/odprysk 1

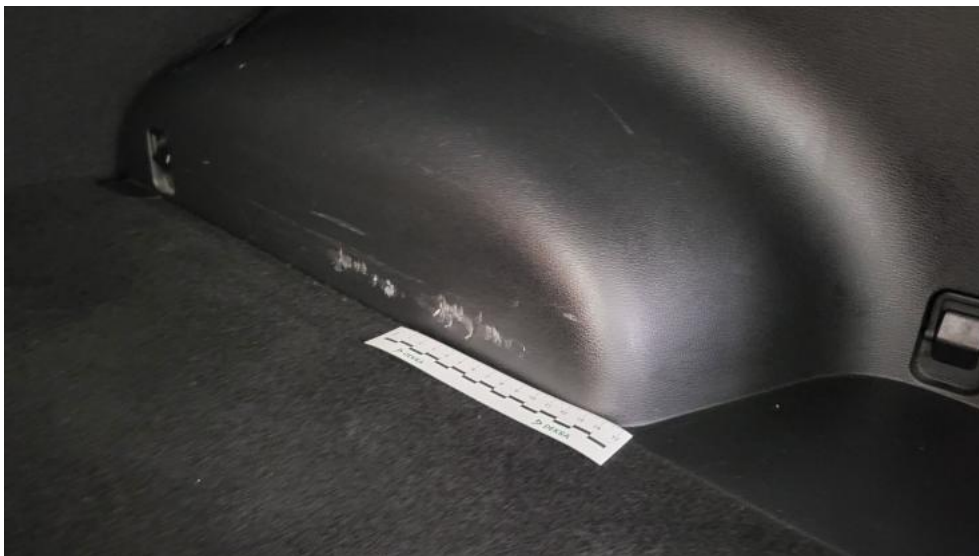
Photo 65.
Wykładzina przestrzeni bagażowej - Rysa/odprysk 1

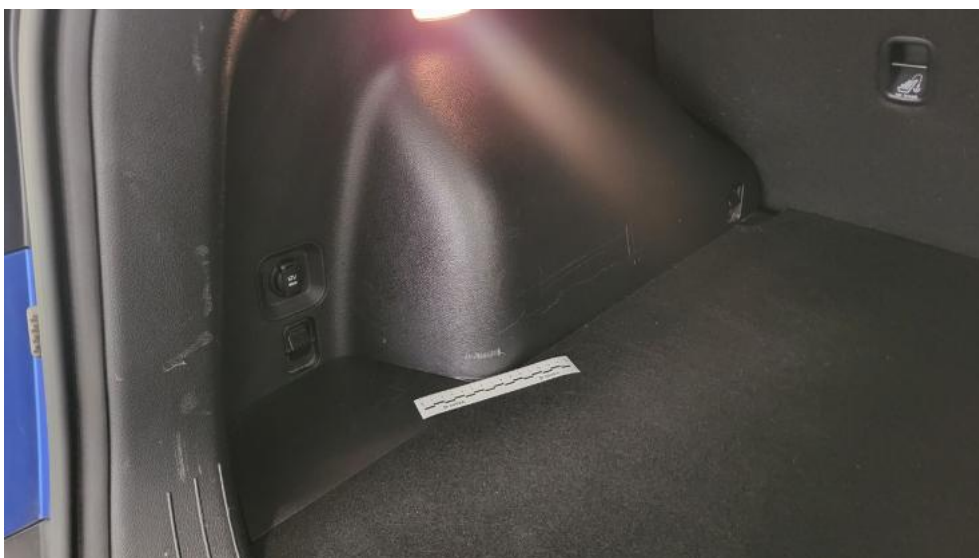
Photo 66.
Wykładzina przestrzeni bagażowej - Rysa/odprysk 2
