DEKRA's commission No. : PKOL(W)/LODZ/80122/26/08/27  
commission/ damage No. : 24/035606  
Date of commission: 27-08-2026

| Manufacturer | VOLVO |
| Model | V60 18-21 |
| Type / version | V60 B3 B Momentum Core aut |

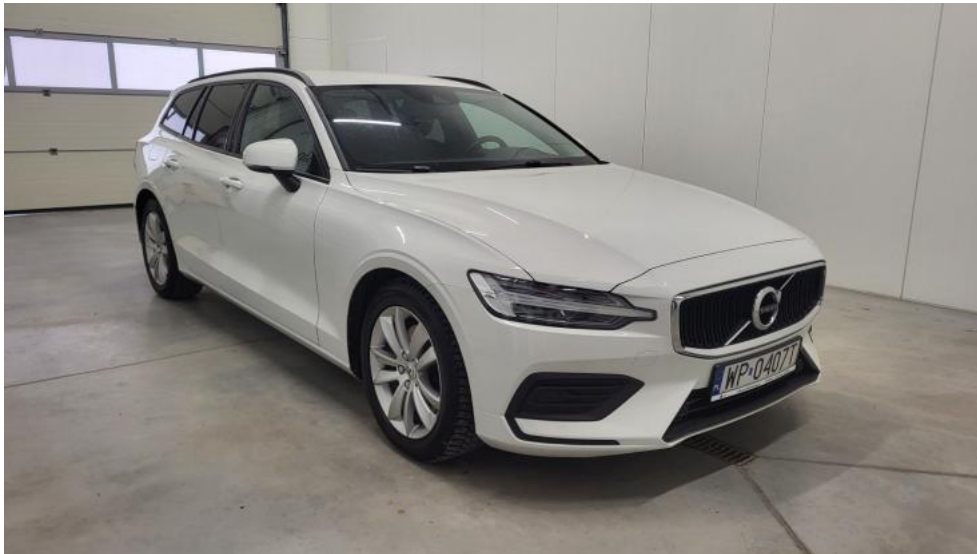
**Photo 3.**

Przekątna przednia prawa

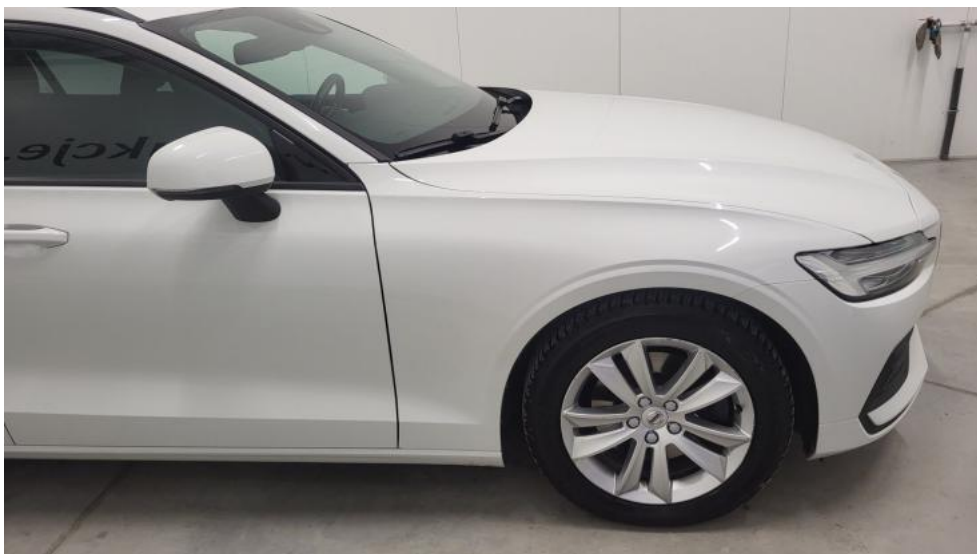
**Photo 4.**

Bok prawy z przodu

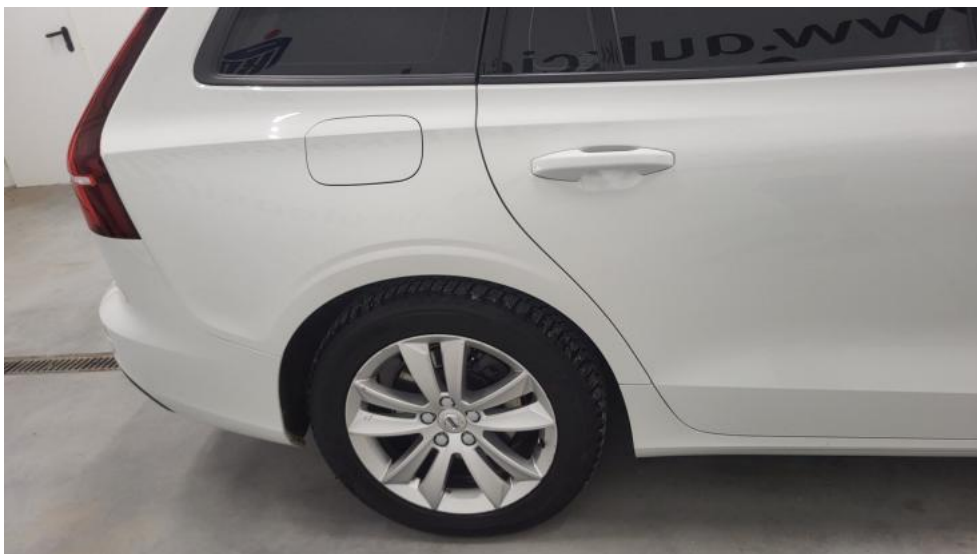
**Photo 5.**  
Bok prawy z tyłu

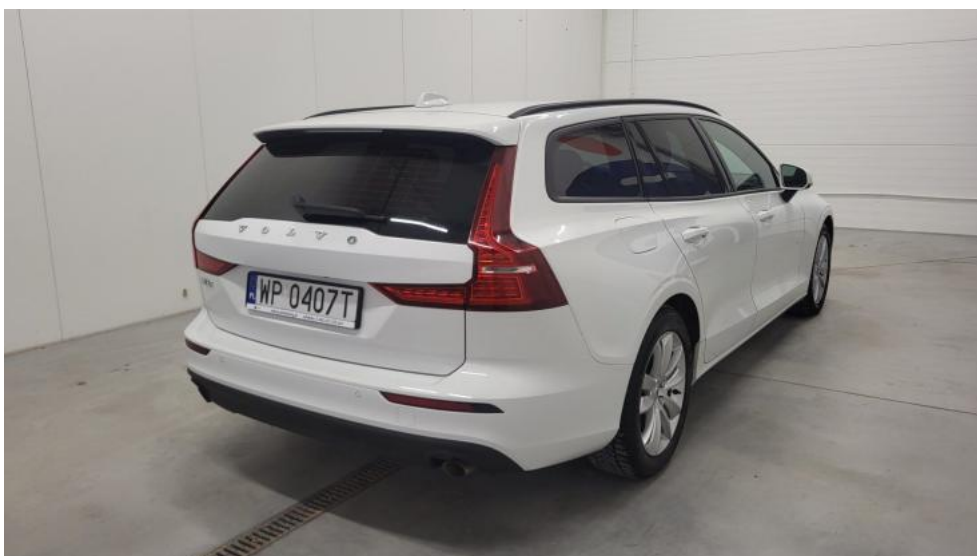
**Photo 6.**  
Przekątna tylna prawa

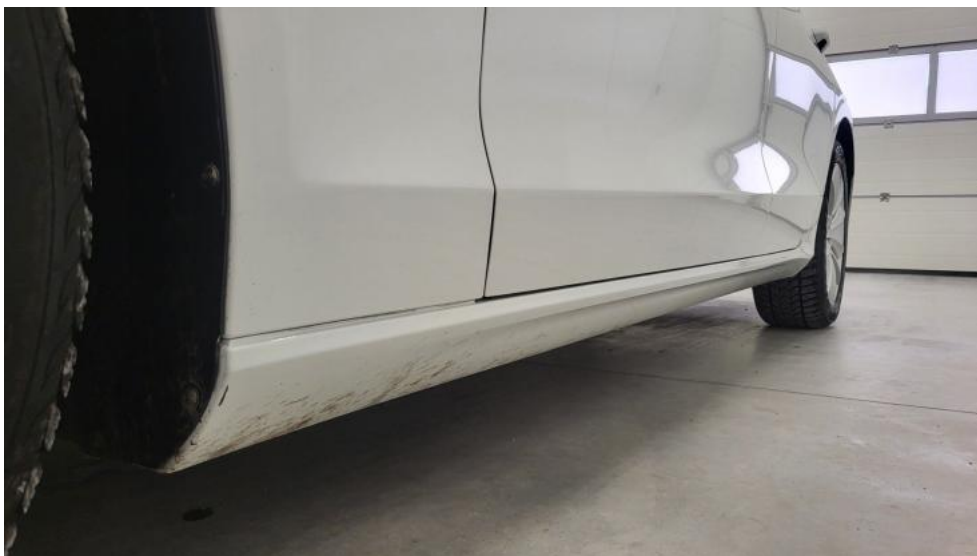
**Photo 11.**

Próg lewy (widok od przodu)

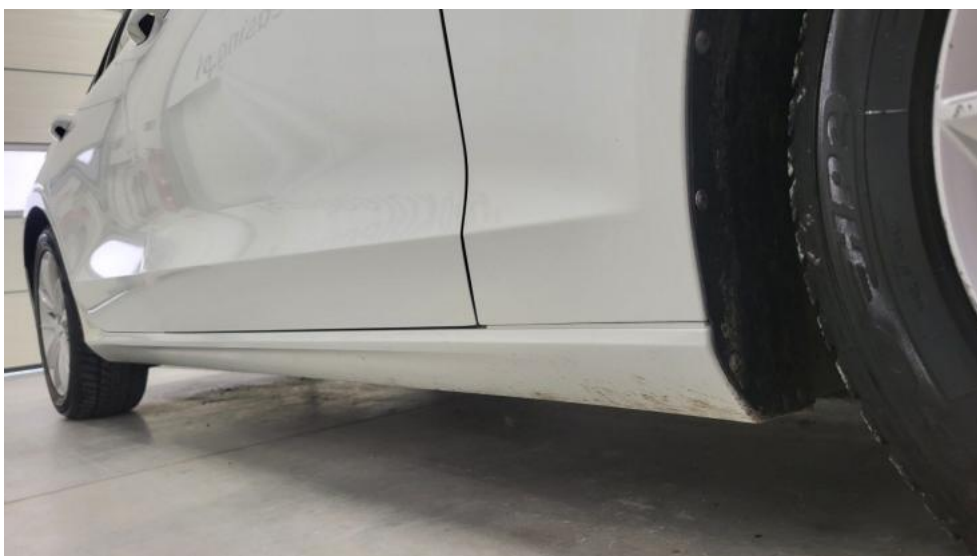
**Photo 12.**

Próg prawy (widok od przodu)

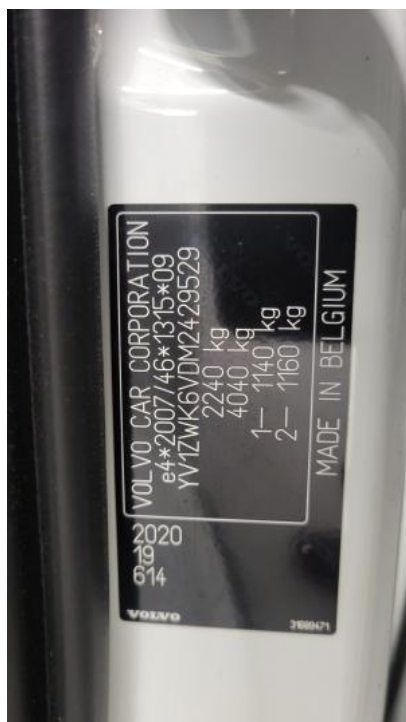
**Photo 23.**

Tabliczka znamionowa

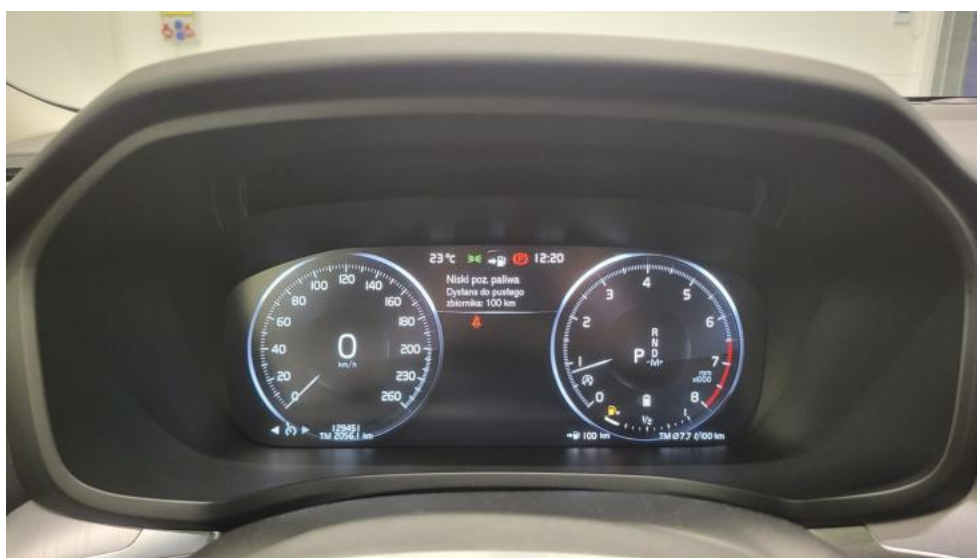
**Photo 24.**

Zestaw wskaźników - przebieg
