DEKRA's commission No. : PKOL(W)/LODZ/26412/25/04/10  
commission/ damage No. : FUTURA  
Date of commission: 10-04-2025

**DEKRA Poland - Headquarters**  
02-673 Warszawa, ul. Konstruktorska 12A

| Manufacturer | SEAT |
| Type / version | Ibiza 1.0 MPI EVO Reference S&S |

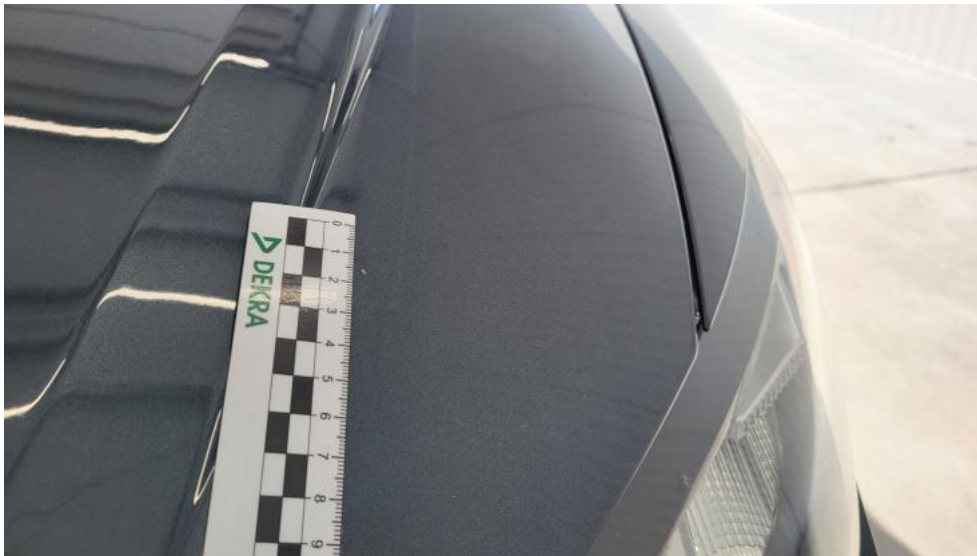
**Photo 33.**

Pokrywa komory silnika - Rysa/odprysk 1

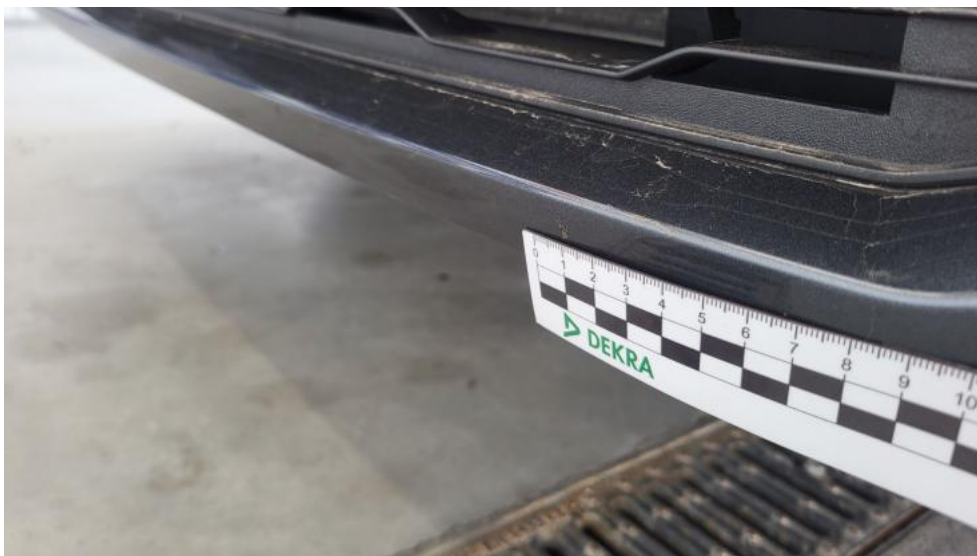
**Photo 34.**

Zderzak - Rysa/odprysk 1

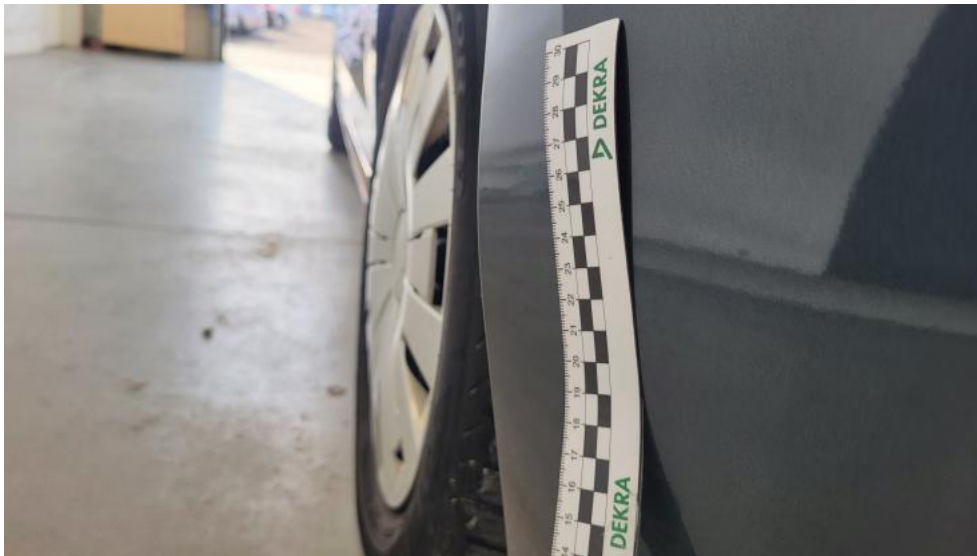
**Photo 35.**

Zderzak - Wgniecenie/odkształcenie 1

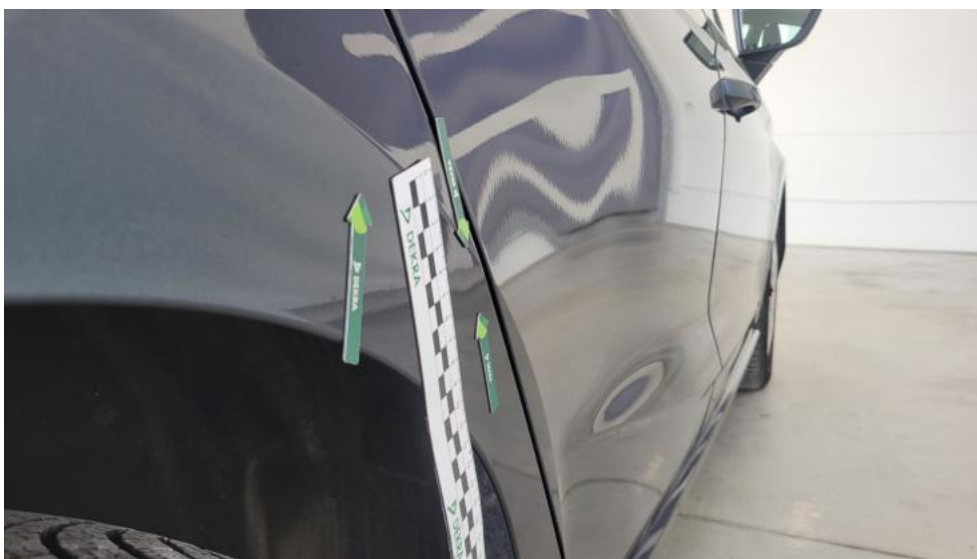
**Photo 41.**

Błotnik tylny P / Ściana boczna P - Wgniecenie/odkształcenie 1

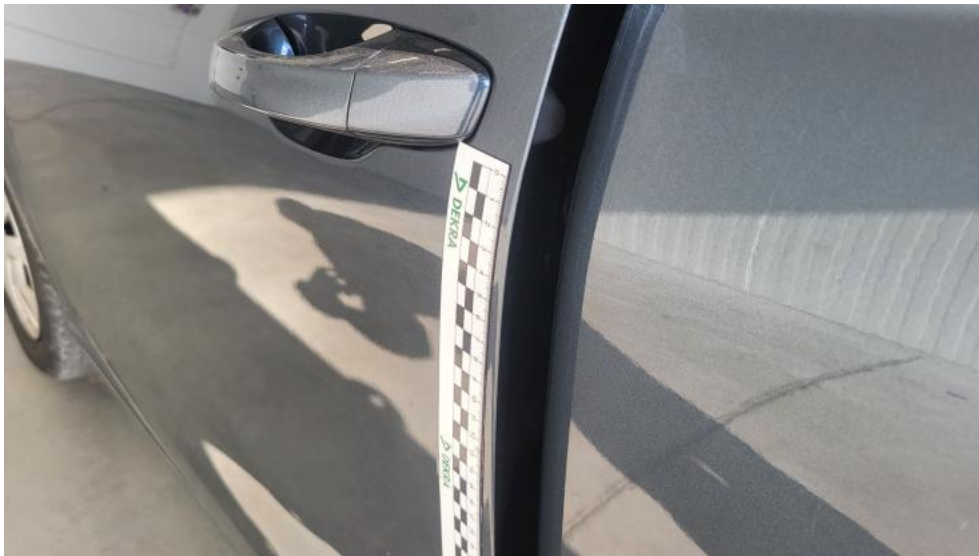
**Photo 43.**

Drzwi przed L - Rysa/odprysk 1

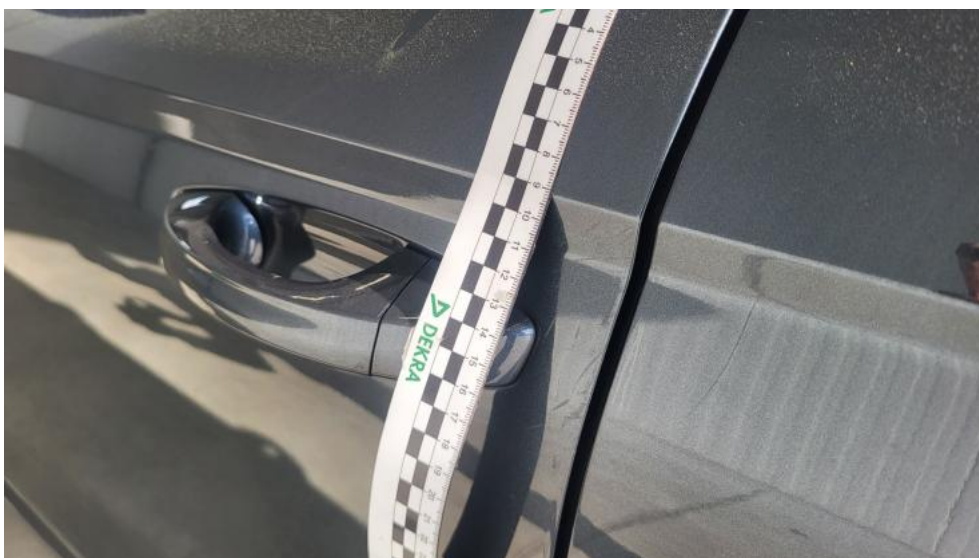
**Photo 44.**

Drzwi przed L - Rysa/odprysk 2

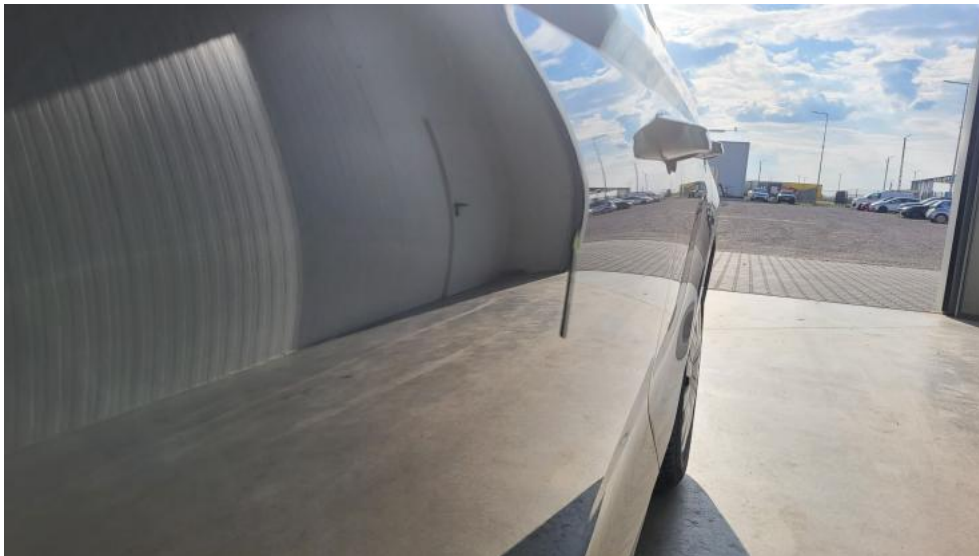
**Photo 45.**

Drzwi przed L - Wgniecenie/odkształcenie 1

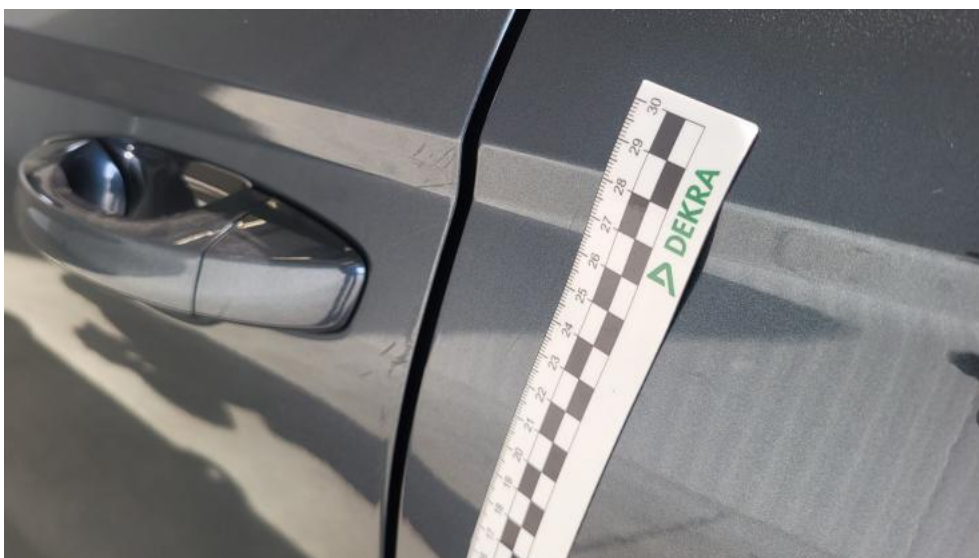
**Photo 46.**

Drzwi tylne L - Rysa/odprysk 1

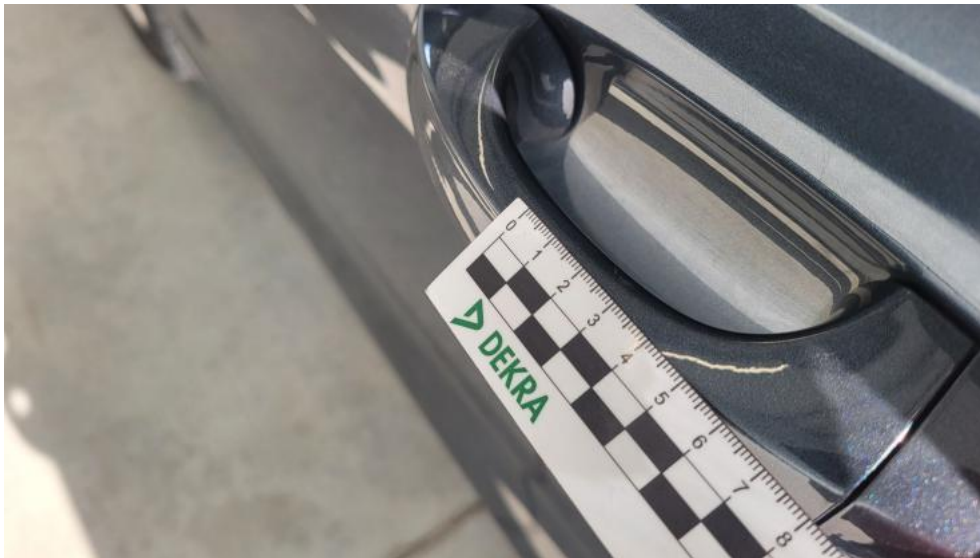
**Photo 47.**

Klamka drzwi prz L - Rysa/odprysk 1

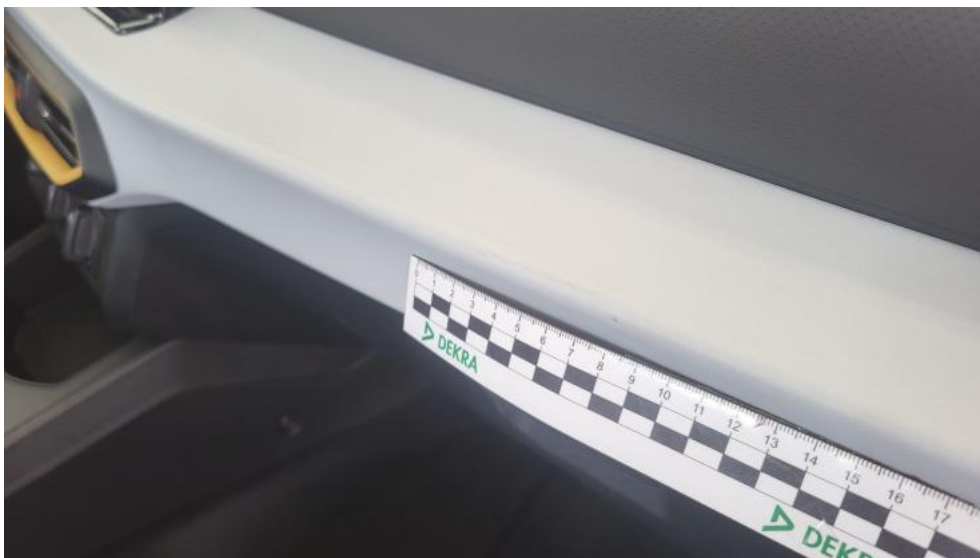
**Photo 48.**

Deska rozdzielcza - Inne 1
