DEKRA's commission No. : PKOL(W)/LODZ/32881/25/05/07  
commission/ damage No. : 21/023151  
Date of commission: 07-05-2025

| Manufacturer | TOYOTA |
| Model | Corolla Sedan 18-22 |
| Registration /record No. | WOT82510 |

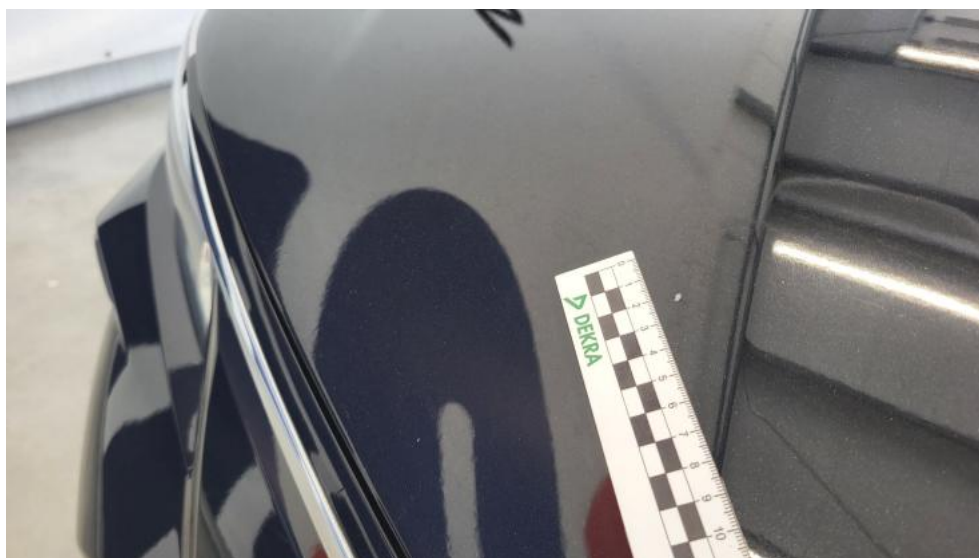
**Photo 38.**

Pokrywa komory silnika - Rysa/odprysk 1

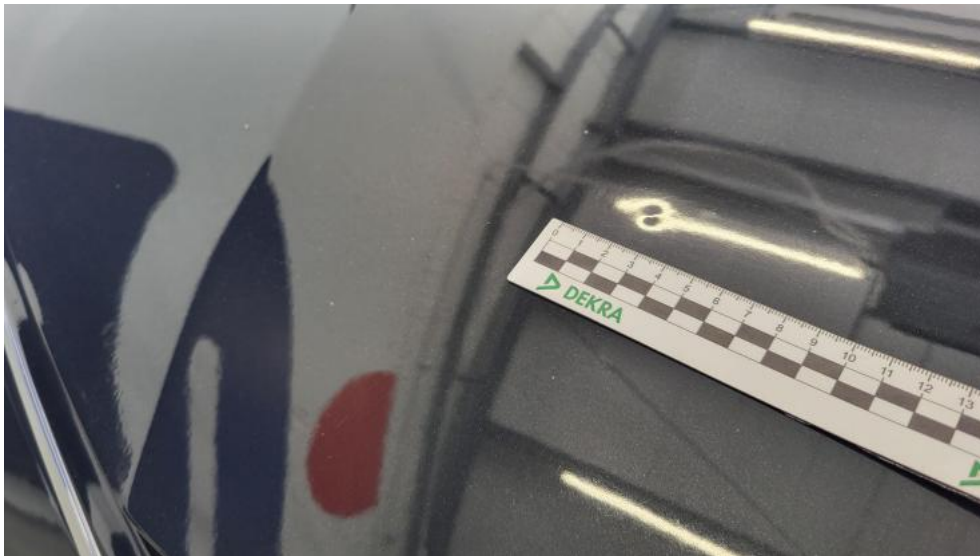
**Photo 39.**

Pokrywa komory silnika - Wgniecenie/odkształcenie 1

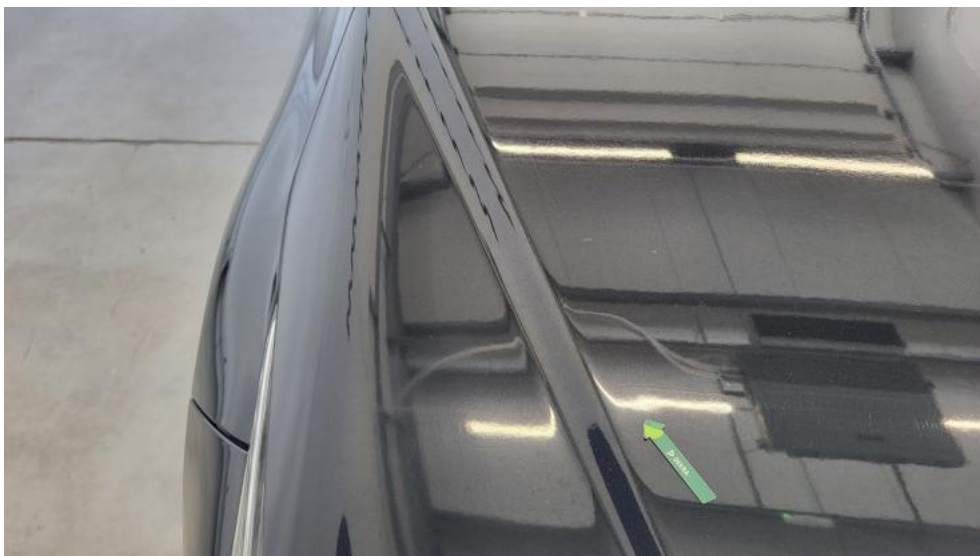
**Photo 40.**

Pokrywa komory silnika - Wgniecenie/odkształcenie 2

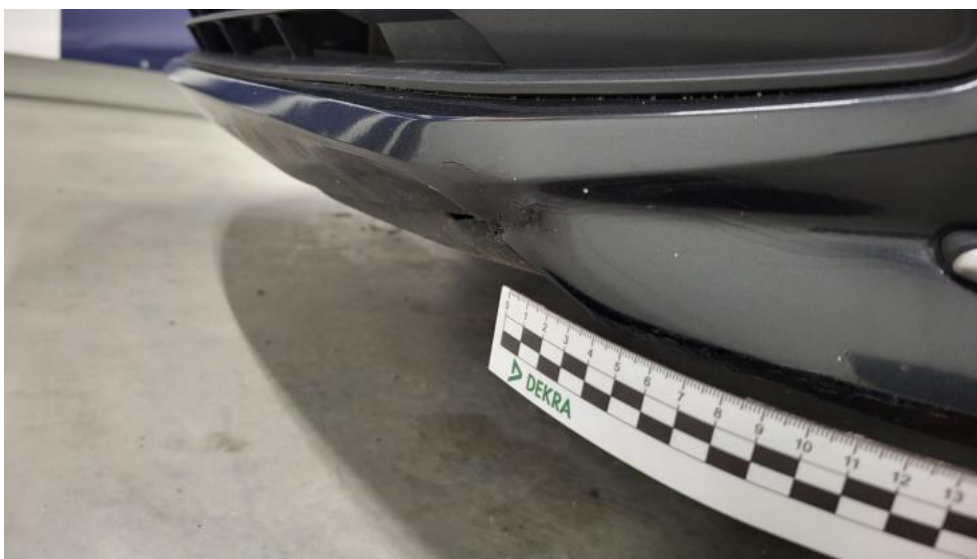
**Photo 41.**

Zderzak - Wgniecenie/odkształcenie 1

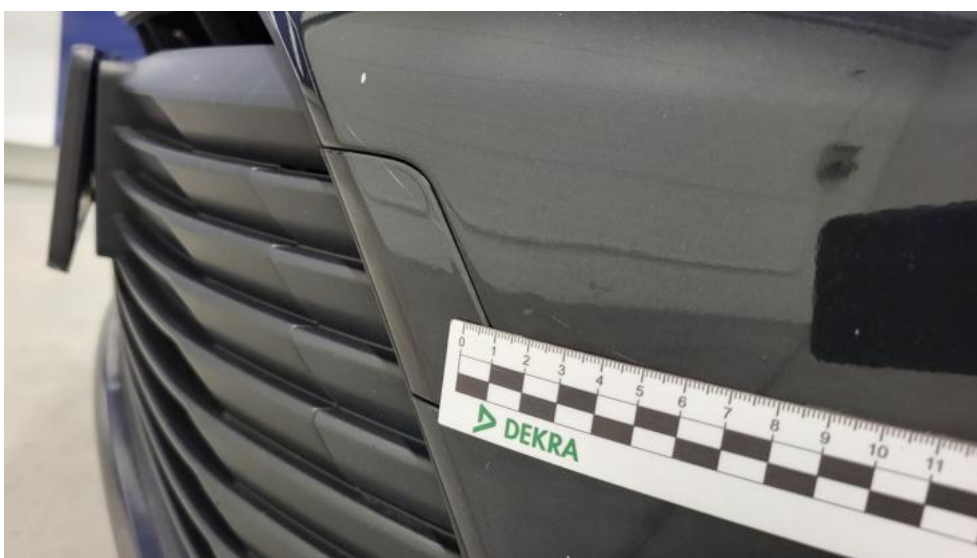
**Photo 42.**

Zderzak - Wgniecenie/odkształcenie 2

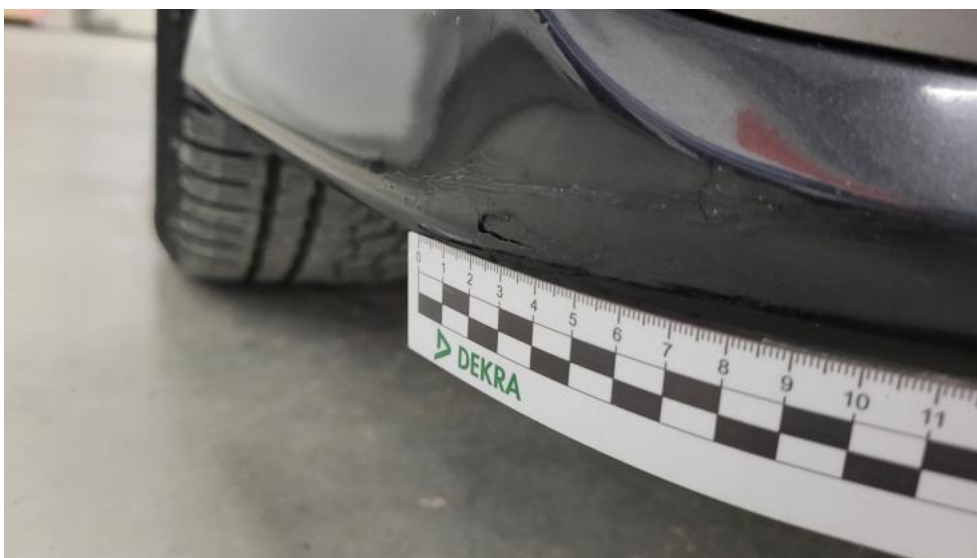
**Photo 44.**

Zderzak - Pęknięcie/rozerwanie 1

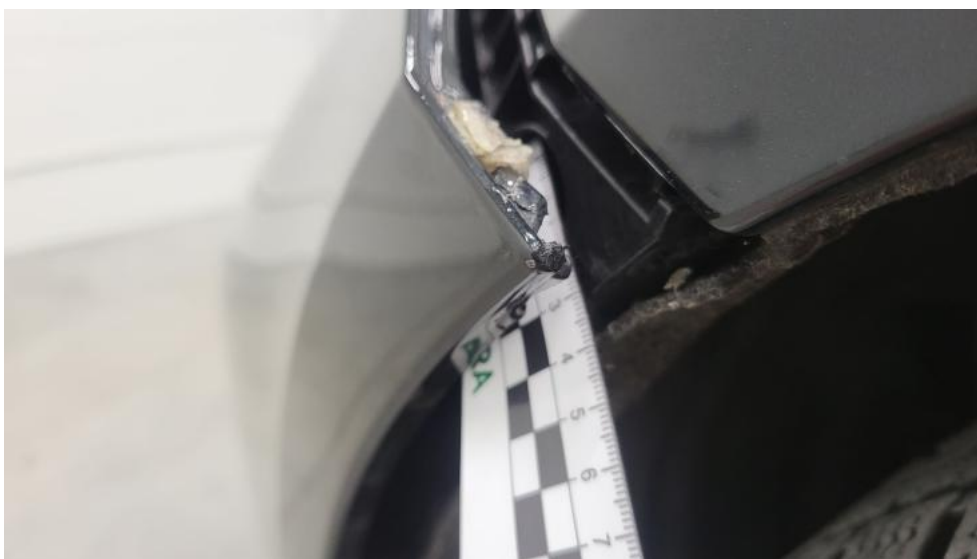
**Photo 45.**

Zderzak - Pęknięcie/rozerwanie 2

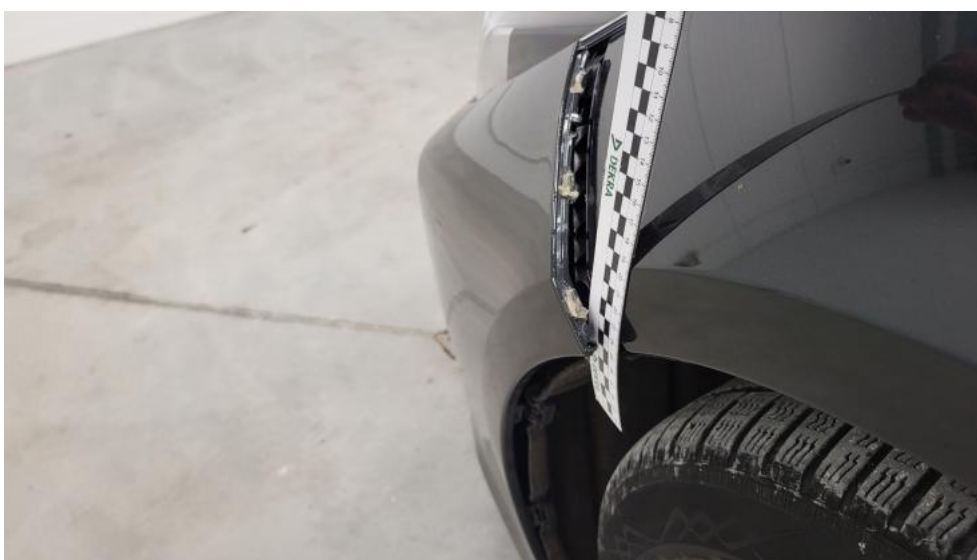
**Photo 46.**

Zderzak - Inne 1

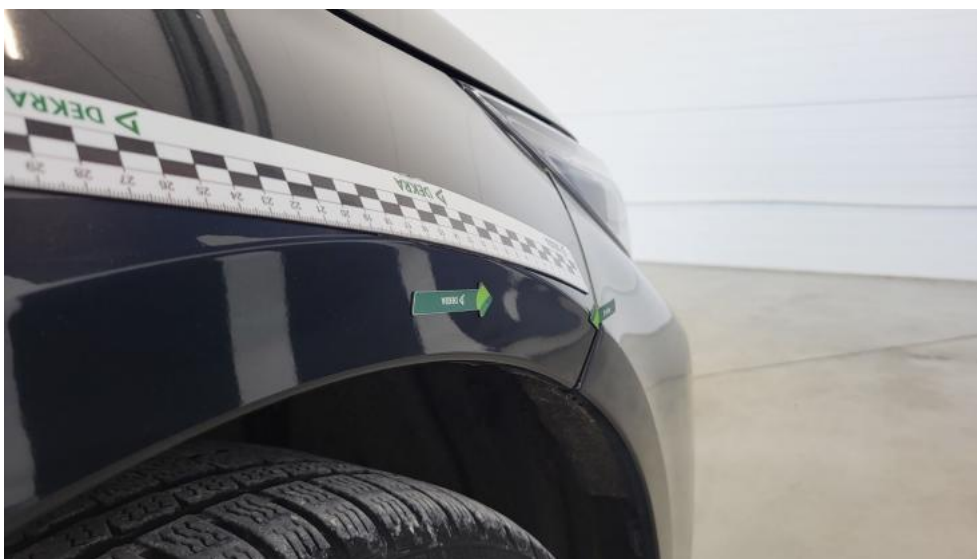
**Photo 47.**

Błotnik przedni P - Wgniecenie/odkształcenie 1

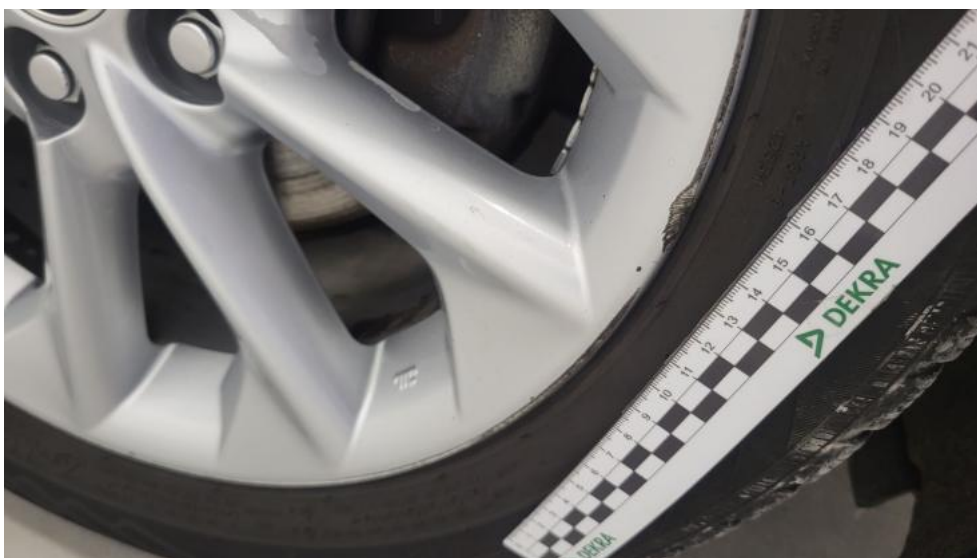
**Photo 48.**

Felga aluminiowa przednia P - Rysa/odprysk 1

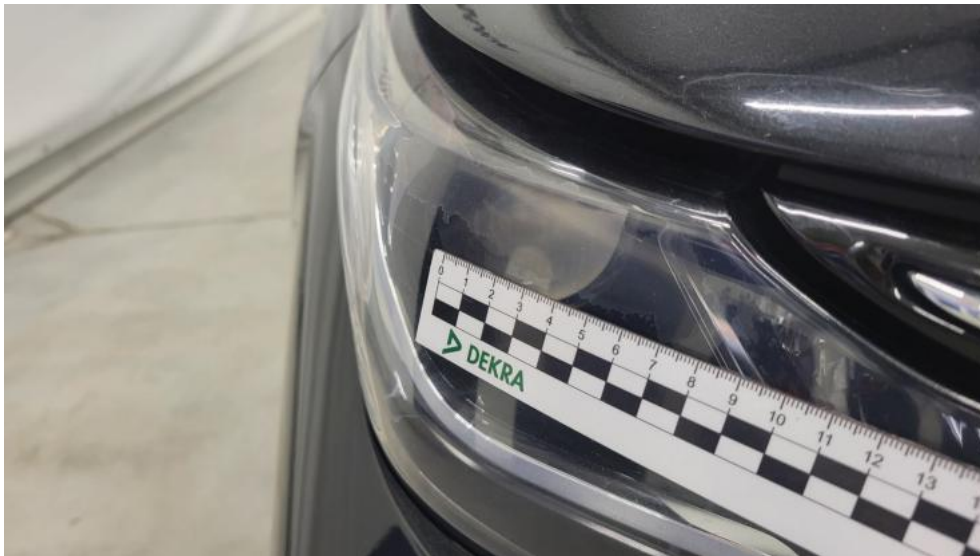
**Photo 49.**  
Reflektor P - Inne 1

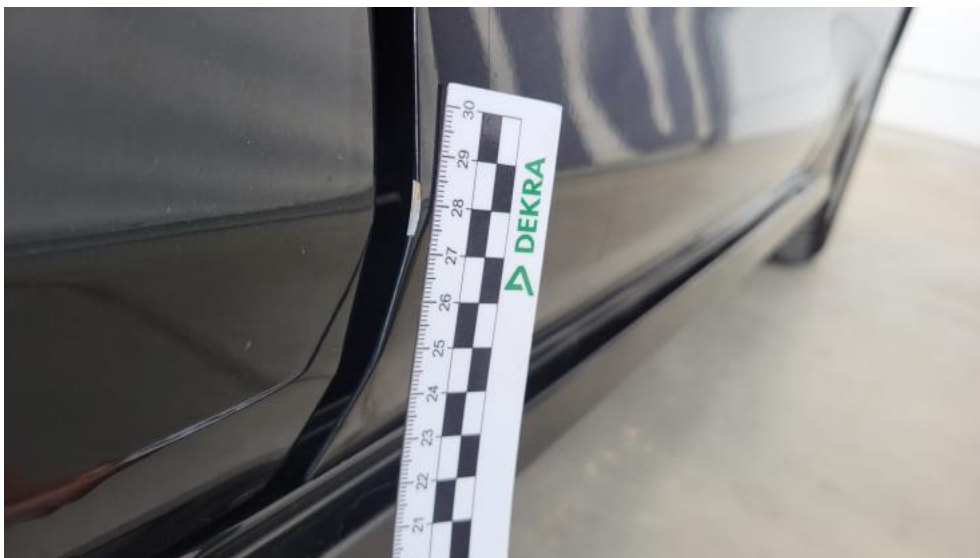
**Photo 50.**  
Drzwi przednie P - Rysa/odprysk 1

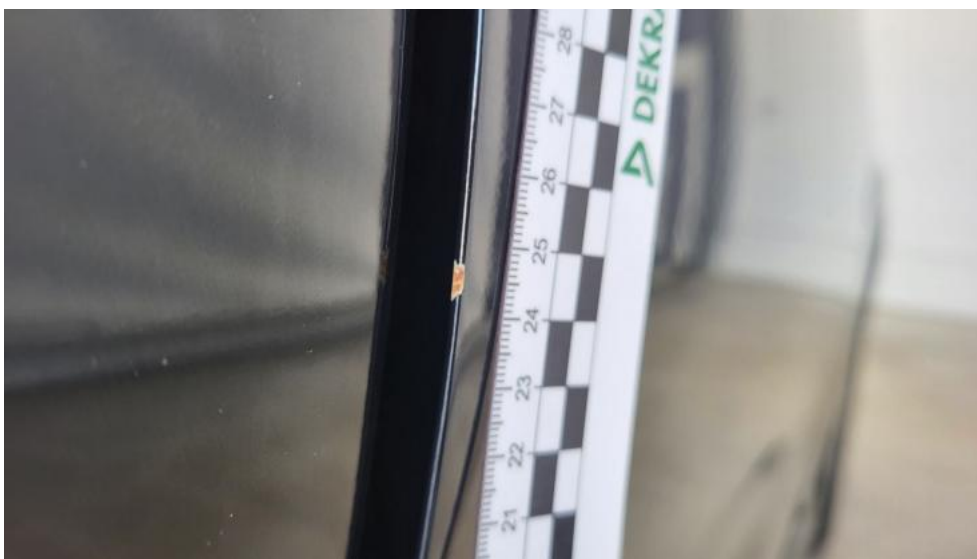
**Photo 53.**

Drzwi przednie P - Inne 2

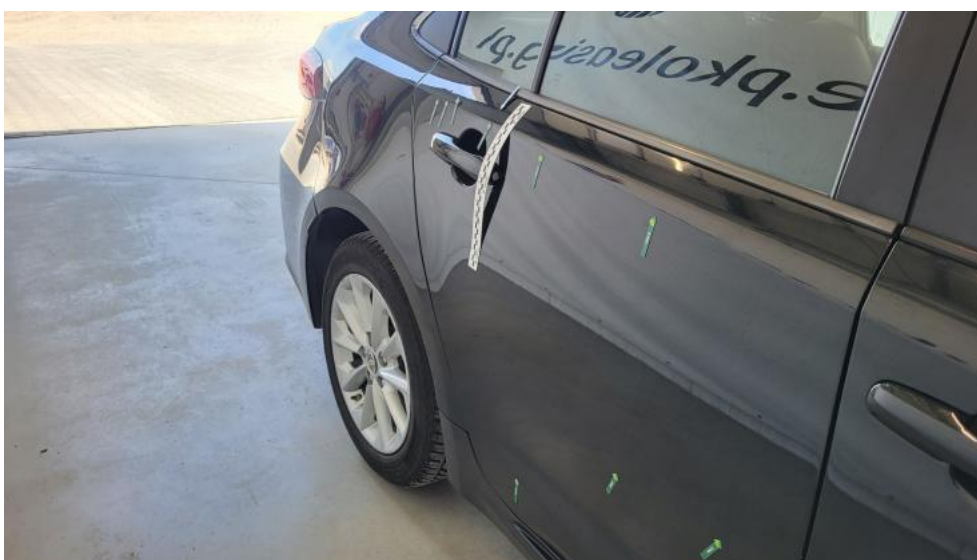
**Photo 54.**

Drzwi tylne P - Wgniecenie/odkształcenie 1

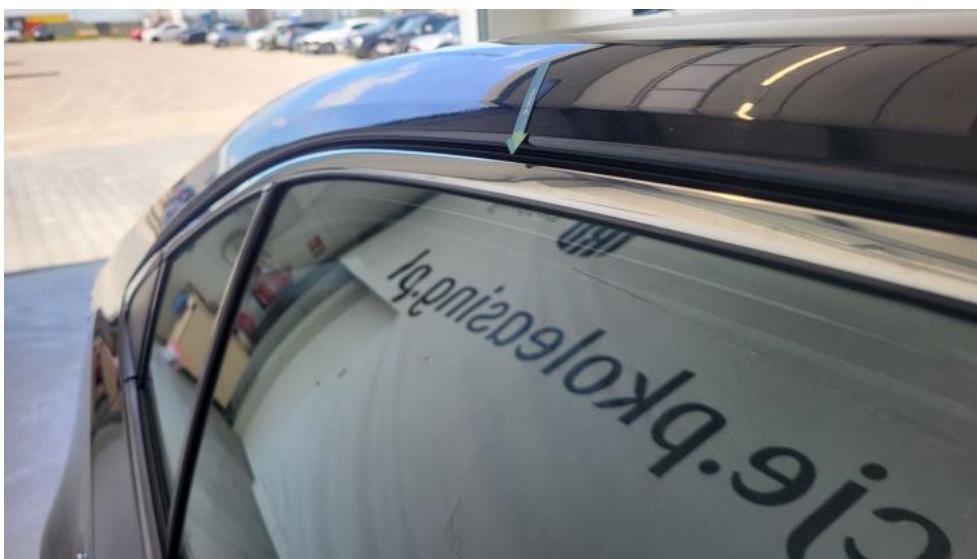
**Photo 57.**

Listwa drzwi tylnych P - Wgniecenie/odkształcenie 1

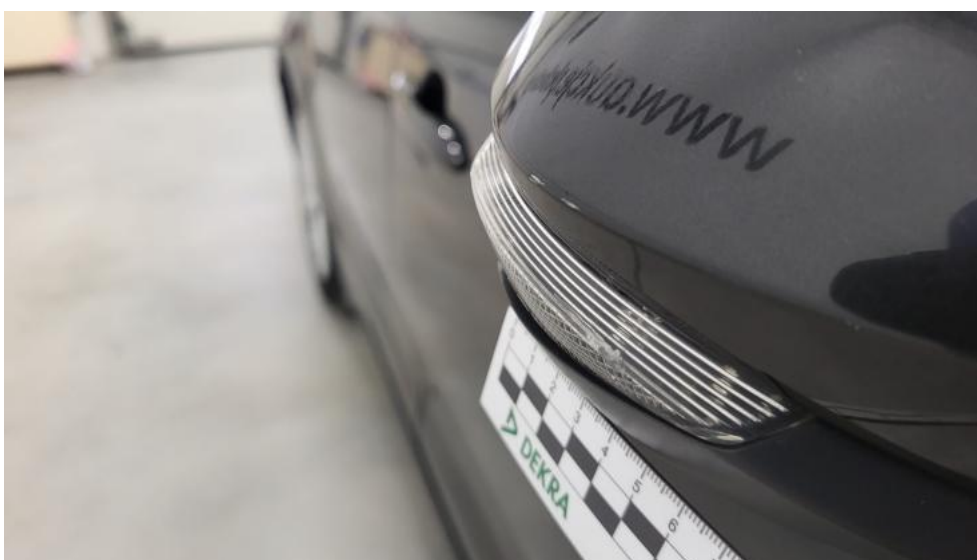
**Photo 58.**

Lusterko zew P - Rysa/odprysk 1

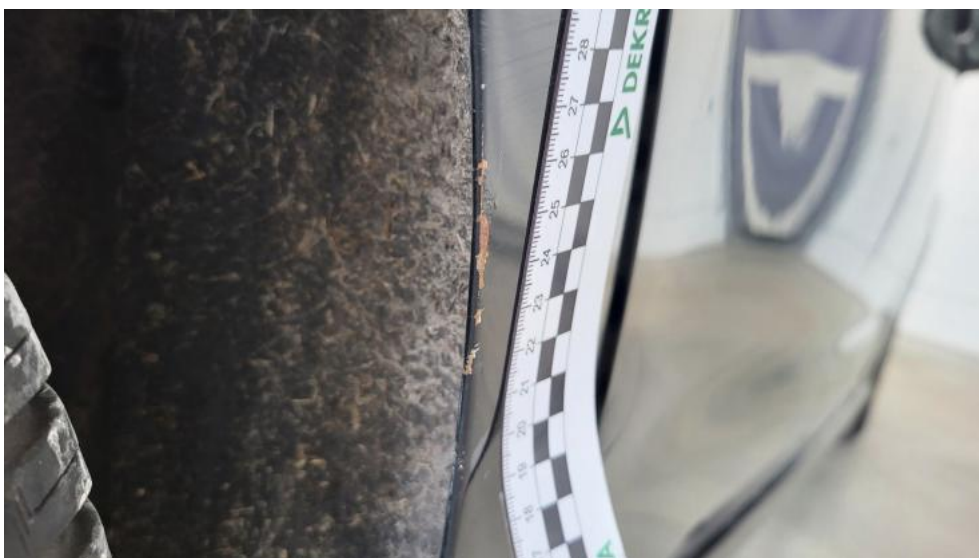
**Photo 62.**

Błotnik tylny P / Ściana boczna P - Inne 1

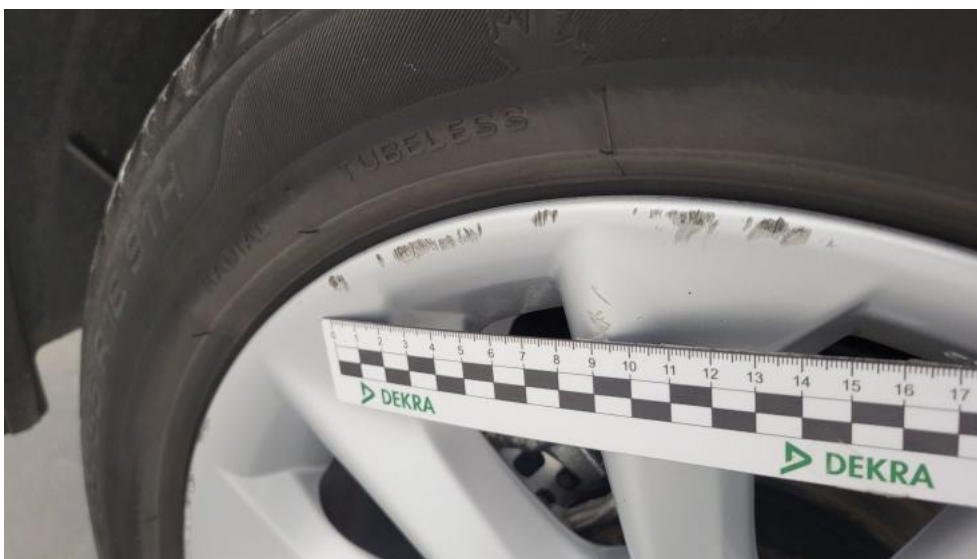
**Photo 63.**

Felga aluminiowa tylna P - Rysa/odprysk 1

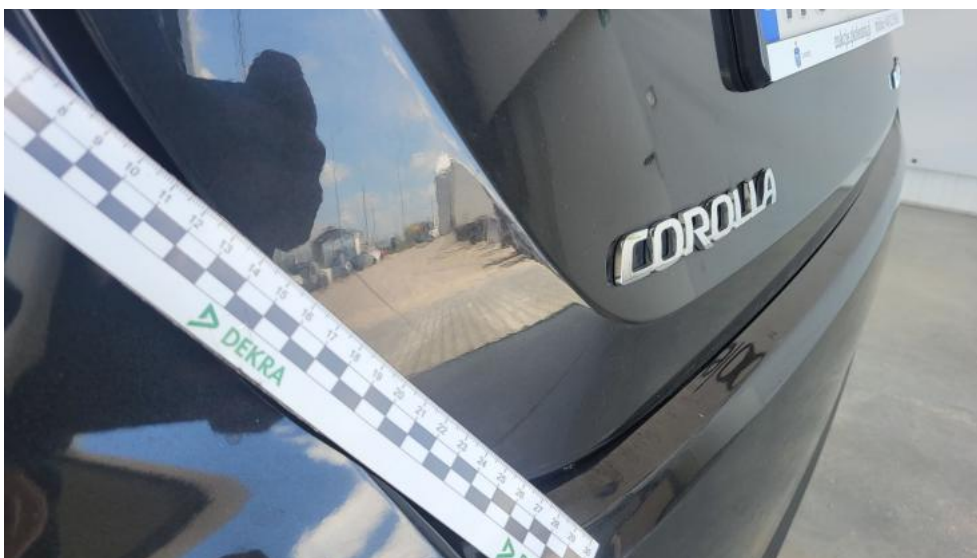
**Photo 64.**

Pokrywy bagażnika - Rysa/odprysk 1

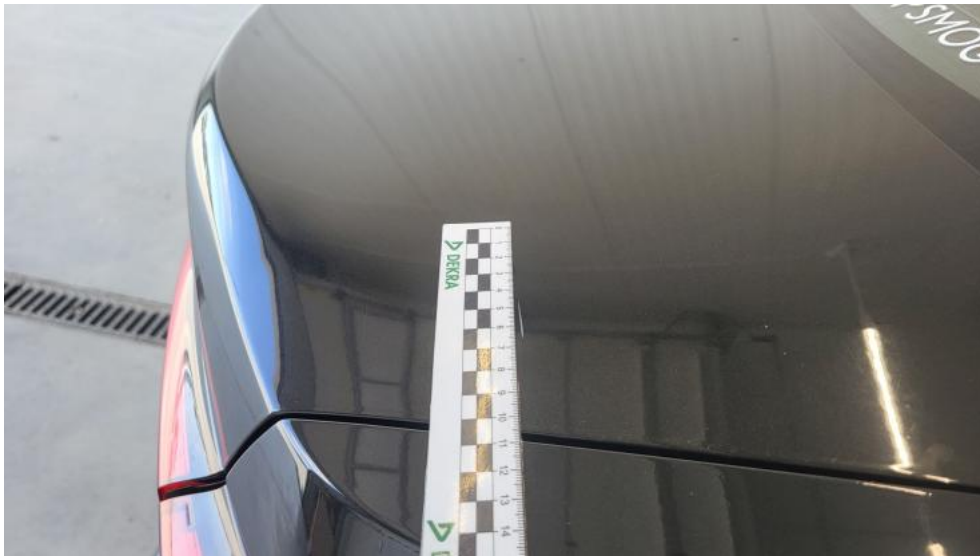
**Photo 65.**

Pokrywy bagażnika - Rysa/odprysk 2

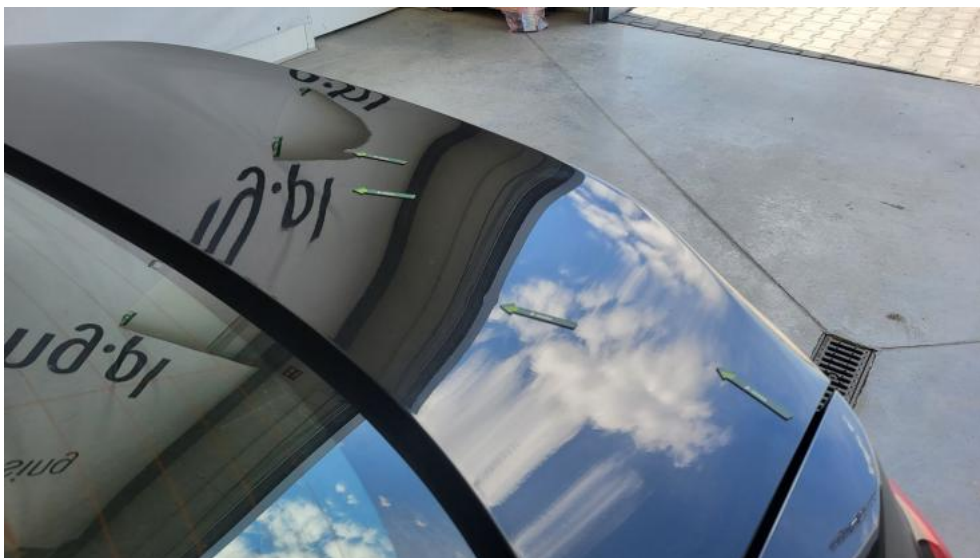
**Photo 66.**

Pokrywy bagażnika - Wgniecenie/odkształcenie 1

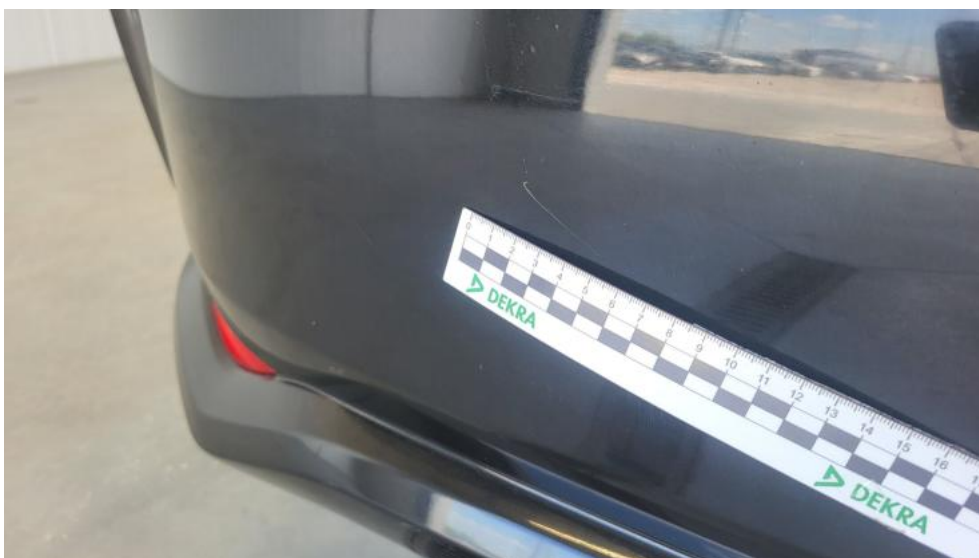
**Photo 68.**

Zderzak tylny - Rysa/odprysk 2

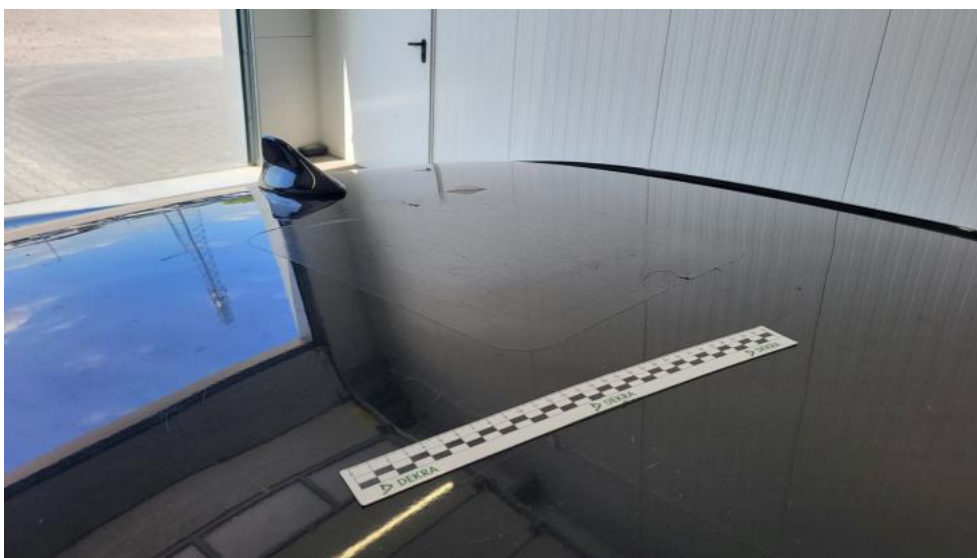
**Photo 72.**

Dach - Inne 1

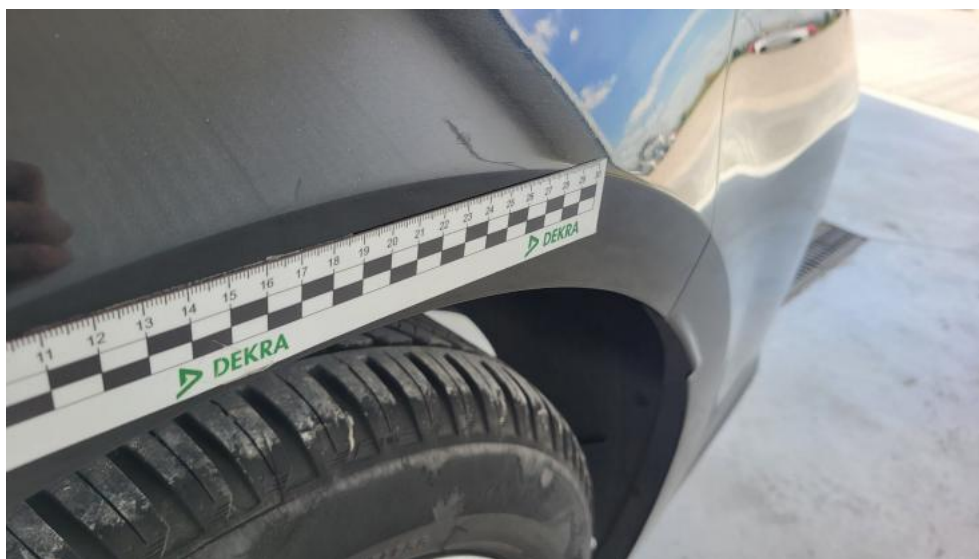
**Photo 73.**

Błotnik tylny L / Ściana boczna L - Rysa/odprysk 1

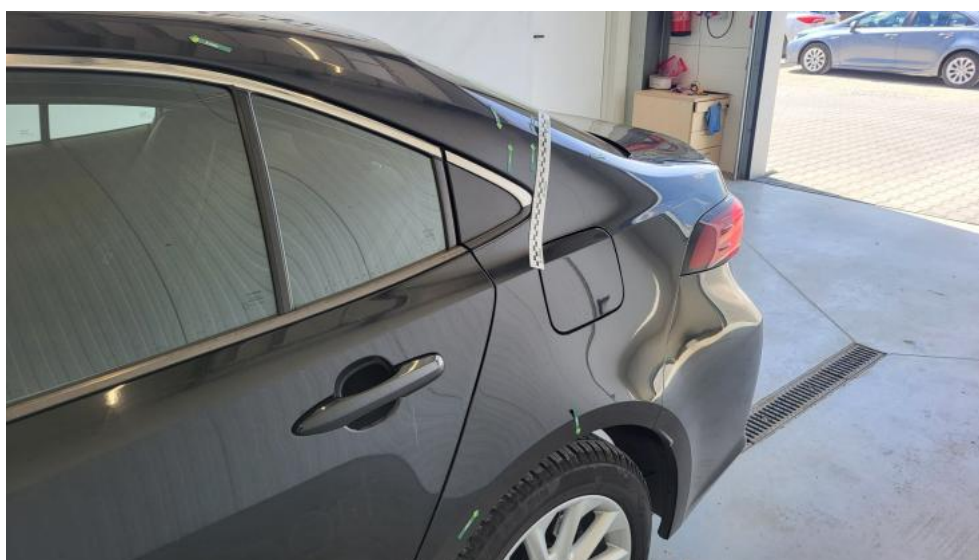
**Photo 74.**

Błotnik tylny L / Ściana boczna L - Wgniecenie/odkształcenie 1

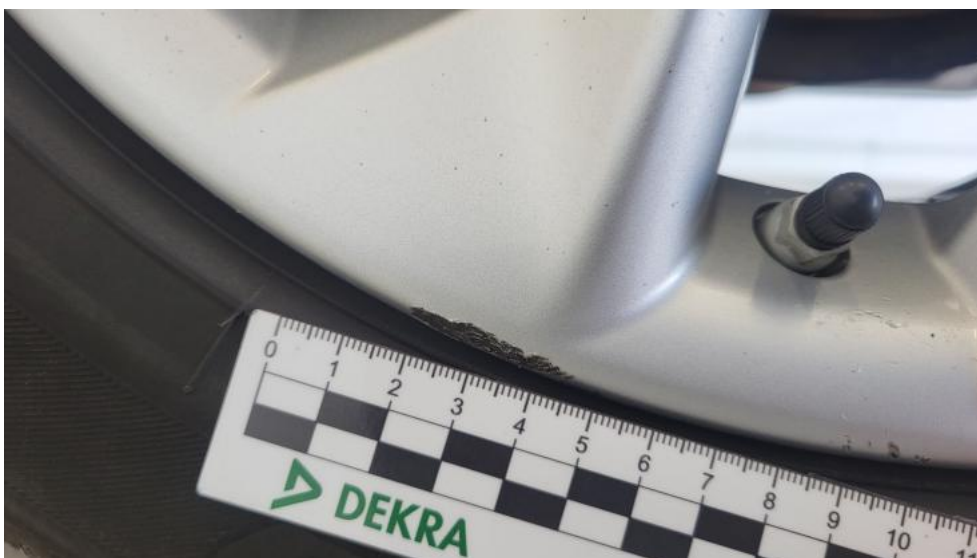
**Photo 76.**

Felga aluminiowa tylna L - Rysa/odprysk 1

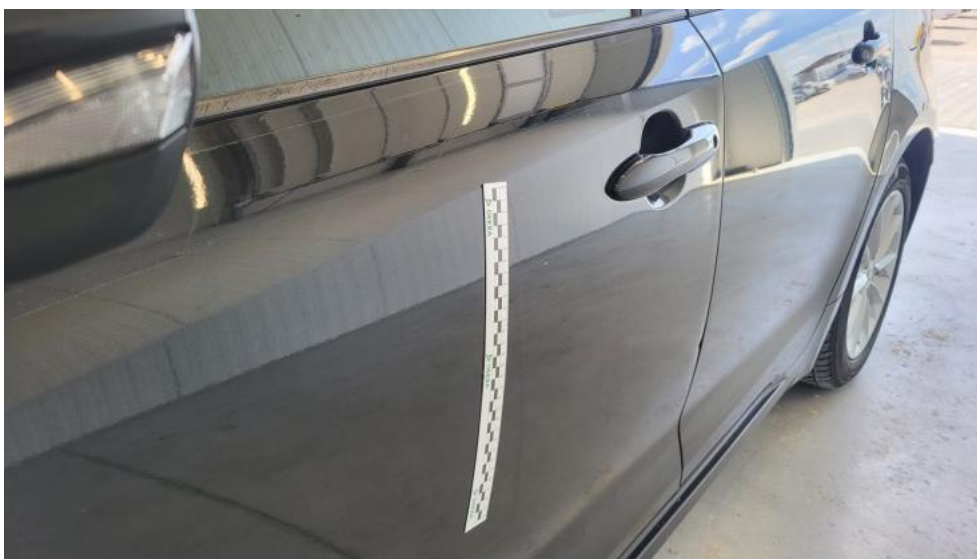
**Photo 79.**

Drzwi przed L - Inne 1

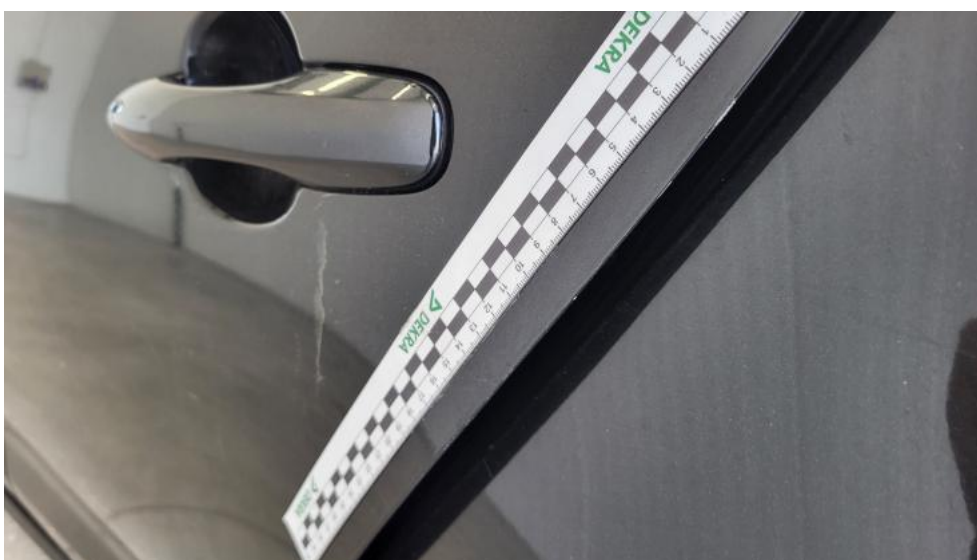
**Photo 80.**

Drzwi tylne L - Rysa/odprysk 1

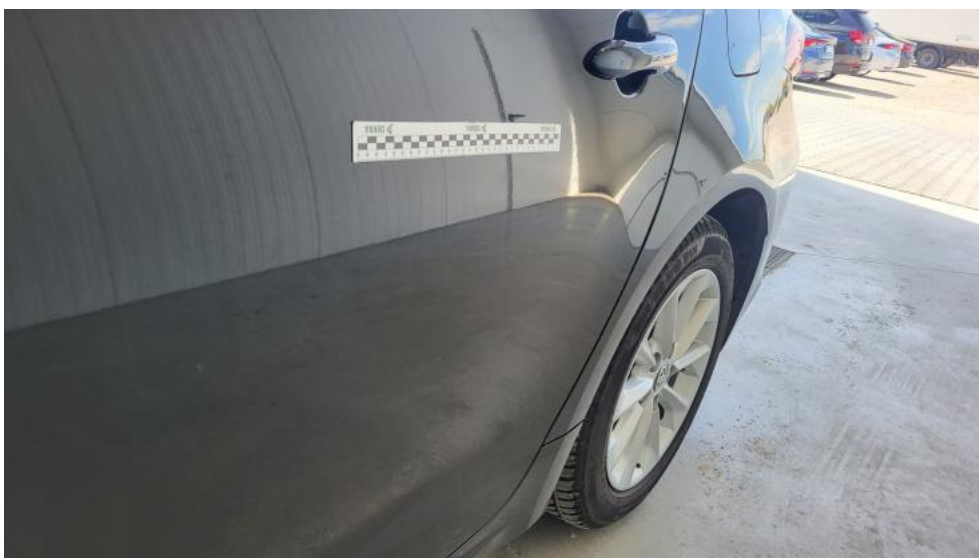
**Photo 82.**

Drzwi tylne L - Inne 1

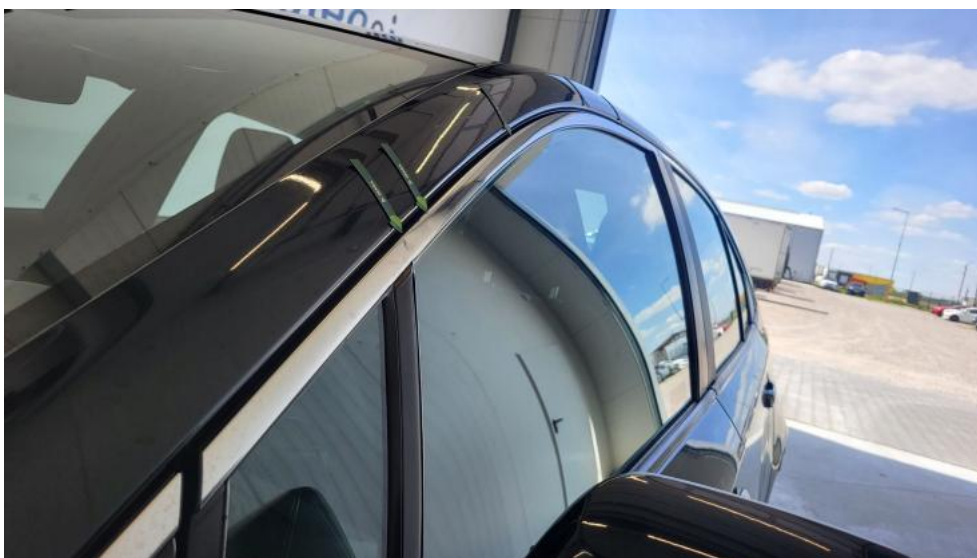
**Photo 84.**

Listwa drzwi przednich L - Wgniecenie/odkształcenie 1

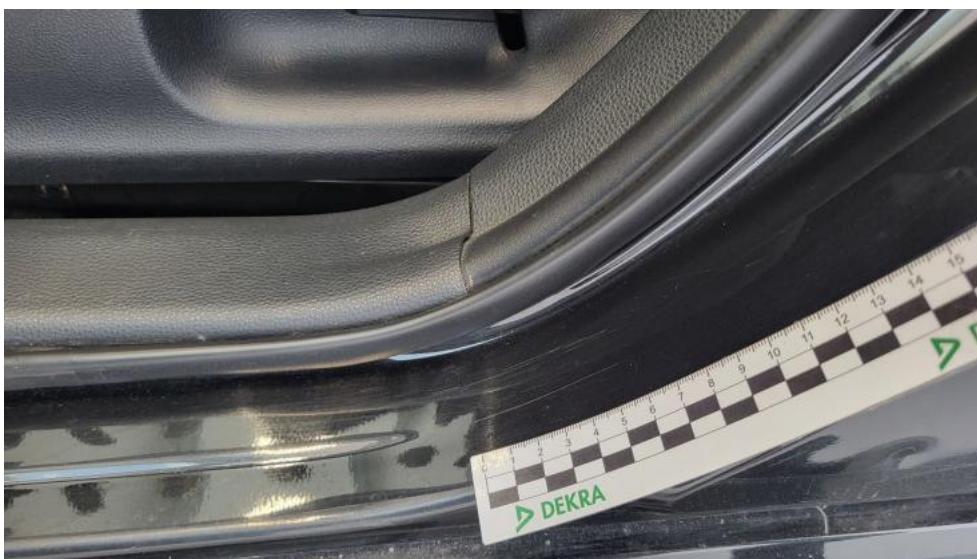
**Photo 85.**

Próg L - Rysa/odprysk 1

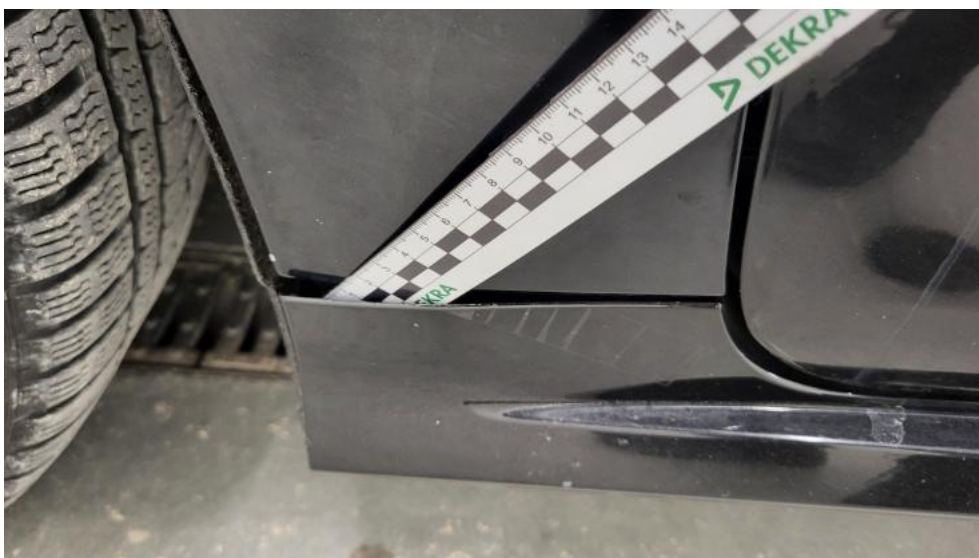
**Photo 88.**

Próg L - Inne 1

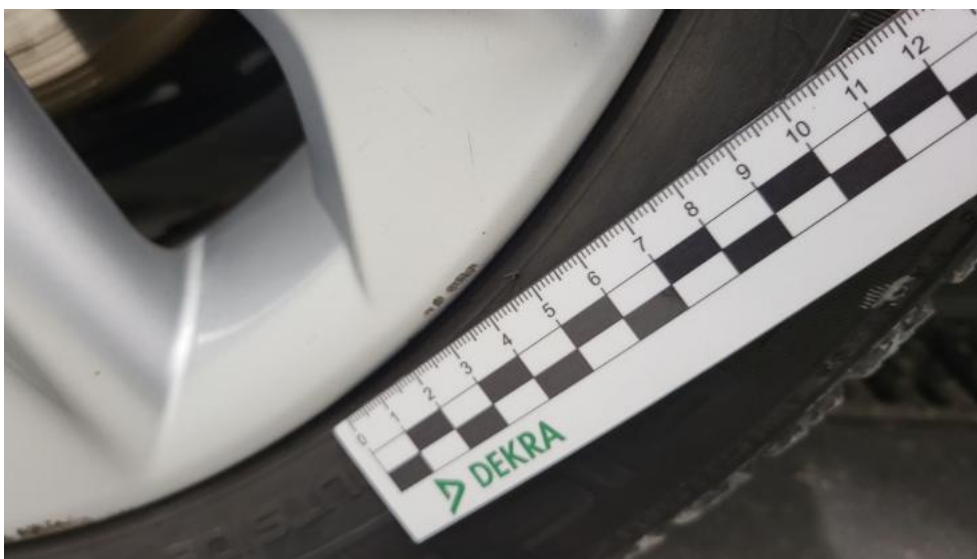
**Photo 91.**

Felga Aluminiowa przednia L - Rysa/odprysk 1

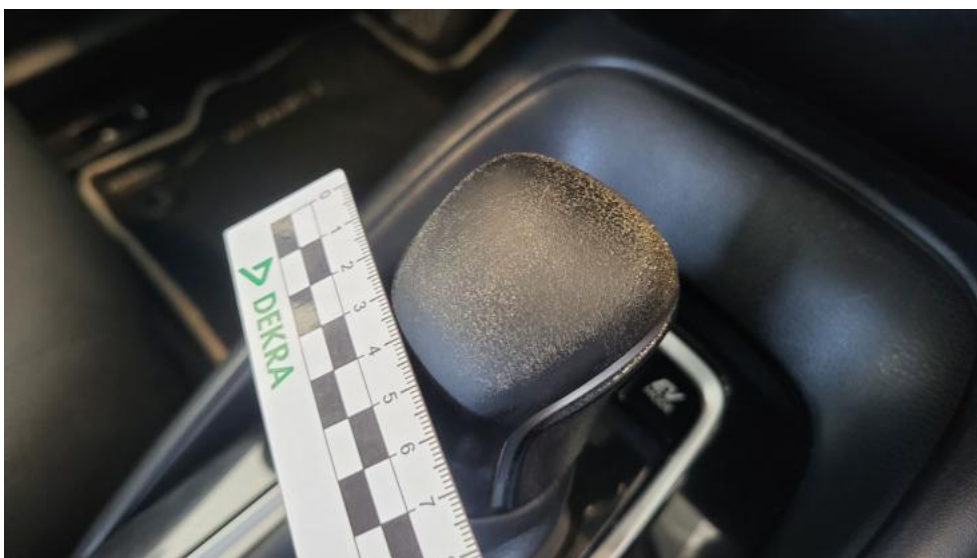
**Photo 92.**

Gałka dźwigni zmiany biegów - Inne 1

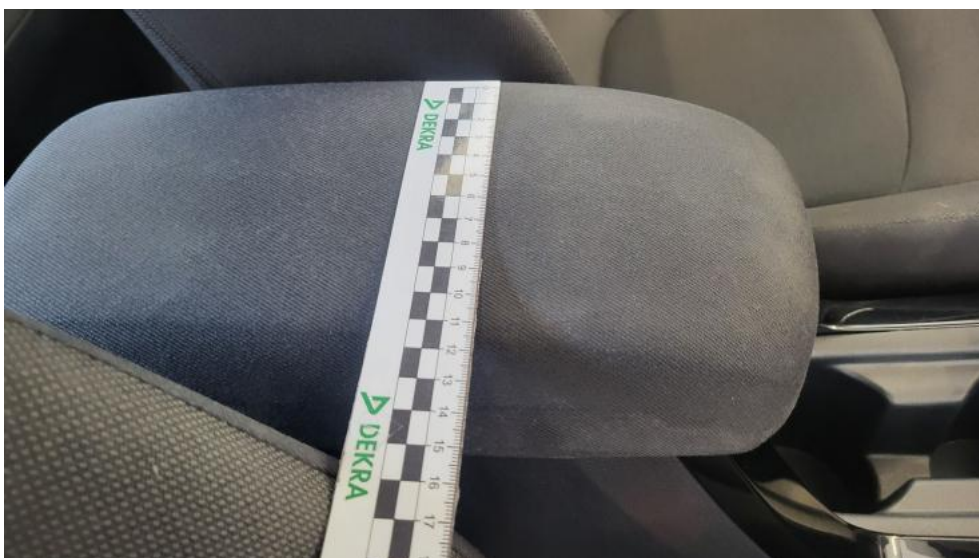
**Photo 94.**

Podłokietnik środkowy przedni - Inne 1

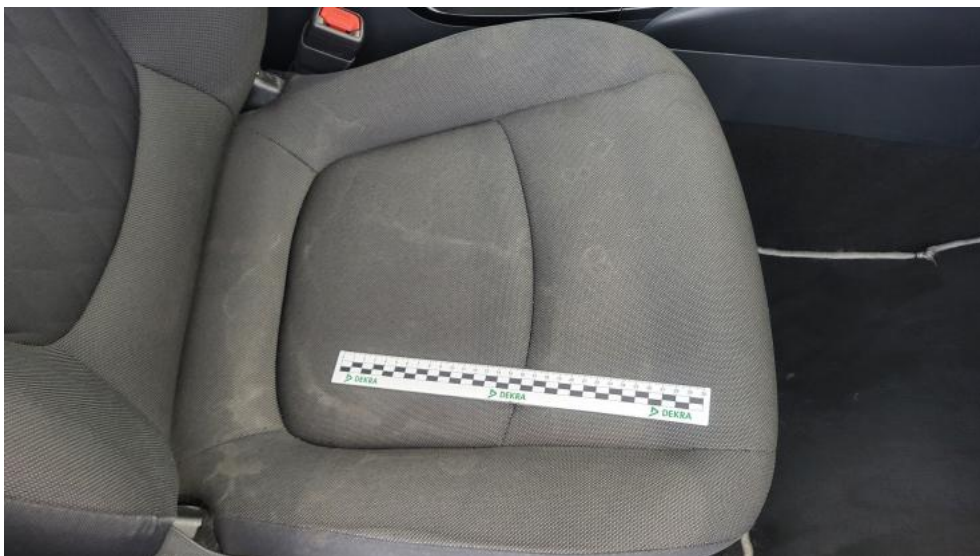
**Photo 96.**

Fotel prz. praw. - Inne 1

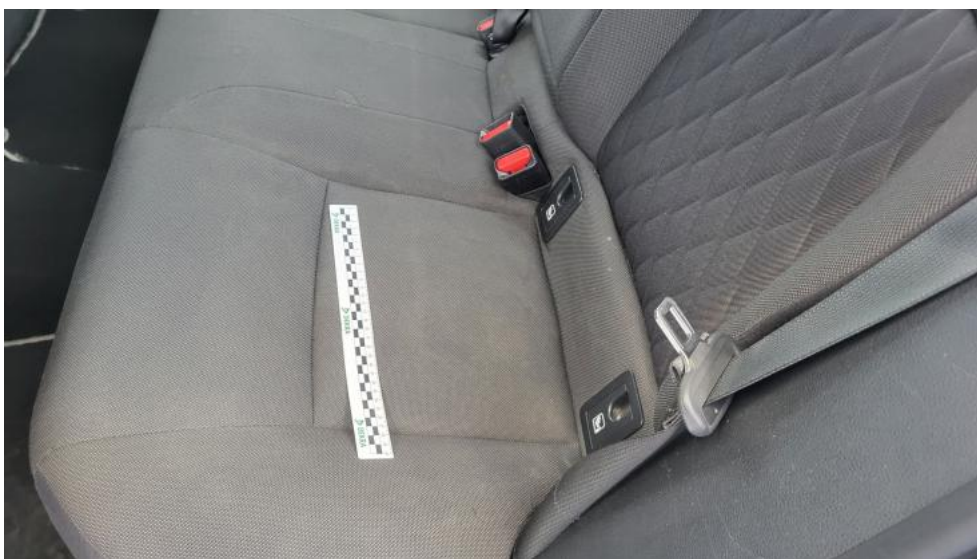
**Photo 97.**  
Kanapa tyl. - Inne 1

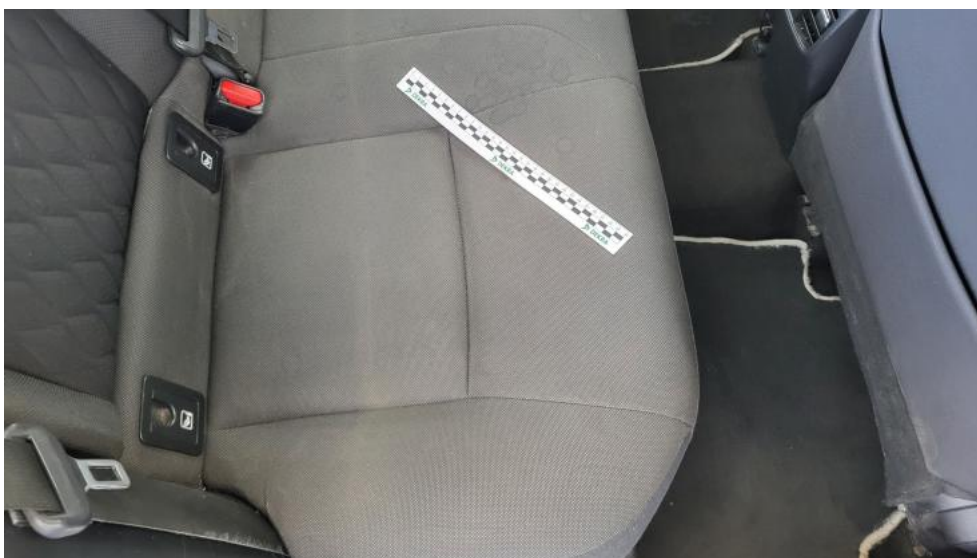
**Photo 98.**  
Kanapa tyl. - Inne 2

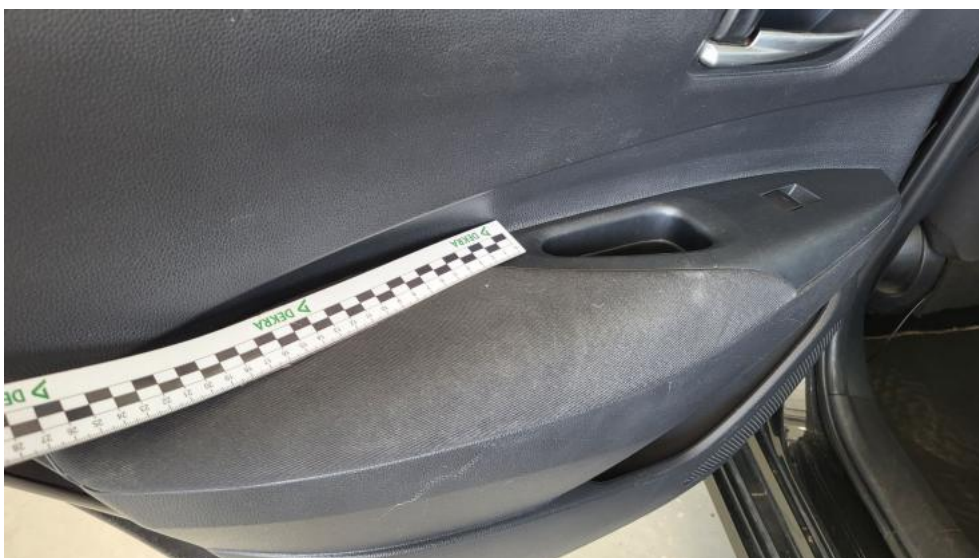
**Photo 100.**

Tapicerka drzwi tylnych L - Inne 1

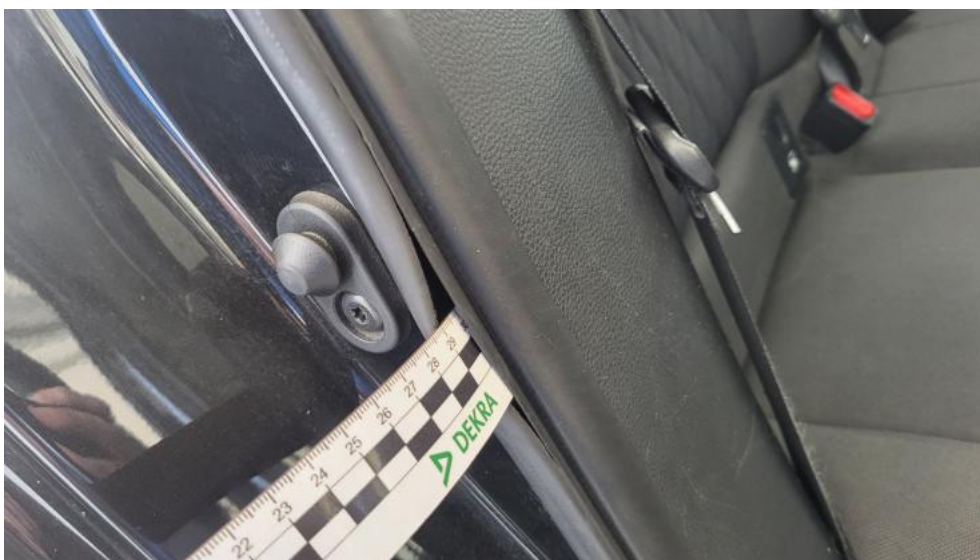
**Photo 102.**

Uszczelka drzwi tylnych P - Pęknięcie/rozerwanie 1

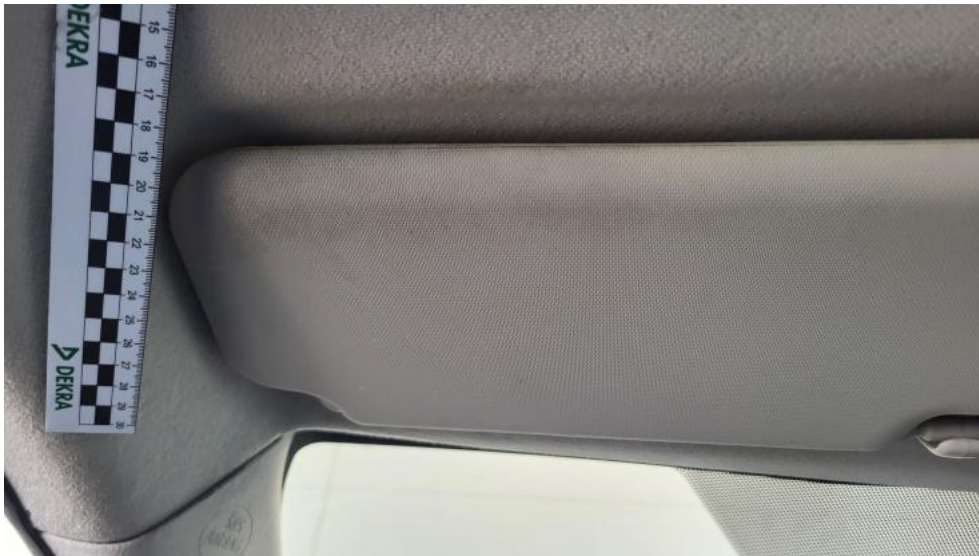
**Photo 103.**

Osłona p/słoneczna lewa - Inne 1
