DEKRA's commission No. : PKOL(W)/LODZ/32881/25/05/07  
commission/ damage No. : 21/023151  
Date of commission: 07-05-2025

| Manufacturer | TOYOTA |
| Model | Corolla Sedan 18-22 |
| Registration /record No. | WOT82510 |

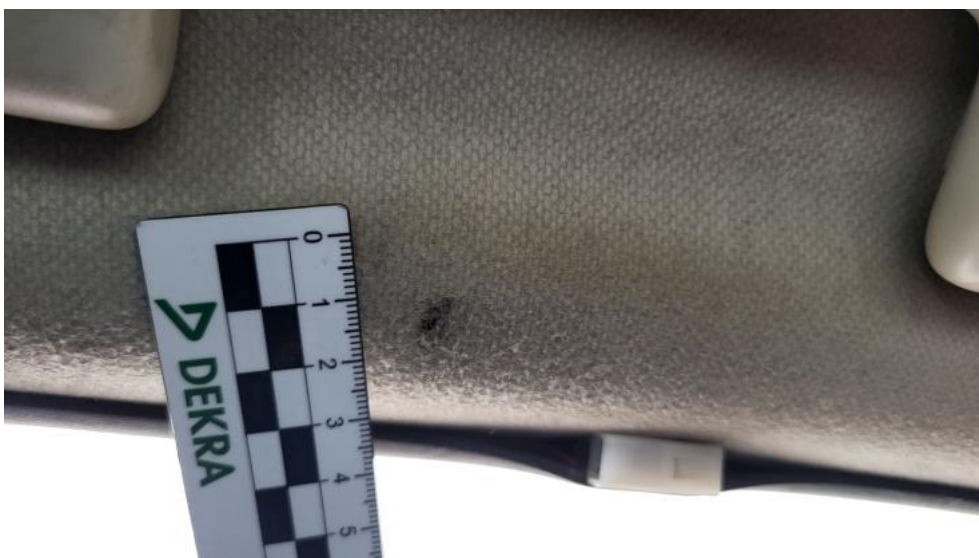
**Photo 104.**

Podsufitka - Inne 1

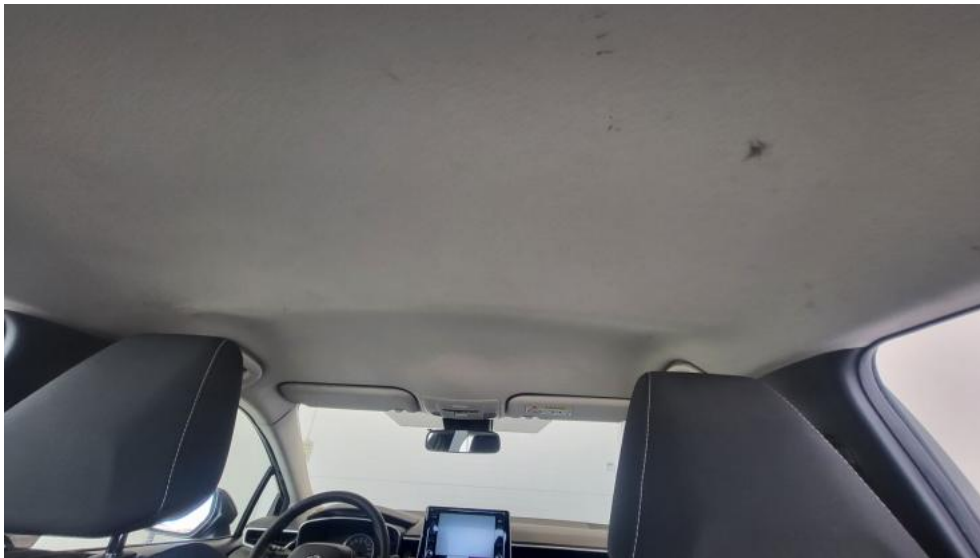
**Photo 105.**

Podsufitka - Inne 2
