DEKRA's commission No. : PKOL(W)/LODZ/25808/25/04/08  
commission/ damage No. : Futura  
Date of commission: 08-04-2025

| Manufacturer | VOLKSWAGEN |
| Model | Passat Variant [B8] 19-24 |
| Registration /record No. | WD2652S |

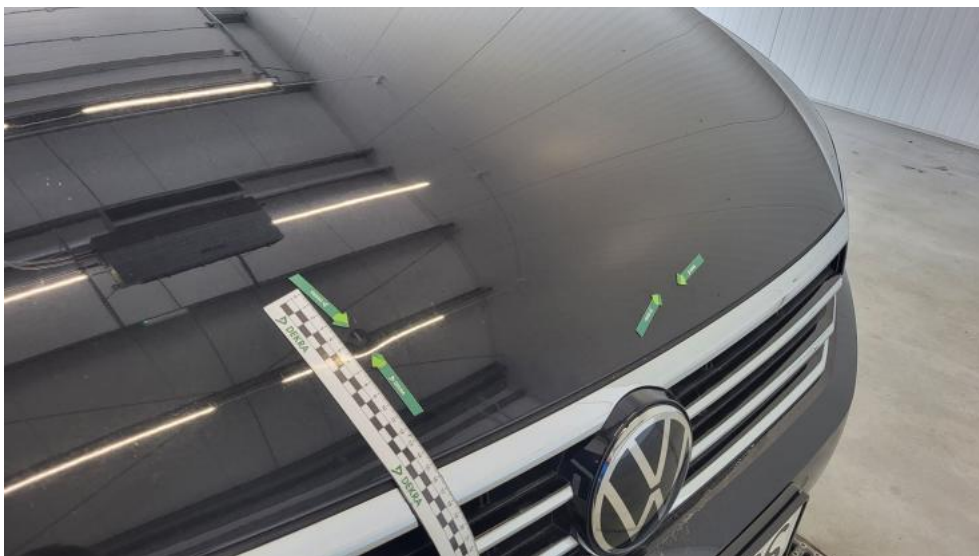
**Photo 38.**

Pokrywa komory silnika - Wgniecenie/odkształcenie 1

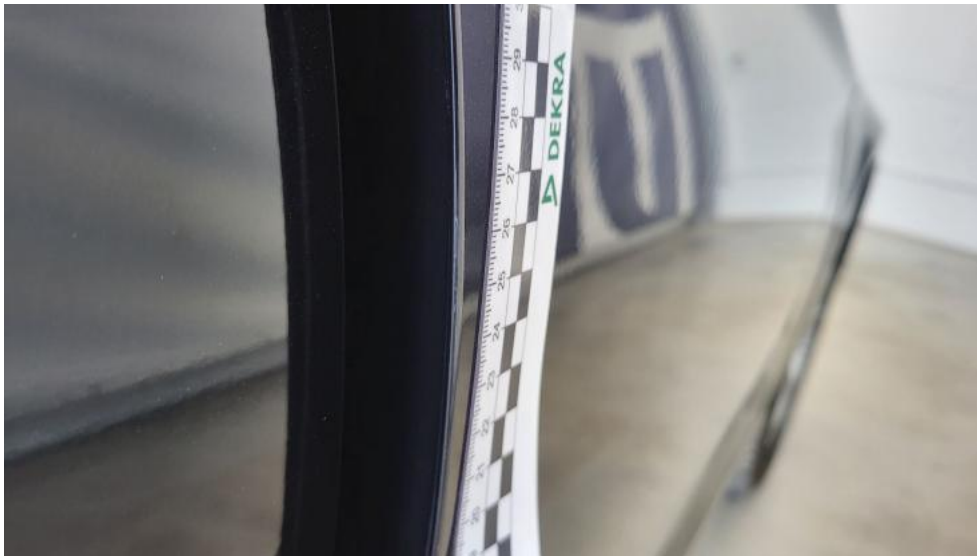
**Photo 39.**

Drzwi przednie P - Rysa/odprysk 1

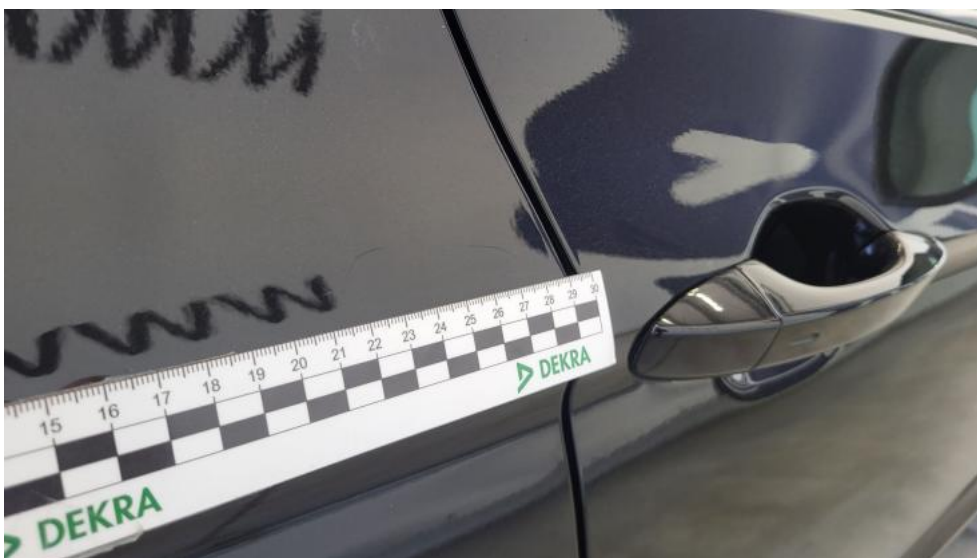
**Photo 40.**

Drzwi tylne P - Rysa/odprysk 1

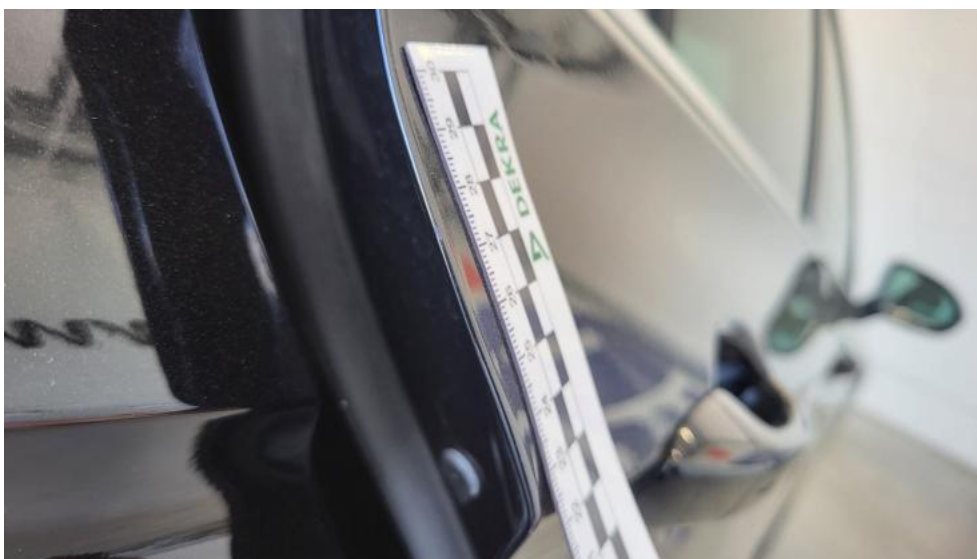
**Photo 41.**

Drzwi tylne P - Rysa/odprysk 2

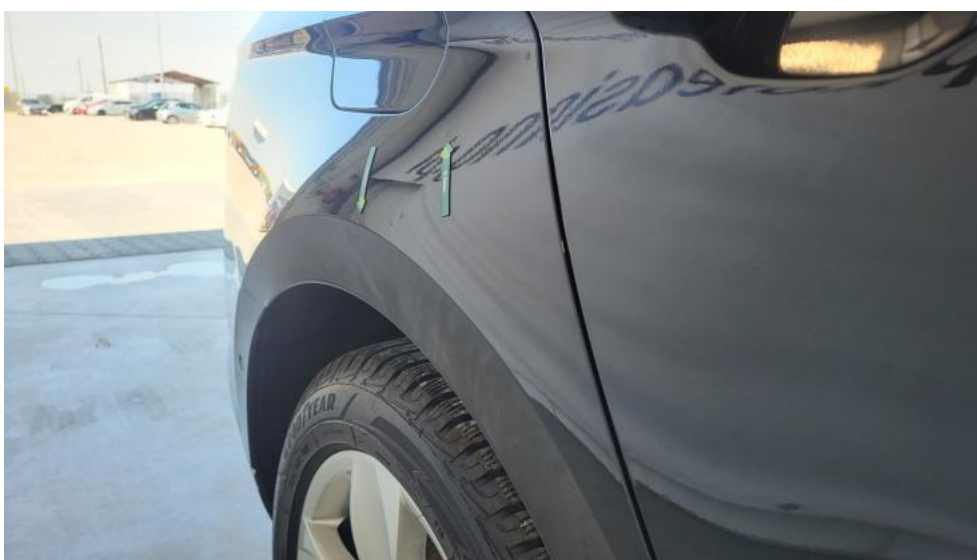
**Photo 42.**

Łotnik tylny P / Ściana boczna P - Wgniecenie/odkształcenie 1

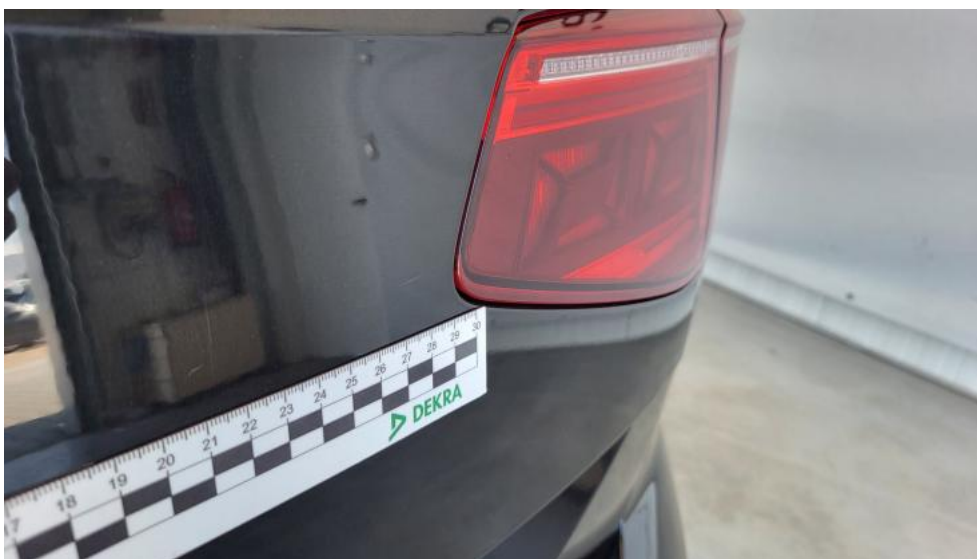
**Photo 43.**

Pokrywy bagażnika - Rysa/odprysk 1

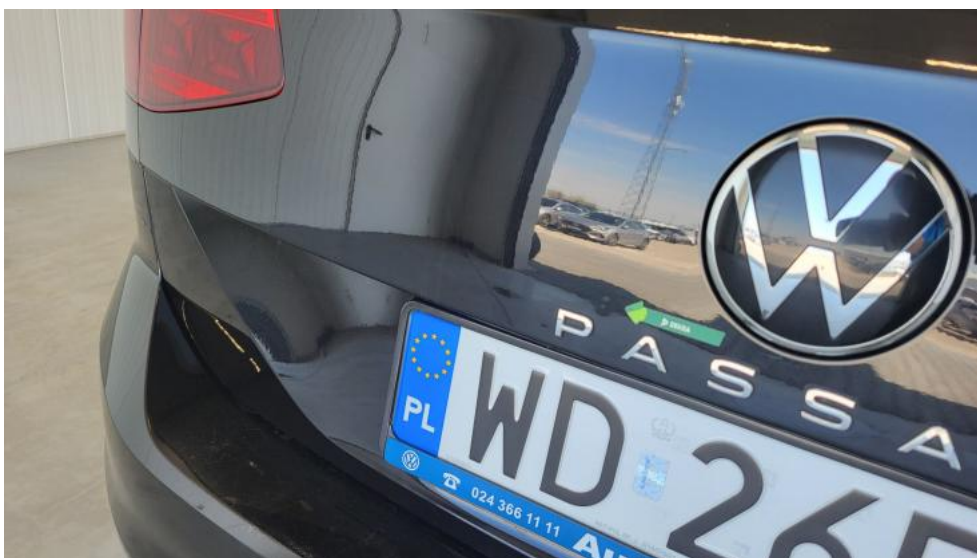
**Photo 44.**

Pokrywy bagażnika - Wgniecenie/odkształcenie 1

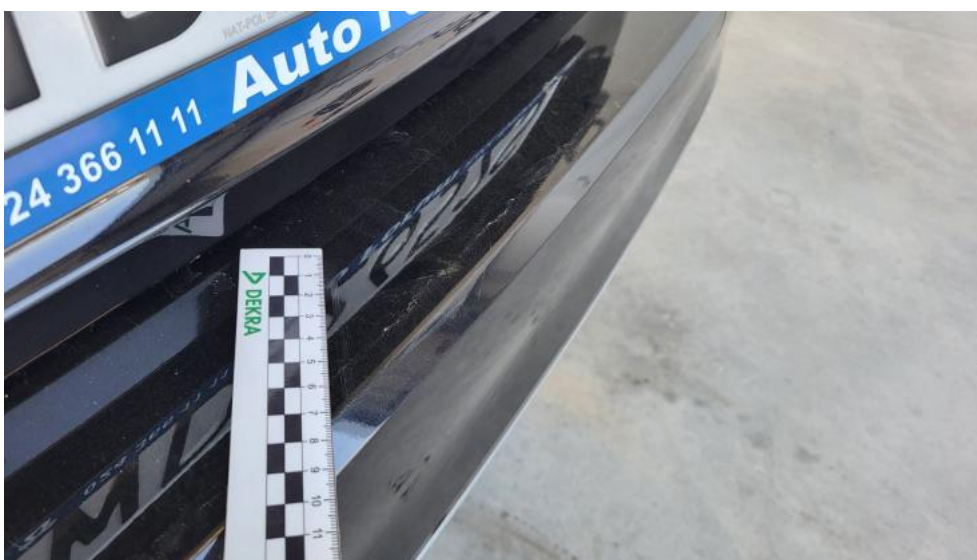
**Photo 46.**

Zderzak tylny - Rysa/odprysk 2

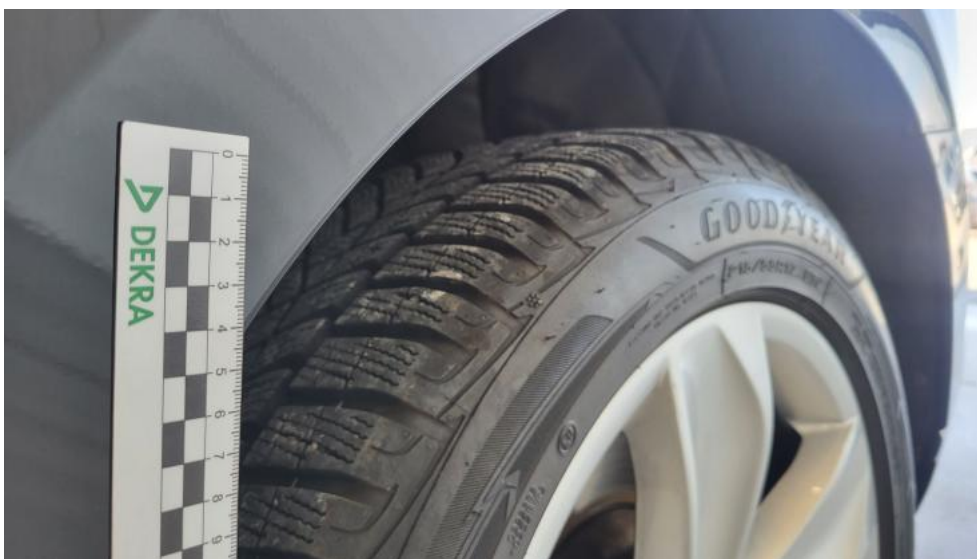
**Photo 47.**

Błotnik tylny L / Ściana boczna L - Rysa/odprysk 1

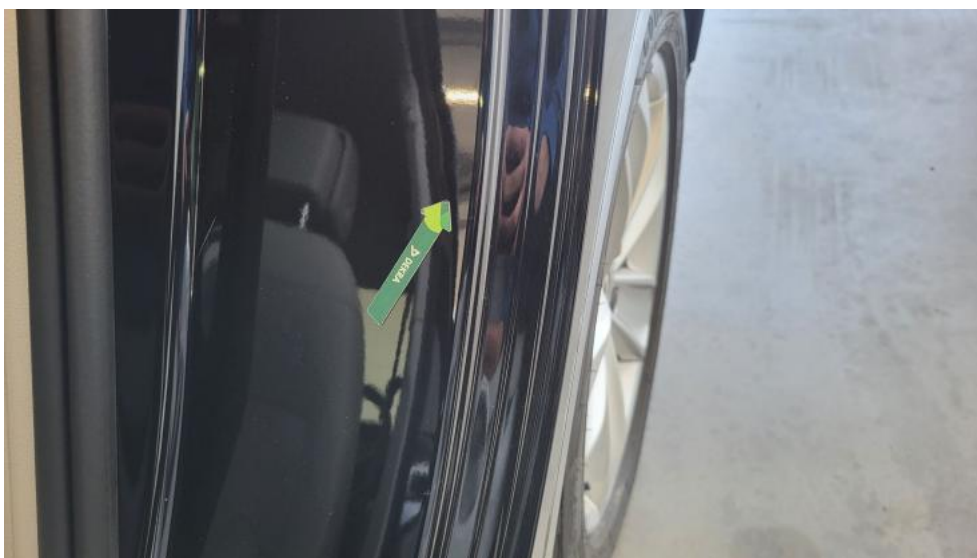
**Photo 48.**

Błotnik tylny L / Ściana boczna L - Wgniecenie/odkształcenie 1

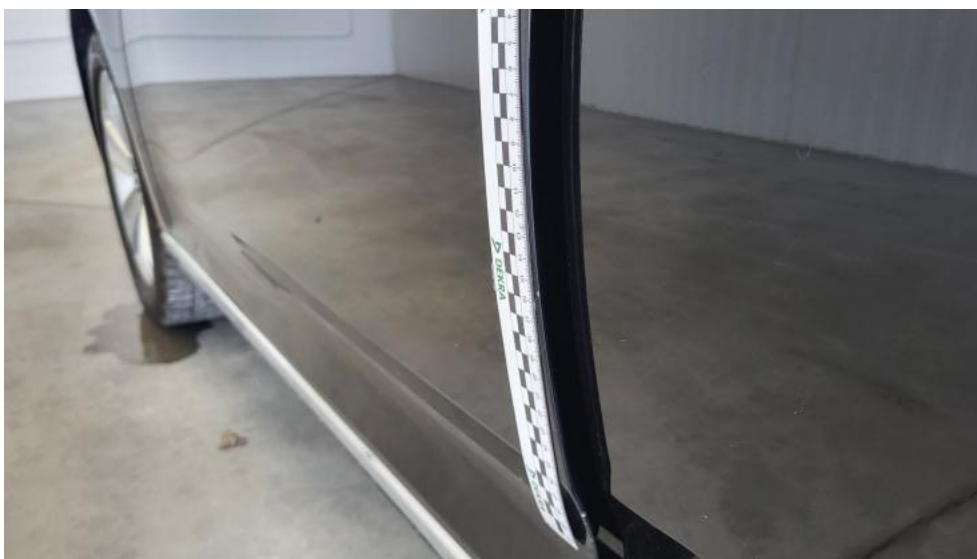
**Photo 49.**

Drzwi przed L - Rysa/odprysk 1

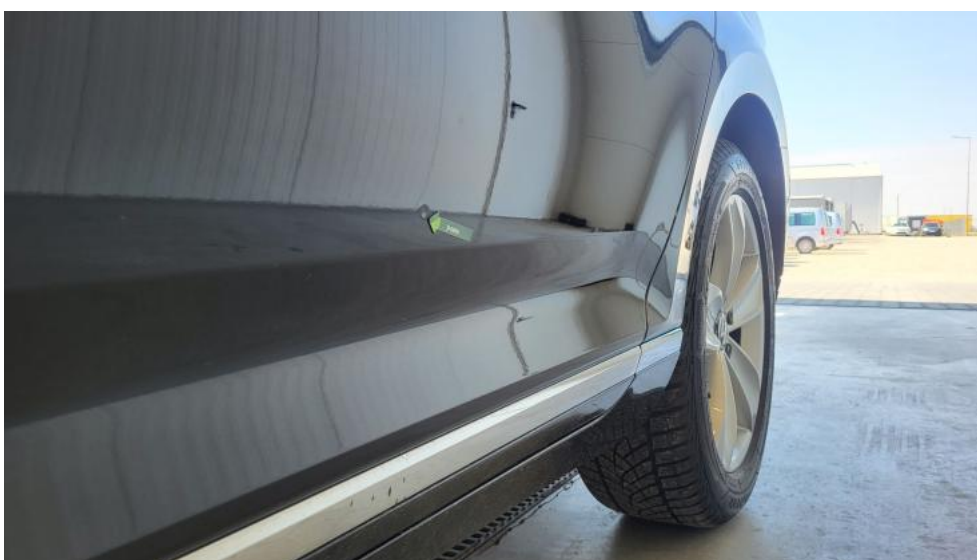
**Photo 50.**

Drzwi tylne L - Wgniecenie/odkształcenie 1

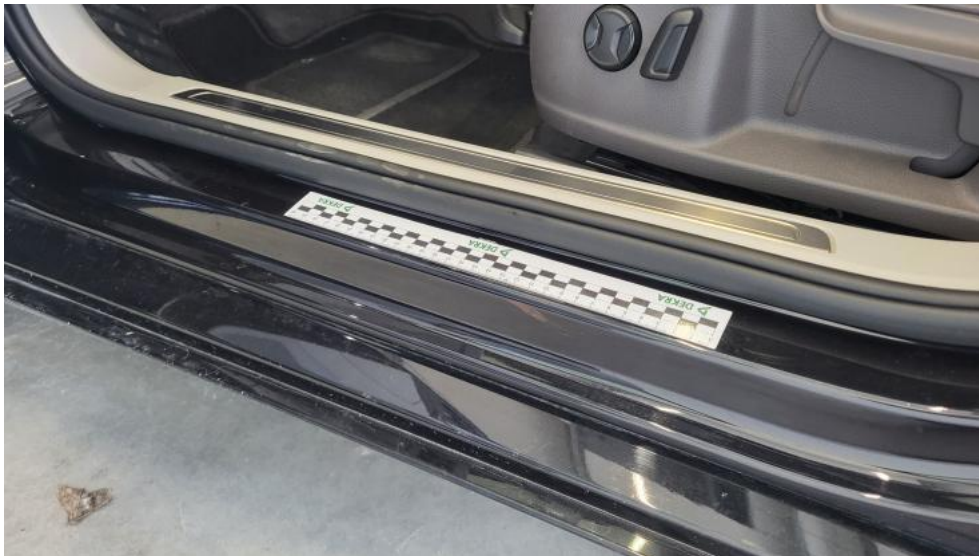
**Photo 51.**

Próg L - Rysa/odprysk 1

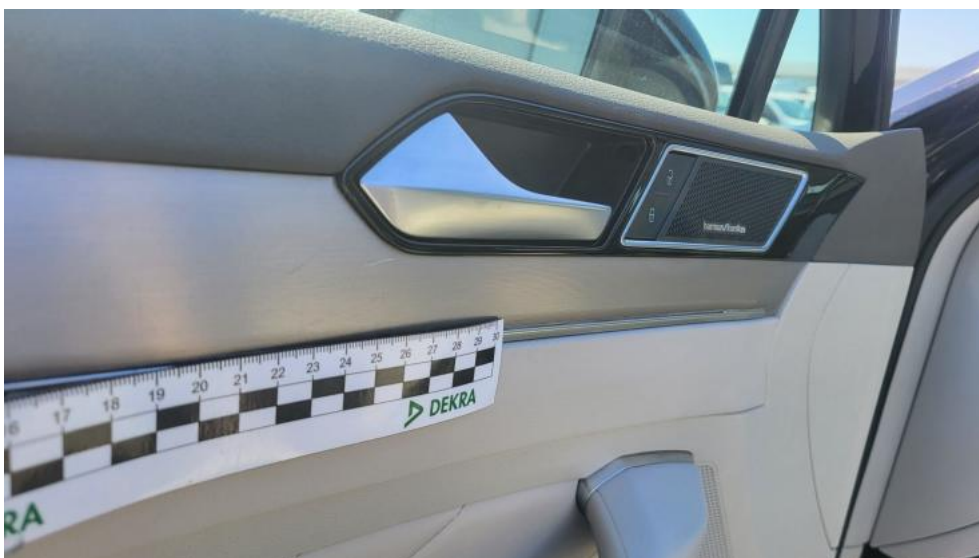
**Photo 52.**

Tapicerka drzwi przednich L - Rysa/odprysk 1
