DEKRA's commission No. : PKOL(W)/LODZ/26418/25/04/10  
commission/ damage No. : Futura  
Date of commission: 10-04-2025

| Manufacturer | PEUGEOT |
| Model | 308 SW 17-21 |
| Registration /record No. | WD9726P |

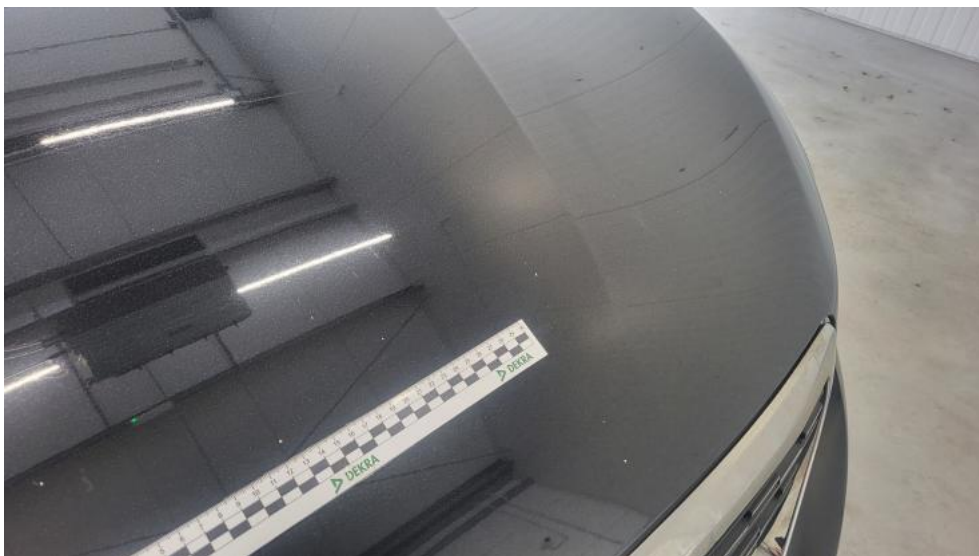
**Photo 40.**

Pokrywa komory silnika - Rysa/odprysk 1

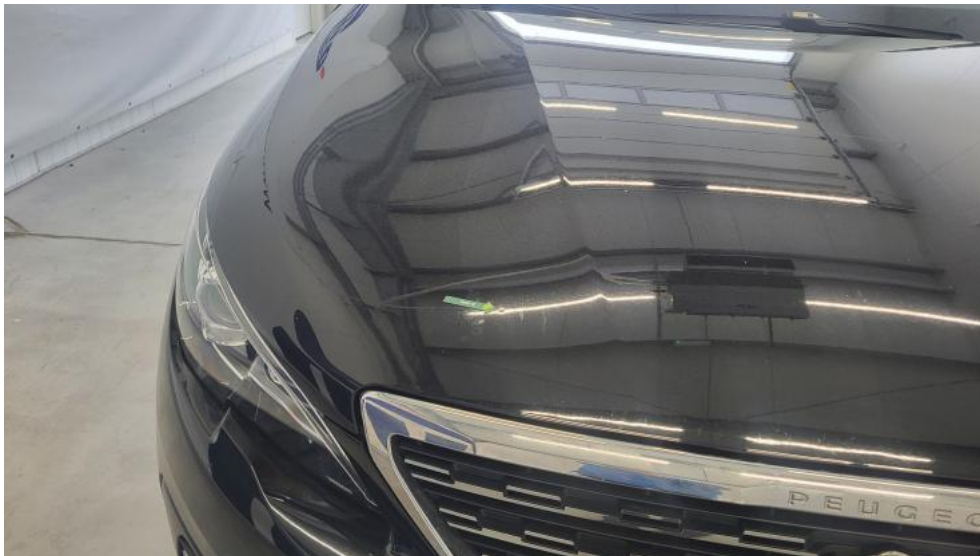
**Photo 41.**

Pokrywa komory silnika - Wgniecenie/odkształcenie 1

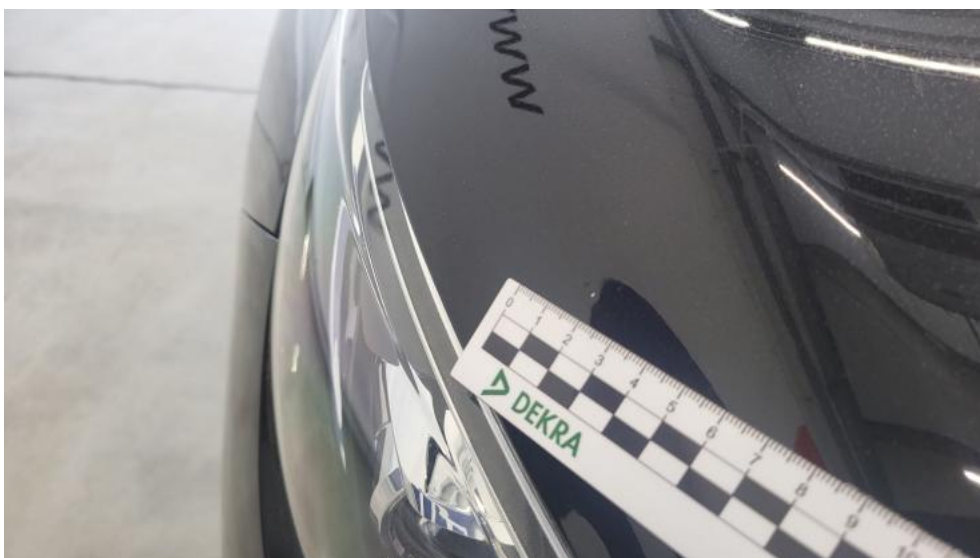
**Photo 42.**

Pokrywa komory silnika - Wgniecenie/odkształcenie 2

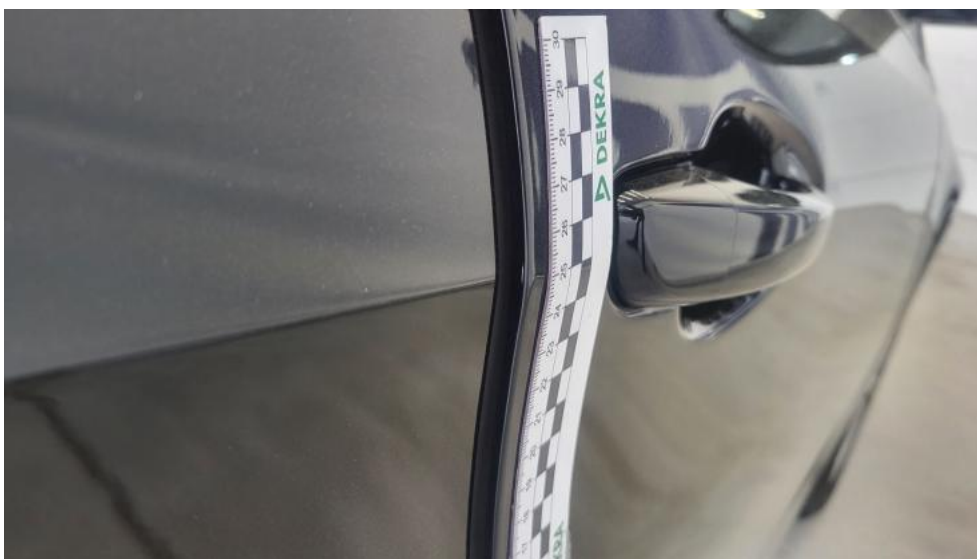
**Photo 43.**

Drzwi przednie P - Rysa/odprysk 1

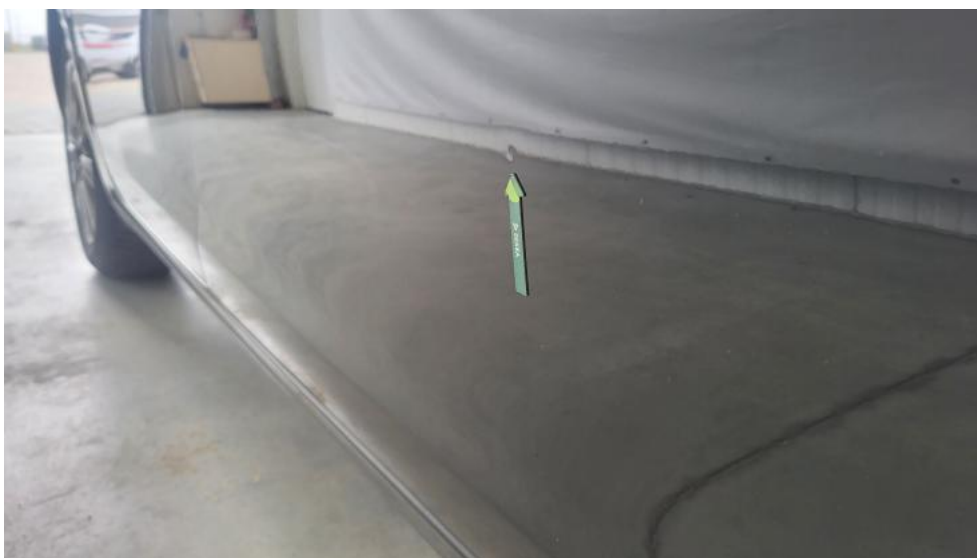
**Photo 44.**

Drzwi przednie P - Wgniecenie/odkształcenie 1

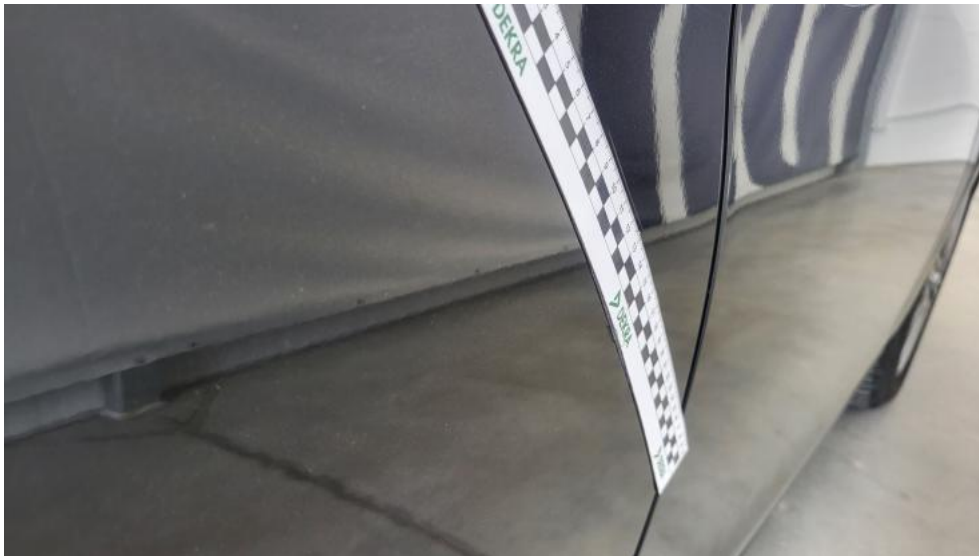
**Photo 45.**

Drzwi tylne P - Rysa/odprysk 1

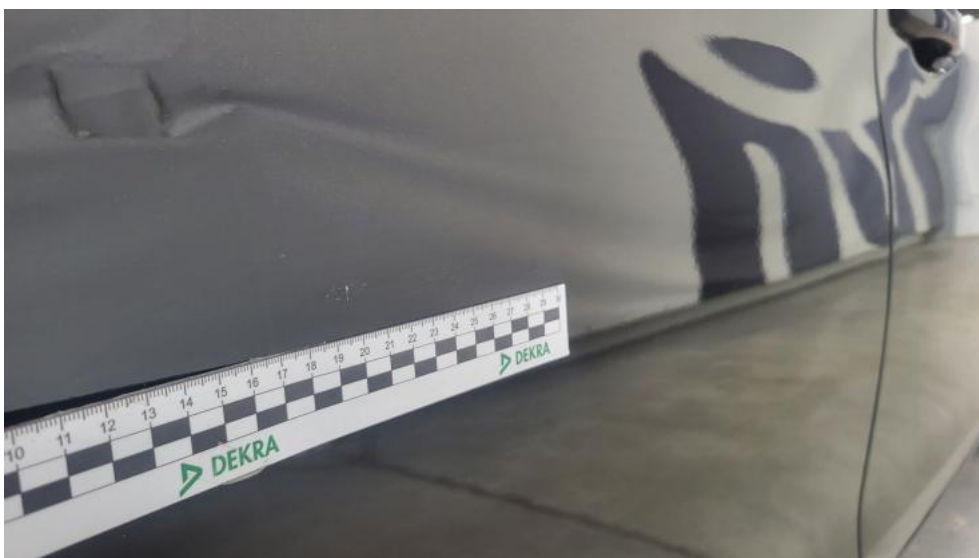
**Photo 46.**

Drzwi tylne P - Rysa/odprysk 2

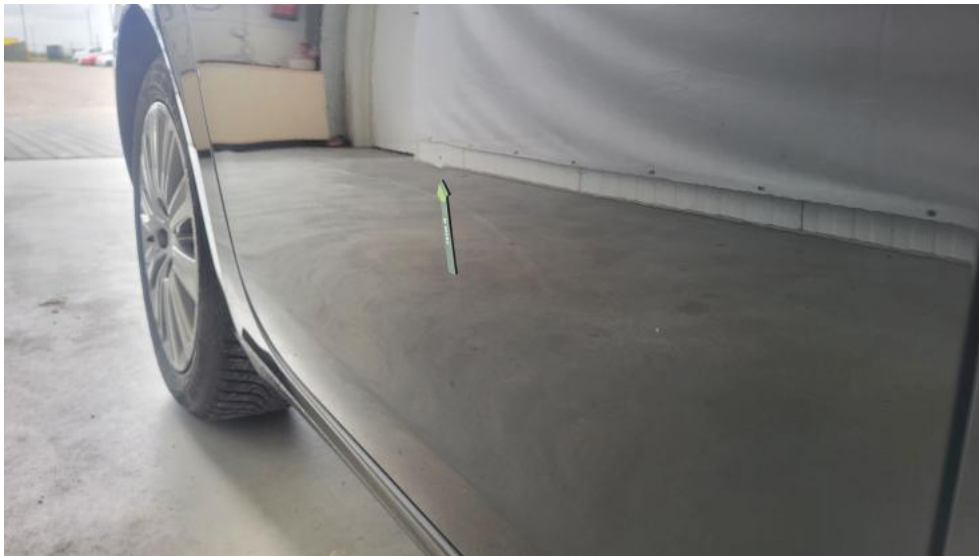
**Photo 47.**

Drzwi tylne P - Wgniecenie/odkształcenie 1

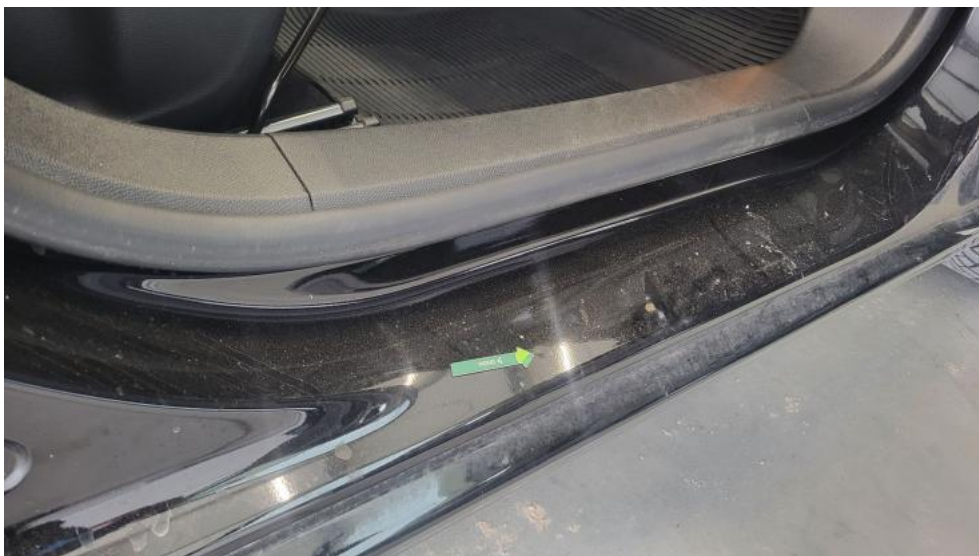
**Photo 48.**

Próg P - Wgniecenie/odkształcenie 1

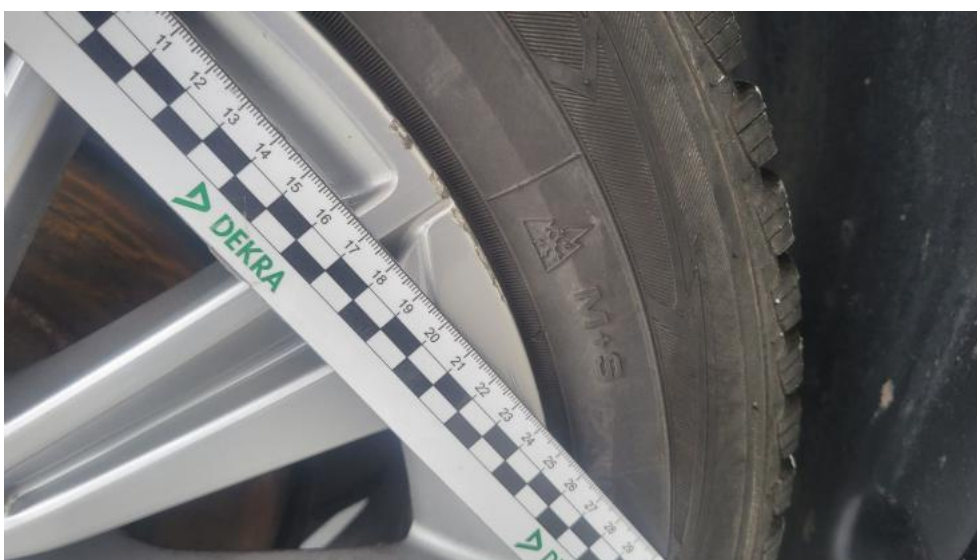
**Photo 50.**

Felga aluminiowa tylna P - Rysa/odprysk 1

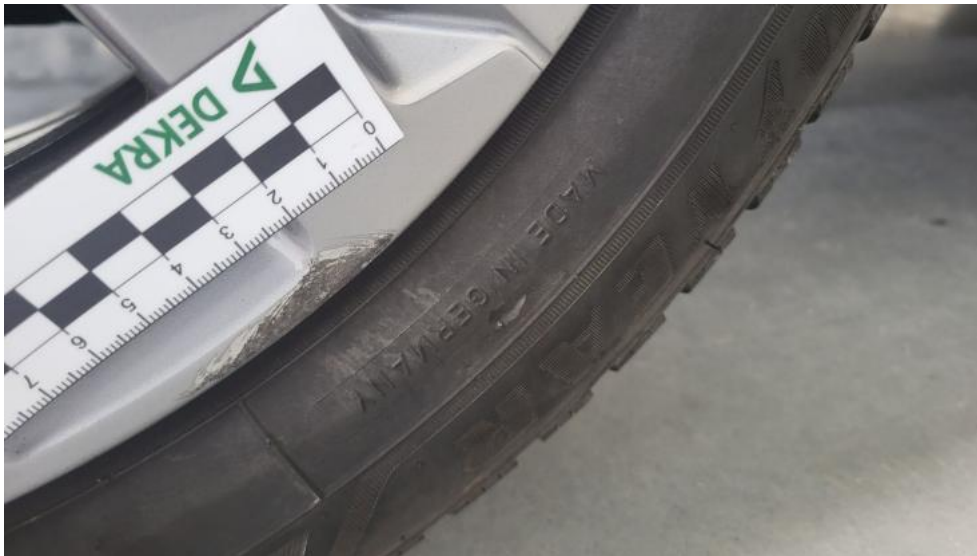
**Photo 51.**

Felga aluminiowa tylna P - Rysa/odprysk 2

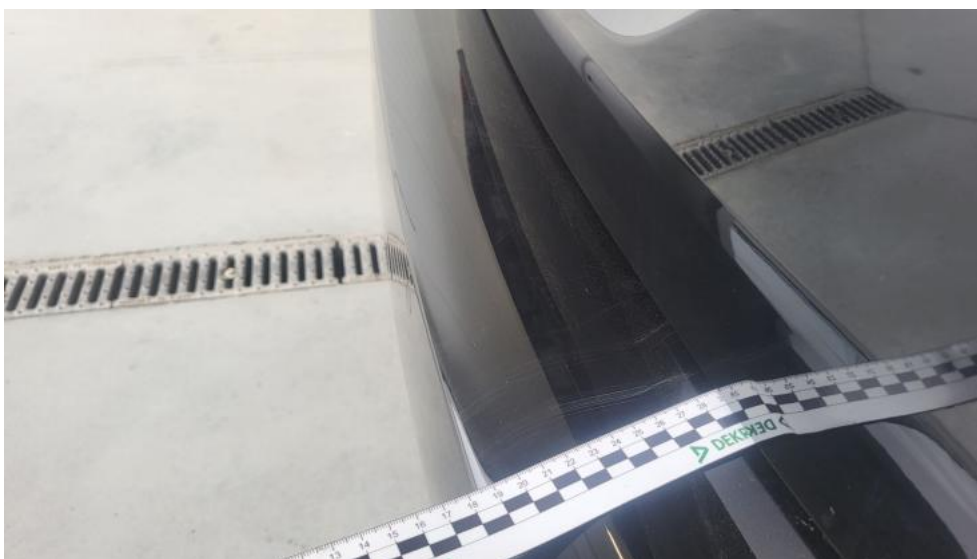
**Photo 53.**

Zderzak tylny - Rysa/odprysk 1

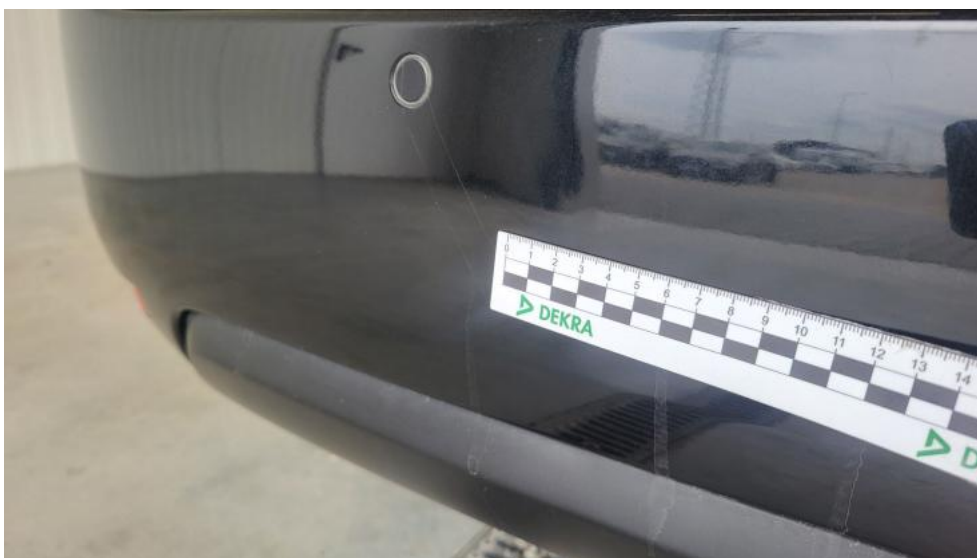
**Photo 54.**

Zderzak tylny - Wgniecenie/odkształcenie 1

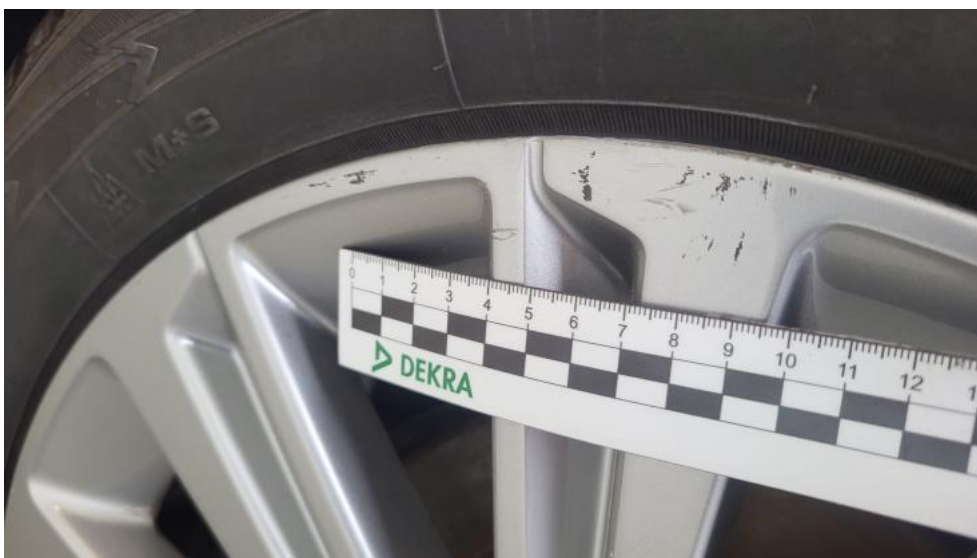
**Photo 56.**

Felga aluminiowa tylna L - Rysa/odprysk 1

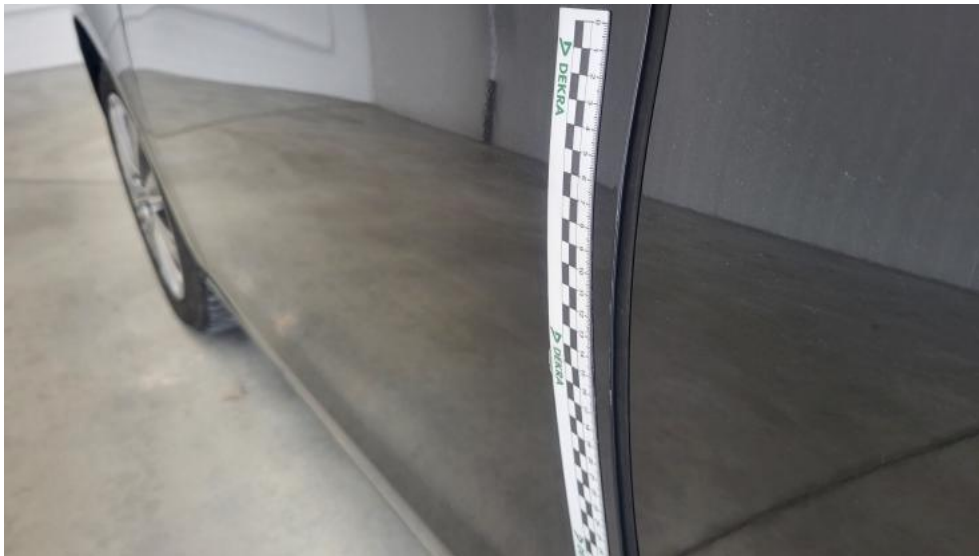
**Photo 57.**

Drzwi przed L - Rysa/odprysk 1

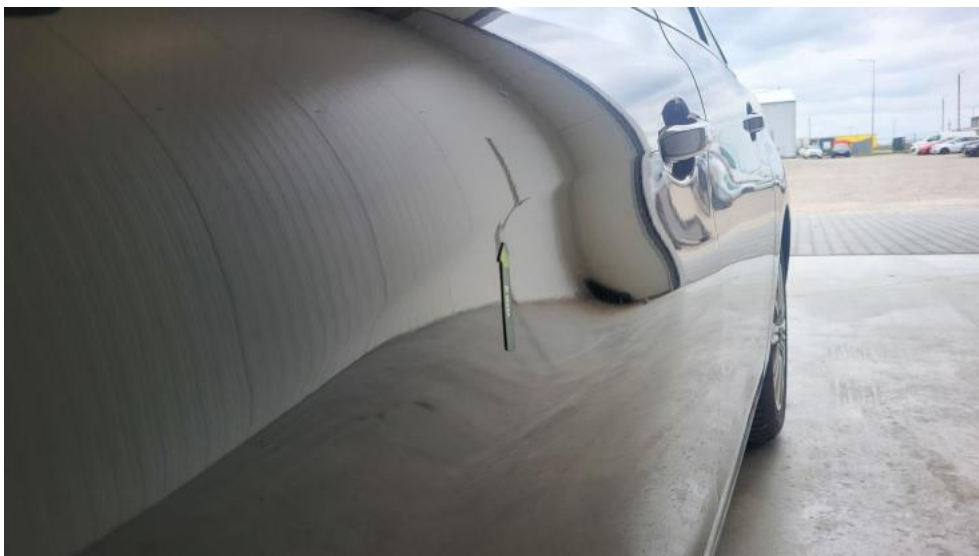
**Photo 58.**

Drzwi przed L - Wgniecenie/odkształcenie 1

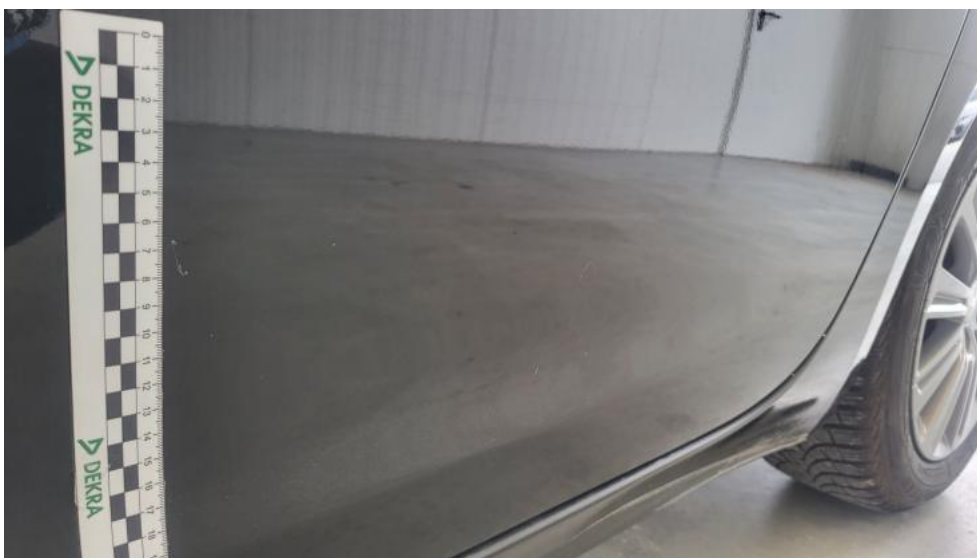
**Photo 60.**

Drzwi tylne L - Rysa/odprysk 2

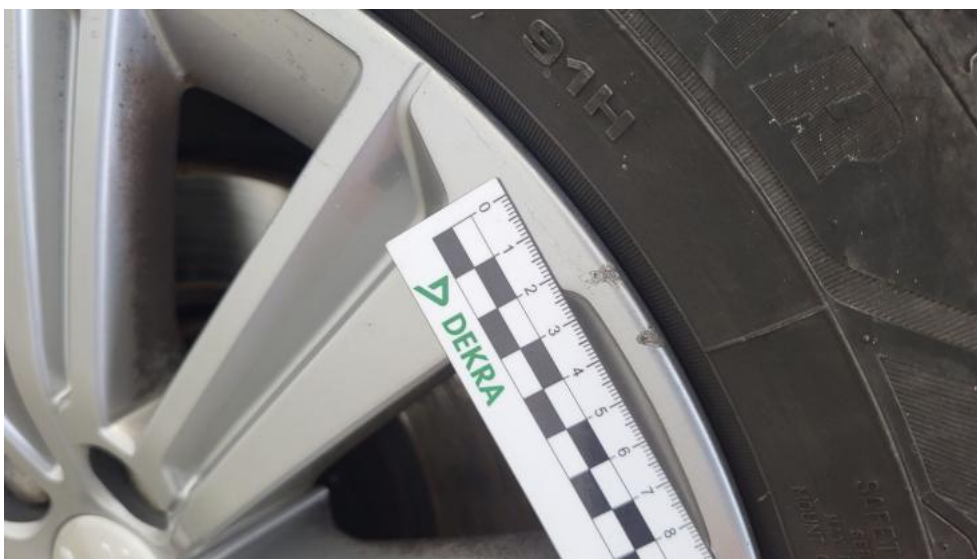
**Photo 63.**

Felga Aluminiowa przednia L - Rysa/odprysk 1

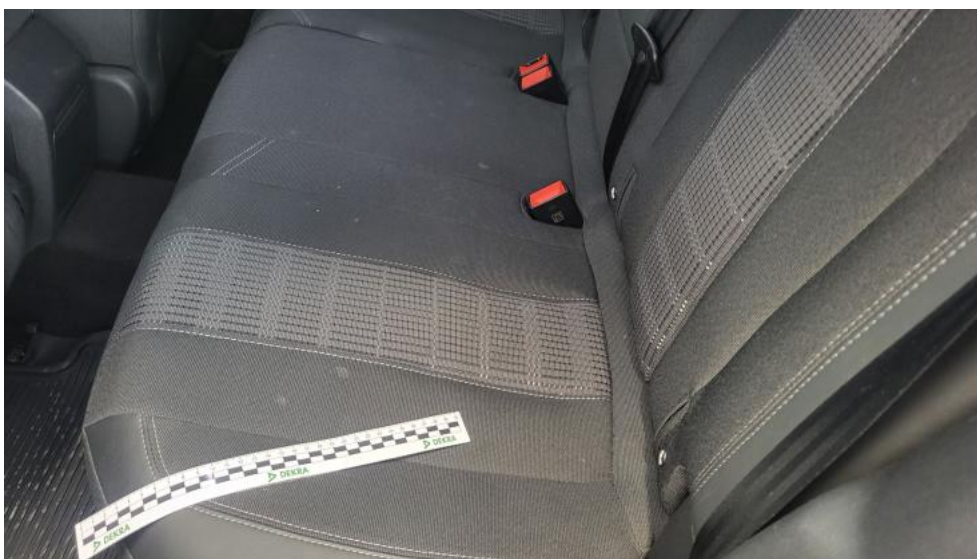
**Photo 67.**

Kanapa tyl. - Inne 1

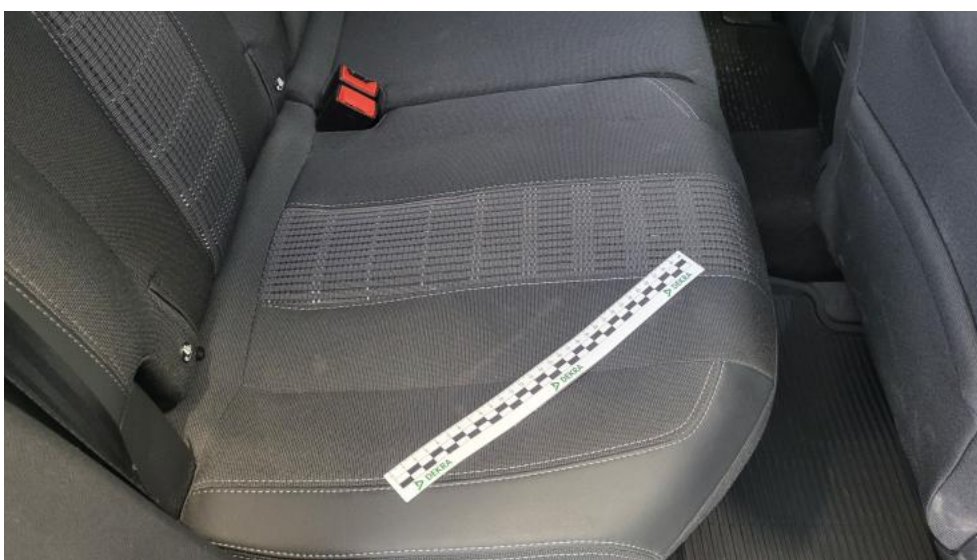
**Photo 68.**

Kanapa tyl. - Inne 2

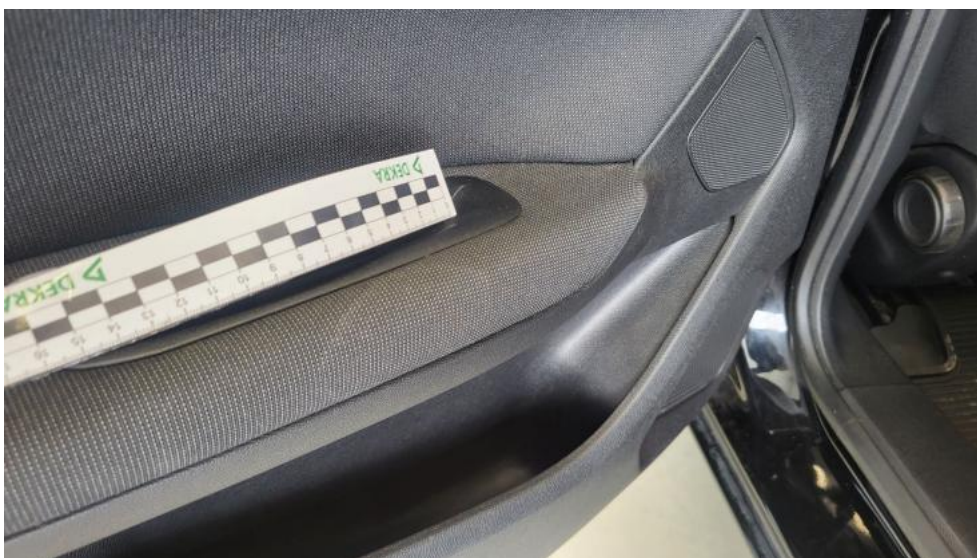
**Photo 70.**

Tapicerka drzwi tylnych L - Inne 1

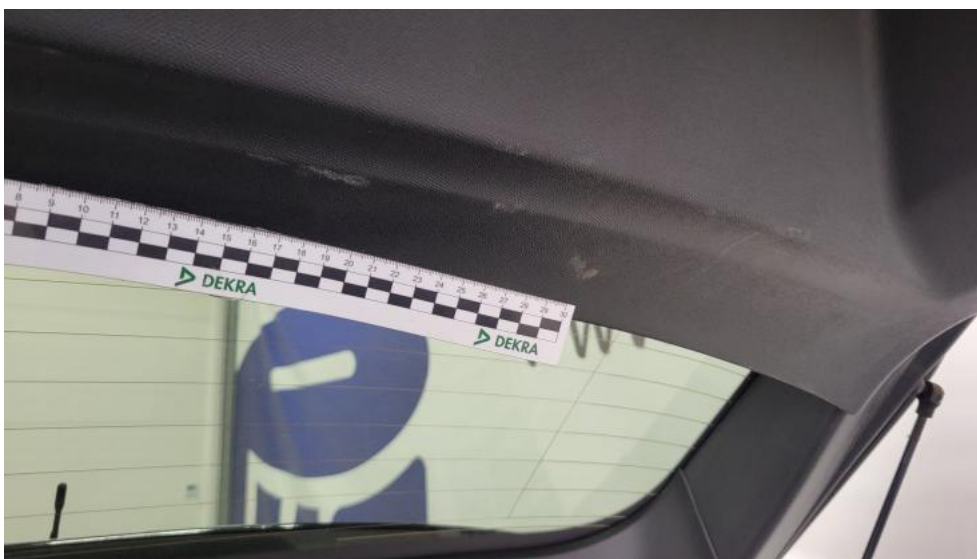
**Photo 71.**

Wykładzina pokrywy tylnej - Inne 1
