DEKRA's commission No. : PKOL(W)/LODZ/36256/25/05/20  
commission/ damage No. : FUTURA  
Date of commission: 20-05-2025

| Manufacturer | TOYOTA |
| Type / version | Yaris Hybrid 1.5 Selection Style |
| VIN / serial number | VNKKBAC3X0A196125 |

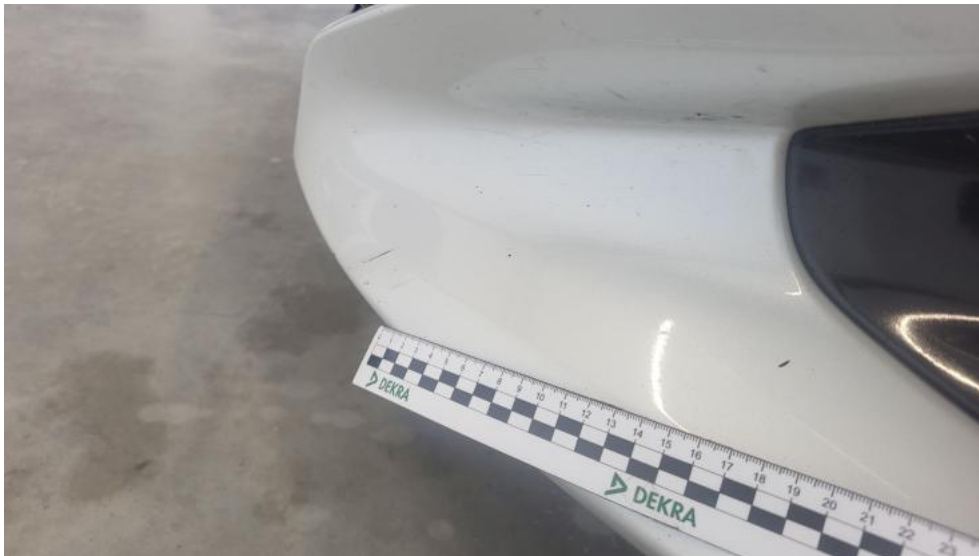
**Photo 39.**

Zderzak - Rysa/odprysk 1

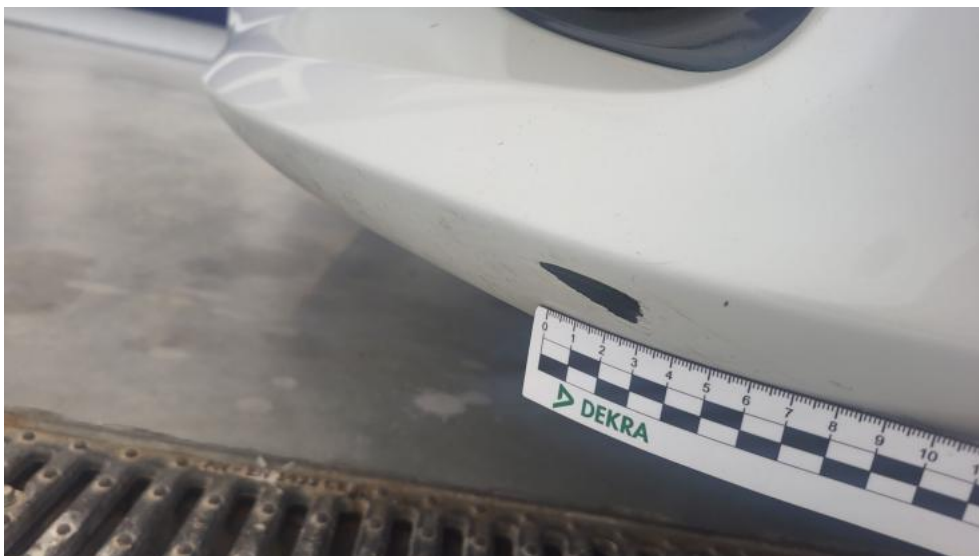
**Photo 40.**

Zderzak - Rysa/odprysk 2

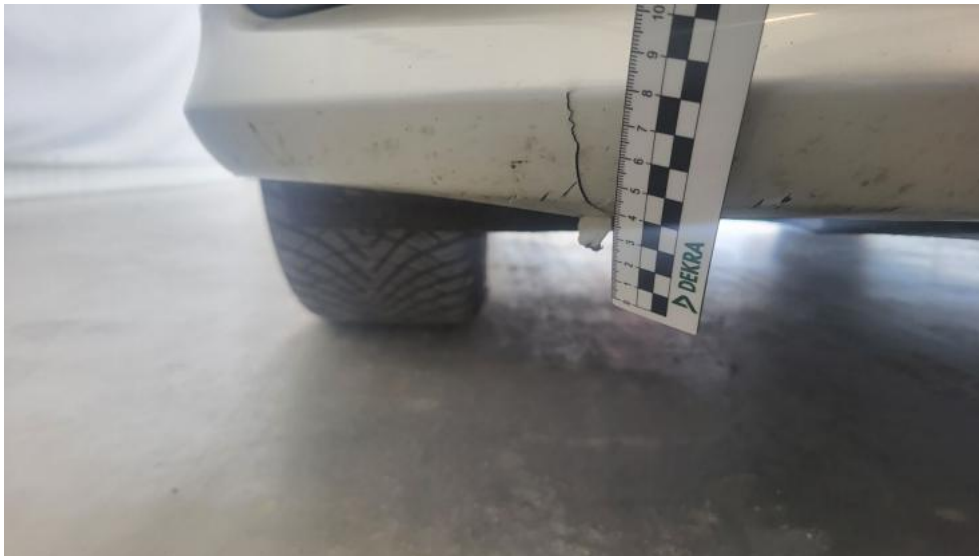
**Photo 41.**

Zderzak - Pęknięcie/rozerwanie 1

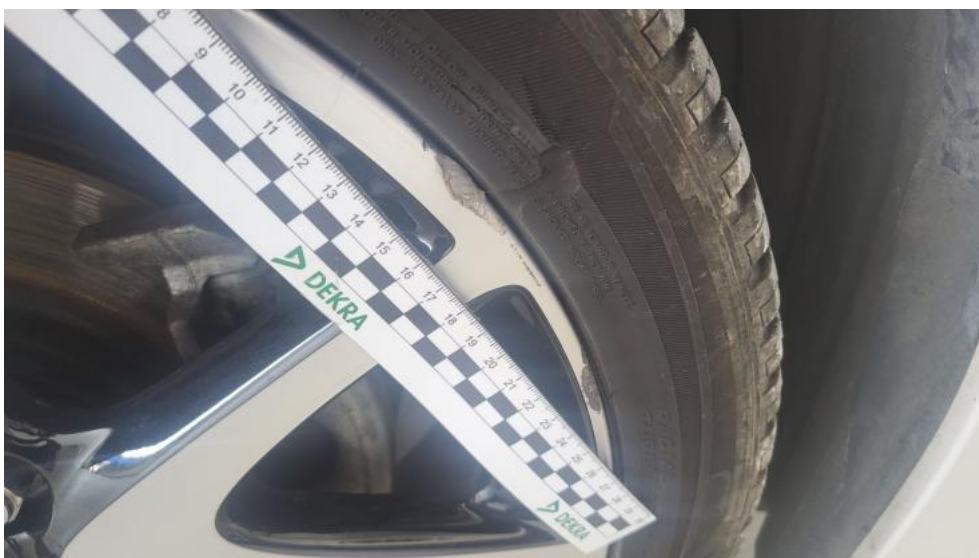
**Photo 42.**

Felga aluminiowa przednia P - Rysa/odprysk 1

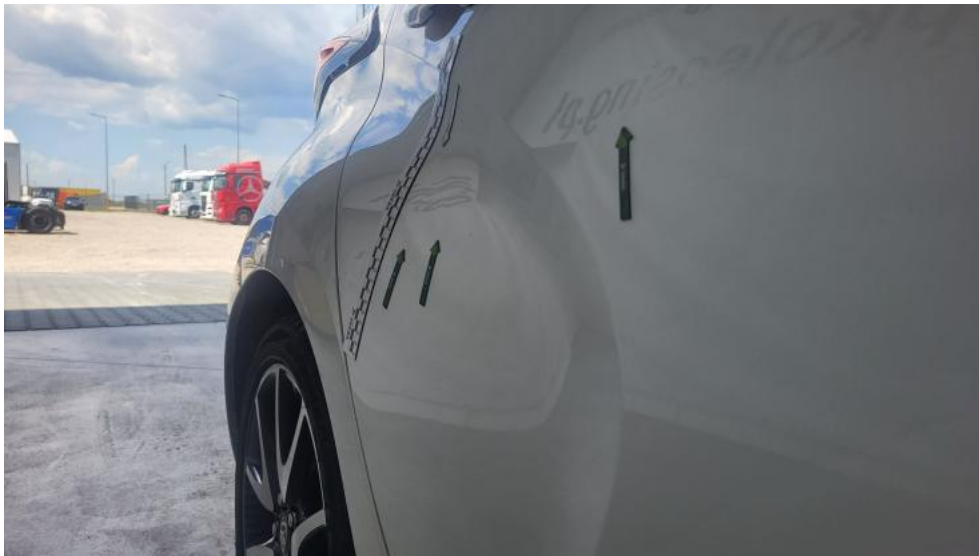
**Photo 45.**

Drzwi tylne P - Wgniecenie/odkształcenie 1

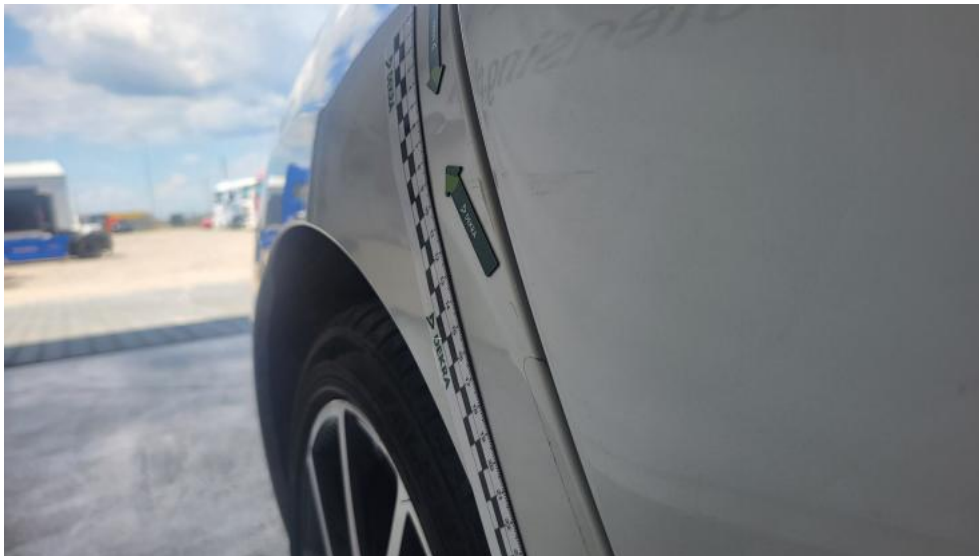
**Photo 47.**

Błotnik tylny P / Ściana boczna P - Wgniecenie/odkształcenie 1

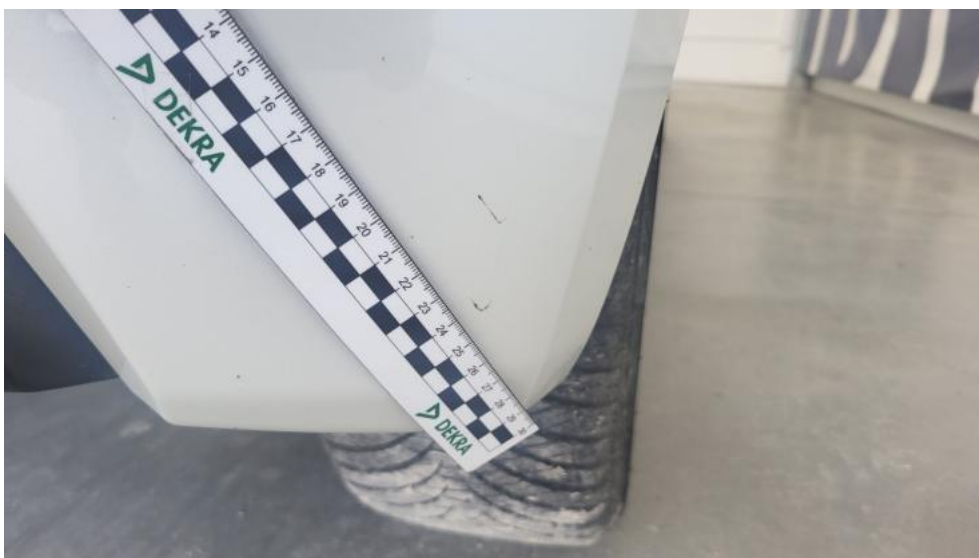
**Photo 48.**

Zderzak tylny - Rysa/odprysk 1

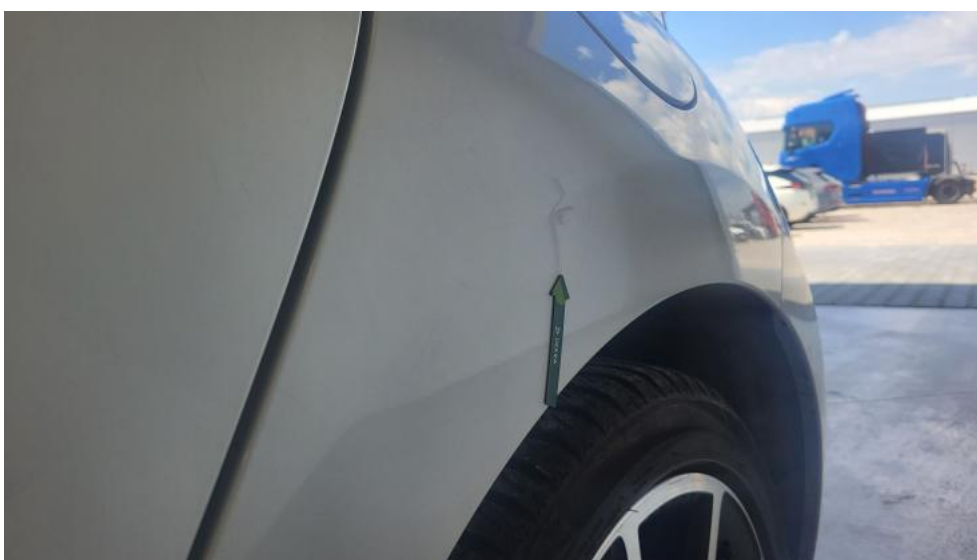
**Photo 50.**

Błotnik tylny L / Ściana boczna L - Wgniecenie/odkształcenie 1

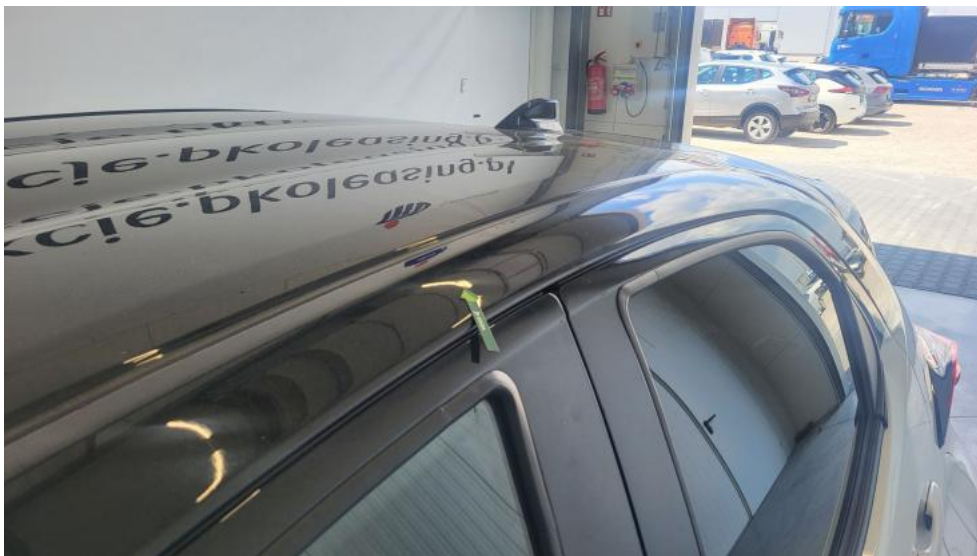
**Photo 51.**

Błotnik tylny L / Ściana boczna L - Wgniecenie/odkształcenie 2

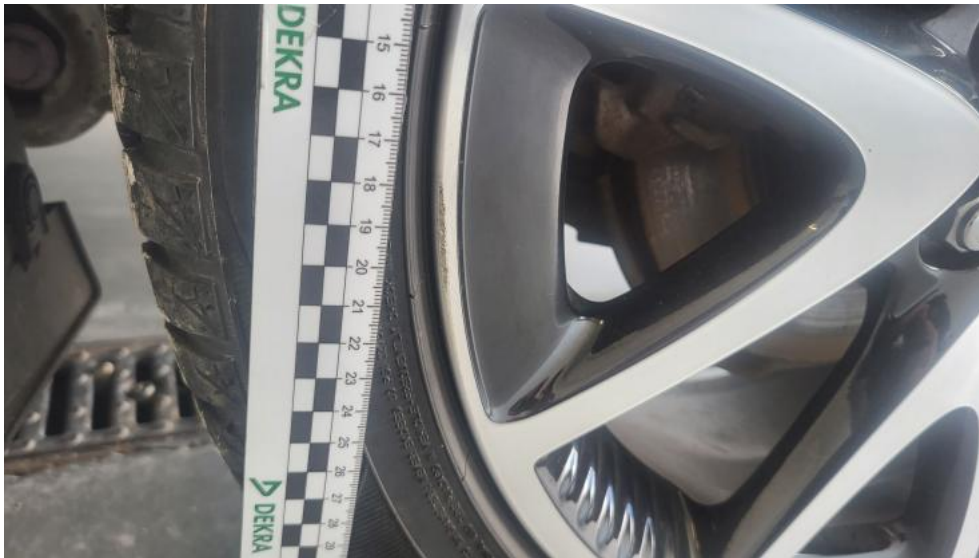
**Photo 53.**

Felga aluminiowa tylna L - Rysa/odprysk 1

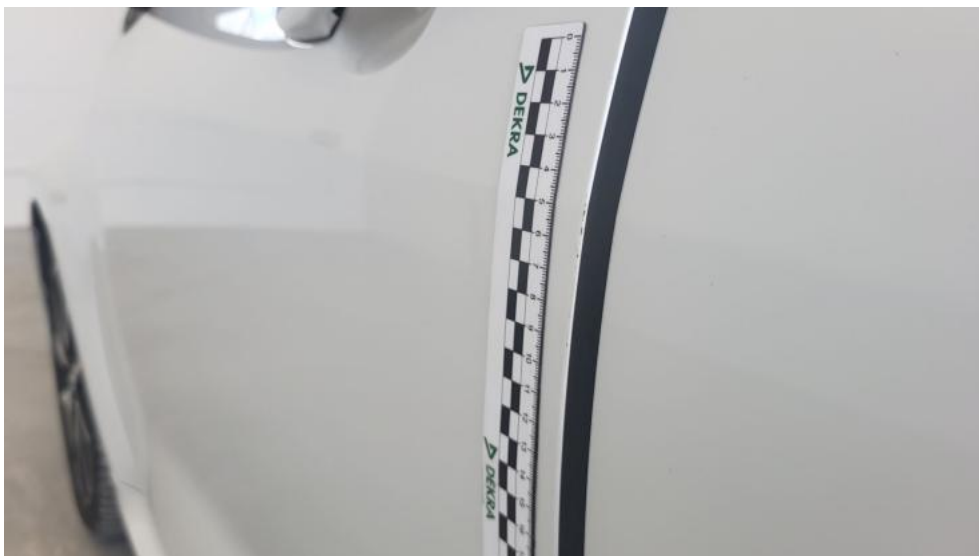
**Photo 54.**

Drzwi przed L - Rysa/odprysk 1

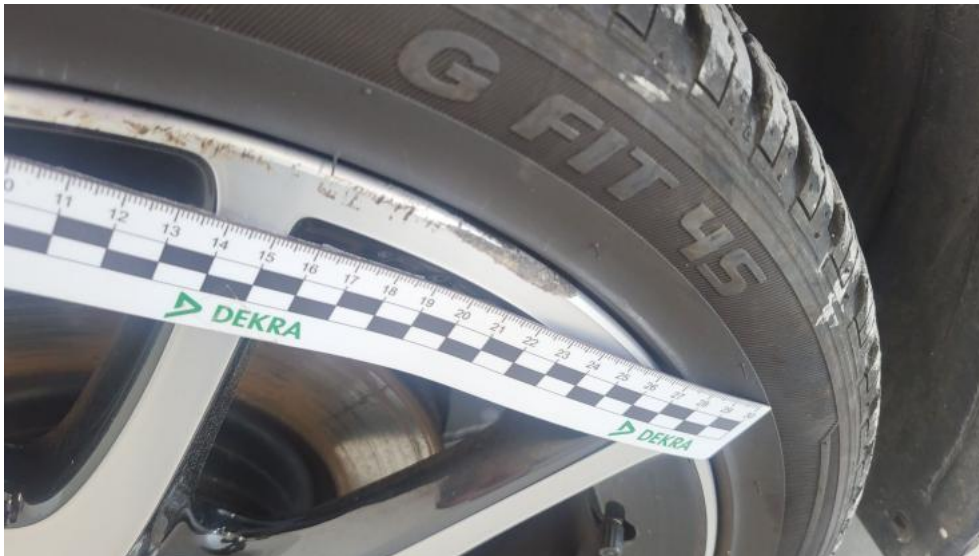
**Photo 55.**

Felga Aluminiowa przednia L - Rysa/odprysk 1

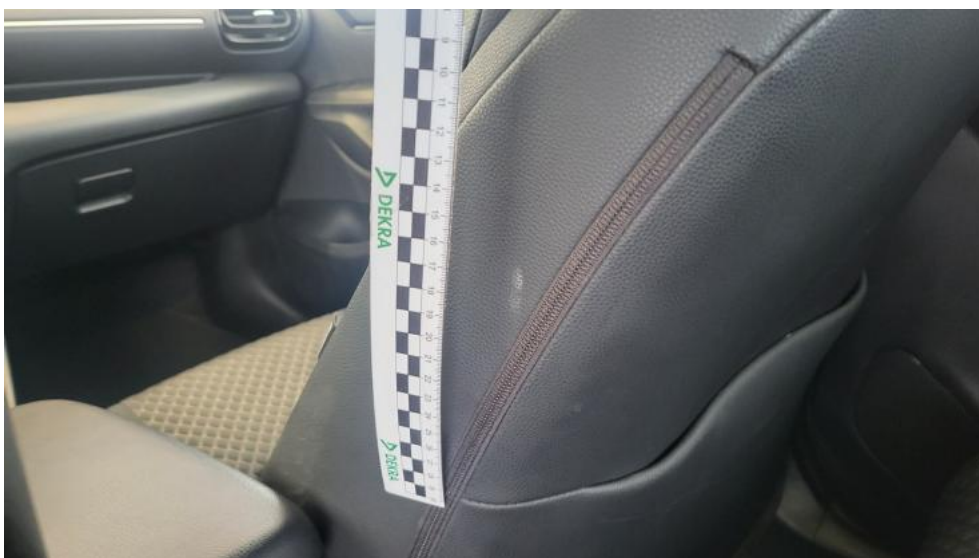
**Photo 56.**

Fotel prz. praw. - Inne 1

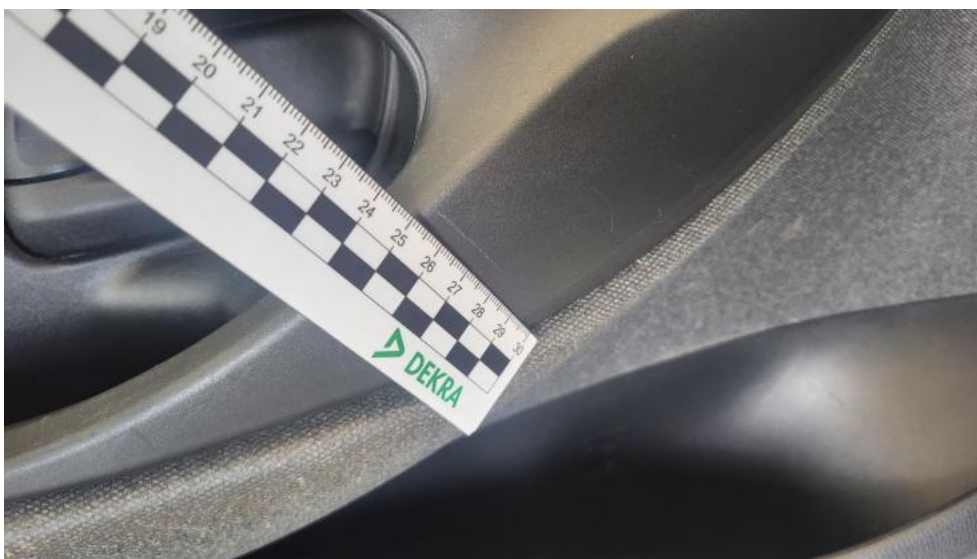
**Photo 57.**

Tapicerka drzwi przednich L - Rysa/odprysk 1
