DEKRA's commission No. : PKOL(W)/LODZ/22920/25/03/28  
commission/ damage No. : FUTURA  
Date of commission: 28-03-2025

**DEKRA Poland - Headquarters**  
02-673 Warszawa, ul. Konstruktorska 12A

| Manufacturer | OPEL |
| Model | Corsa F Hatchback 19-23 |

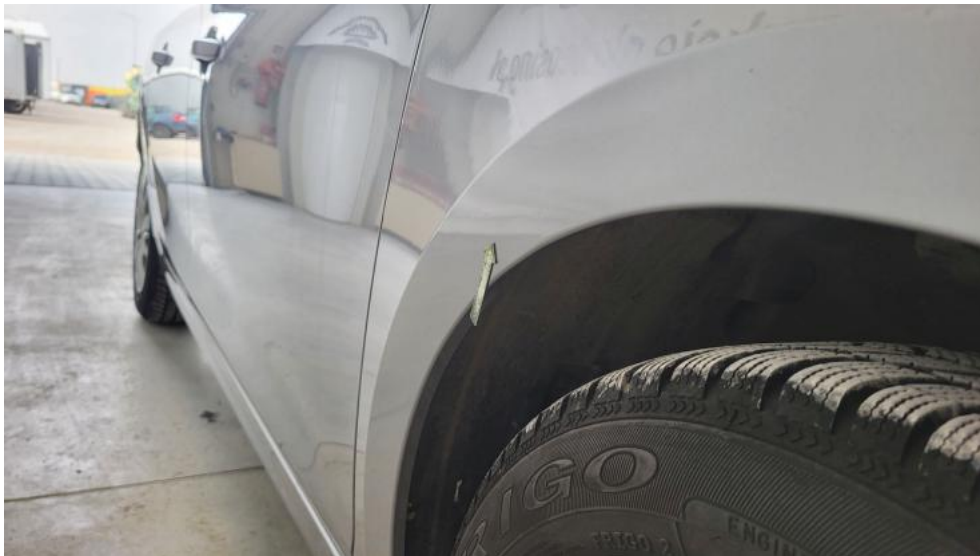
**Photo 35.**

Błotnik przedni P - Wgniecenie/odkształcenie 1

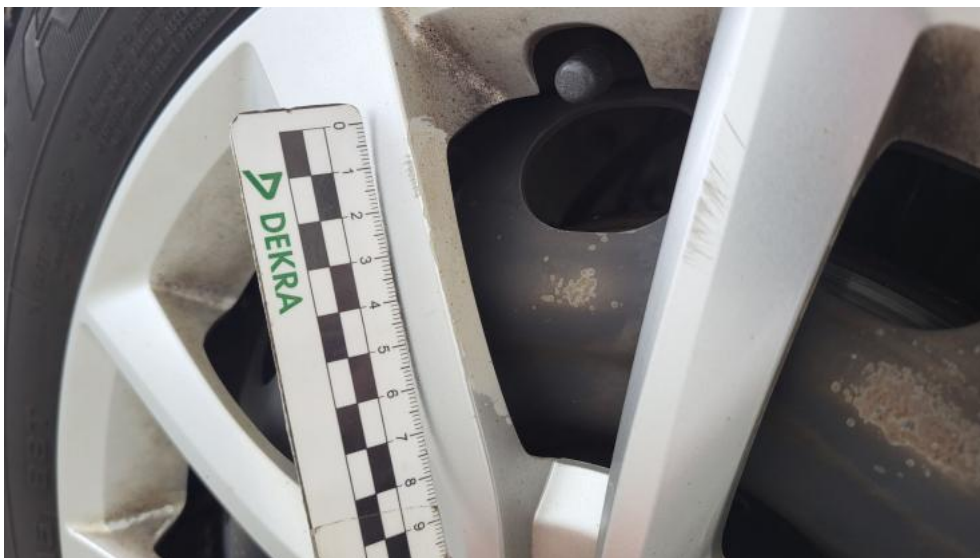
**Photo 36.**

Kołpak przedni P - Rysa/odprysk 1

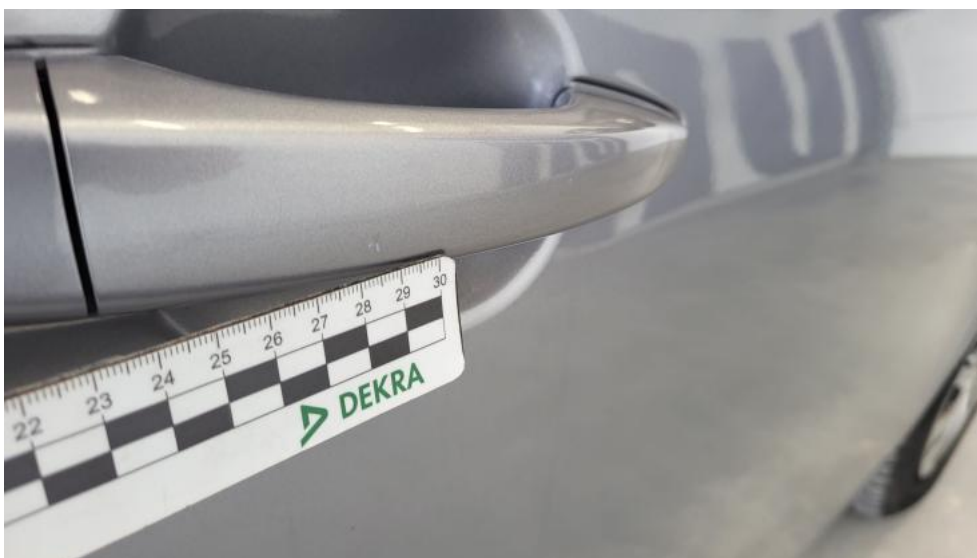
**Photo 38.**

Klamka drzwi prz P - Rysa/odprysk 1

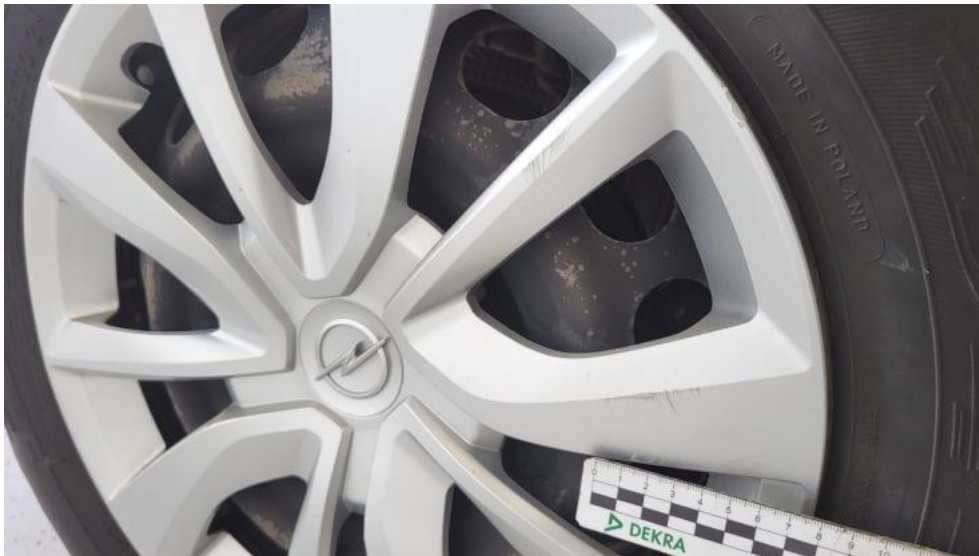
**Photo 41.**

Kołpak tylny P - Rysa/odprysk 1

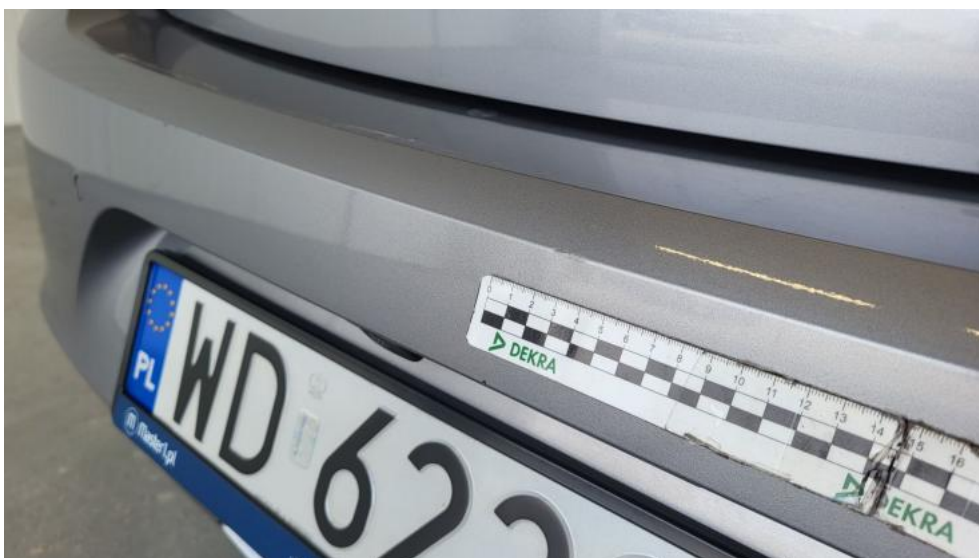
**Photo 42.**

Zderzak tylny - Rysa/odprysk 1

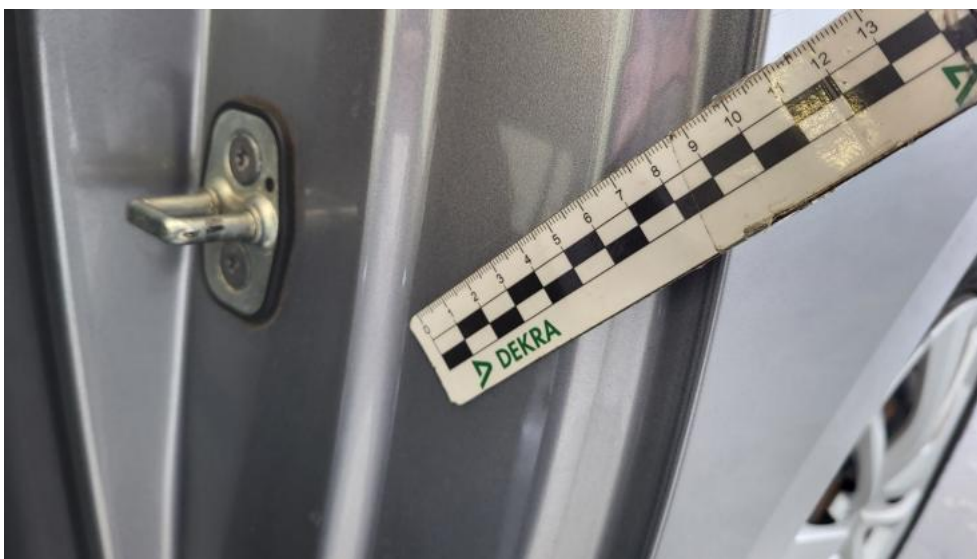
**Photo 43.**

Błotnik tylny L / Ściana boczna L - Rysa/odprysk 1

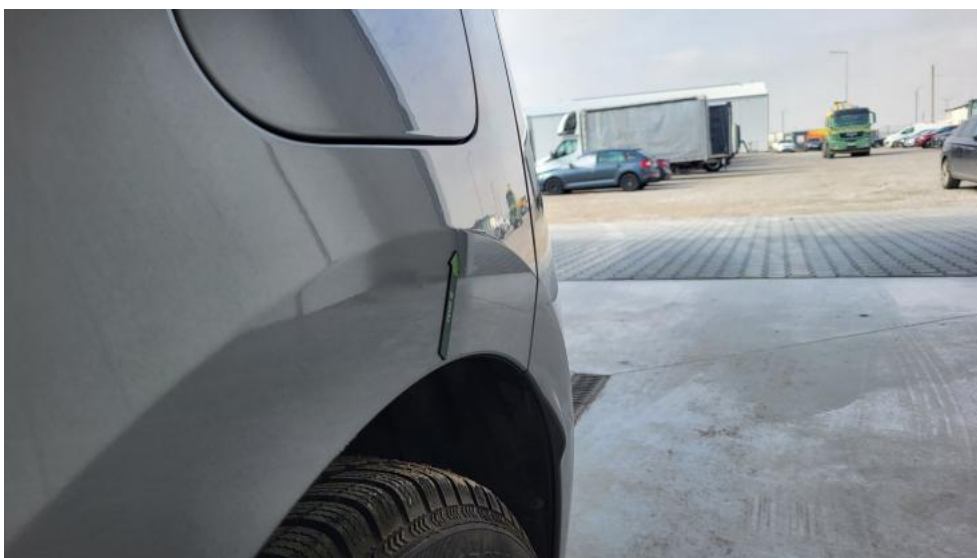
**Photo 44.**

Błotnik tylny L / Ściana boczna L - Wgniecenie/odkształcenie 1

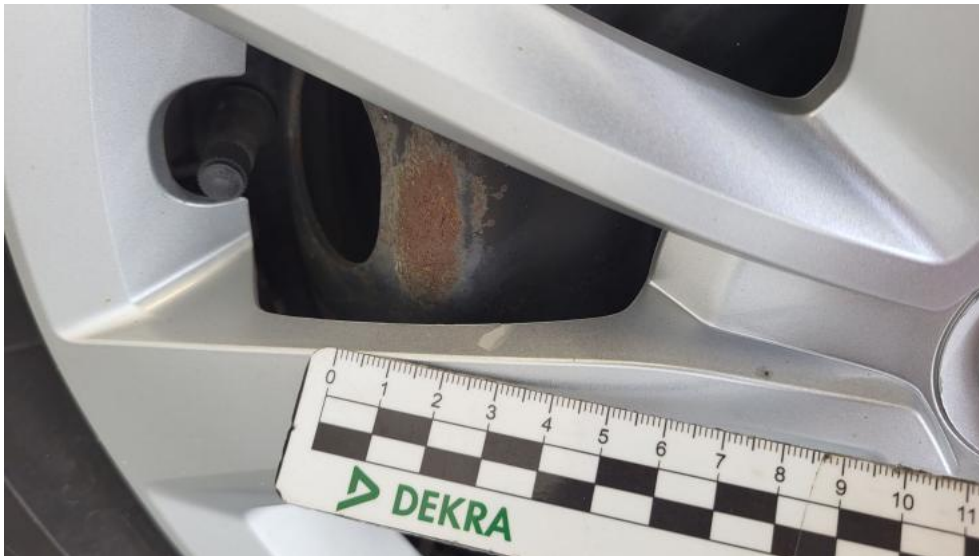
**Photo 45.**

Kołpak tylny L - Rysa/odprysk 1

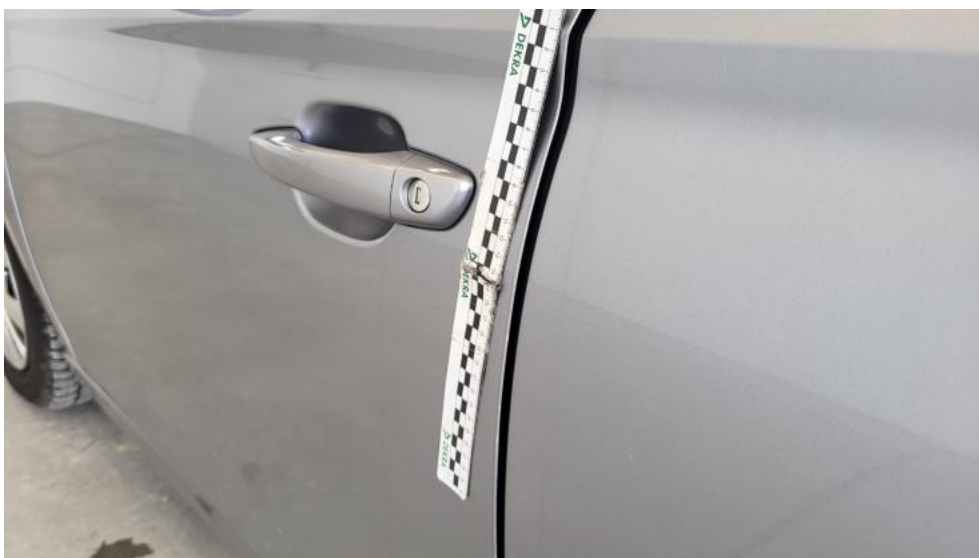
**Photo 46.**

Drzwi przed L - Rysa/odprysk 1

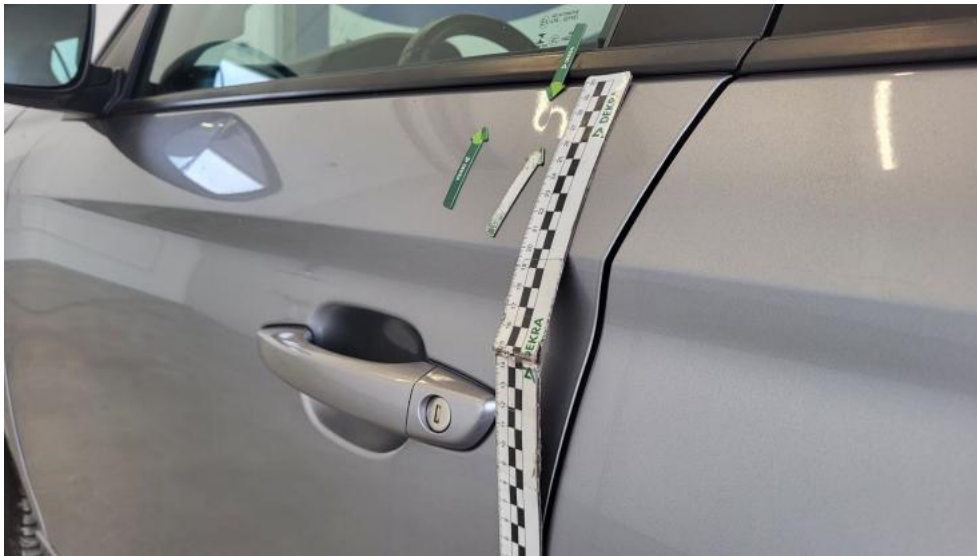
**Photo 47.**

Drzwi przed L - Wgniecenie/odkształcenie 1

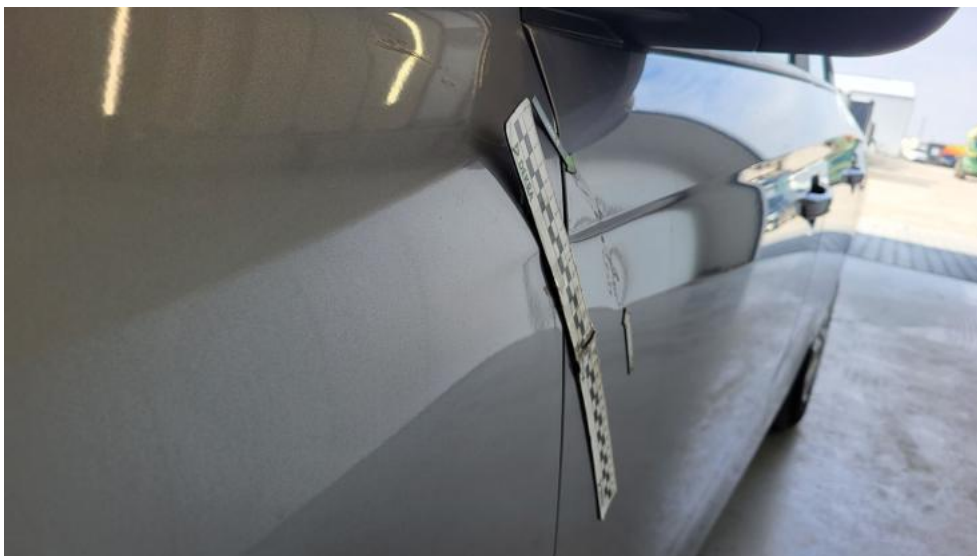
**Photo 48.**

Drzwi przed L - Wgniecenie/odkształcenie 2

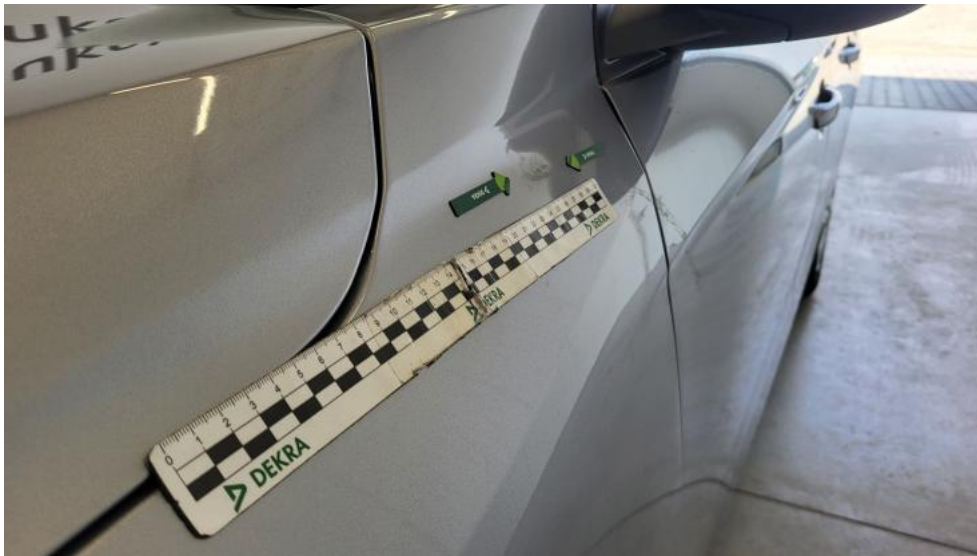
**Photo 49.**

Błotnik przedni L - Wgniecenie/odkształcenie 1

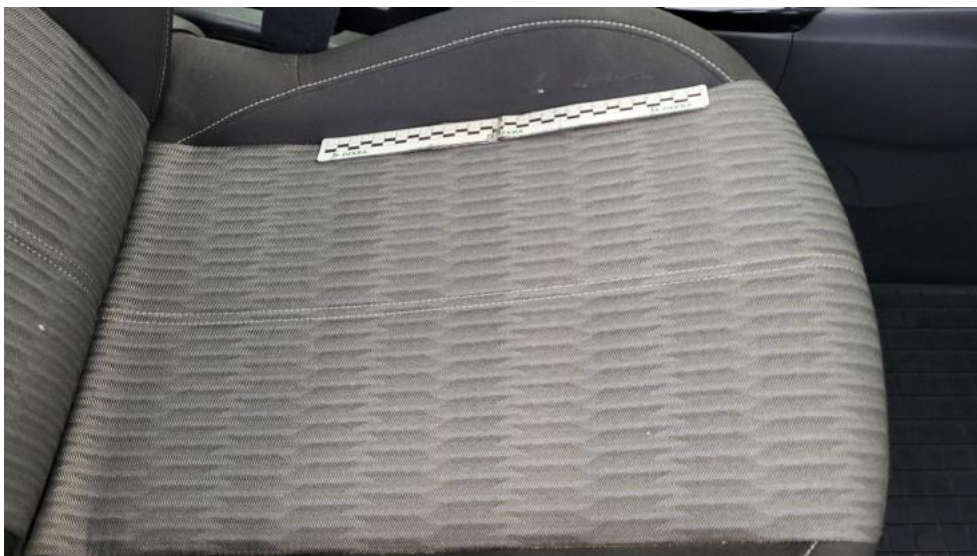
**Photo 50.**

Fotel prz. praw. - Inne 1

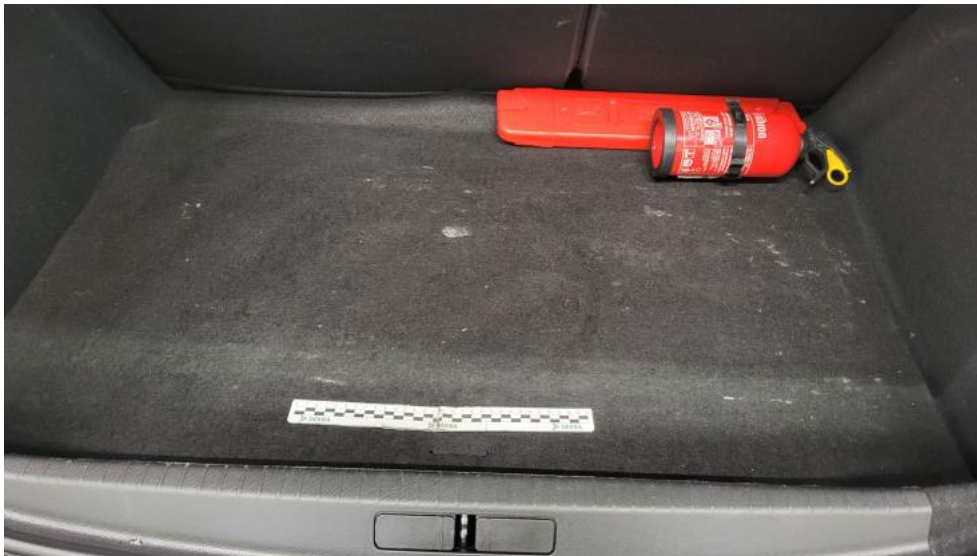
**Photo 53.**

Wykładzina podłogi bagażnika - Inne 1
