DEKRA's commission No. : PKOL(W)/LODZ/74710/24/09/27
 commission/ damage No. : 22/025253
 Date of commission: 27-09-2024

Vehicle data

Measurement of thickness of the vehicle lacquer coating

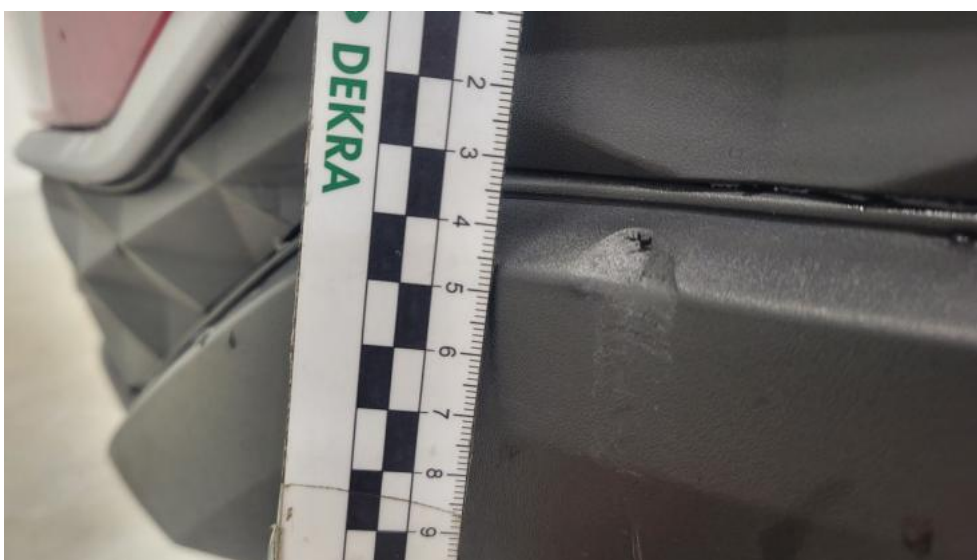
Photo 48.
Zderzak tylny - Pęknięcie/rozerwanie 2

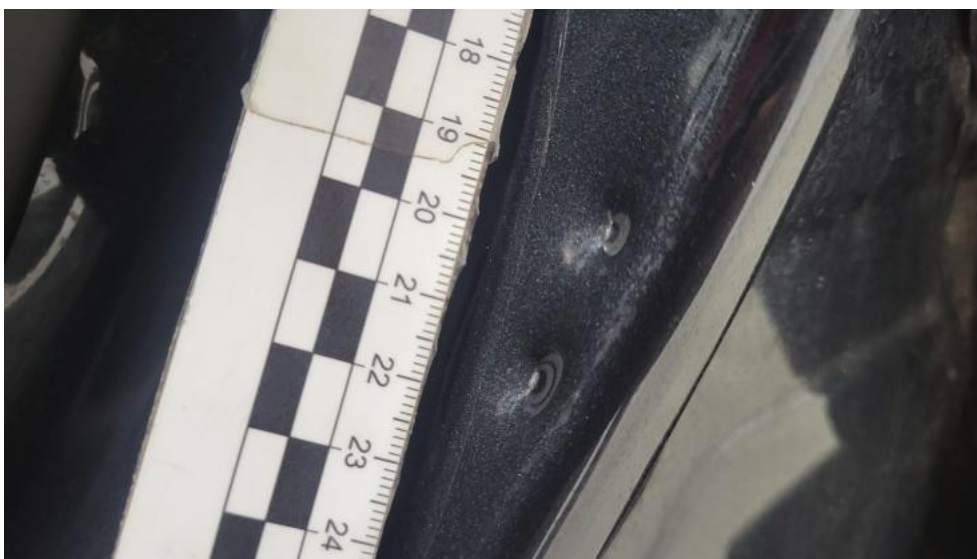
Photo 51.

Stupek środkowy L - Rysa/odprysk 1

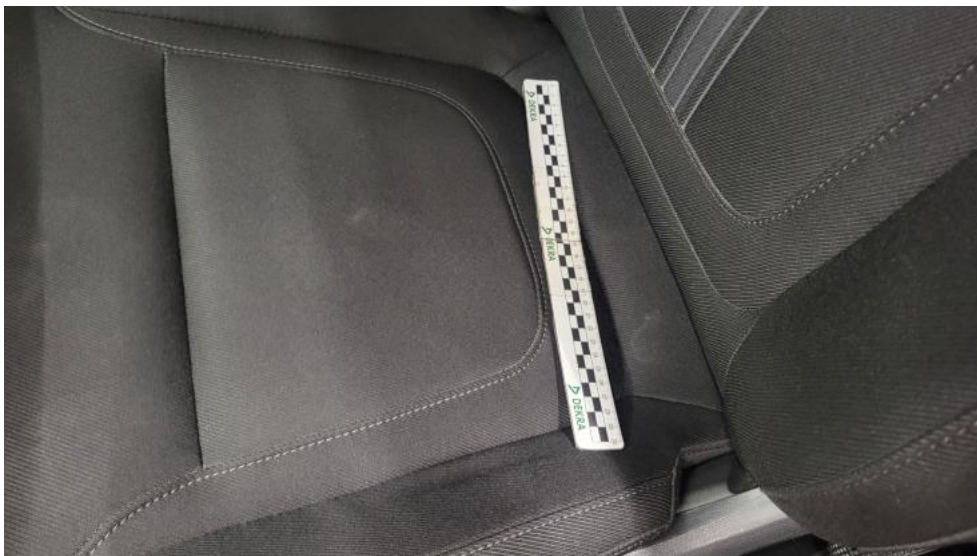
Photo 53.
Fotel prz. lew. - Inne 1

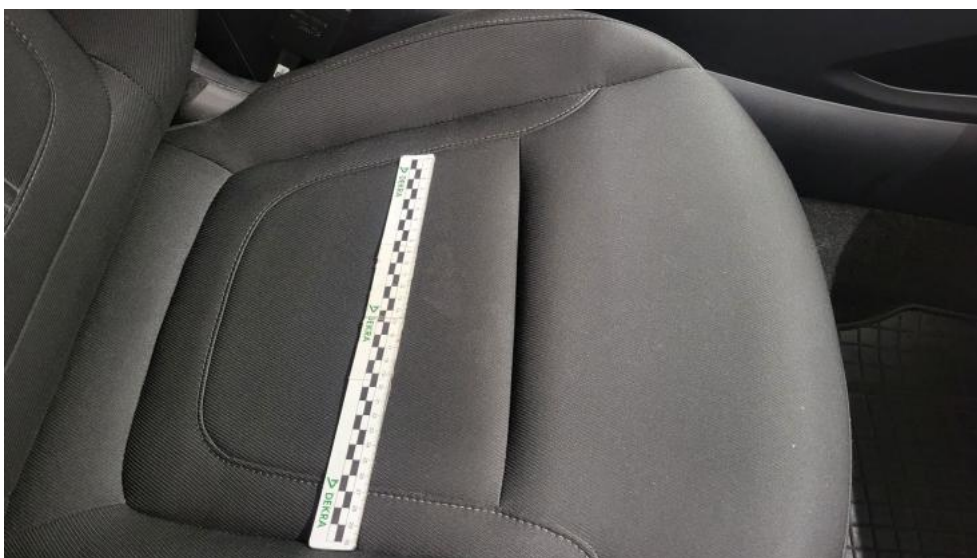
Photo 54.
Fotel prz. praw. - Inne 1

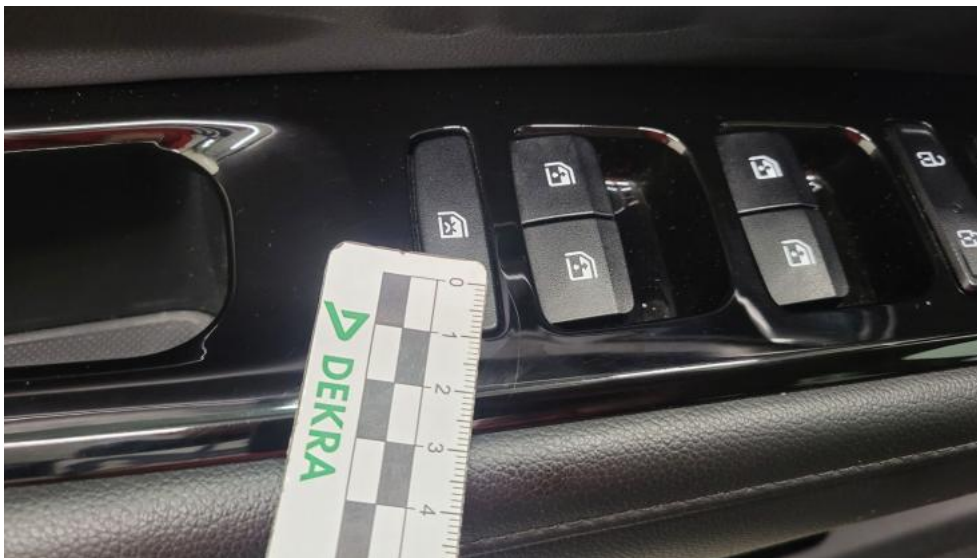
Photo 55.

Tapicerka drzwi przednich L - Rysa/odprysk 1
