DEKRA's commission No. : PKOL(W)/LODZ/78841/24/10/11
 commission/ damage No. :
 Date of commission: 11-10-2024

Vehicle data

Measurement of thickness of the vehicle lacquer coating

PHOTOGRAPHIC DOCUMENTATION

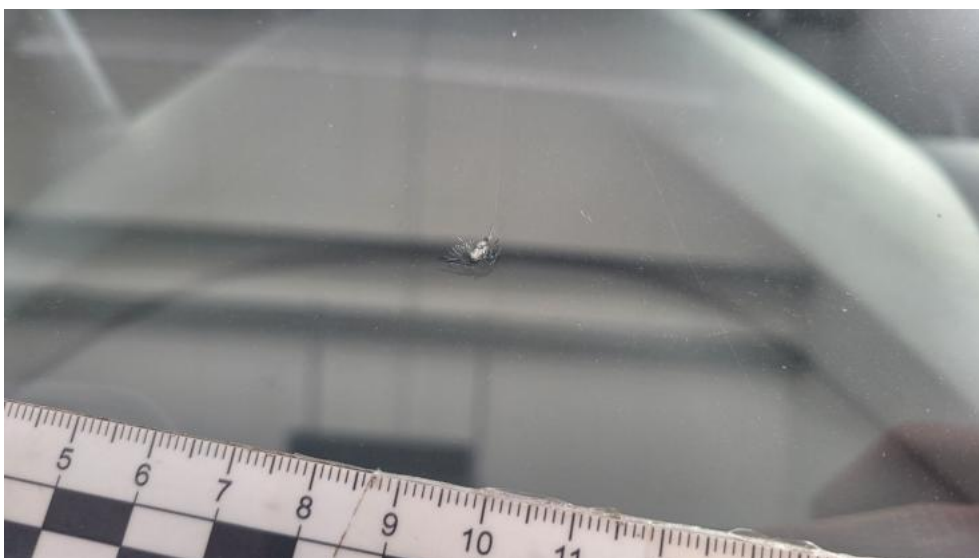
Photo 40.
Szyba czołowa - Rysa/odprysk 1

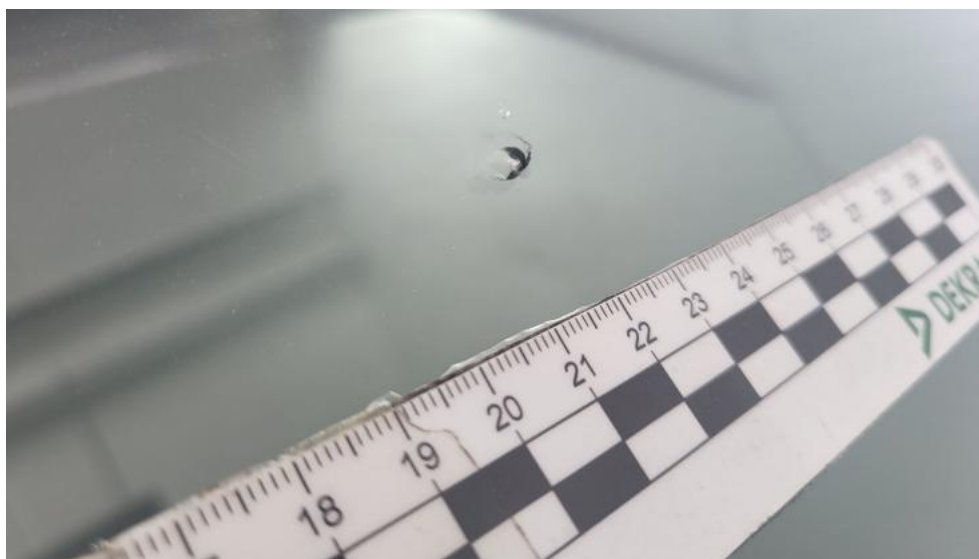
Photo 41.

Szyba czołowa - Rysa/odprysk 2

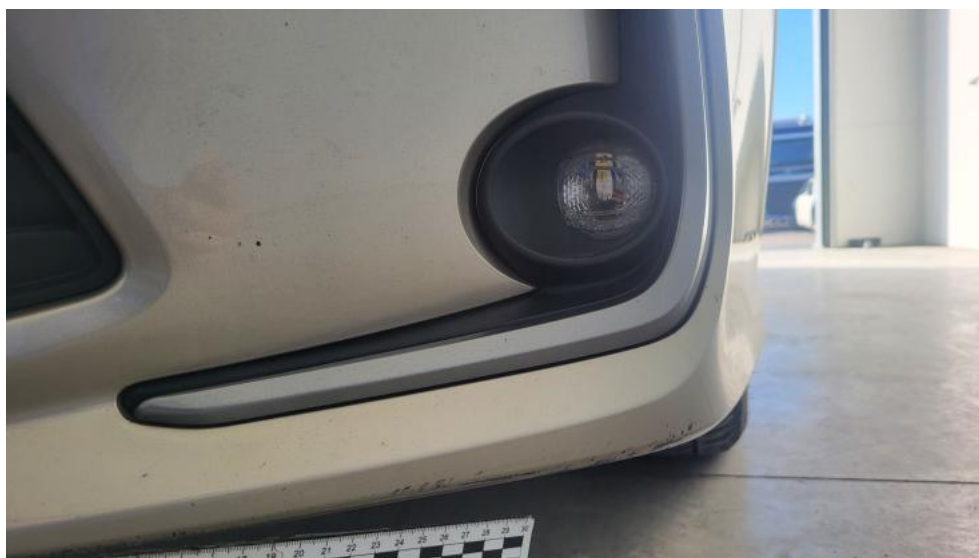
Photo 42.

Zderzak - Rysa/odprysk 1

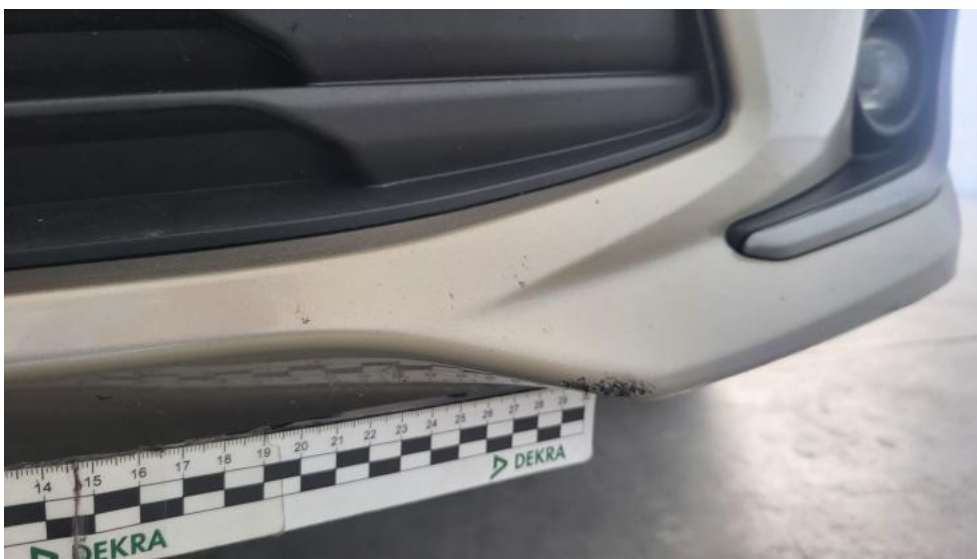
Photo 43.

Zderzak - Rysa/odprysk 2

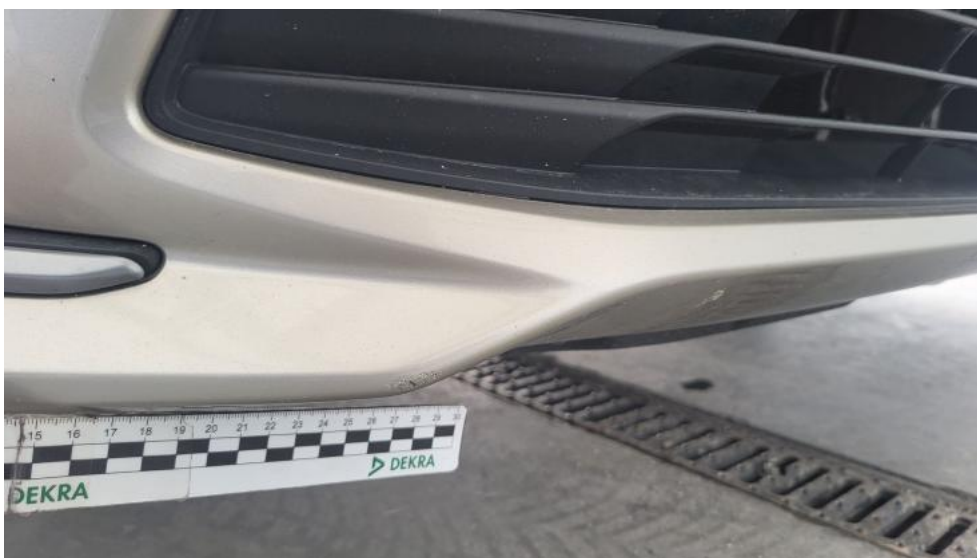
Photo 44.

Zderzak() - Rysa/odprysk 3

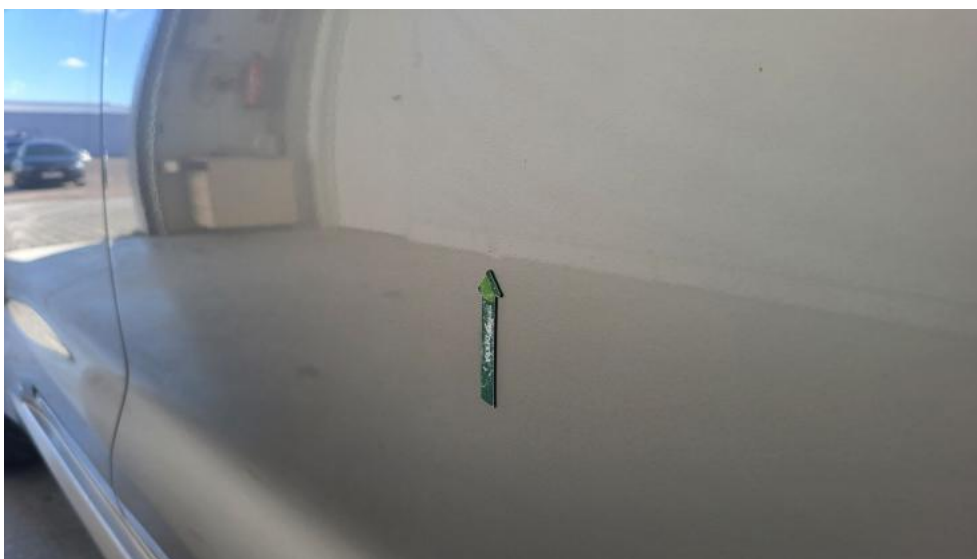
Photo 45.
Drzwi przednie P - Wgniecenie/odkształcenie 1

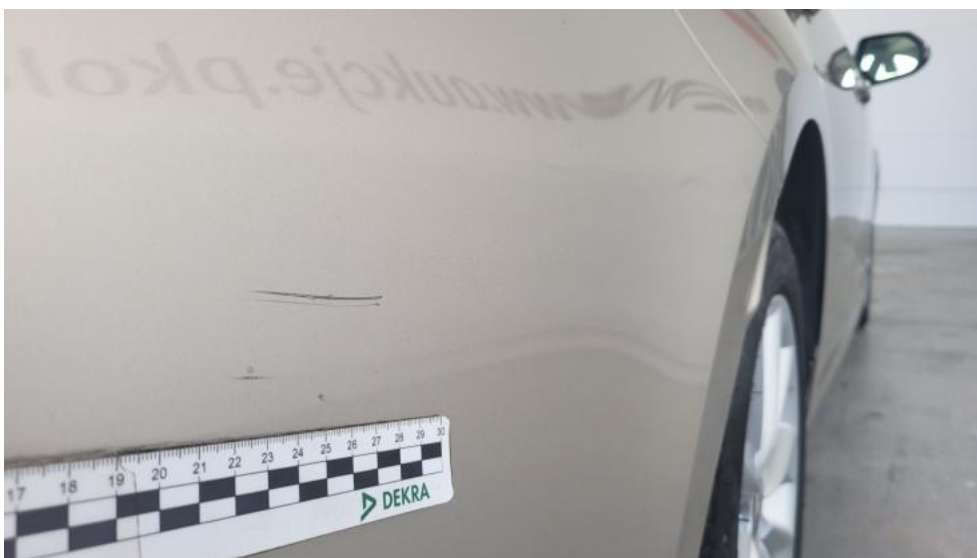
Photo 46.
Zderzak tylny - Rysa/odprysk 1

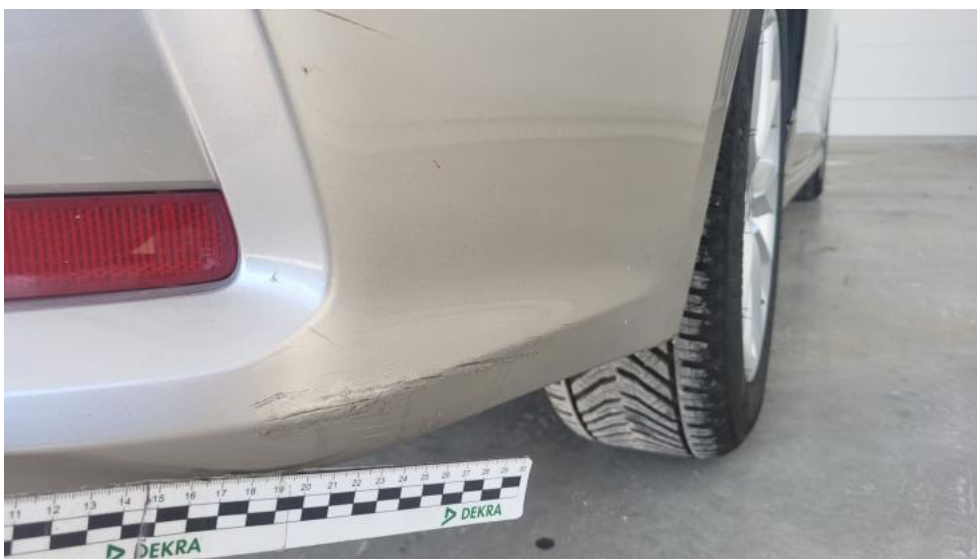
Photo 47.
Zderzak tylny - Rysa/odprysk 2

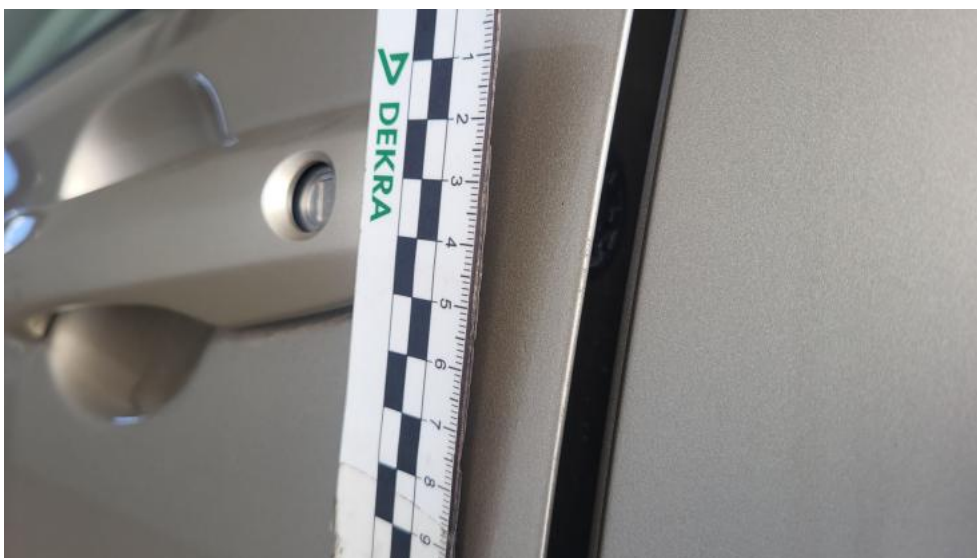
Photo 48.
Drzwi przed L - Rysa/odprysk 1

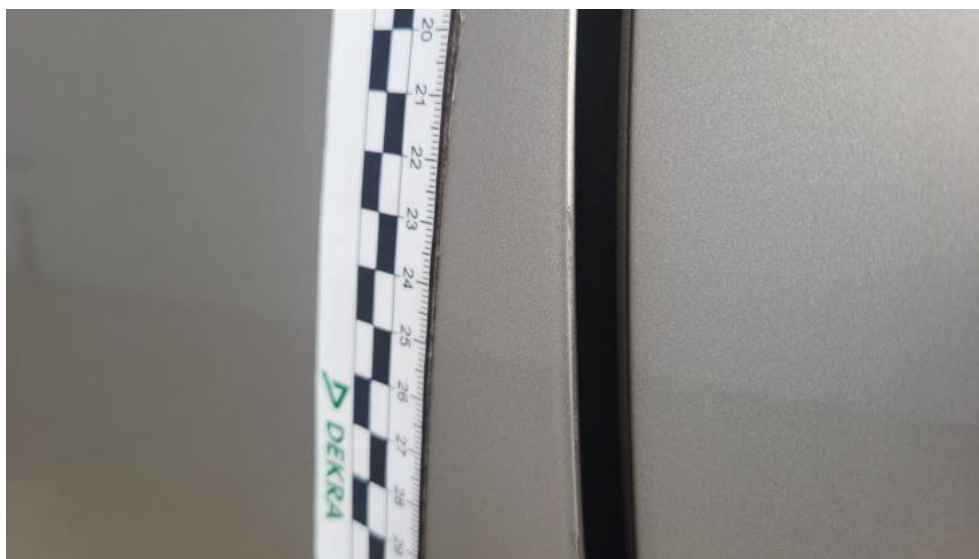
Photo 49.

Drzwi przed L - Rysa/odprysk 2

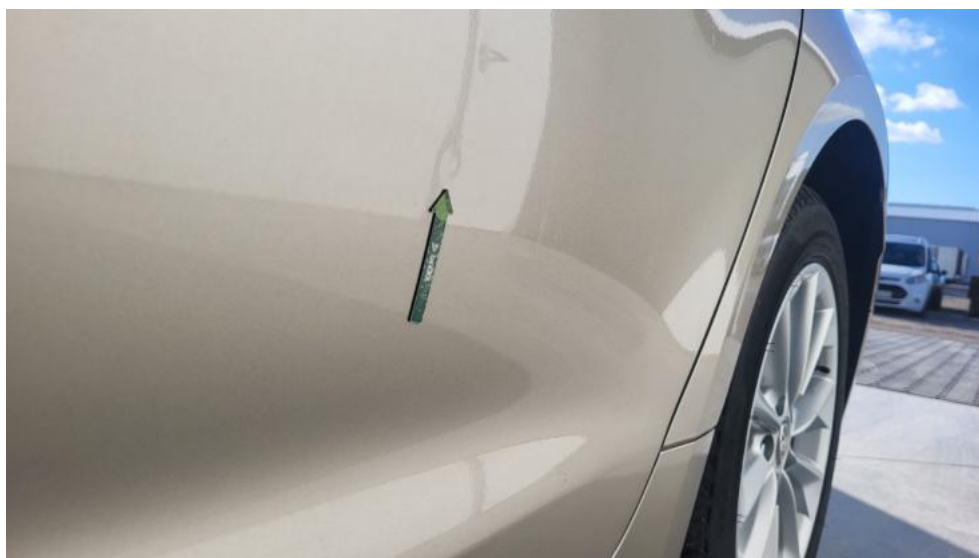
Photo 50.

Drzwi tylne L - Wgniecenie/odkształcenie 1

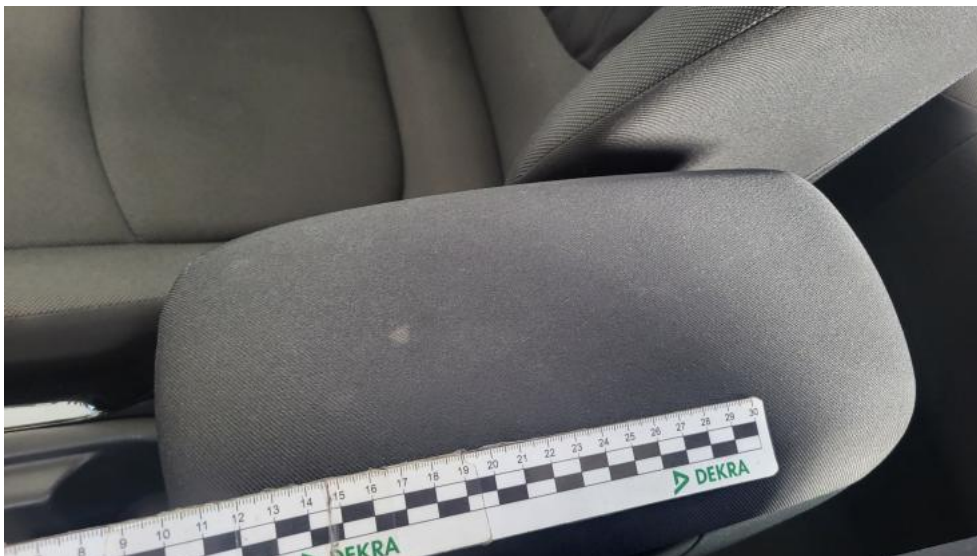
Photo 51.
Podłokietnik środkowy przedni - Inne 1

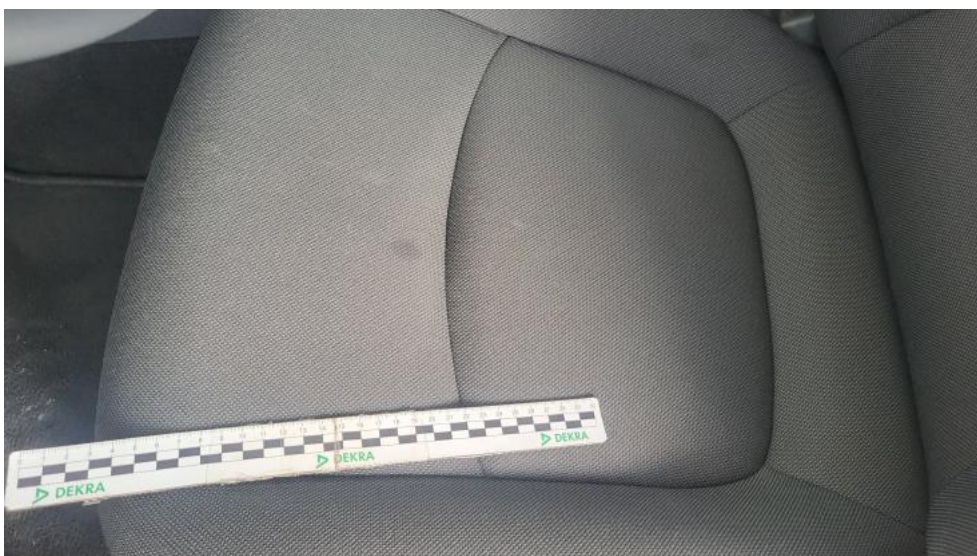
Photo 52.
Fotel prz. lew. - Inne 1

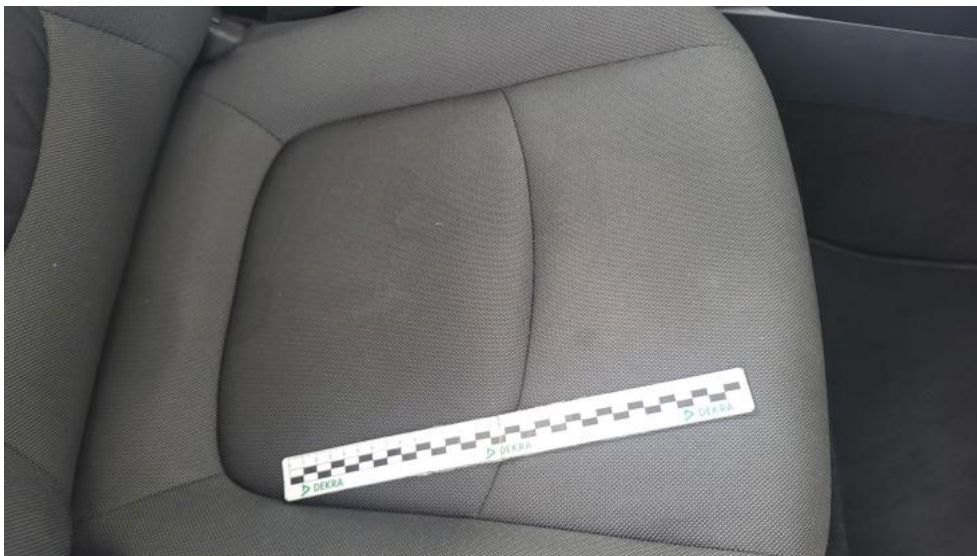
Photo 53.

Fotel prz. praw. - Inne 1
