DEKRA's commission No. : PKOL(W)/LODZ/11137/26/02/11  
commission/ damage No. : 20/053881  
Date of commission: 11-02-2026

**DEKRA Poland - Headquarters**  
02-673 Warszawa, ul. Konstruktorska 12A

Group of objects (Eurotax)	cars
EC code (Eurotax)	0145353
Manufacturer	BMW
Model	Seria 5 [G30/F90] 20-23
Type / version	520d xDrive mHEV M Sport sport-aut
Body type	sedan
Number of doors / seats	4/5
Curb weight [kg]	1735
Gross vehicle weight [kg]	2405
Wheelbase 1/2	2975
Engine type	Automatic ignition
Pollution reduction system	KSC
Engine capacity [ccm]	1995
Engine Power [hp/kW]	190/140
Gearbox	automatic
Registration /record No.	PO9SN61
VIN / serial number	WBA51BL000WX07510
Date of first registration	30-12-2020
Date of next. tech. test	23-12-2026
Year of manufacture	2020 (year has been verified with the manufacturer's base)
Readout [km]	272 823 (read)
Body color / type of coating	black/double-layered, metallized

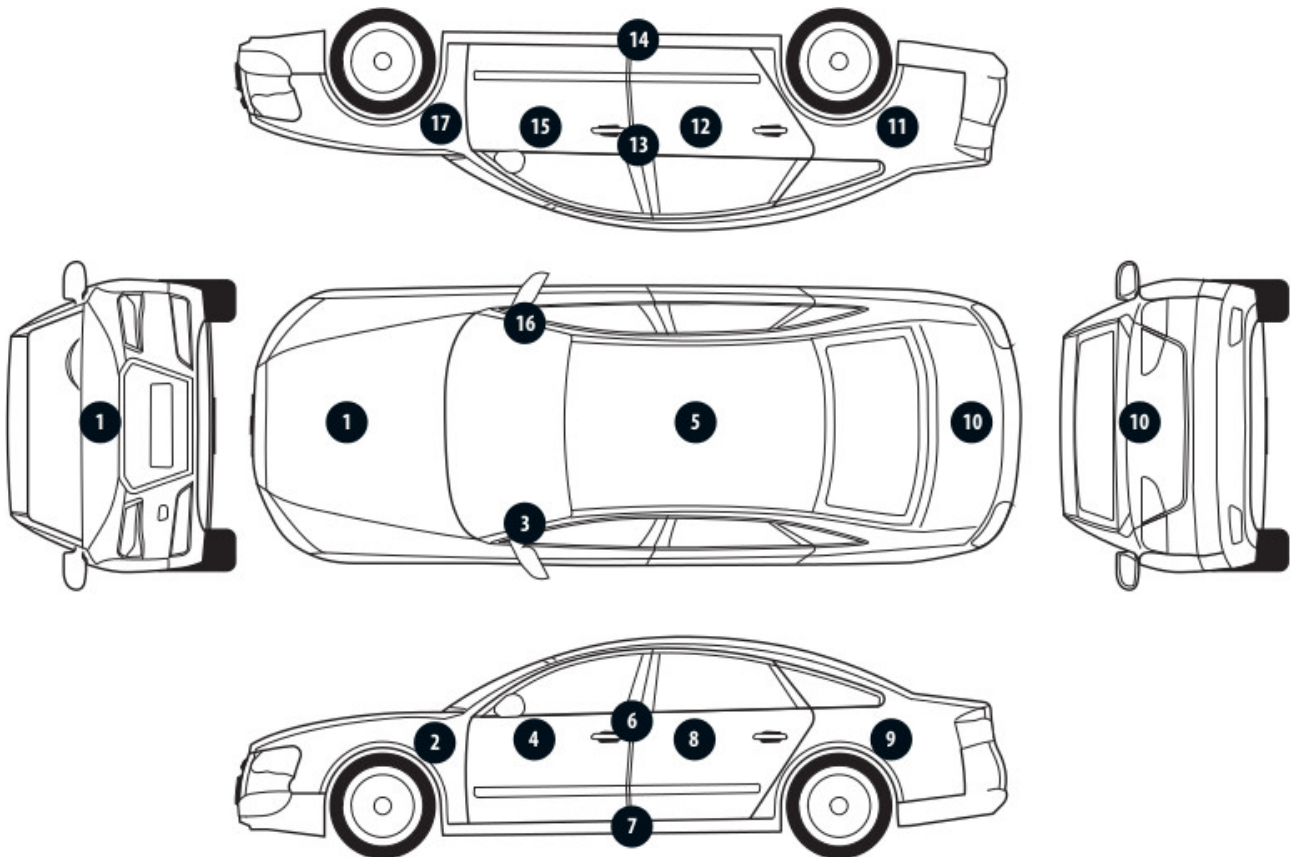
Measurement of thickness of the vehicle lacquer coating

No. of controlled item	Controlled item	Measured range of thickness of the lacquer coat [ $\mu\text{m}$ ]
1	Front cover	to 150
2	Front left fender	to 150
3	Left front pillar	to 150
4	Front left door	to 150
5	Roof	to 150
6	Left middle pillar	to 150
7	Right side sill	to 150
8	Left rear door	to 150
9	Rear left fender	to 150
10	Cover/lid	to 150
11	Right rear fender	150 - 1000
12	Right rear door	to 150
13	Right middle pillar	to 150
14	Right side sill	150 - 300
15	Front right door	150 - 200
16	Right front pillar	150 - 200
17	Front right fender	to 150

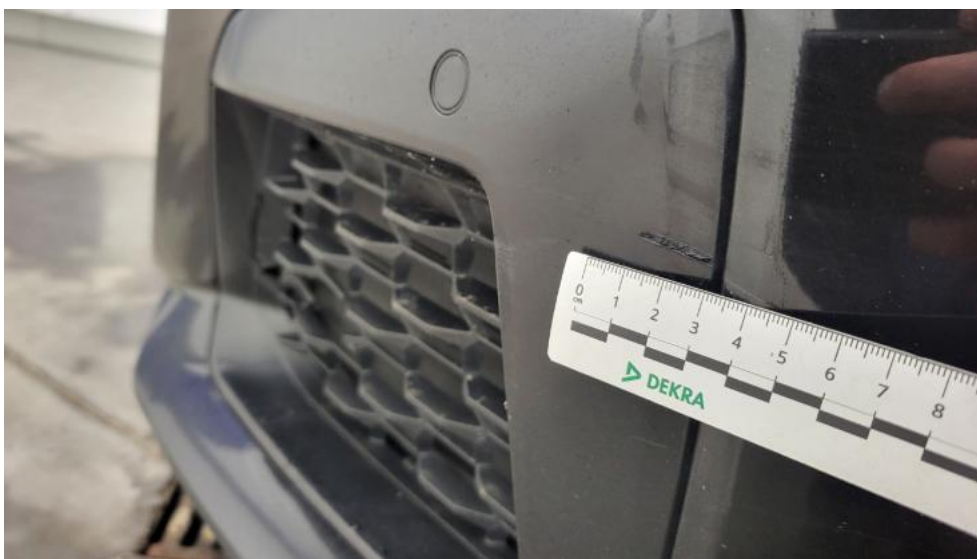
**Photo 39.**  
Kratka/zaślepka halogenu L - Rysa/odprysk 1

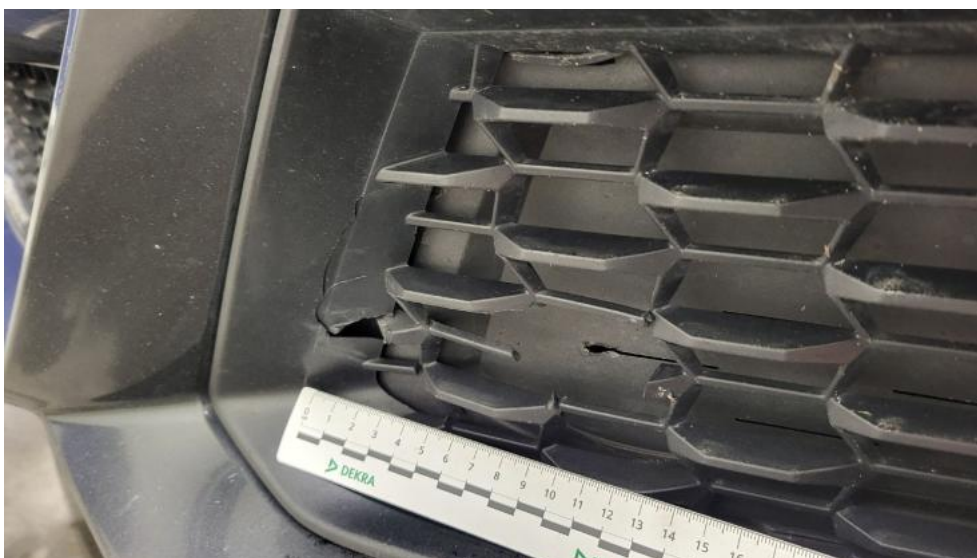
**Photo 40.**  
Kratka/zaślepka halogenu L - Pęknięcie/rozerwanie 1

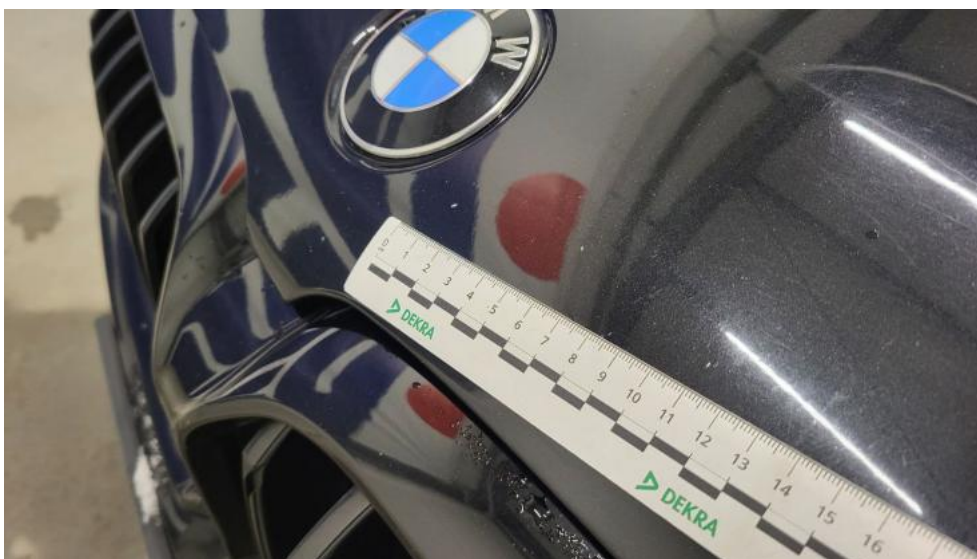
**Photo 41.**  
Pokrywa komory silnika - Rysa/odprysk 1

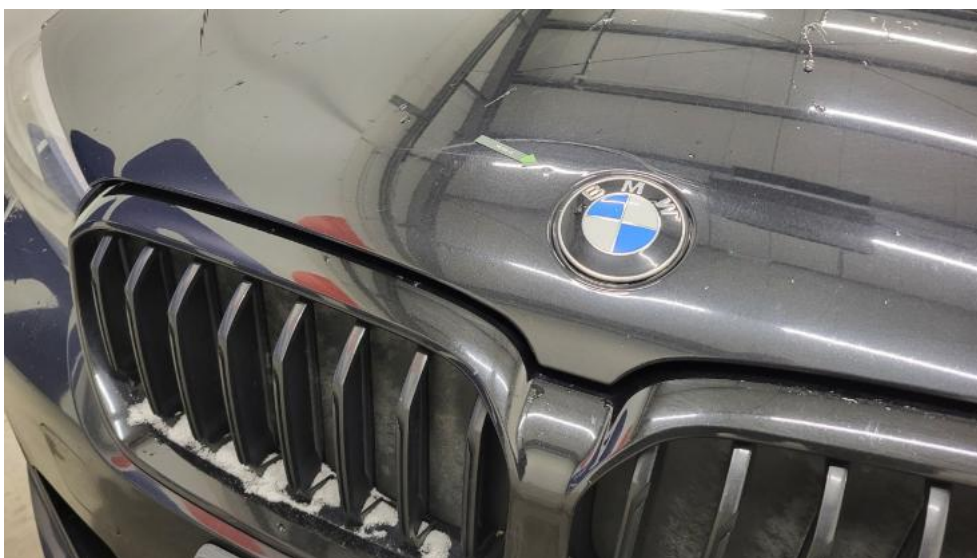
**Photo 42.**  
Pokrywa komory silnika - Wgniecenie/odkształcenie 1

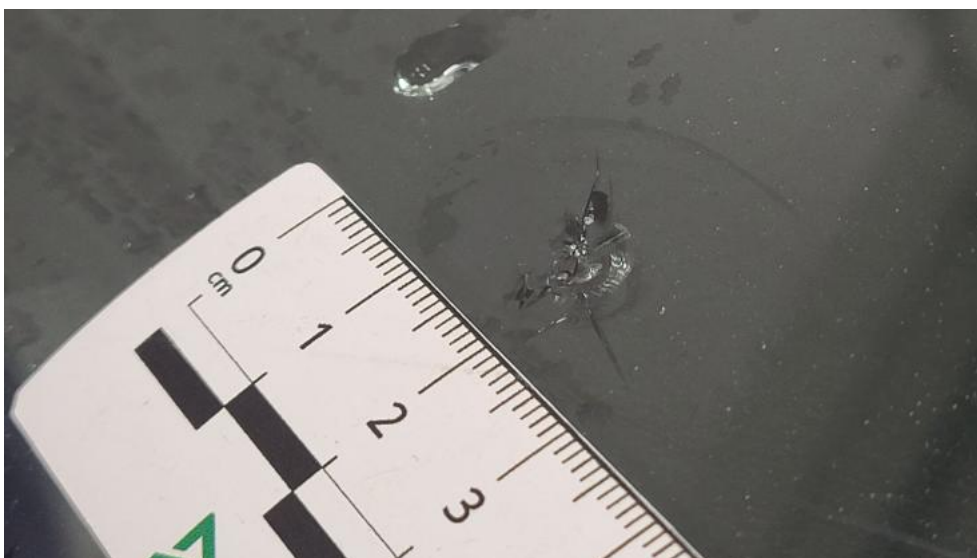
Niesprawne przyciski funkcyjne w jednym z kluczyków, grot prawidłowy. Rysy na samochodzie. Aktywna kontrolka silnika. Odpryski na szybie czołowej. Widoczne wady lakiernicze.

**Photo 44.**  
Szyba czołowa - Pęknięcie/rozerwanie 1

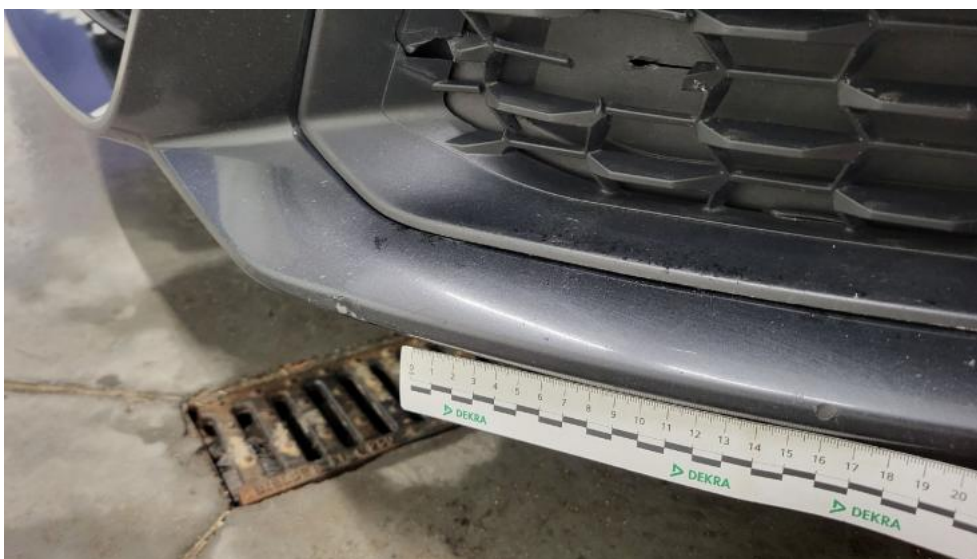
**Photo 45.**

Zderzak - Rysa/odprysk 1

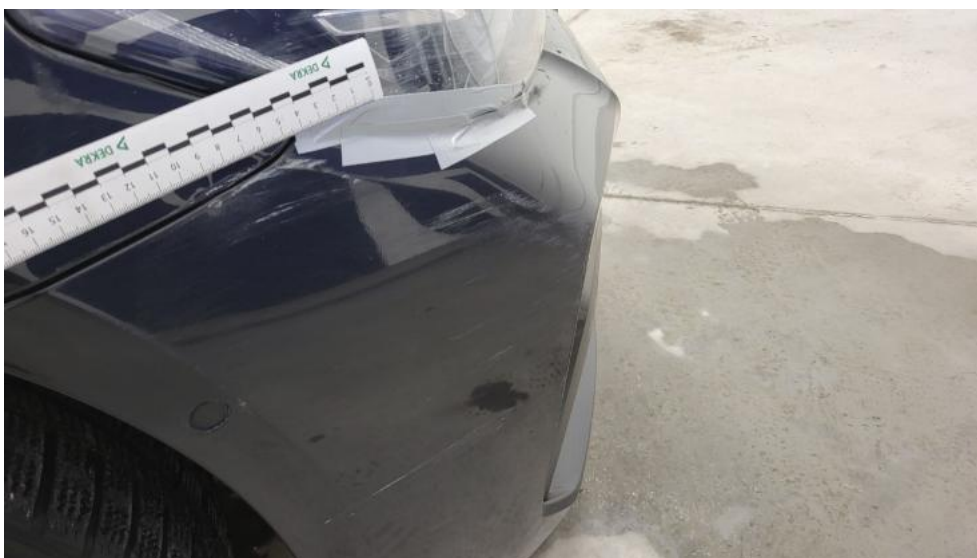
**Photo 46.**

Zderzak - Rysa/odprysk 2

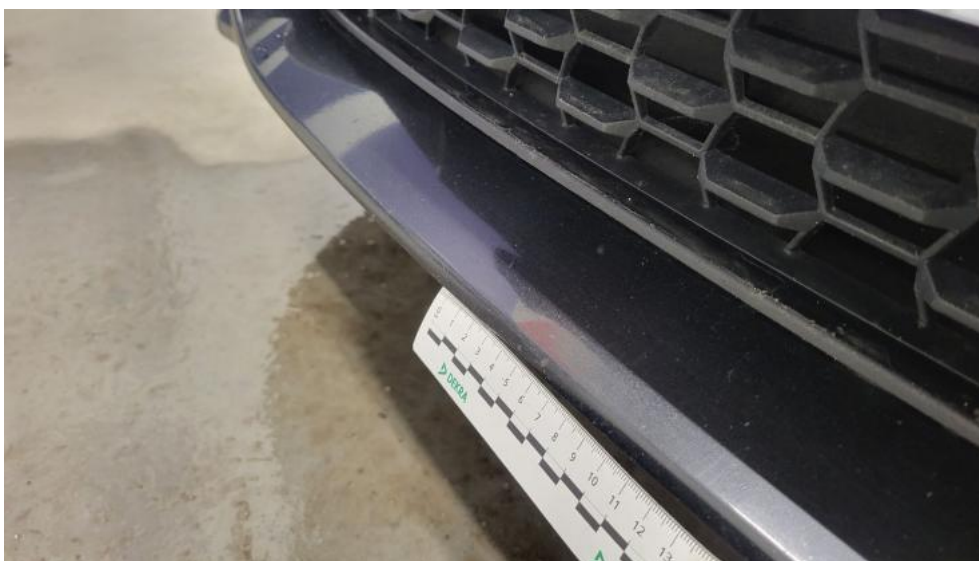
**Photo 47.**

Zderzak - Wgniecenie/odkształcenie 1

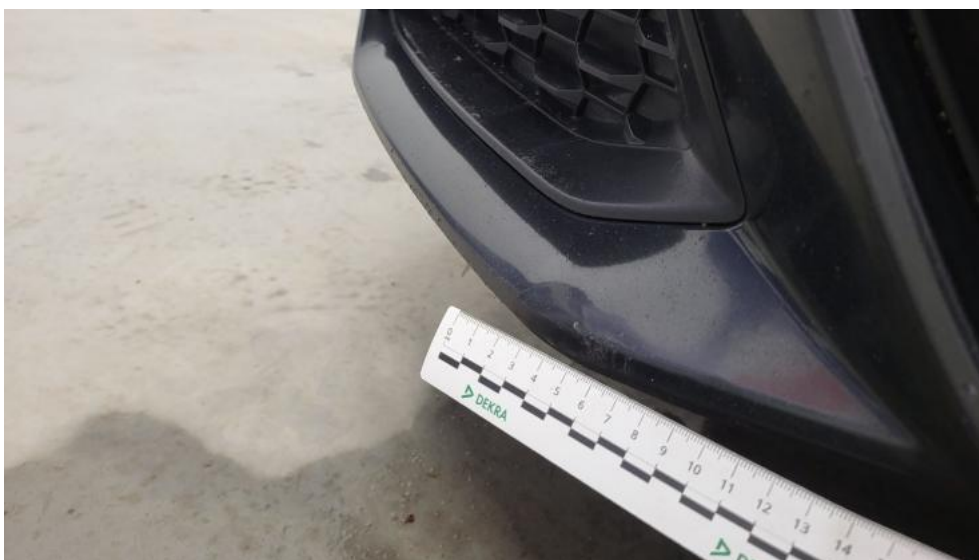
**Photo 48.**

Zderzak - Wgniecenie/odkształcenie 2

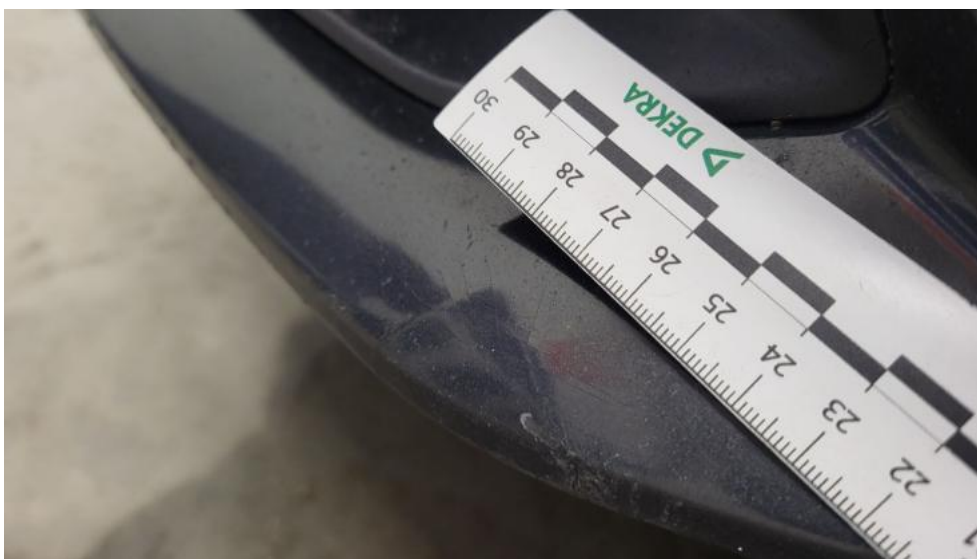
**Photo 49.**  
Zderzak - Pęknięcie/rozerwanie 1

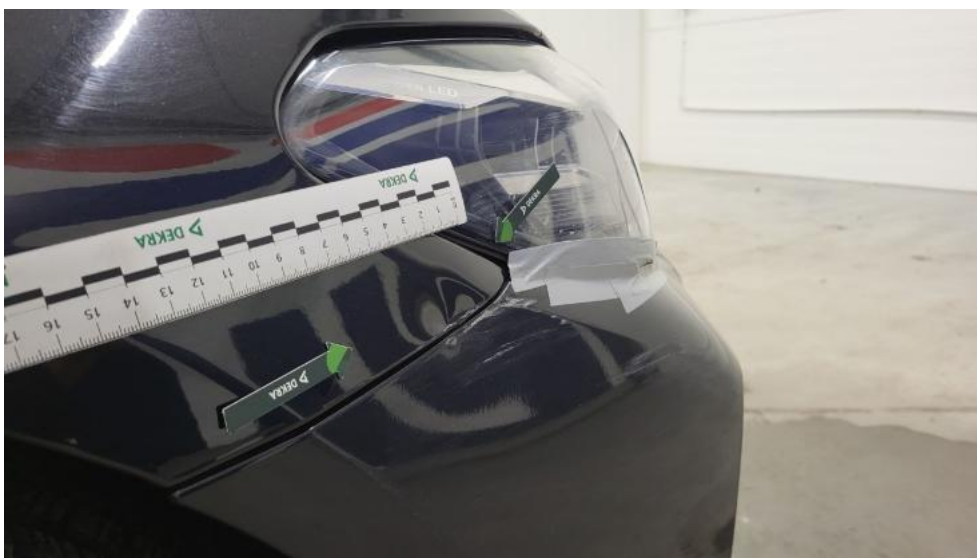
**Photo 50.**  
Błotnik przedni P - Wgniecenie/odkształcenie 1

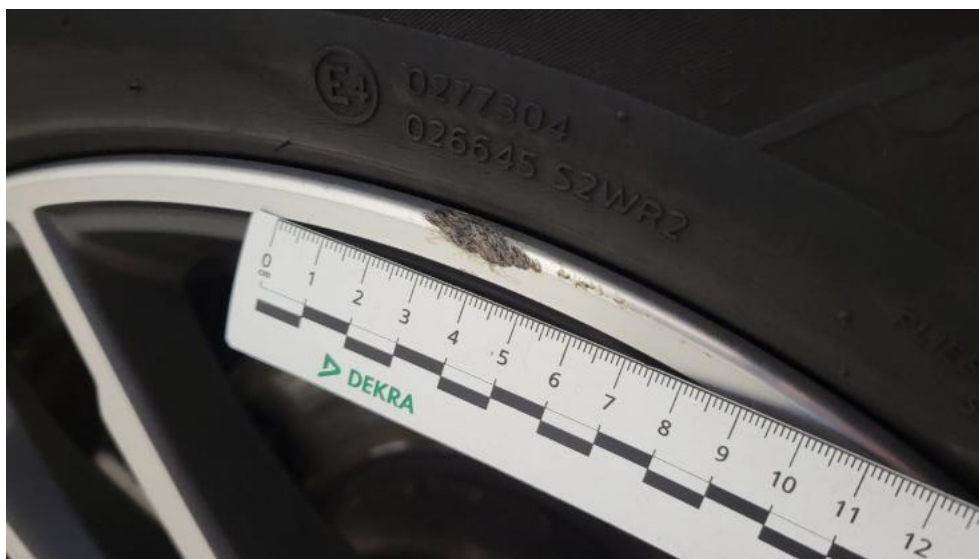
**Photo 51.**  
Felga aluminiowa przednia P - Rysa/odprysk 1

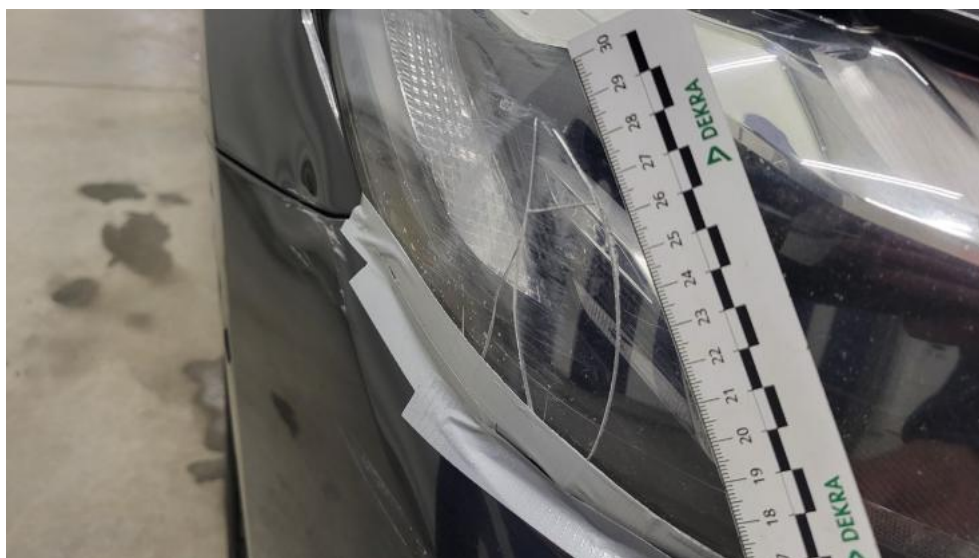
**Photo 52.**  
Reflektor P - Pęknięcie/rozerwanie 1

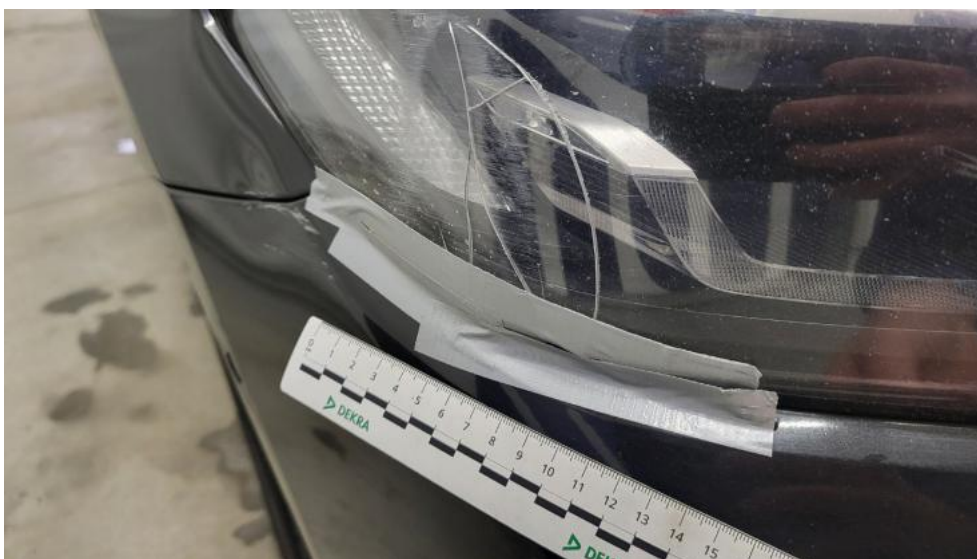
**Photo 53.**  
Reflektor P - Inne 1

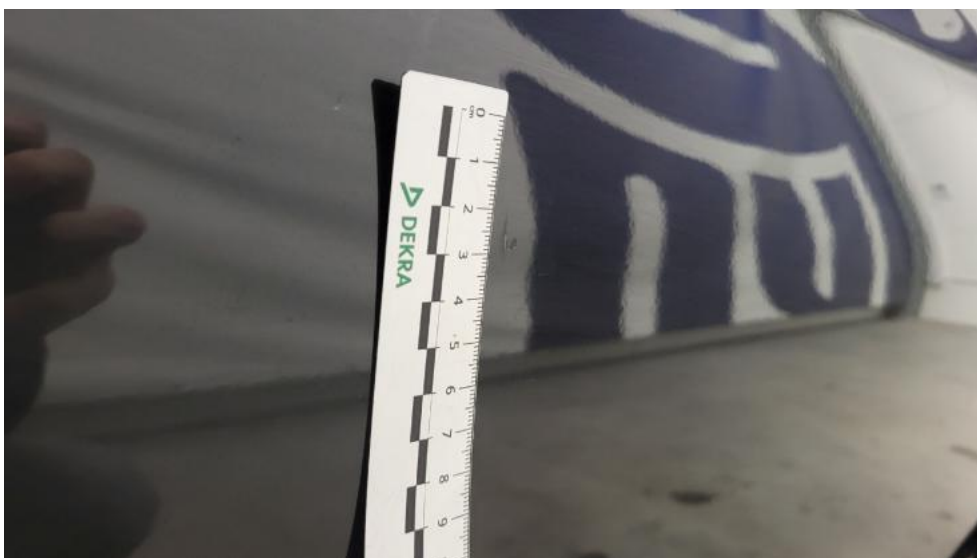
**Photo 54.**  
Drzwi przednie P - Rysa/odprysk 1

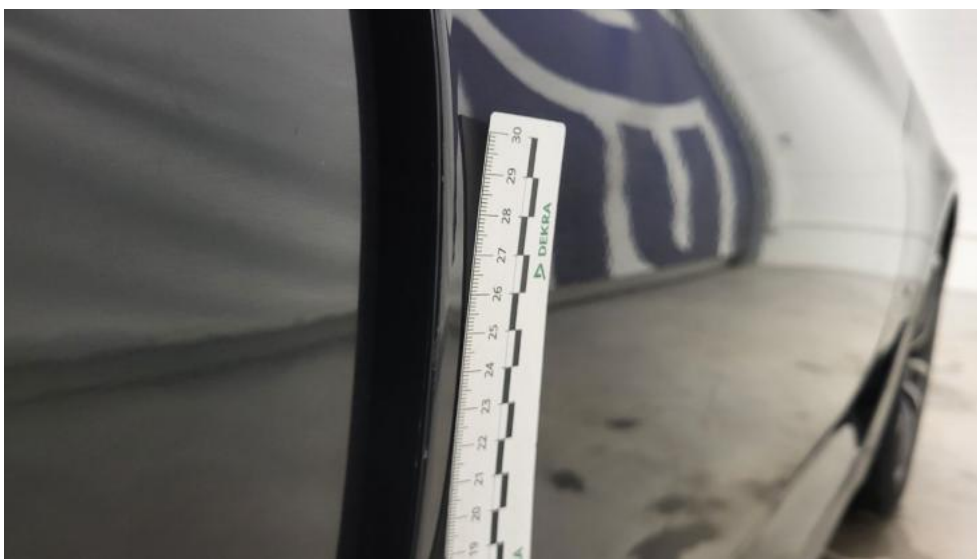
**Photo 55.**  
Drzwi przednie P - Rysa/odprysk 2

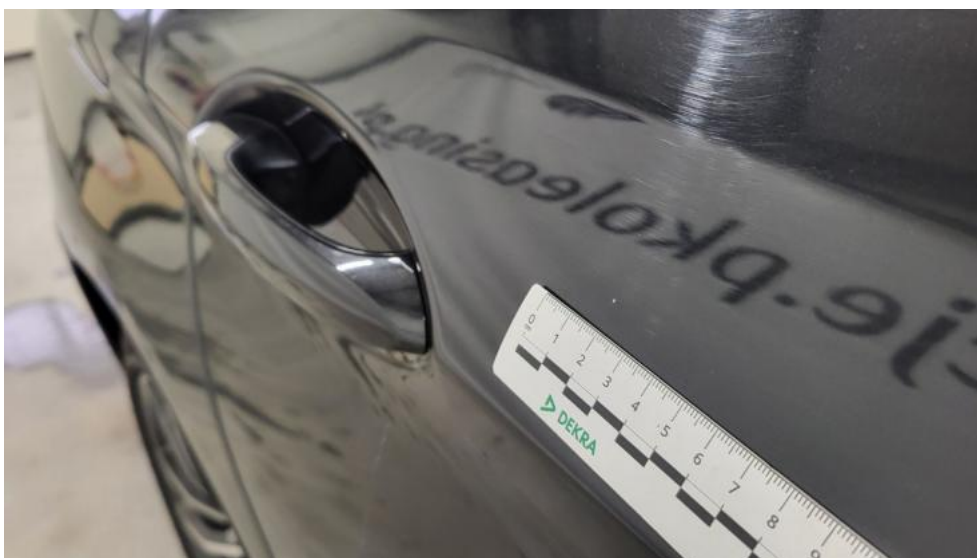
**Photo 56.**  
Drzwi tylne P - Rysa/odprysk 1

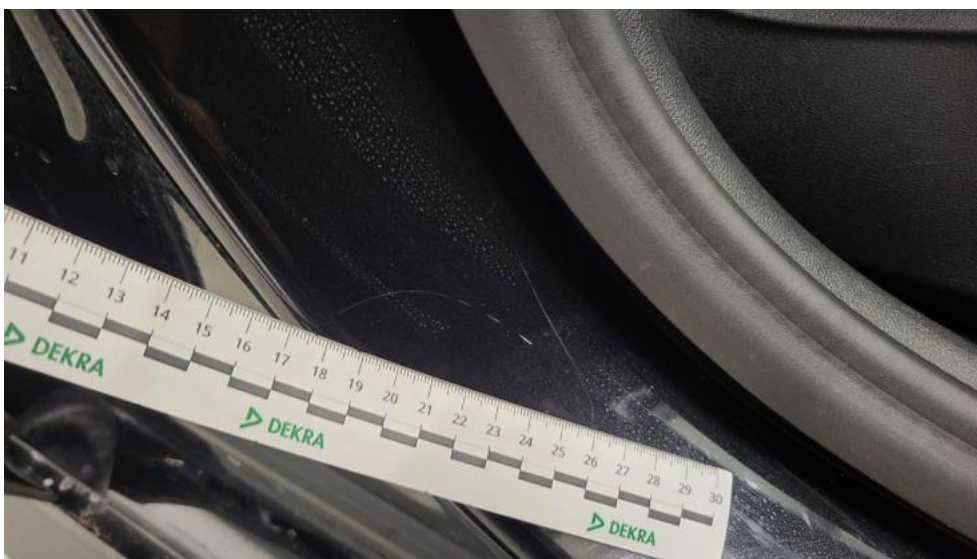
**Photo 57.**

Stupek środkowy P - Rysa/odprysk 1

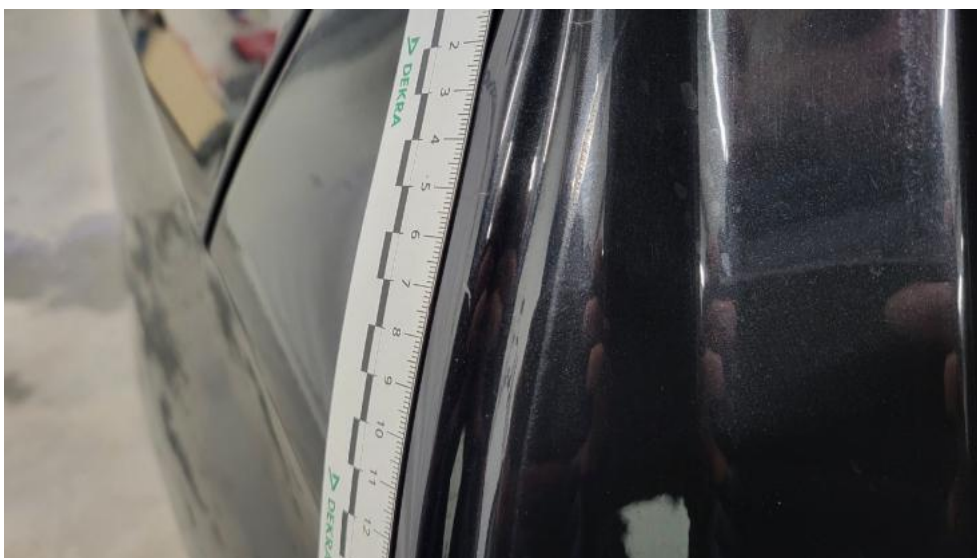
**Photo 58.**

Błotnik tylny P / Ściana boczna P - Rysa/odprysk 1

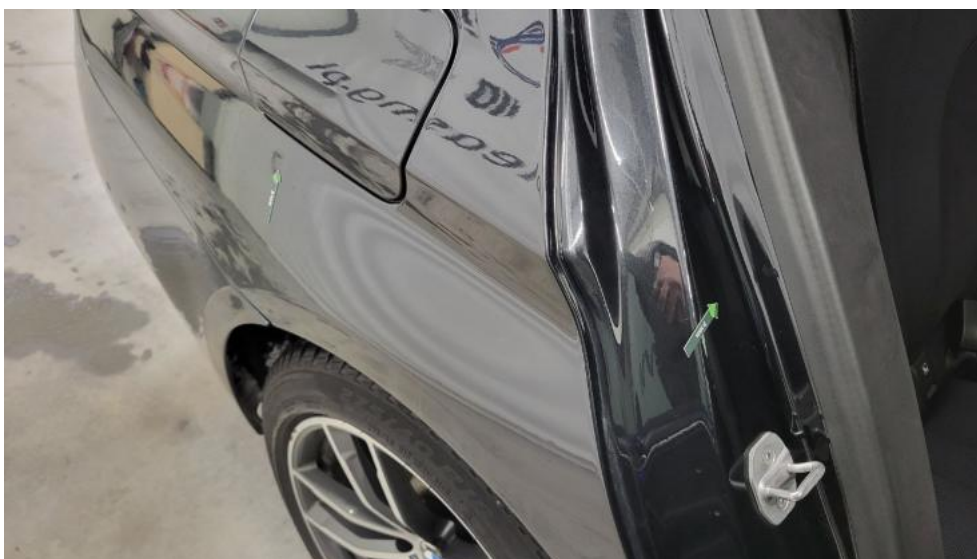
**Photo 59.**  
Błotnik tylny P / Ściana boczna P - Wgniecenie/odkształcenie 1

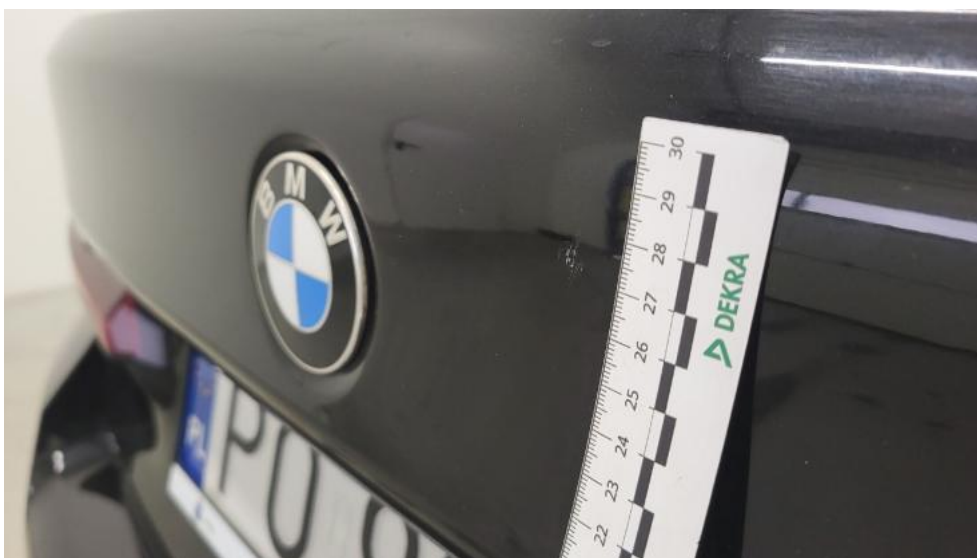
**Photo 60.**  
Pokrywy bagażnika - Rysa/odprysk 1

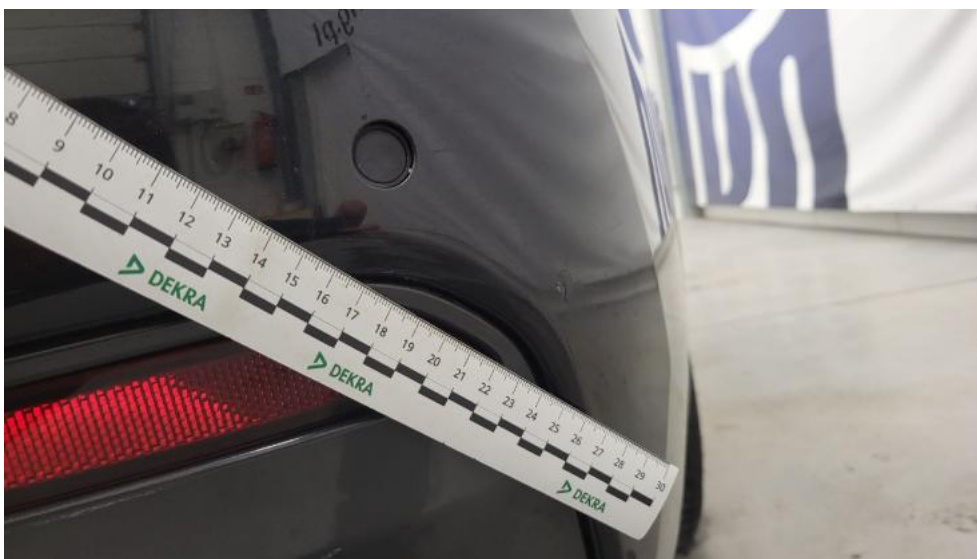
**Photo 61.**

Zderzak tylny - Rysa/odprysk 1

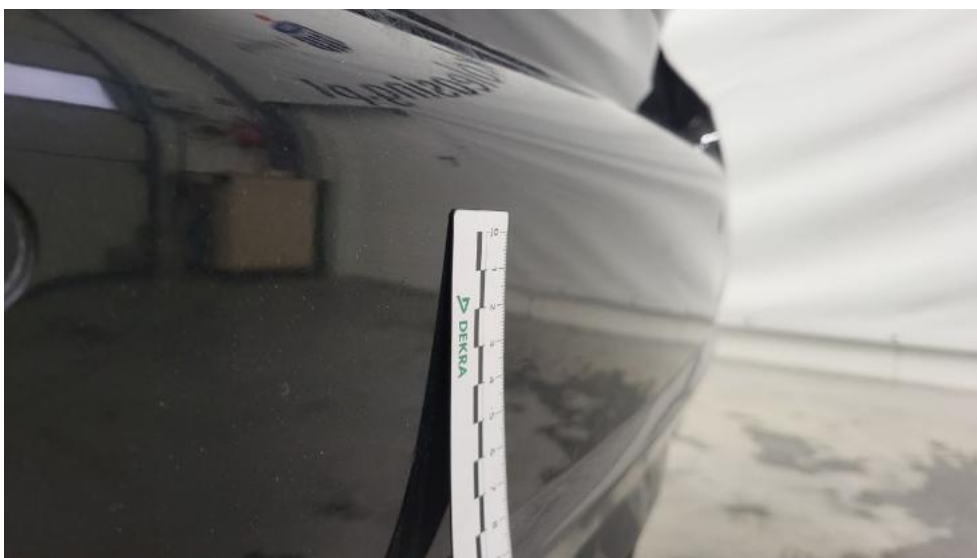
**Photo 62.**

Zderzak tylny - Wgniecenie/odkształcenie 1

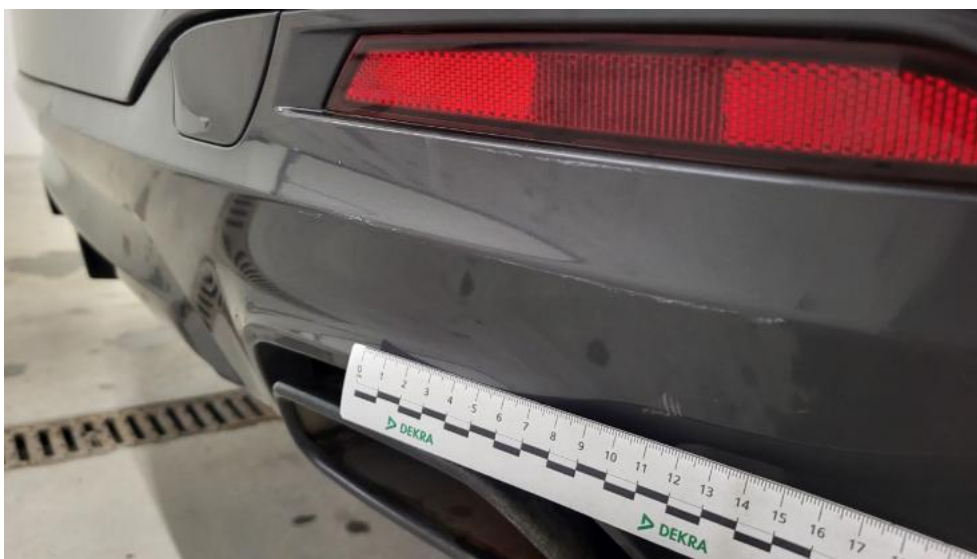
**Photo 63.**  
Zderzak tylny cz dolna - Rysa/odprysk 1

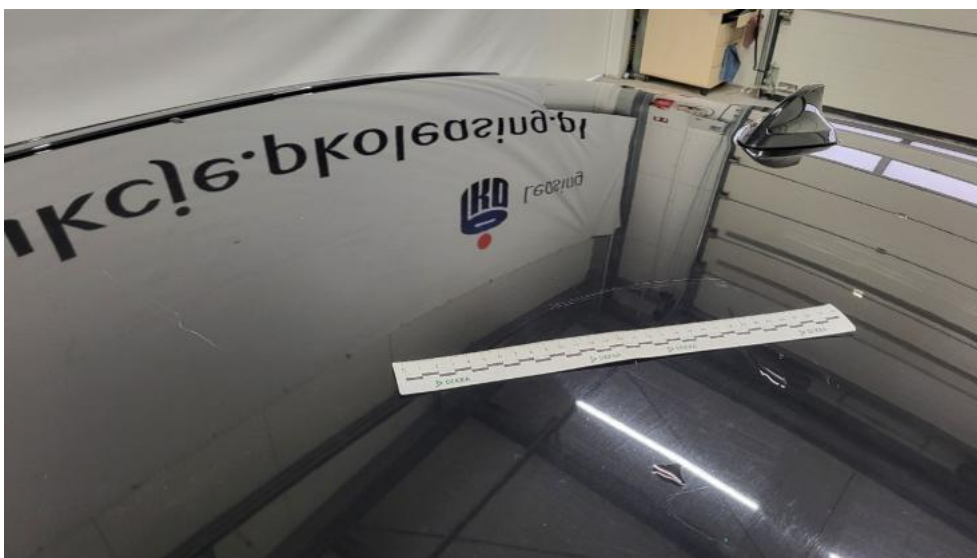
**Photo 64.**  
Dach - Rysa/odprysk 1

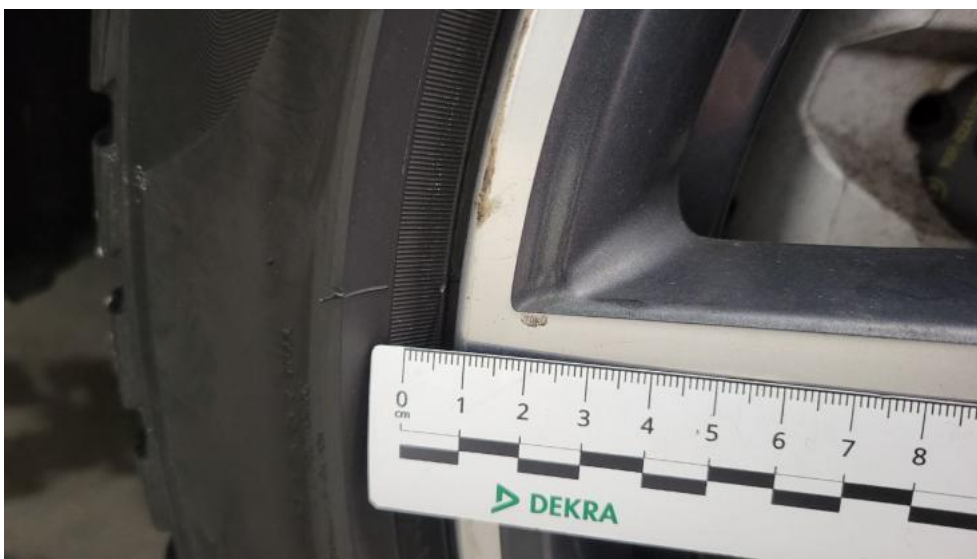
**Photo 65.**  
Felga aluminiowa tylna L - Rysa/odprysk 1

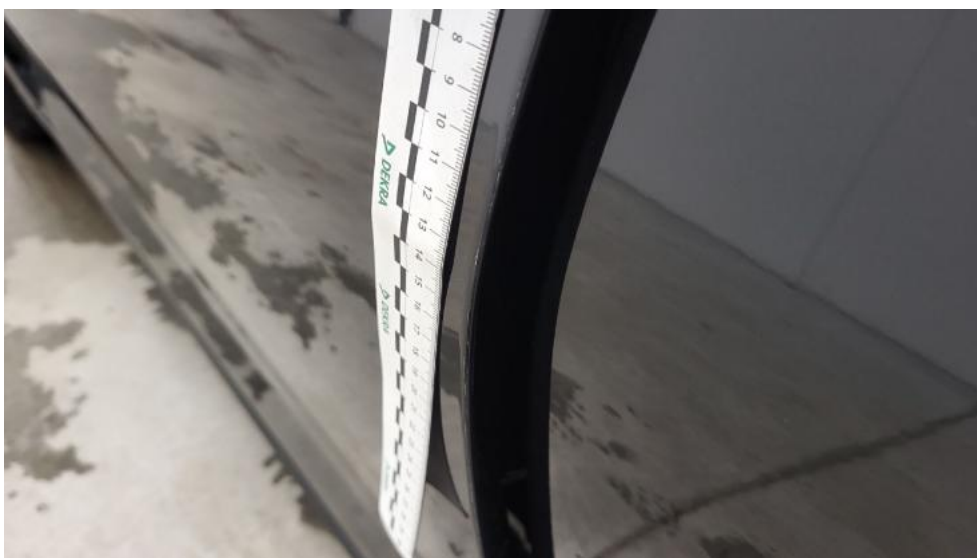
**Photo 66.**  
Drzwi przed L - Rysa/odprysk 1

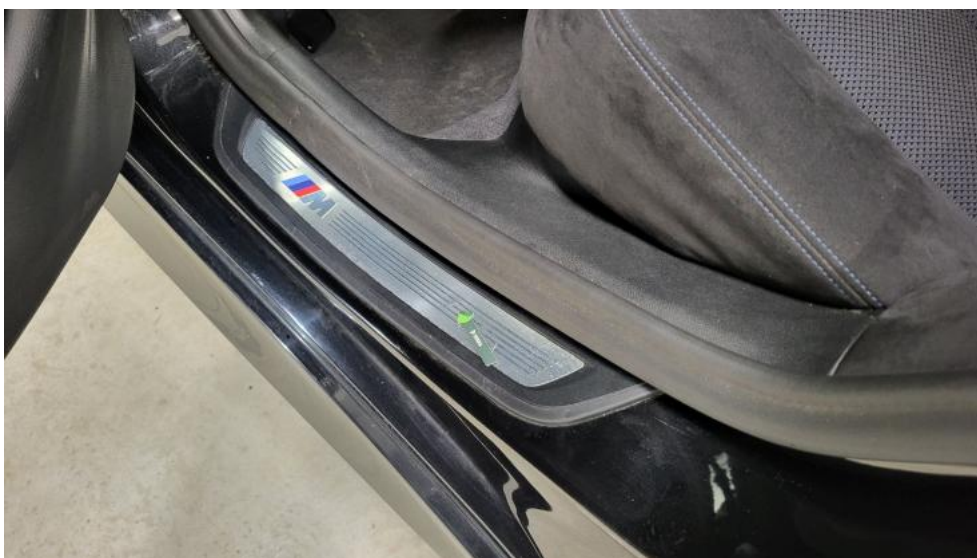
**Photo 68.**  
Próg L - Wgniecenie/odkształcenie 1

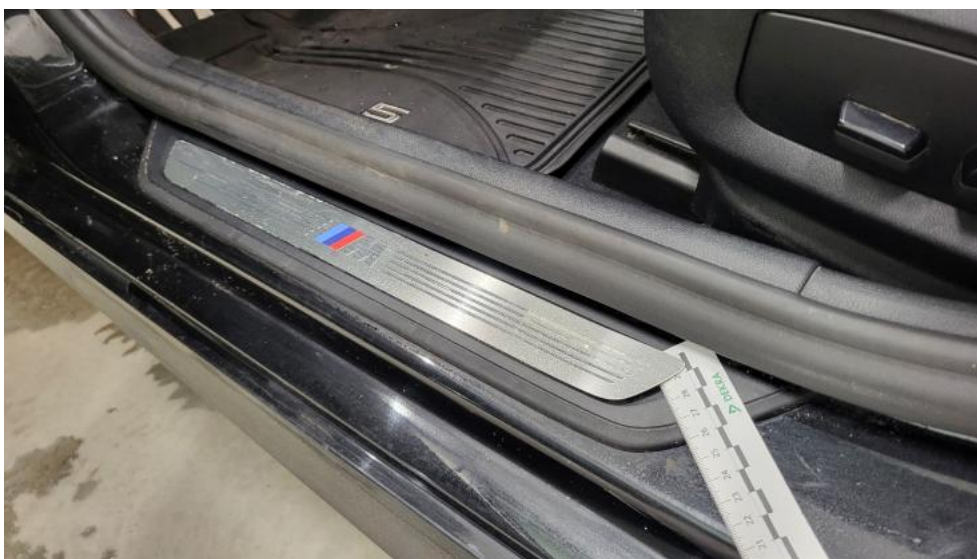
**Photo 69.**  
Próg L - Inne 1

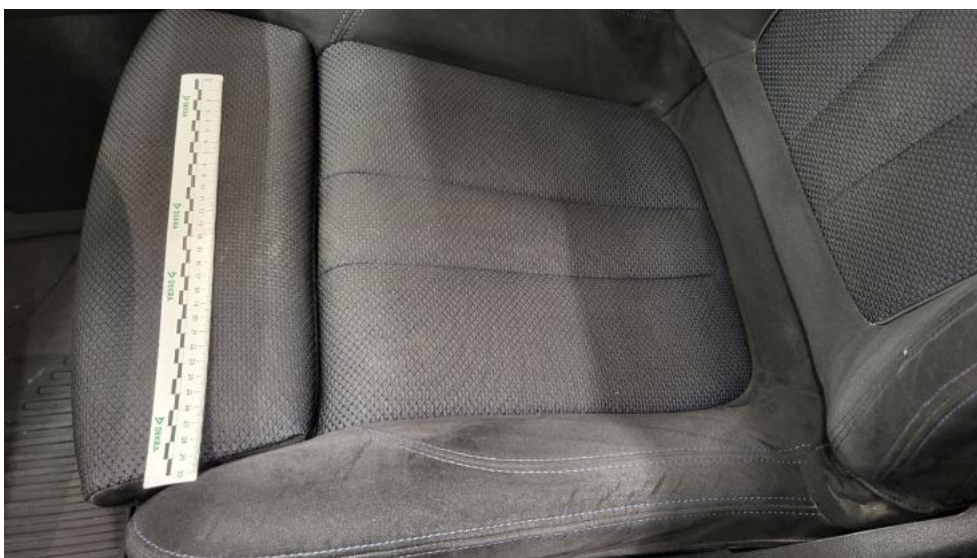
**Photo 70.**  
Fotel prz. lew. - Inne 1

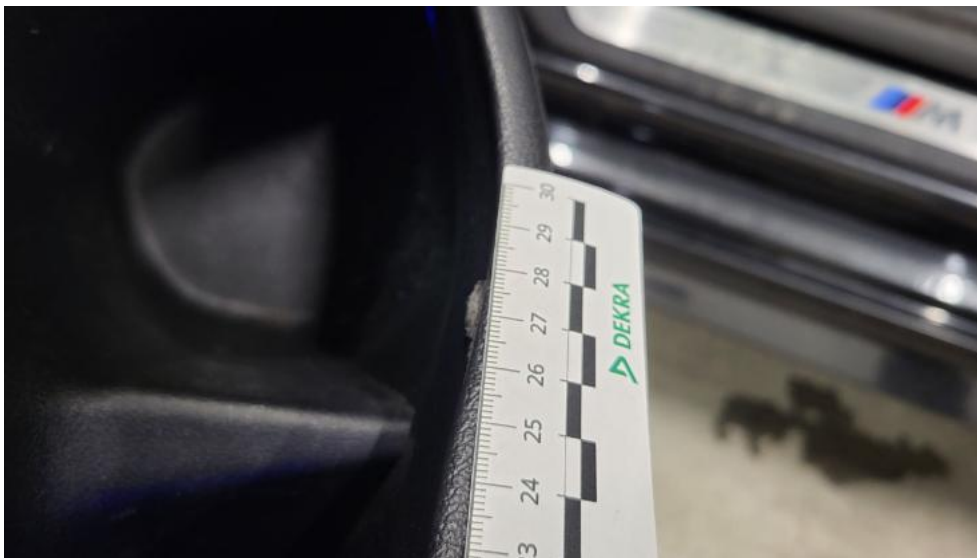
**Photo 71.**  
Tapicerka drzwi przednich L - Pęknięcie/rozerwanie 1

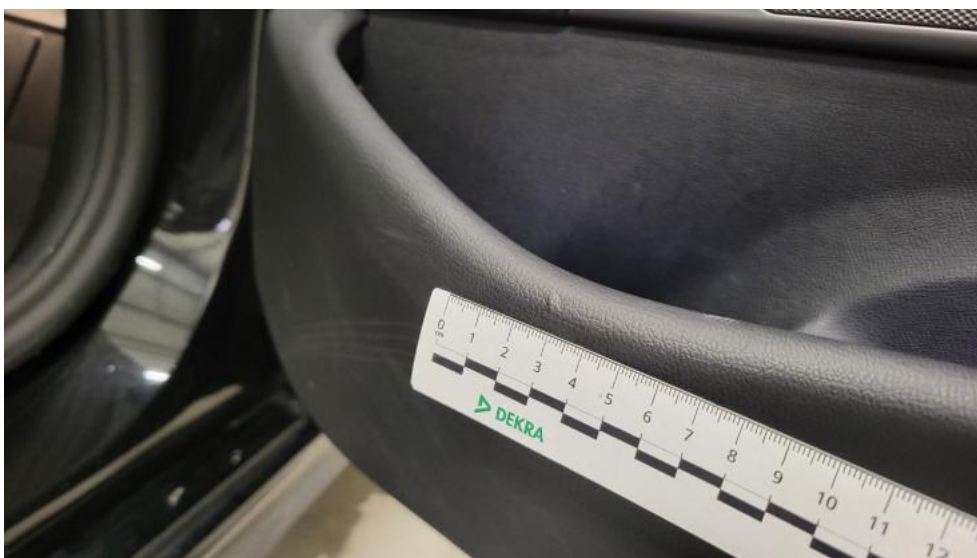
**Photo 72.**  
Tapicerka drzwi przednich P - Wgniecenie/odkształcenie 1

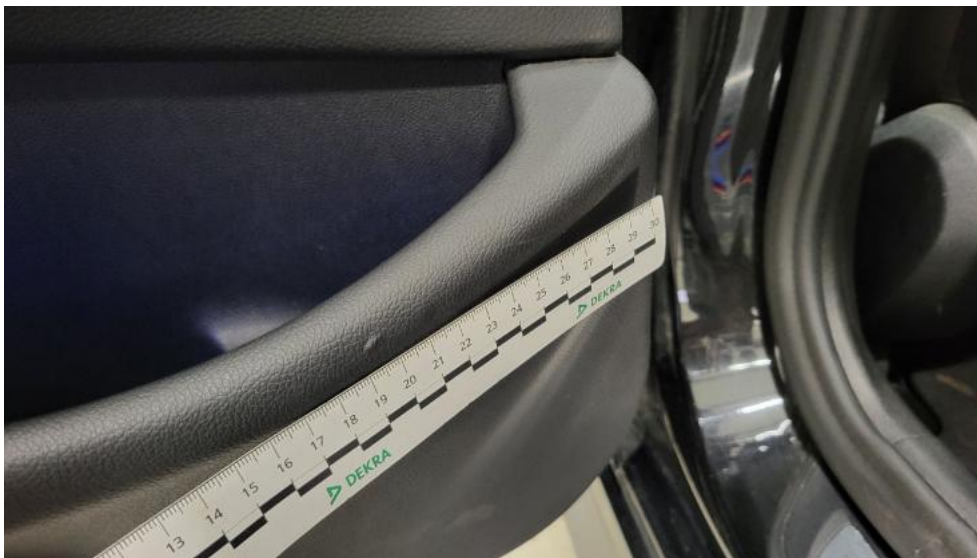
**Photo 73.**  
Tapicerka drzwi tylnych L - Wgniecenie/odkształcenie 1

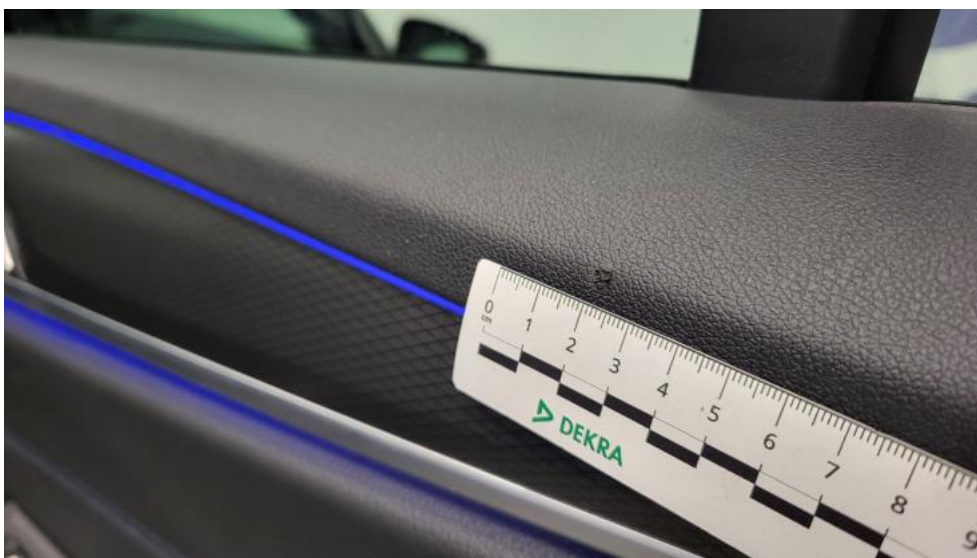
**Photo 74.**  
Tapicerka drzwi tylnych P - Rysa/odprysk 1

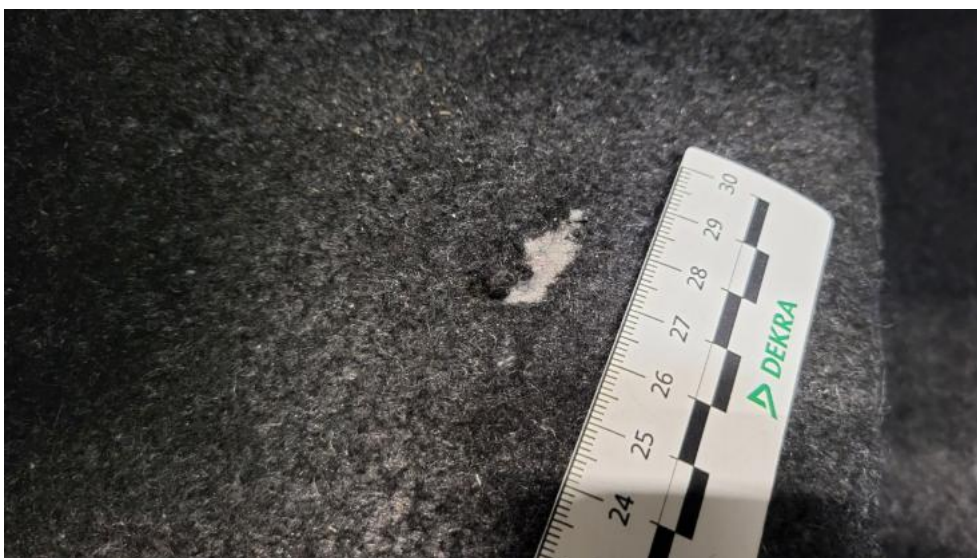
**Photo 76.**

Wykładzina podłogi bagażnika - Pęknięcie/rozerwanie 1
