DEKRA's commission No. : PKOL(W)/LODZ/22560/26/03/13
 commission/ damage No. : 25/044030
 Date of commission: 13-03-2026

Group of objects (Eurotax)	cars
EC code (Eurotax)	0137425
Manufacturer	MERCEDES-BENZ
Model	CLA [C 118] 19-23
Type / version	CLA 200 AMG Line 7G-DCT
Body type	sedan
Number of doors / seats	4/5
Curb weight [kg]	1405
Gross vehicle weight [kg]	1950
Wheelbase 1/2	2729
Engine type	spark ignition
Pollution reduction system	GPF
Engine capacity [ccm]	1332
Engine Power [hp/kW]	163/120
Gearbox	automatic
Registration /record No.	DX89976
VIN / serial number	W1K1183871N132763
Date of first registration	17-08-2020
Date of next. tech. test	22-08-2026
Year of manufacture	2020
Readout [km]	78 495 (read)
Body color / type of coating	white/double-layered, metallized

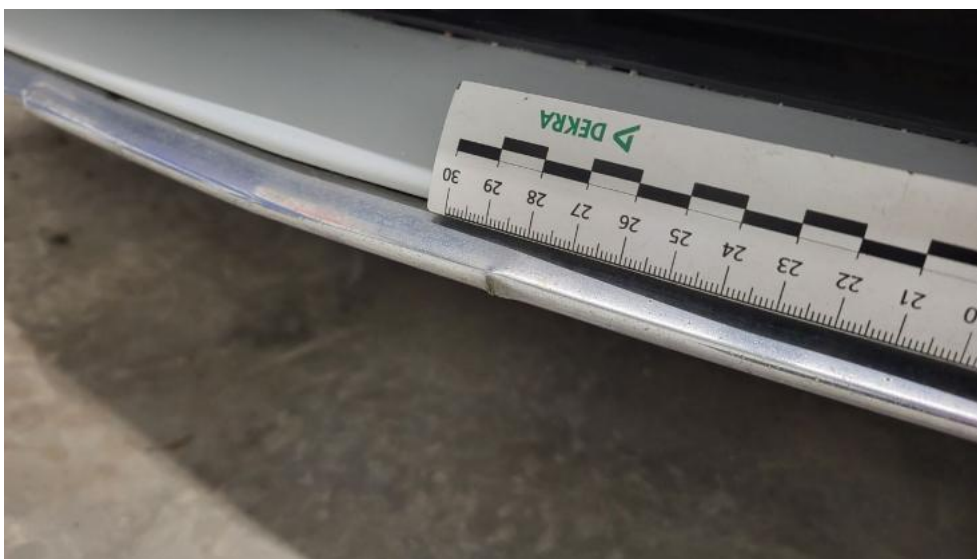
Photo 43.

Spoiler zderzaka przedniego - Wgniecenie/odkształcenie 1

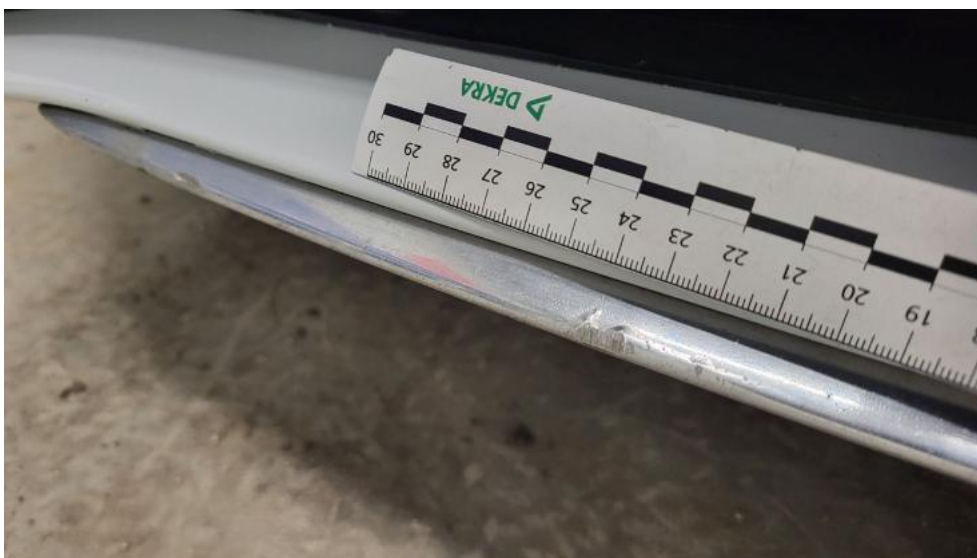
Photo 44.

Spoiler zderzaka przedniego - Wgniecenie/odkształcenie 2

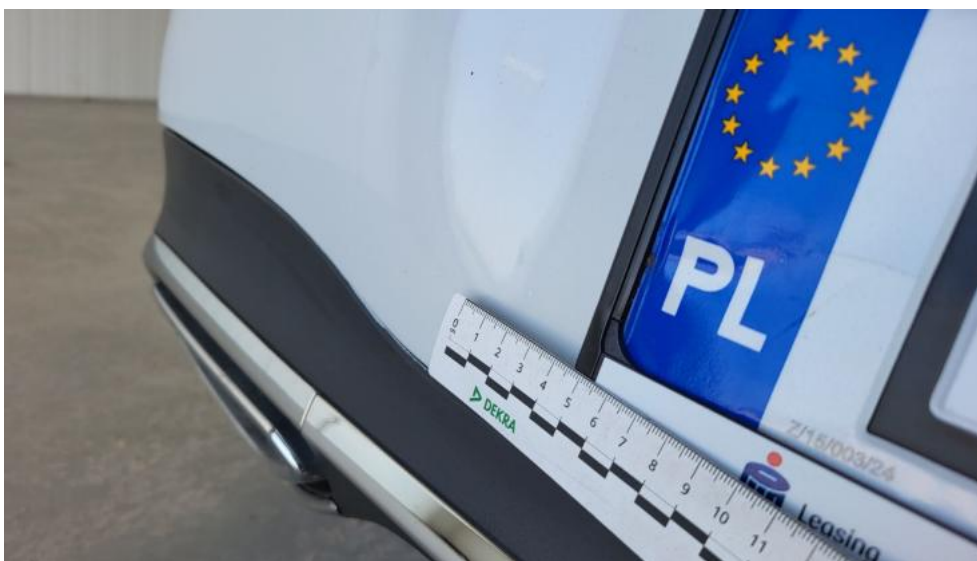
Photo 51.
Zderzak tylny - Wgniecenie/odkształcenie 1

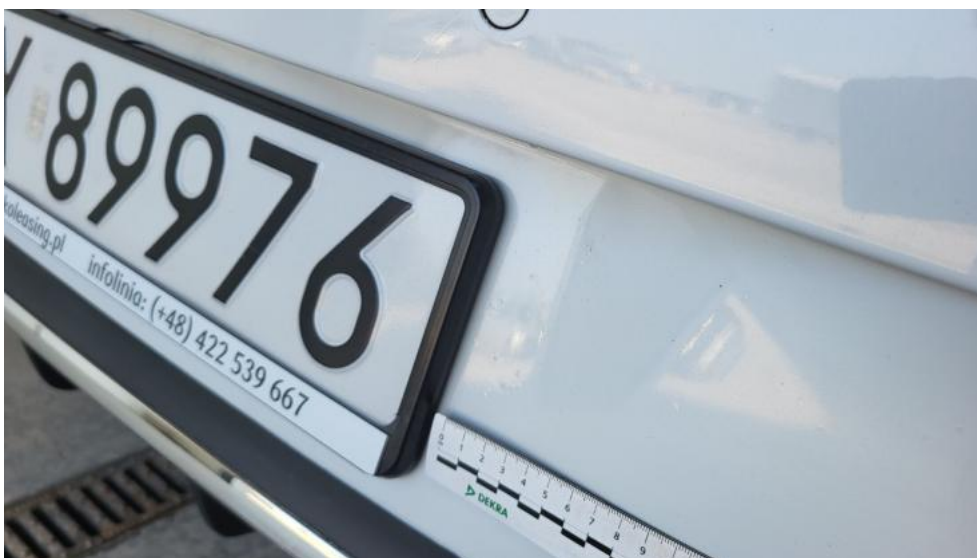
Photo 52.
Zderzak tylny - Wgniecenie/odkształcenie 2

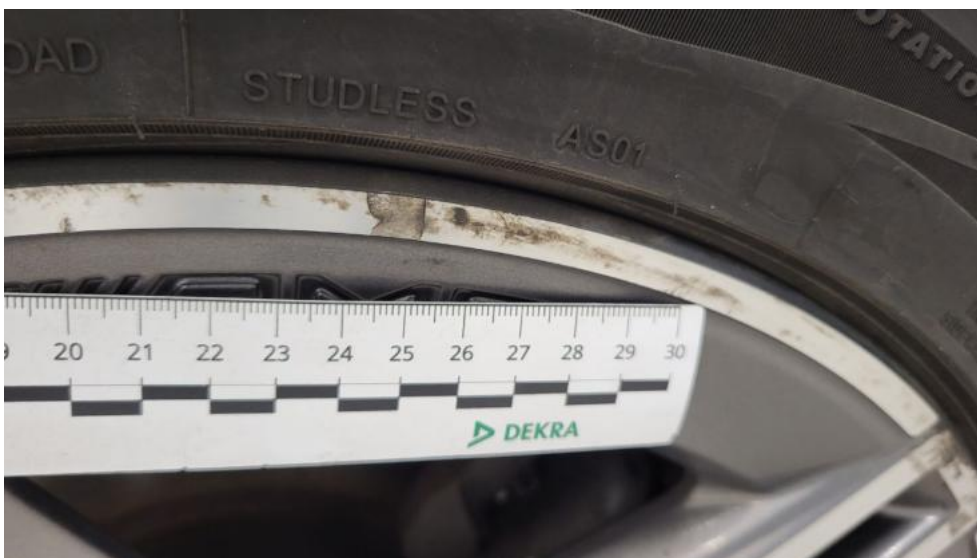
Photo 54.
Felga aluminiowa tylna L - Rysa/odprysk 1

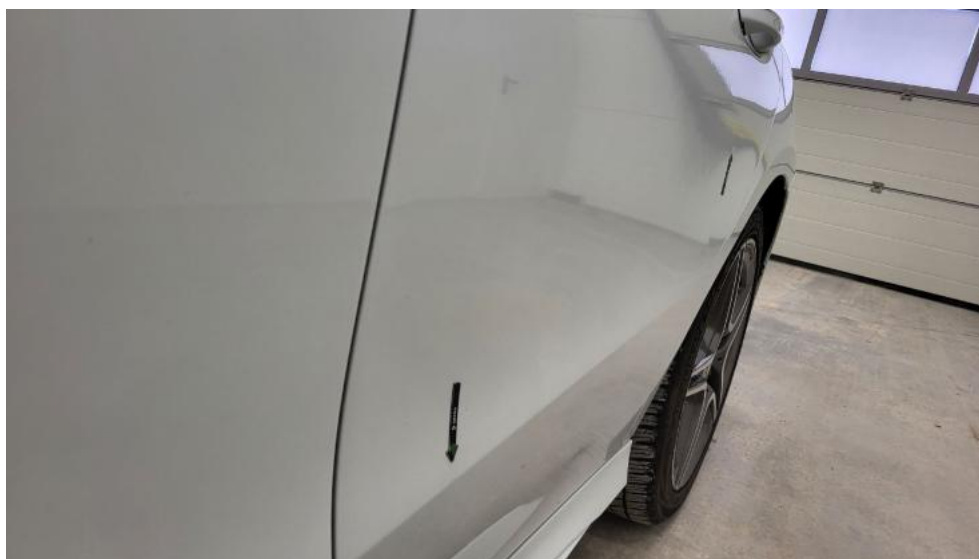
Photo 57.
Drzwi tylne L - Wgniecenie/odkształcenie 1

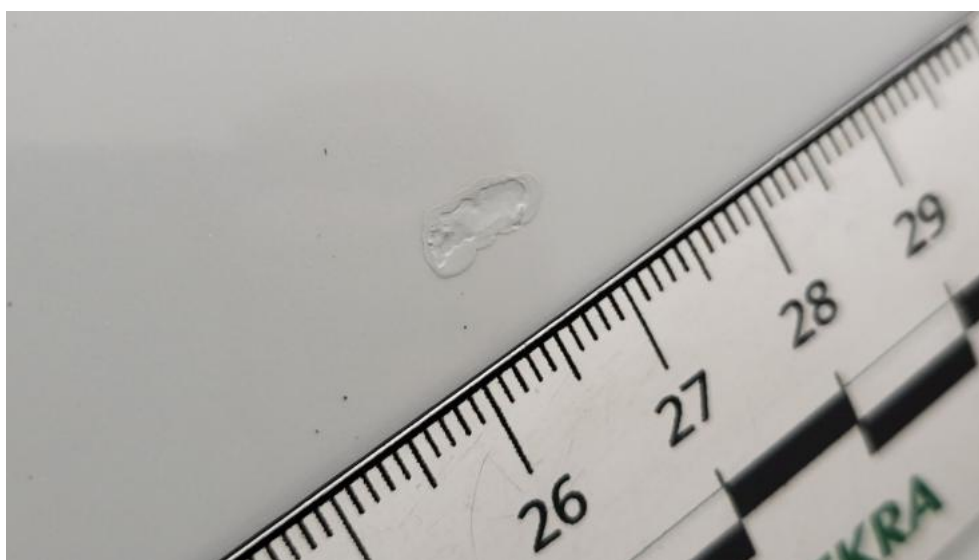
Photo 58.
Drzwi tylne L - Inne 1

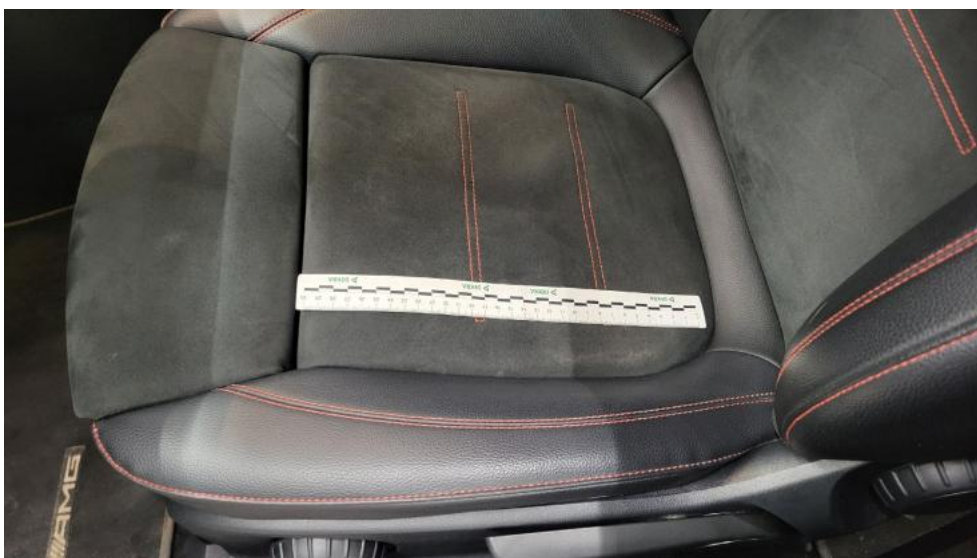
Photo 62.

Fotel prz. lew. - Inne 1

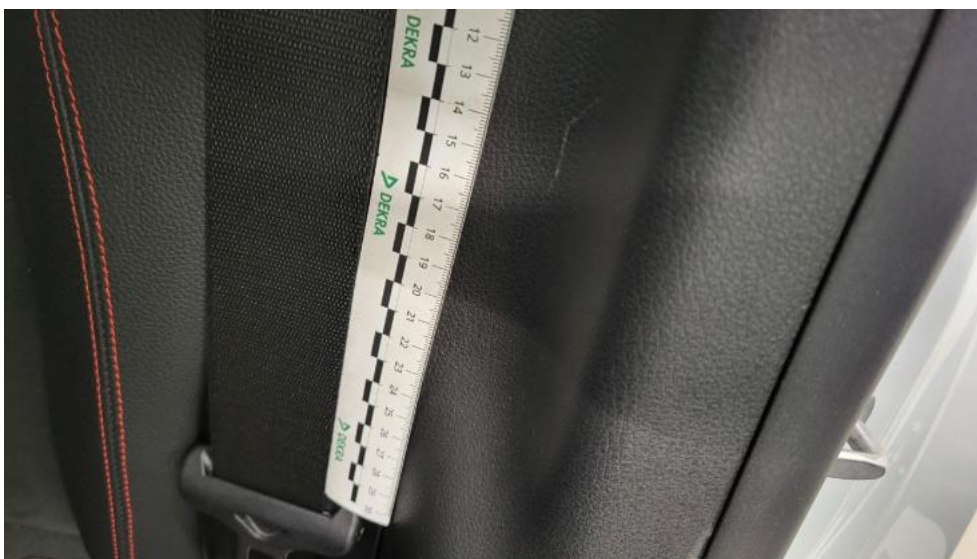
Photo 63.

Wykładzina(y) słupka tylnego L - Rysa/odprysk 1
