DEKRA's commission No. : PKOL(W)/LODZ/20588/26/03/09
 commission/ damage No. : 23/013831
 Date of commission: 09-03-2026

Vehicle data

Measurement of thickness of the vehicle lacquer coating

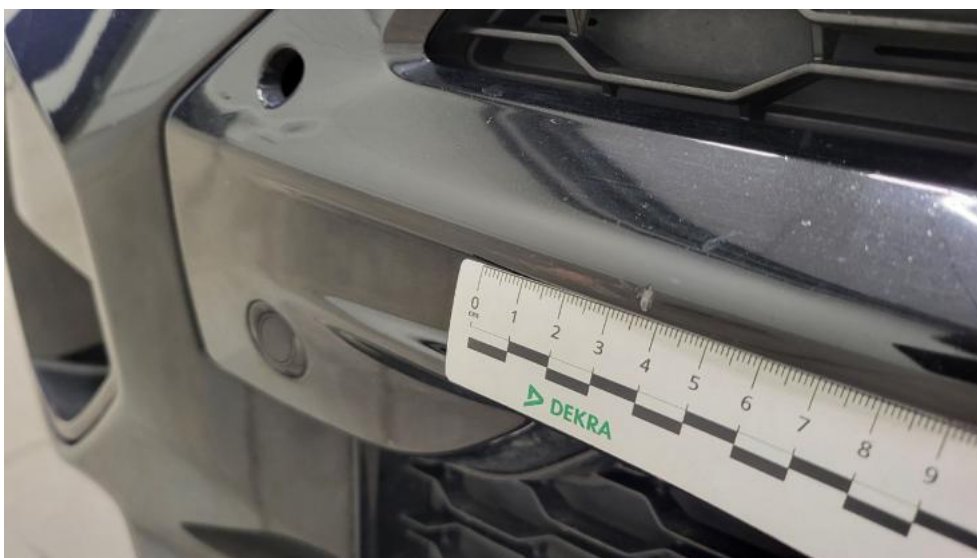
Photo 42.
Kratka/zaślepka halogenu L - Rysa/odprysk 1

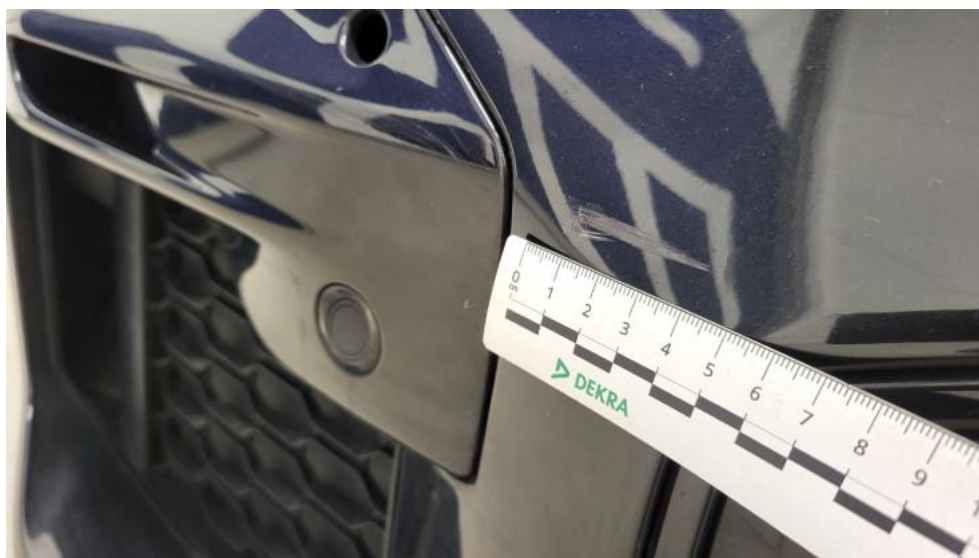
Photo 46.
Zderzak - Rysa/odprysk 1

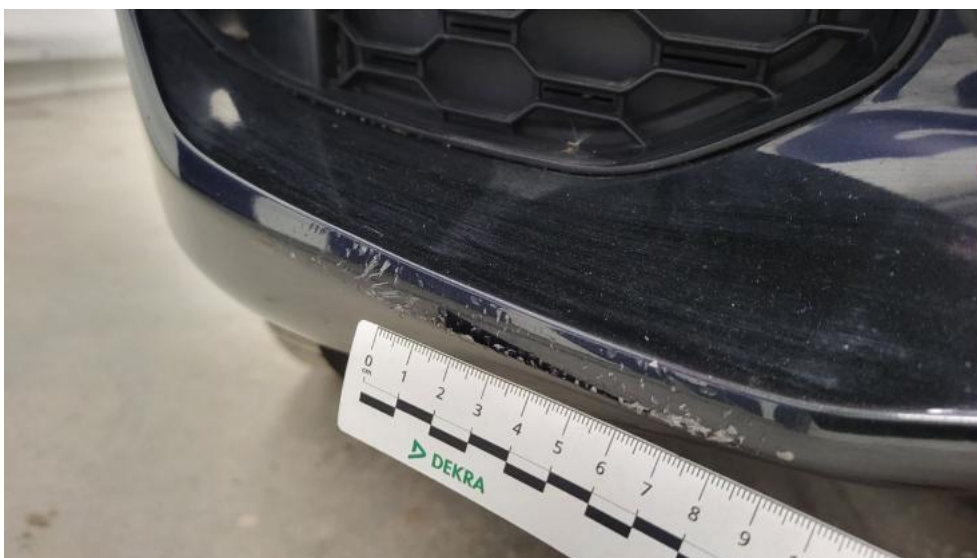
Photo 48.
Zderzak() - Rysa/odprysk 3

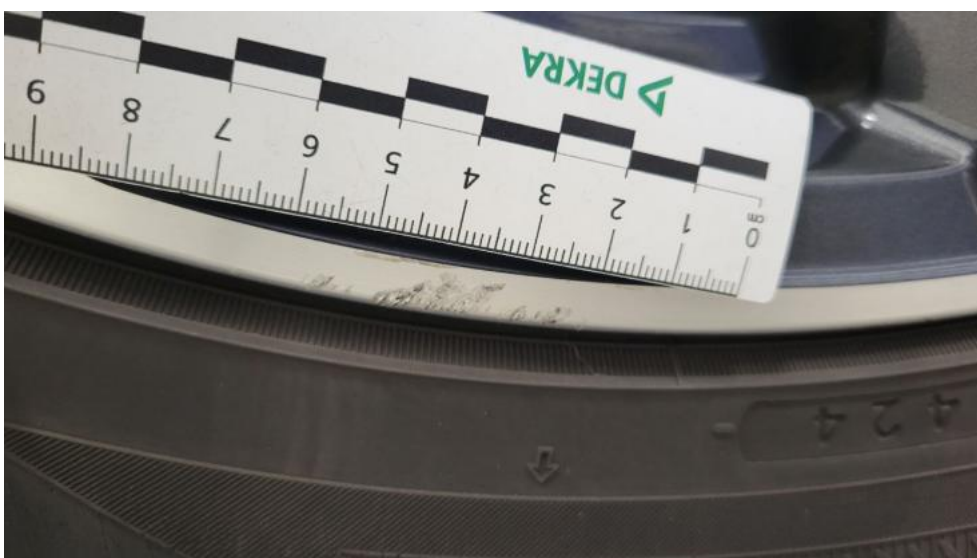
Photo 50.
Felga aluminiowa przednia P - Rysa/odprysk 1

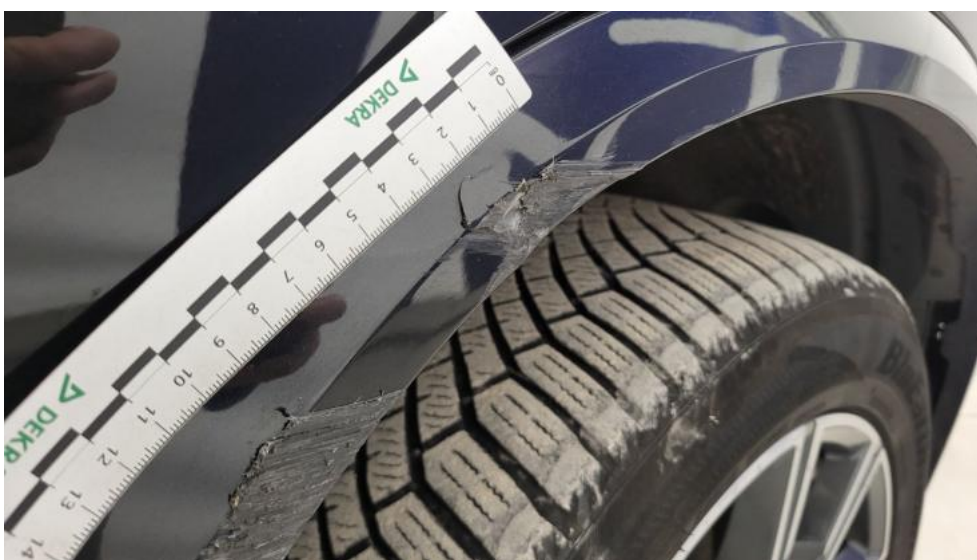
Listwa błotnika przedniego P - Wgniecenie/odkształcenie 1

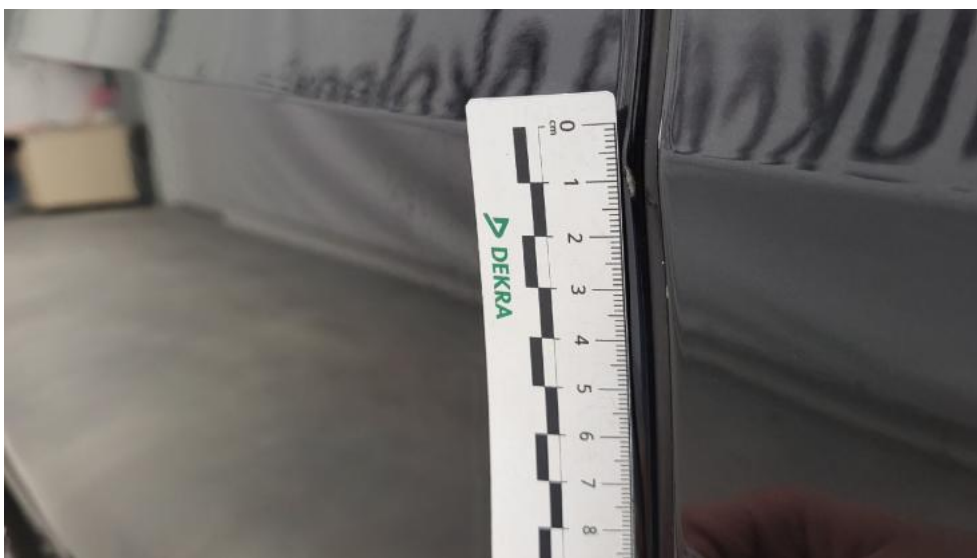
Photo 56.
Drzwi tylne P - Rysa/odprysk 1

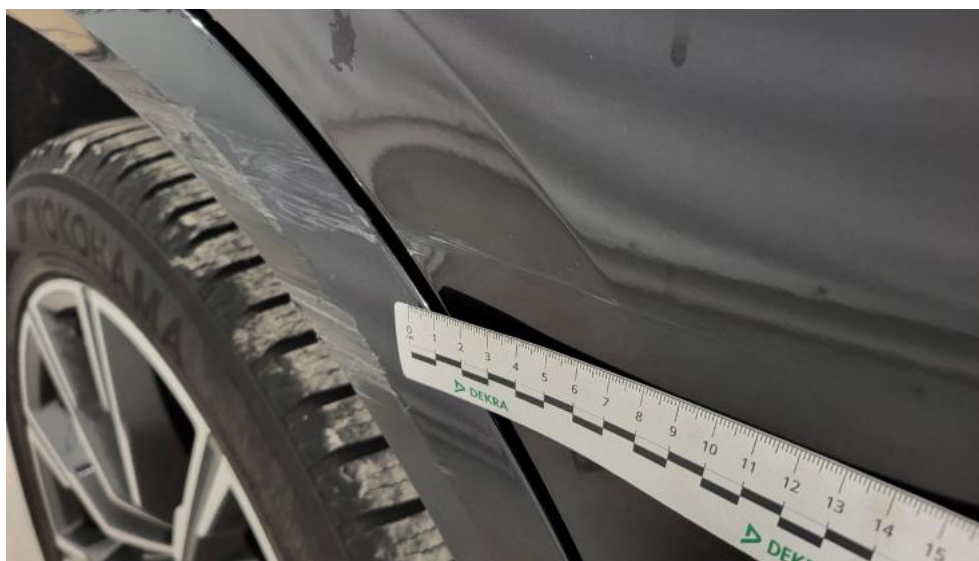
Drzwi tylne P - Rysa/odprysk 2

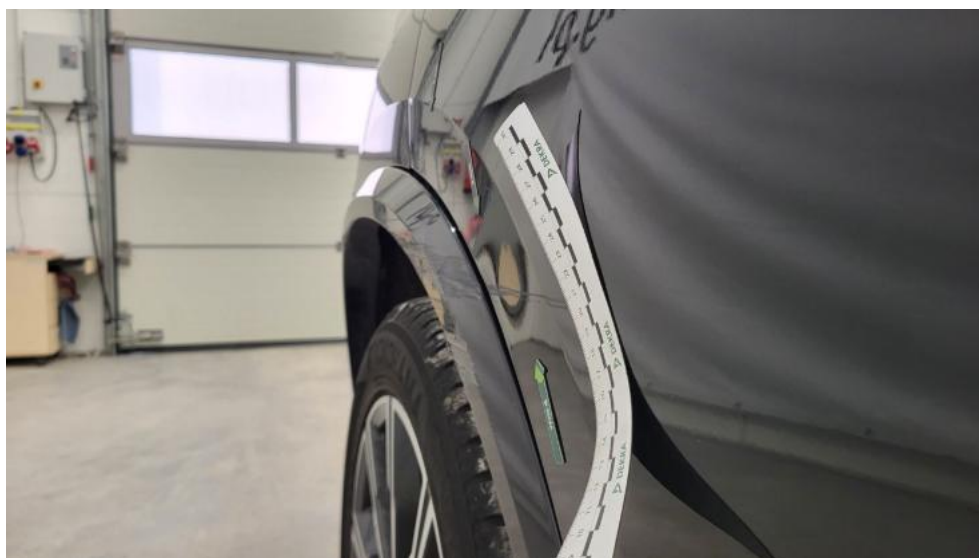
Drzwi tylne P - Wgniecenie/odkształcenie 1

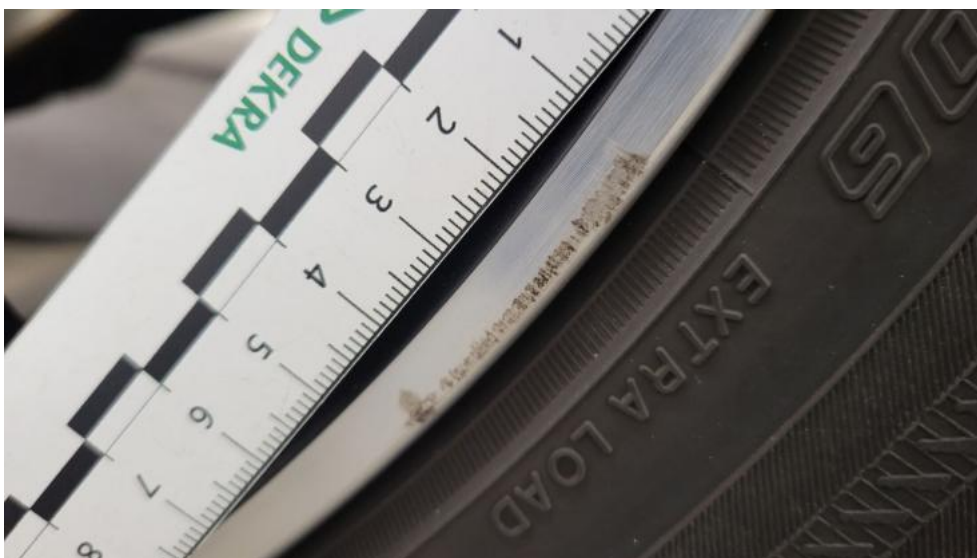
Photo 60.
Felga aluminiowa tylna P - Rysa/odprysk 1

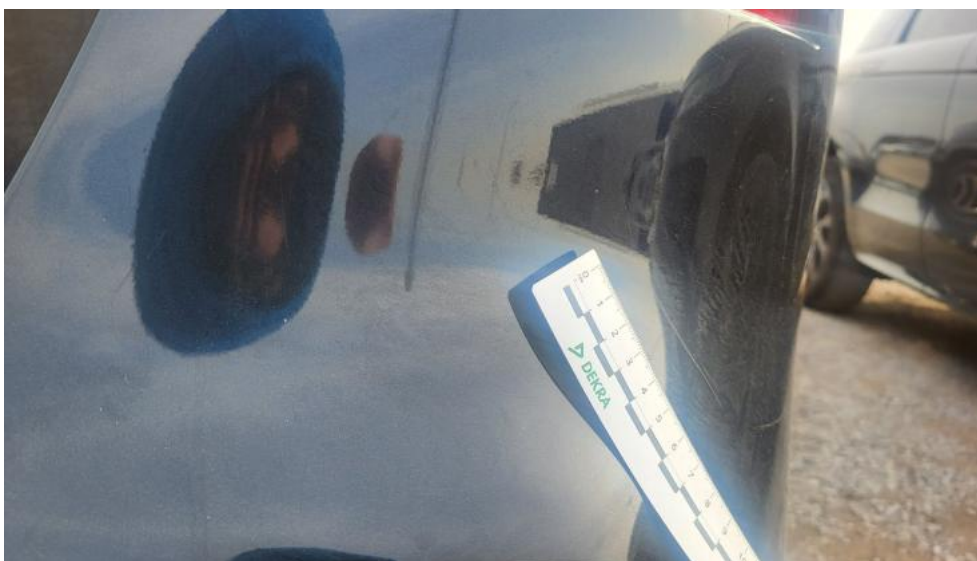
Photo 65.
Zderzak tylny - Rysa/odprysk 1

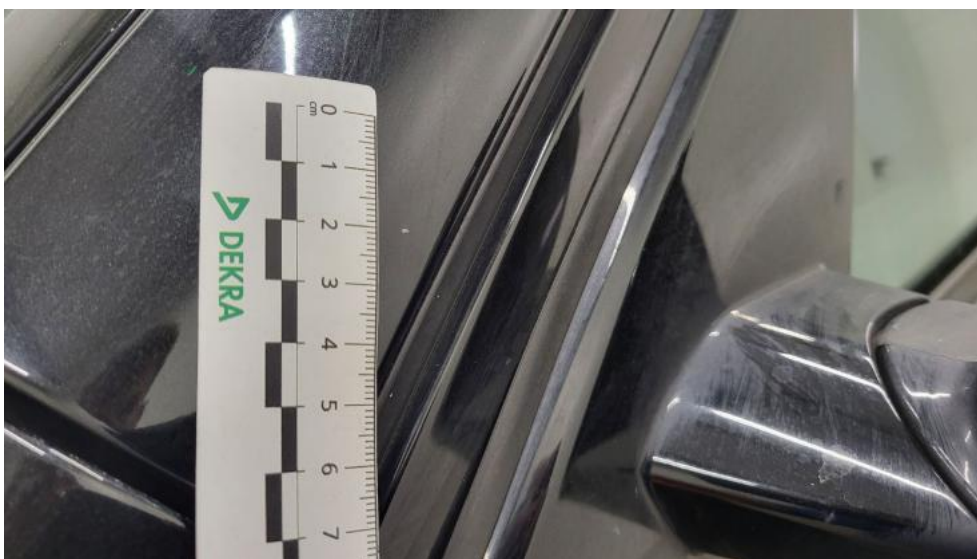
Photo 73.
Stupek przedni L - Rysa/odprysk 1

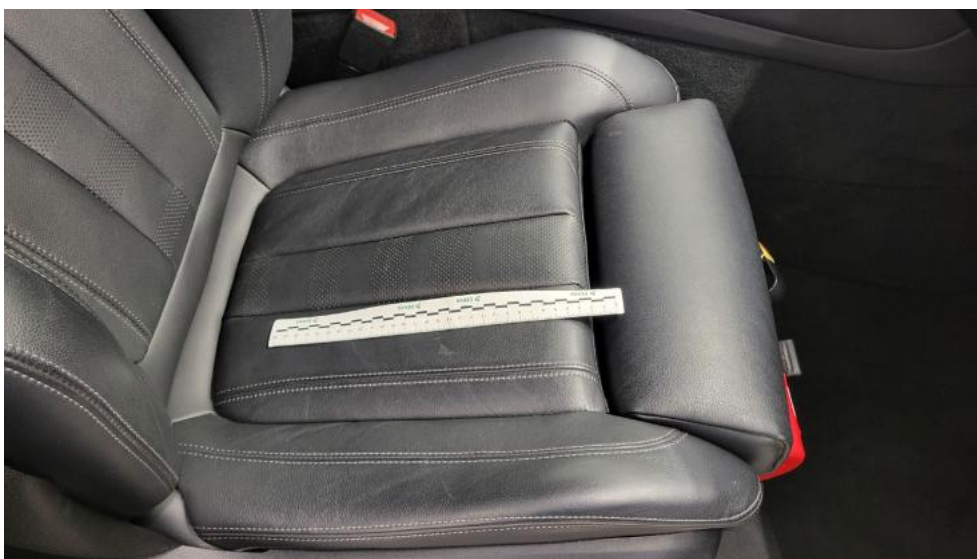
Photo 77.
Fotel prz. praw. - Inne 1

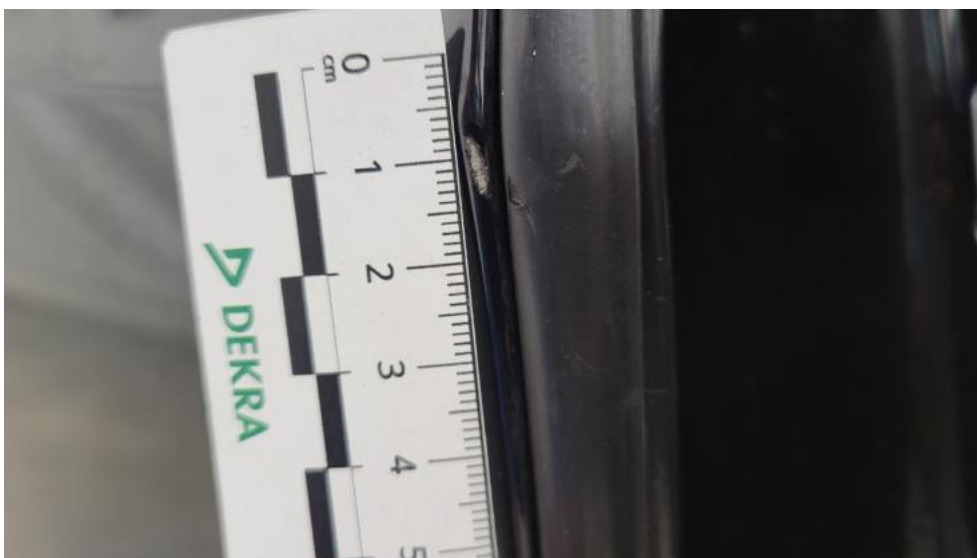
Photo 78.
Uszczelka drzwi tylnych P - Rysa/odprysk 1

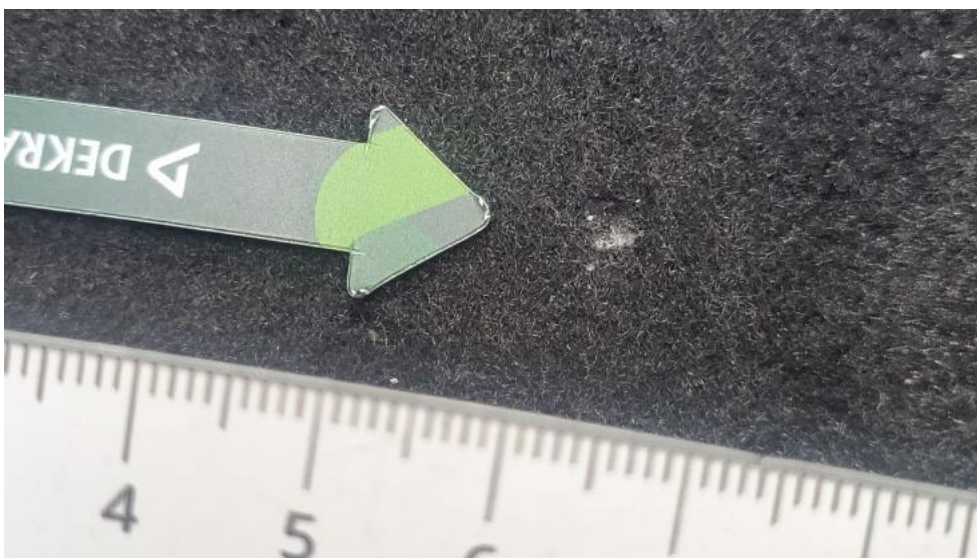
Wykładzina podłogi - Inne 1
