DEKRA's commission No. : PKOL(W)/LODZ/36217/26/04/24  
 commission/ damage No. : 23/021091  
 Date of commission: 24-04-2026

**DEKRA Poland - Headquarters**  
 02-673 Warszawa, ul. Konstruktorska 12A

PKO Leasing SA  
 Świętokrzyska 36  
 00-116 Warszawa

Group of objects (Eurotax)	jeeps
EC code (Eurotax)	107575
Manufacturer	BMW
Model	X6 [F16/F86] 14-19
Type / version	X6 M50d
Body type	hatchback
Number of doors / seats	5/4
Curb weight [kg]	2185
Gross vehicle weight [kg]	2900
Wheelbase 1/2	2933
Engine type	Automatic ignition
Engine capacity [ccm]	2993
Engine Power [hp/kW]	381/280
Gearbox	automatic
Registration /record No.	NO435AR
VIN / serial number	WBAKV610X00W36837
Date of first registration	10-10-2017
Date of next. tech. test	19-02-2027
Year of manufacture	2017 (year has been verified with the manufacturer's base)
Readout [km]	131 385 (read)
Body color / type of coating	white/UNI

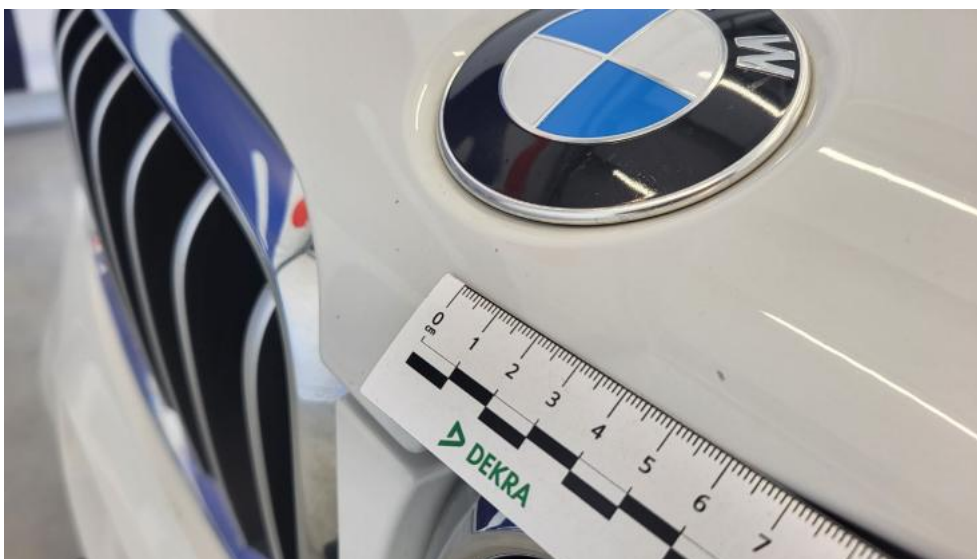
**Photo 41.**  
Pokrywa komory silnika - Rysa/odprysk 1

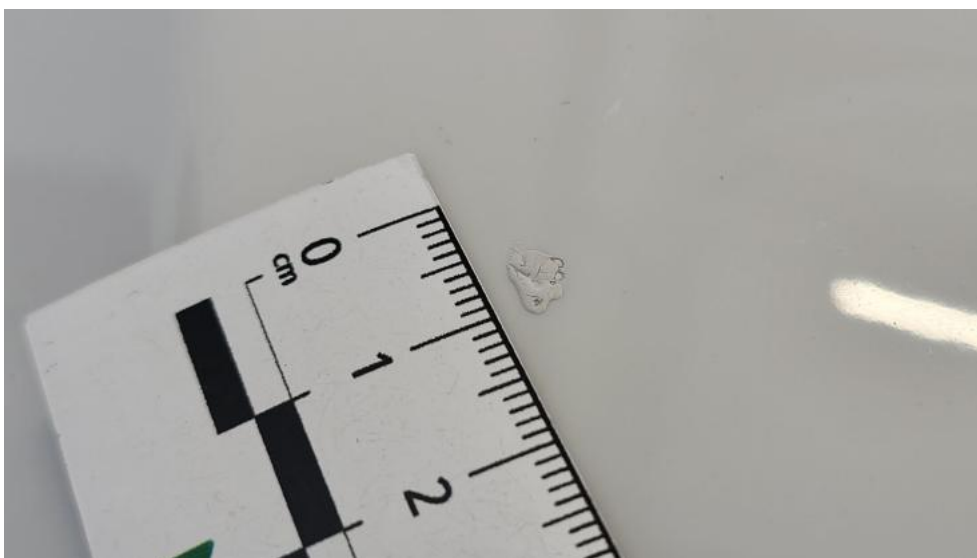
**Photo 42.**  
Pokrywa komory silnika - Inne 1

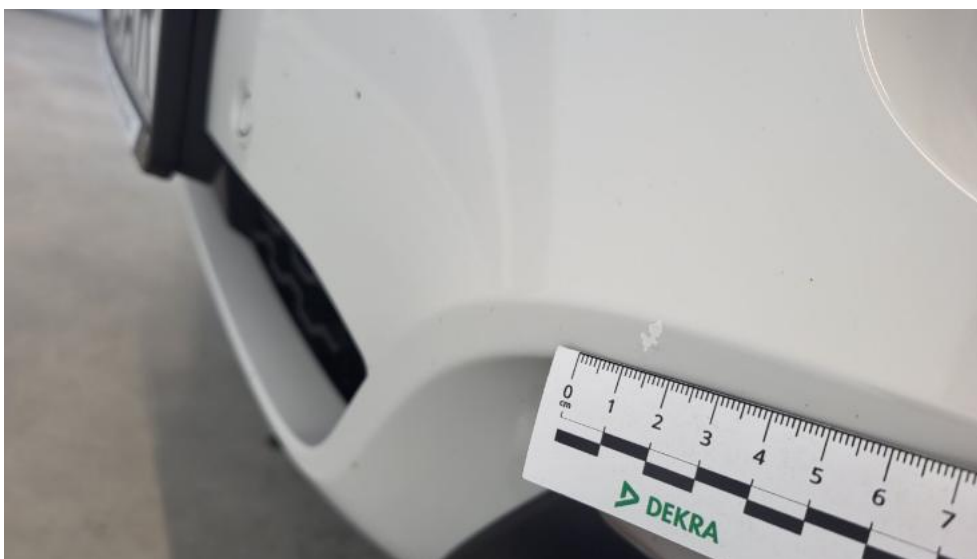
**Photo 43.**  
Zderzak - Rysa/odprysk 1

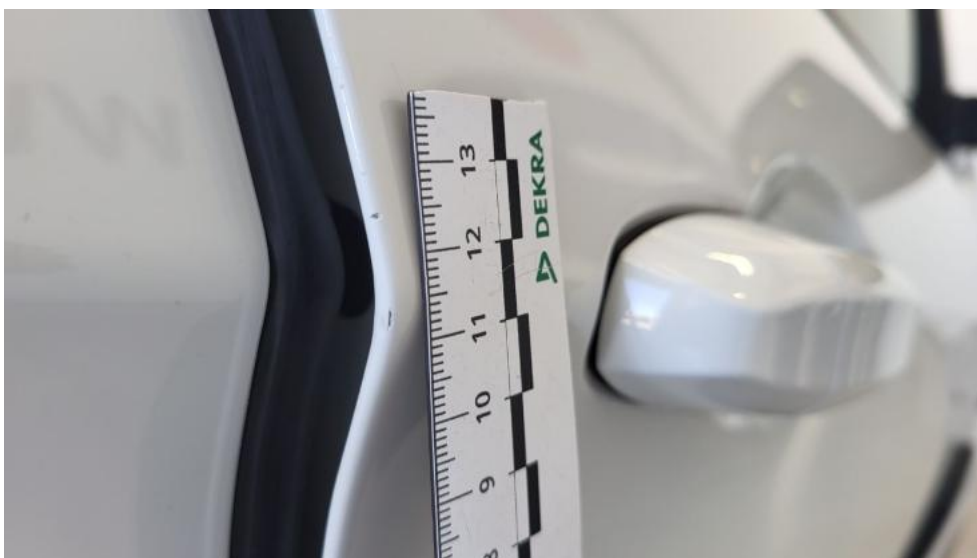
No. of controlled item	Controlled item	Measured range of thickness of the lacquer coat [ $\mu\text{m}$ ]
1	Front cover	to 150
3	Left front pillar	to 150
4	Left front wall	to 150
5	Roof	to 150
6	Left middle pillar	to 150
7	Left side sill	to 150
8	Left rear wall	to 150
9	Left side wall	to 150
10	Cover/tailgate	to 150
11	Side right wall	to 150
12	Rear right door	to 150
13	Middle right pillar	to 150
14	Front right door	150 - 200
15	Right side sill	to 150
16	Right front pillar	to 150

**Photo 44.**  
Drzwi przednie P - Rysa/odprysk 1

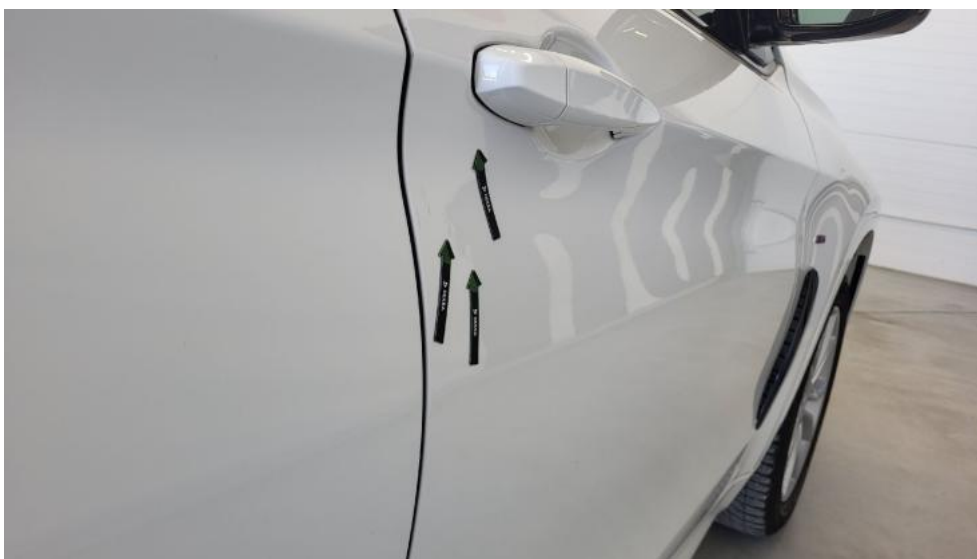
**Photo 45.**  
Drzwi przednie P - Wgniecenie/odkształcenie 1

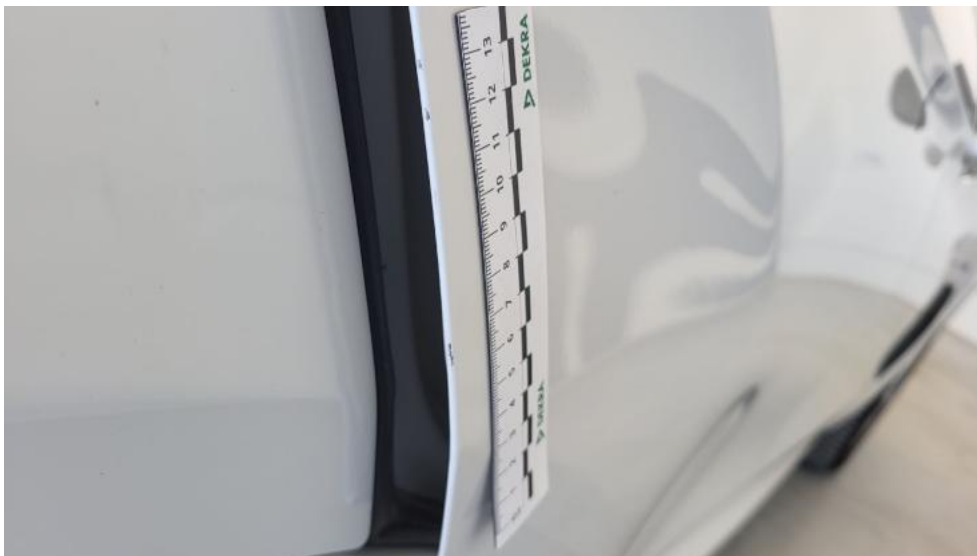
**Photo 47.**

Drzwi tylne P - Rysa/odprysk 1

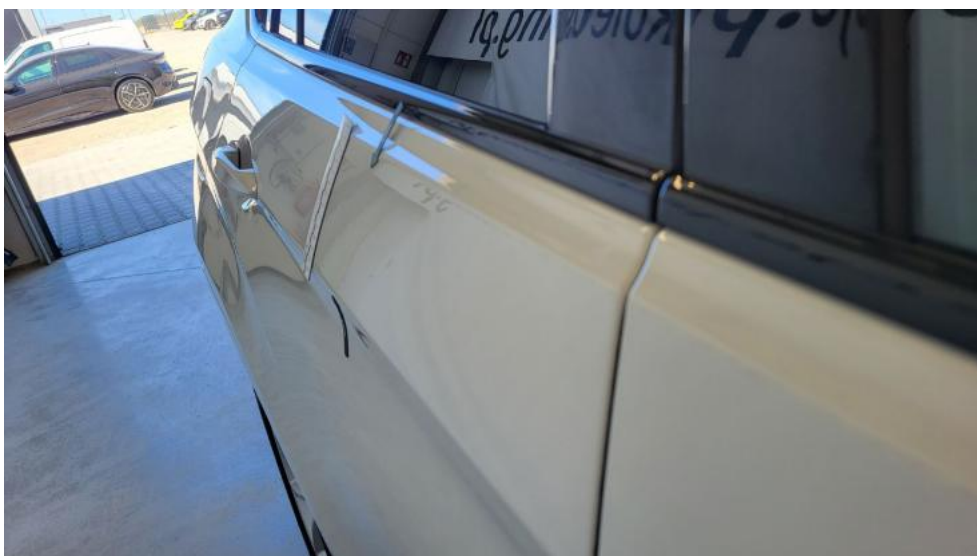
**Photo 48.**

Drzwi tylne P - Wgniecenie/odkształcenie 1

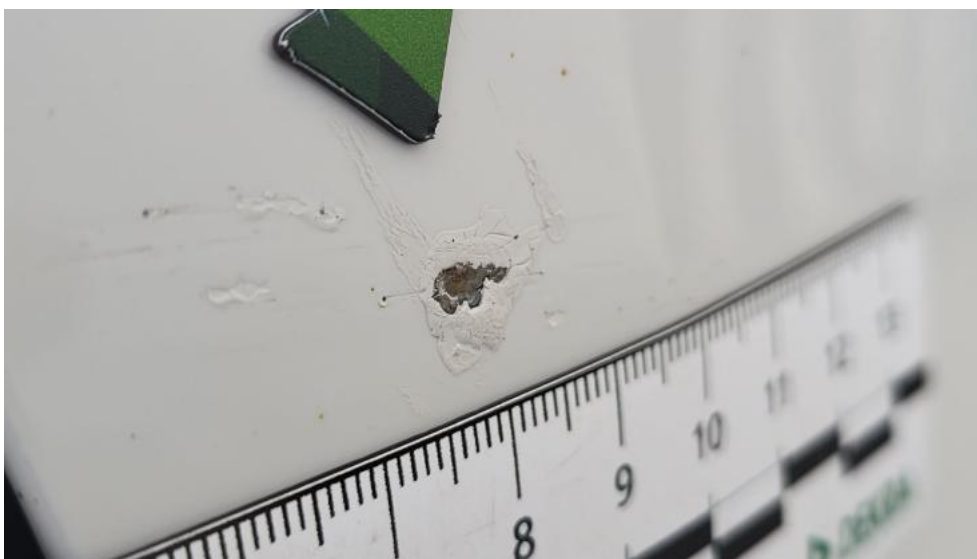
**Photo 49.**  
Drzwi tylne P - Inne 1

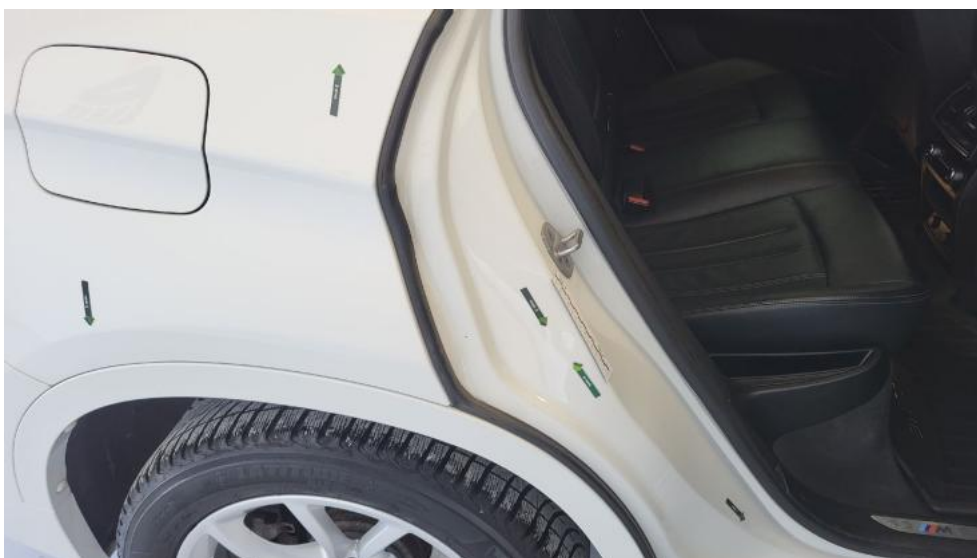
**Photo 50.**  
Błotnik tylny P / Ściana boczna P - Wgniecenie/odkształcenie 1

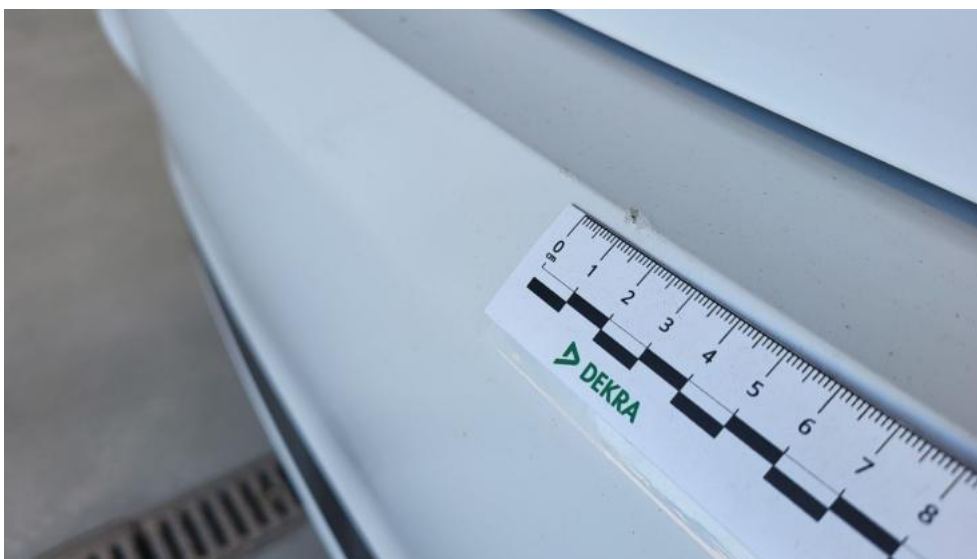
**Photo 51.**  
Zderzak tylny - Rysa/odprysk 1

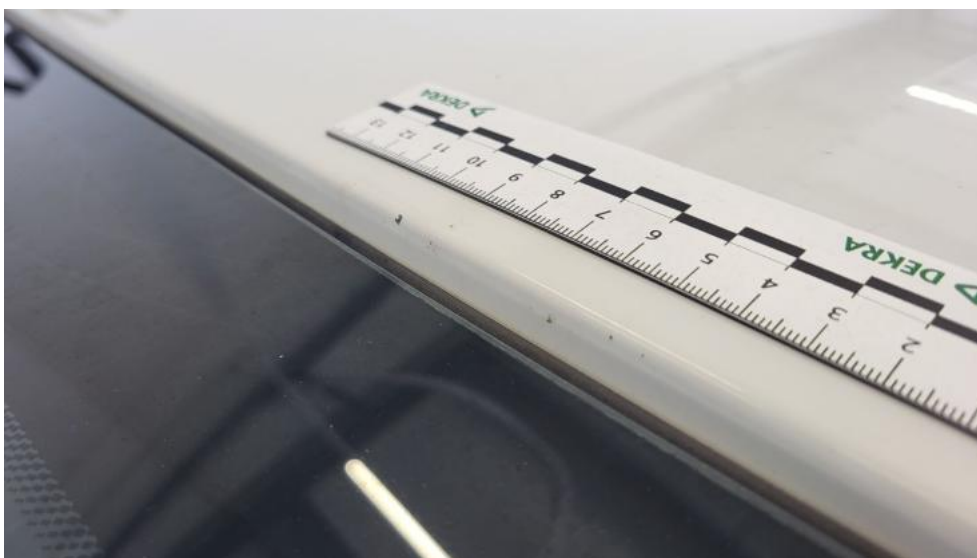
**Photo 52.**  
Dach - Rysa/odprysk 1

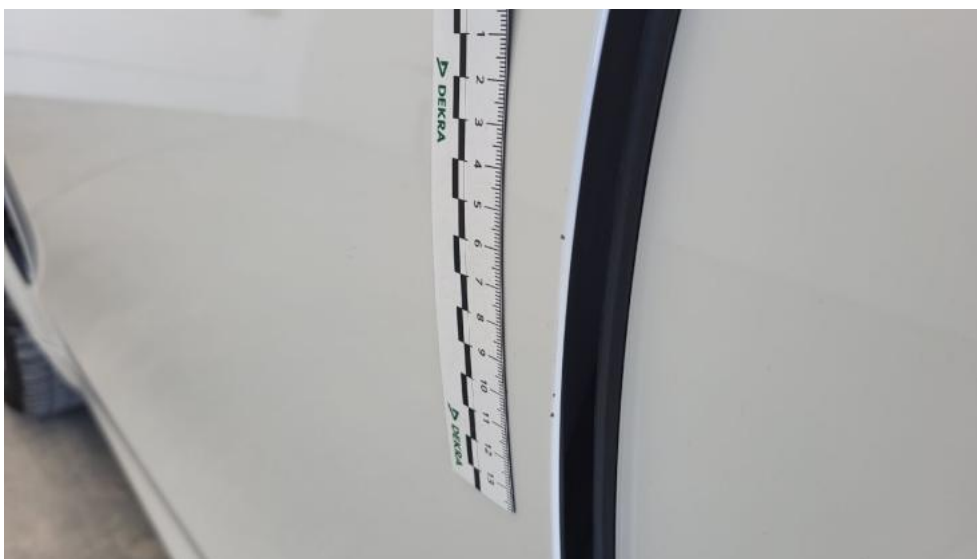
**Photo 53.**

Drzwi przed L - Rysa/odprysk 1

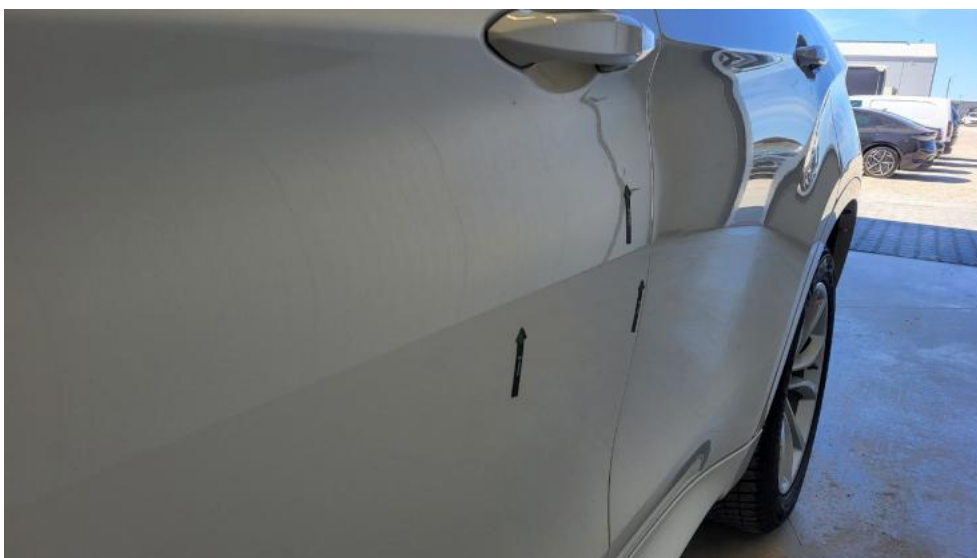
**Photo 54.**

Drzwi przed L - Wgniecenie/odkształcenie 1

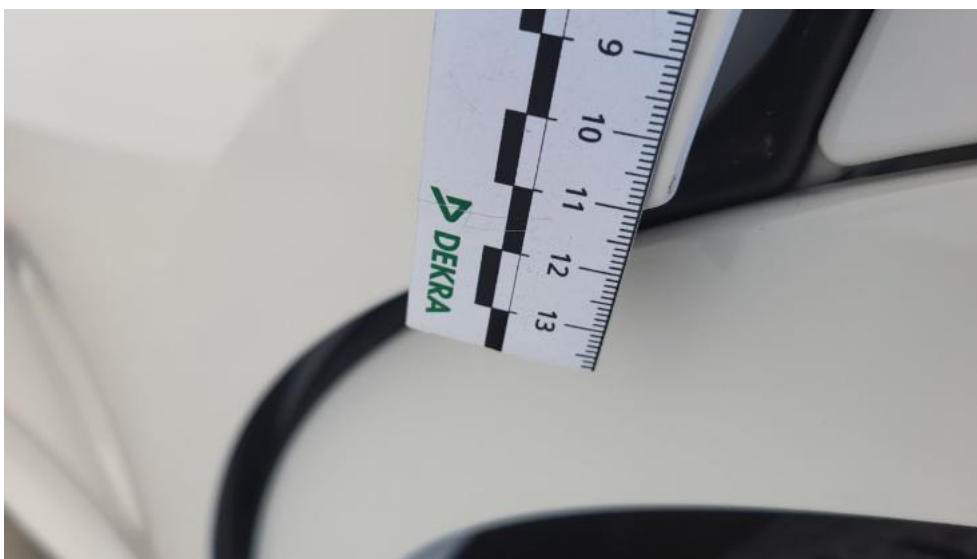
**Photo 55.**

Drzwi tylne L - Rysa/odprysk 1

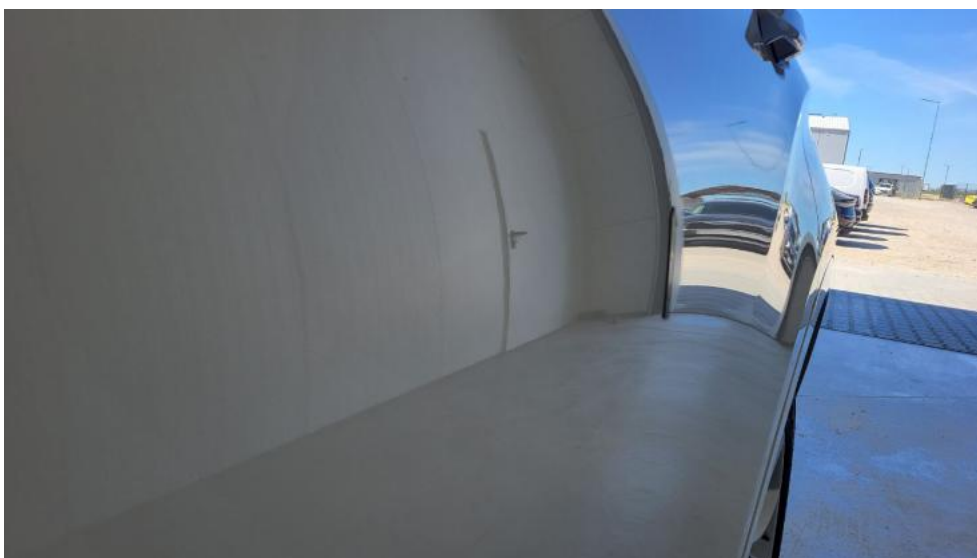
**Photo 56.**

Drzwi tylne L - Wgniecenie/odkształcenie 1

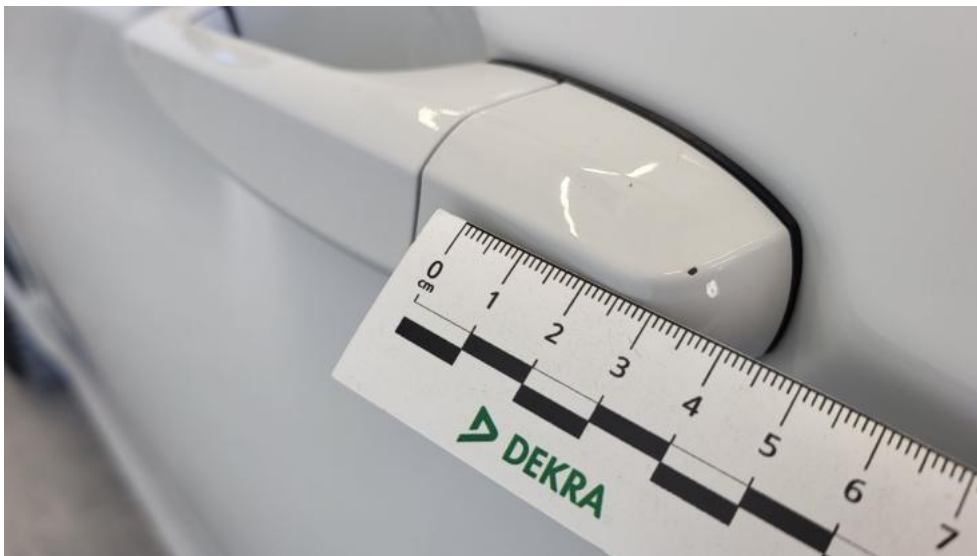
**Photo 57.**  
Klamka drzwi prz L - Rysa/odprysk 1

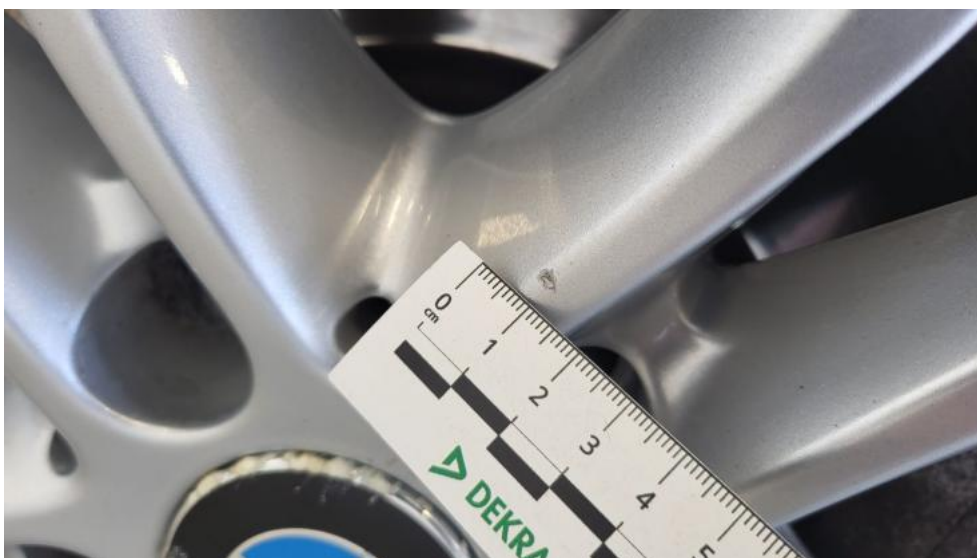
**Photo 58.**  
Felga Aluminiowa przednia L - Rysa/odprysk 1

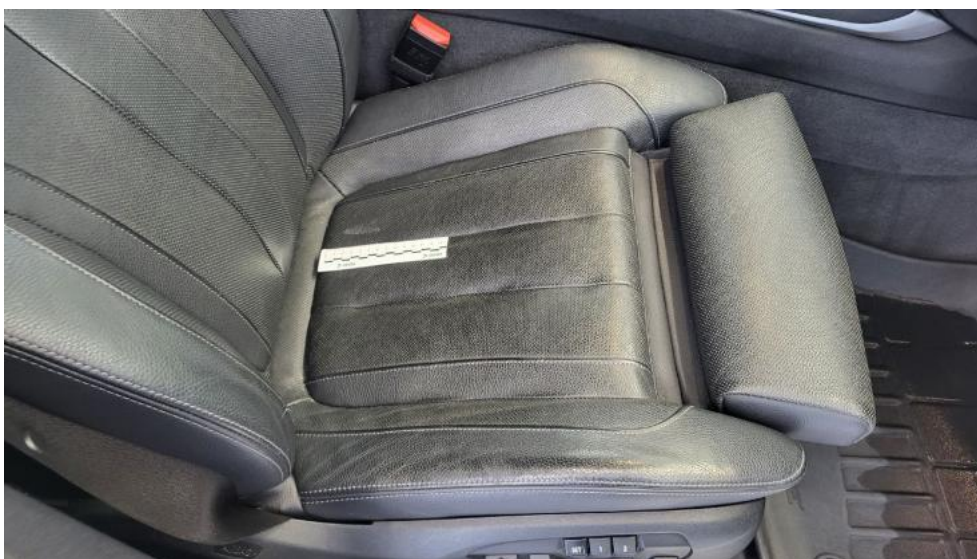
**Photo 59.**  
Fotel prz. praw. - Inne 1

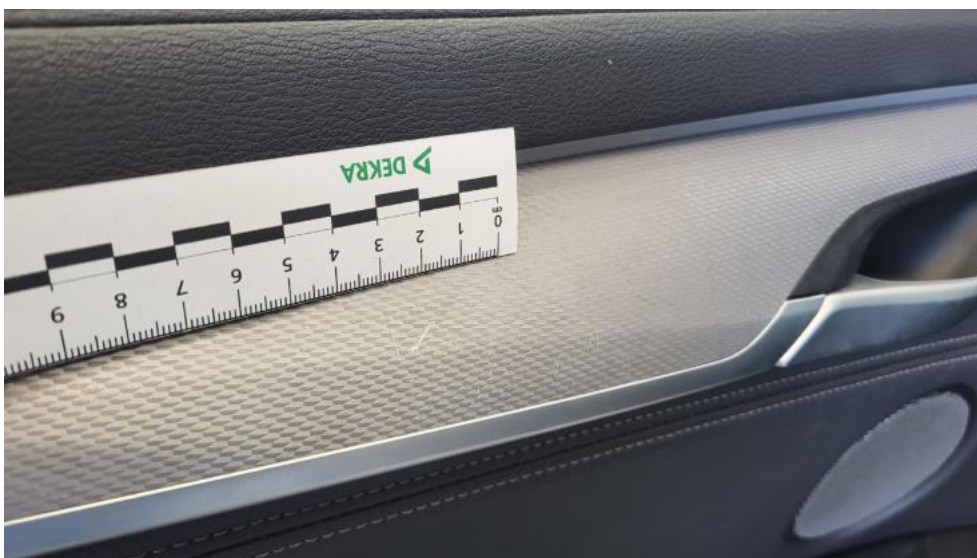
**Photo 60.**  
Tapicerka drzwi przednich L - Rysa/odprysk 1
