DEKRA's commission No. : PKOL(W)/LODZ/93858/25/12/01  
commission/ damage No. : 21/058718  
Date of commission: 01-12-2025

| Manufacturer | JEEP |
| Type / version | Compass 1.3 TMair Limited FWD S&S DDCT |
| Registration /record No. | PO1VV98 |

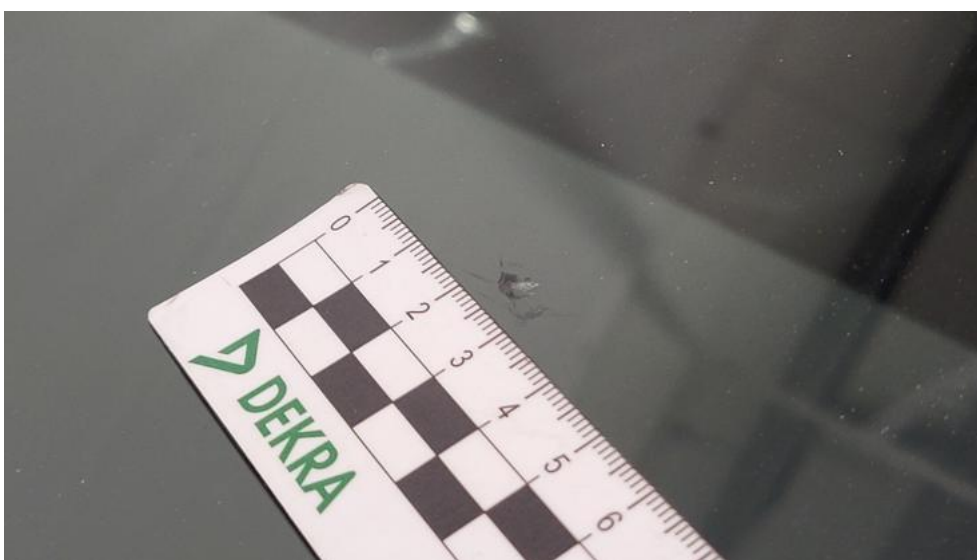
**Photo 38.**

Niesprawne przyciski funkcyjne w jednym z kluczyków, grot prawidłowy. Rysy na samochodzie. Odpryski na szybie czołowej.

Szyba czołowa - Pęknięcie/rozerwanie 1

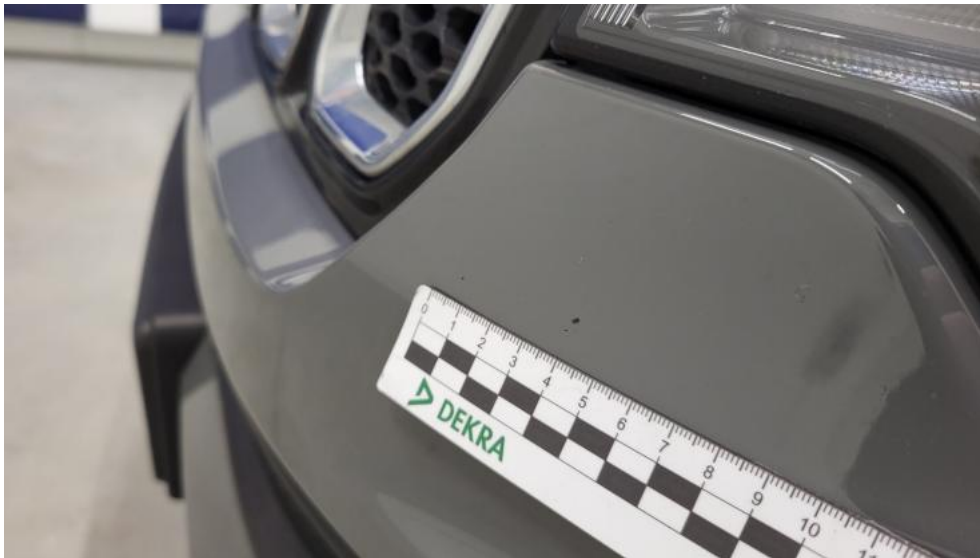
**Photo 39.**

Zderzak - Rysa/odprysk 1

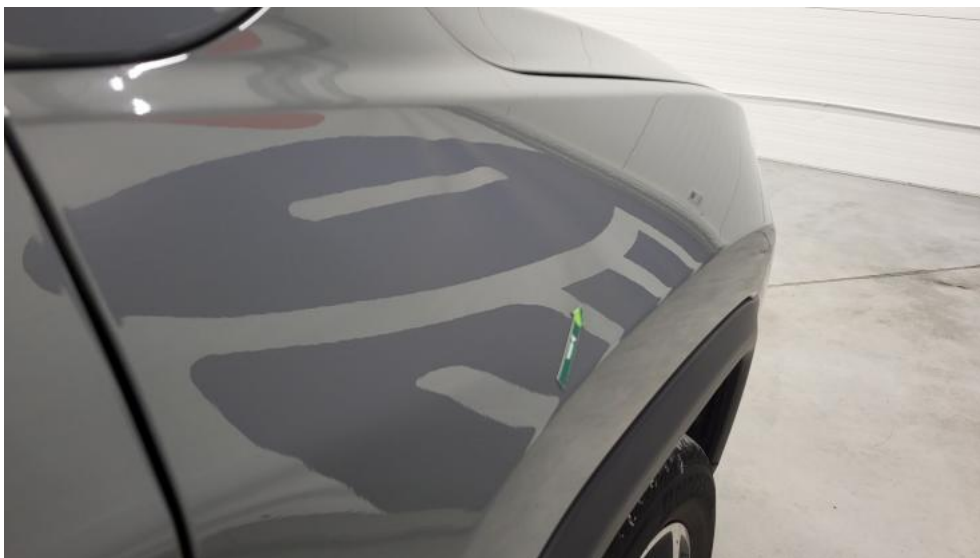
**Photo 40.**

Ślotnik przedni P - Wgniecenie/odkształcenie 1

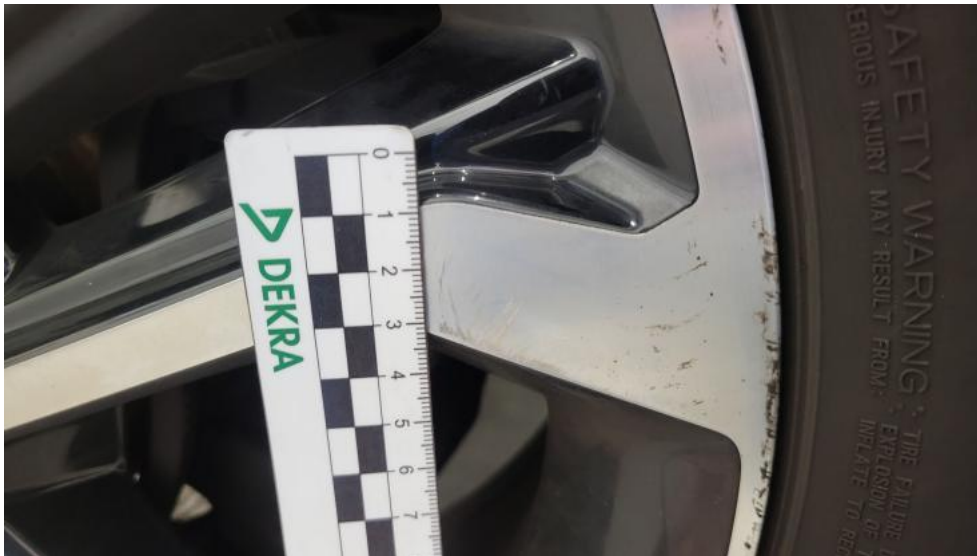
**Photo 41.**

Felga aluminiowa przednia P - Rysa/odprysk 1

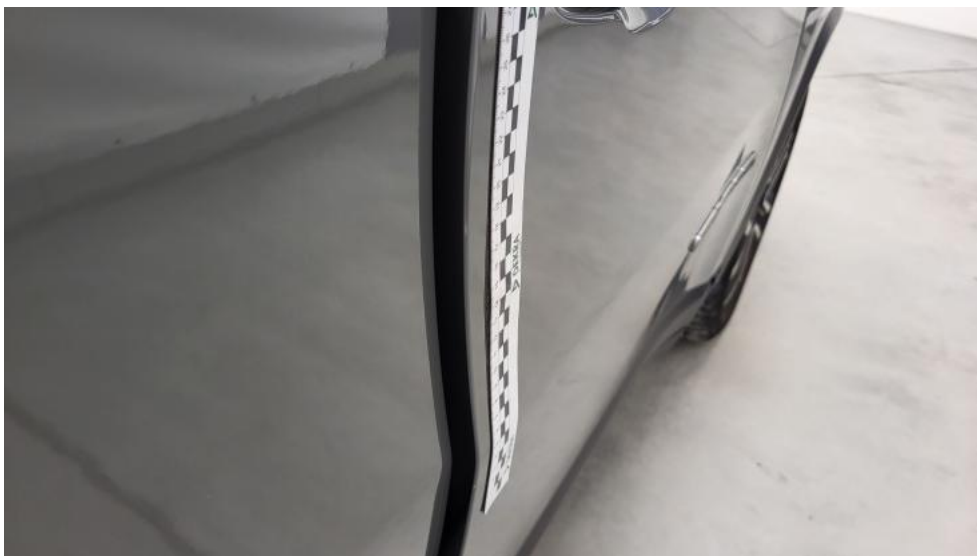
**Photo 42.**

Drzwi przednie P - Rysa/odprysk 1

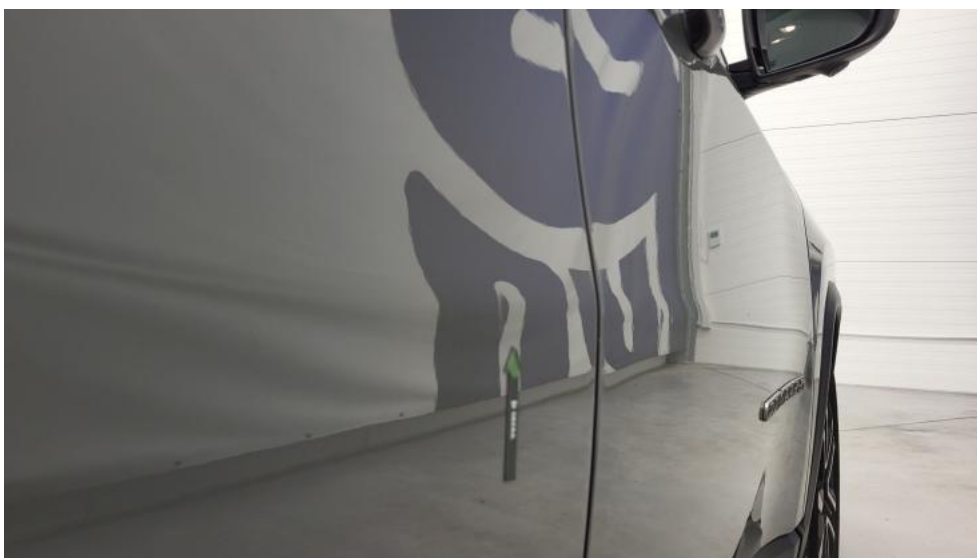
**Photo 44.**

Drzwi tylne P - Wgniecenie/odkształcenie 1

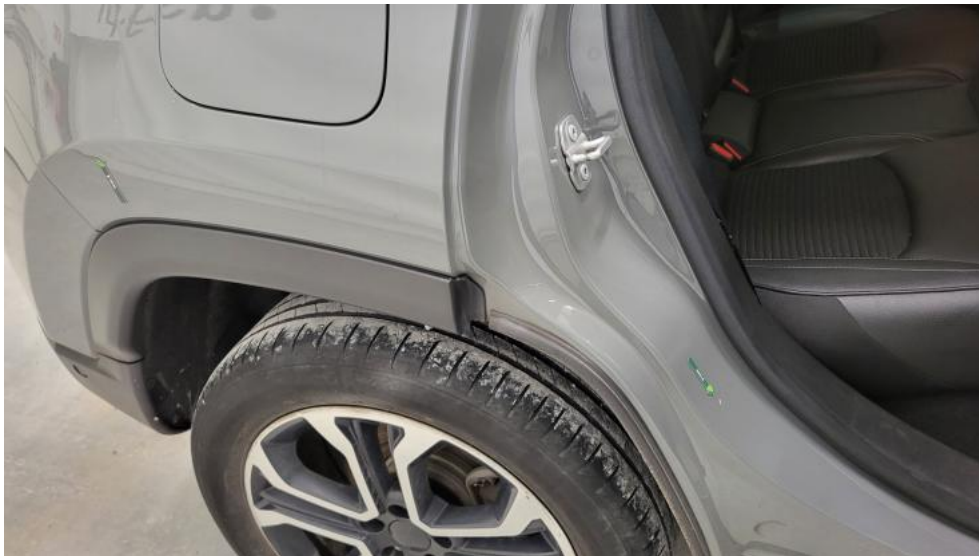
**Photo 45.**

Błotnik tylny P / Ściana boczna P - Wgniecenie/odkształcenie 1

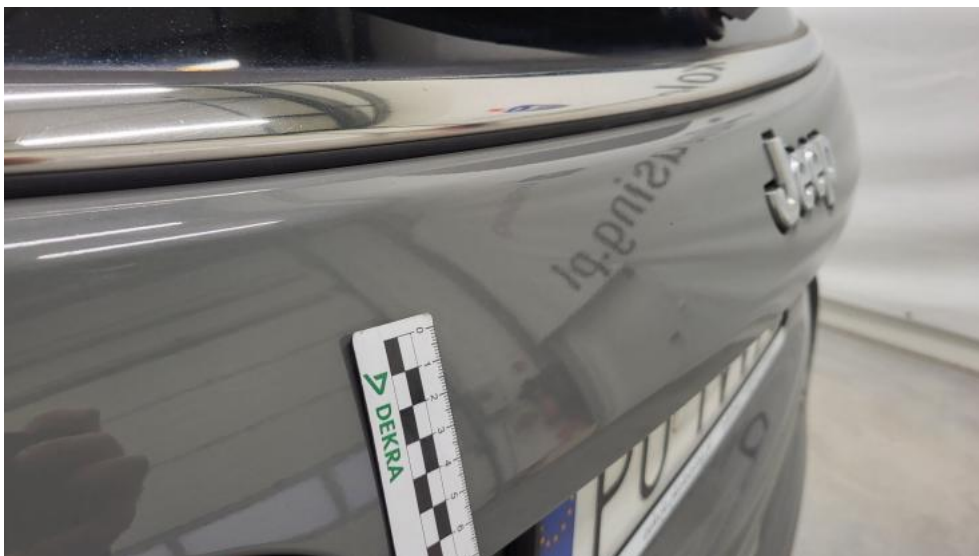
**Photo 46.**

Pokrywy bagażnika - Wgniecenie/odkształcenie 1

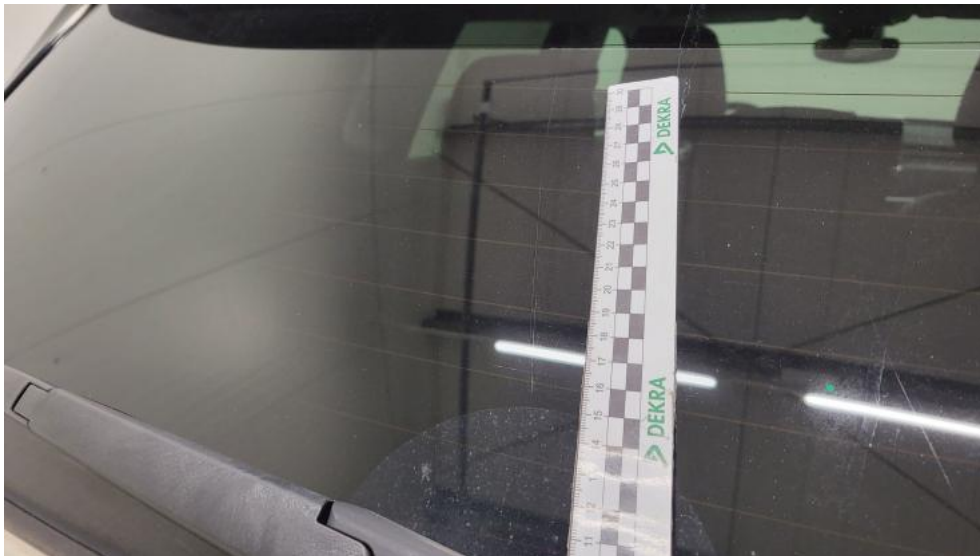
**Photo 47.**

Szyba tylna - Rysa/odprysk 1

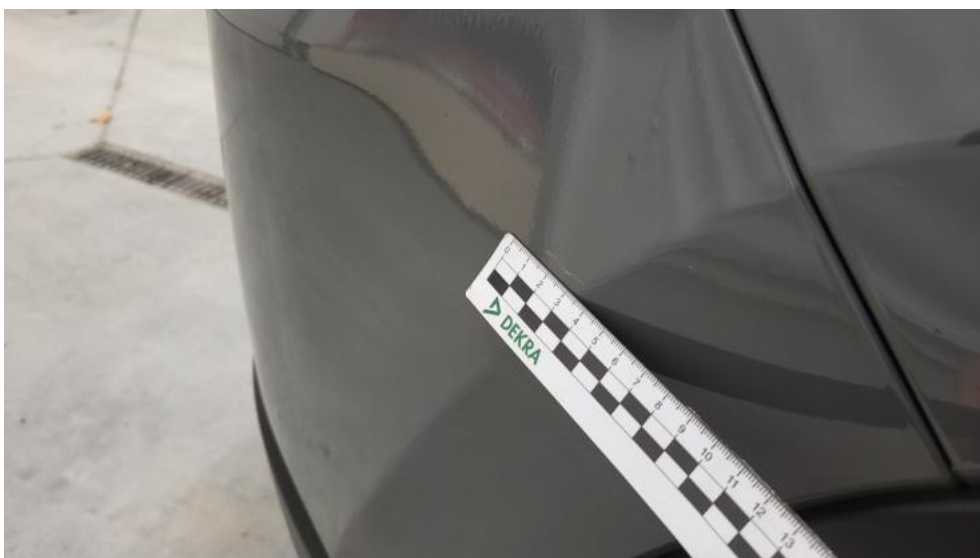
**Photo 48.**

Zderzak tylny - Rysa/odprysk 1

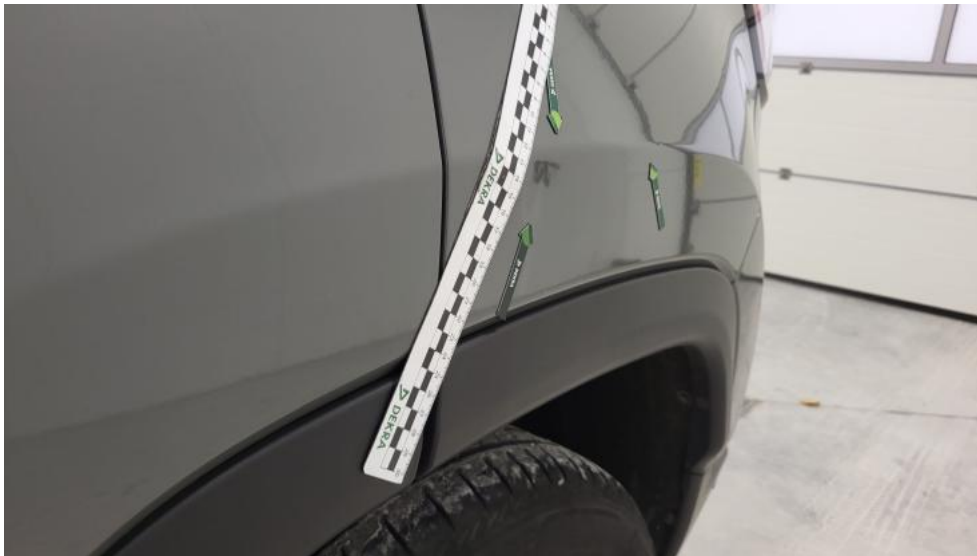
**Photo 53.**

Błotnik tylny L / Ściana boczna L - Wgniecenie/odkształcenie 1

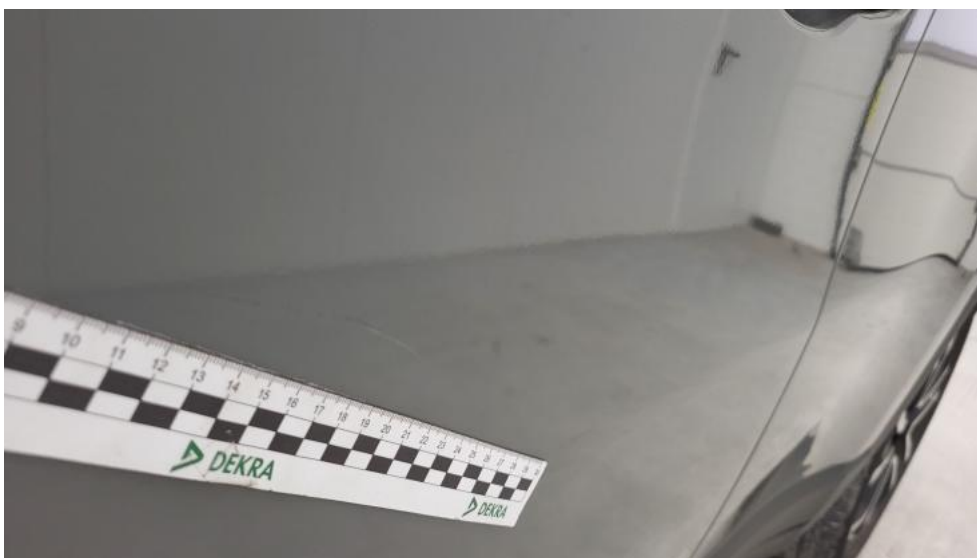
**Photo 56.**

Drzwi przed L - Rysa/odprysk 2

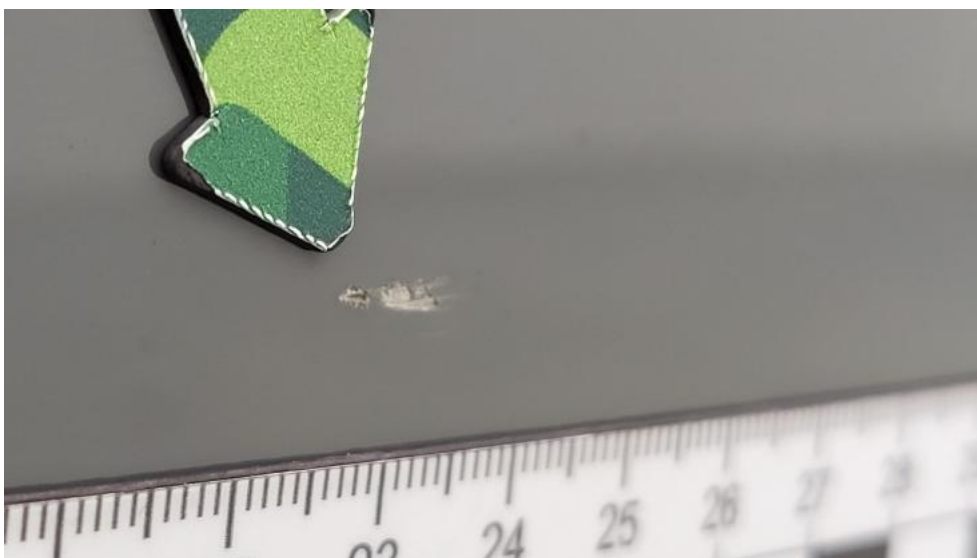
**Photo 58.**

Drzwi tylne L - Inne 1

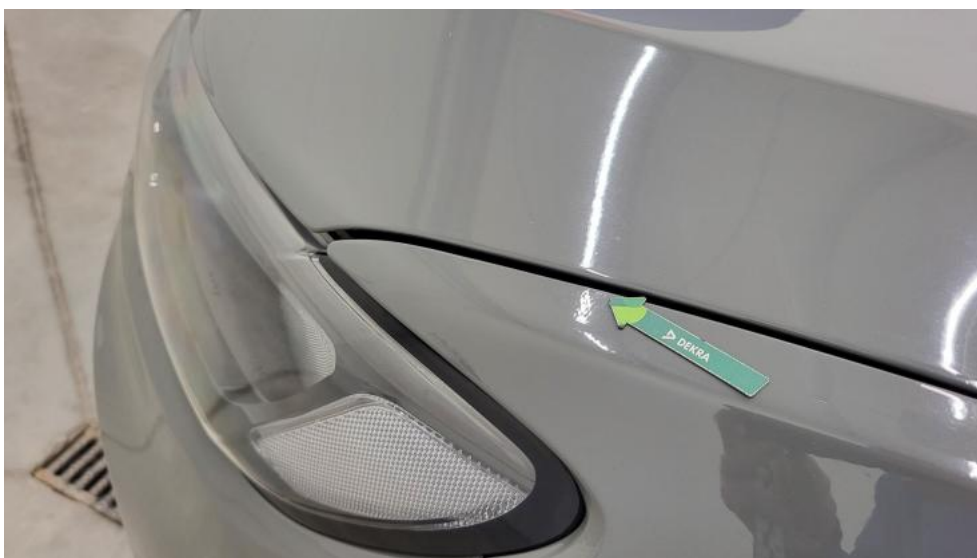
**Photo 60.**

Światnik przedni L - Wgniecenie/odkształcenie 1

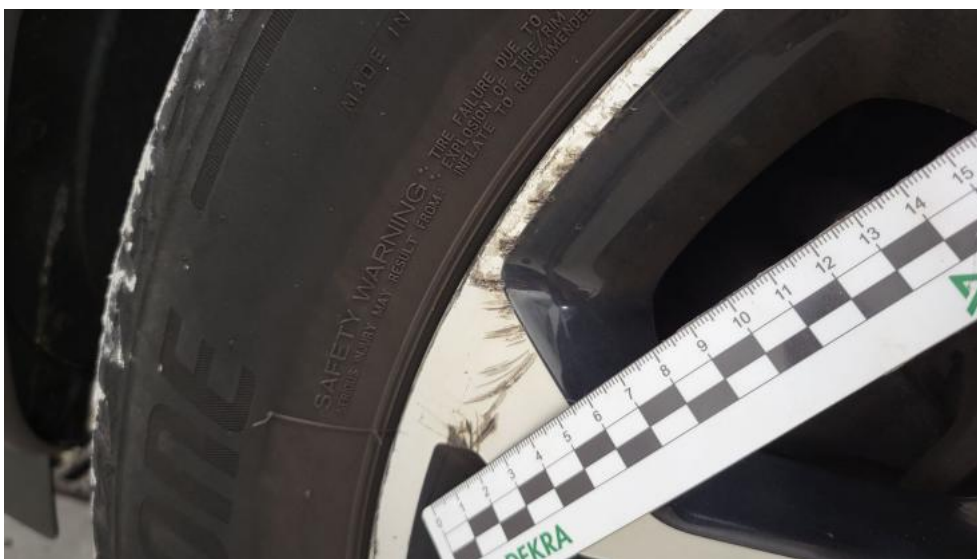
**Photo 61.**

Felga Aluminiowa przednia L - Rysa/odprysk 1

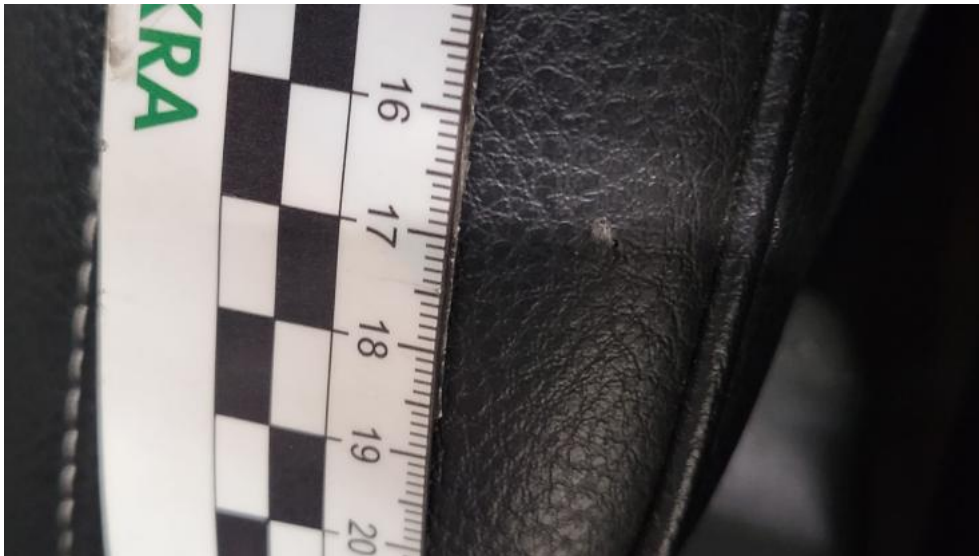
**Photo 63.**

Fotel prz. lew. - Pęknięcie/rozerwanie 1

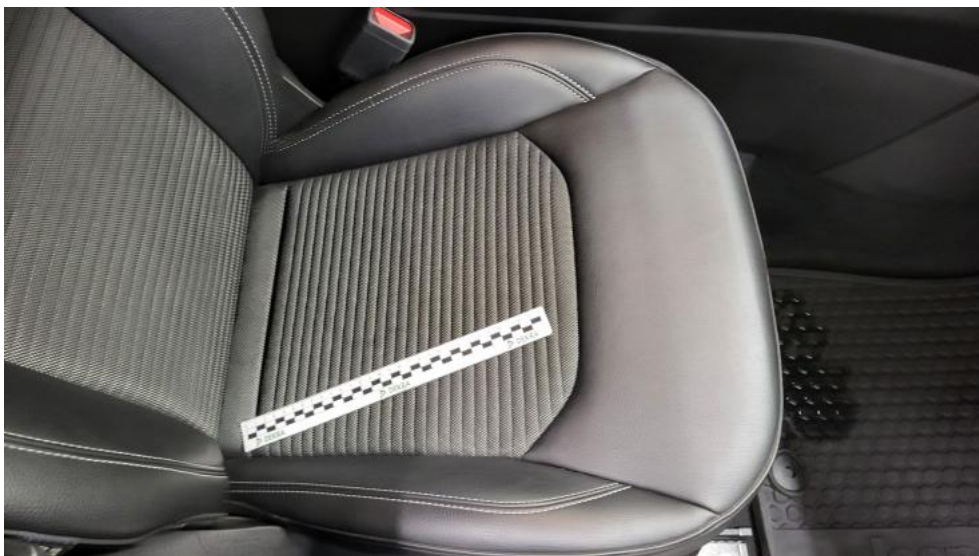
**Photo 64.**

Fotel prz. praw. - Inne 1

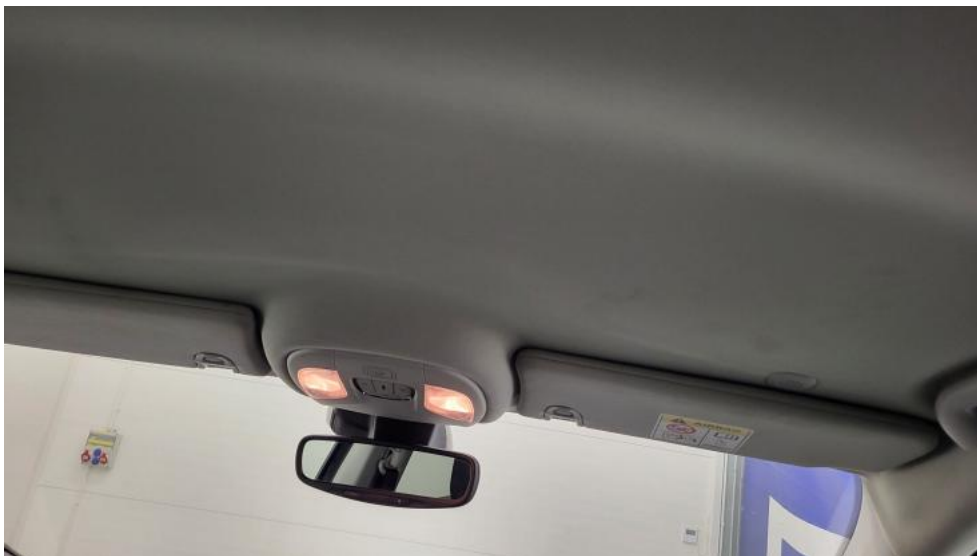
**Photo 65.**

Podsufitka - Inne 1
