DEKRA's commission No. : PKOL(W)/LODZ/100049/25/12/17
 commission/ damage No. : PMI USŁUGI OGULNOBUDOWLANE 02-078 Warszawa ul. Konstruktorska 12A
 Date of commission: 17-12-2025

Vehicle data

Group of objects (Eurotax)	jeeps
EC code (Eurotax)	0145250
Manufacturer	ISUZU
Model	D-Max 20-24
Type / version	D-Max 1.9 d DC LSE aut
Body type	PIC
Number of doors / seats	4/5
Curb weight [kg]	2010
Gross vehicle weight [kg]	3100
Wheelbase 1/2	3125
Engine type	Automatic ignition
Pollution reduction system	DPF
Engine capacity [ccm]	1898
Engine Power [hp/kW]	163/120
Gearbox	automatic
Registration /record No.	GA237HJ
VIN / serial number	MPATFS87JLT000915
Date of first registration	14-12-2020
Date of next. tech. test	12-12-2026
Year of manufacture	2020
Readout [km]	99 358 (read)
Body color / type of coating	white/double-layered, metallized

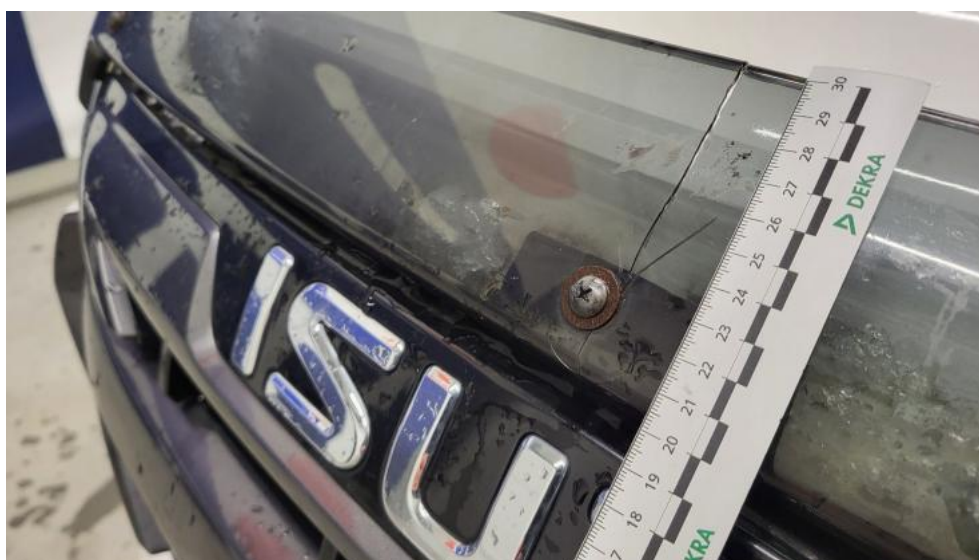
Photo 38.
Listwa śr zderzaka przedniego - Pęknięcie/rozerwanie 1

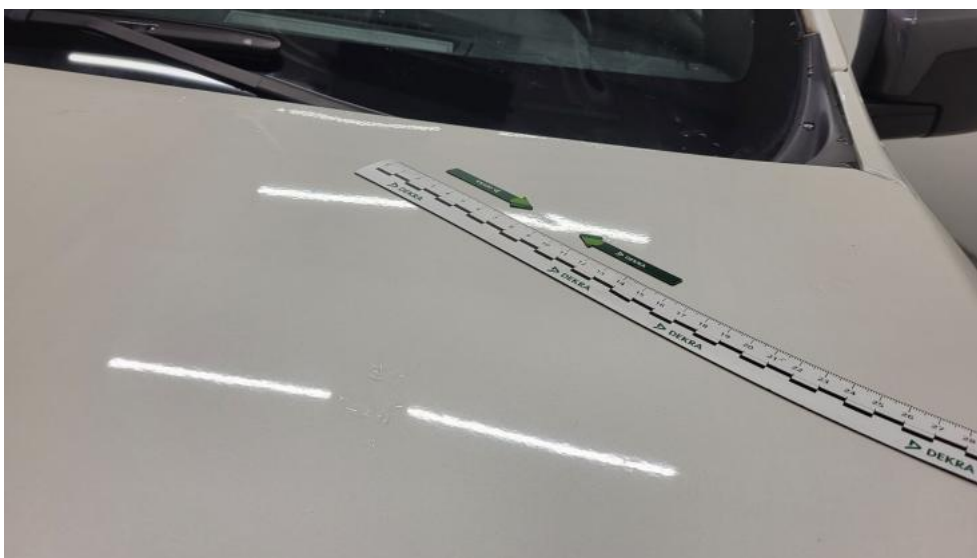
Photo 40.
Pokrywa komory silnika - Wgniecenie/odkształcenie 1

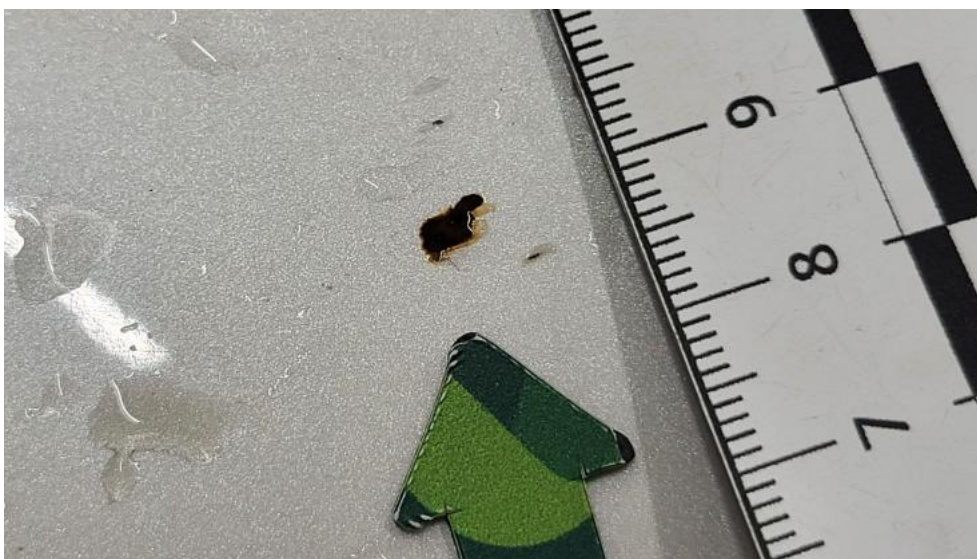
Photo 41.

Pokrywa komory silnika - Inne 1

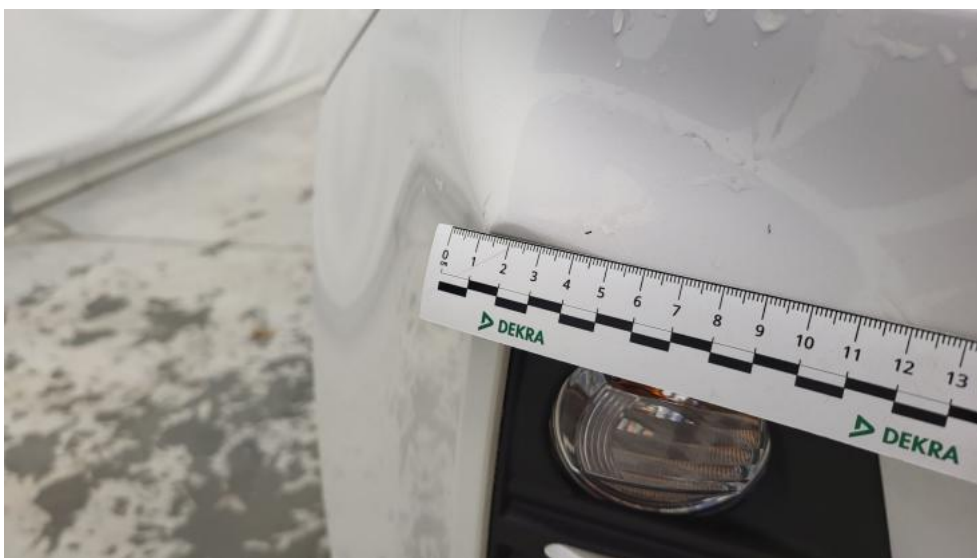
Photo 42.

Zderzak - Rysa/odprysk 1

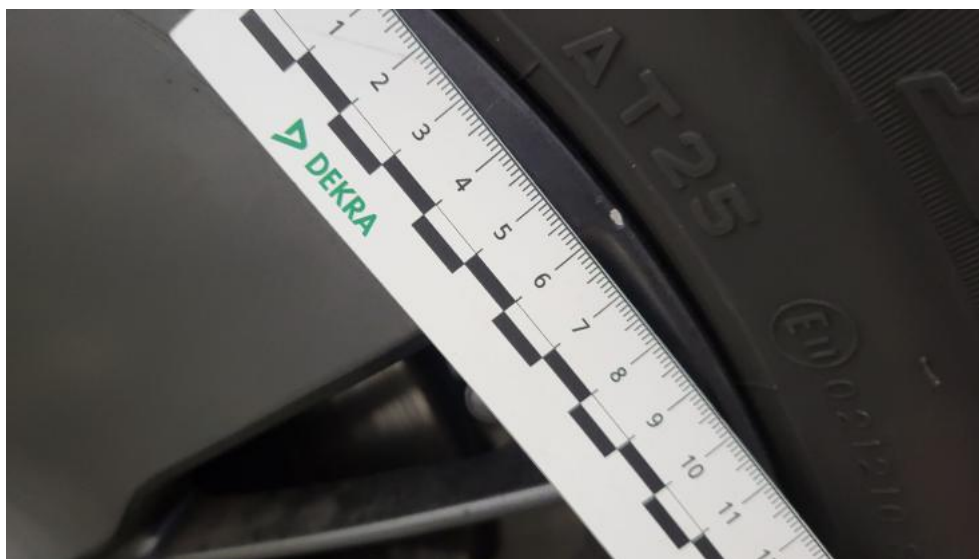
Photo 43.

Felga aluminiowa przednia P - Rysa/odprysk 1

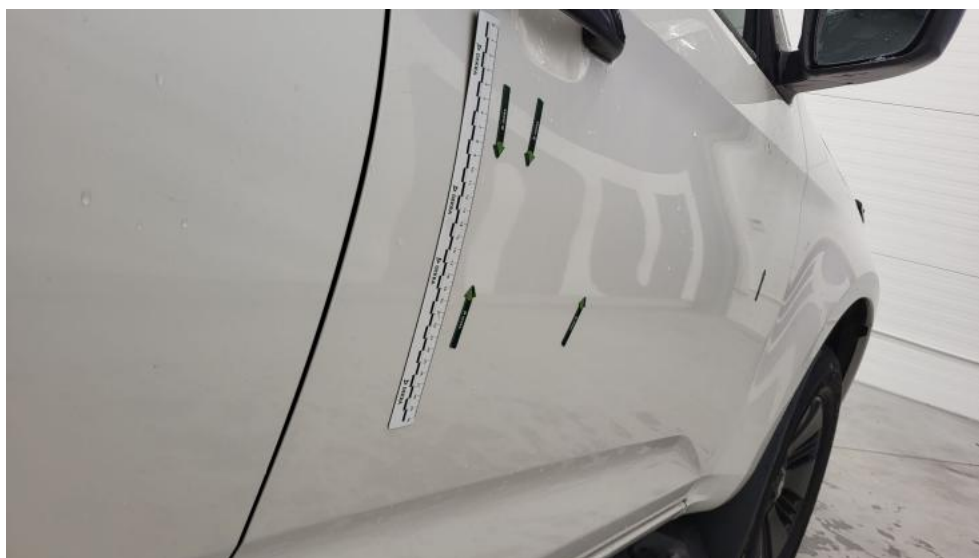
Photo 44.

Drzwi przednie P - Wgniecenie/odkształcenie 1

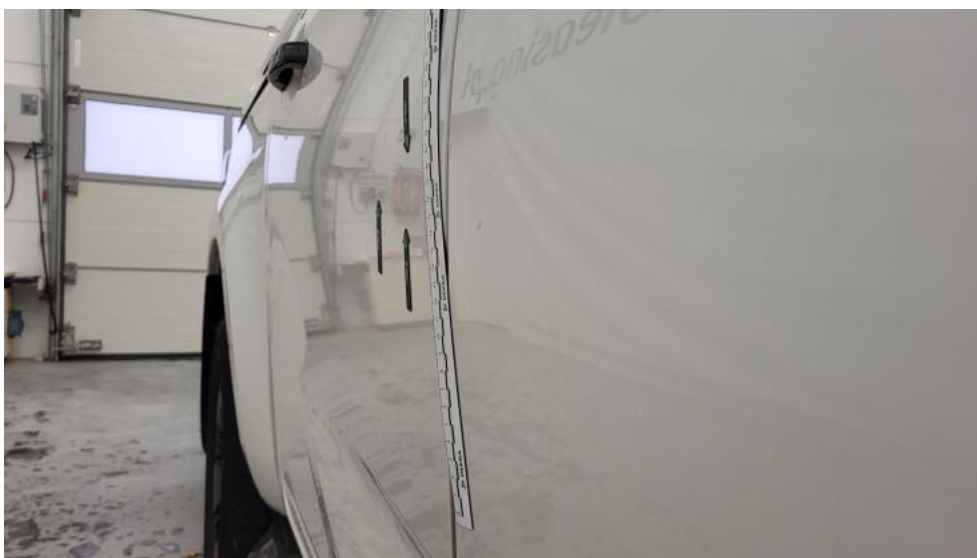
Photo 46.

Drzwi tylne P - Wgniecenie/odkształcenie 1

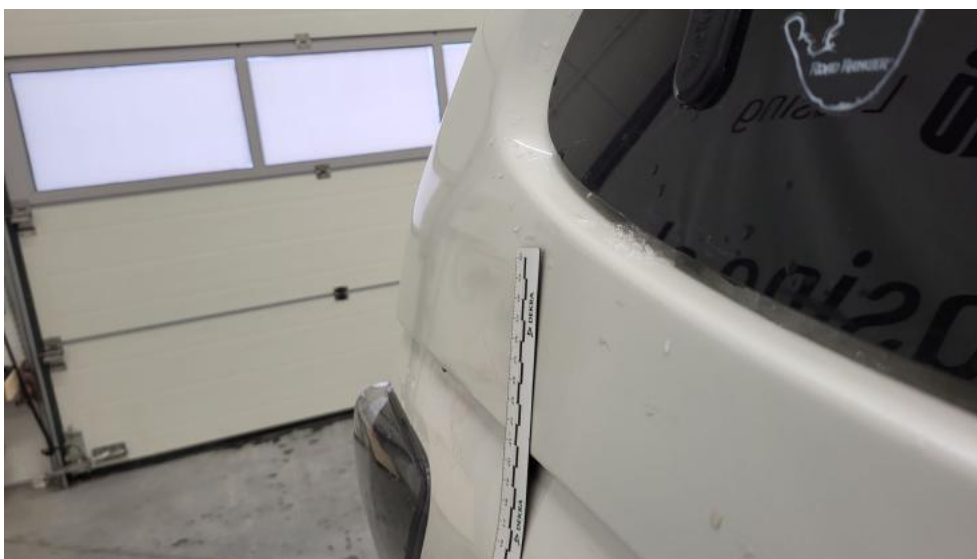
Photo 47.
Błotnik tylny P / Ściana boczna P - Wgniecenie/odkształcenie 1

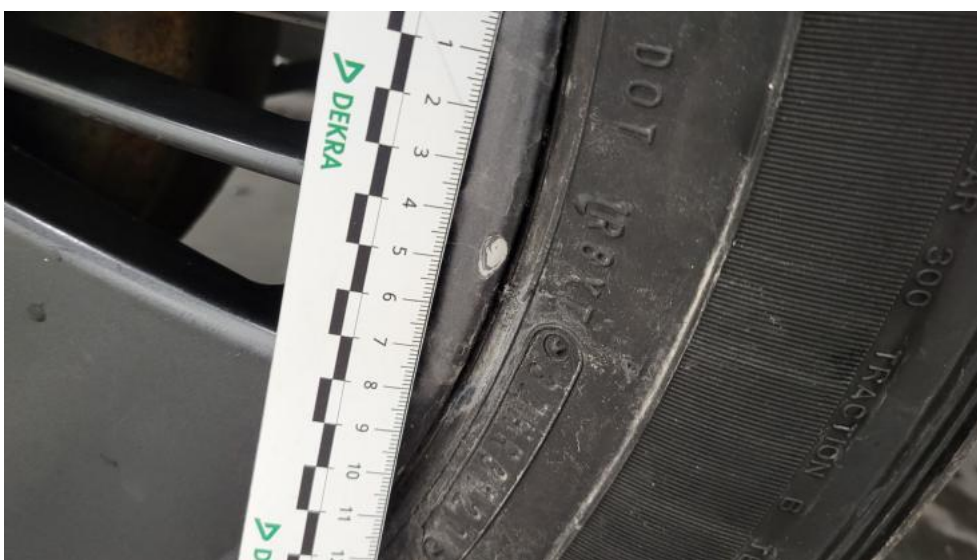
Photo 48.
Felga aluminiowa tylna P - Rysa/odprysk 1

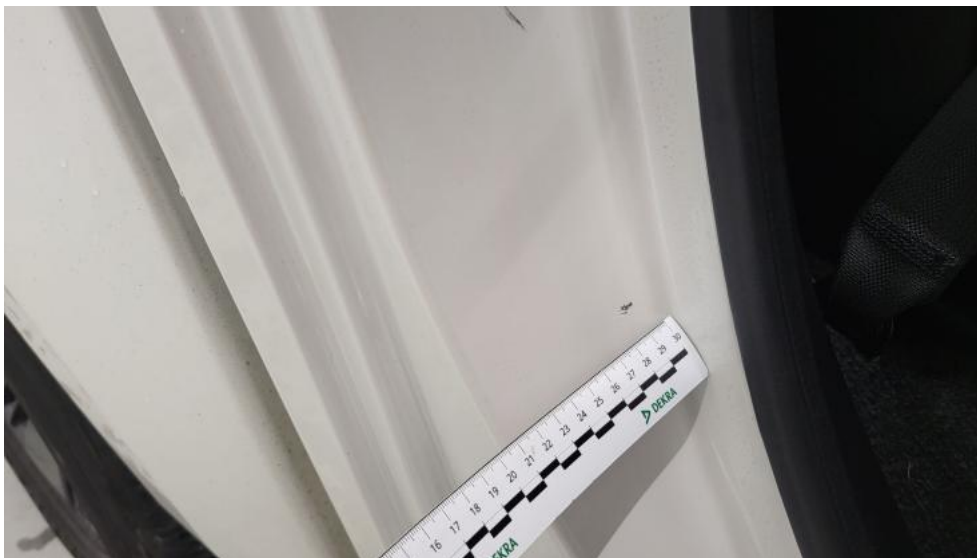
Photo 49.
Stupek tylny prawy - Rysa/odprysk 1

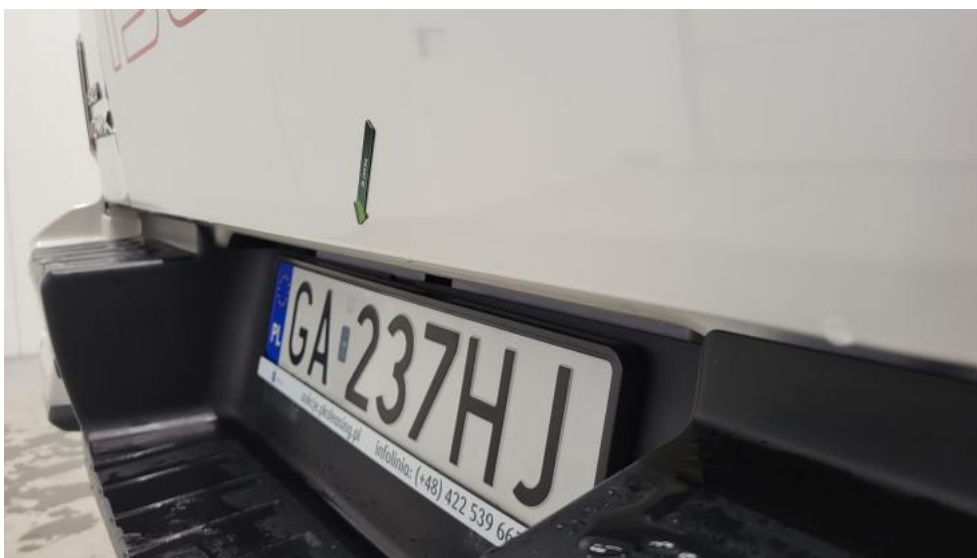
Photo 50.
Pokrywy bagażnika - Wgniecenie/odkształcenie 1

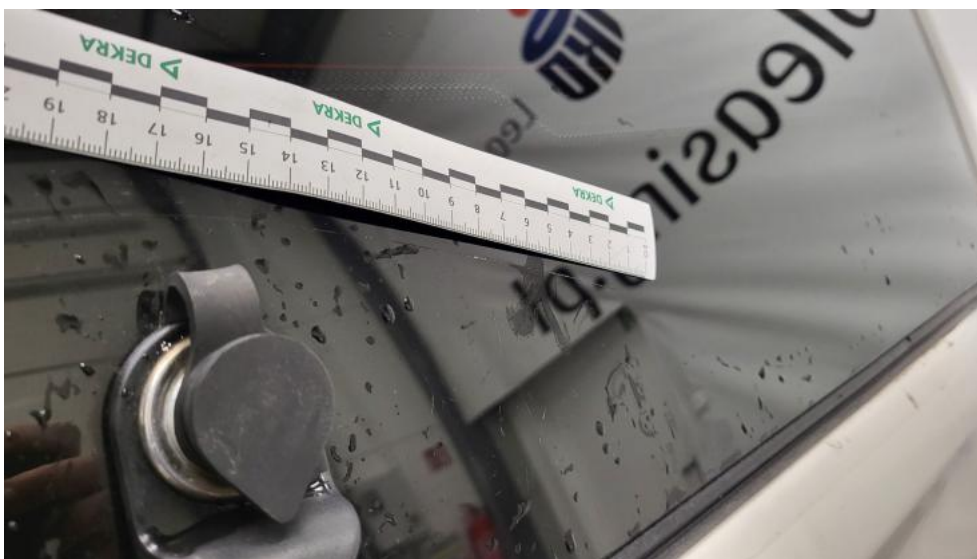
Photo 51.
Szyba tylna - Rysa/odprysk 1

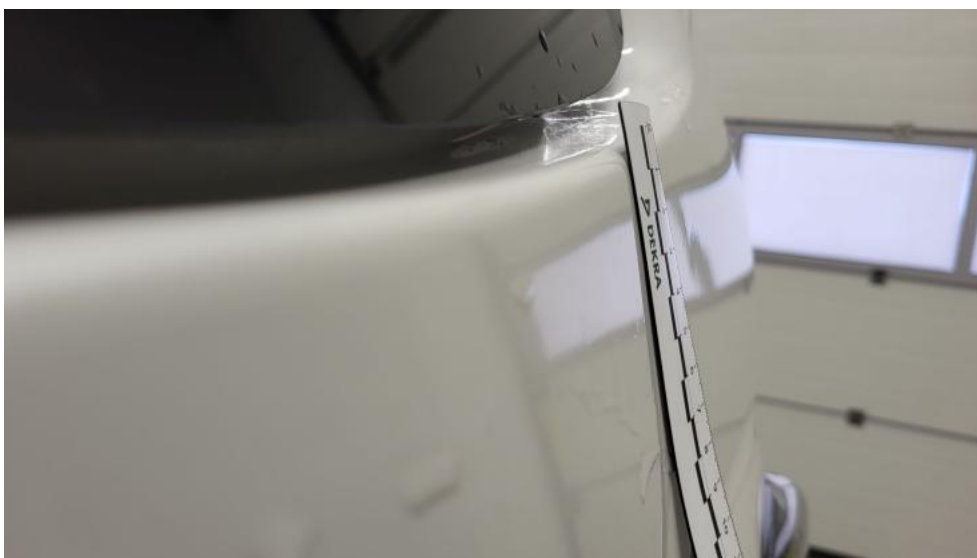
Photo 52.
Błotnik tylny L / Ściana boczna L - Wgniecenie/odkształcenie 1

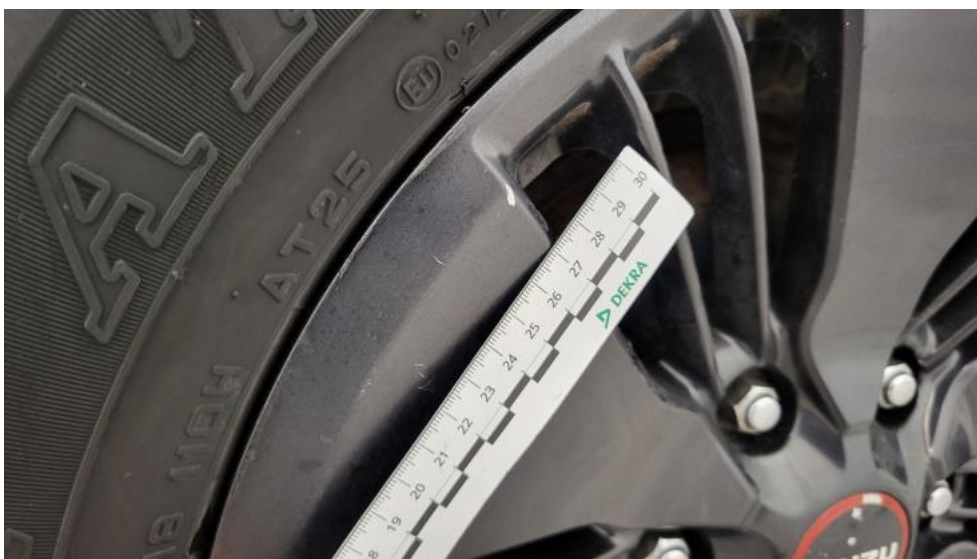
Photo 53.
Felga aluminiowa tylna L - Rysa/odprysk 1

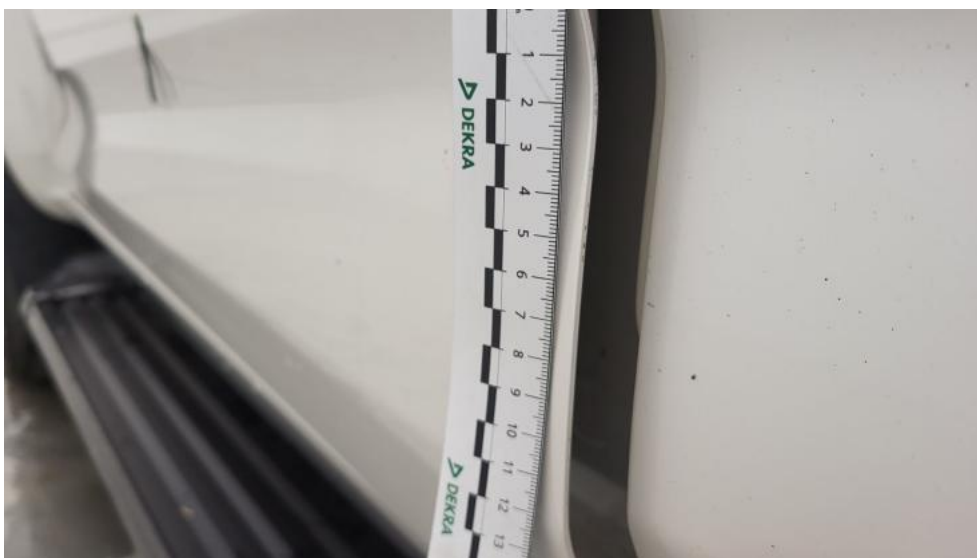
Photo 54.
Drzwi przed L - Rysa/odprysk 1

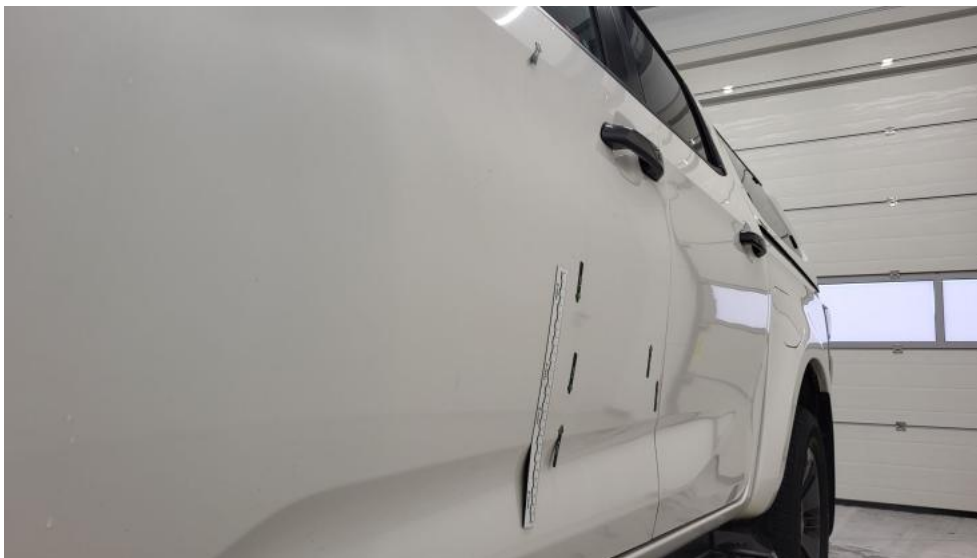
Photo 55.
Drzwi przed L - Wgniecenie/odkształcenie 1

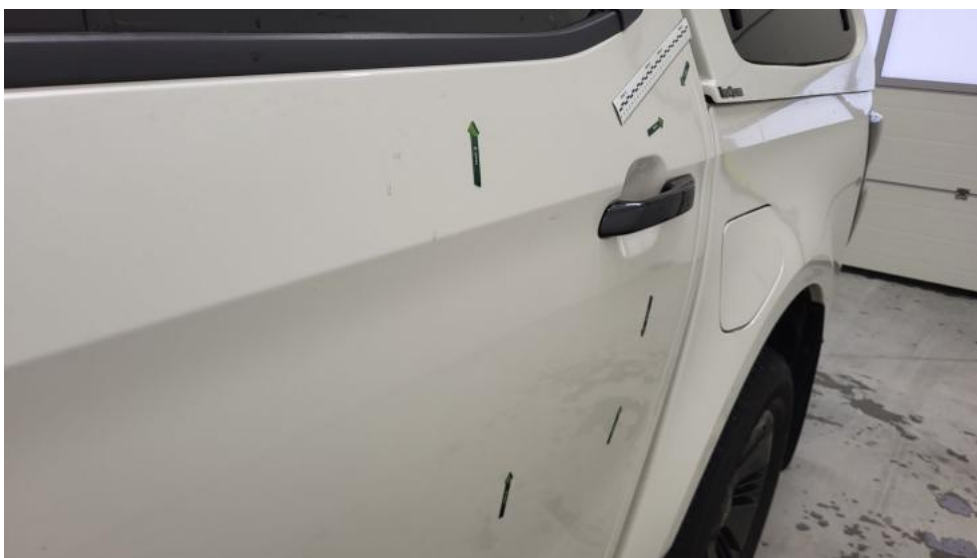
Photo 56.
Drzwi tylne L - Wgniecenie/odkształcenie 1

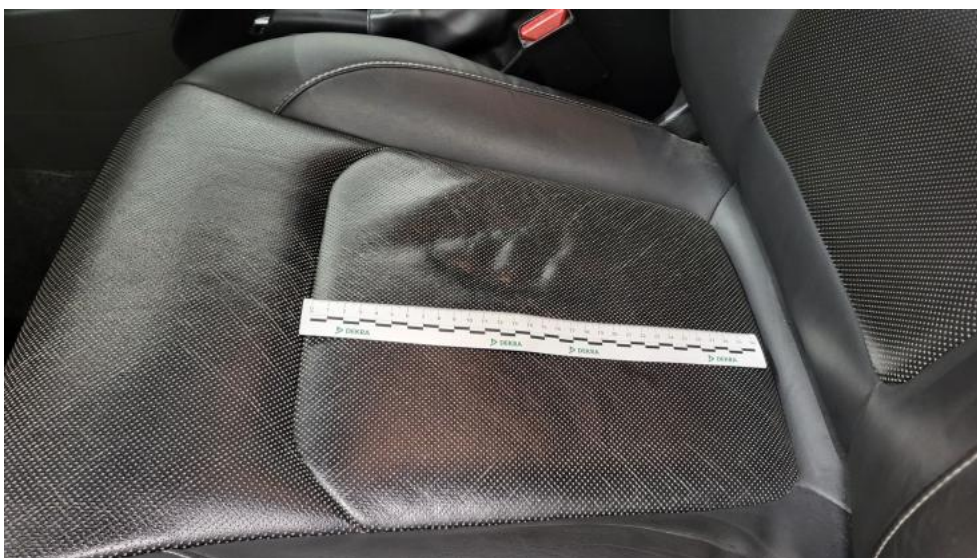
Photo 58.
Fotel prz. lew. - Wgniecenie/odkształcenie 1
