DEKRA's commission No. : PKOL(W)/LODZ/52276/25/07/16  
commission/ damage No. : 23/000171  
Date of commission: 16-07-2025

**Vehicle data**

| Manufacturer | BMW |
| Model | Seria 7 [G11, G12] 15-19 |

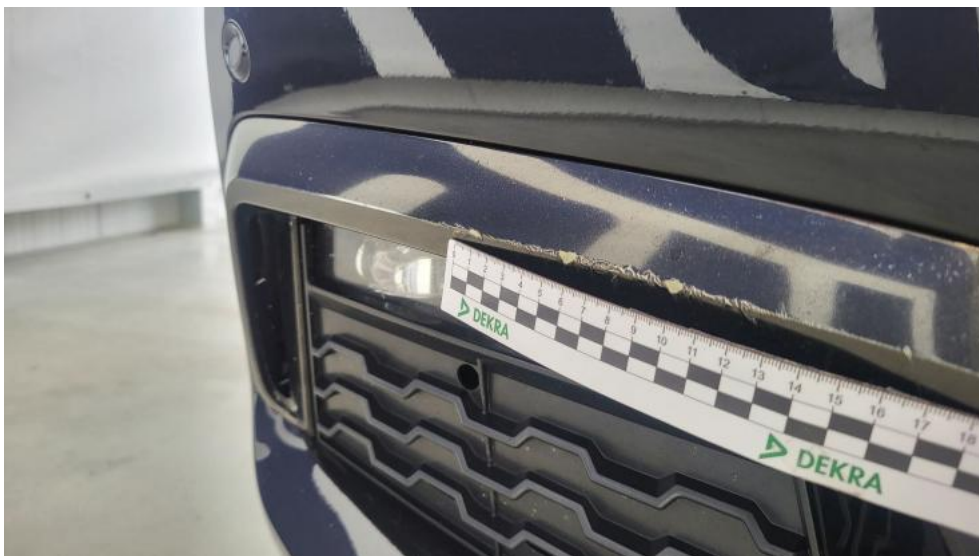
**Photo 44.**

Kratka/zaślepka halogenu P - Rysa/odprysk 1

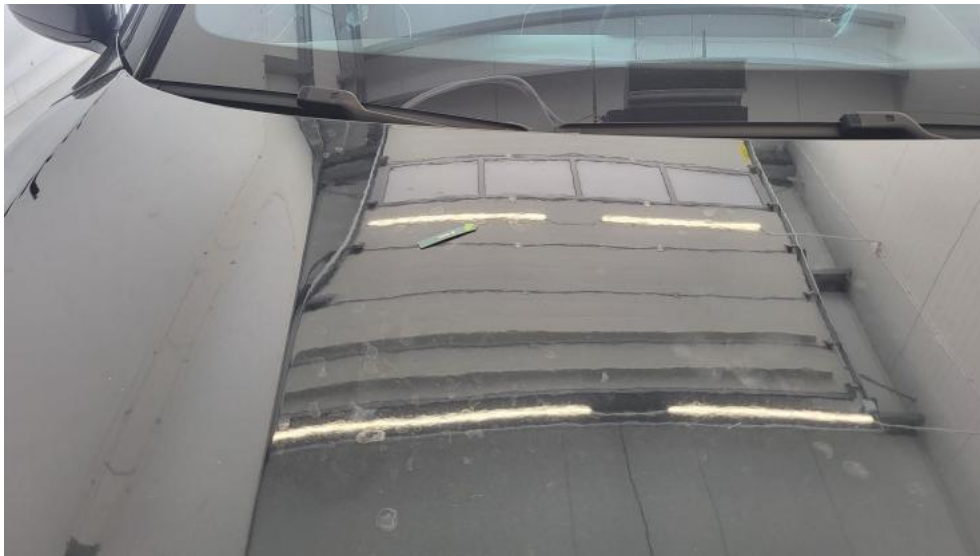
**Photo 45.**

Pokrywa komory silnika - Wgniecenie/odkształcenie 1

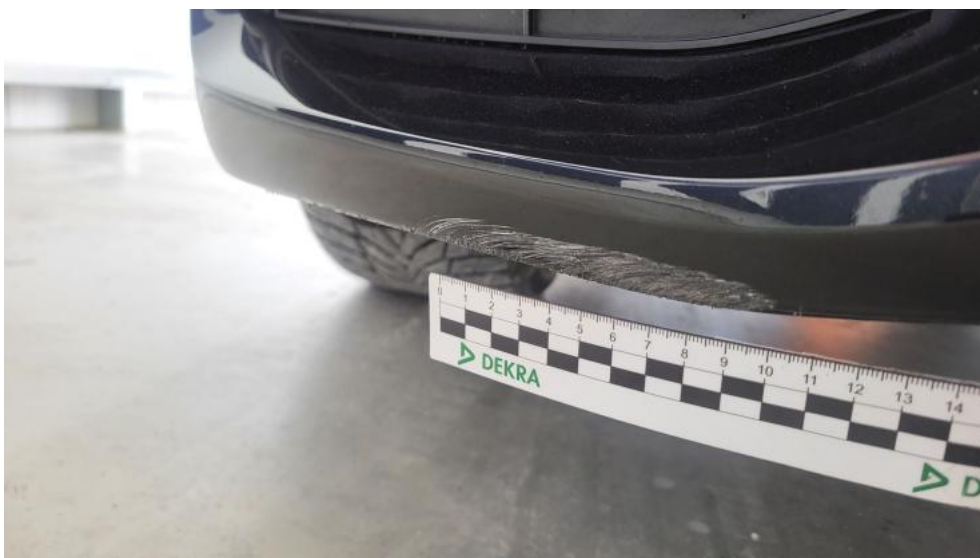
**Photo 46.**

Zderzak - Rysa/odprysk 1

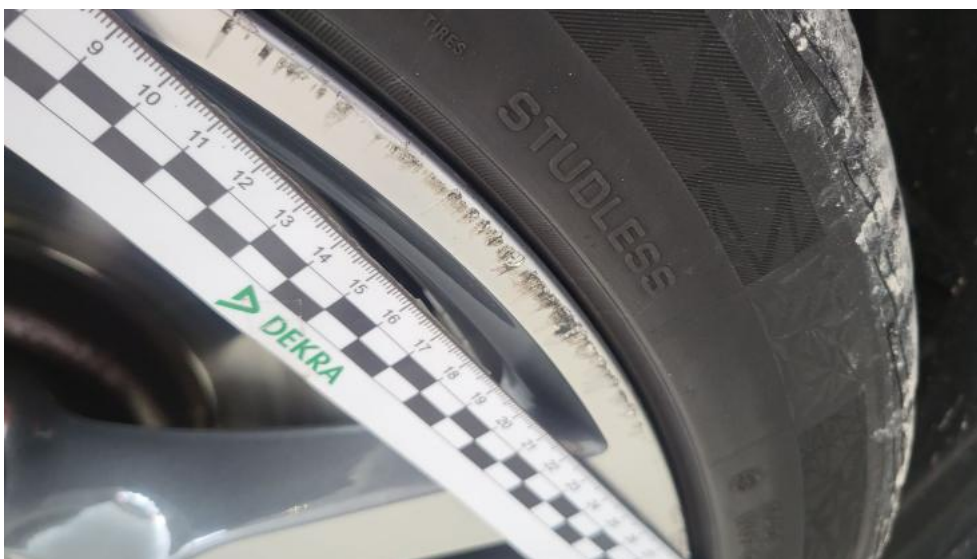
**Photo 47.**

Felga aluminiowa przednia P - Rysa/odprysk 1

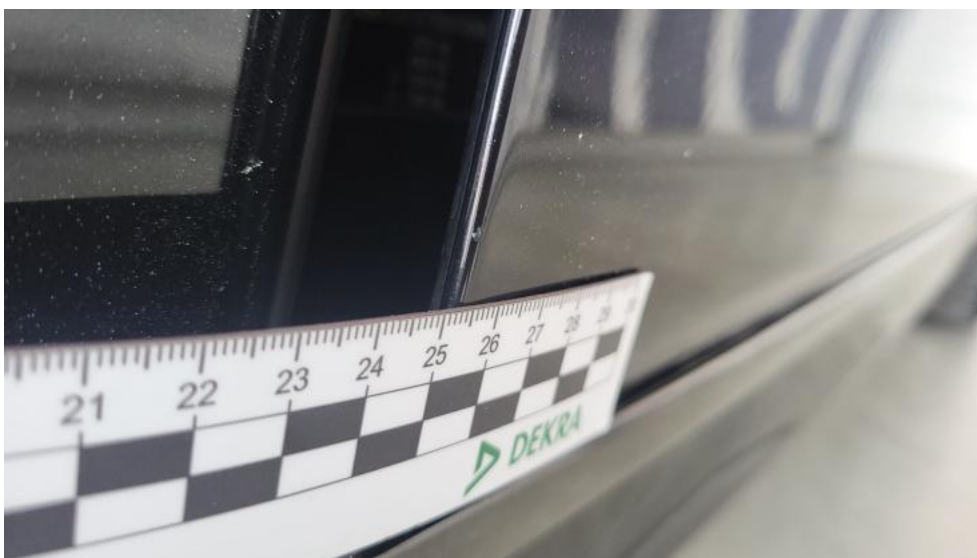
**Photo 48.**

Drzwi przednie P - Rysa/odprysk 1

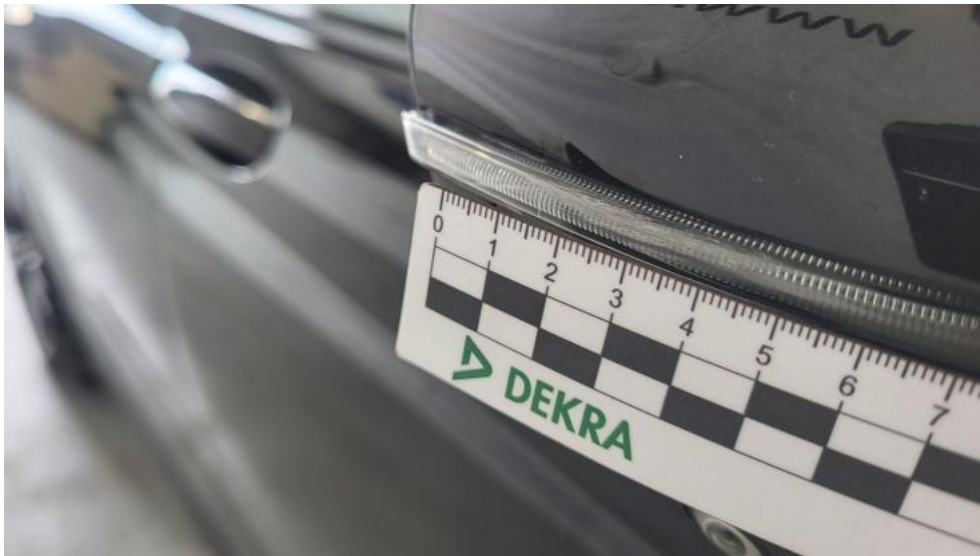
**Photo 49.**

Lusterko zew P - Rysa/odprysk 1

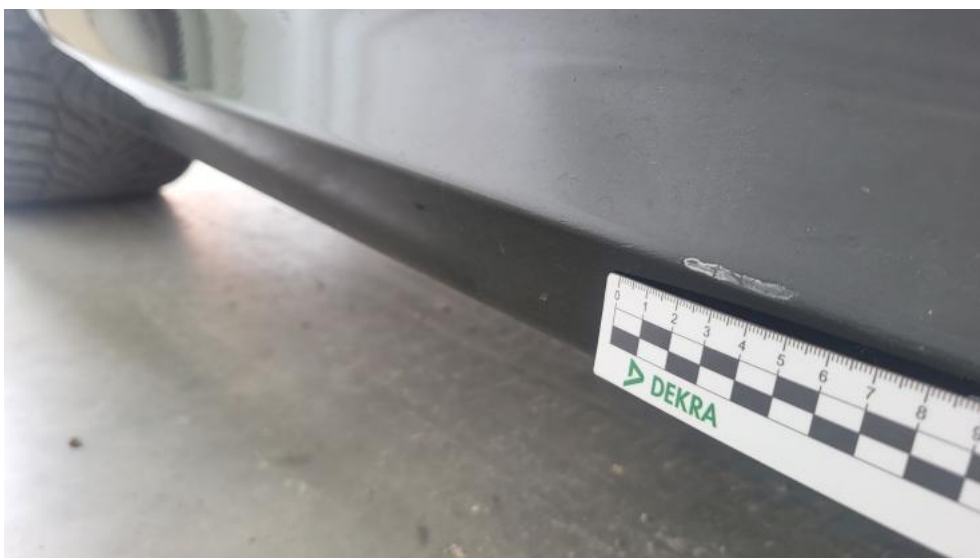
**Photo 50.**

Próg P - Rysa/odprysk 1

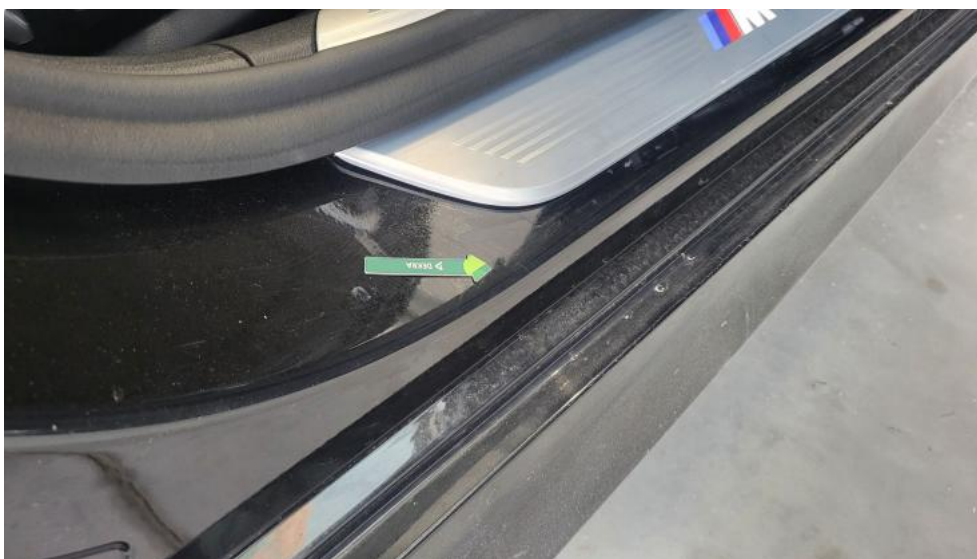
**Photo 51.**

Próg P - Wgniecenie/odkształcenie 1

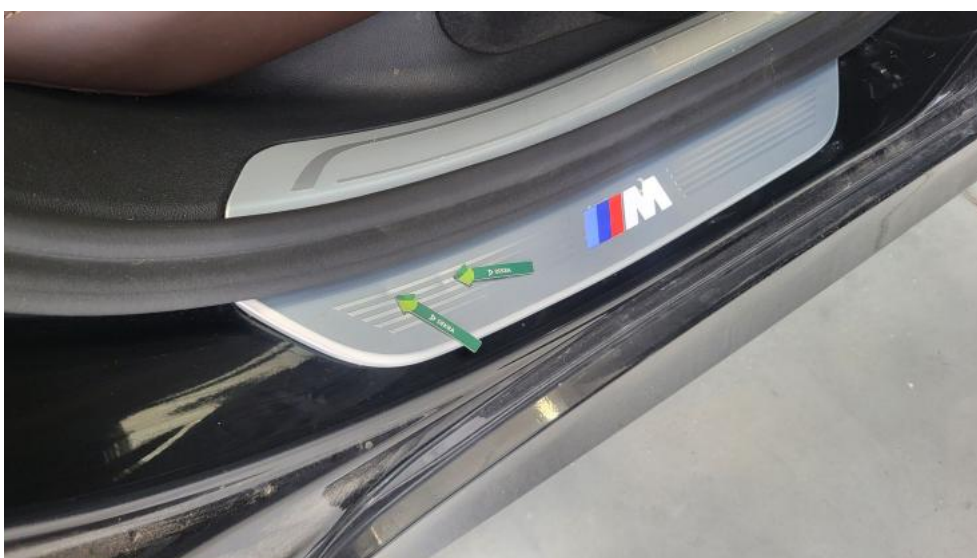
**Photo 52.**

Próg P - Wgniecenie/odkształcenie 2

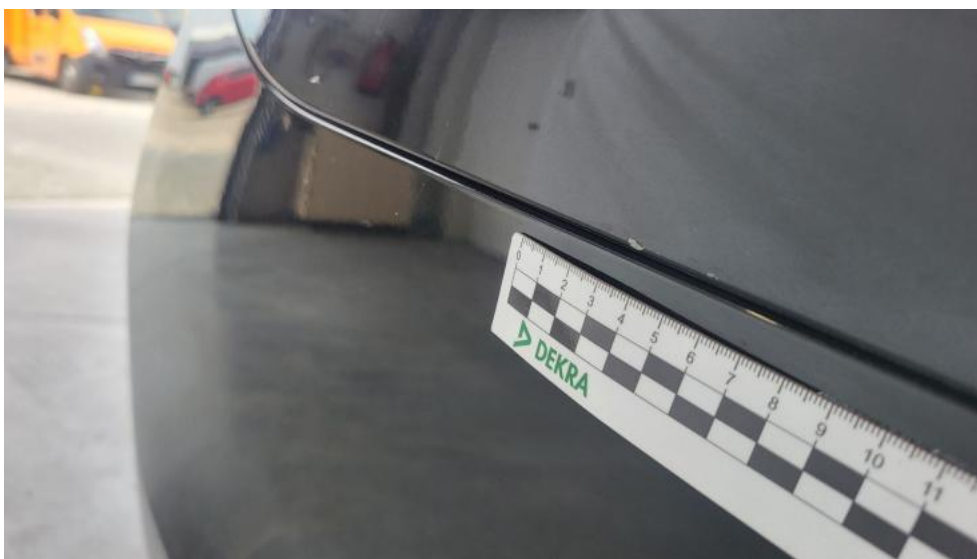
**Photo 53.**

Błotnik tylny P / Ściana boczna P - Rysa/odprysk 1

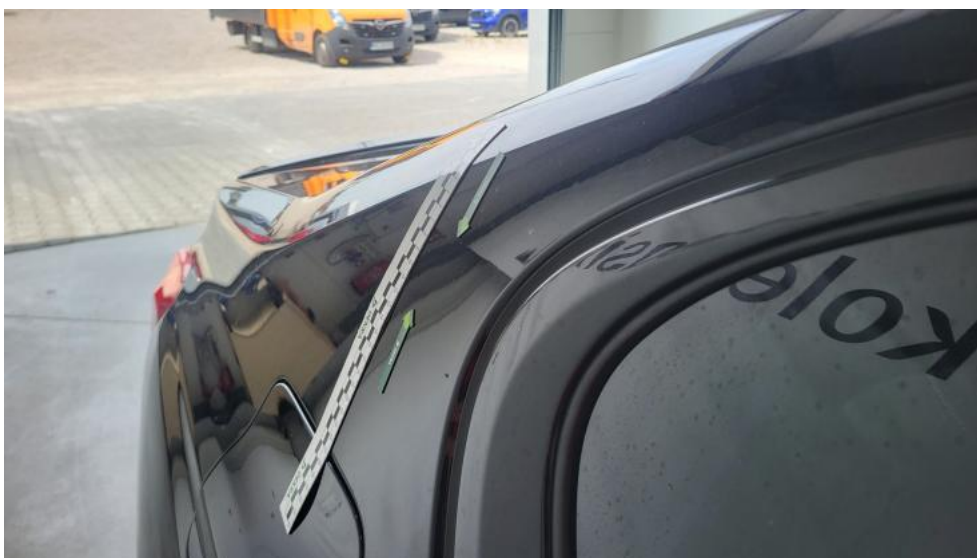
**Photo 54.**

Błotnik tylny P / Ściana boczna P - Wgniecenie/odkształcenie 1

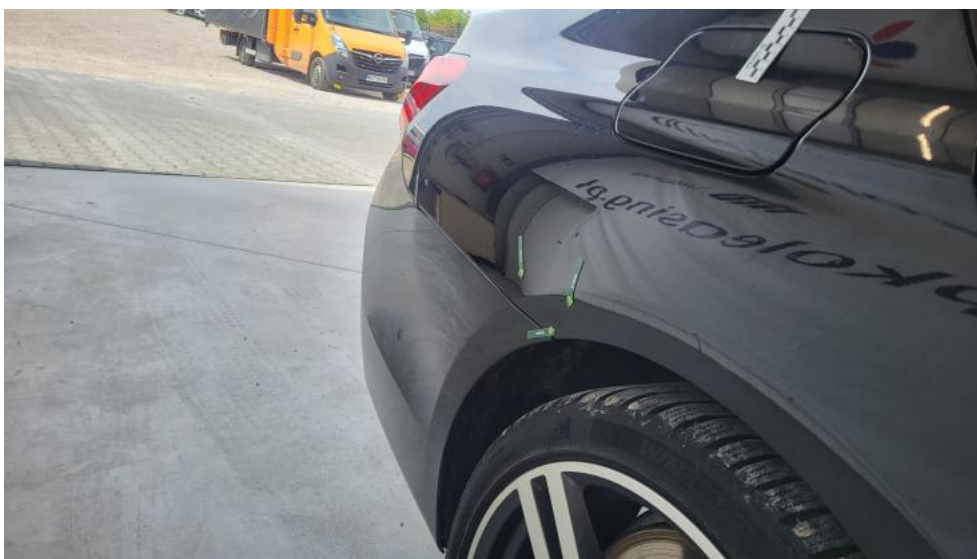
**Photo 55.**

Błotnik tylny P / Ściana boczna P - Wgniecenie/odkształcenie 2

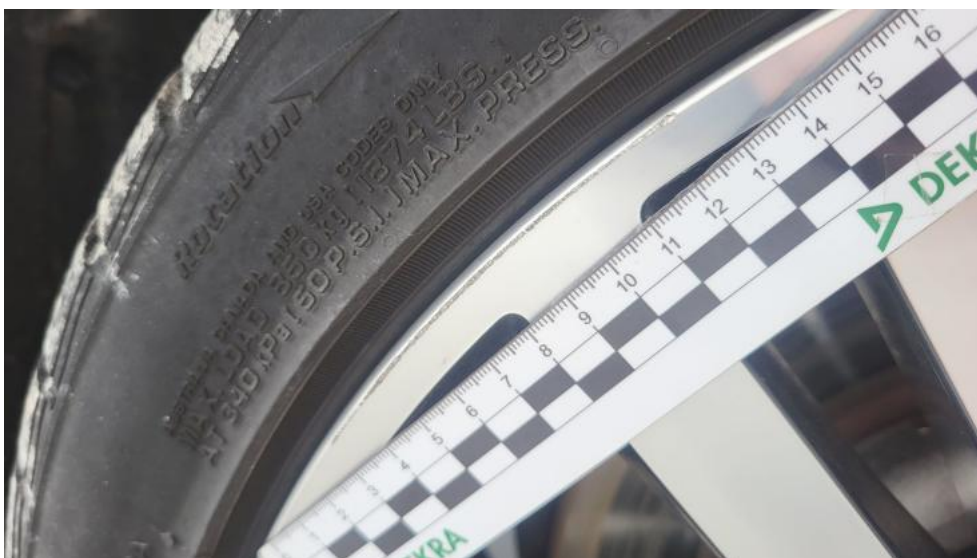
**Photo 56.**

Felga aluminiowa tylna P - Rysa/odprysk 1

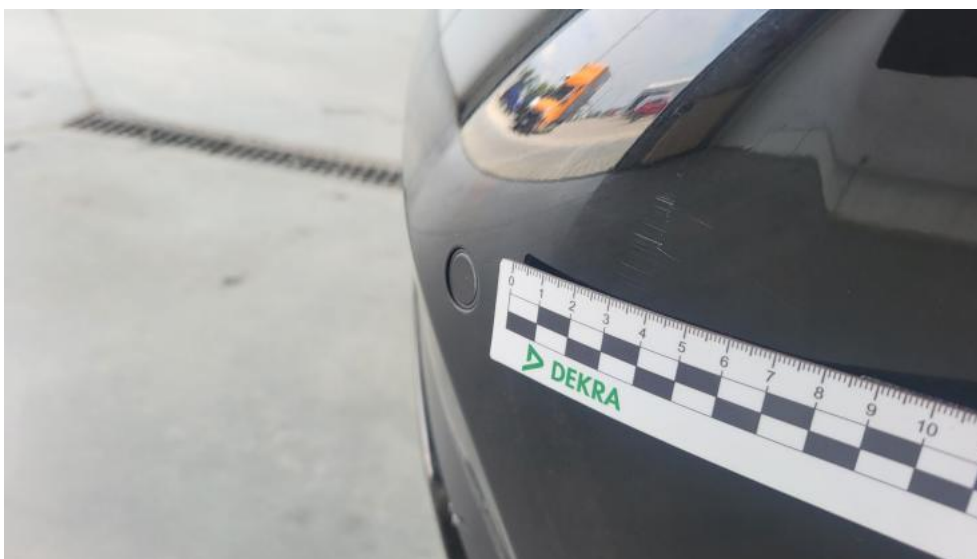
**Photo 57.**

Zderzak tylny - Rysa/odprysk 1

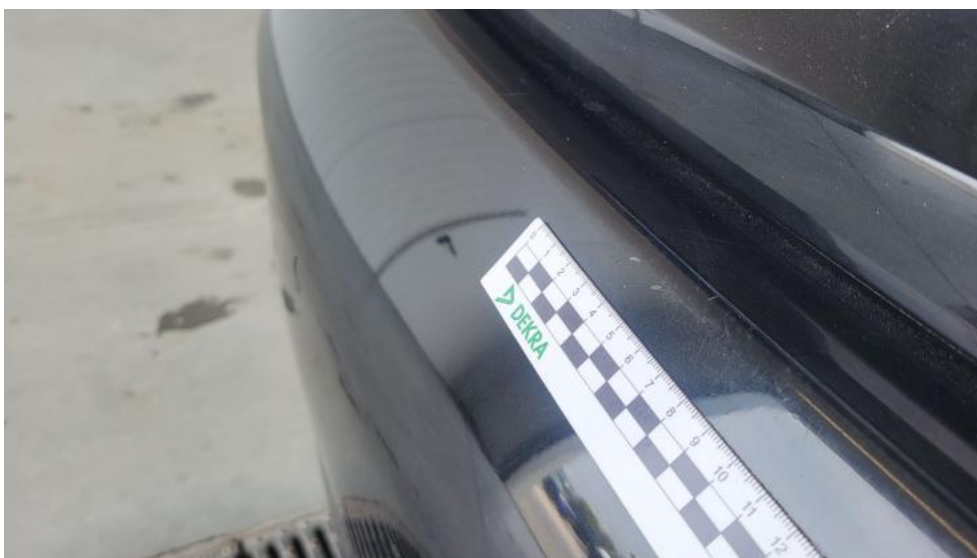
**Photo 58.**

Zderzak tylny - Rysa/odprysk 2

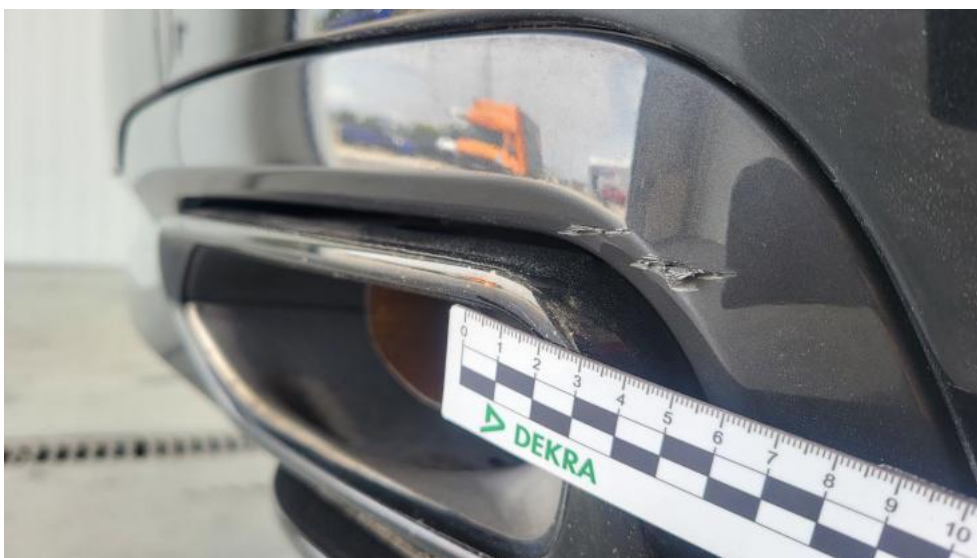
**Photo 60.**

Zderzak tylny cz dolna - Rysa/odprysk 1

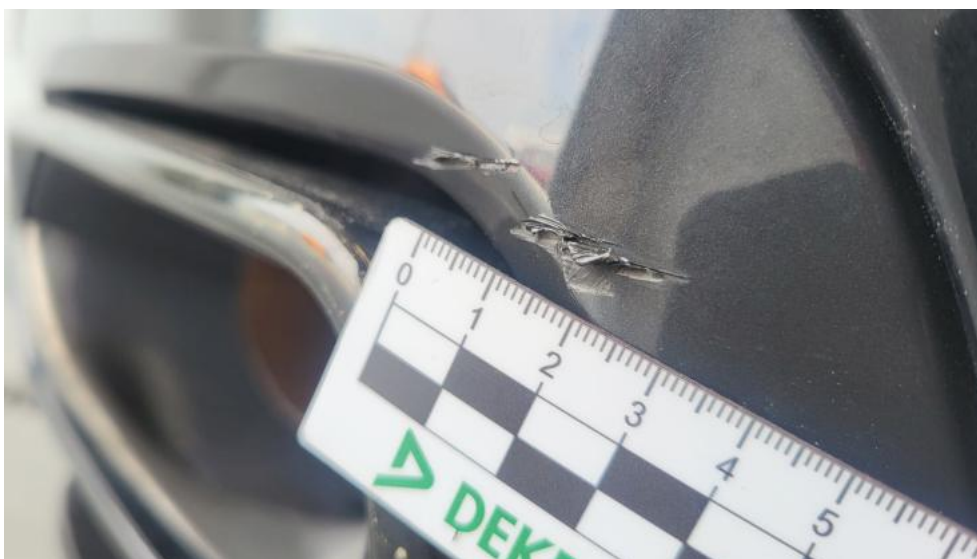
**Photo 61.**

Zderzak tylny cz dolna - Pęknięcie/rozerwanie 1

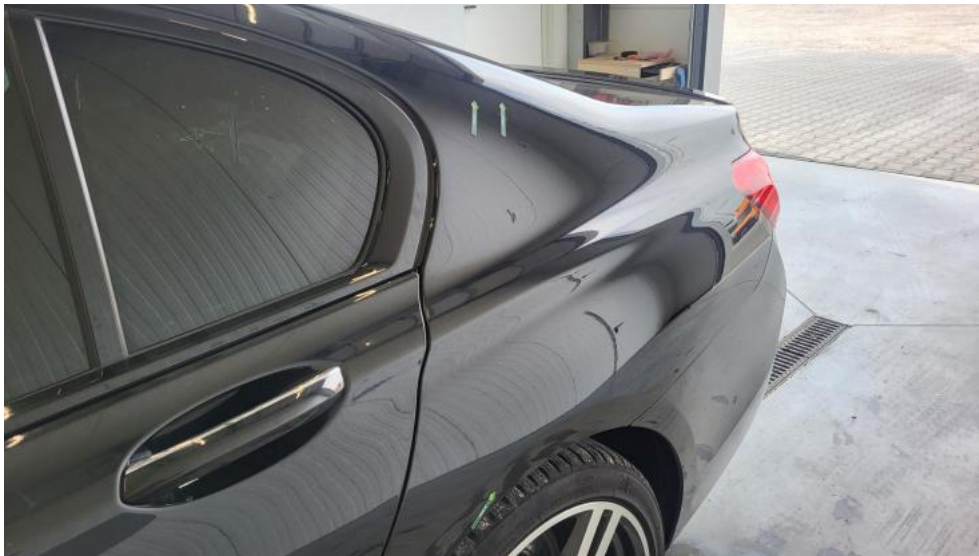
**Photo 65.**

Błotnik tylny L / Ściana boczna L - Wgniecenie/odkształcenie 1

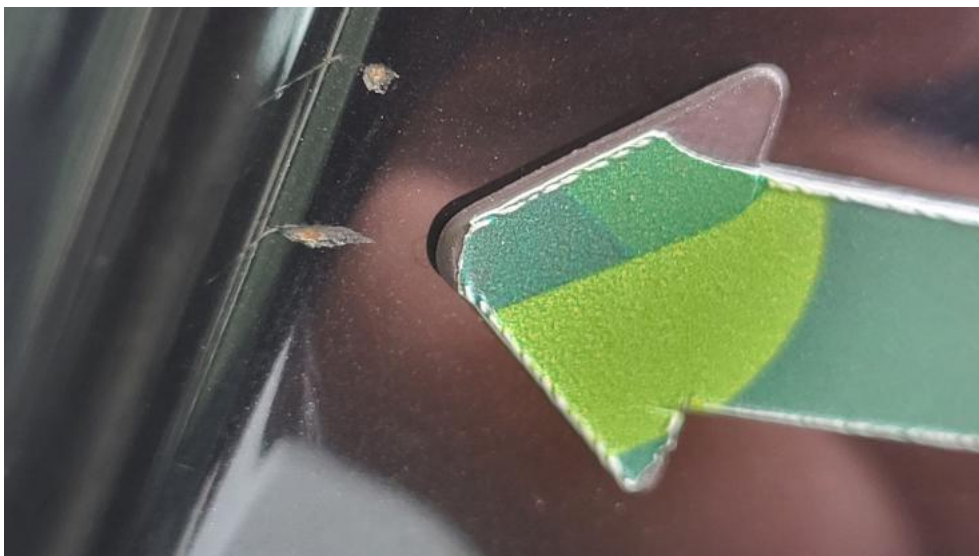
**Photo 66.**

Błotnik tylny L / Ściana boczna L - Inne 1

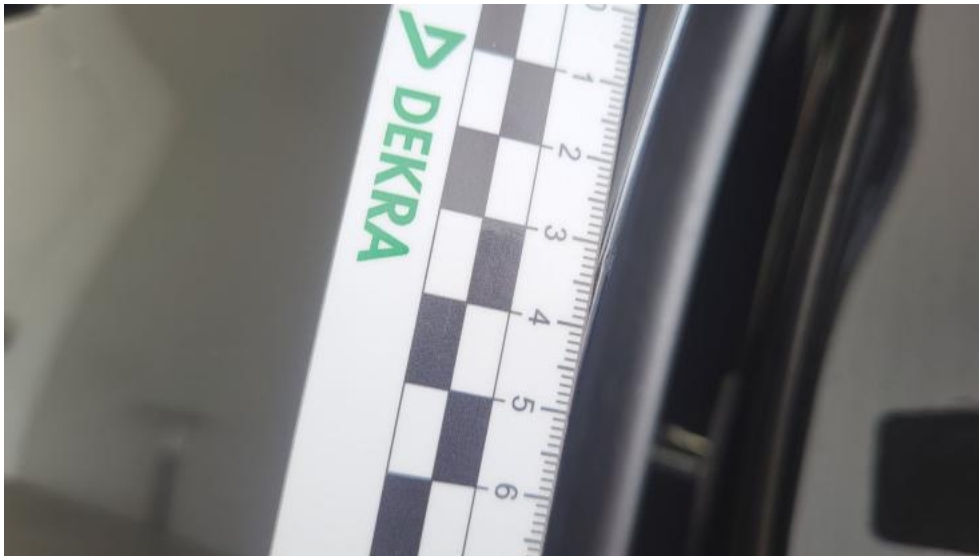
**Photo 67.**

Drzwi przed L - Wgniecenie/odkształcenie 1

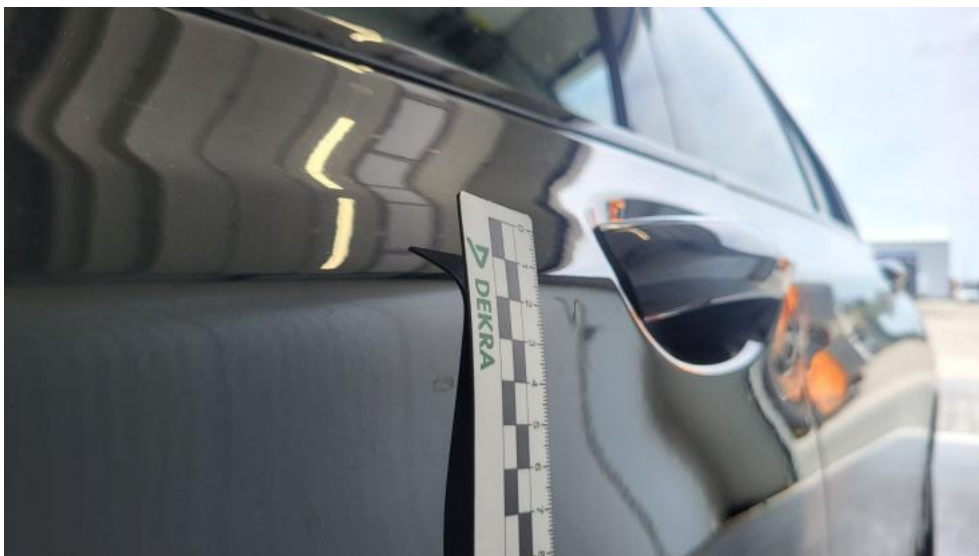
**Photo 68.**

Drzwi przed L - Wgniecenie/odkształcenie 2

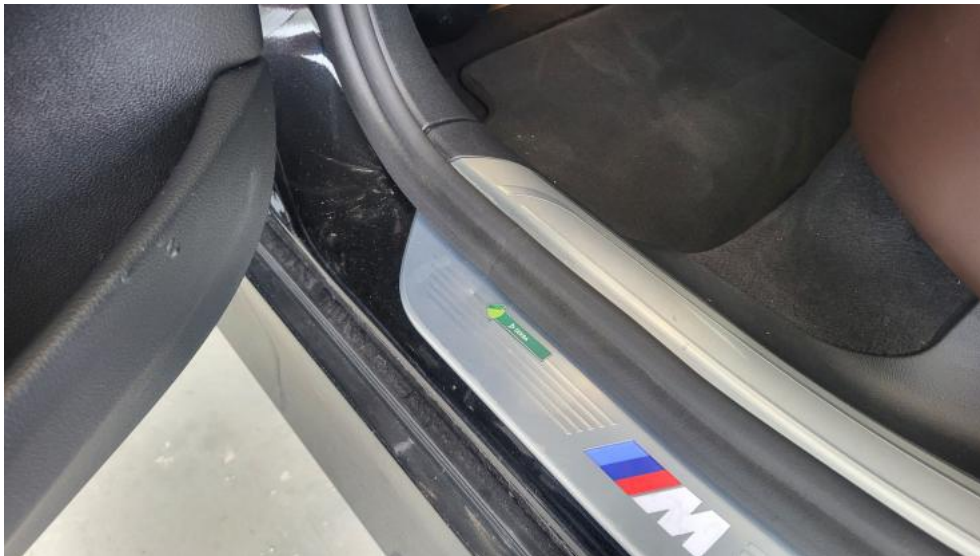
**Photo 69.**

Próg L - Wgniecenie/odkształcenie 1

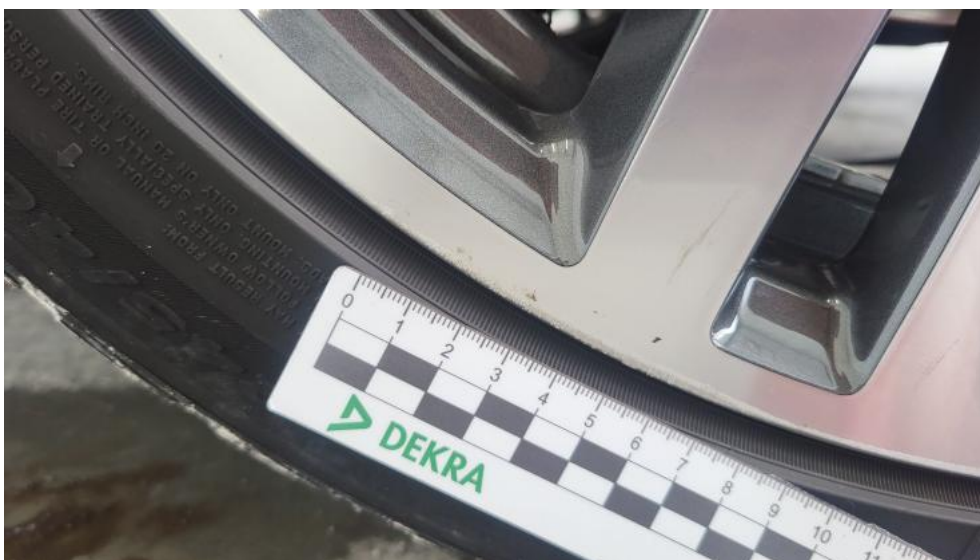
**Photo 70.**

Felga Aluminiowa przednia L - Rysa/odprysk 1

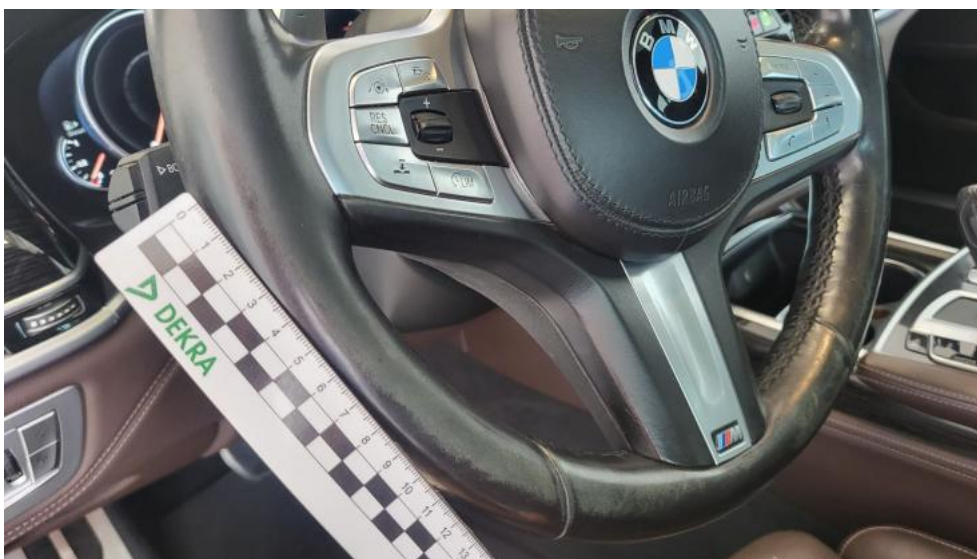
**Photo 71.**

Koło kierownicy - Inne 1

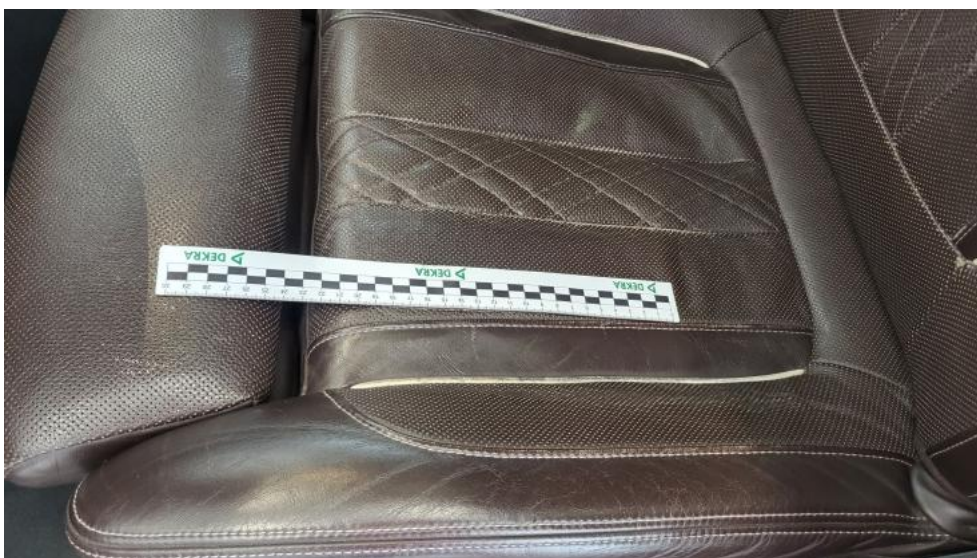
**Photo 72.**

Fotel prz. lew. - Inne 1

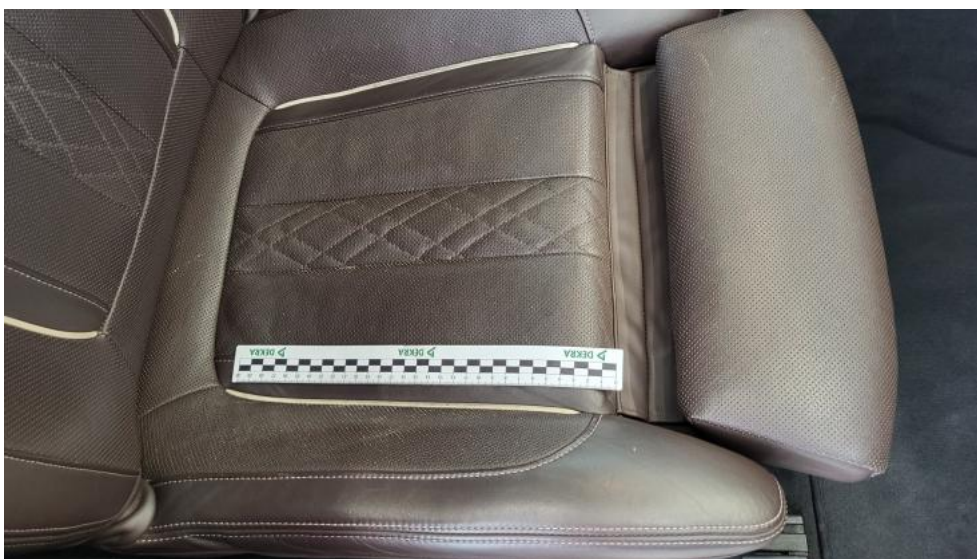
**Photo 73.**

Fotel prz. praw. - Inne 1

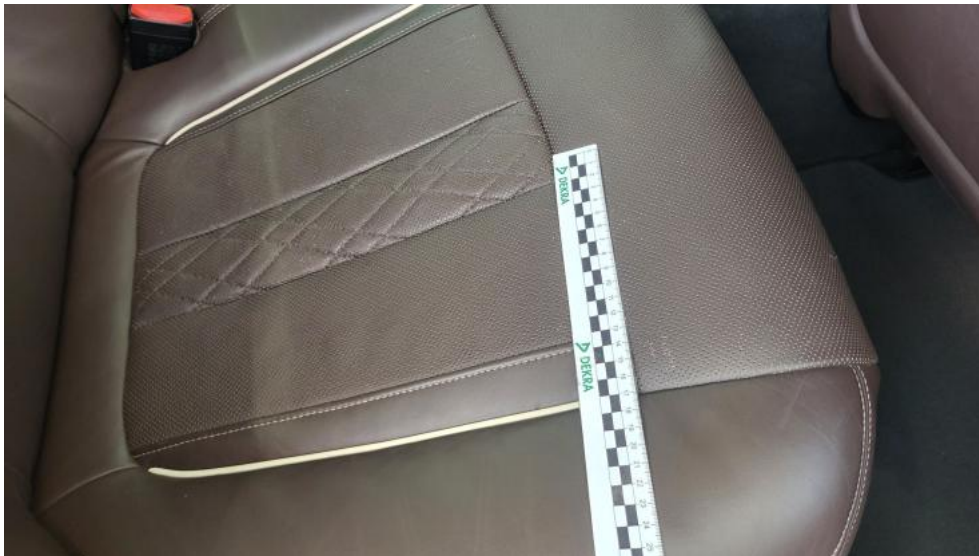
**Photo 75.**

Kanapa tyl. - Rysa/odprysk 2

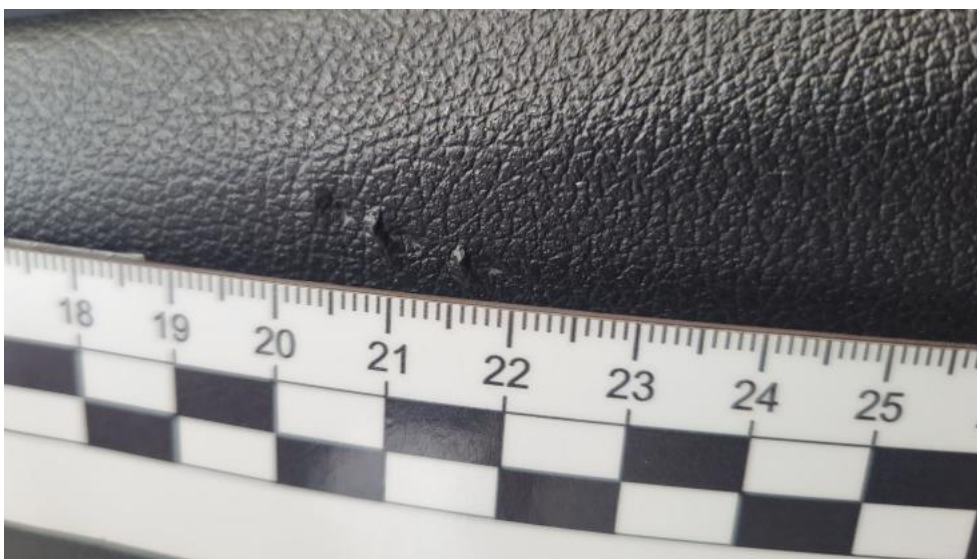
**Photo 77.**

Tapicerka drzwi przednich L - Pęknięcie/rozerwanie 1

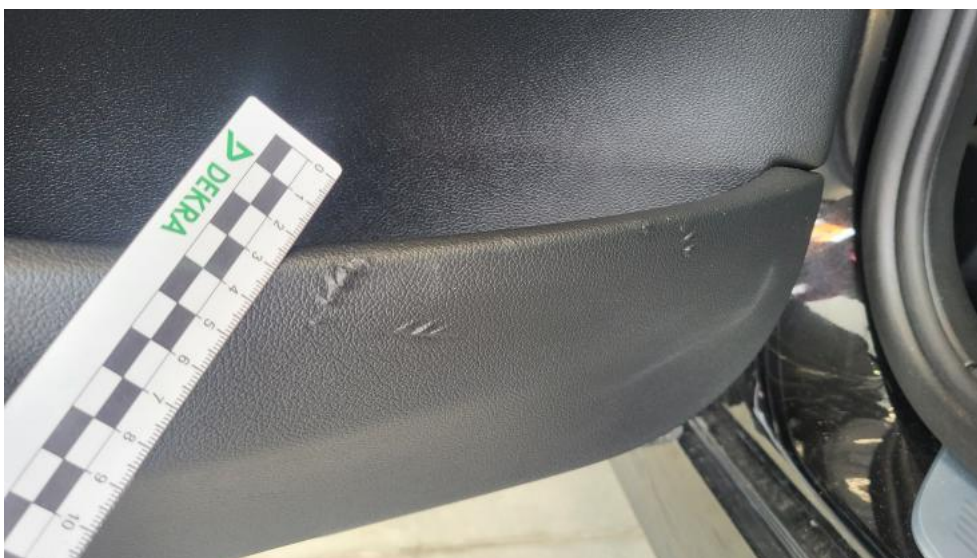
**Photo 78.**

Tapicerka drzwi tylnych L - Pęknięcie/rozerwanie 1

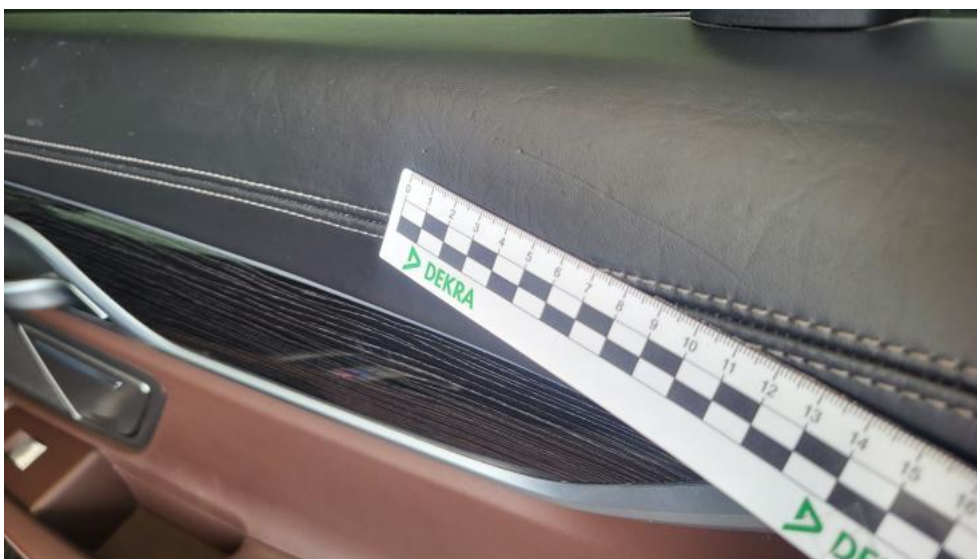
**Photo 79.**

Tapicerka drzwi tylnych P - Rysa/odprysk 1
