DEKRA's commission No. : PKOL(W)/LODZ/73874/25/09/30  
commission/ damage No. : 22/013785  
Date of commission: 30-09-2025

| Manufacturer | BMW |
| Model | Seria 6 Gran Turismo [G32] 17-20 |
| Registration /record No. | D8ZENON |

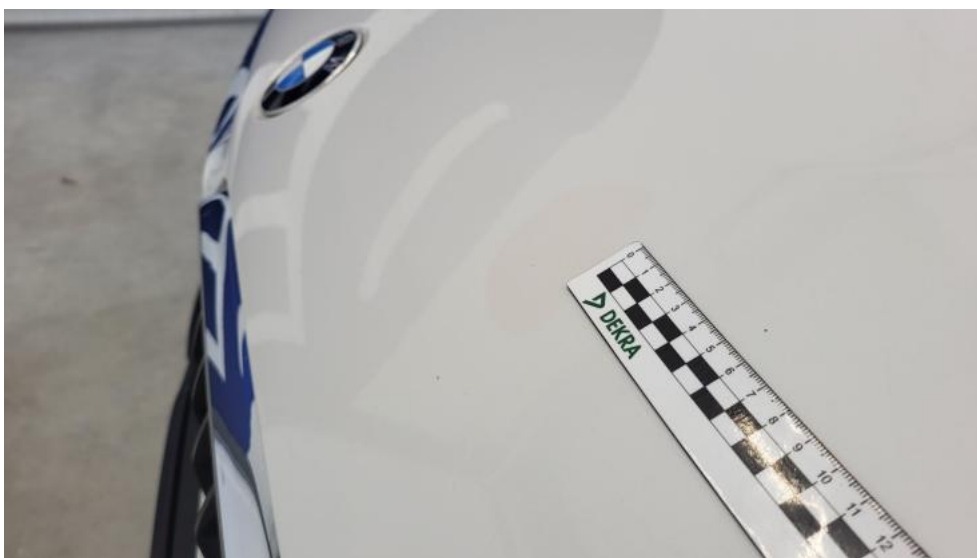
**Photo 40.**

Pokrywa komory silnika - Rysa/odprysk 1

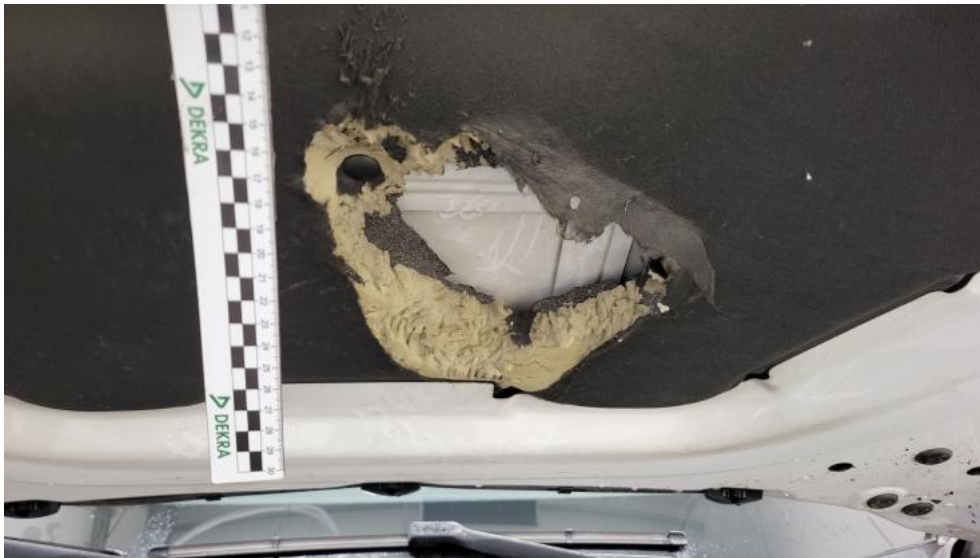
**Photo 41.**

Wykładzina pokrywy komory silnika - Pęknięcie/rozerwanie 1

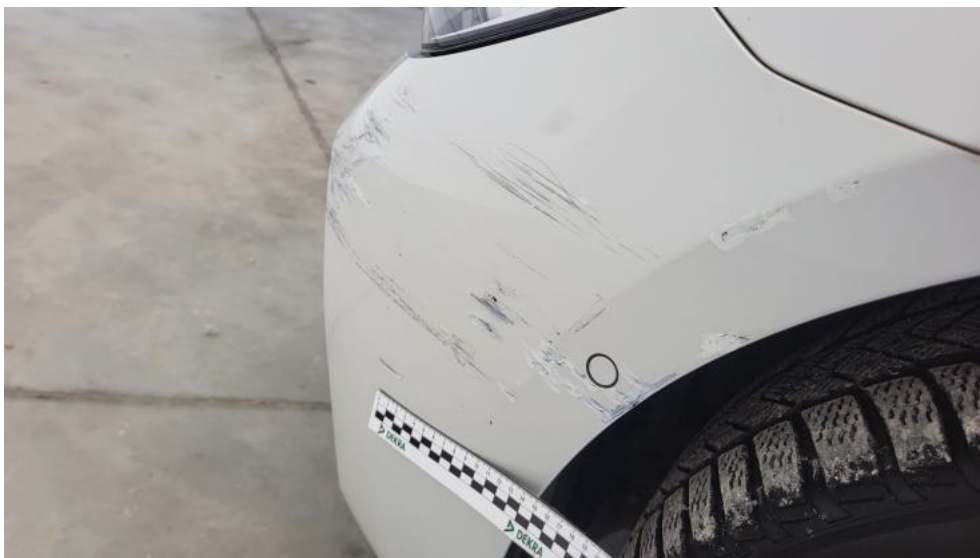
**Photo 42.**

Zderzak - Rysa/odprysk 1

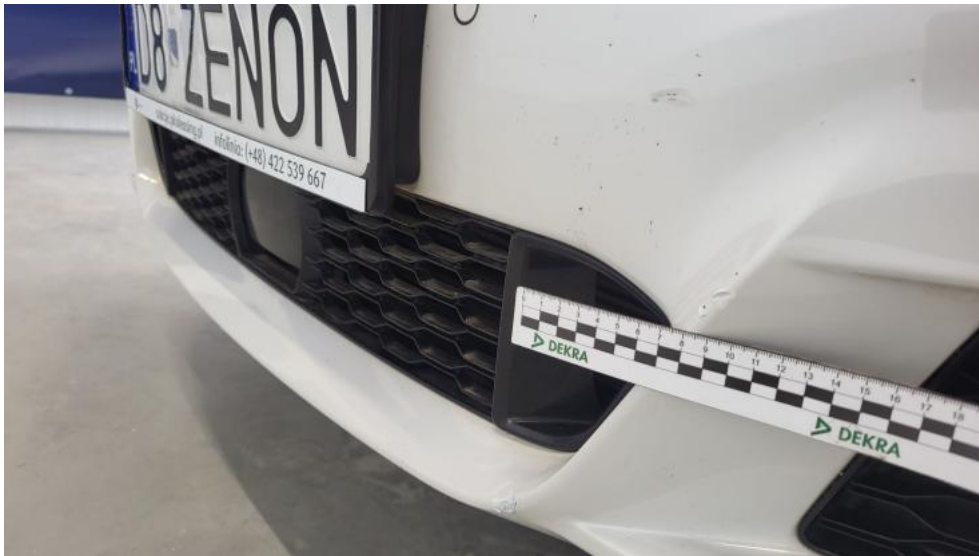
**Photo 43.**

Zderzak - Rysa/odprysk 2

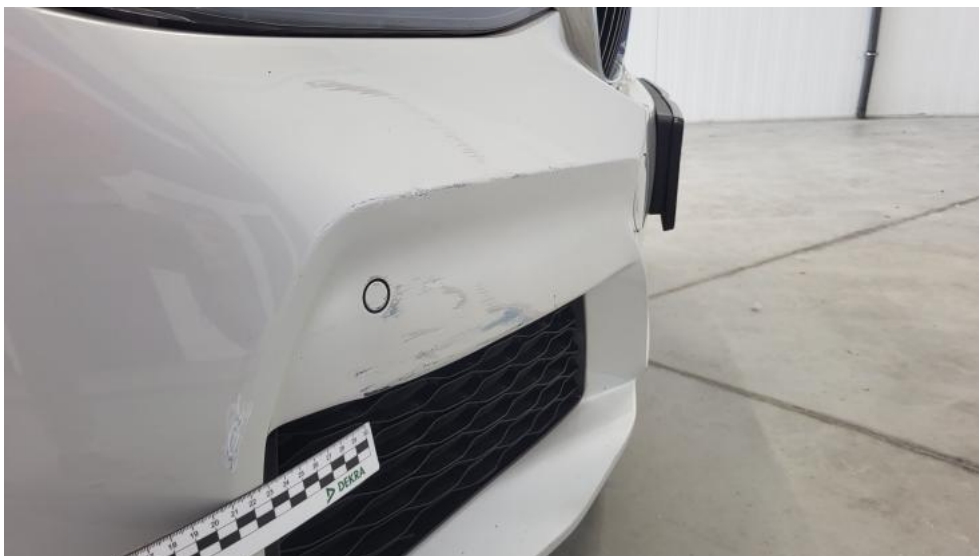
**Photo 44.**

Zderzak() - Rysa/odprysk 3

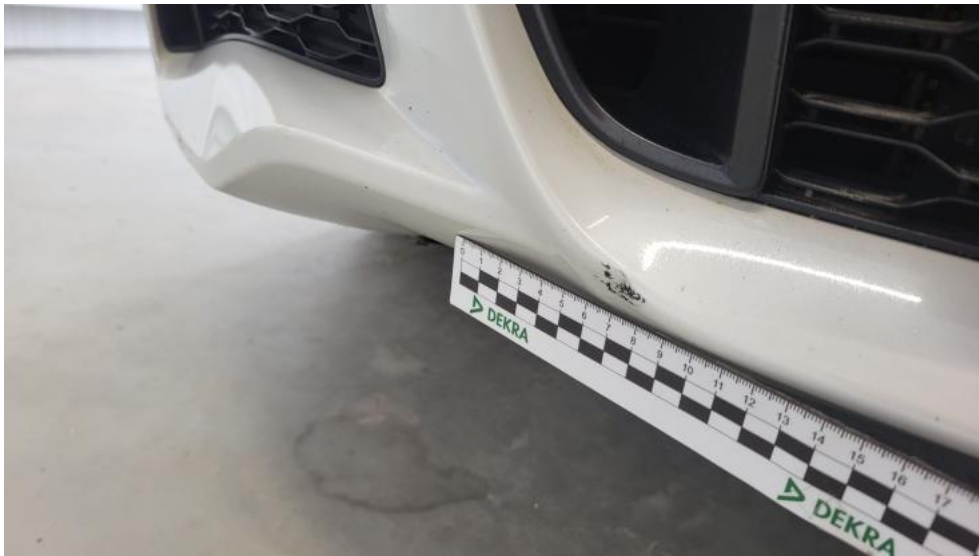
**Photo 45.**

Zderzak - Wgniecenie/odkształcenie 1

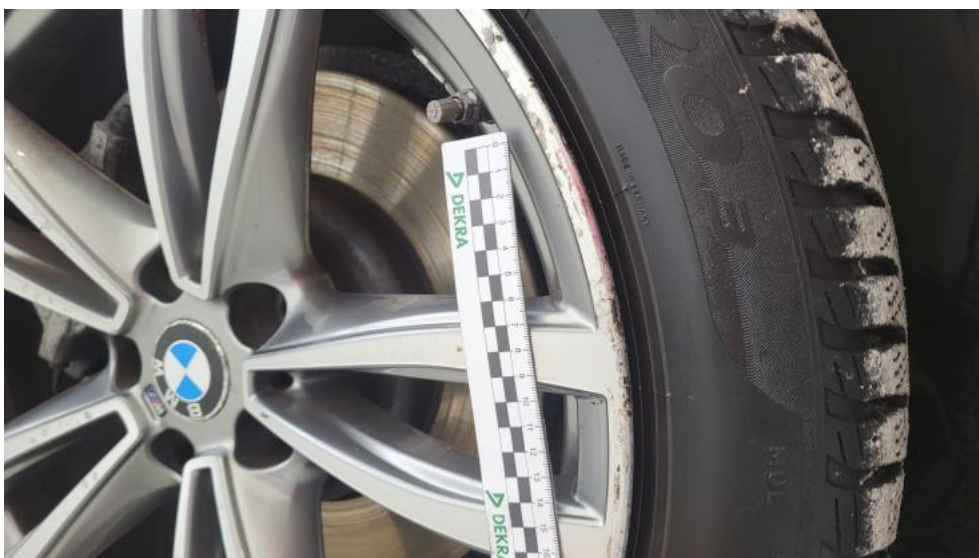
**Photo 46.**

Felga aluminiowa przednia P - Rysa/odprysk 1

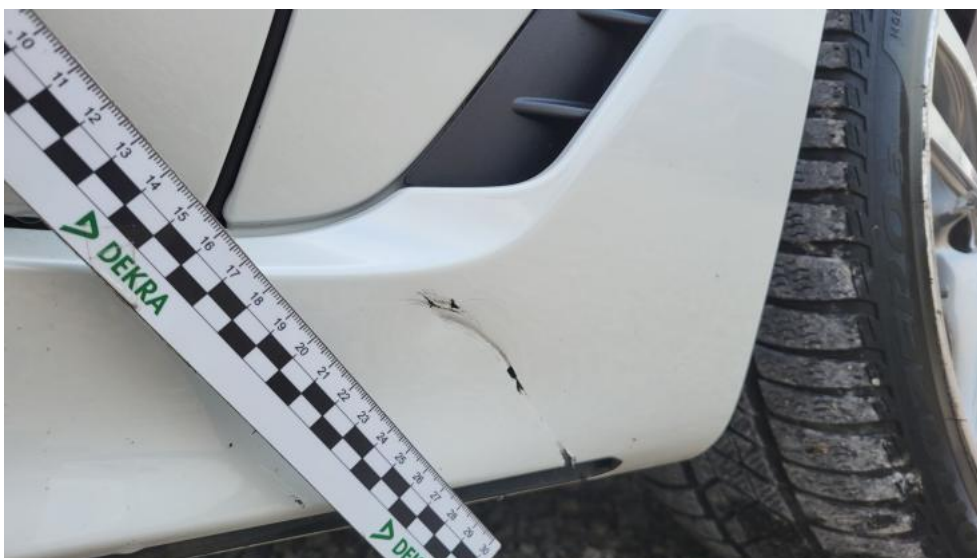
**Photo 48.**

Próg P - Wgniecenie/odkształcenie 2

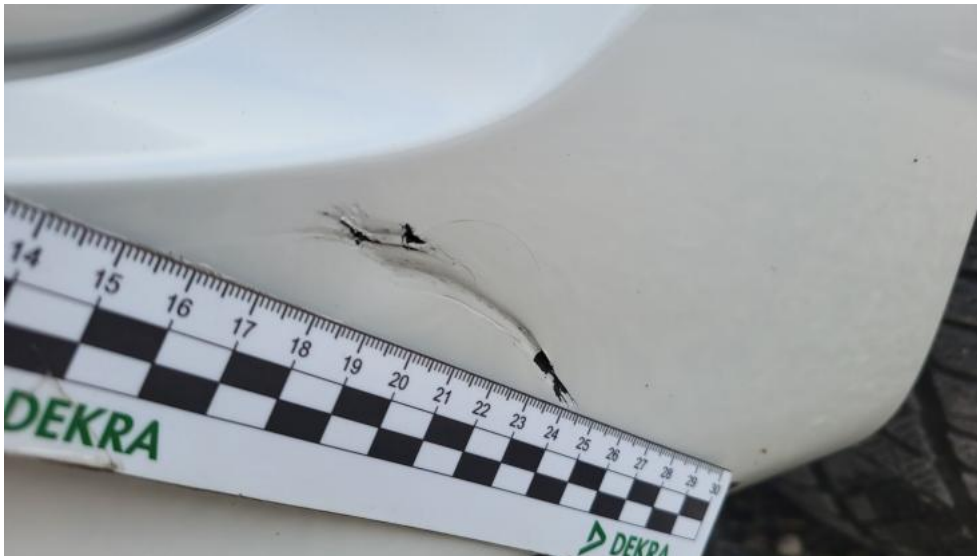
**Photo 49.**

Próg P - Pęknięcie/rozerwanie 1

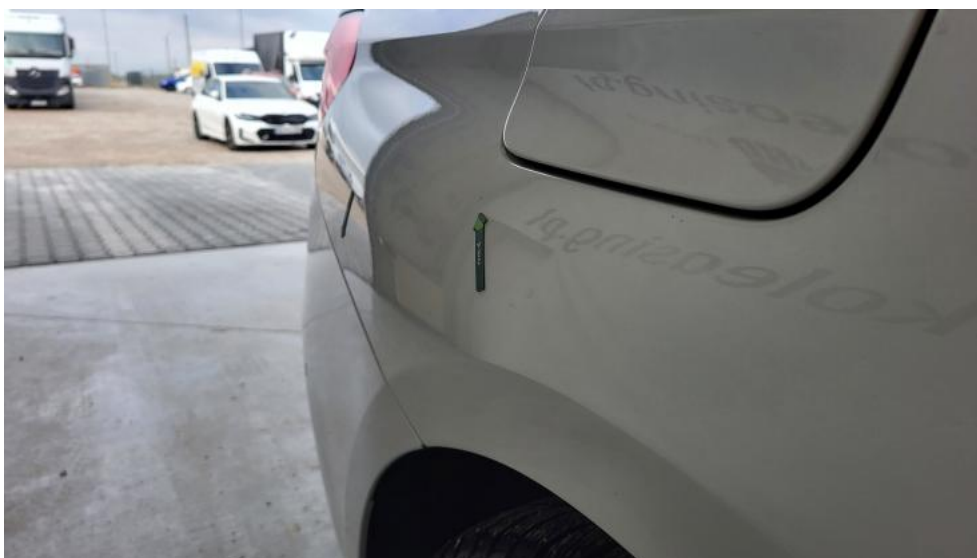
**Photo 50.**

Ścianka tylna P / Ścianka boczna P - Wgniecenie/odkształcenie 1

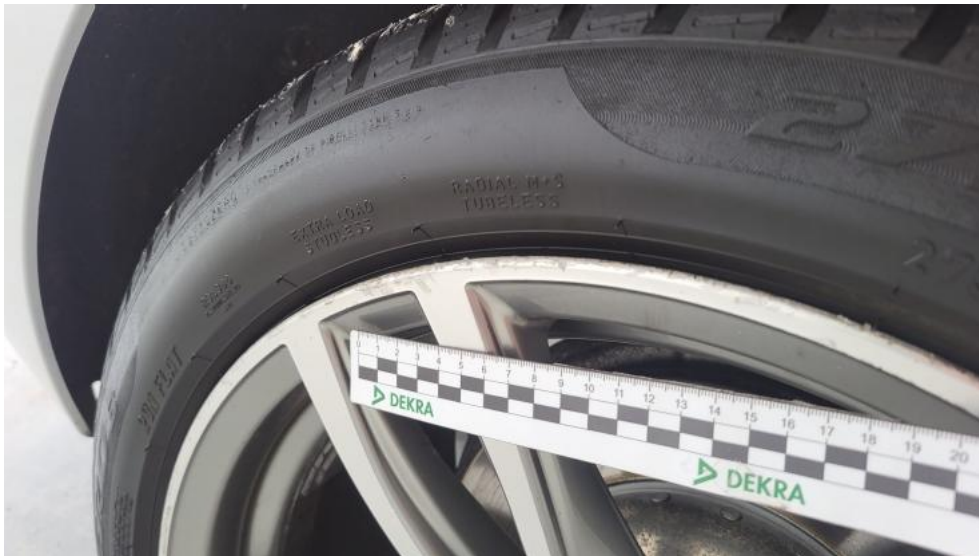
**Photo 51.**

Felga aluminiowa tylna P - Rysa/odprysk 1

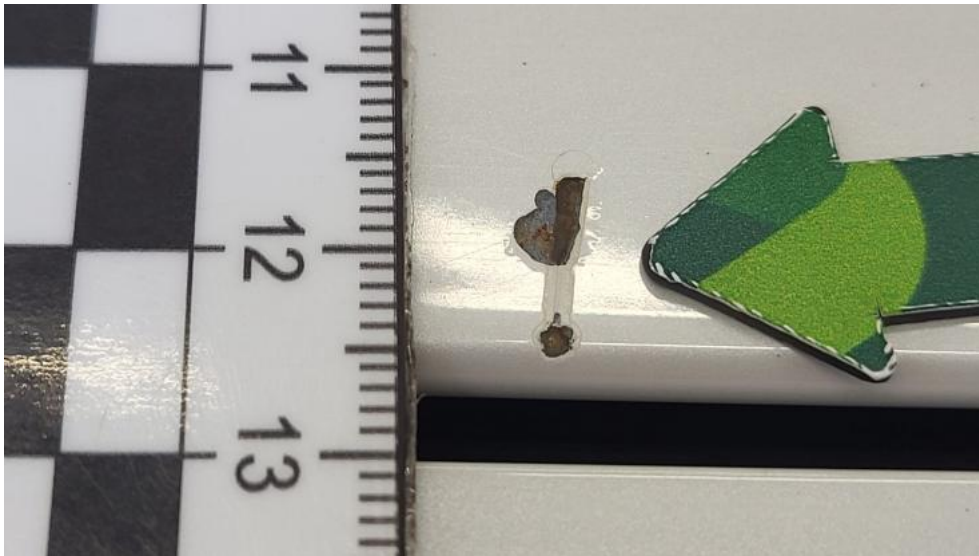
**Photo 53.**

Pokrywy bagażnika - Inne 1

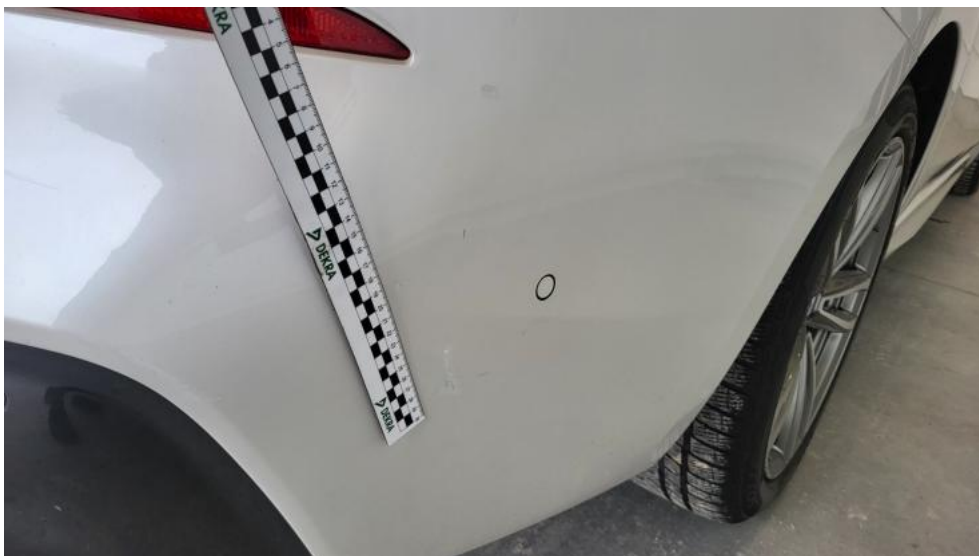
**Photo 54.**

Zderzak tylny - Rysa/odprysk 1

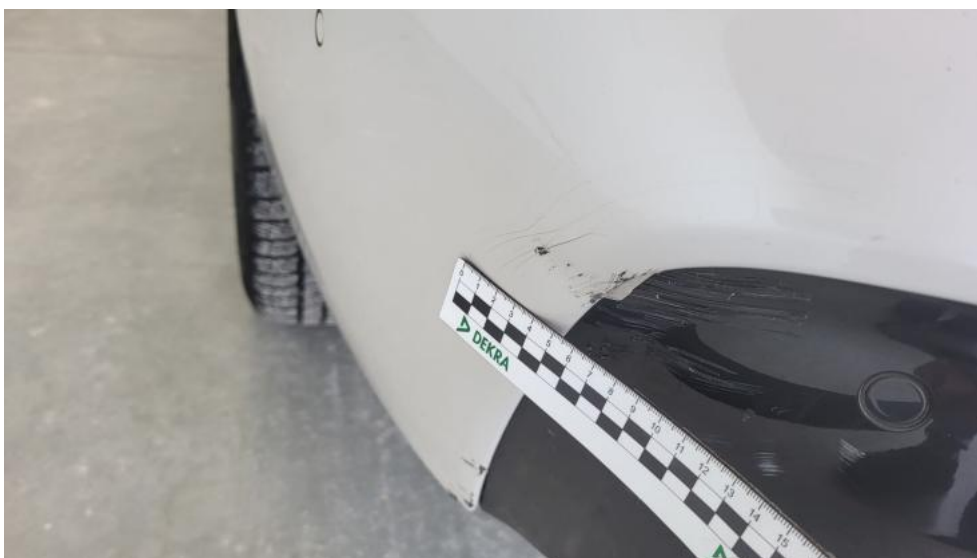
**Photo 56.**

Zderzak tylny - Wgniecenie/odkształcenie 1

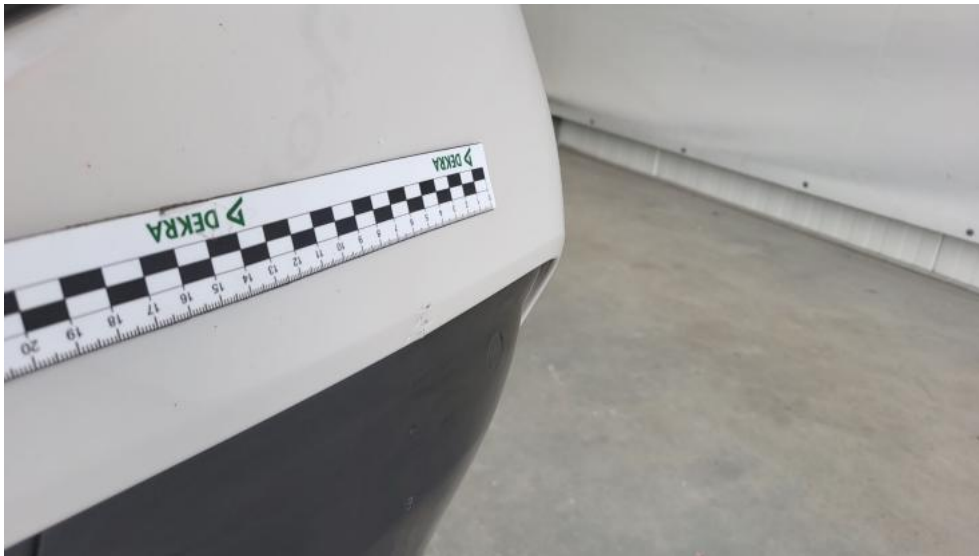
**Photo 57.**

Zderzak tylny - Wgniecenie/odkształcenie 2

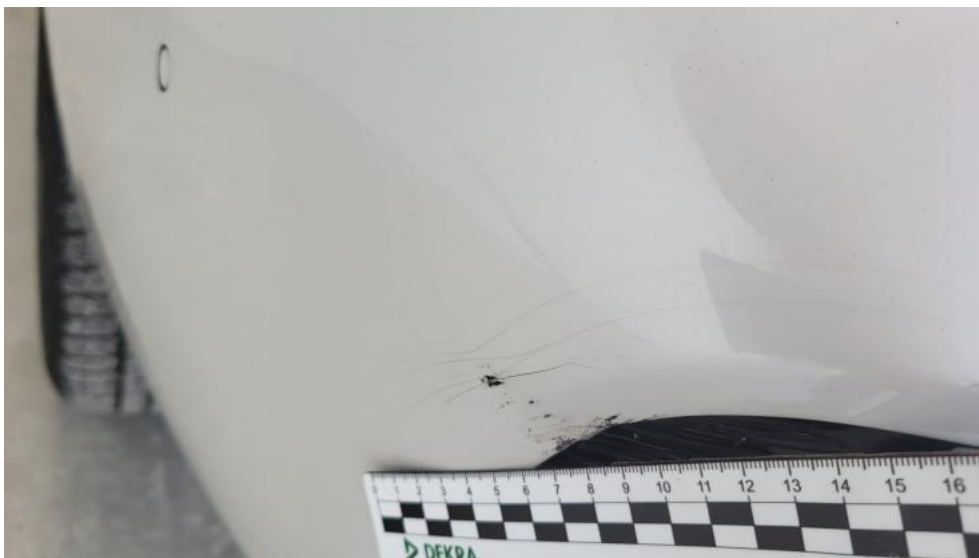
**Photo 58.**

Zderzak tylny - Pęknięcie/rozerwanie 1

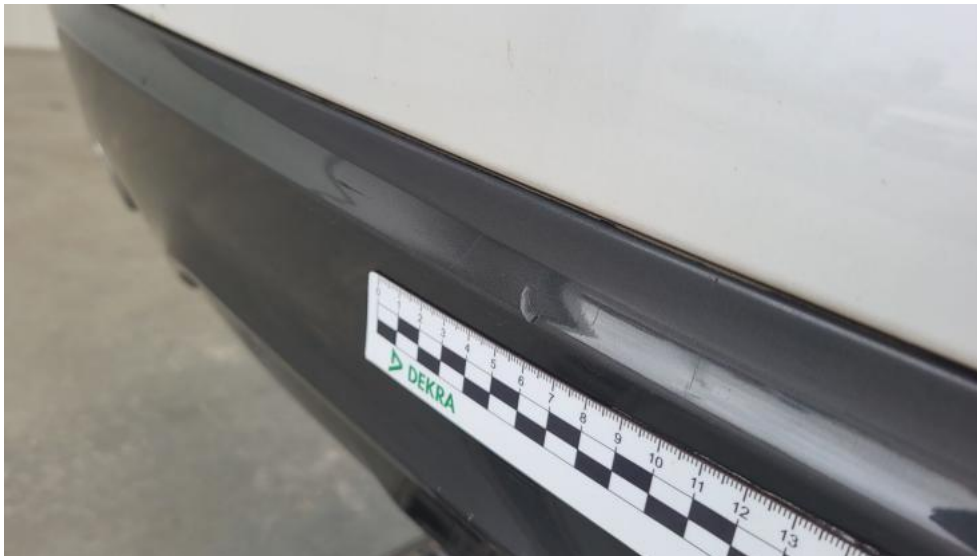
**Photo 59.**

Zderzak tylny cz dolna - Rysa/odprysk 1

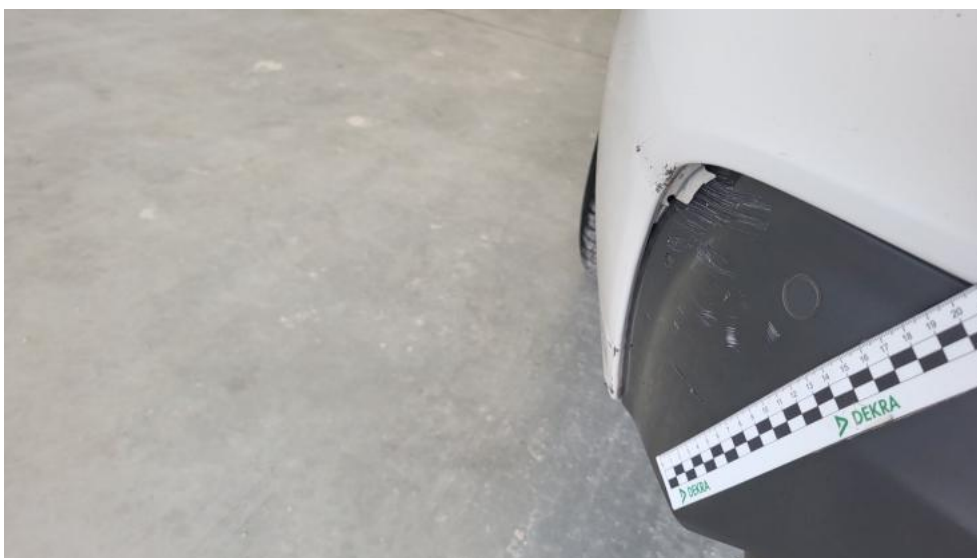
**Photo 60.**

Zderzak tylny cz dolna - Wgniecenie/odkształcenie 1

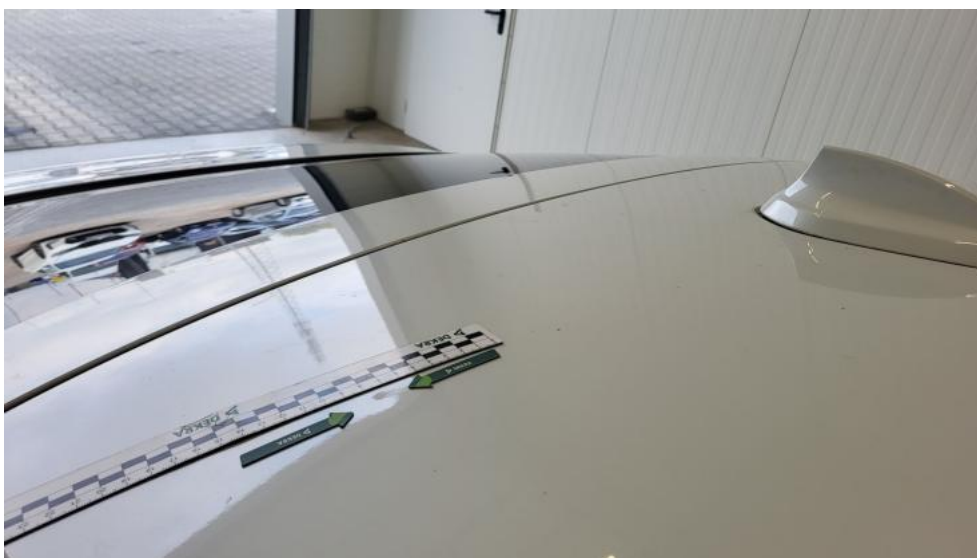
**Photo 62.**

Dach - Wgniecenie/odkształcenie 1

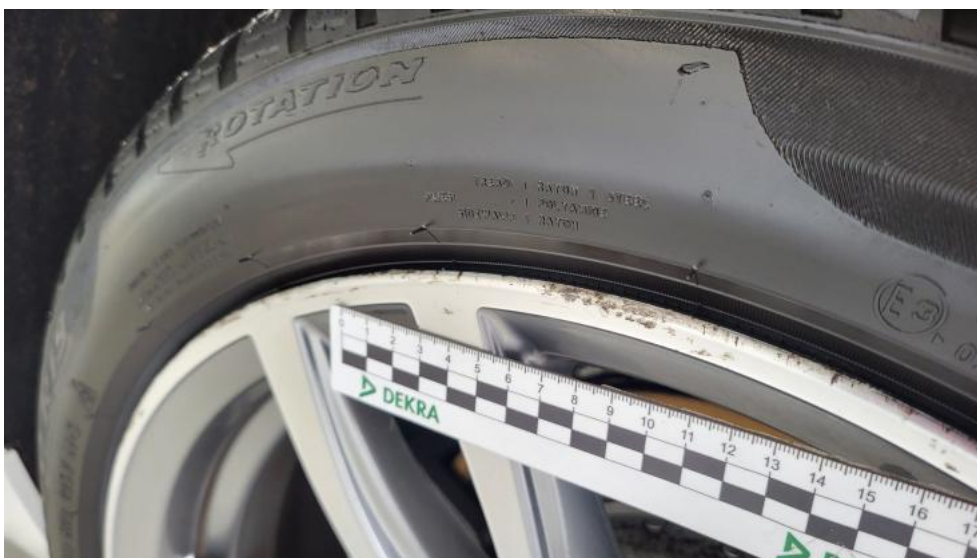
**Photo 64.**

Felga aluminiowa tylna L - Rysa/odprysk 1

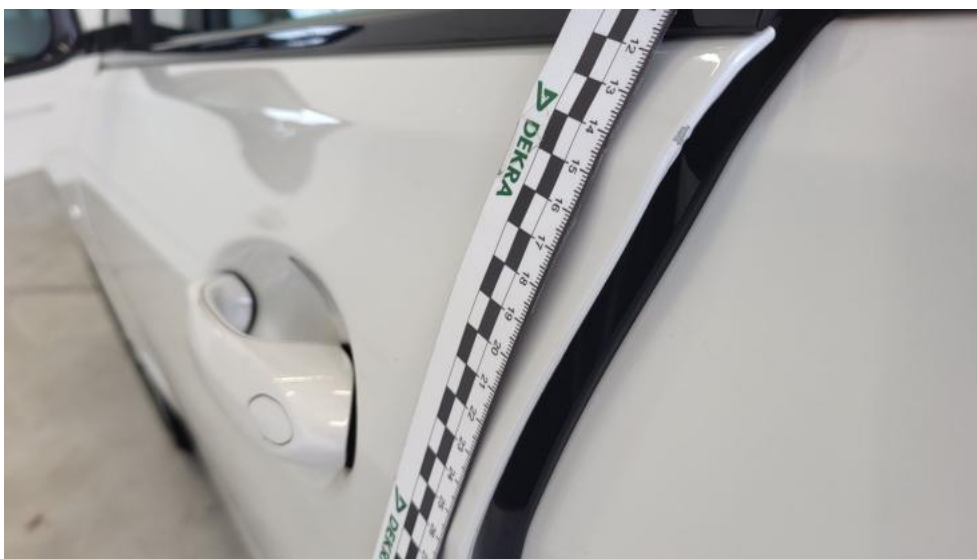
**Photo 65.**

Drzwi przed L - Rysa/odprysk 1

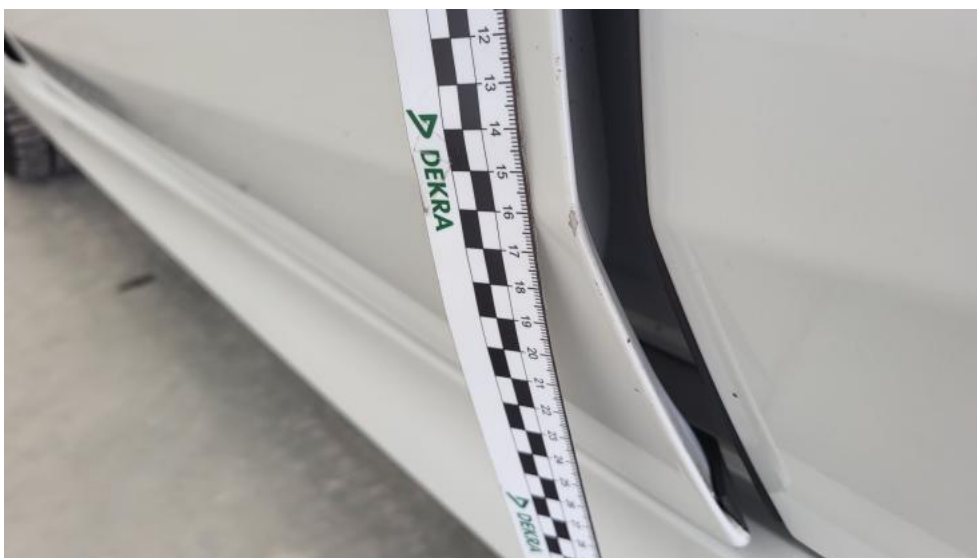
**Photo 66.**

Drzwi przed L - Rysa/odprysk 2

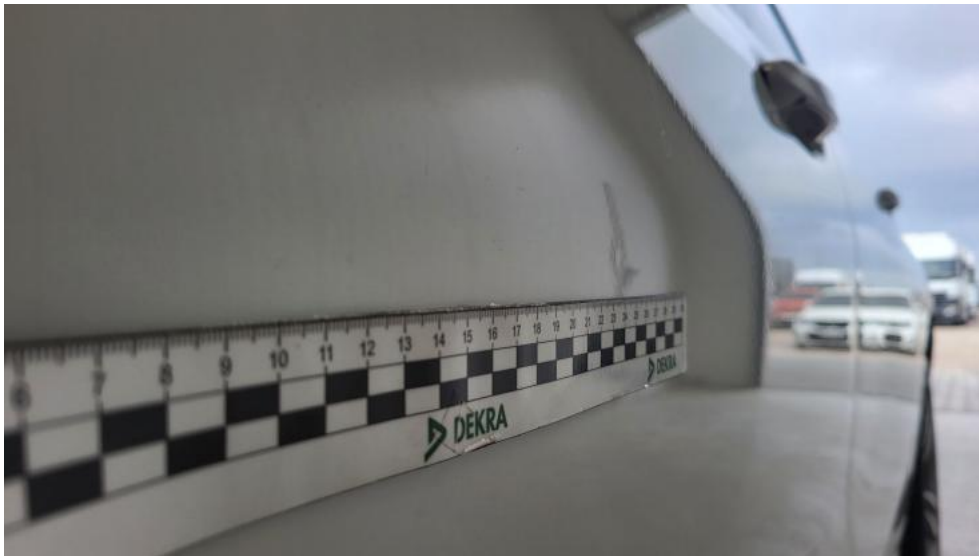
**Photo 67.**

Drzwi przed L - Wgniecenie/odkształcenie 1

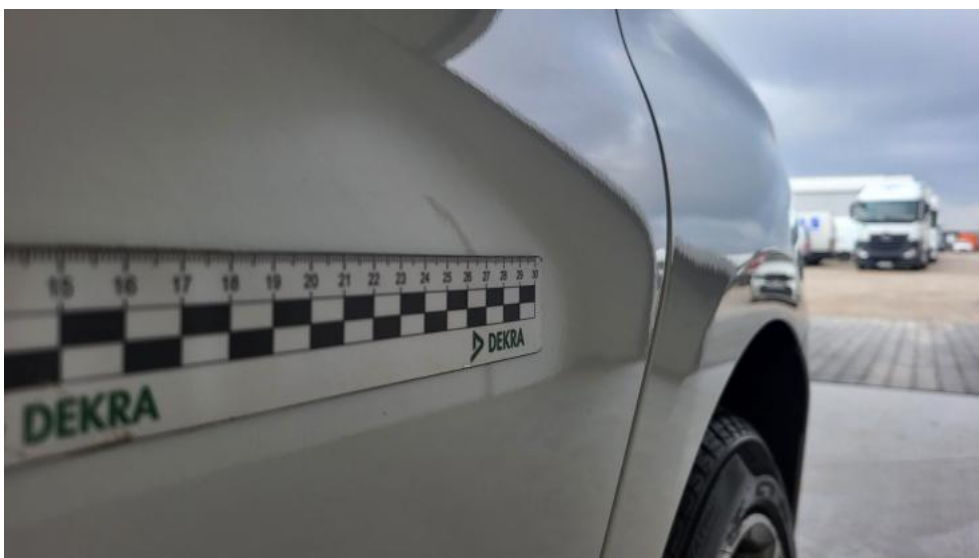
**Photo 68.**

Drzwi tylne L - Wgniecenie/odkształcenie 1

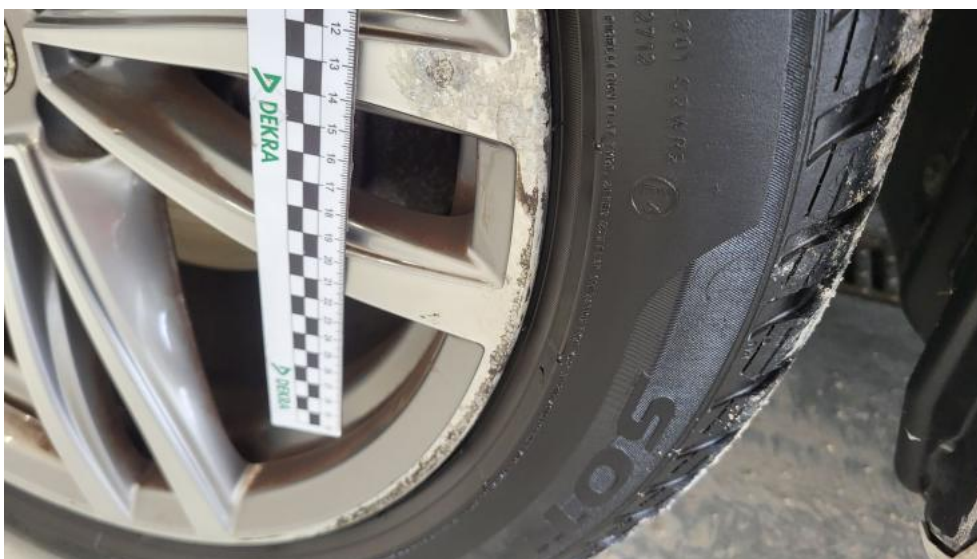
**Photo 69.**

Felga Aluminiowa przednia L - Rysa/odprysk 1

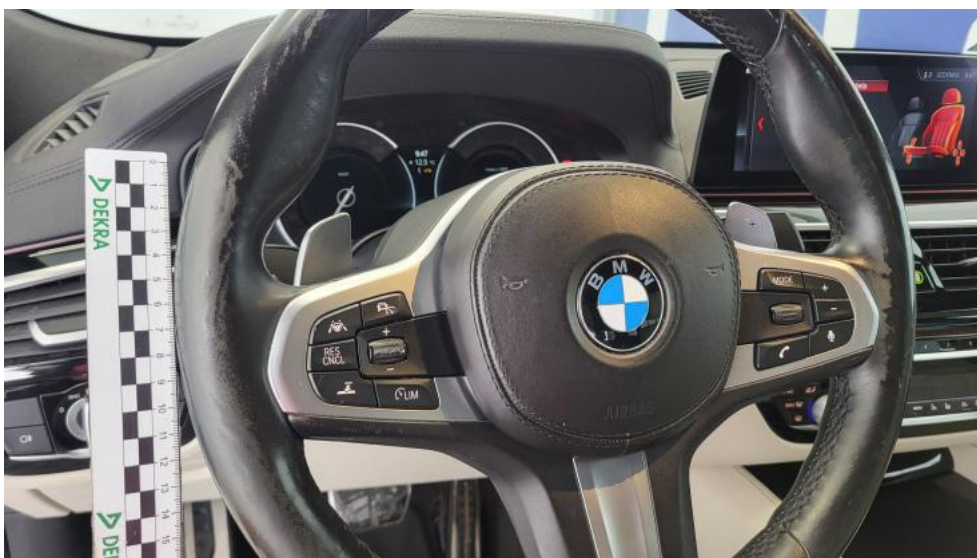
**Photo 70.**

Koło kierownicy - Inne 1

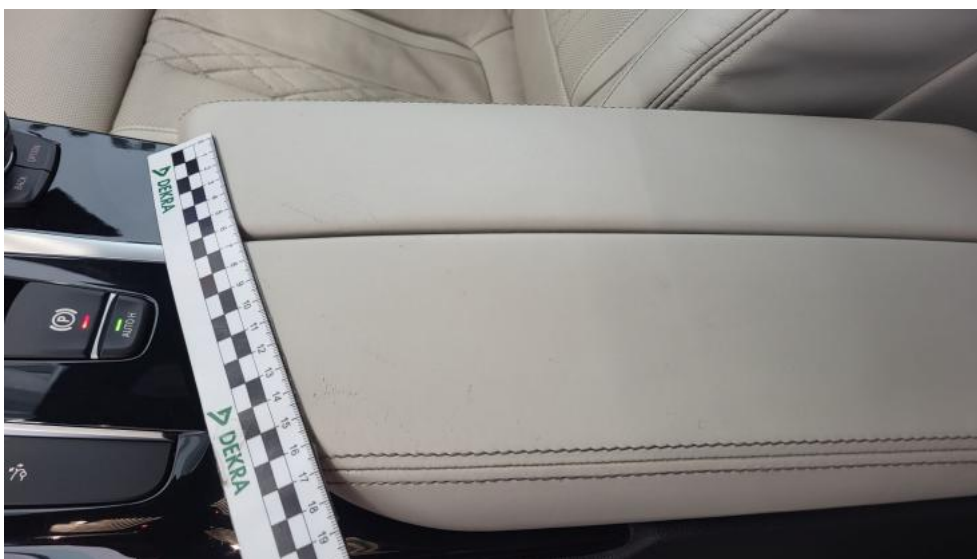
**Photo 71.**

Podłokietnik środkowy przedni - Rysa/odprysk 1

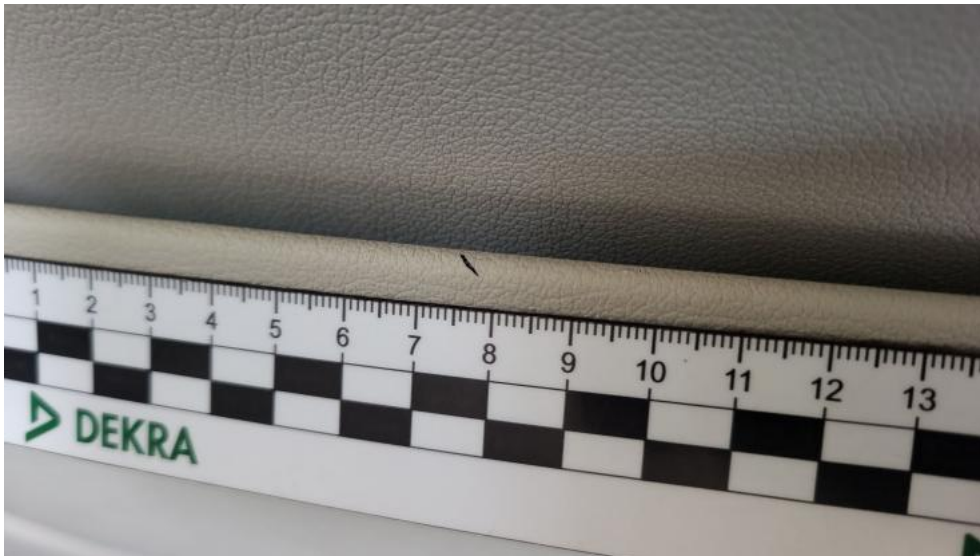
**Photo 73.**

Fotel prz. praw. - Pęknięcie/rozerwanie 1

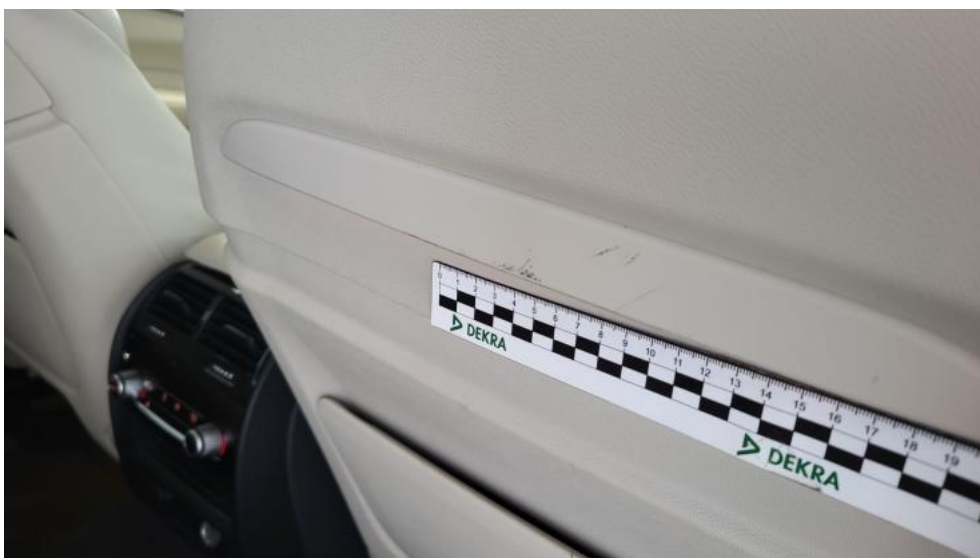
**Photo 74.**

Fotel prz. praw. - Inne 1

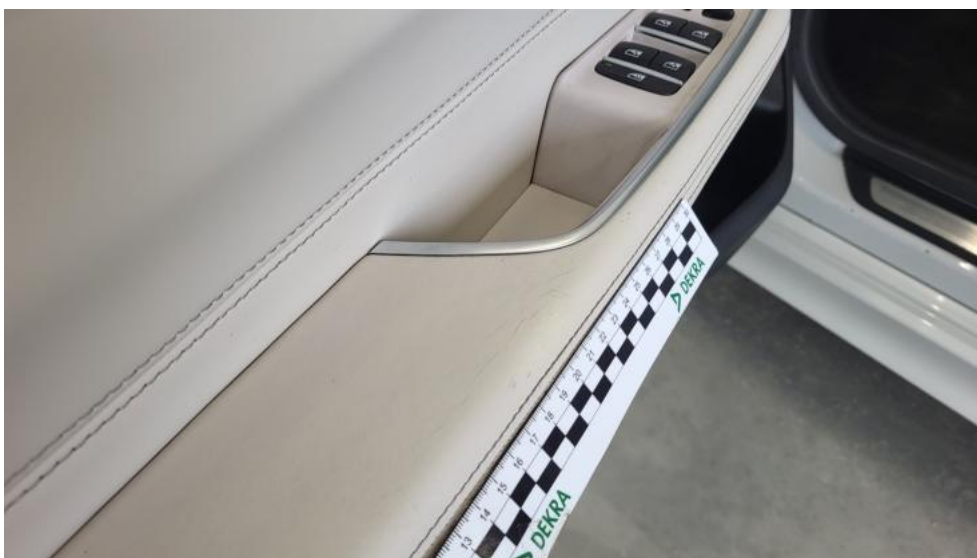
**Photo 76.**

Tapicerka drzwi przednich L - Inne 1

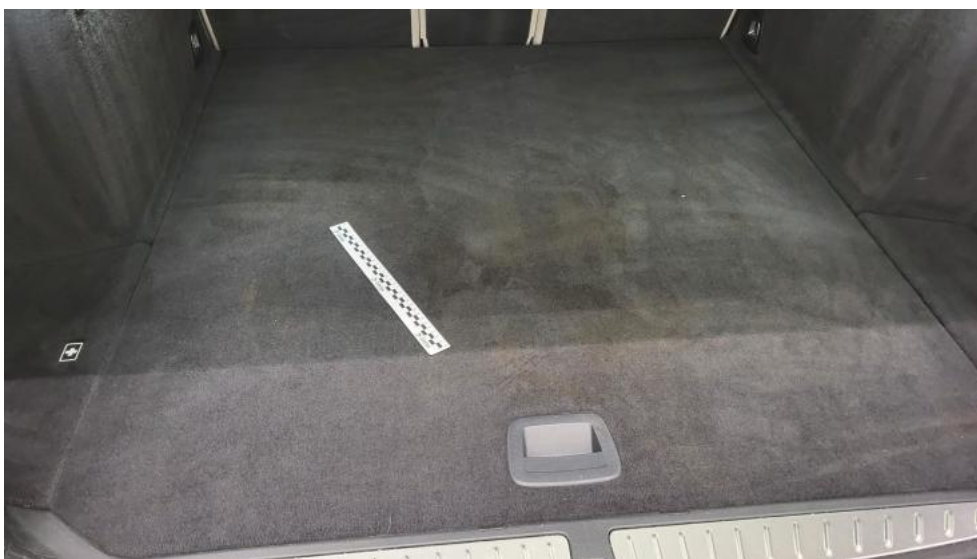
**Photo 77.**

Wykładzina podłogi bagażnika - Inne 1

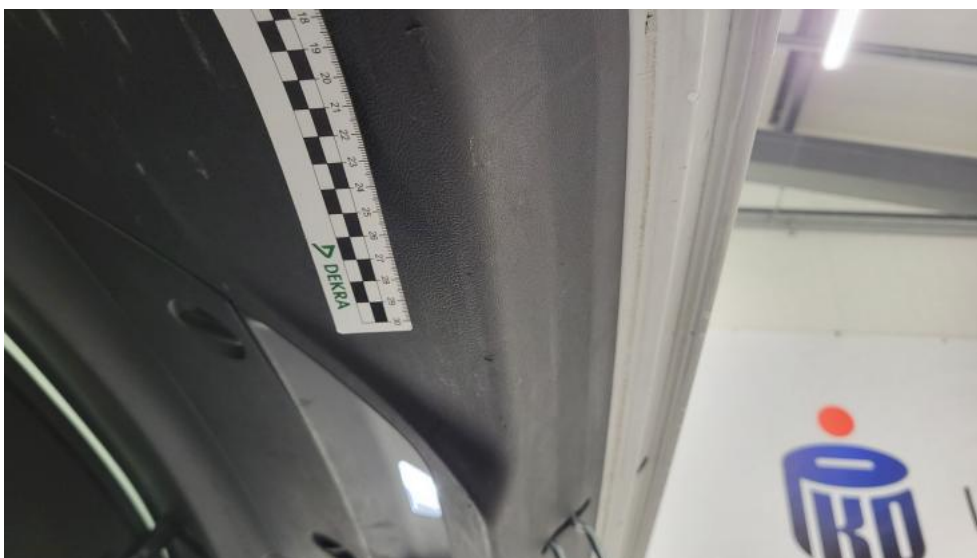
**Photo 78.**

Wykładzina pokrywy tylnej - Rysa/odprysk 1
