DEKRA's commission No. : PKOL(W)/LODZ/55117/24/07/18  
commission/ damage No. : 23/022955  
Date of commission: 18-07-2024

| Manufacturer | LAND ROVER |
| Type / version | Defender 130 3.0 D250 mHEV S |
| Registration /record No. | GD4J890 |

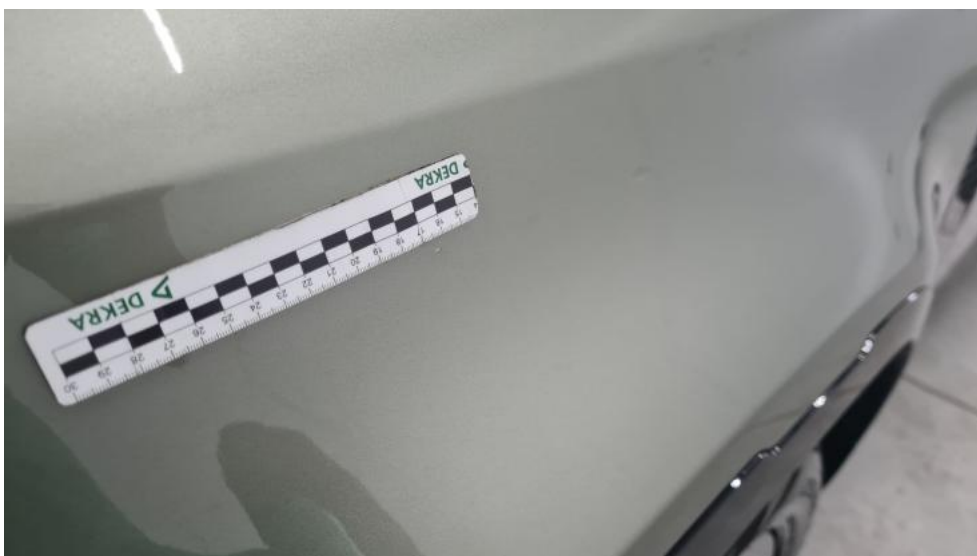
**Photo 38.**

Błotnik przedni L - Rysa/odprysk 1
