DEKRA's commission No. : PKOL(W)/LODZ/21353/25/03/24  
commission/ damage No. : 05840/EO/22  
Date of commission: 24-03-2025

| Manufacturer | MERCEDES-BENZ |
| Model | EQS [V 297] 21- |
| VIN / serial number | W1K2971231A008685 |

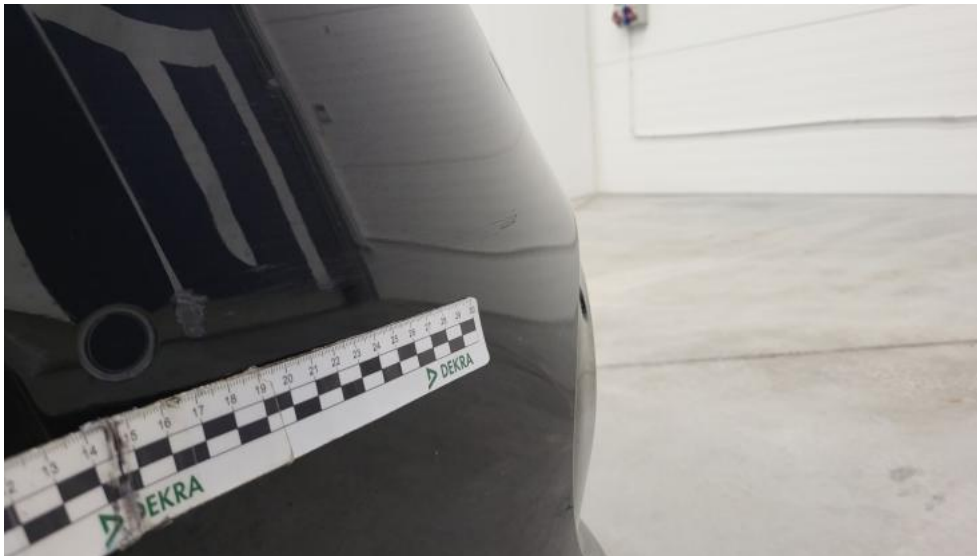
**Photo 49.**

Zderzak - Wgniecenie/odkształcenie 1

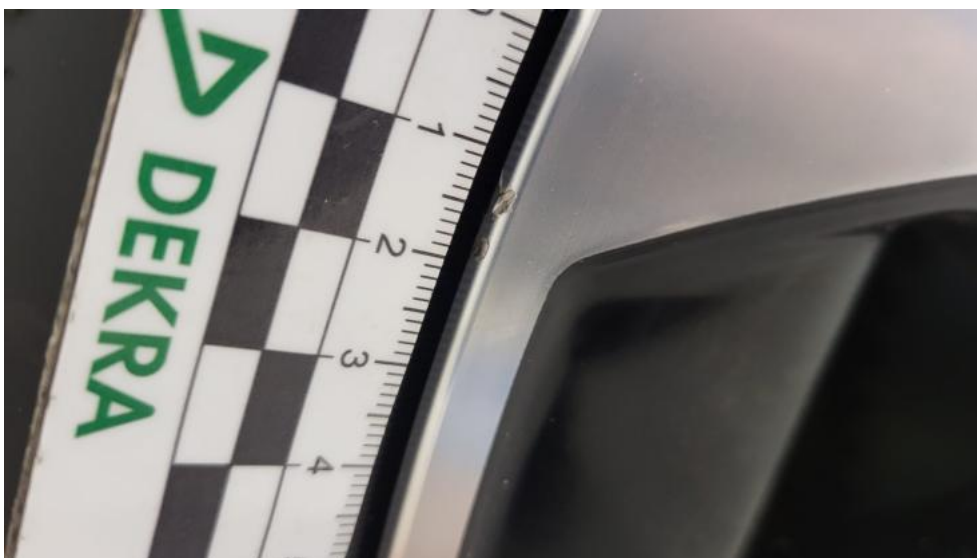
**Photo 50.**

Felga Aluminiowa przednia L - Rysa/odprysk 1
