DEKRA's commission No. : PKOL(W)/LODZ/27086/25/04/14  
commission/ damage No. : FUTURA  
Date of commission: 14-04-2025

| Manufacturer | HYUNDAI |
| Model | i30 20-24 |
| Registration /record No. | WD9075S |

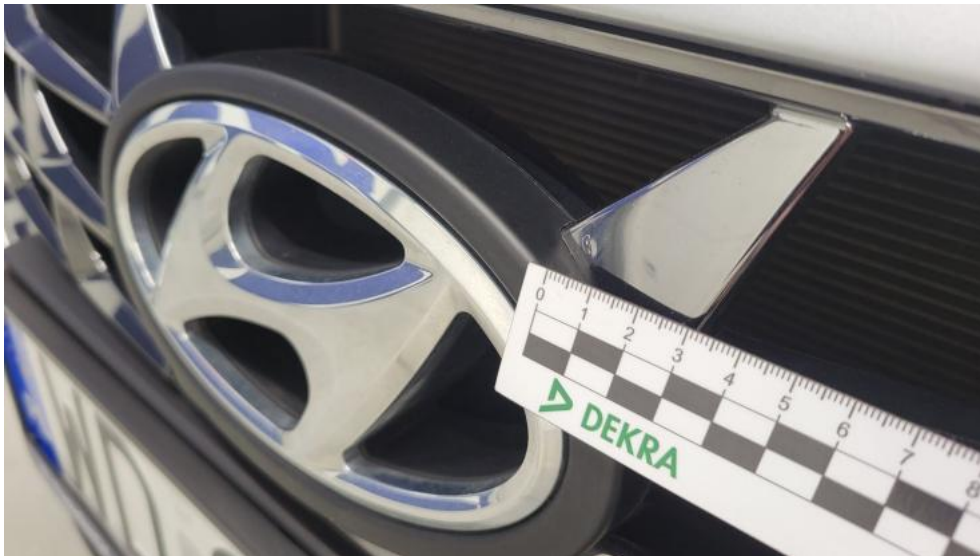
**Photo 37.**

Atrapa przednia - Wgniecenie/odkształcenie 1

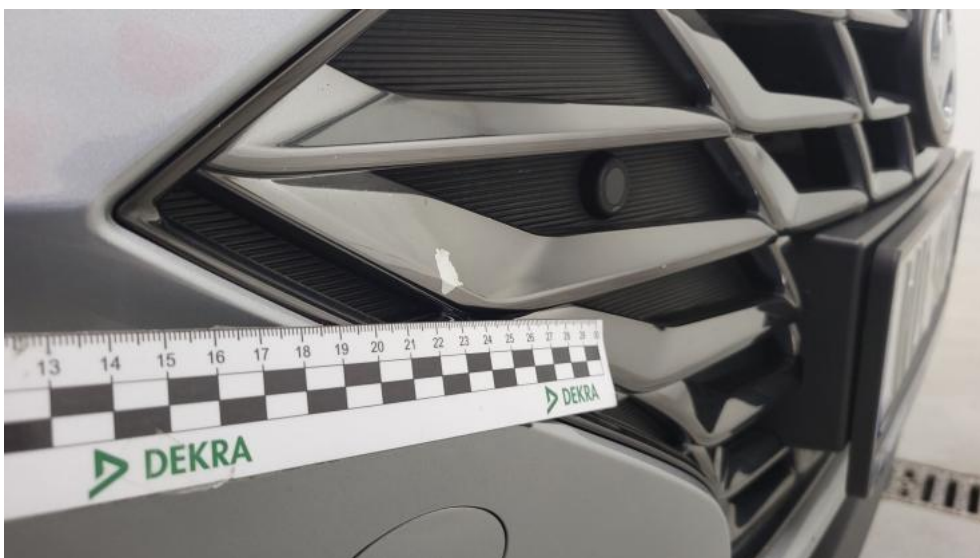
**Photo 38.**

Atrapa przednia - Inne 1

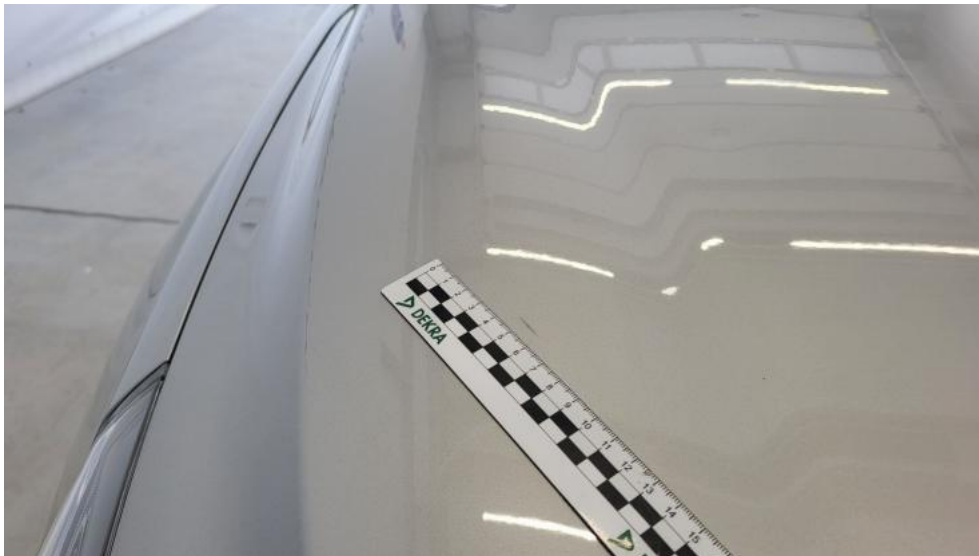
**Photo 39.**

Pokrywa komory silnika - Rysa/odprysk 1

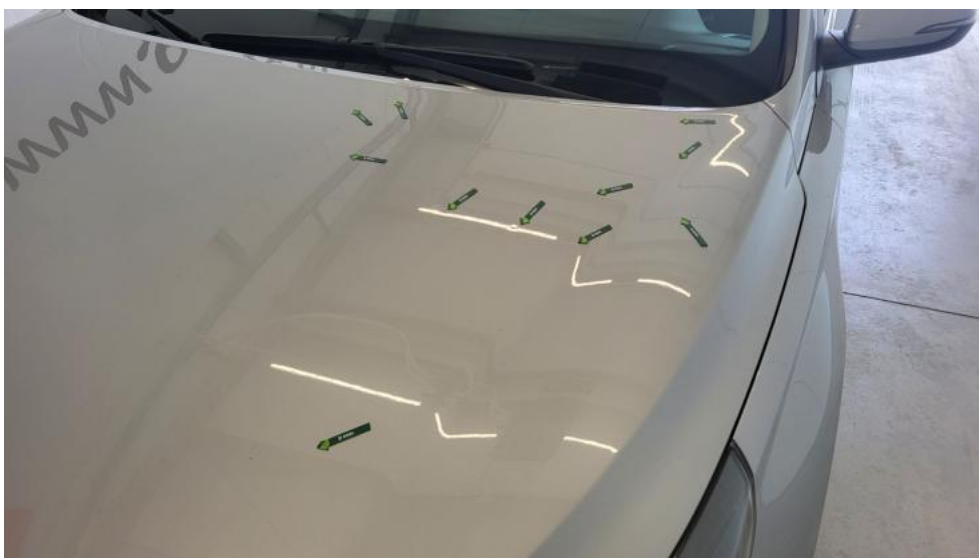
**Photo 40.**

Pokrywa komory silnika - Wgniecenie/odkształcenie 1

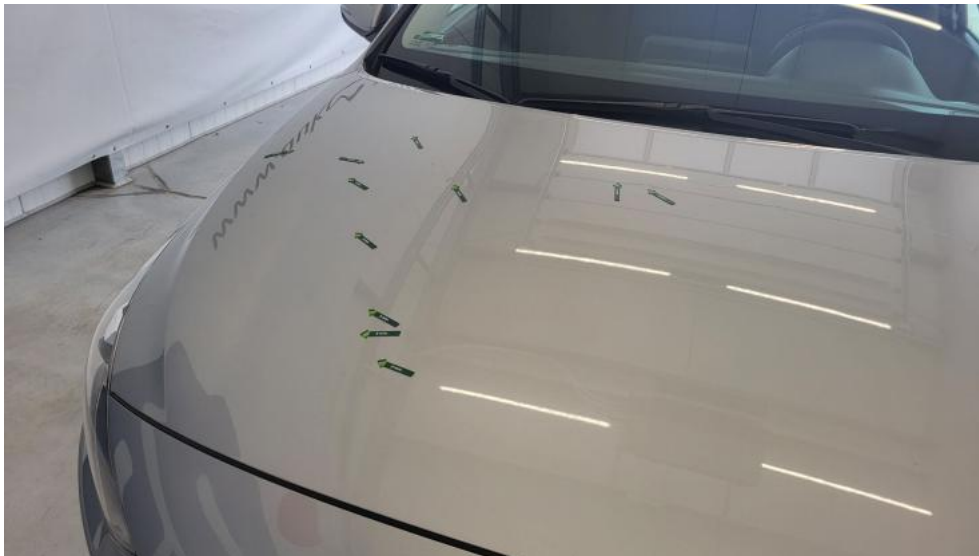
**Photo 41.**

Pokrywa komory silnika - Wgniecenie/odkształcenie 2

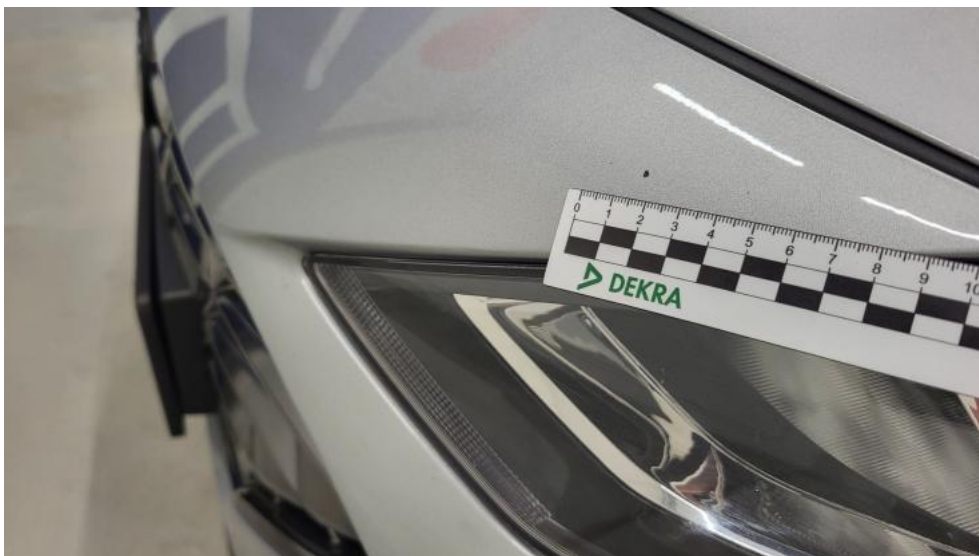
**Photo 42.**

Zderzak - Rysa/odprysk 1

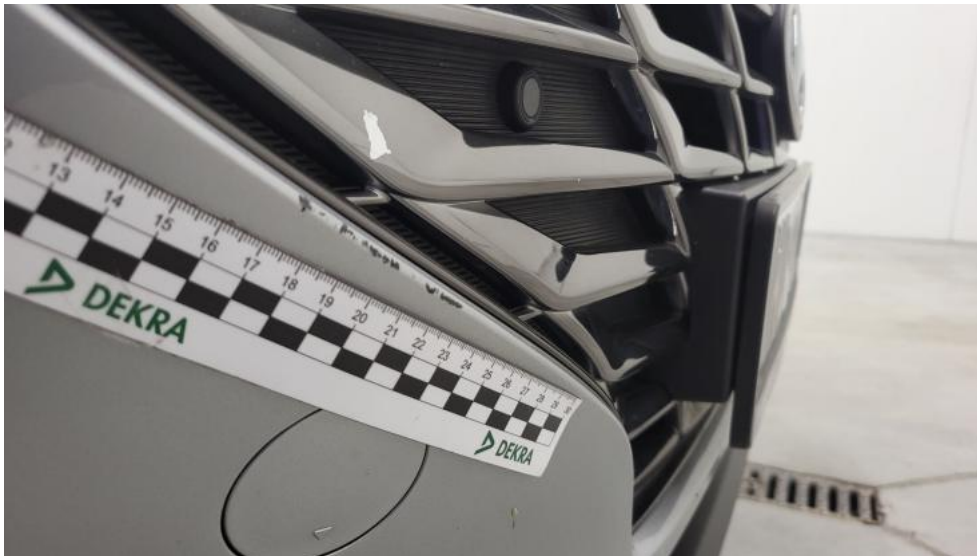
**Photo 43.**

Zderzak - Rysa/odprysk 2

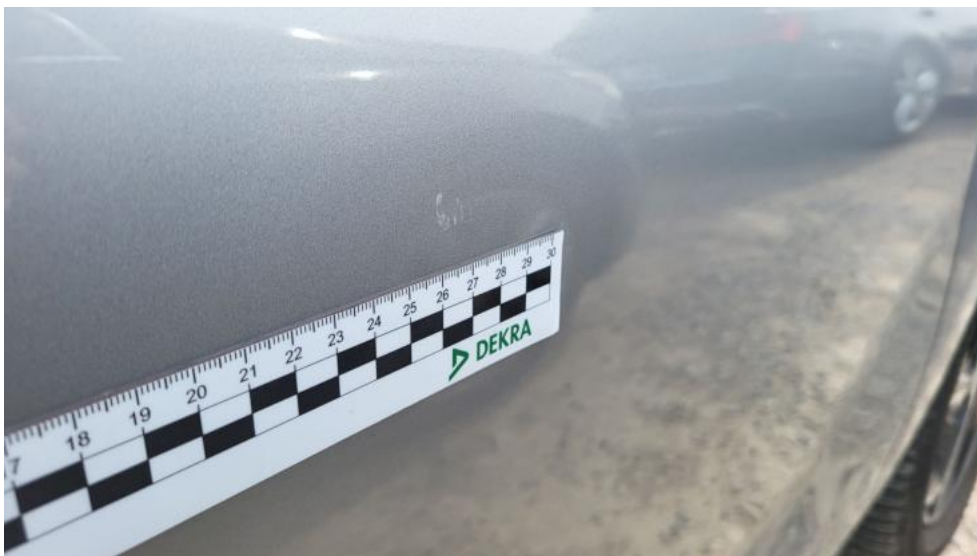
**Photo 44.**

Drzwi przednie P - Rysa/odprysk 1

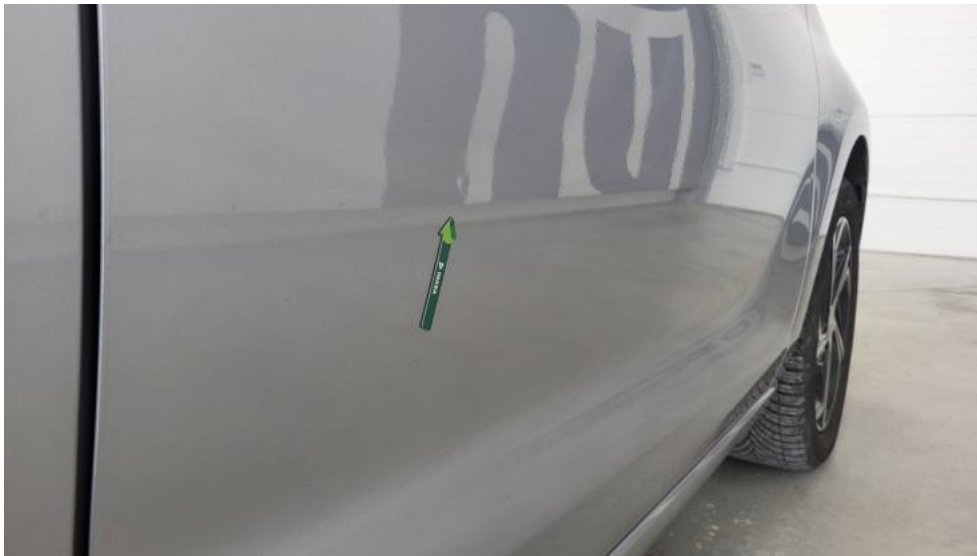
**Photo 45.**

Drzwi przednie P - Wgniecenie/odkształcenie 1

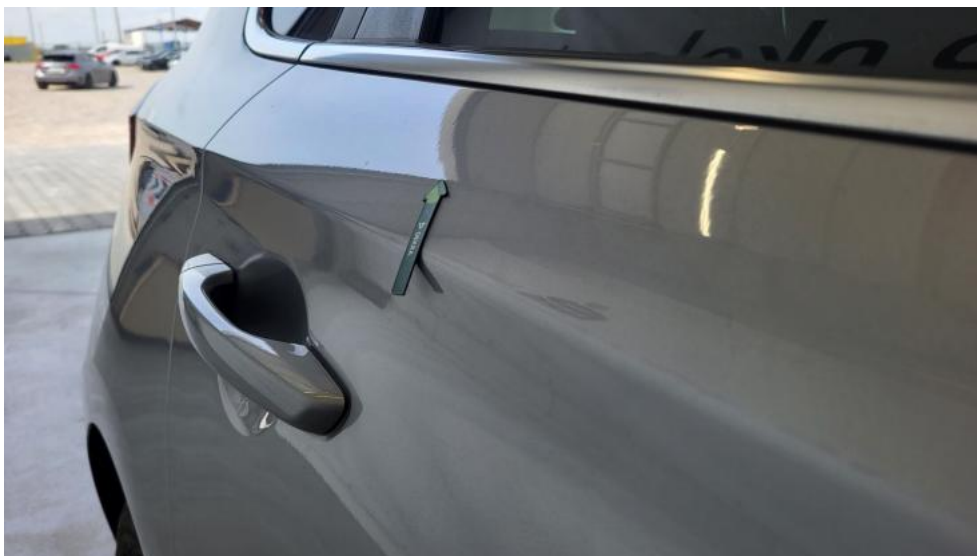
**Photo 46.**

Drzwi tylne P - Wgniecenie/odkształcenie 1

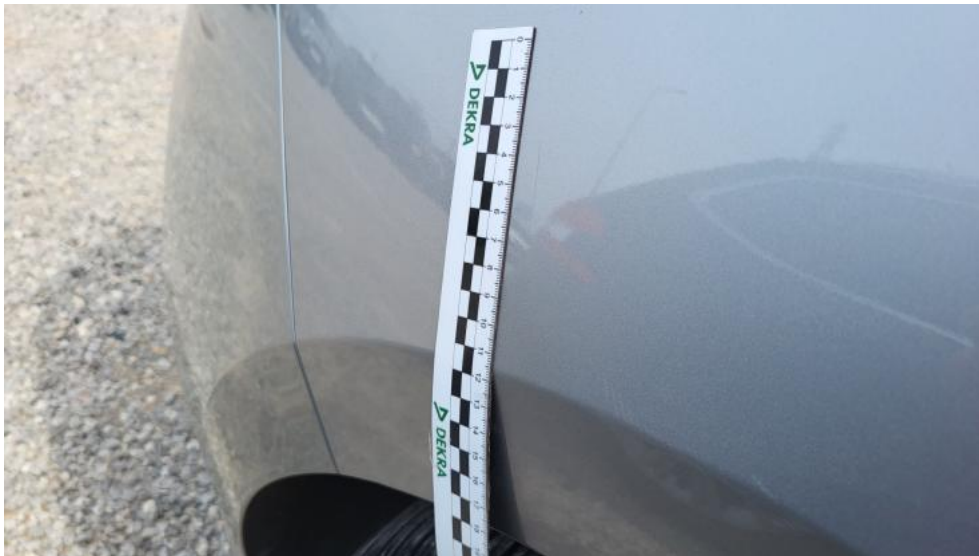
**Photo 49.**

Błotnik tylny P / Ściana boczna P - Rysa/odprysk 1

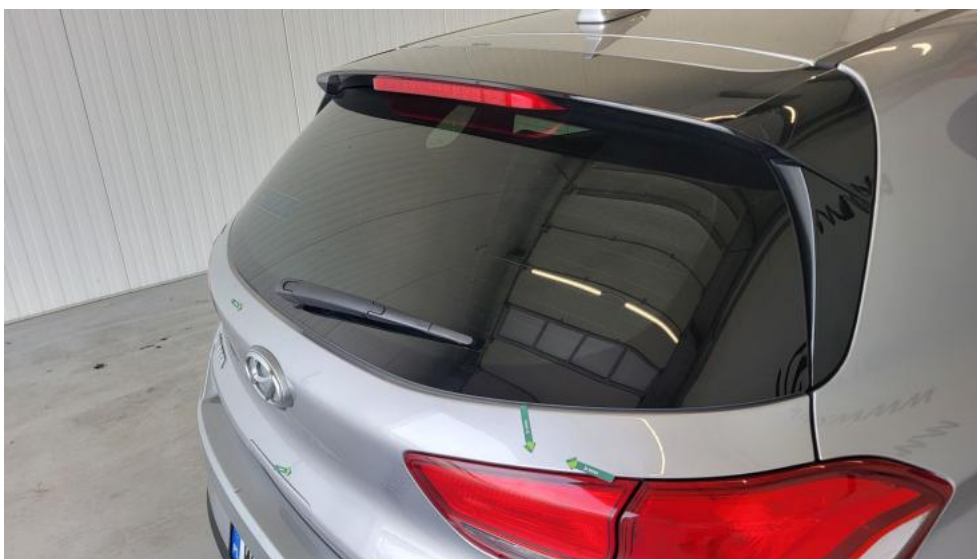
**Photo 51.**

Pokrywy bagażnika - Wgniecenie/odkształcenie 1

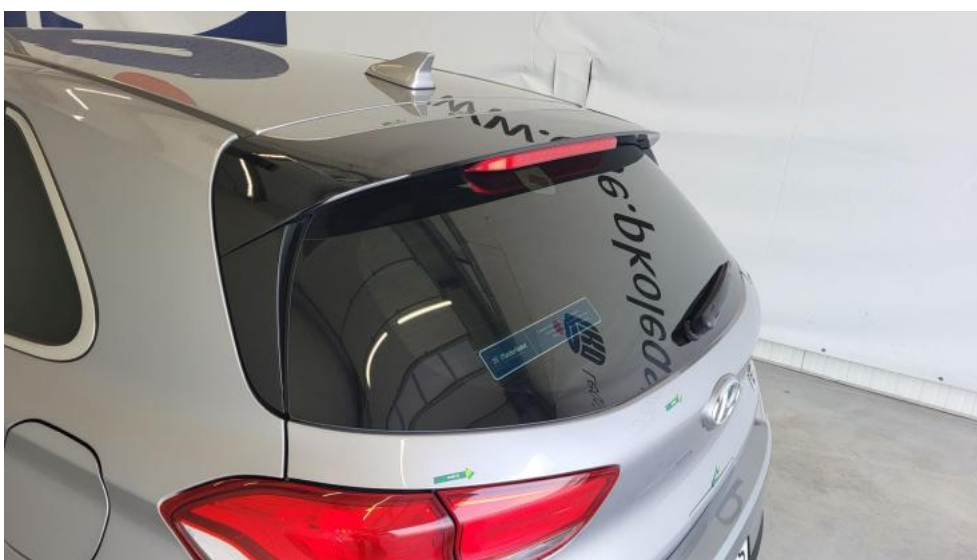
**Photo 52.**

Pokrywy bagażnika - Wgniecenie/odkształcenie 2

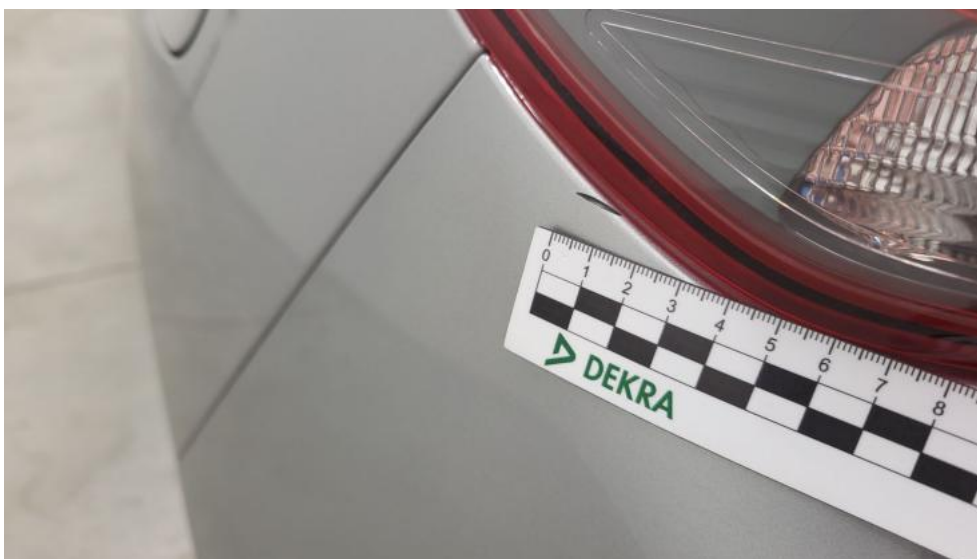
**Photo 53.**

Zderzak tylny - Rysa/odprysk 1

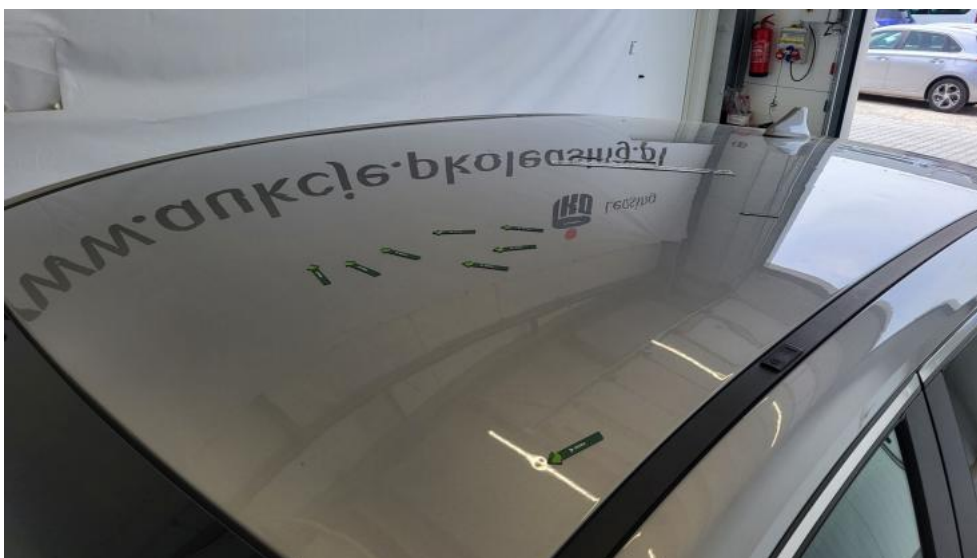
**Photo 54.**

Rysy na samochodzie. Pojazd po gradobiciu. Bardzo liczne wgniecenia. Odpryski na szybie czołowej.

Dach - Wgniecenie/odkształcenie 1

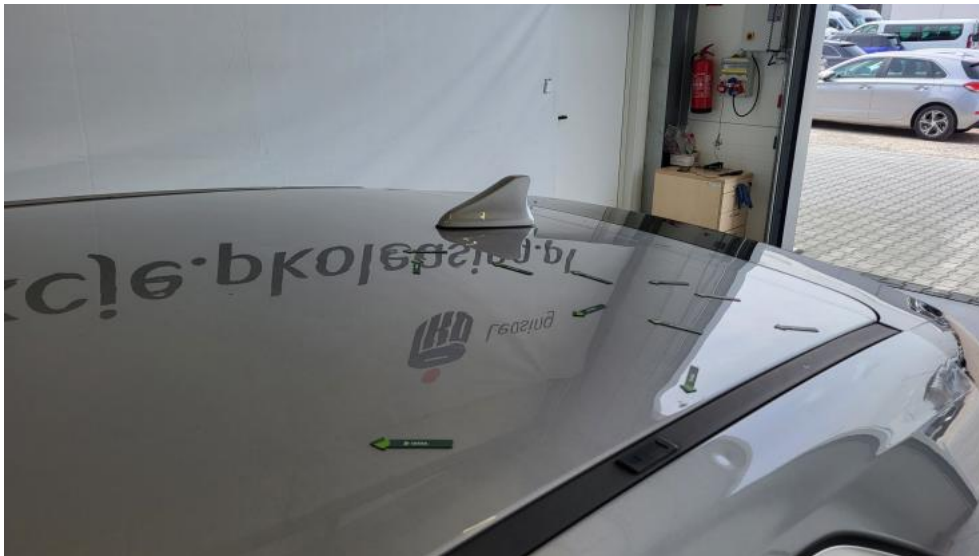
**Photo 55.**

Dach - Wgniecenie/odkształcenie 2

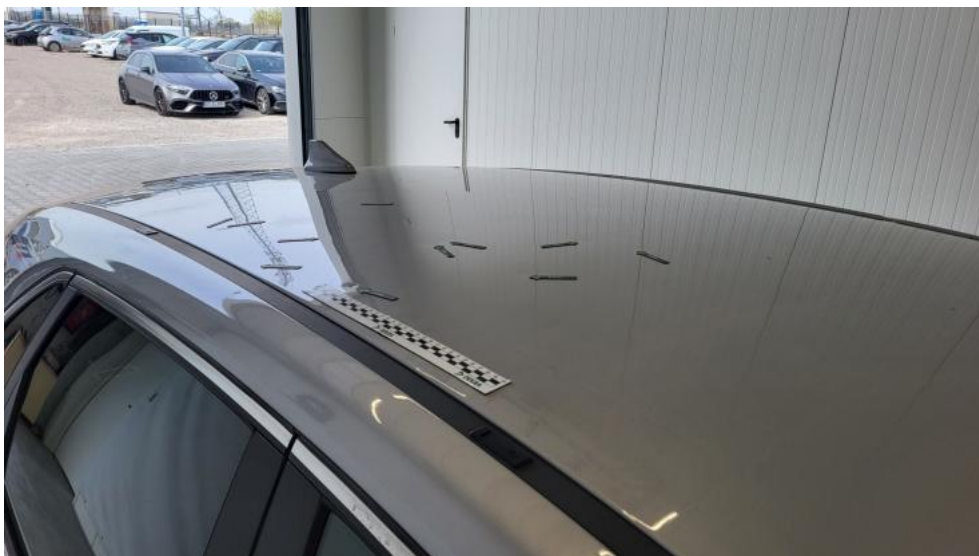
**Photo 56.**

Dach() - Wgniecenie/odkształcenie 3

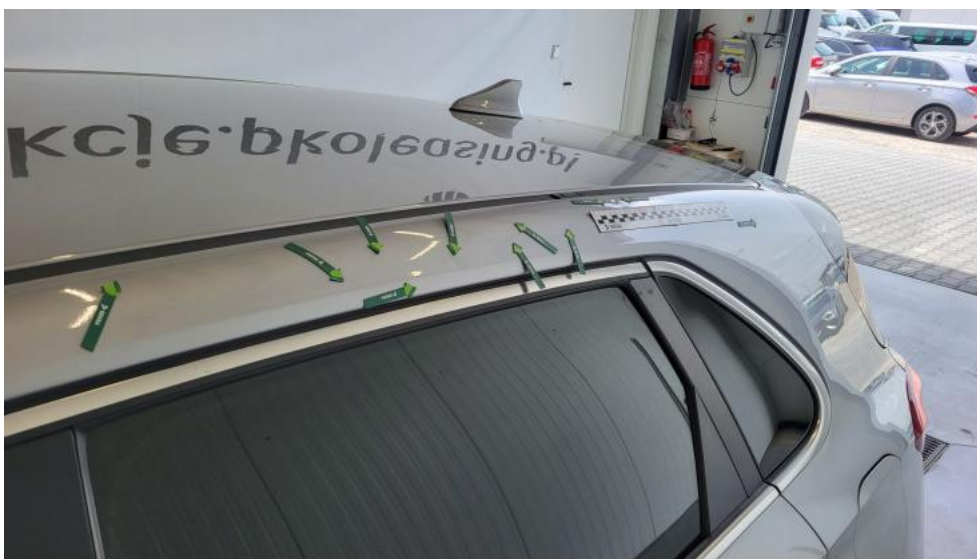
**Photo 57.**

Błotnik tylny L / Ściana boczna L - Wgniecenie/odkształcenie 1

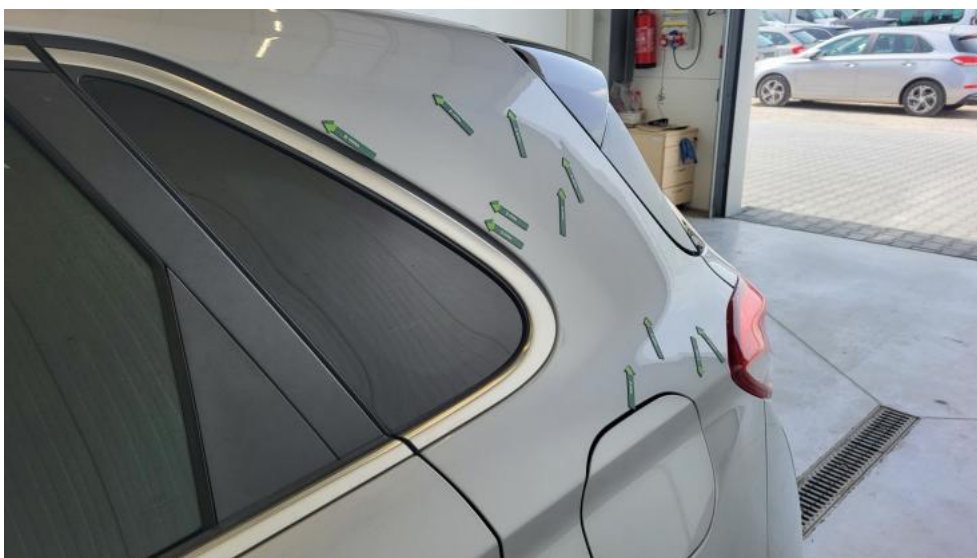
**Photo 58.**

Błotnik tylny L / Ściana boczna L - Wgniecenie/odkształcenie 2

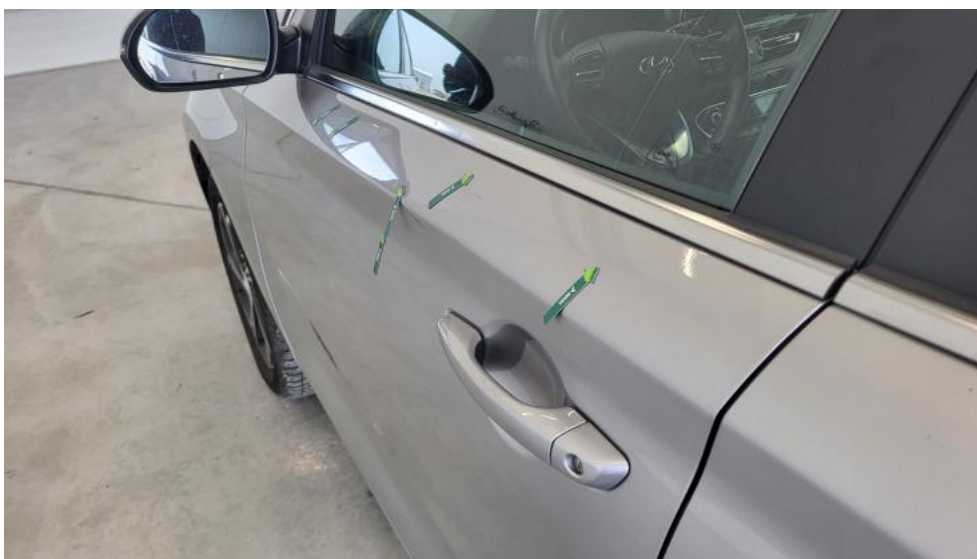
**Photo 59.**

Drzwi przed L - Wgniecenie/odkształcenie 1

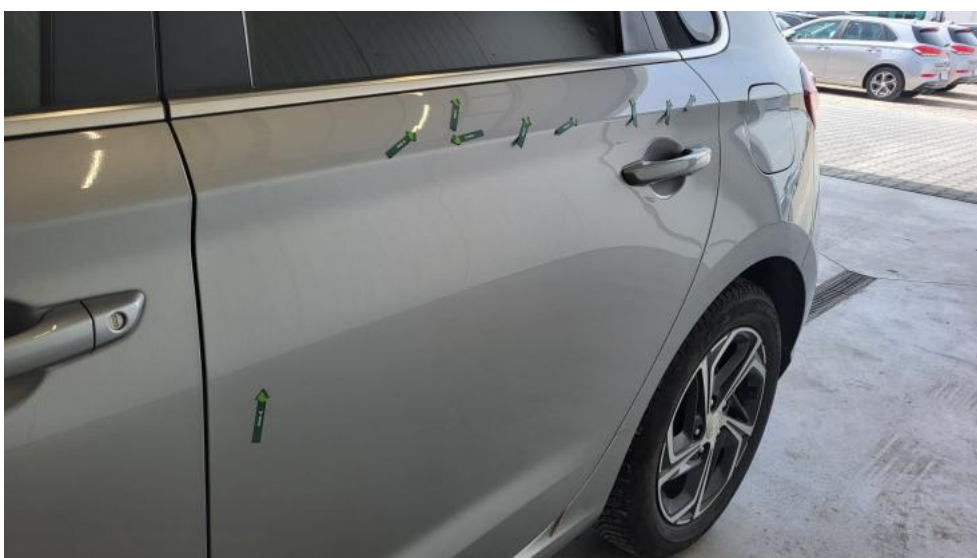
**Photo 60.**

Drzwi tylne L - Wgniecenie/odkształcenie 1

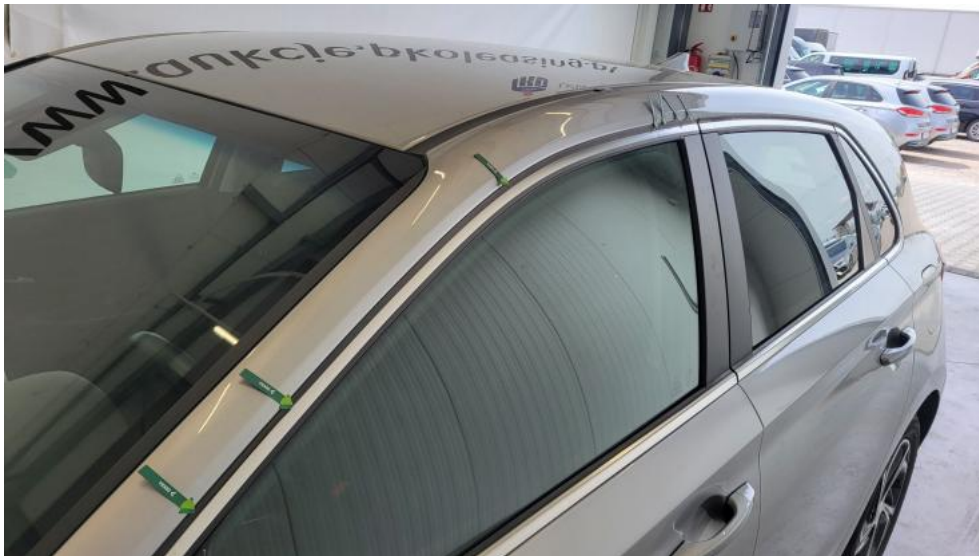
**Photo 61.**

Listwa drzwi przednich L - Wgniecenie/odkształcenie 1

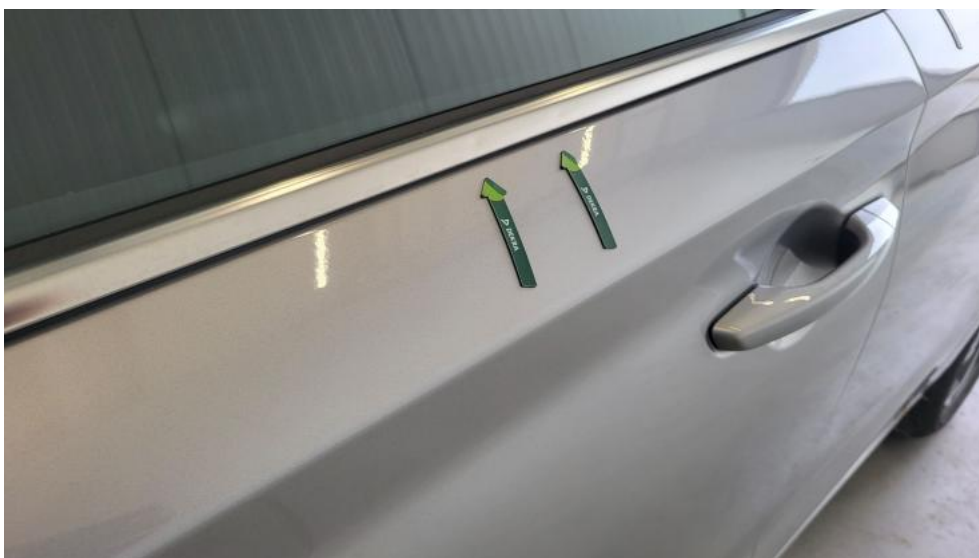
**Photo 62.**

Listwa drzwi przednich L - Wgniecenie/odkształcenie 2

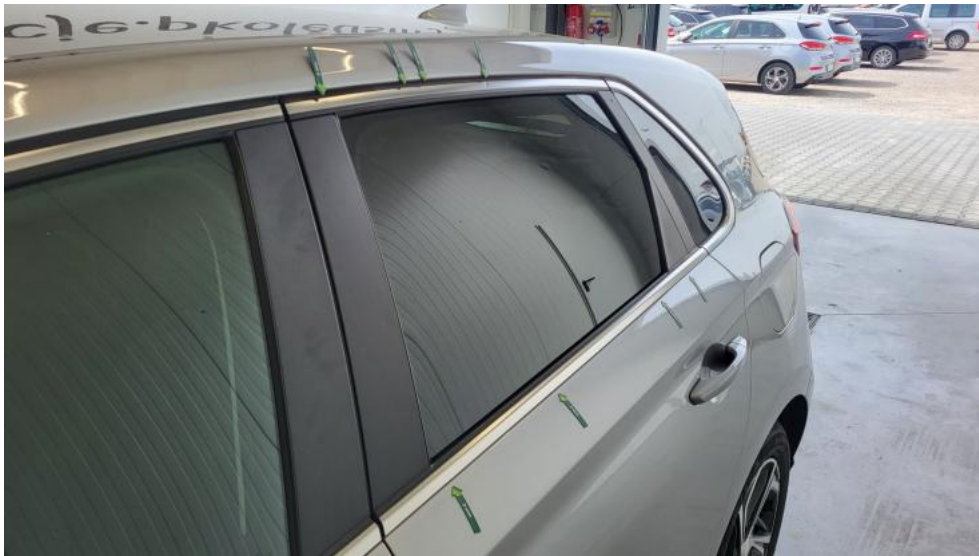
**Photo 63.**

Listwa drzwi tylnych L - Wgniecenie/odkształcenie 1

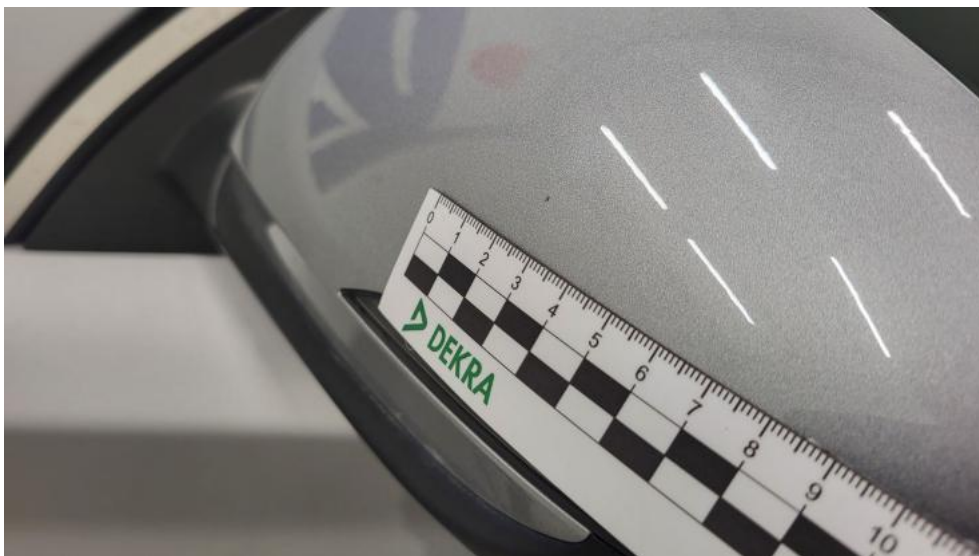
**Photo 64.**

Lusterko zew L - Rysa/odprysk 1

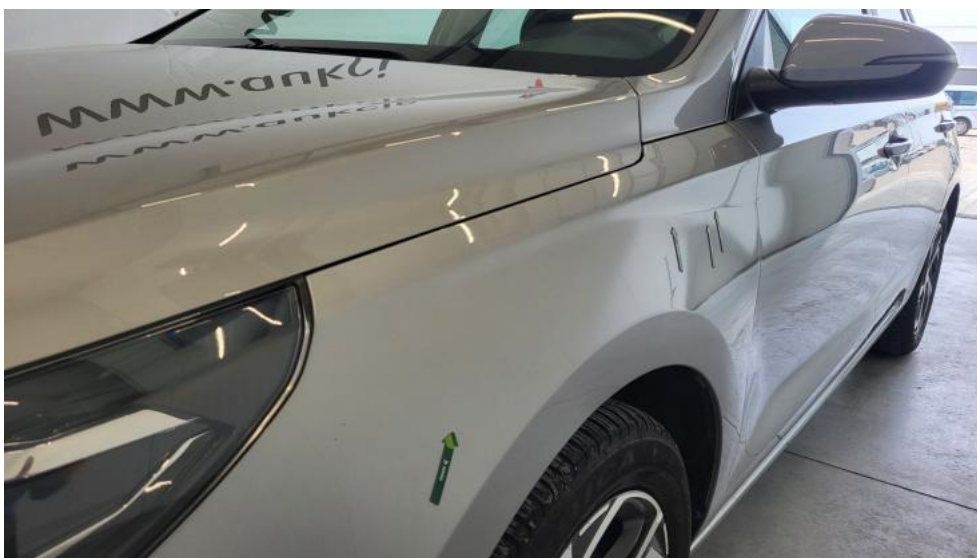
**Photo 66.**

Śłupek przedni L - Wgniecenie/odkształcenie 1

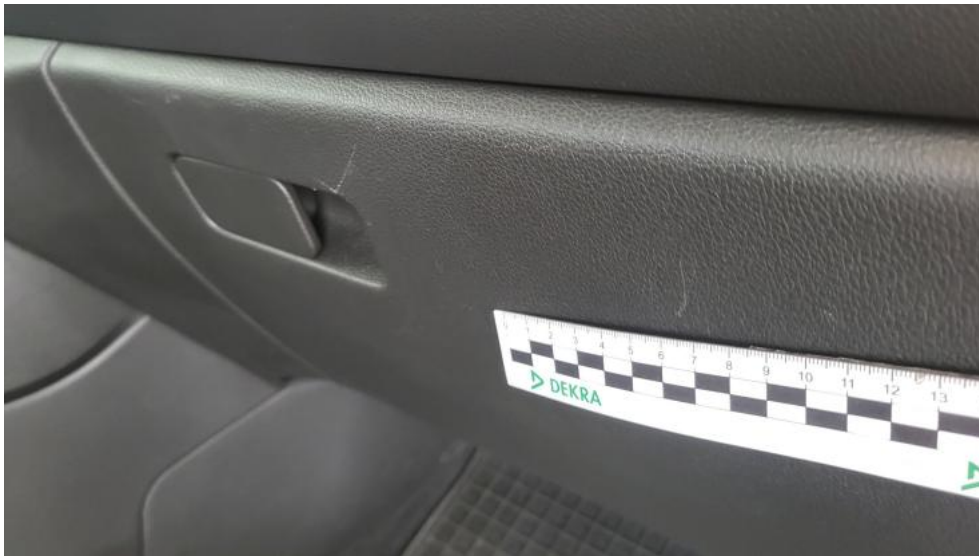
**Photo 67.**

Pokrywa schowka deski rozdzielczej - Rysa/odprysk 1

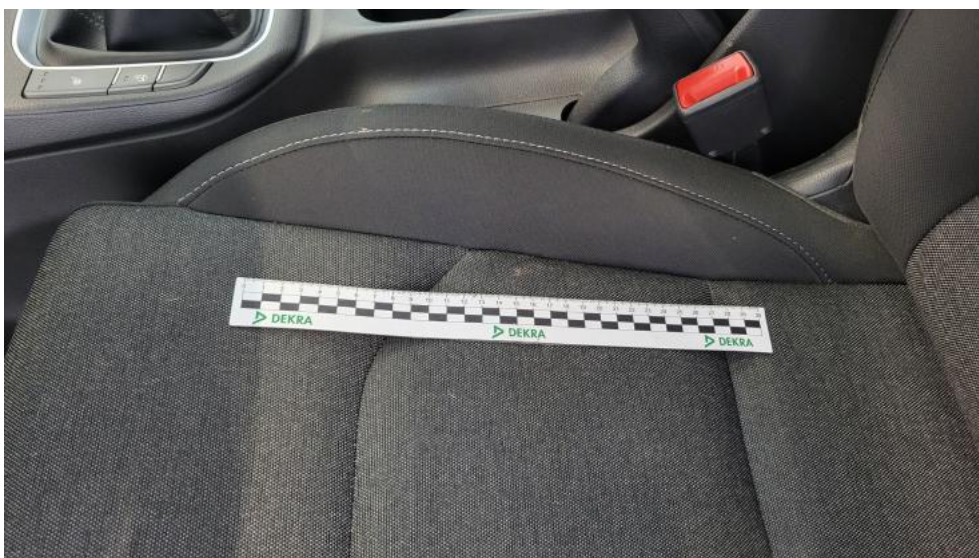
**Photo 68.**

Fotel prz. lew. - Inne 1

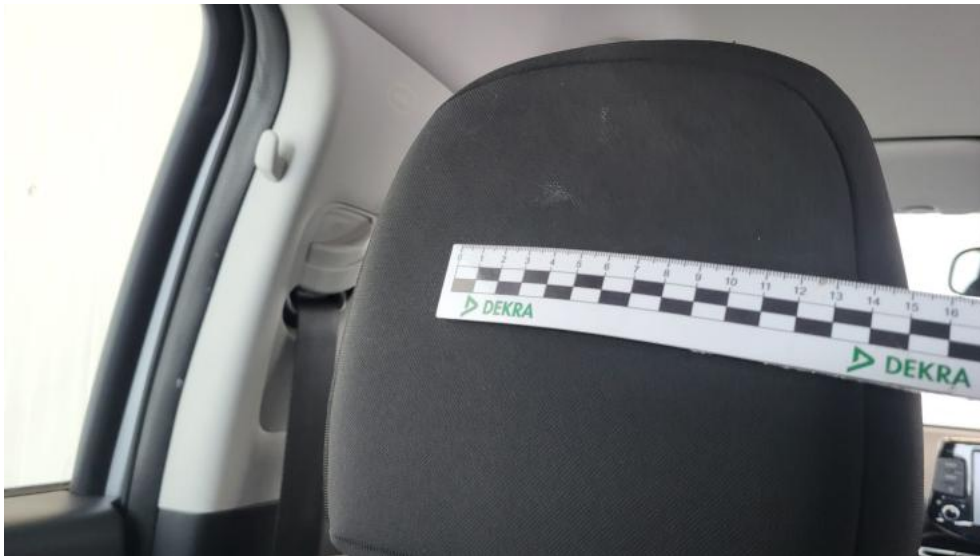
**Photo 69.**

Zaglówek fotela prz. L - Inne 1

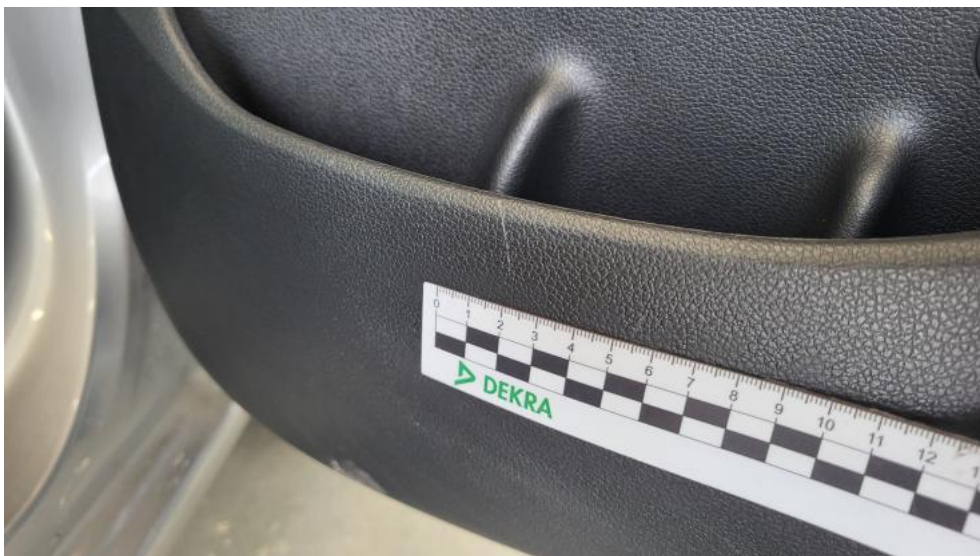
**Photo 70.**

Tapicerka drzwi przednich P - Rysa/odprysk 1

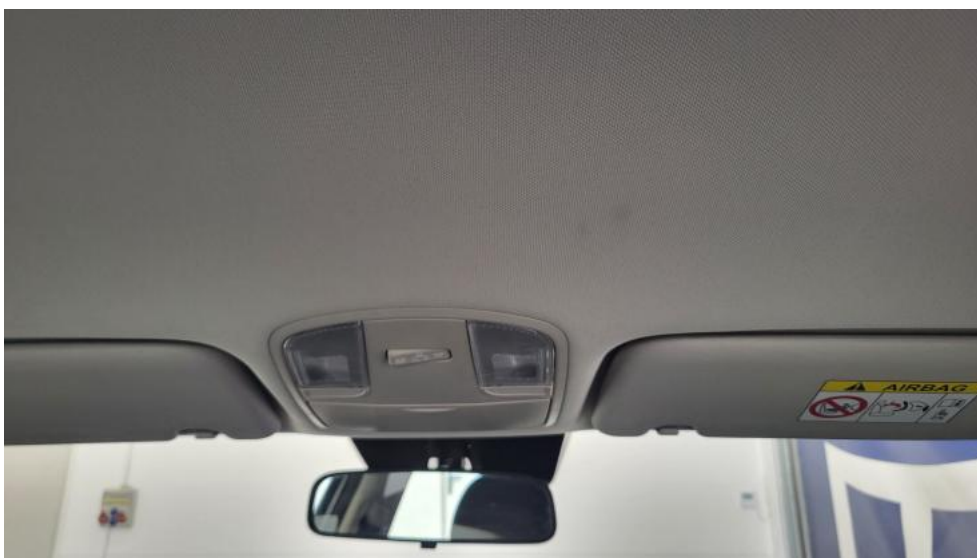
**Photo 72.**

Podsufitka - Inne 2

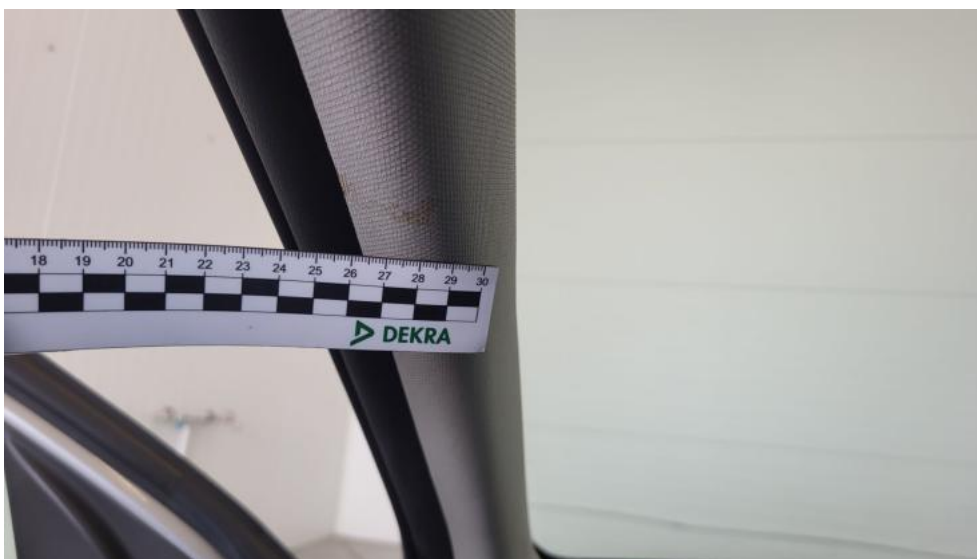
**Photo 73.**

Wykładzina(y) słupka przedniego L - Inne 1
