DEKRA's commission No. : PKOL(W)/LODZ/51660/26/06/03  
 commission/ damage No. : 21/060320  
 Date of commission: 03-06-2026

Group of objects (Eurotax)	jeeps
EC code (Eurotax)	0153715
Manufacturer	VOLVO
Model	XC40 17-21
Type / version	XC40 B4 B AWD R-Design aut
Body type	hatchback
Number of doors / seats	5/5
Curb weight [kg]	1699
Gross vehicle weight [kg]	2270
Wheelbase 1/2	2702
Engine type	spark ignition
Pollution reduction system	GPF
Engine capacity [ccm]	1969
Engine Power [hp/kW]	197/145
Gearbox	automatic
Registration /record No.	SC846AT
VIN / serial number	YV1XZK8VMN2713585
Date of first registration	17-12-2021
Date of next. tech. test	17-12-2026
Year of manufacture	2021 (year has been verified with the manufacturer's base)
Readout [km]	60 053 (read)
Body color / type of coating	gray/double-layered, metallized

Description of the technical condition

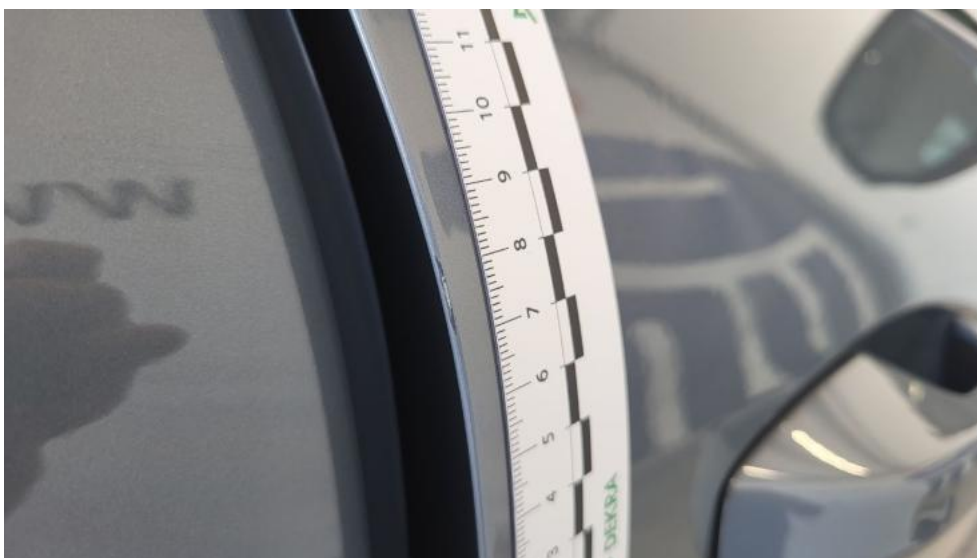
**Photo 46.**  
Drzwi przednie P - Rysa/odprysk 1

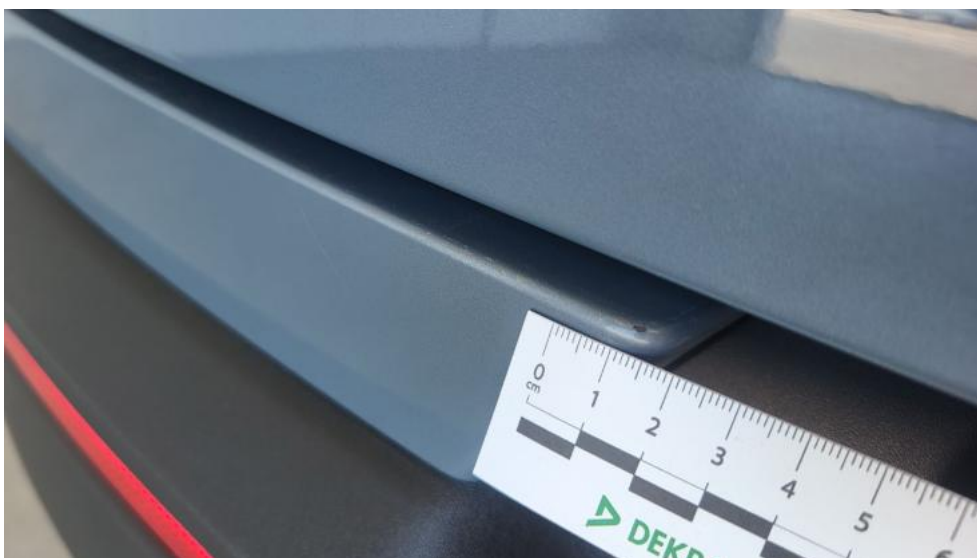
**Photo 50.**  
Zderzak tylny cz L - Rysa/odprysk 1

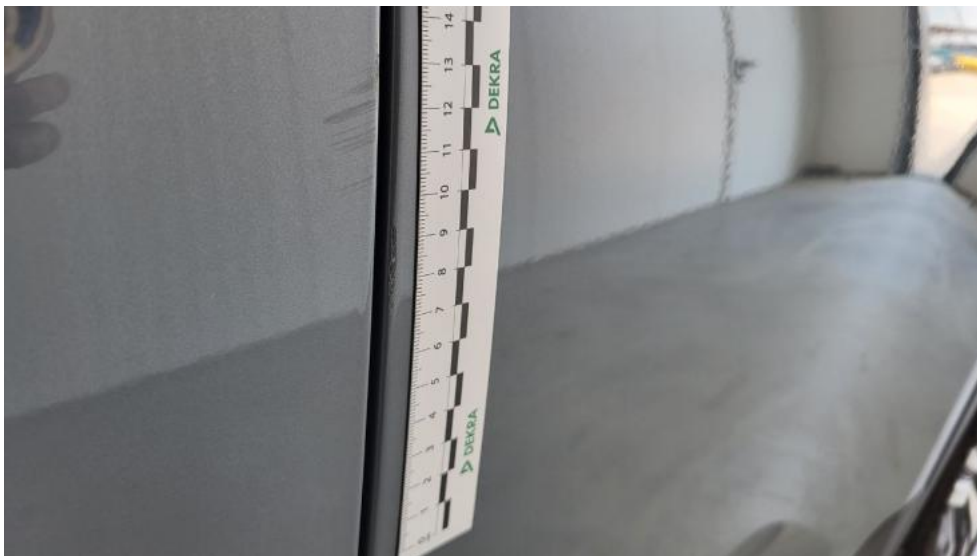
**Photo 55.**  
Drzwi tylne L - Rysa/odprysk 1

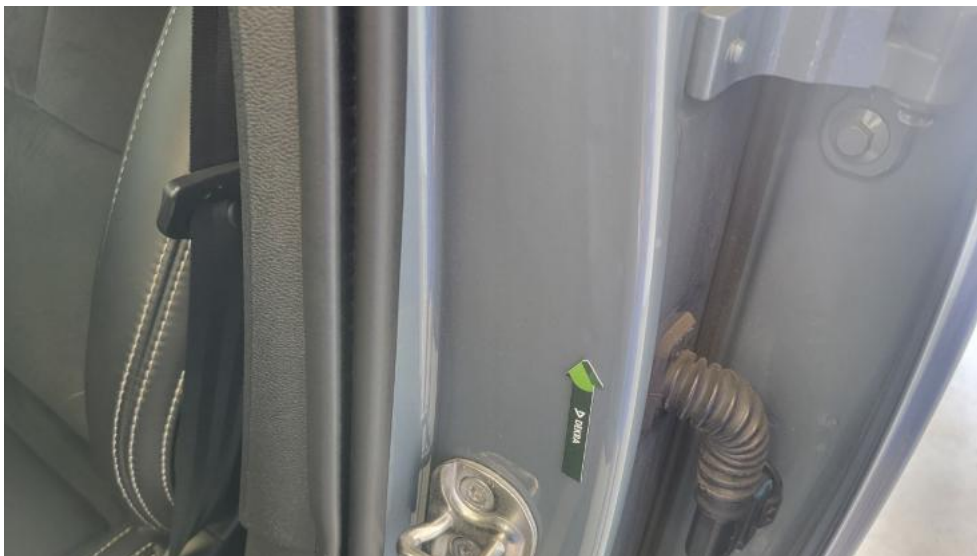
**Photo 57.**  
Stupek środkowy L - Wgniecenie/odkształcenie 1

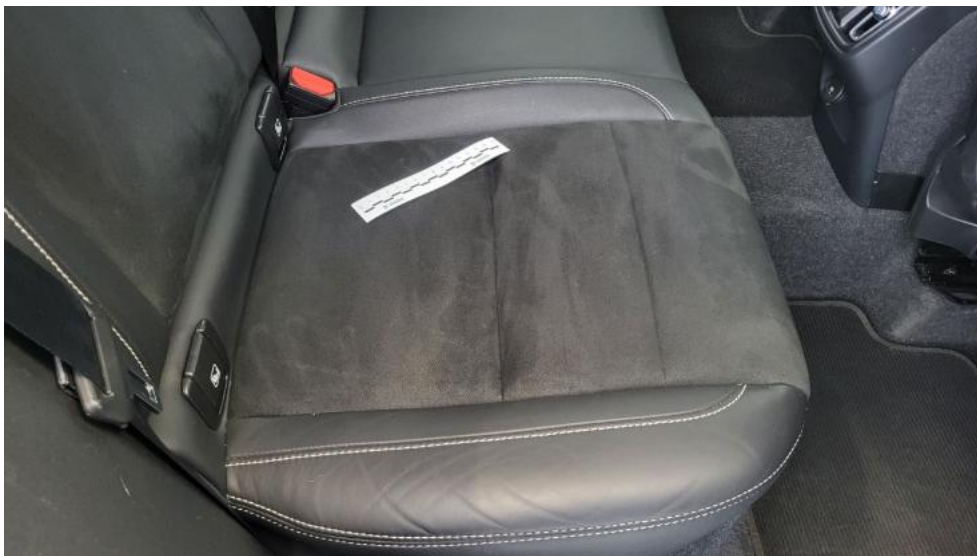
**Photo 63.**  
Kanapa tyl. - Inne 2

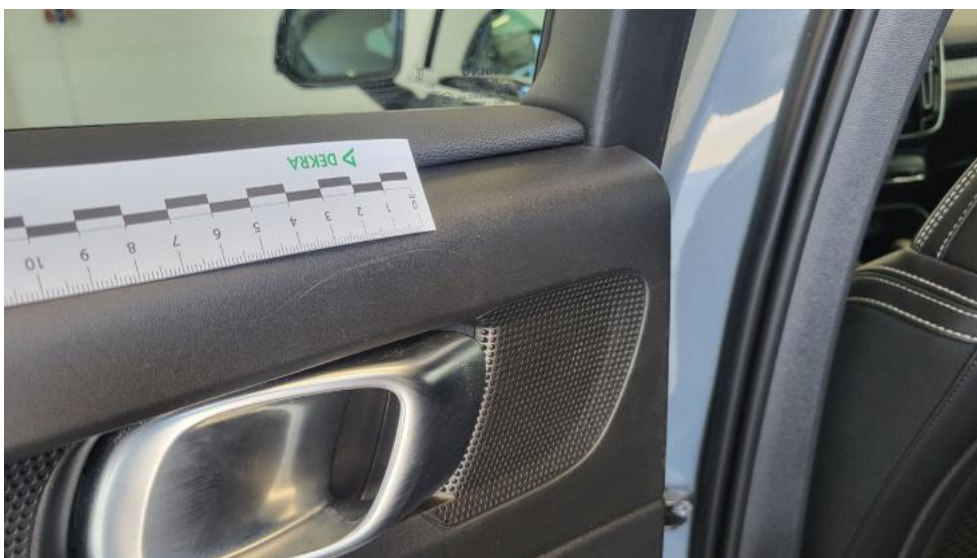
**Photo 64.**  
Tapicerka drzwi tylnych L - Rysa/odprysk 1

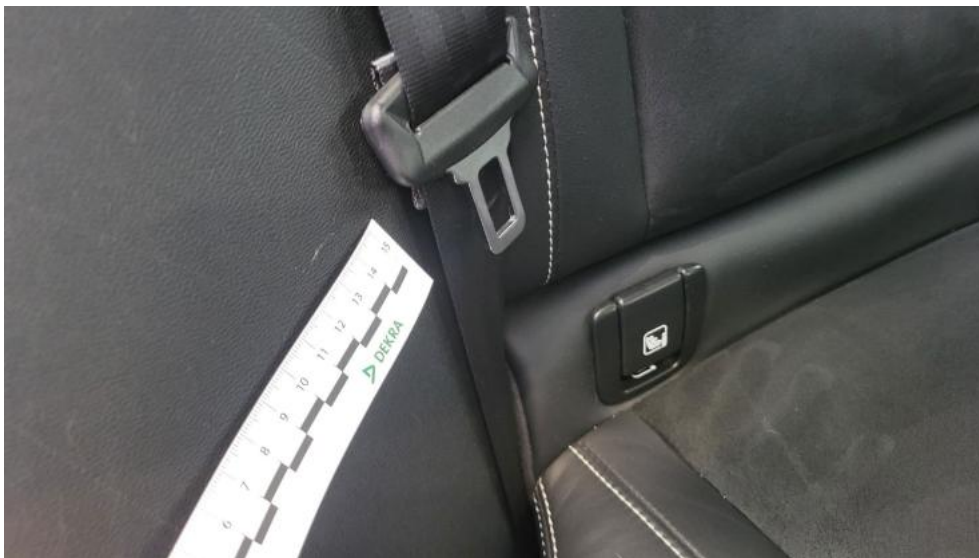
**Photo 65.**  
Wykładzina(y) słupka tylnego P - Rysa/odprysk 1

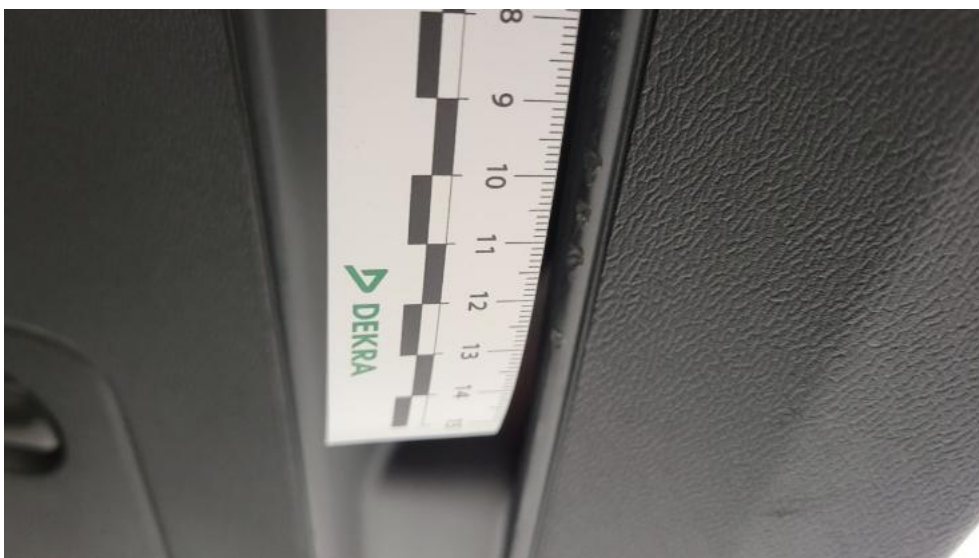
**Photo 66.**  
Wykładzina pokrywy tylnej - Rysa/odprysk 1
