DEKRA's commission No. : PKOL(W)/LODZ/69483/26/07/27  
commission/ damage No. : 23/030243  
Date of commission: 27-07-2026

**Vehicle data**

| Manufacturer | BMW |
| Type / version | 330d xDrive M Sport sport-aut |

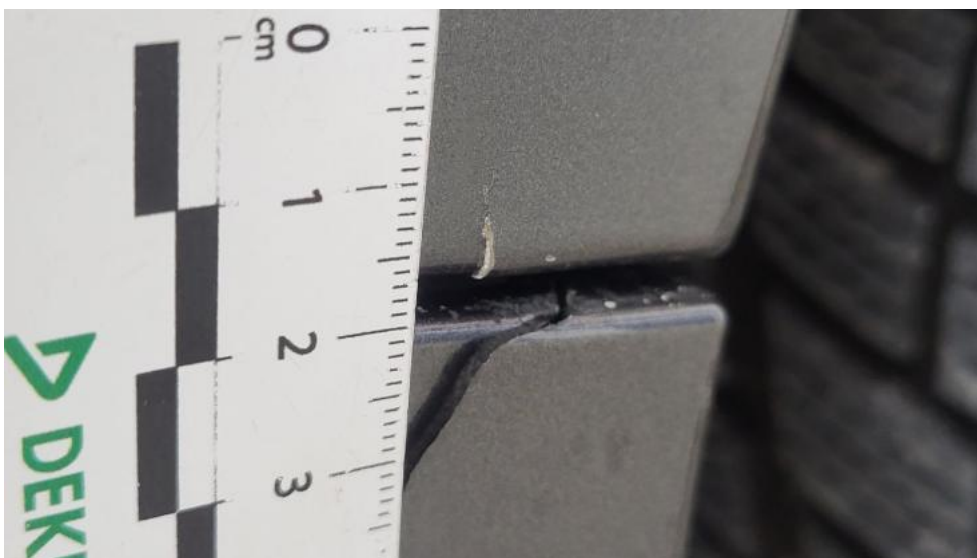
**Photo 46.**

Błotnik przedni P - Pęknięcie/rozerwanie 1

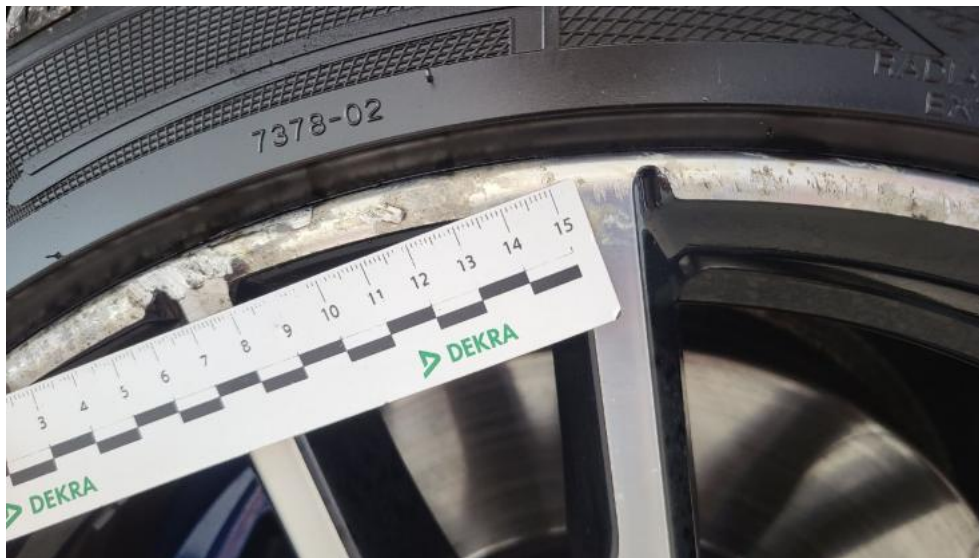
**Photo 47.**

Felga aluminiowa przednia P - Rysa/odprysk 1

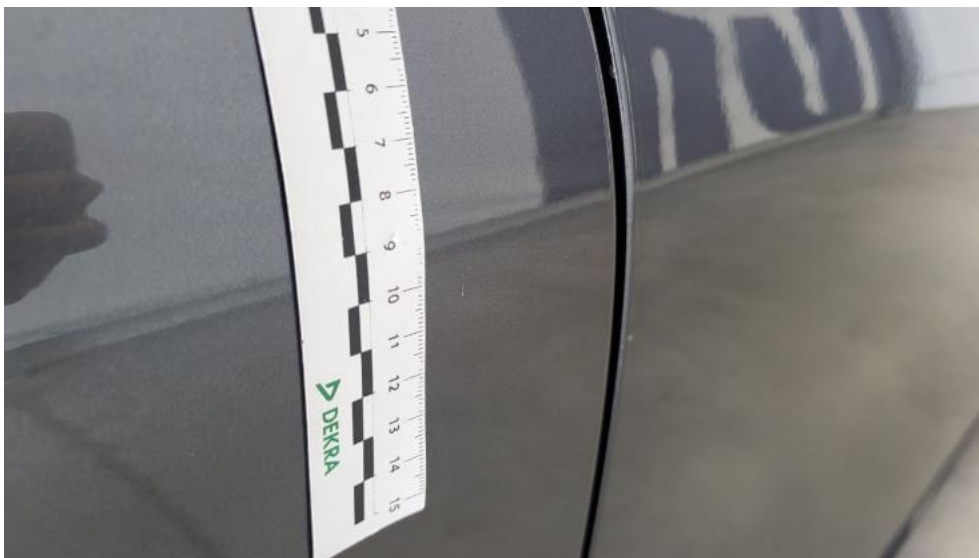
**Photo 48.**

Drzwi tylne P - Rysa/odprysk 1

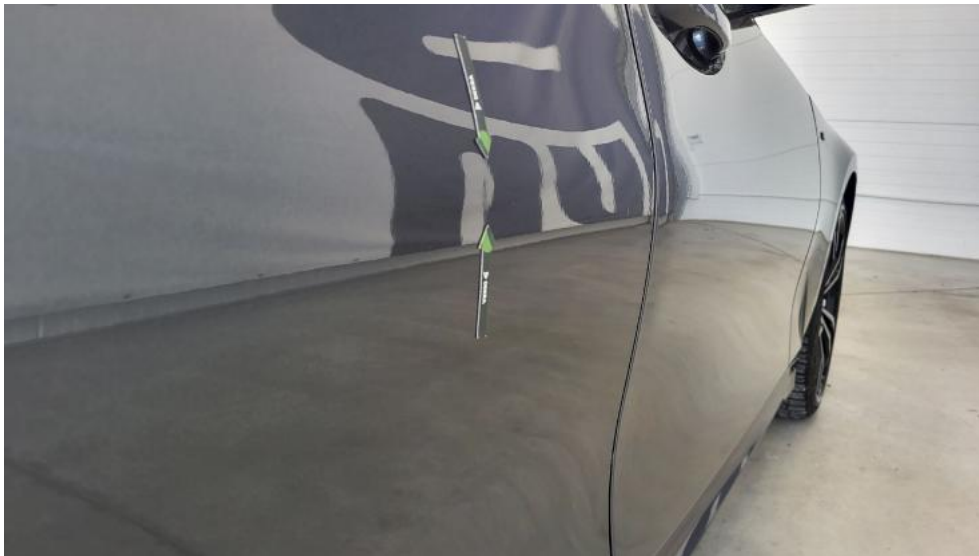
**Photo 49.**

Drzwi tylne P - Wgniecenie/odkształcenie 1

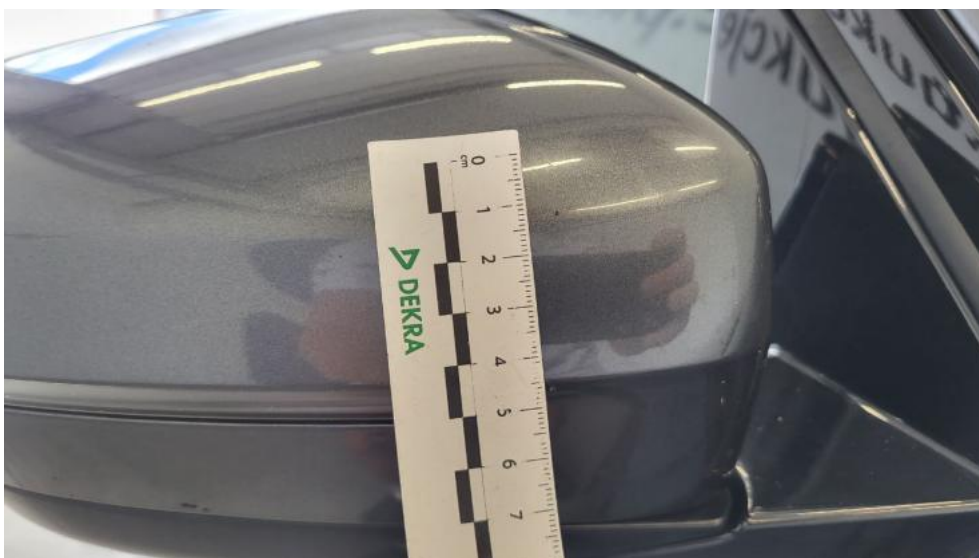
**Photo 50.**

Lusterko zew P - Rysa/odprysk 1

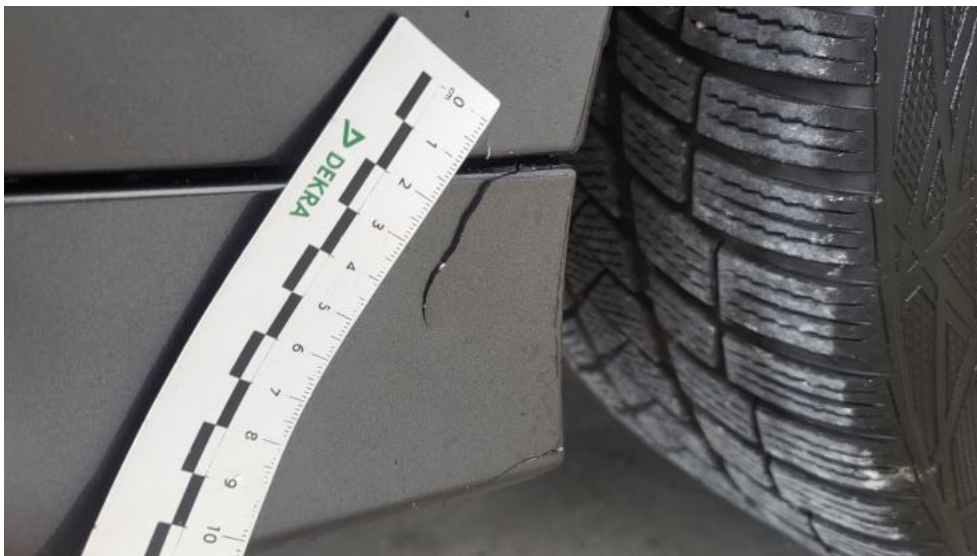
**Photo 51.**

Próg P - Pęknięcie/rozerwanie 1

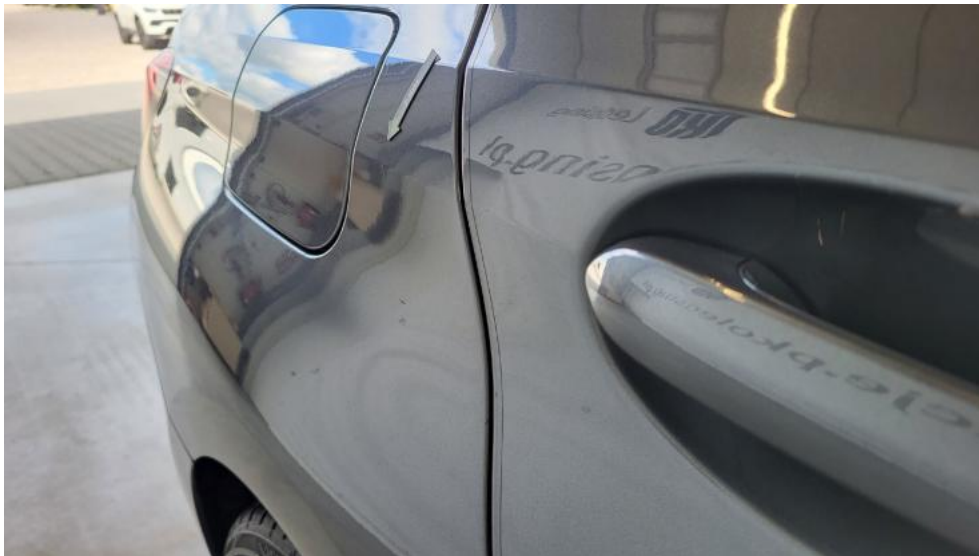
**Photo 53.**

Błotnik tylny P / Ściana boczna P - Wgniecenie/odkształcenie 1

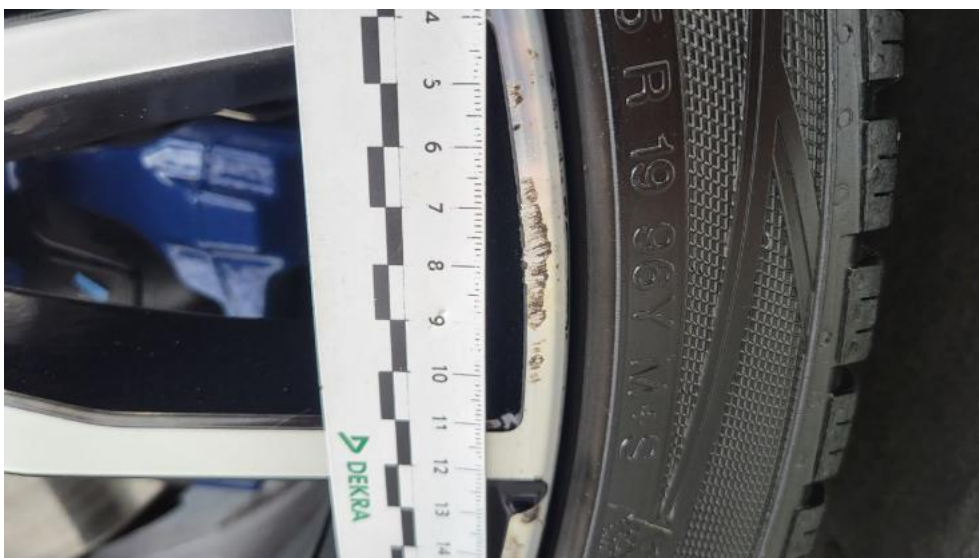
**Photo 54.**

Felga aluminiowa tylna P - Rysa/odprysk 1

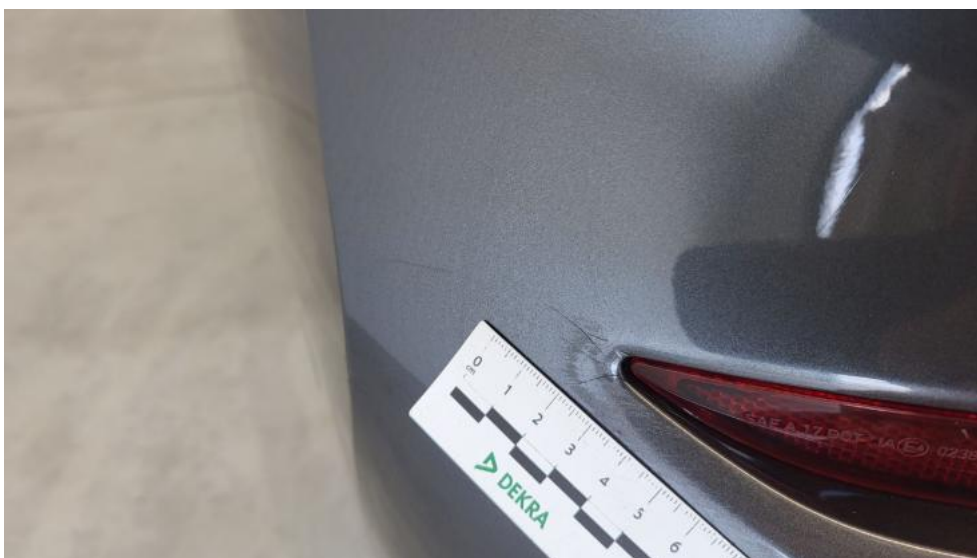
**Photo 58.**

Zderzak tylny - Pęknięcie/rozerwanie 1

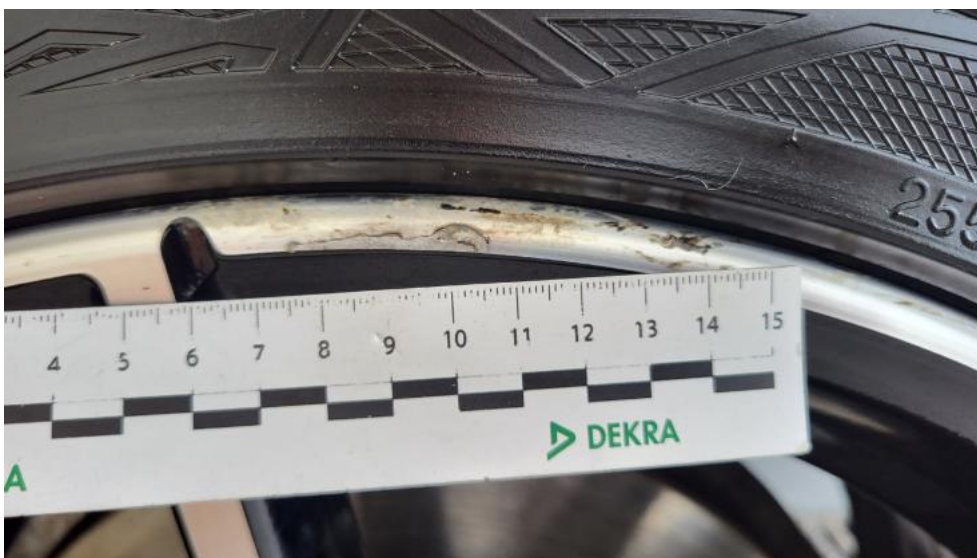
**Photo 64.**

Felga aluminiowa tylna L - Rysa/odprysk 1

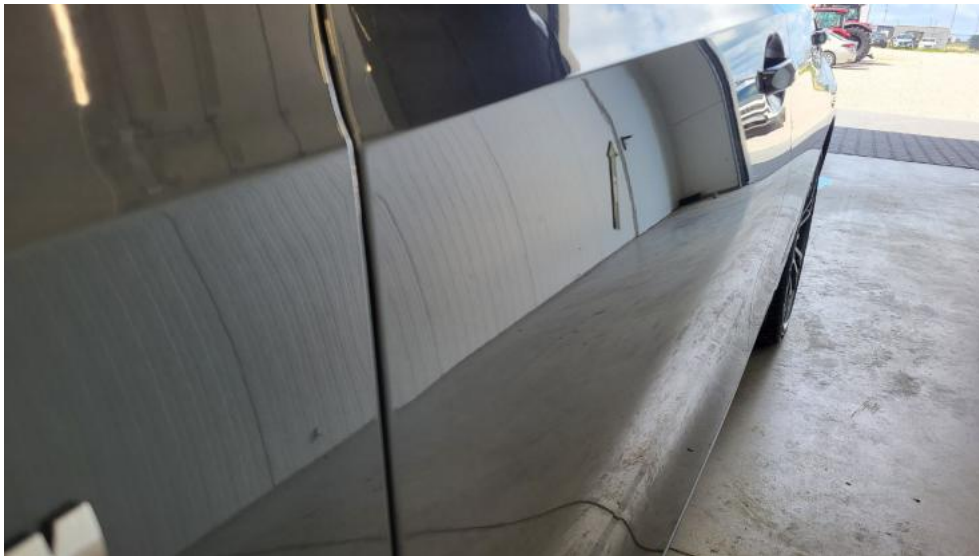
**Photo 65.**

Drzwi przed L - Wgniecenie/odkształcenie 1

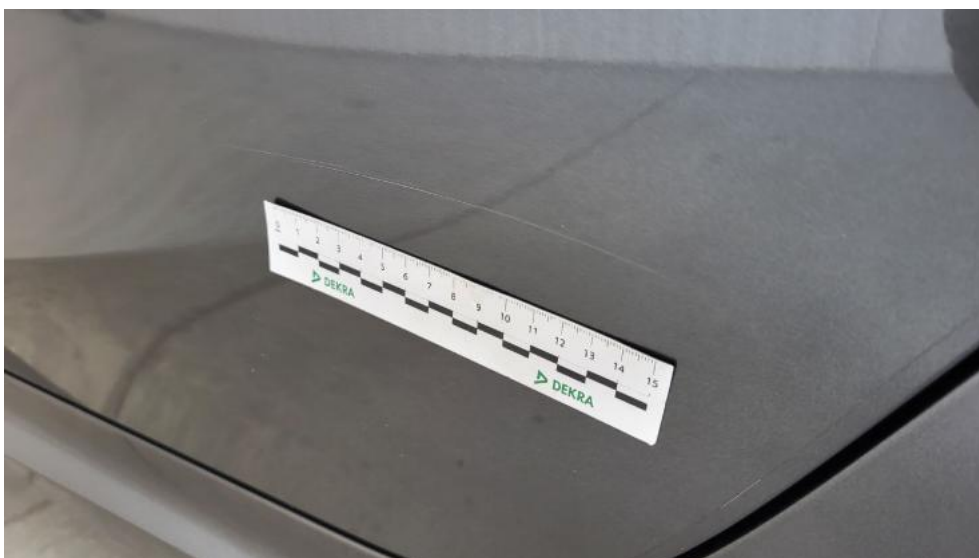
**Photo 66.**

Drzwi tylne L - Rysa/odprysk 1

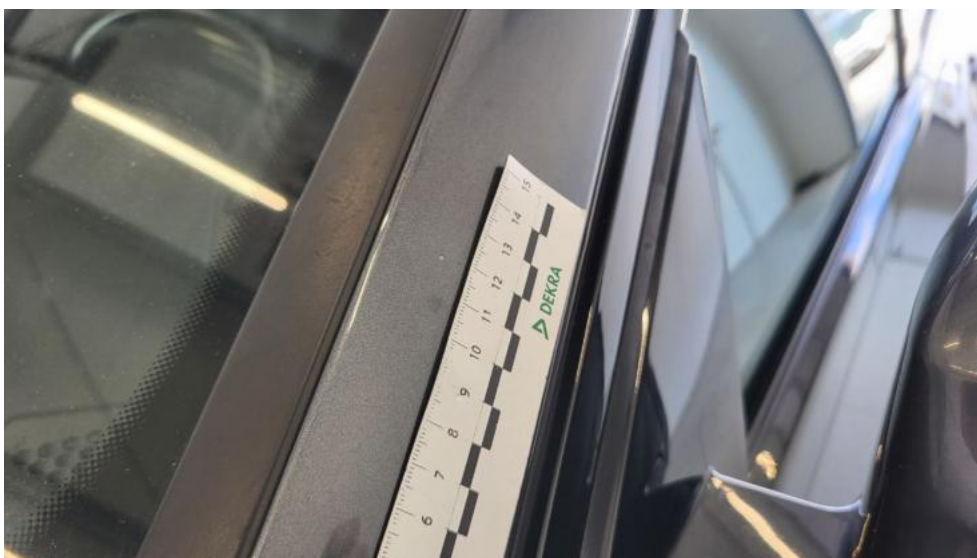
**Photo 68.**

Słupek przedni L - Rysa/odprysk 1

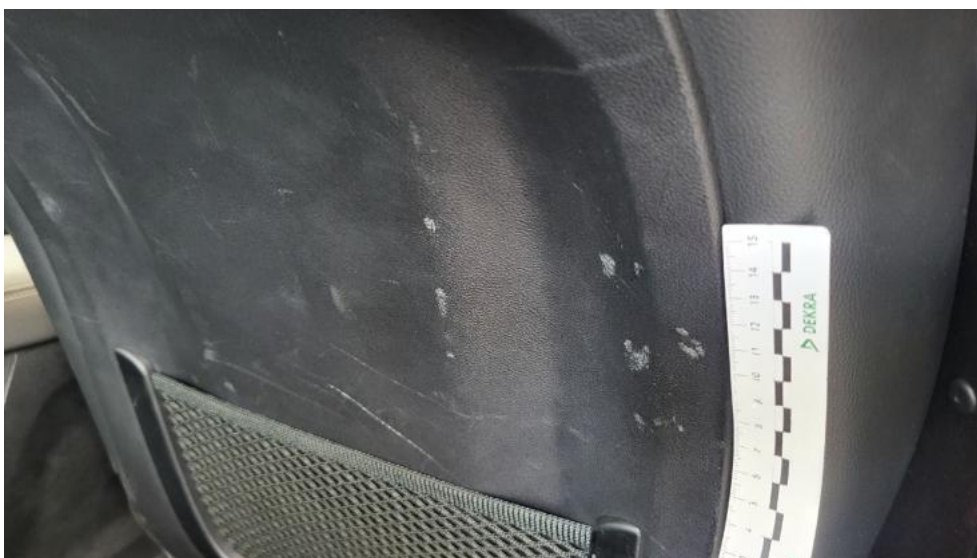
**Photo 74.**

Fotel prz. praw. - Rysa/odprysk 1

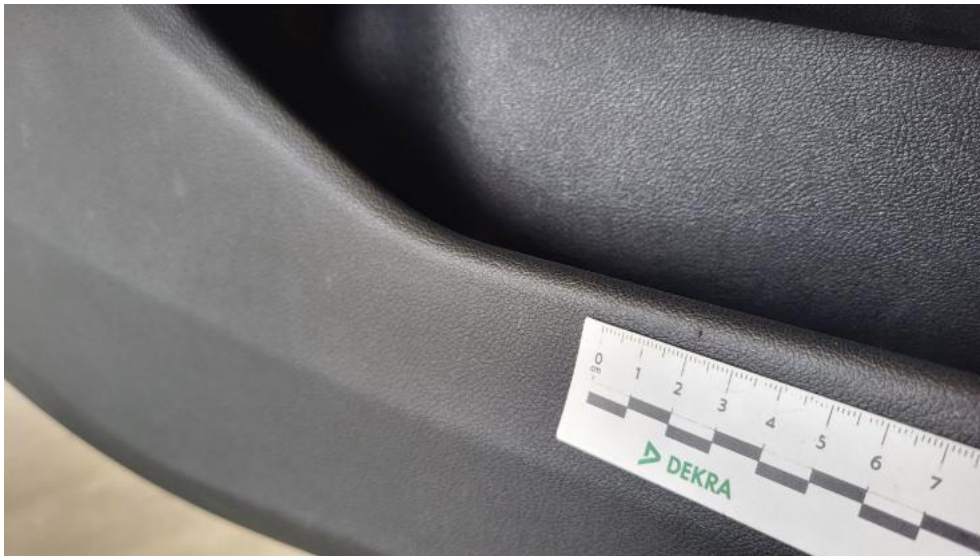
**Photo 75.**

Tapicerka drzwi przednich L - Rysa/odprysk 1

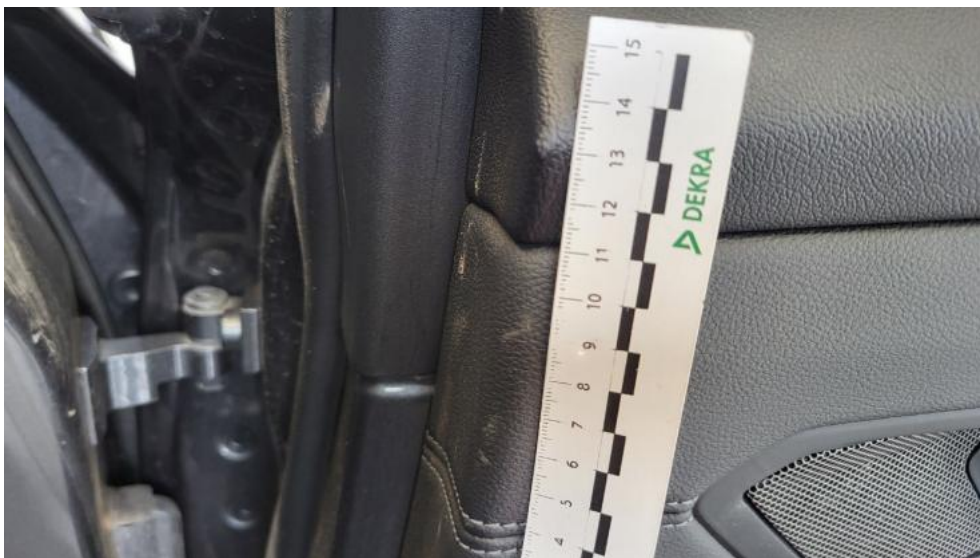
**Photo 76.**

Tapicerka drzwi tylnych P - Rysa/odprysk 1
