DEKRA's commission No. : PKOL(W)/LODZ/58982/26/06/26  
 commission/ damage No. : 00452/EO/23  
 Date of commission: 26-06-2026

| Manufacturer | PORSCHE |
| Type / version | Taycan Turbo S |
| Registration /record No. | KR9XY71 |

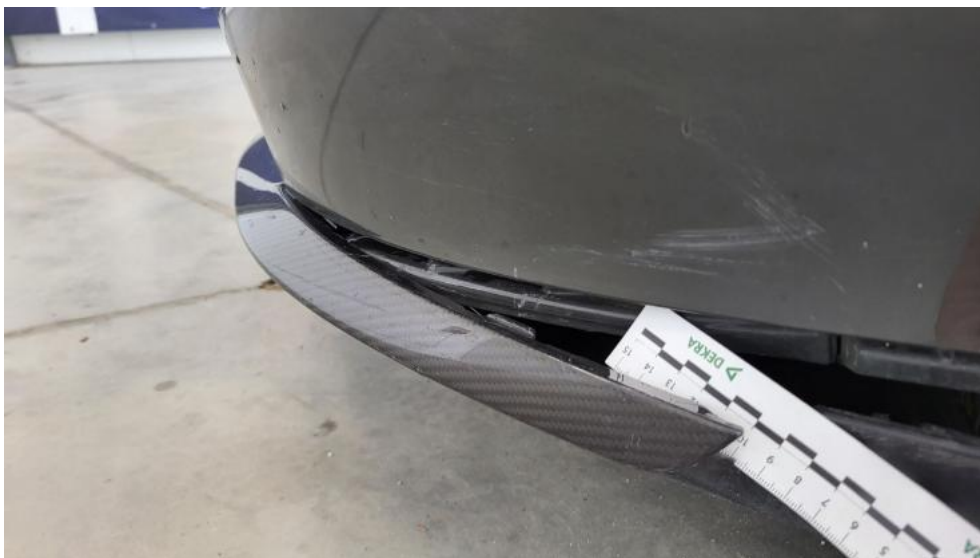
Listwa śr zderzaka przedniego - Inne 1

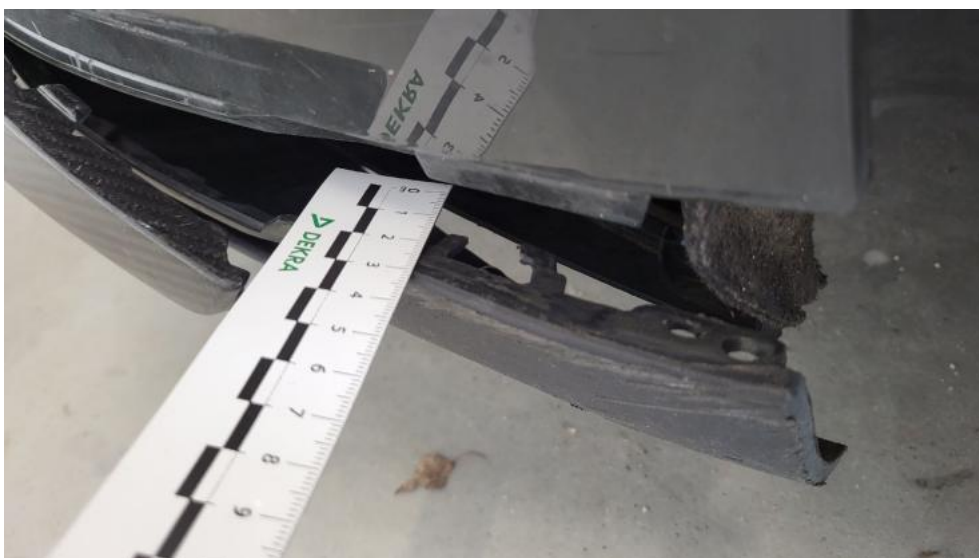
Spoiler zderzaka przedniego - Pęknięcie/rozerwanie 1

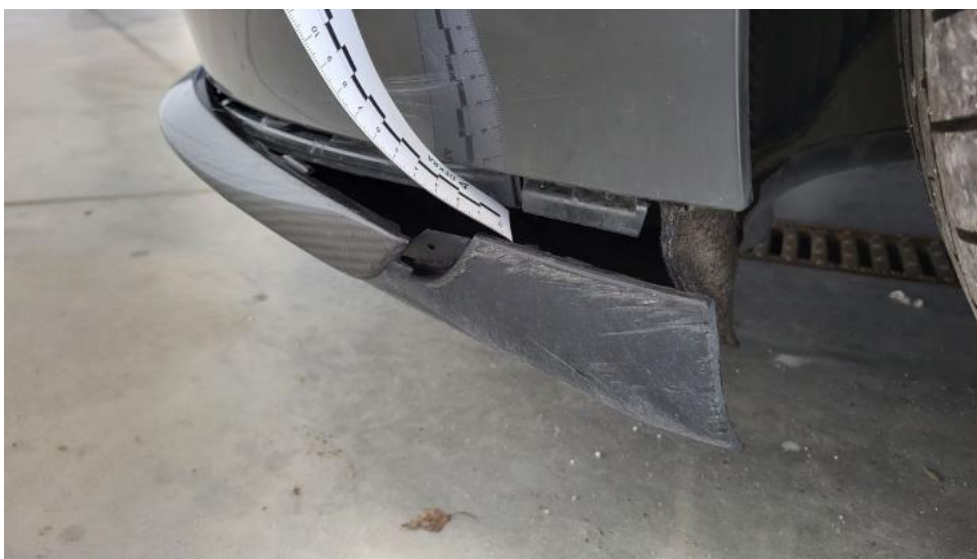
Spoiler zderzaka przedniego - Inne 1

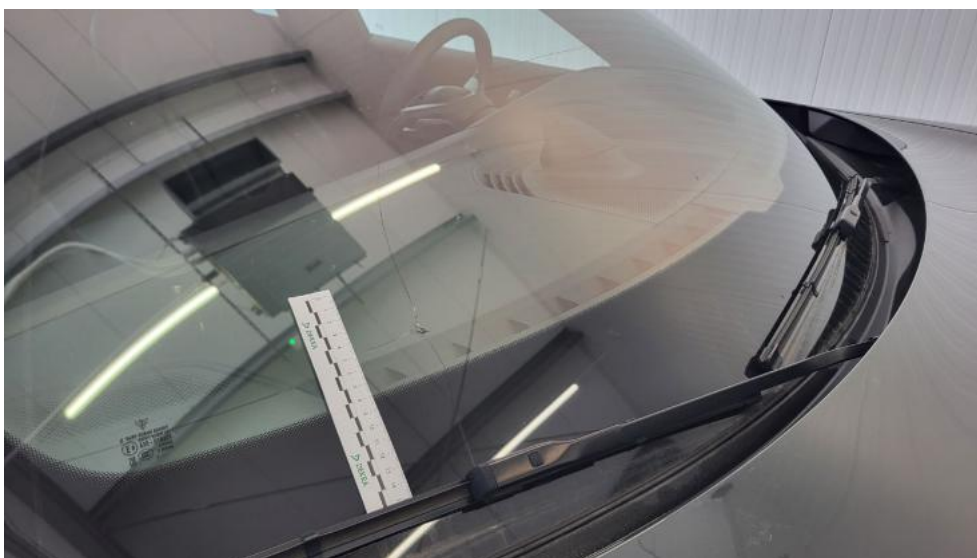
Szyba czołowa - Pęknięcie/rozerwanie 1

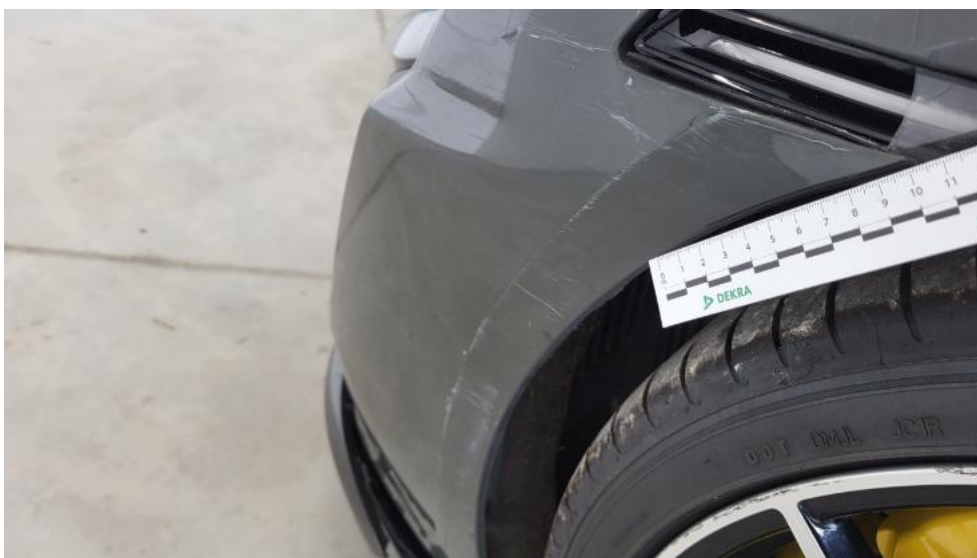
Zderzak - Rysa/odprysk 1

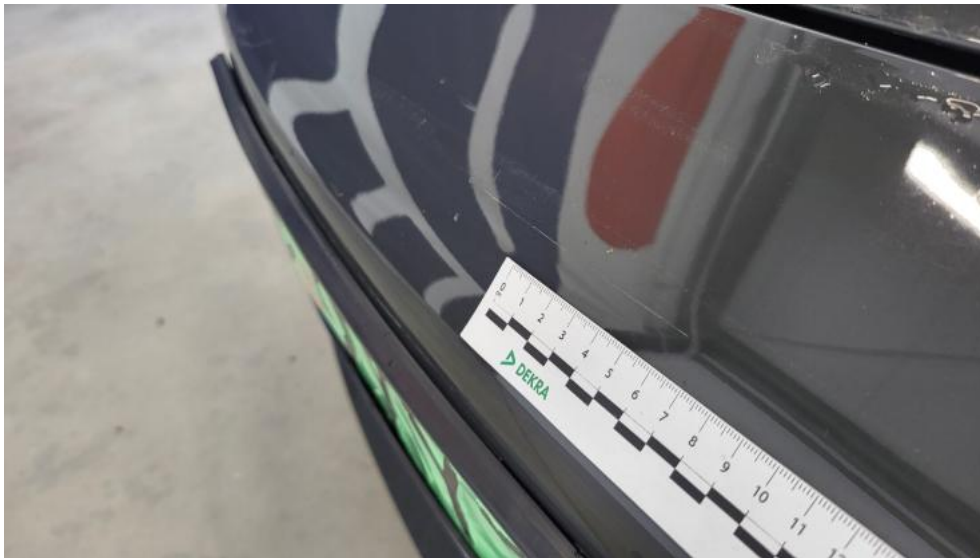
Zderzak - Rysa/odprysk 2

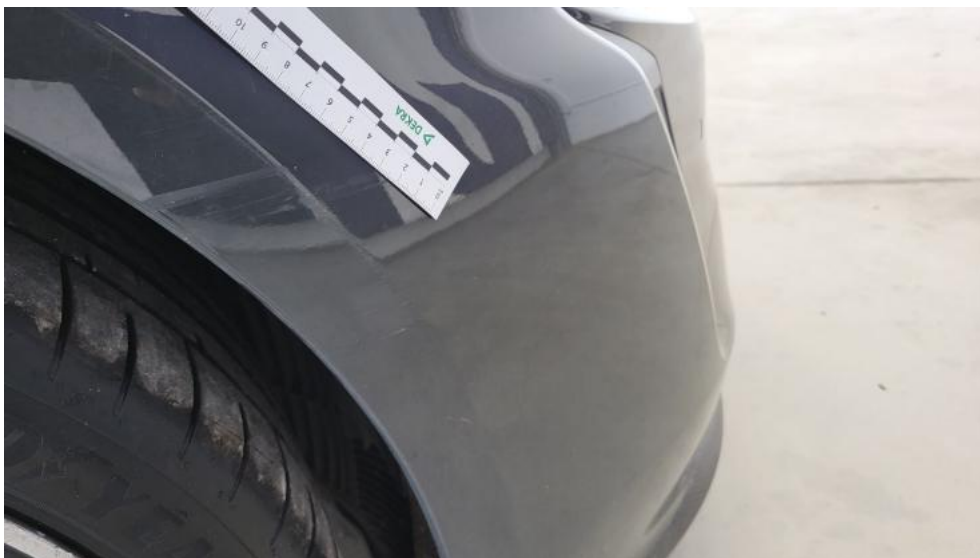
Zderzak() - Rysa/odprysk 3

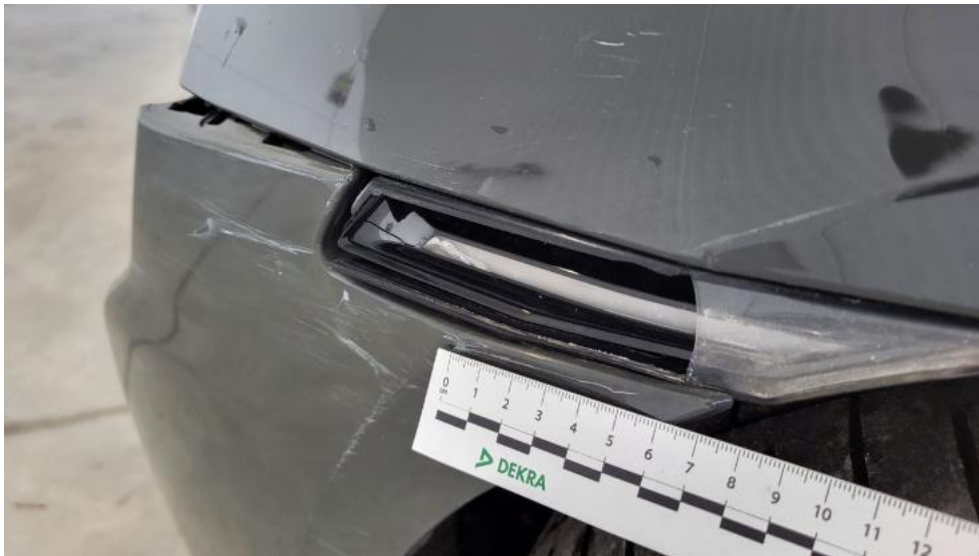
Zderzak - Pęknięcie/rozerwanie 1

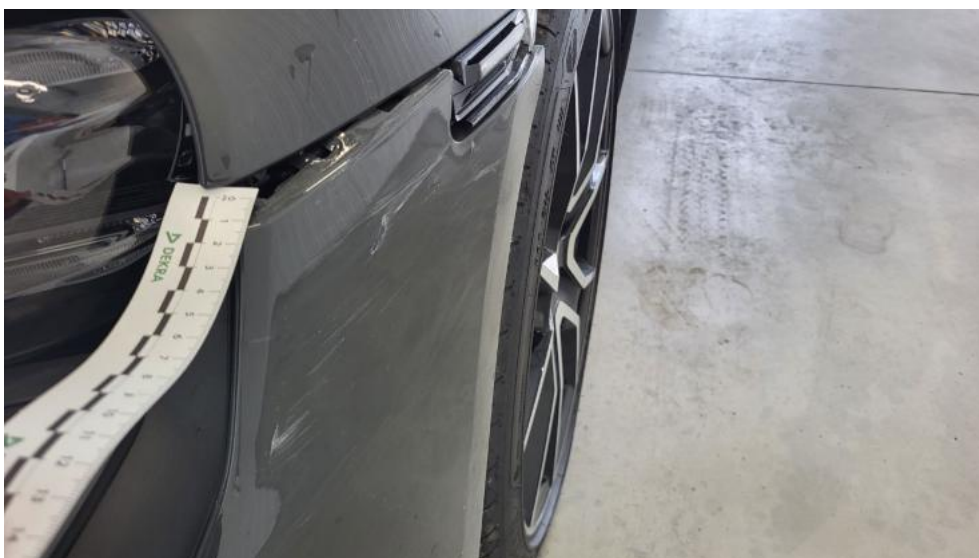
Zderzak - Inne 1

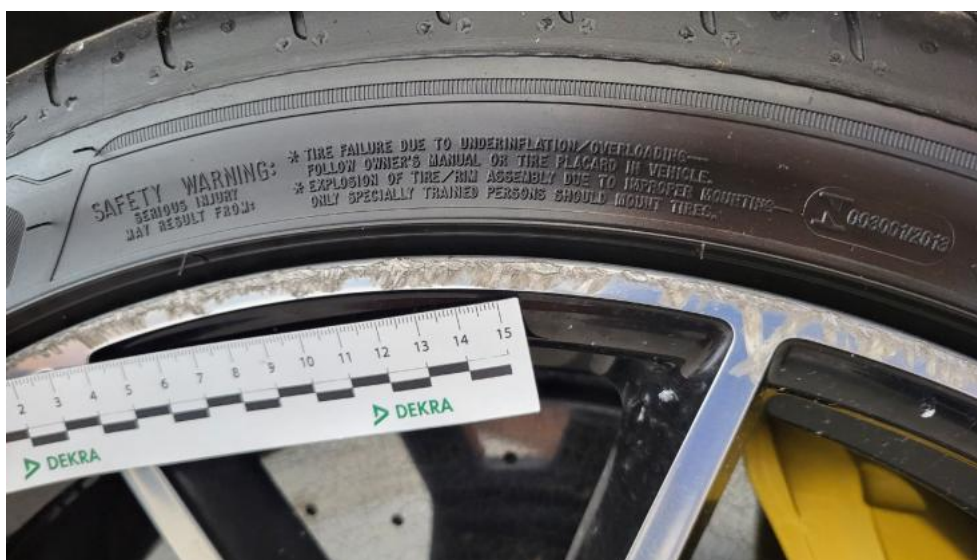
Felga aluminiowa przednia P - Rysa/odprysk 1

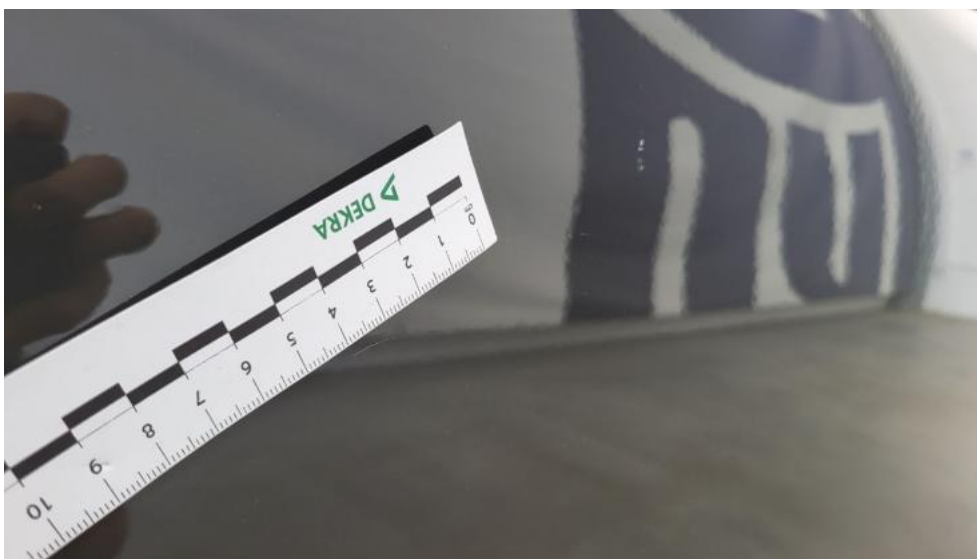
Drzwi przednie P - Rysa/odprysk 1

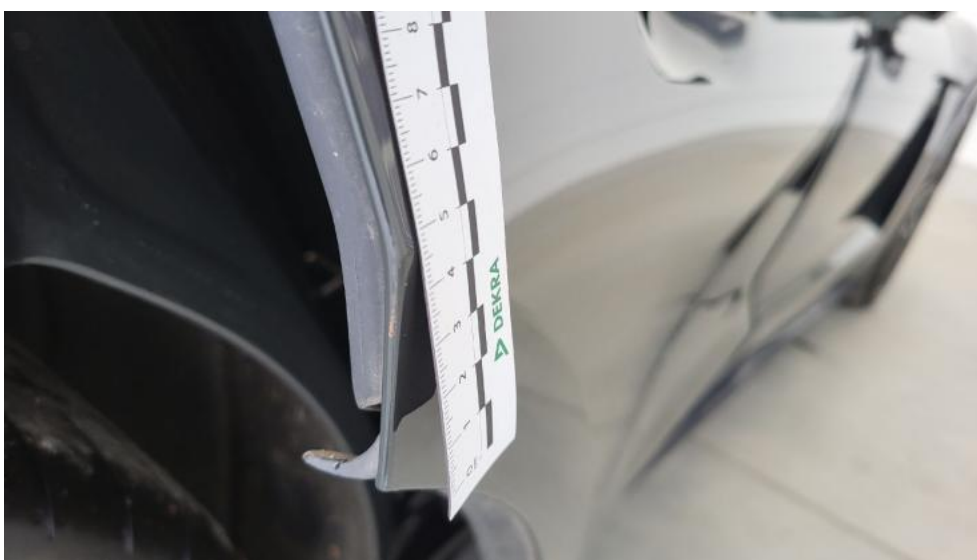
Drzwi tylne P - Rysa/odprysk 1

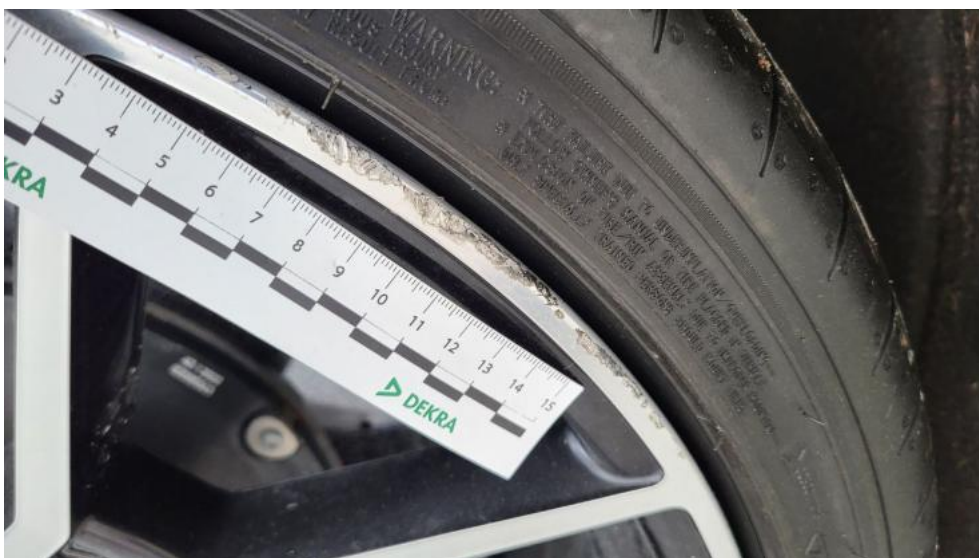
Felga aluminiowa tylna P - Rysa/odprysk 1

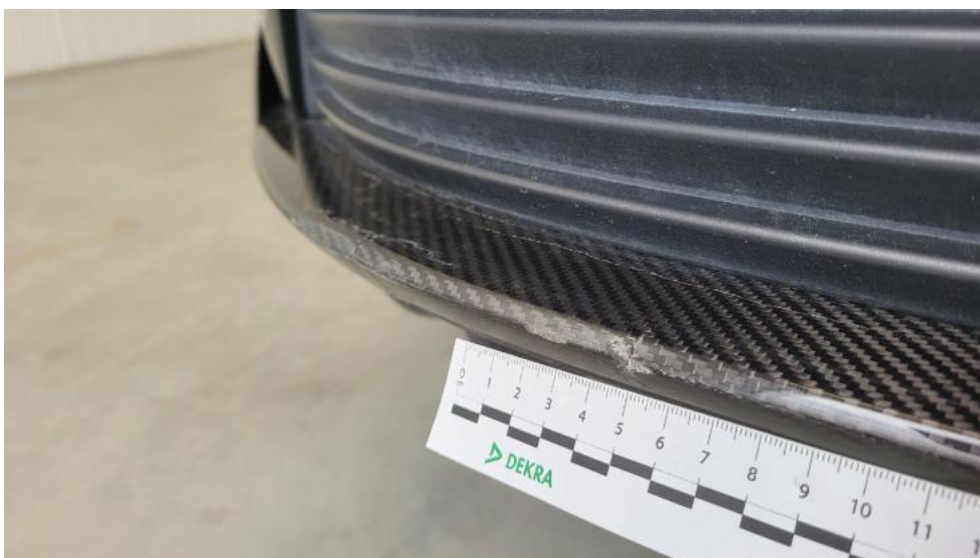
Spojler zderzaka tylnego - Wgniecenie/odkształcenie 1

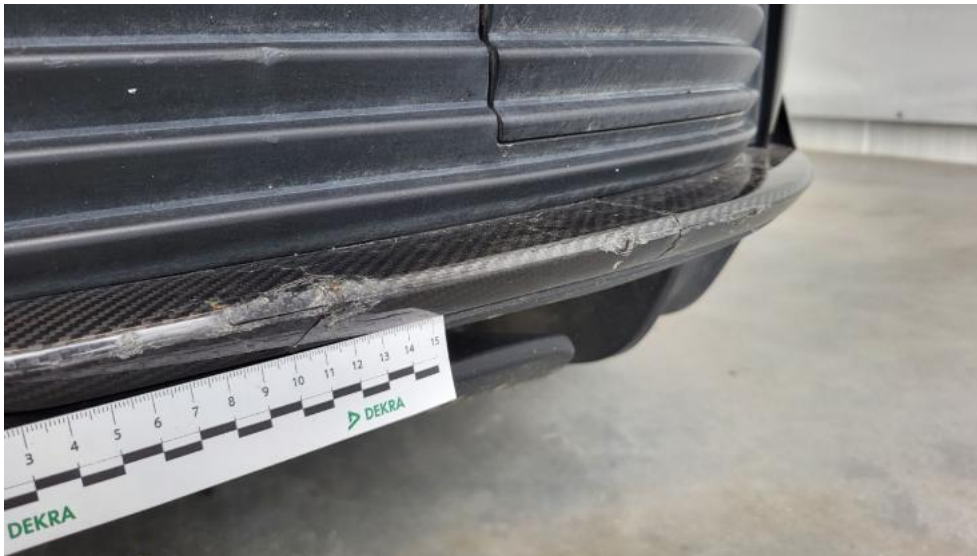
Spojler zderzaka tylnego - Pęknięcie/rozerwanie 1

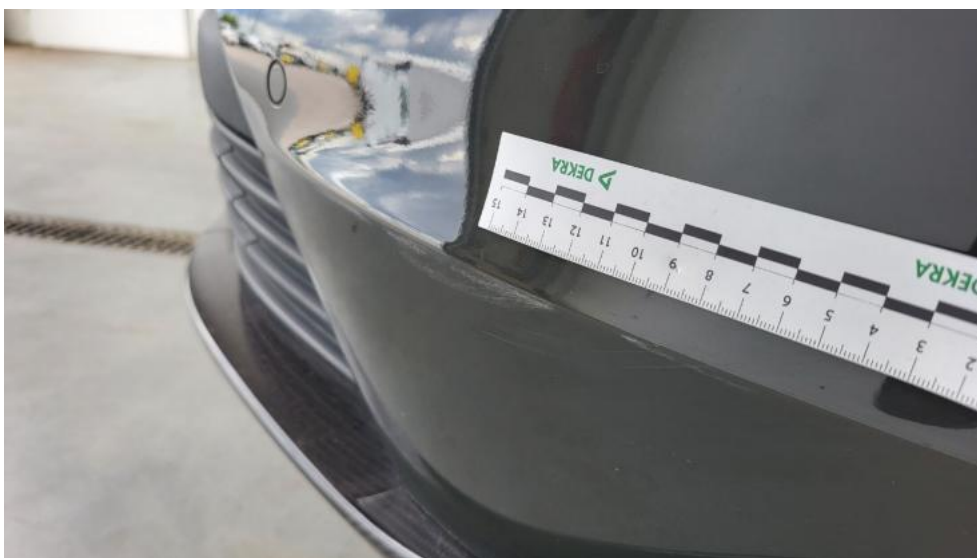
Zderzak tylny - Rysa/odprysk 1

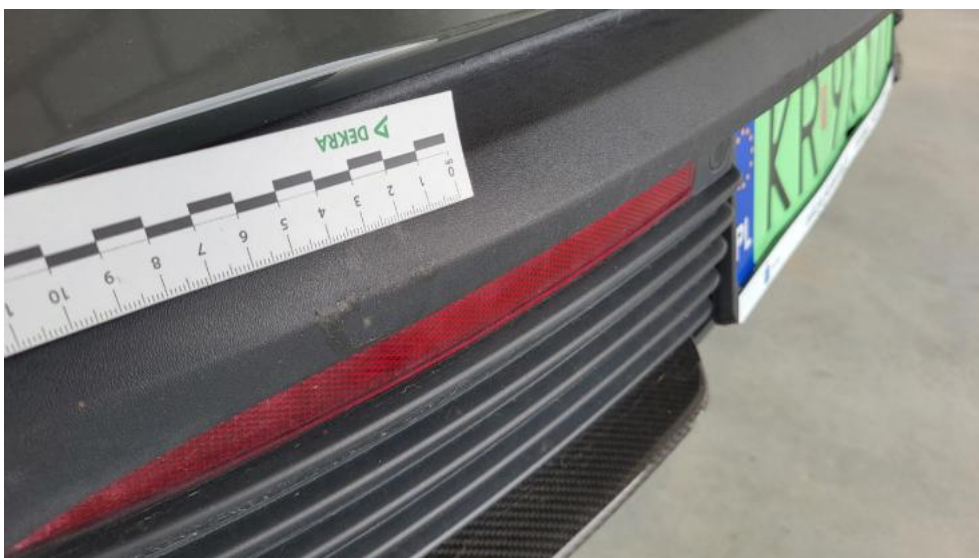
Zderzak tylny cz dolna - Rysa/odprysk 1

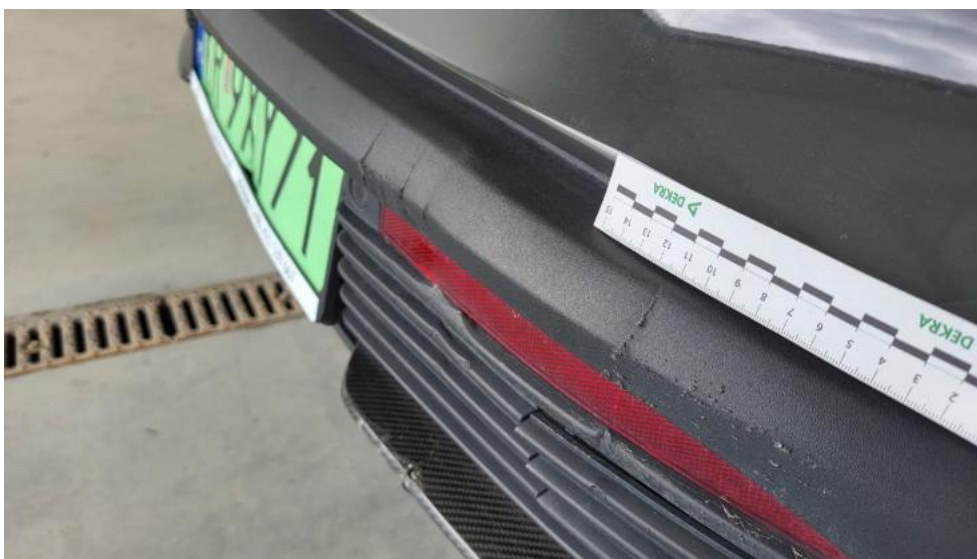
Zderzak tylny cz dolna - Wgniecenie/odkształcenie 1

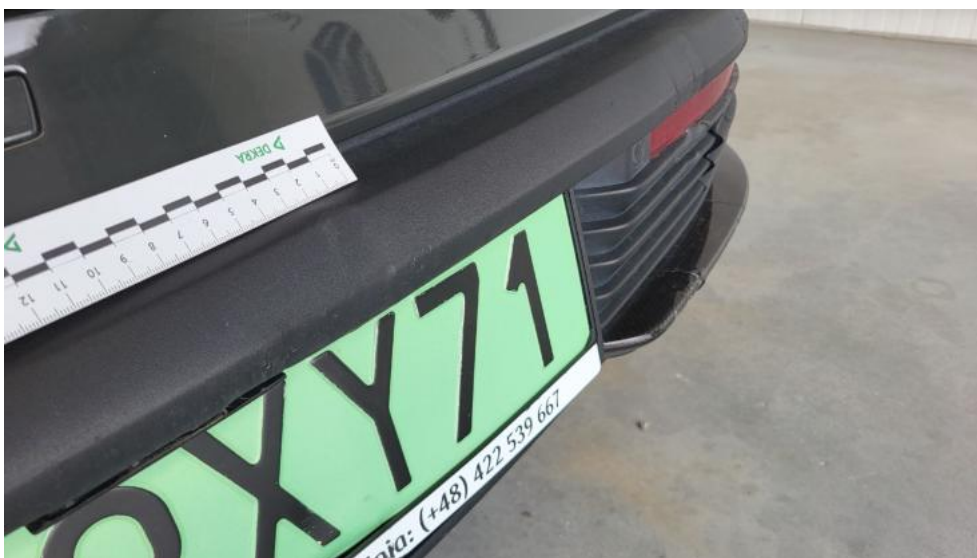
Zderzak tylny cz dolna - Wgniecenie/odkształcenie 2

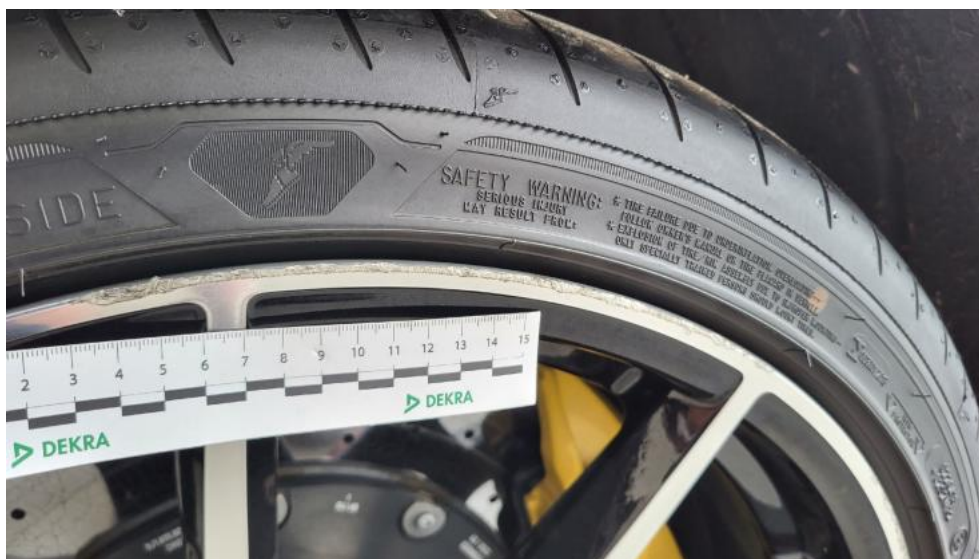
Felga aluminiowa tylna L - Rysa/odprysk 1

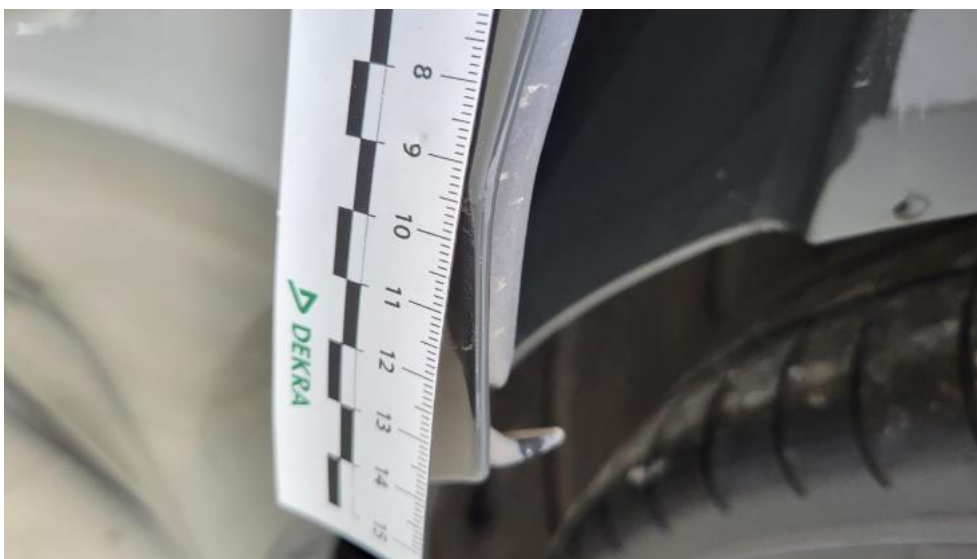
Drzwi tylne L - Rysa/odprysk 1

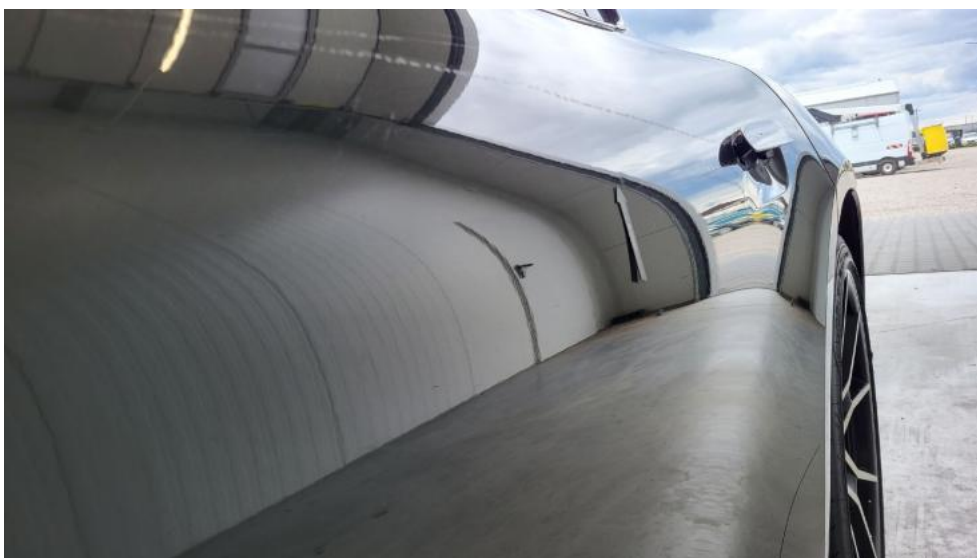
Drzwi tylne L - Wgniecenie/odkształcenie 1

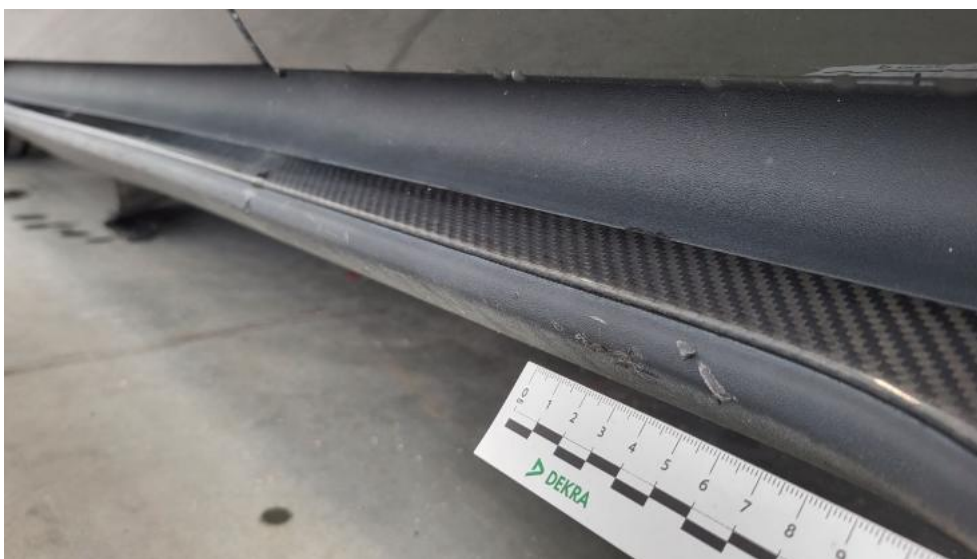
Próg L - Rysa/odprysk 1

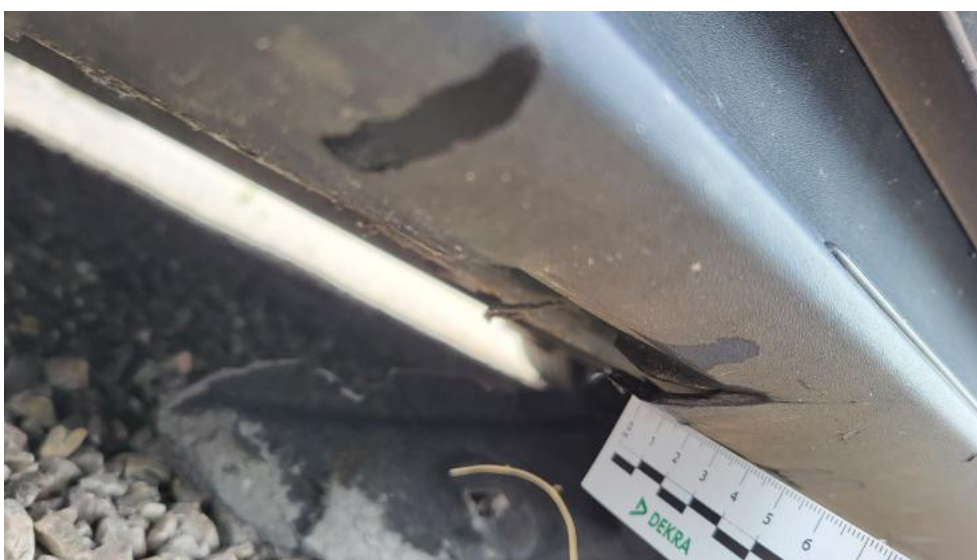
Próg L - Pęknięcie/rozerwanie 1

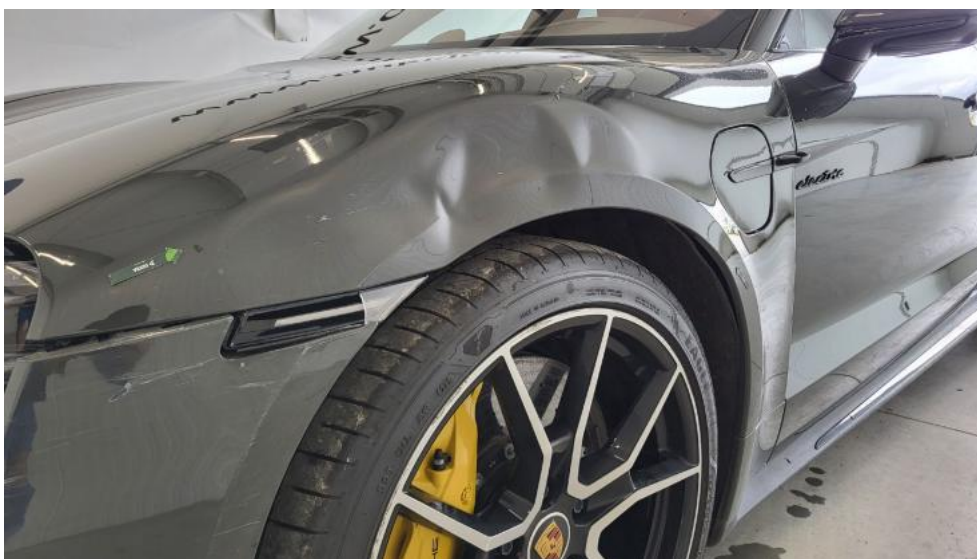
Błotnik przedni L - Wgniecenie/odkształcenie 1

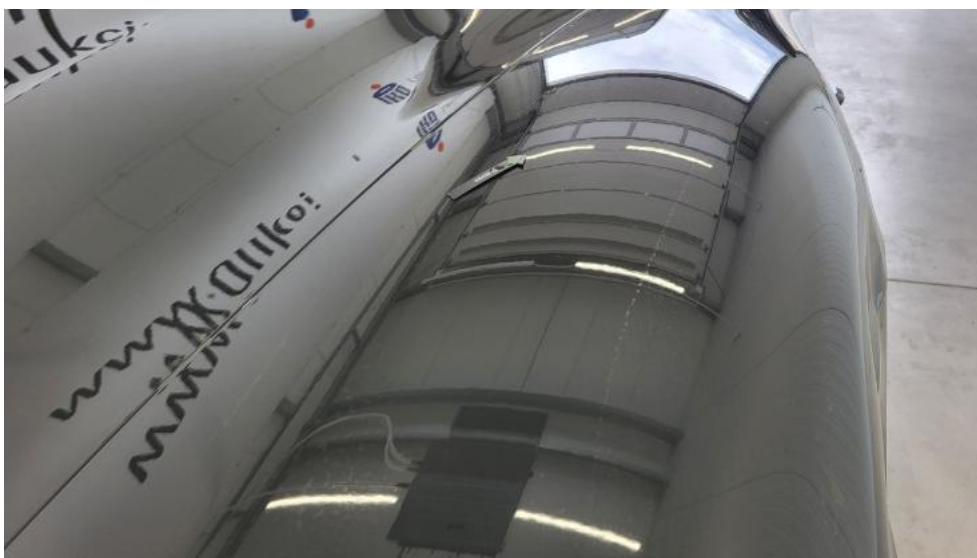
Błotnik przedni L - Wgniecenie/odkształcenie 2

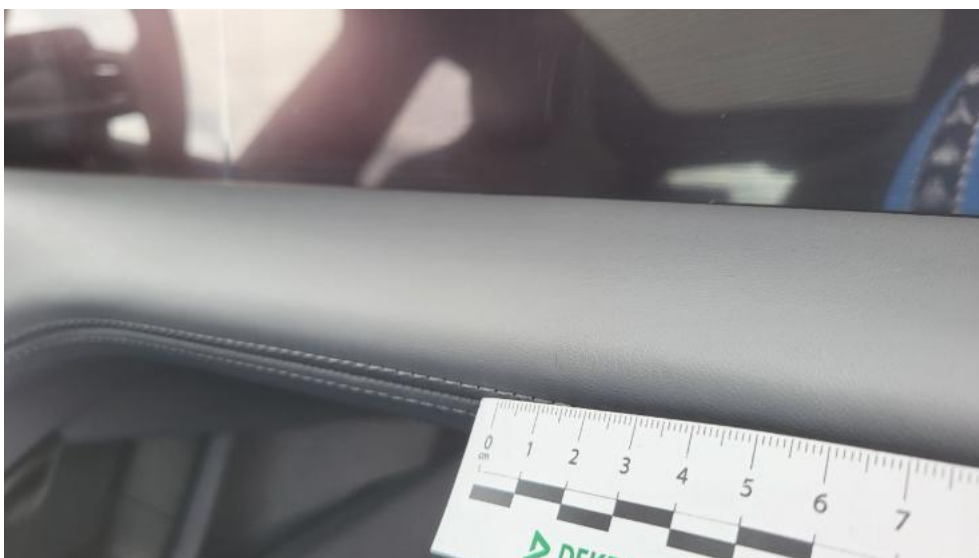
Deska rozdzielcza - Rysa/odprysk 1

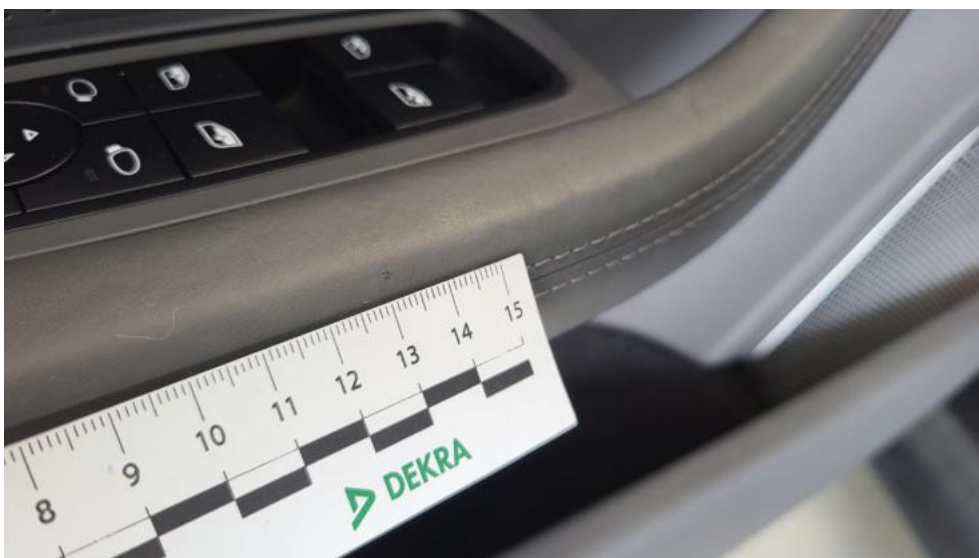
Tapicerka drzwi przednich L - Rysa/odprysk 1

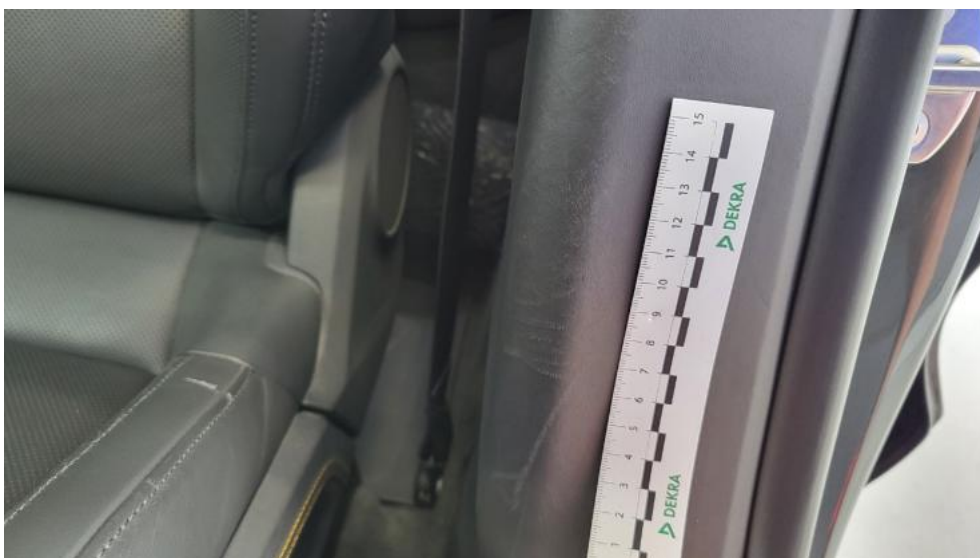
Wykładzina(y) słupka środkowego L - Rysa/odprysk 1

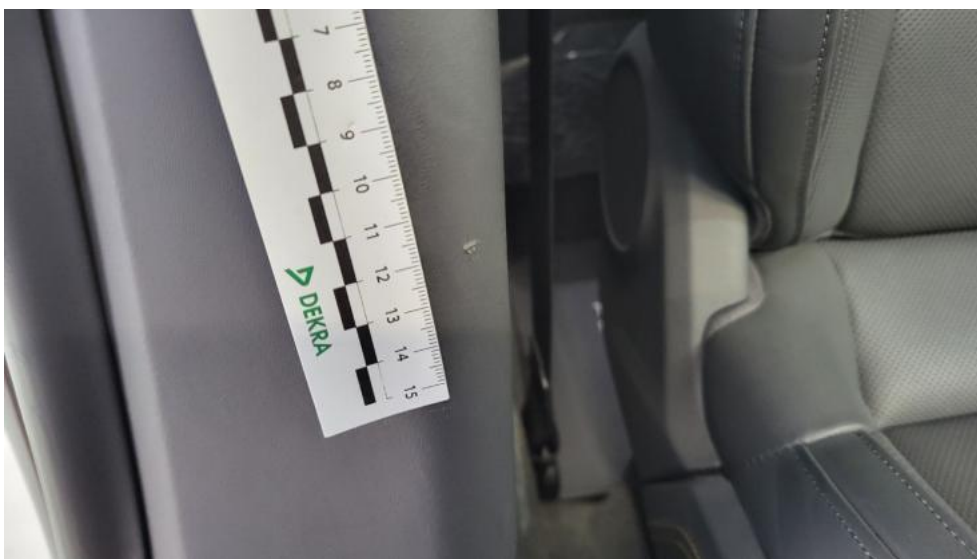
Wykładzina(y) słupka środkowego P - Rysa/odprysk 1
