DEKRA's commission No. : PKOL(W)/LODZ/13205/26/02/18
commission/ damage No. : 24/030259
Date of commission: 18-02-2026

PKO Leasing SA
Świętokrzyska 36
00-116 Warszawa

Group of objects (Eurotax)	jeeps
EC code (Eurotax)	0155860
Manufacturer	MAZDA
Model	CX-60 22-
Type / version	CX-60 3.3 D mHEV Takumi aut
Body type	KOM
Number of doors / seats	5/5
Curb weight [kg]	1910
Gross vehicle weight [kg]	2516
Wheelbase 1/2	2870
Engine type	Automatic ignition
Pollution reduction system	KSC
Engine capacity [ccm]	3283
Engine Power [hp/kW]	254/187
Gearbox	automatic
Registration /record No.	K8RAY8
VIN / serial number	JMZKH0HE001153132
Date of first registration	24-06-2024
Date of next. tech. test	24-06-2027
Year of manufacture	2024 (year has been verified with the manufacturer's base)
Readout [km]	43 058 (read)
Body color / type of coating	beżowy/double-layered, metallized

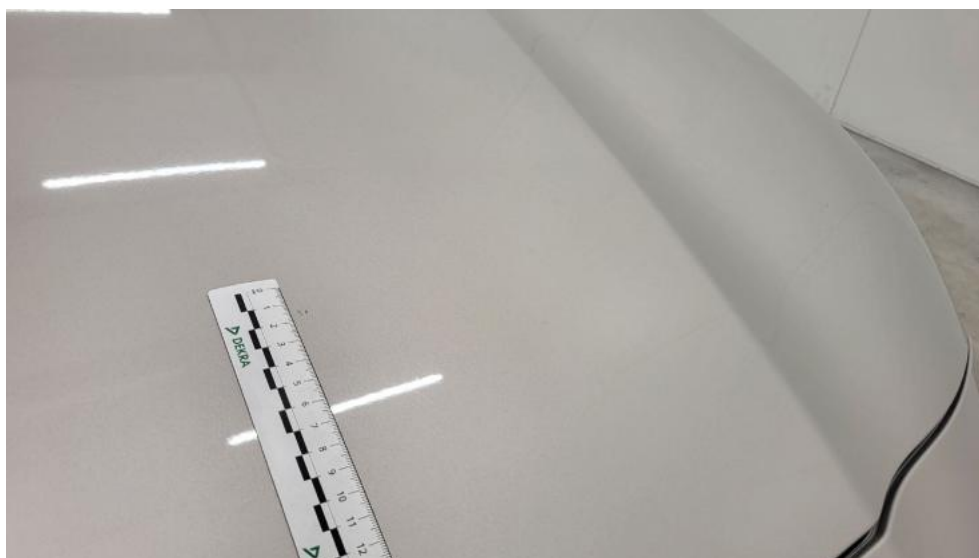
Photo 40.
Pokrywa komory silnika - Rysa/odprysk 1

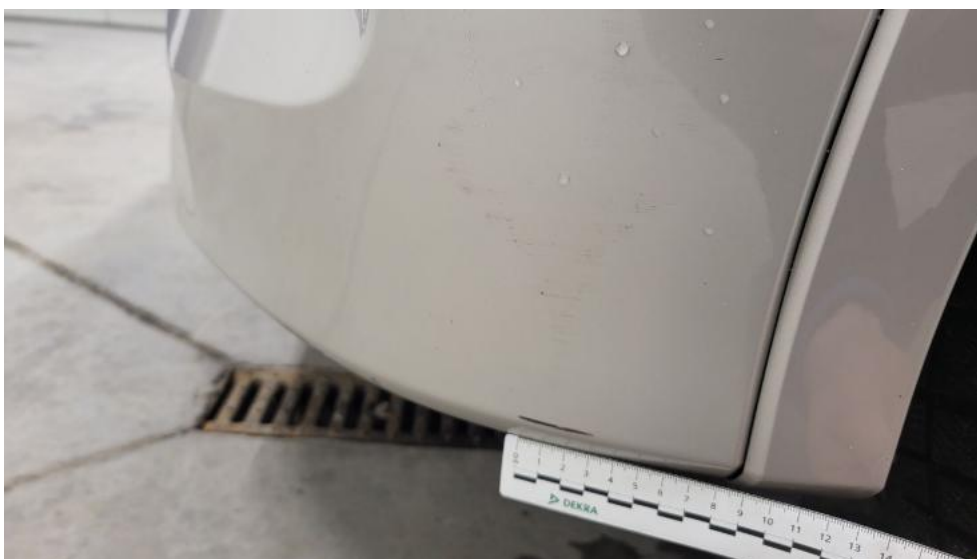
Photo 41.
Zderzak - Rysa/odprysk 1

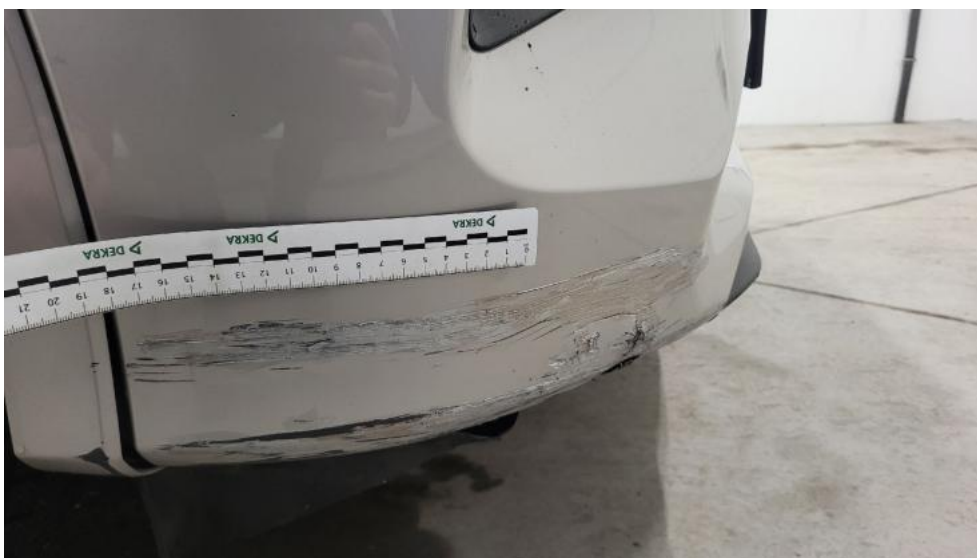
Photo 42.
Zderzak - Rysa/odprysk 2

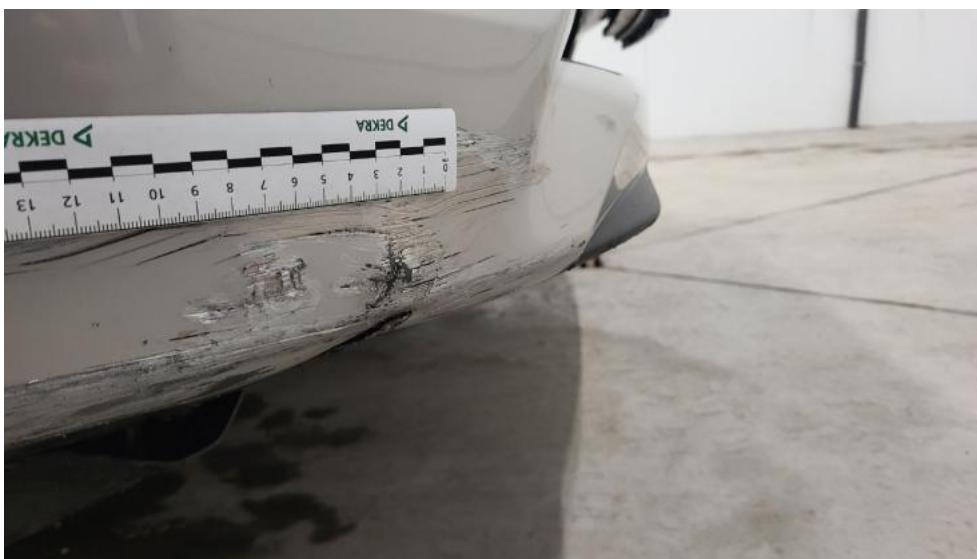
Photo 43.
Zderzak - Wgniecenie/odkształcenie 1

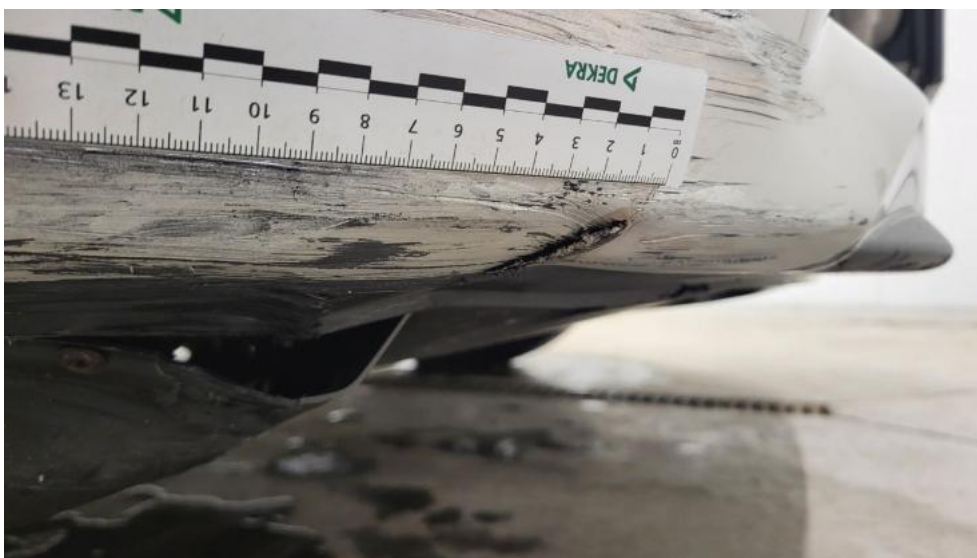
Photo 44.
Zderzak - Pęknięcie/rozerwanie 1

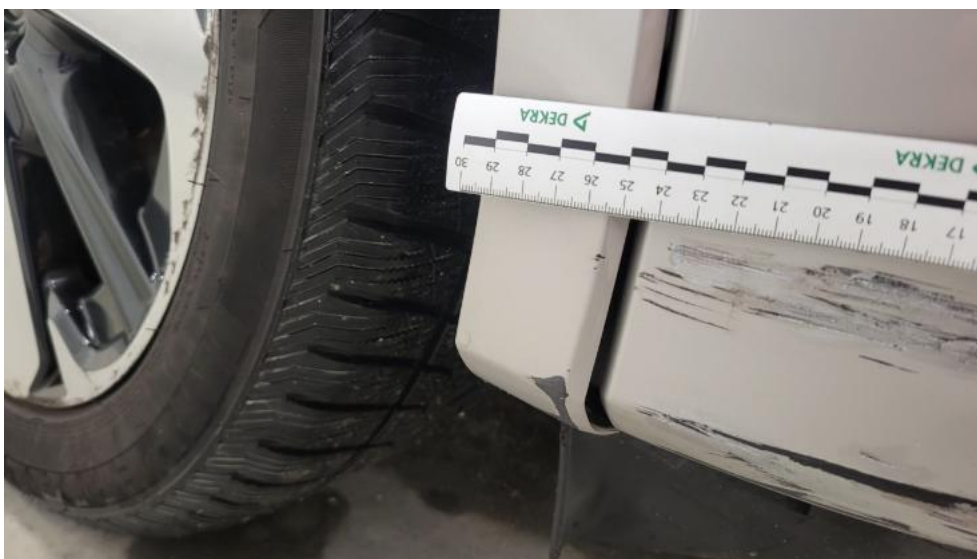
Photo 45.

Listwa błotnika przedniego P - Rysa/odprysk 1

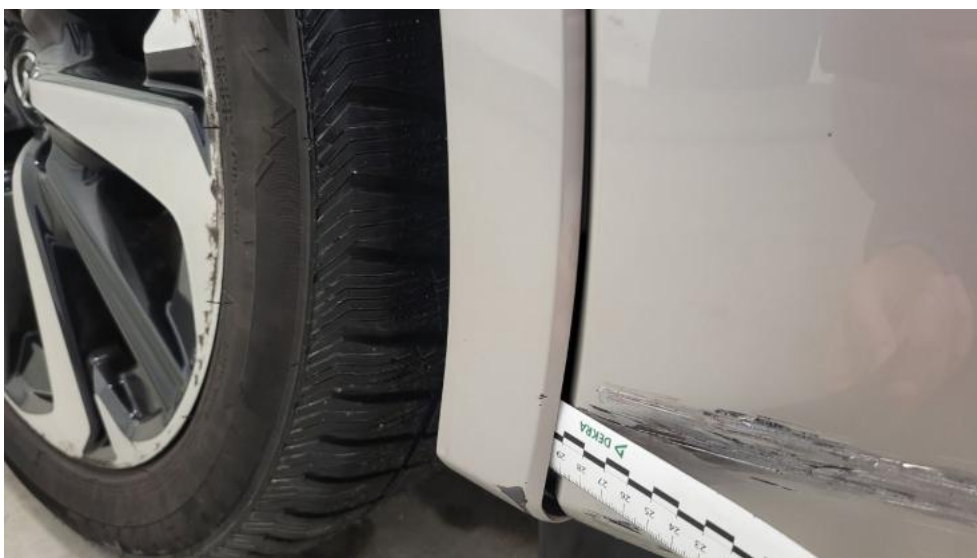
Photo 46.

Listwa błotnika przedniego P - Inne 1

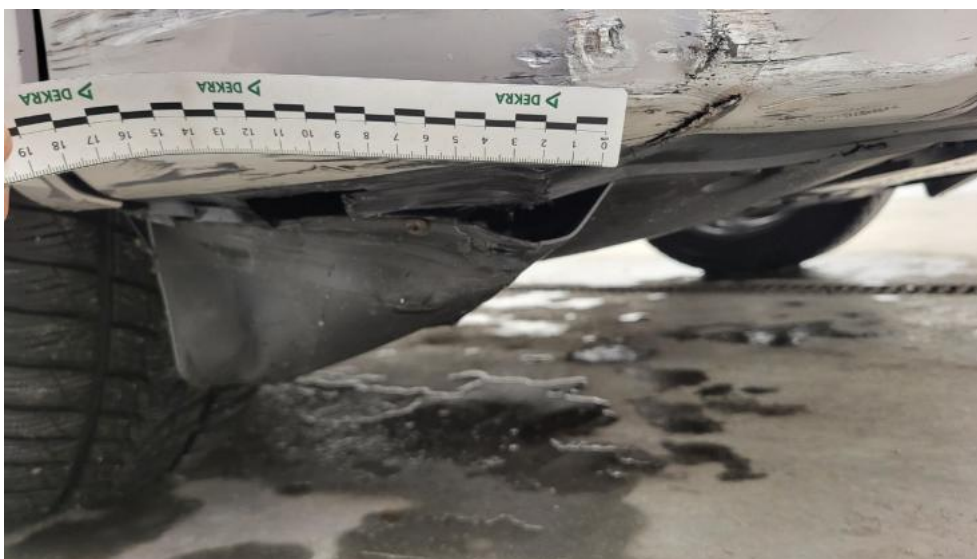
Photo 47.
Nadkole przednie P - Wgniecenie/odkształcenie 1

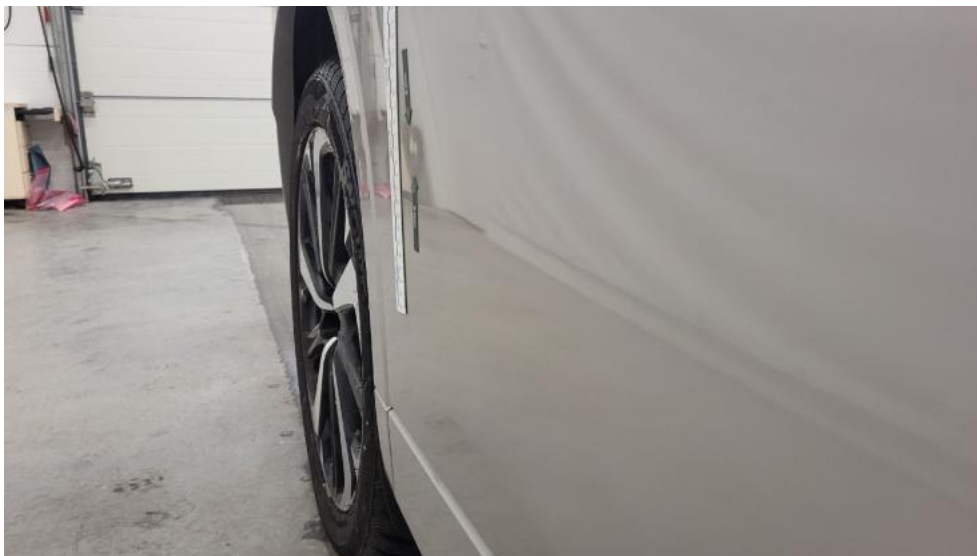
Photo 49.
Drzwi tylne P - Wgniecenie/odkształcenie 1

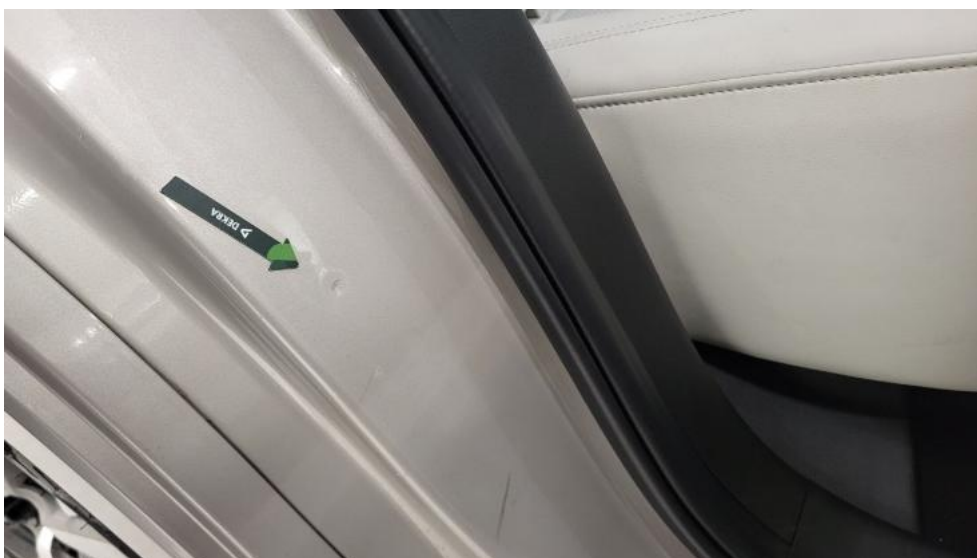
Photo 50.
Błotnik tylny P / Ściana boczna P - Wgniecenie/odkształcenie 1

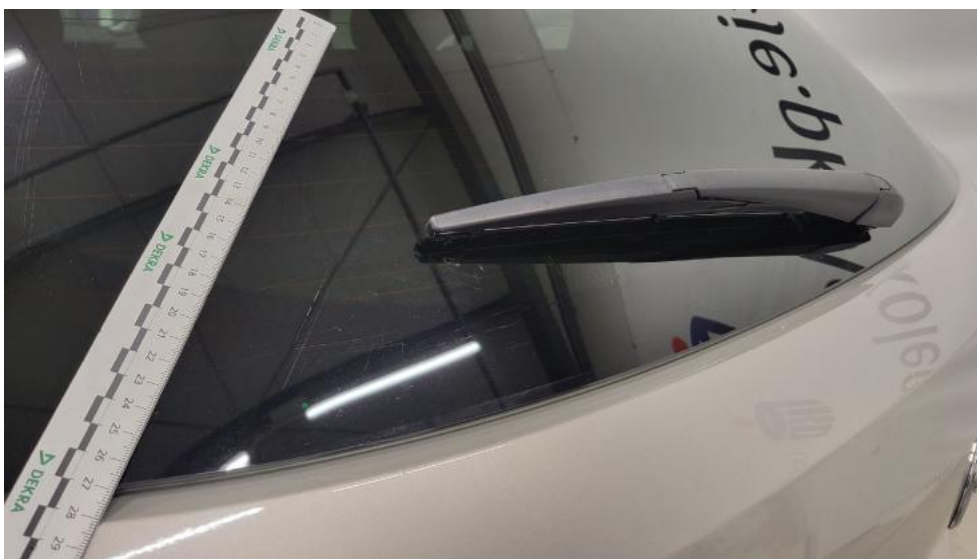
Photo 51.
Szyba tylna - Rysa/odprysk 1

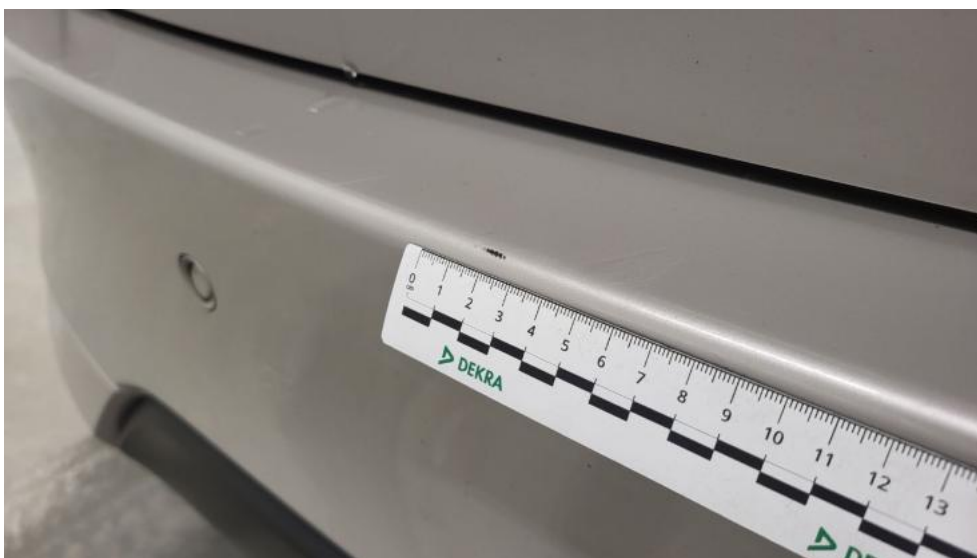
Photo 52.
Zderzak tylny - Rysa/odprysk 1

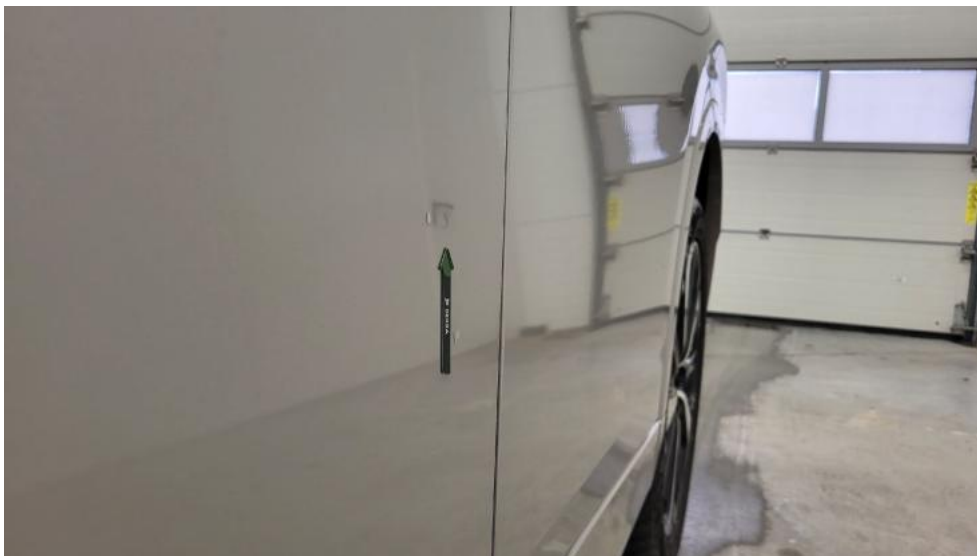
Photo 53.
Drzwi przed L - Wgniecenie/odkształcenie 1

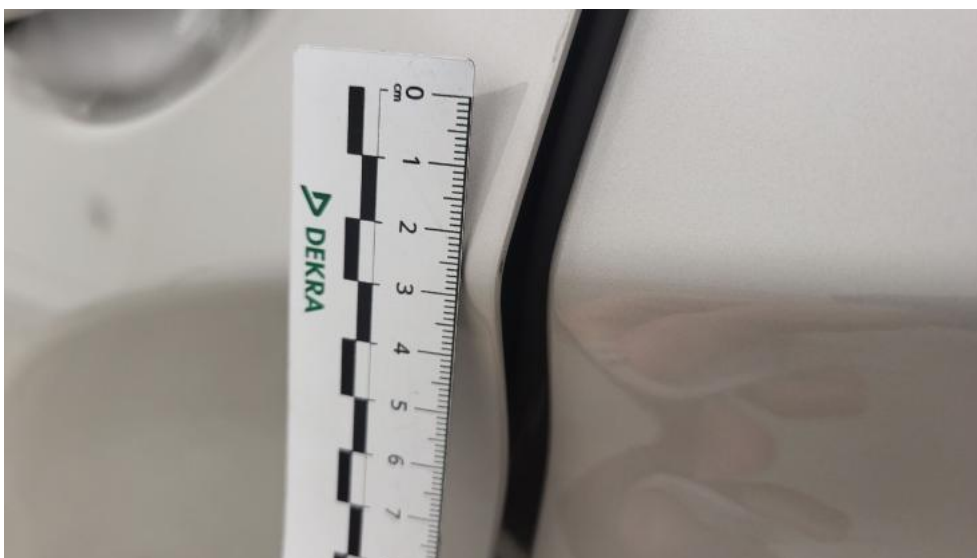
Photo 54.
Drzwi tylne L - Rysa/odprysk 1

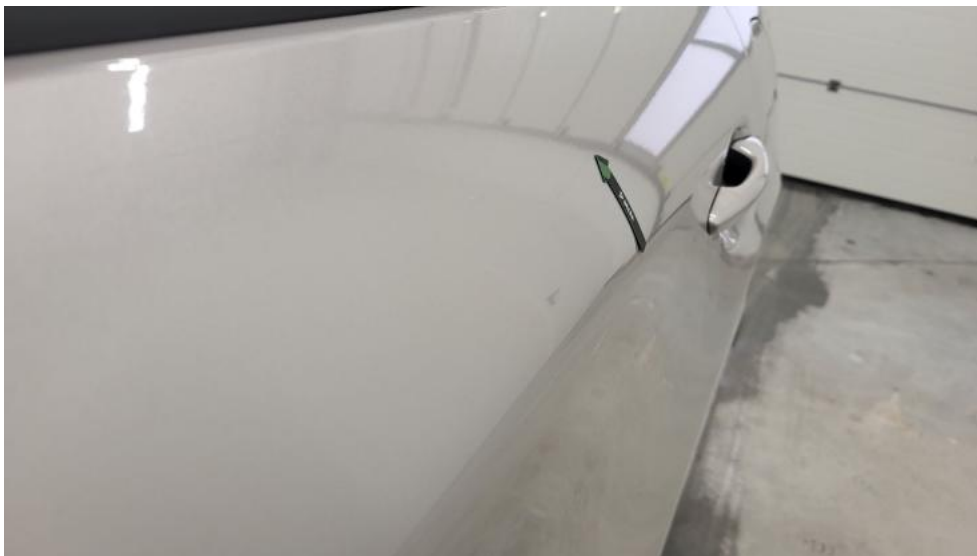
Photo 55.
Drzwi tylne L - Wgniecenie/odkształcenie 1

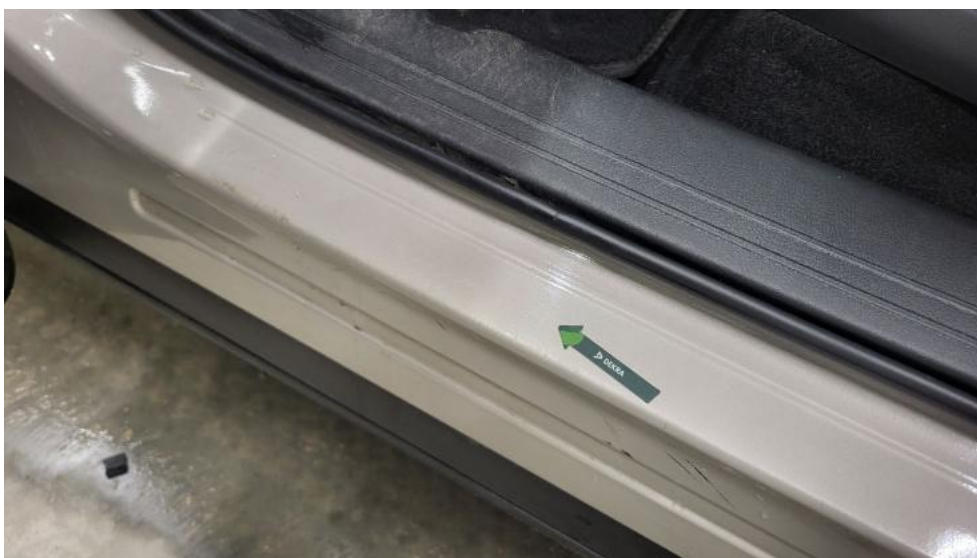
Photo 56.
Próg L - Wgniecenie/odkształcenie 1

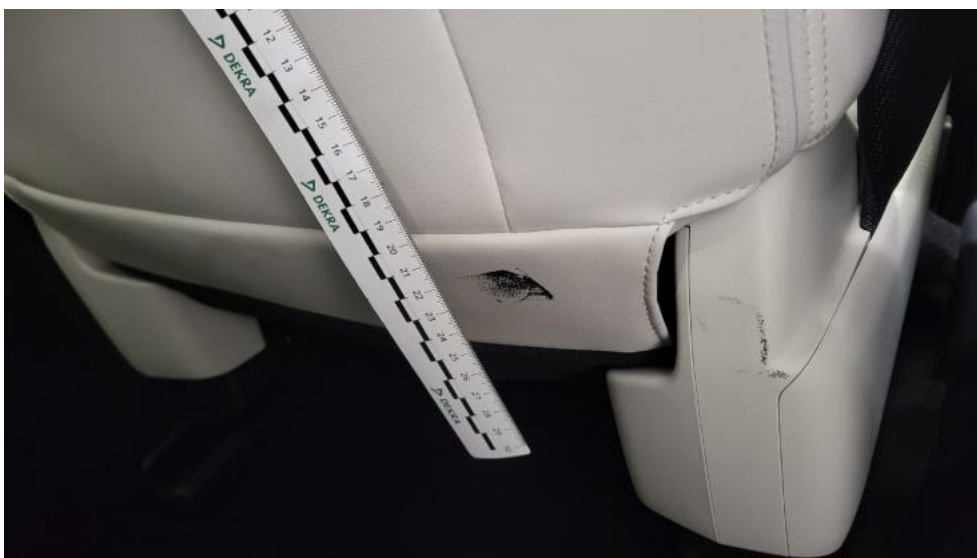
Photo 58.
Fotel prz. praw. - Inne 1

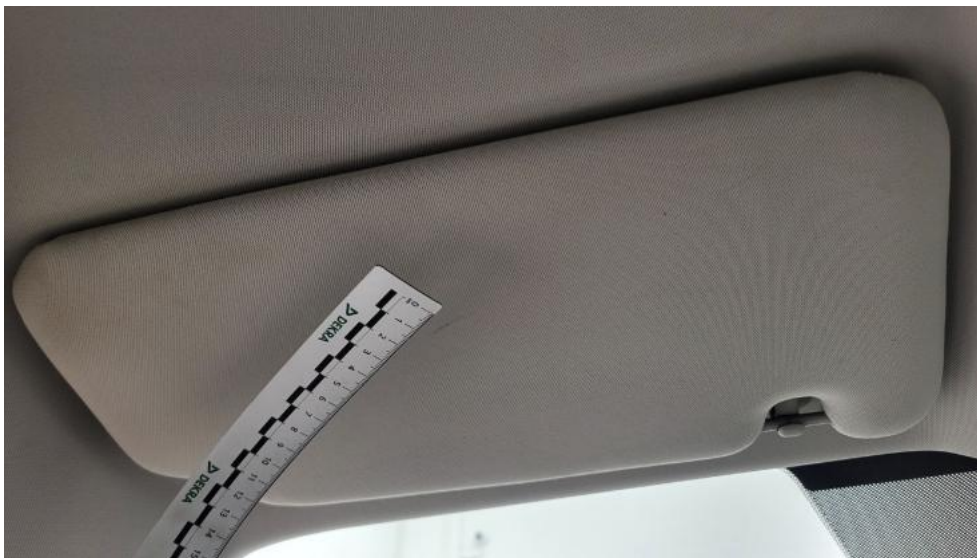
Photo 59.

Osłona p/słoneczna lewa - Inne 1

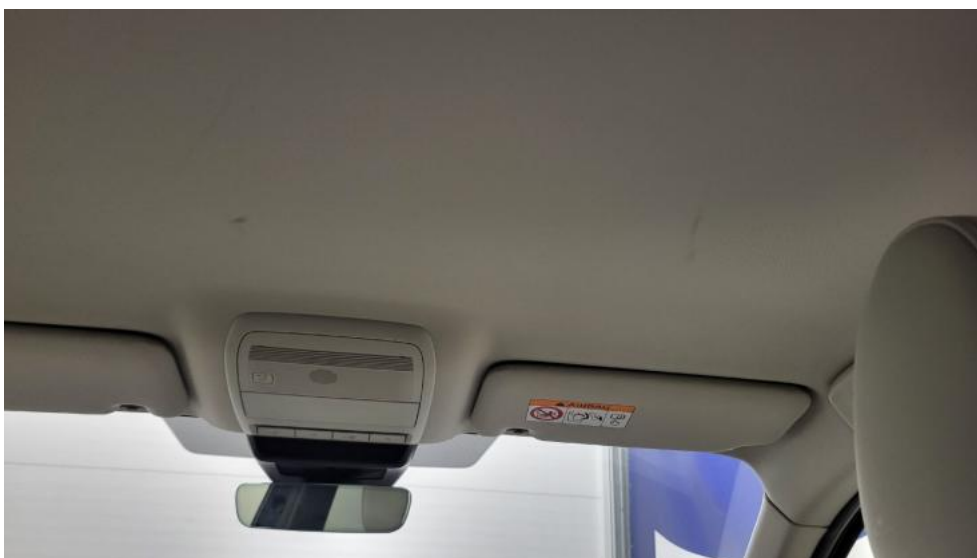
Photo 60.

Podsufitka - Inne 1

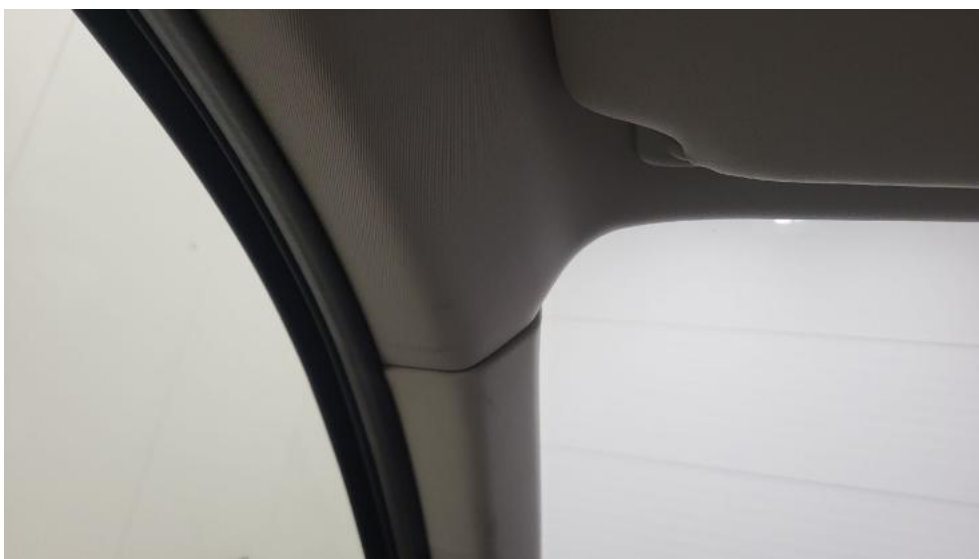
Photo 61.
Podsufitka - Inne 2

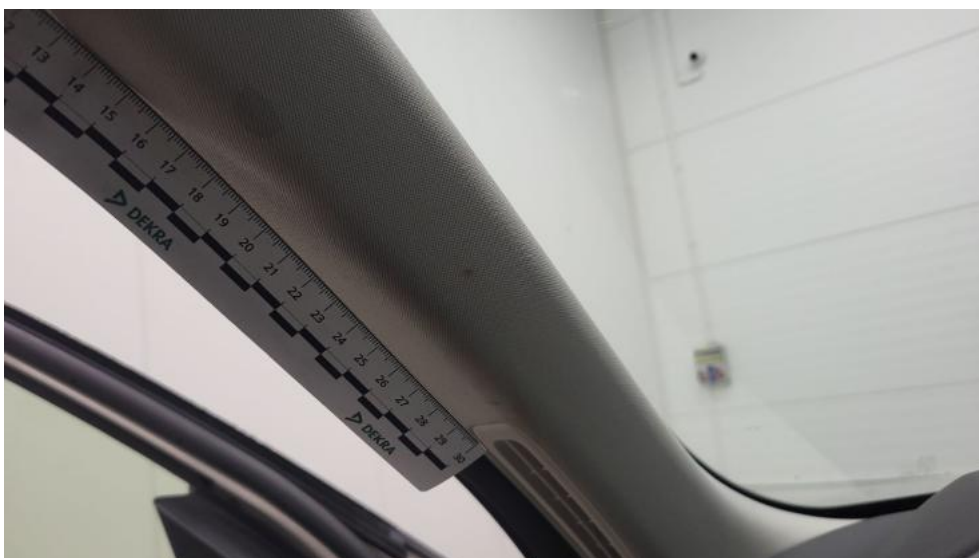
Photo 62.
Wykładzina(y) słupka przedniego L - Inne 1

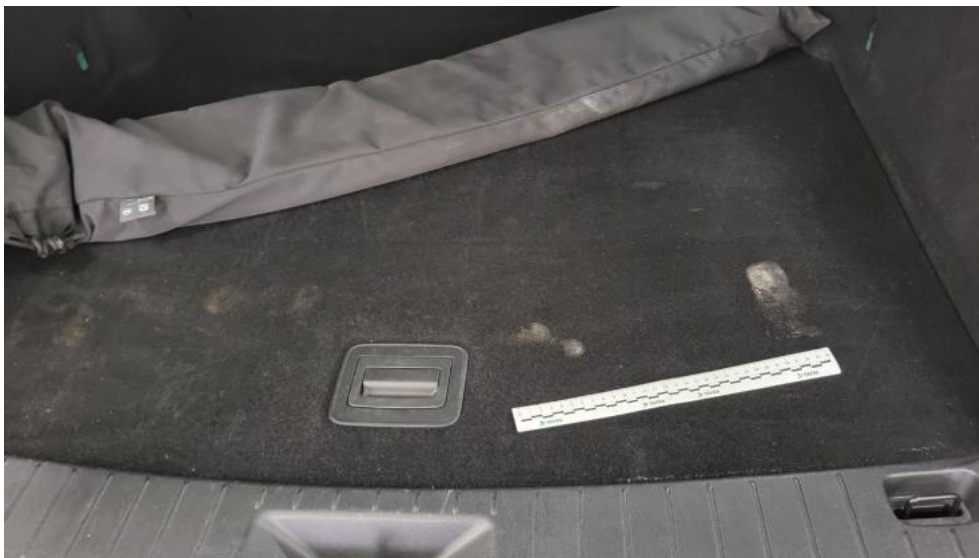
Photo 63.

Wykładzina podłogi bagażnika - Inne 1
