DEKRA's commission No. : PKOL(W)/LODZ/13006/26/02/17
commission/ damage No. : 23/030878
Date of commission: 17-02-2026

PKO Leasing SA
Świętokrzyska 36
00-116 Warszawa

Group of objects (Eurotax)	jeeps
EC code (Eurotax)	0147528
Manufacturer	HYUNDAI
Model	Tucson 20-24
Type / version	Tucson 1.6 T-GDi Executive 2WD
Body type	KOM
Number of doors / seats	5/5
Curb weight [kg]	1466
Gross vehicle weight [kg]	2050
Wheelbase 1/2	2680
Engine type	spark ignition
Pollution reduction system	GPF
Engine capacity [ccm]	1598
Engine Power [hp/kW]	150/110
Gearbox	manual 6- gear
Registration /record No.	PY60586
VIN / serial number	TMAJC81BAPJ380563
Date of first registration	28-09-2023
Date of next. tech. test	28-09-2026
Year of manufacture	2023 (year has been verified with the manufacturer's base)
Readout [km]	43 532 (read)
Body color / type of coating	grafitowy/double-layered, metallized

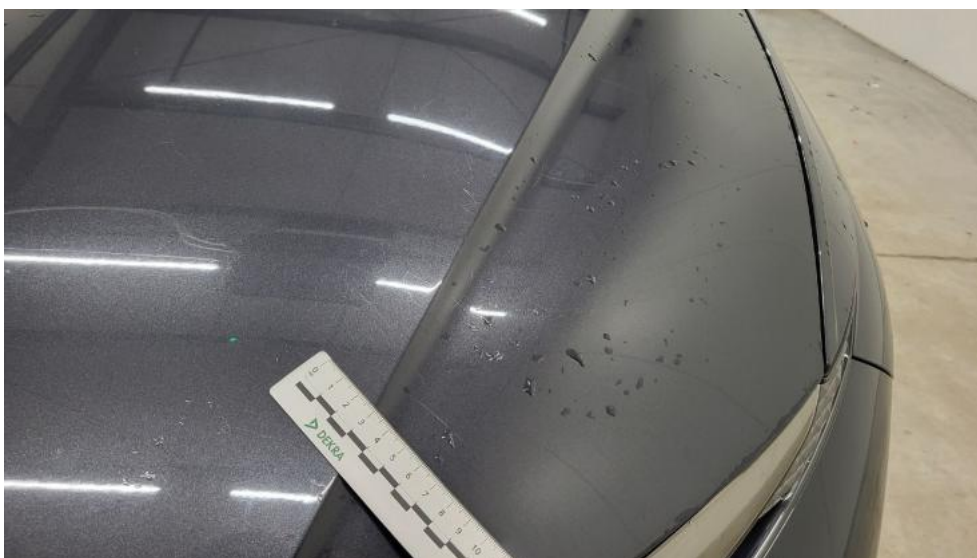
Photo 38.
Pokrywa komory silnika - Rysa/odprysk 1

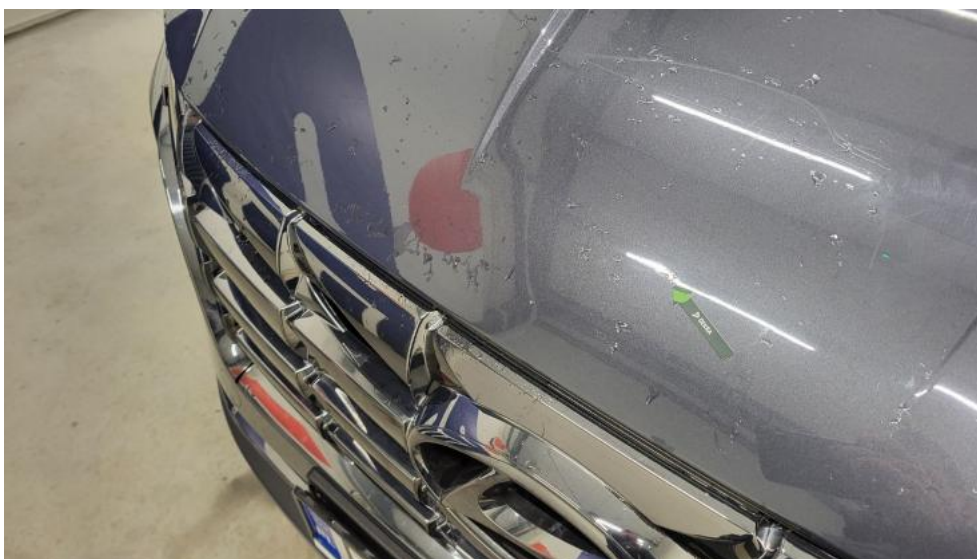
Photo 39.
Pokrywa komory silnika - Wgniecenie/odkształcenie 1

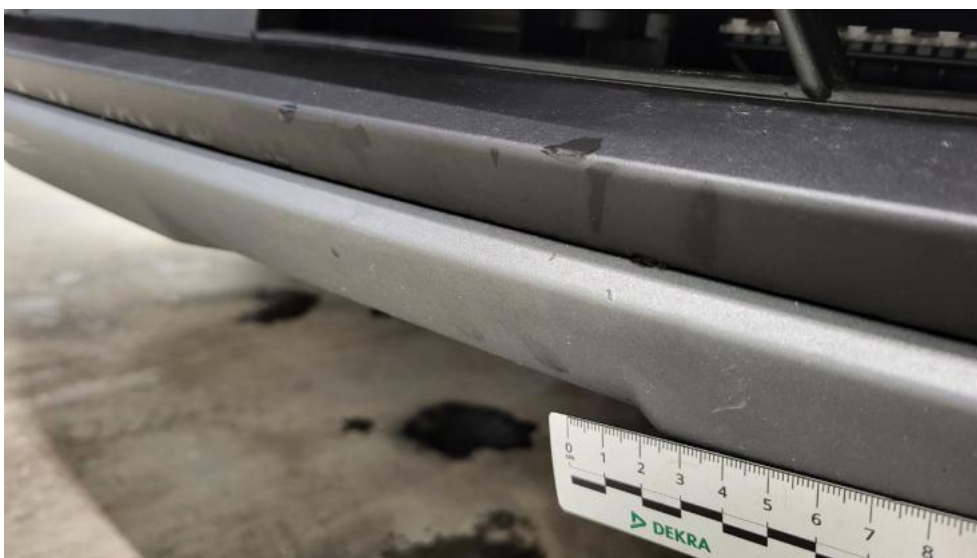
Photo 40.
Spoiler zderzaka przedniego - Rysa/odprysk 1

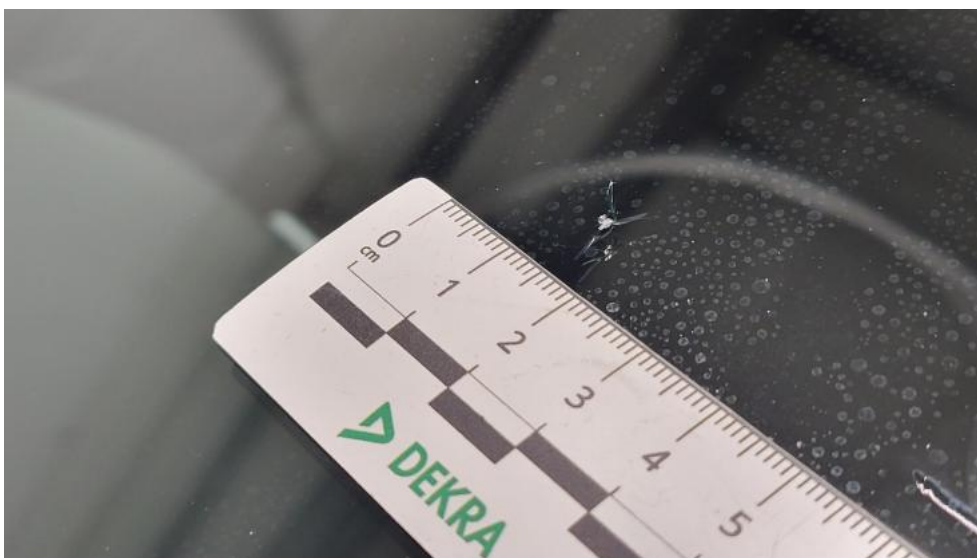
Photo 42.

Szyba czołowa - Pęknięcie/rozerwanie 1

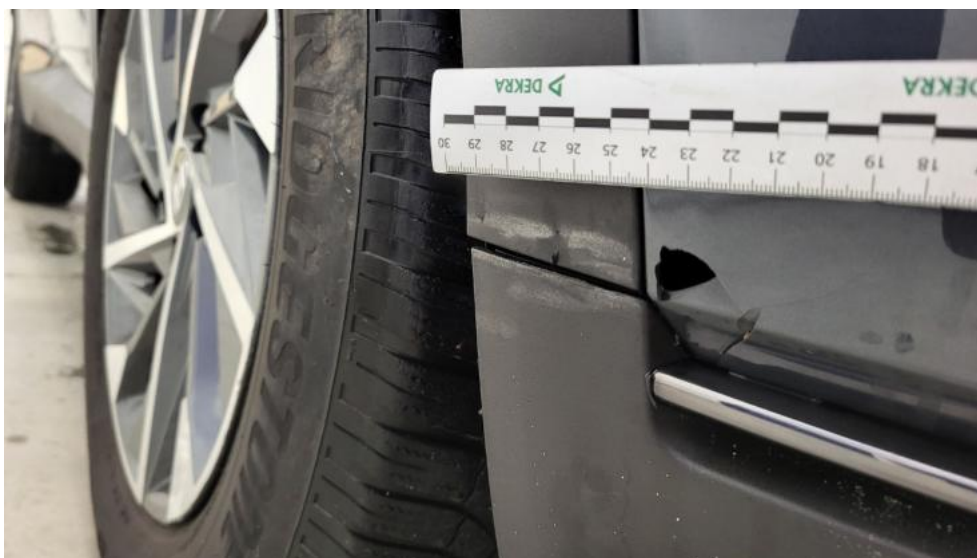
Photo 44.

Listwa błotnika przedniego P - Rysa/odprysk 1

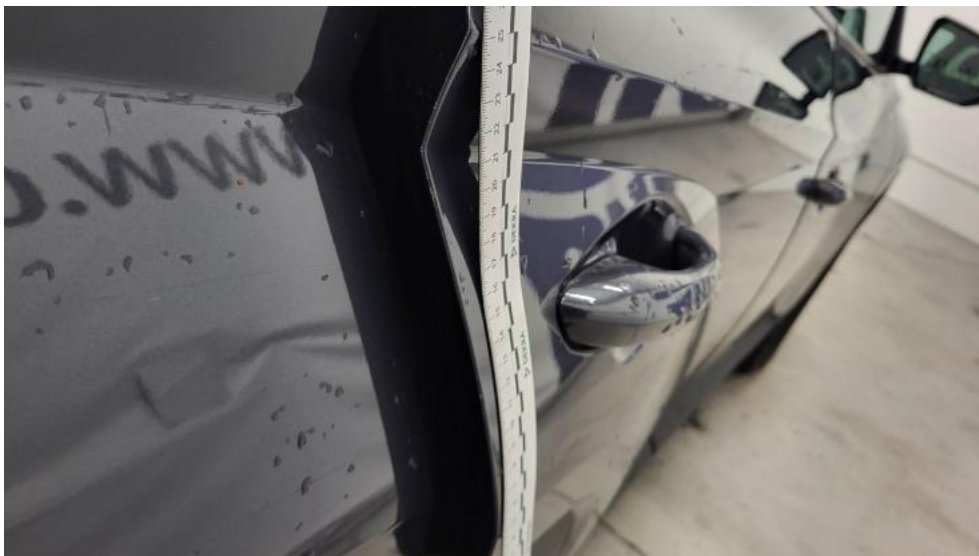
Photo 45.

Drzwi tylne P - Rysa/odprysk 1

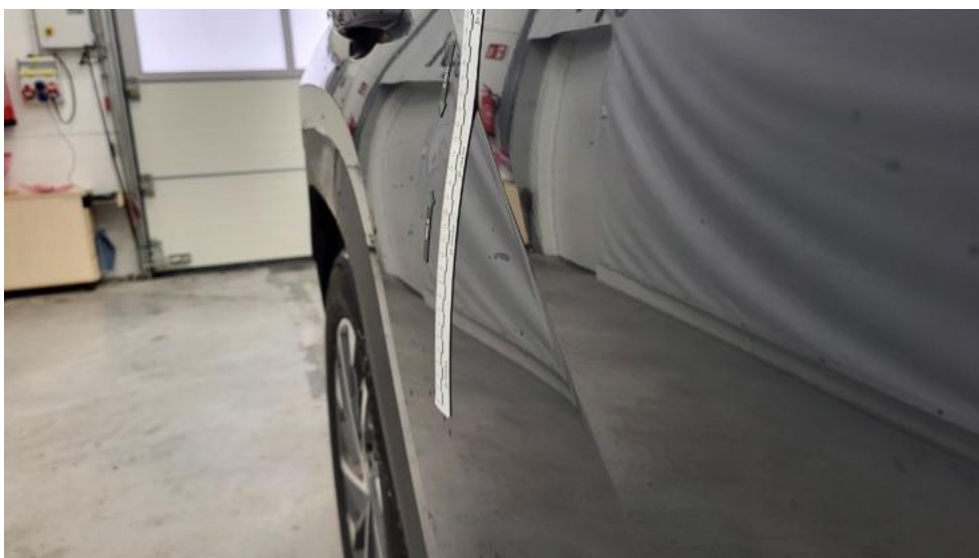
Photo 46.

Drzwi tylne P - Wgniecenie/odkształcenie 1

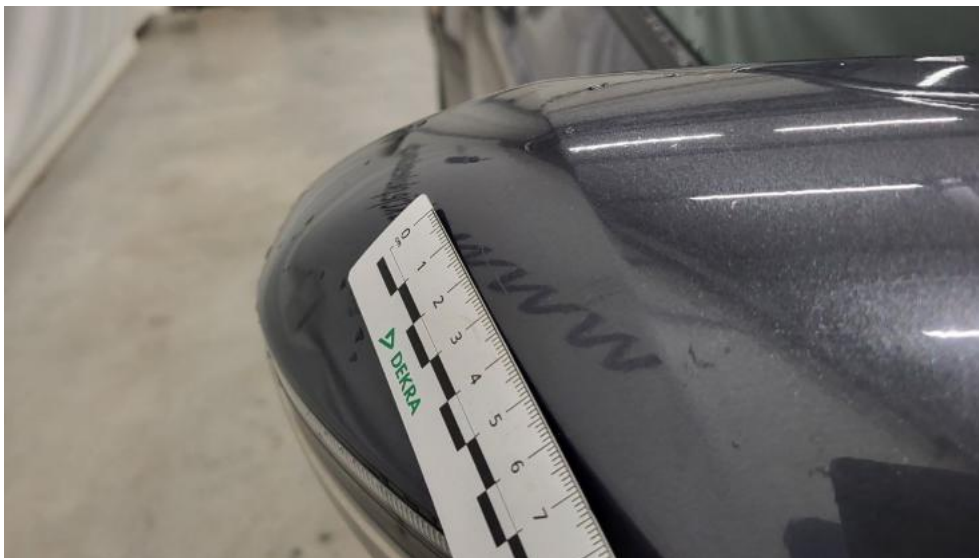
Photo 47.

Lusterko zew P - Rysa/odprysk 1

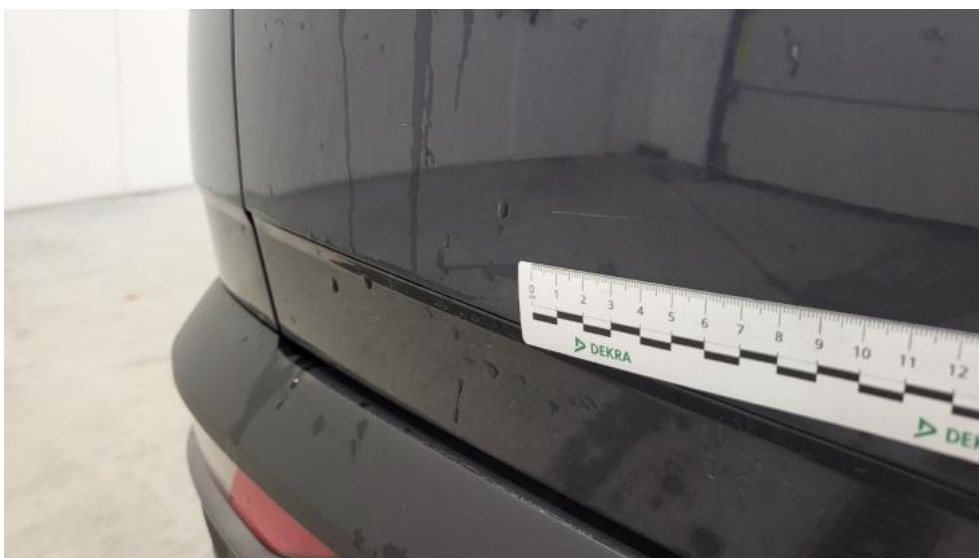
Photo 48.

Pokrywy bagażnika - Rysa/odprysk 1

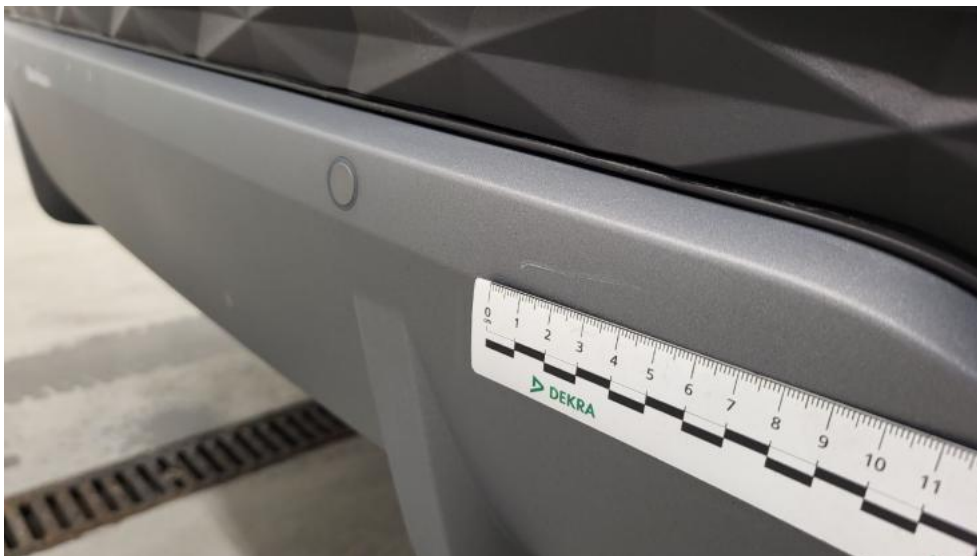
Photo 49.
Zderzak tylny - Rysa/odprysk 1

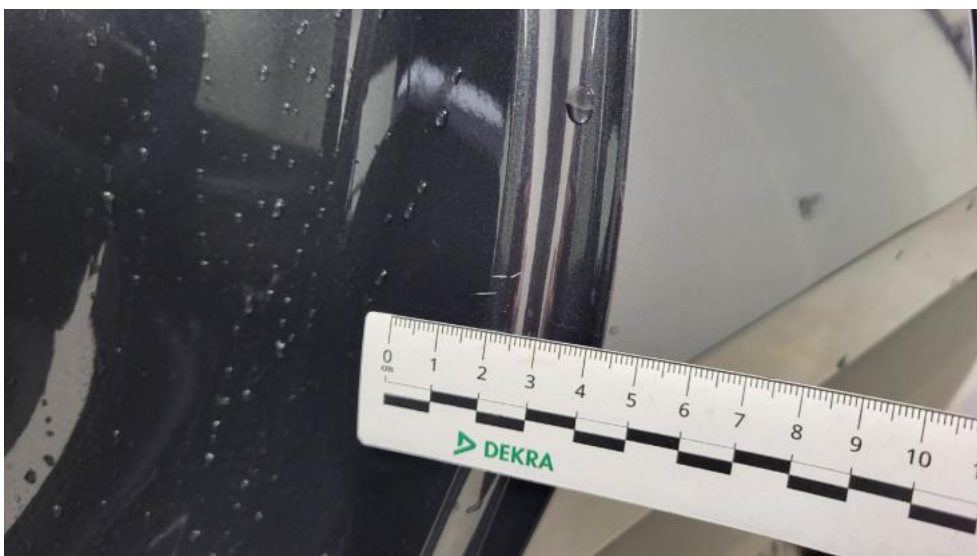
Photo 50.
Błotnik tylny L / Ściana boczna L - Rysa/odprysk 1

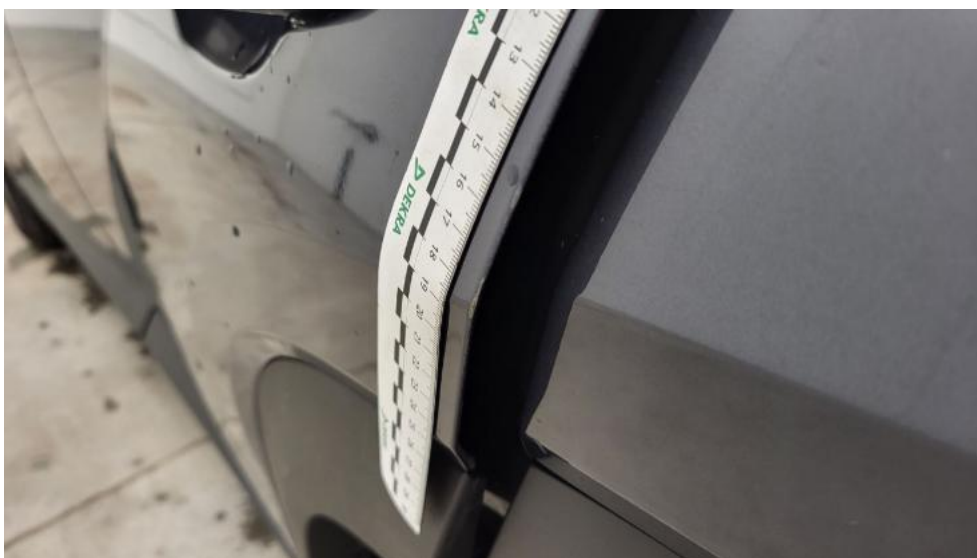
Photo 54.

Drzwi tylne L - Rysa/odprysk 1

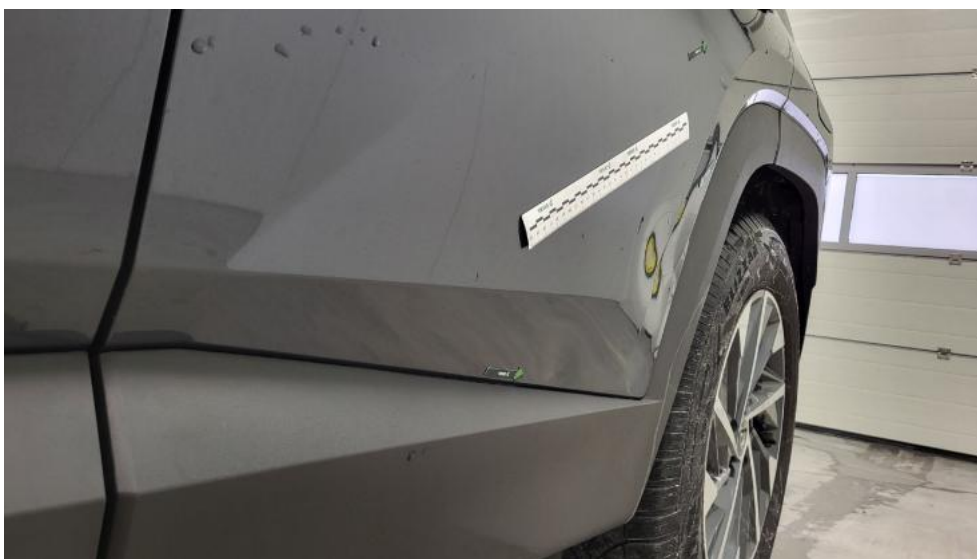
Photo 55.
Drzwi tylne L - Wgniecenie/odkształcenie 1

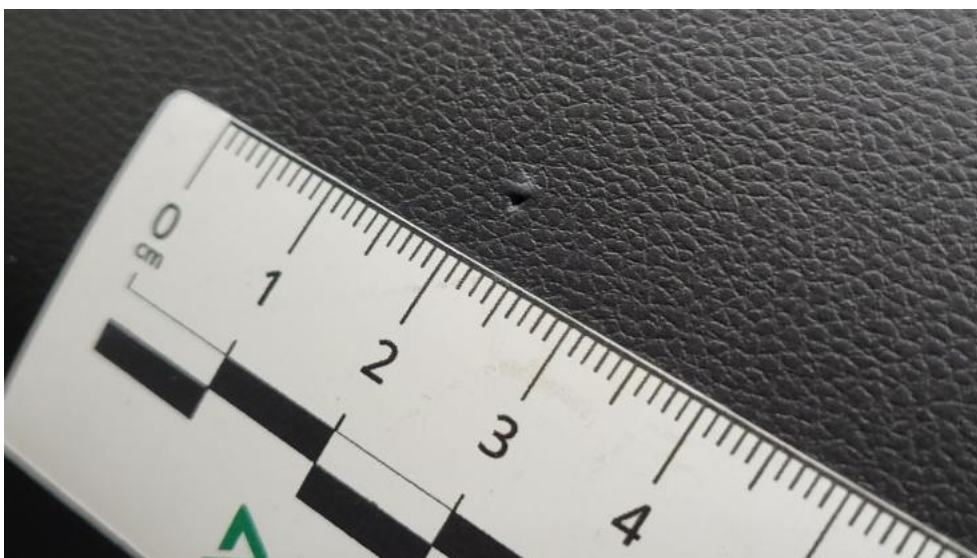
Photo 58.

Deska rozdzielcza - Pęknięcie/rozerwanie 1

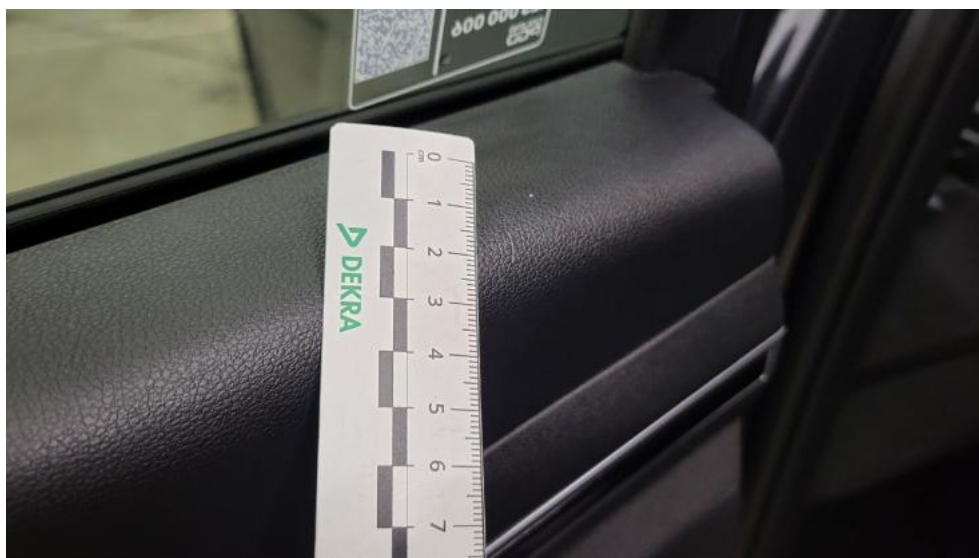
Photo 60.
Tapicerka drzwi tylnych L - Rysa/odprysk 1

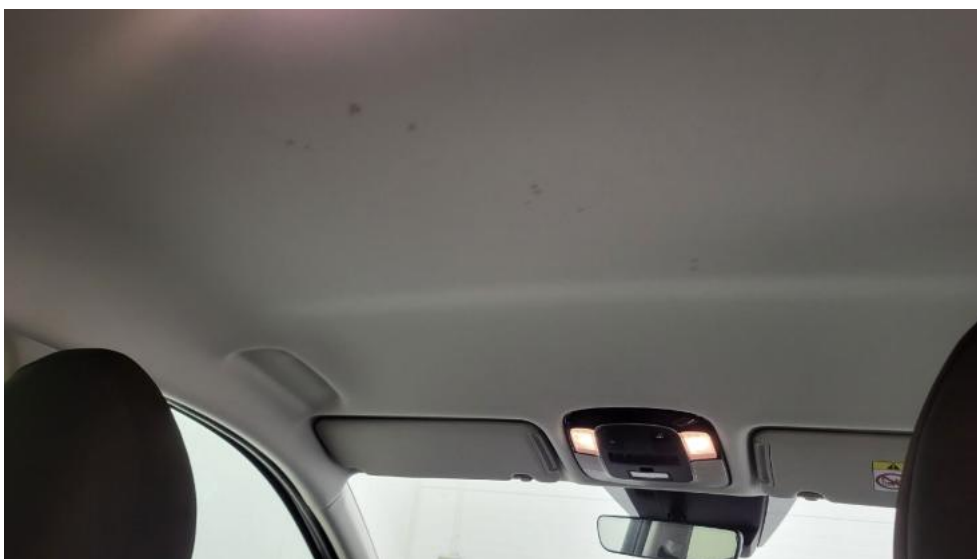
Photo 61.
Podsufitka - Inne 1

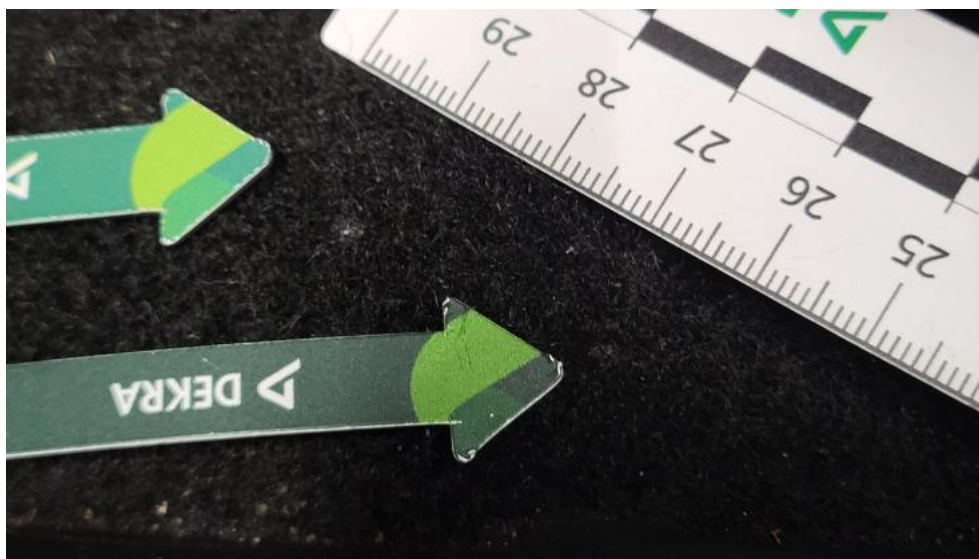
Photo 63.
Wykładzina podłogi - Inne 1

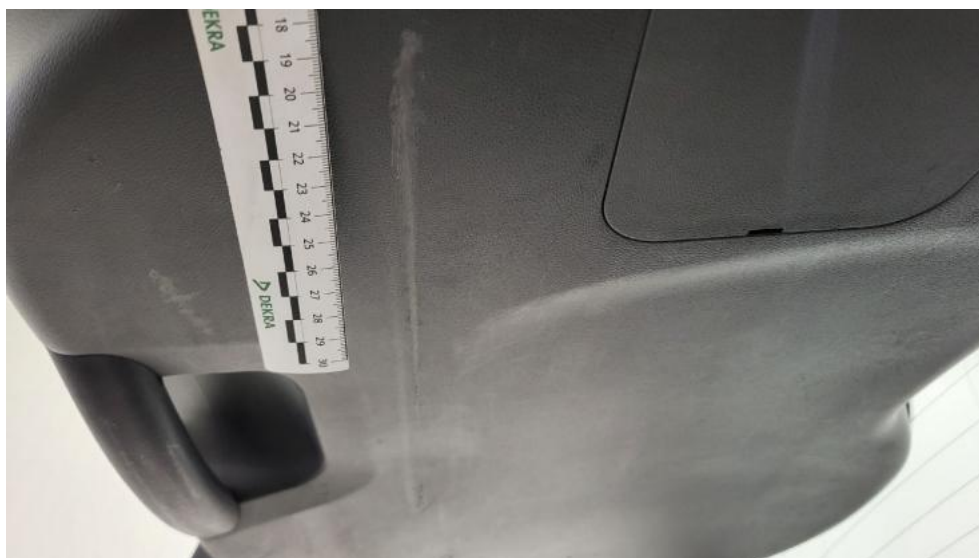
Photo 64.
Wykładzina pokrywy tylnej - Rysa/odprysk 1
