DEKRA's commission No. : PKOL(W)/LODZ/07113/26/01/28
commission/ damage No. : 25/036819
Date of commission: 28-01-2026

Group of objects (Eurotax)	jeeps
EC code (Eurotax)	0148414
Manufacturer	AUDI
Model	Q7 19-24
Type / version	Q7 50 TDI mHEV Quattro Tiptr.
Body type	KOM
Number of doors / seats	5/5
Curb weight [kg]	2296
Gross vehicle weight [kg]	2850
Wheelbase 1/2	2995
Engine type	Automatic ignition
Pollution reduction system	KSC
Engine capacity [ccm]	2967
Engine Power [hp/kW]	286/210
Gearbox	automatic
Registration /record No.	FZ7666V
VIN / serial number	WAUZZZ4M1LD006964
Date of first registration	31-12-2020
Date of next. tech. test	29-01-2027
Year of manufacture	2019
Readout [km]	149 140 (read)
Body color / type of coating	granatowy/double-layered, metallized

Measurement of thickness of the vehicle lacquer coating

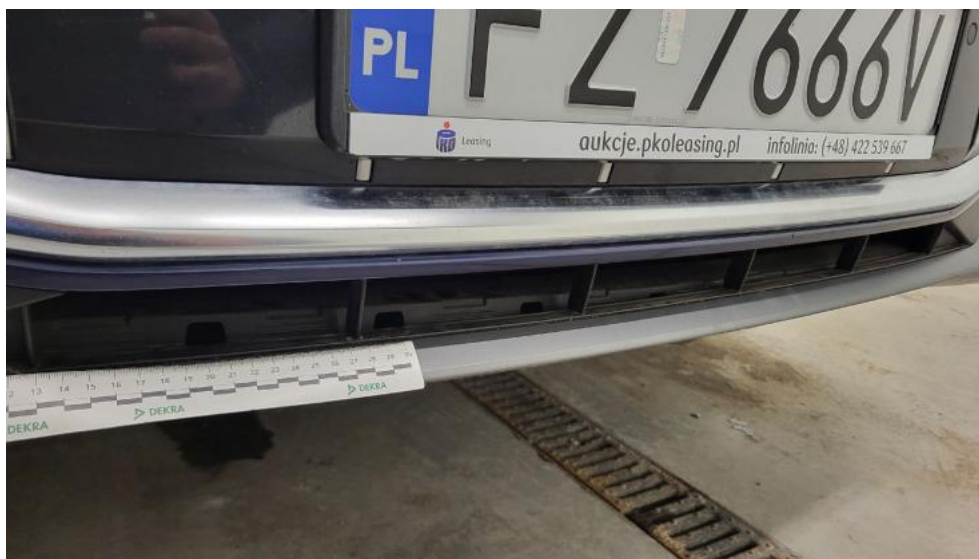
Photo 57.
Kratka zderzaka prz. - Inne 1

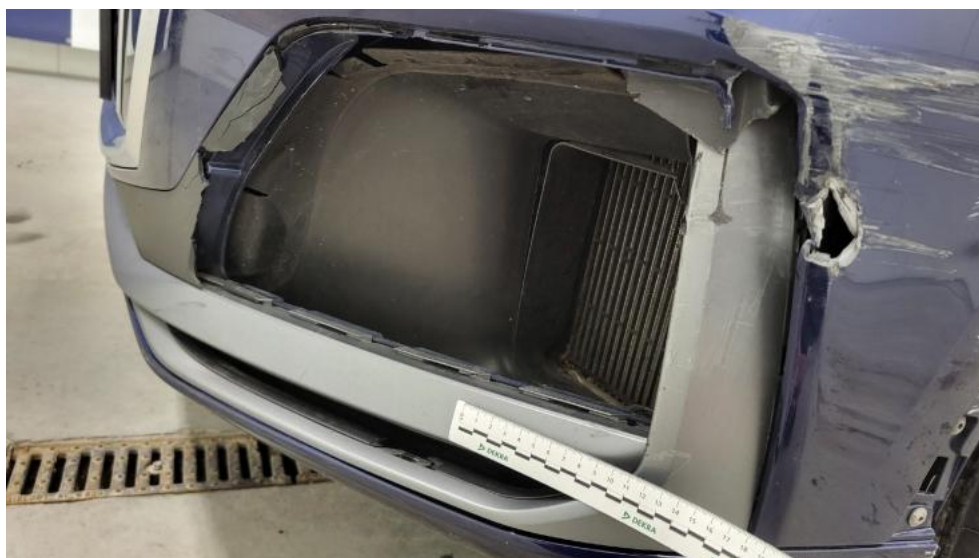
Photo 58.
Kratka/zaślepka halogenu L - Inne 1

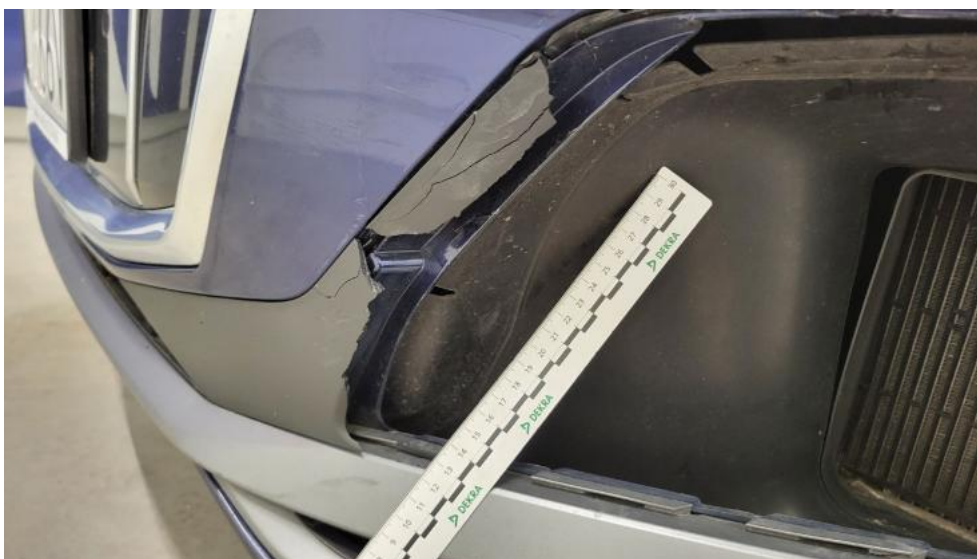
Photo 59.

Listwa śr zderzaka przedniego - Pęknięcie/rozerwanie 1

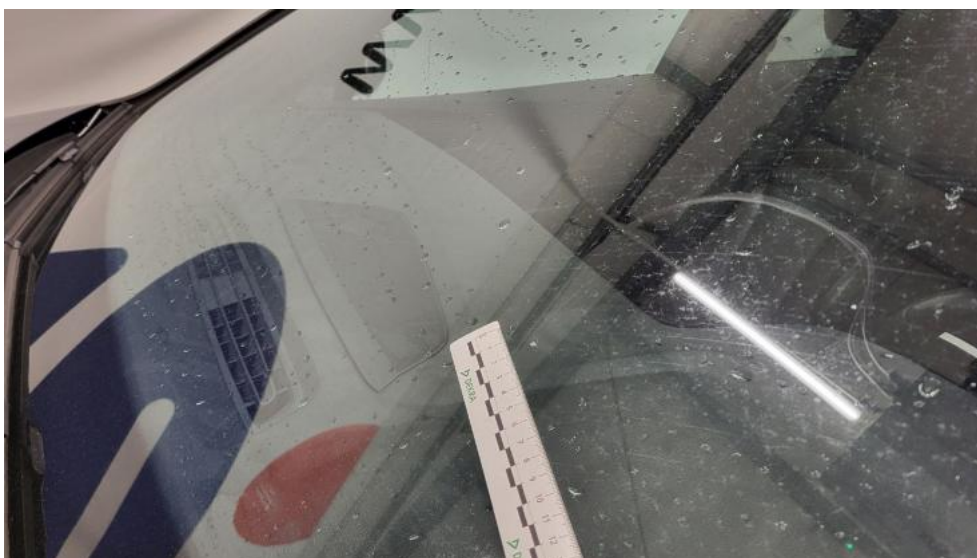
Photo 60.

Szyba czołowa - zdjęcie pogładowe 1

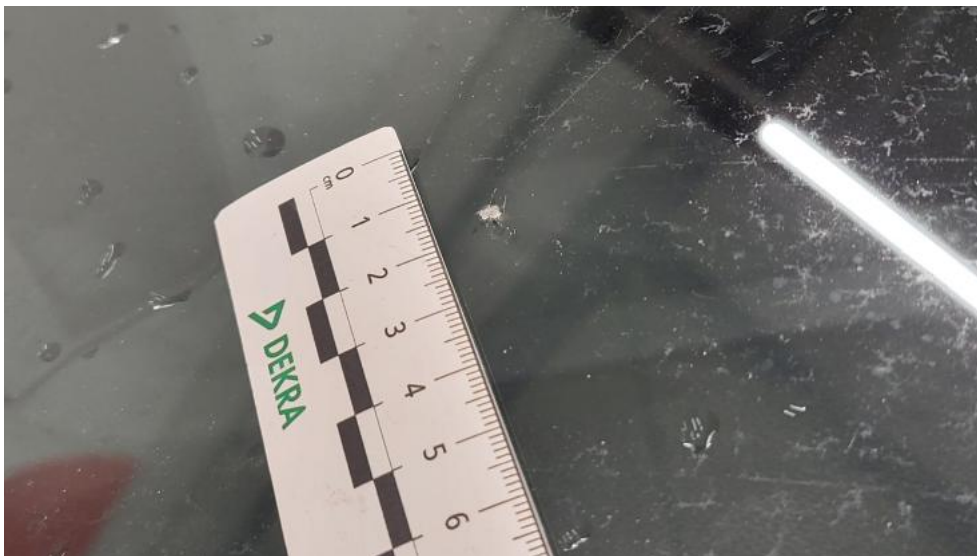
Photo 61.
Szyba czołowa - Pęknięcie/rozerwanie 1

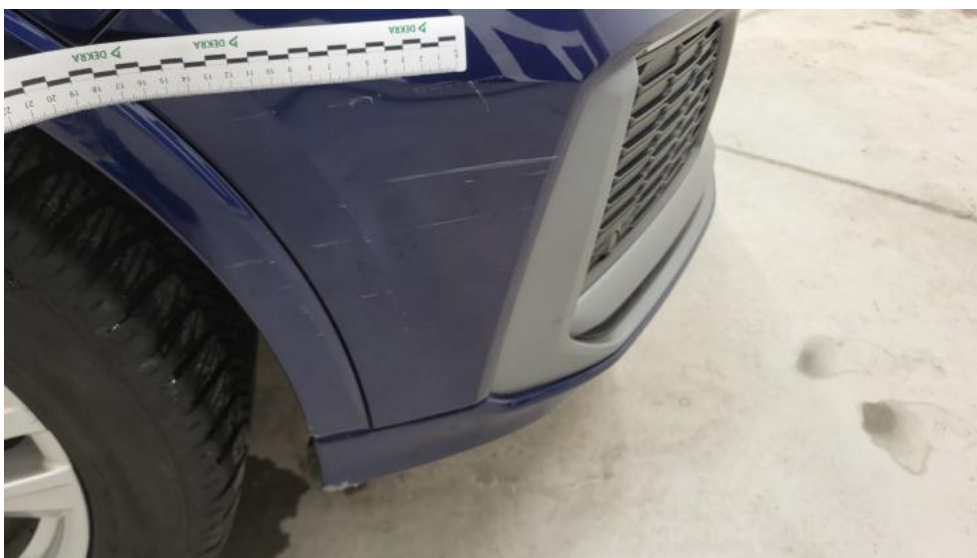
Photo 62.
Zderzak - Rysa/odprysk 1

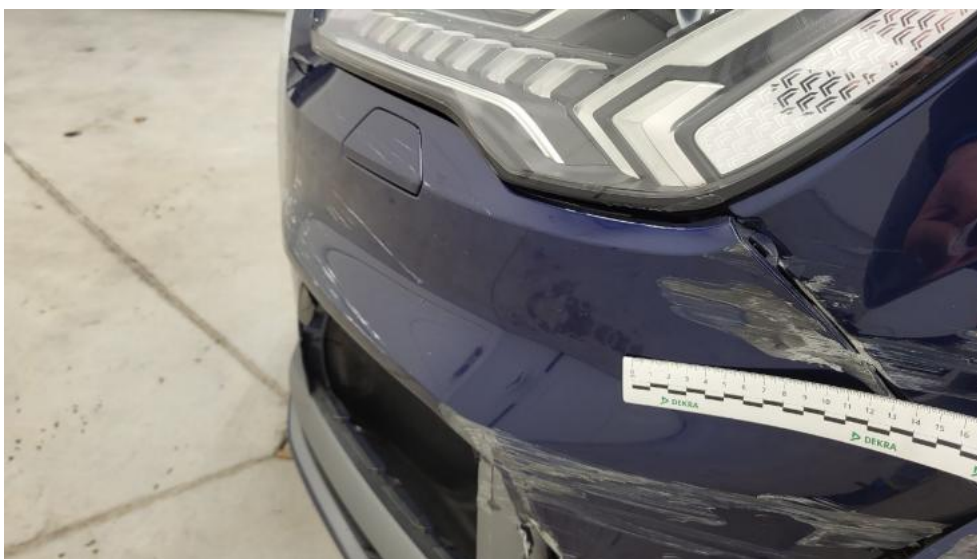
Photo 63.
Zderzak - Rysa/odprysk 2

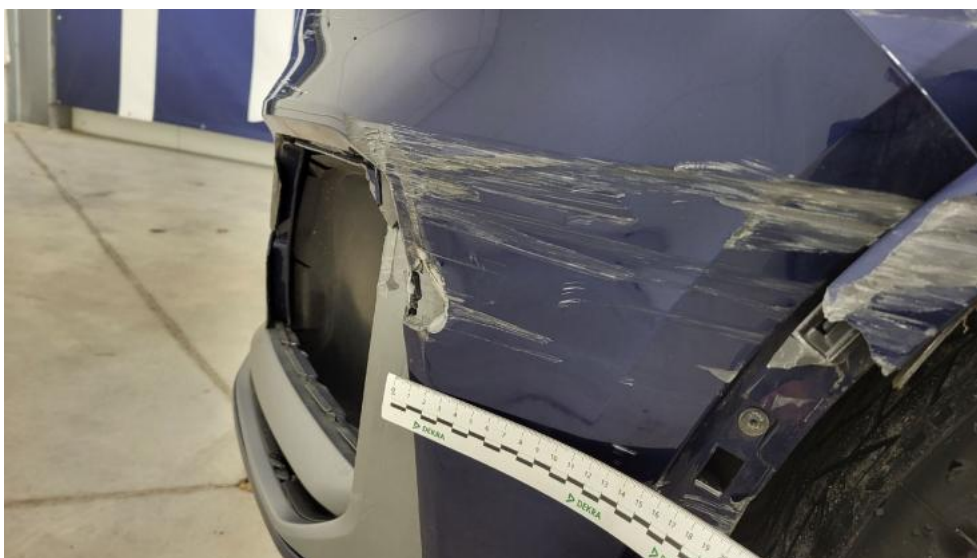
Photo 64.
Zderzak - Pęknięcie/rozerwanie 1

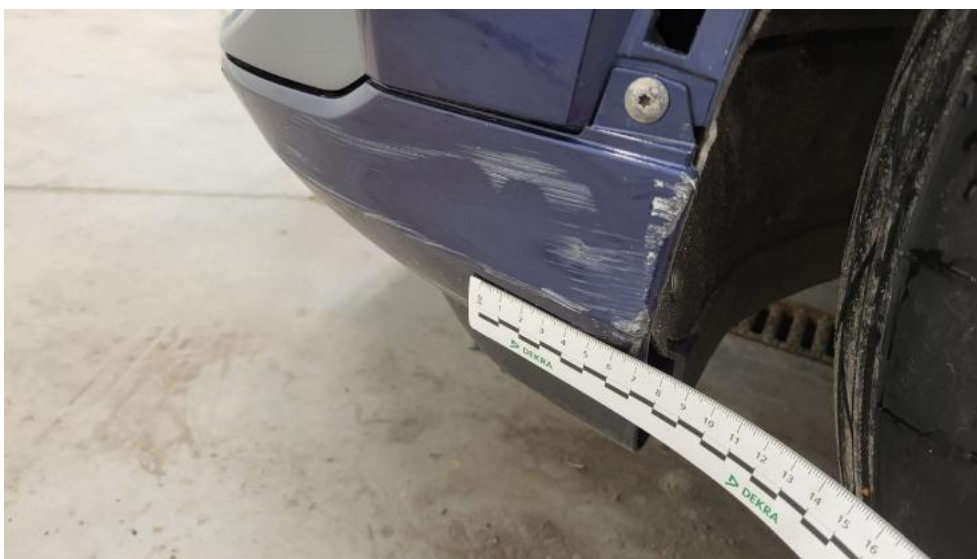
Photo 65.
Zderzak przedni cz dolna - Wgniecenie/odkształcenie 1

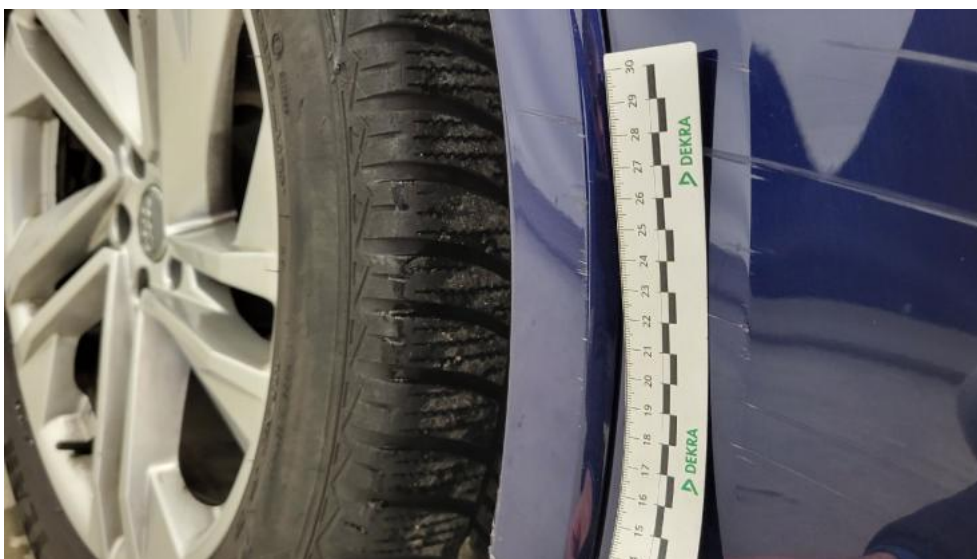
Photo 67.
Listwa błotnika przedniego P - Rysa/odprysk 1

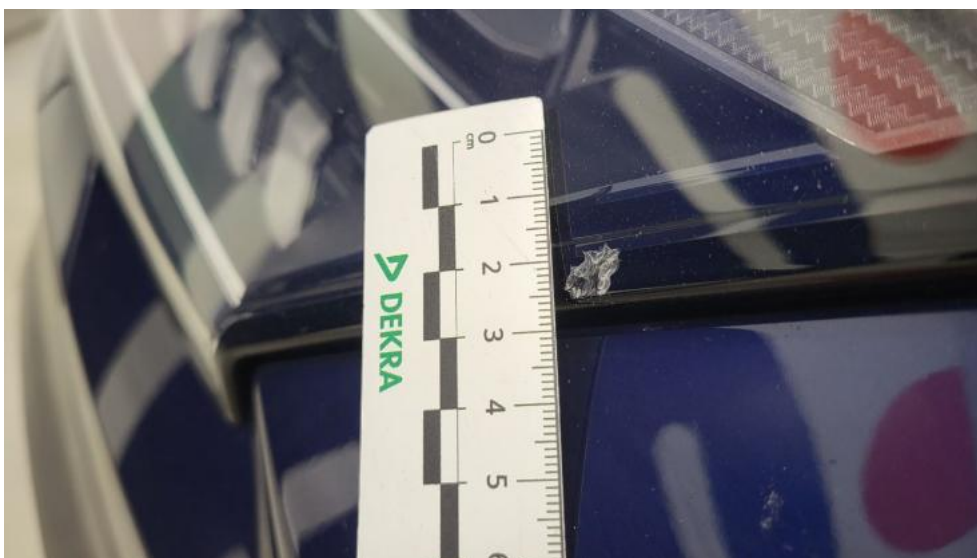
Photo 68.
Reflektor P - Pęknięcie/rozerwanie 1

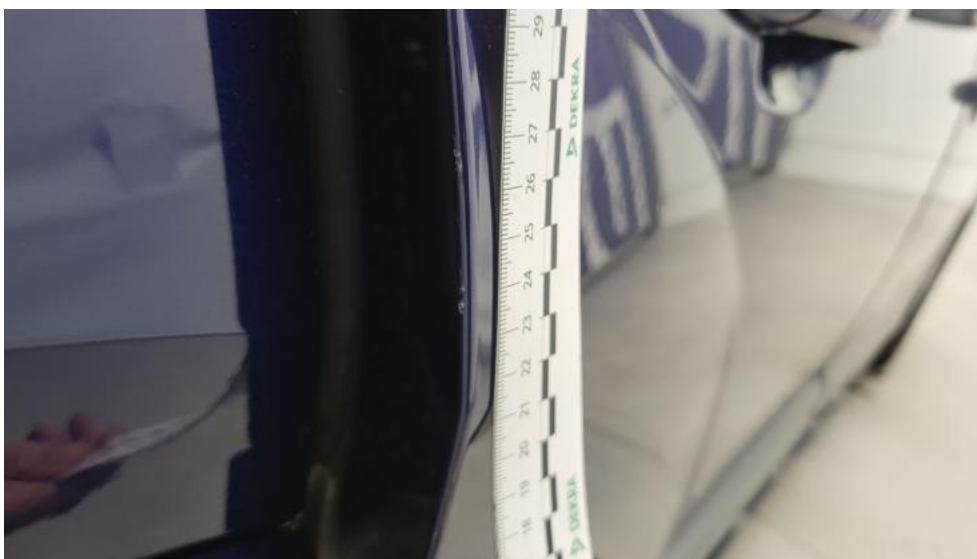
Photo 69.

Drzwi tylne P - Rysa/odprysk 1

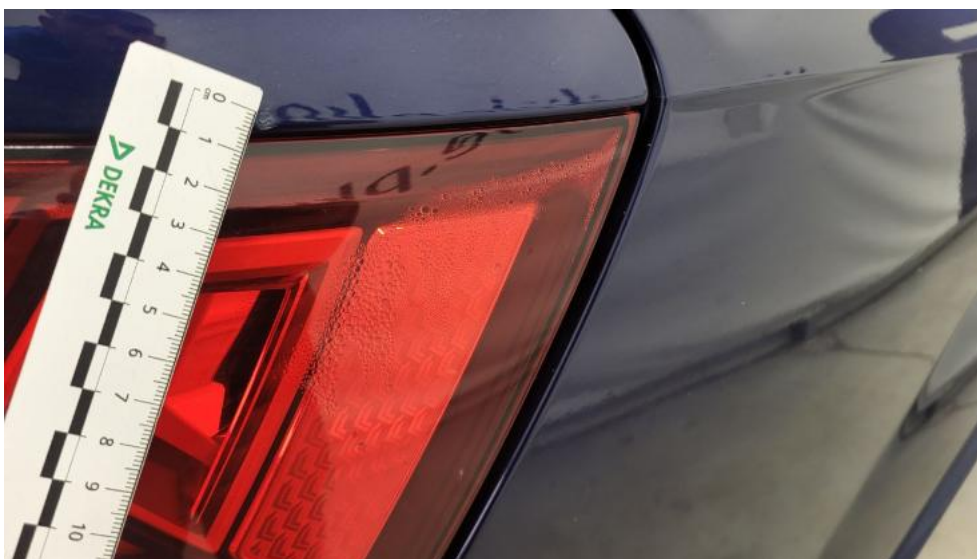
Photo 73.

Lampa zespolona tylna P - Inne 1

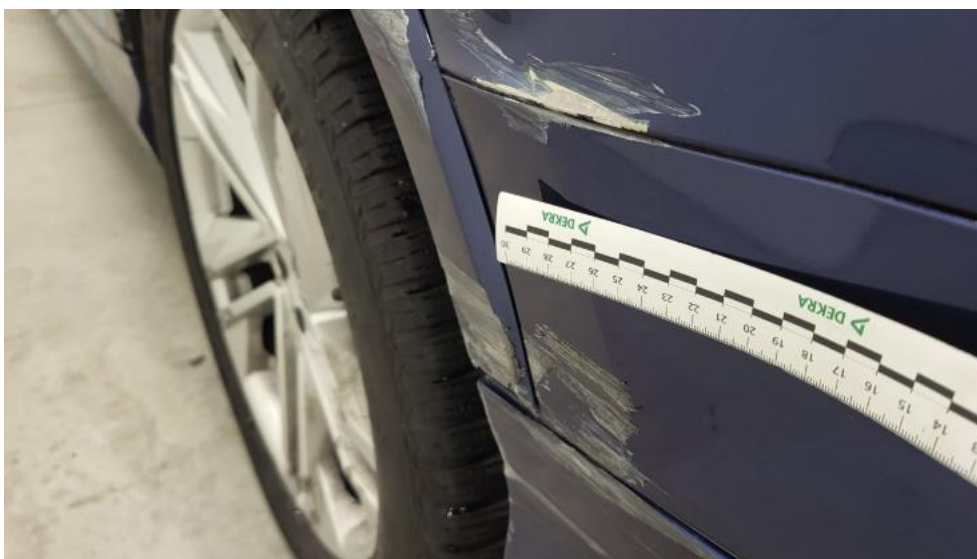
Photo 75.
Zderzak tylny - Rysa/odprysk 1

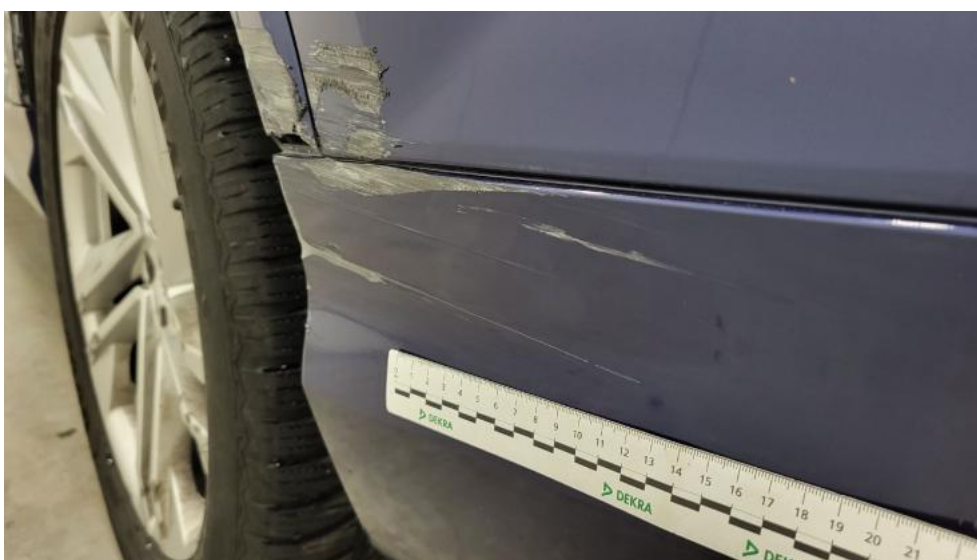
Photo 76.
Zderzak tylny cz dolna - Rysa/odprysk 1

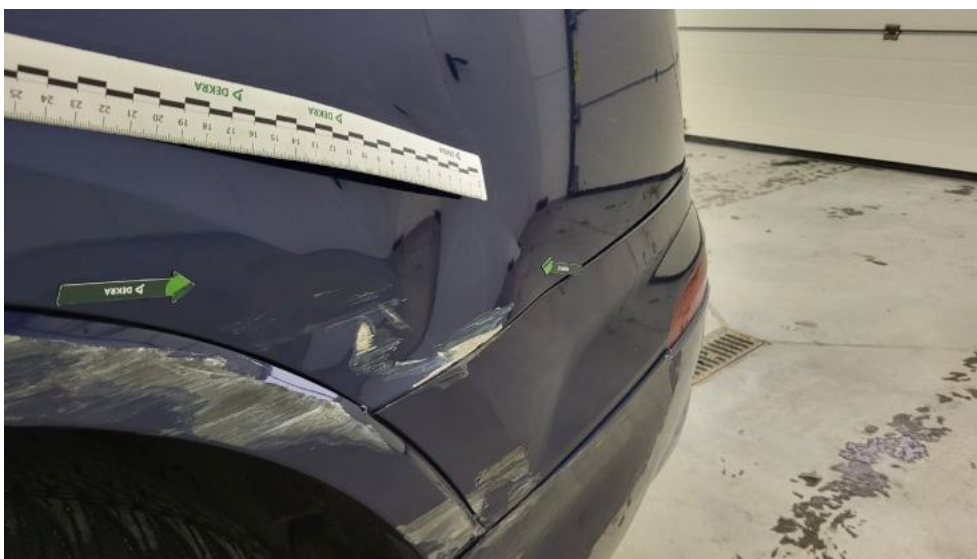
Photo 77.
Błotnik tylny L / Ściana boczna L - Wgniecenie/odkształcenie 1

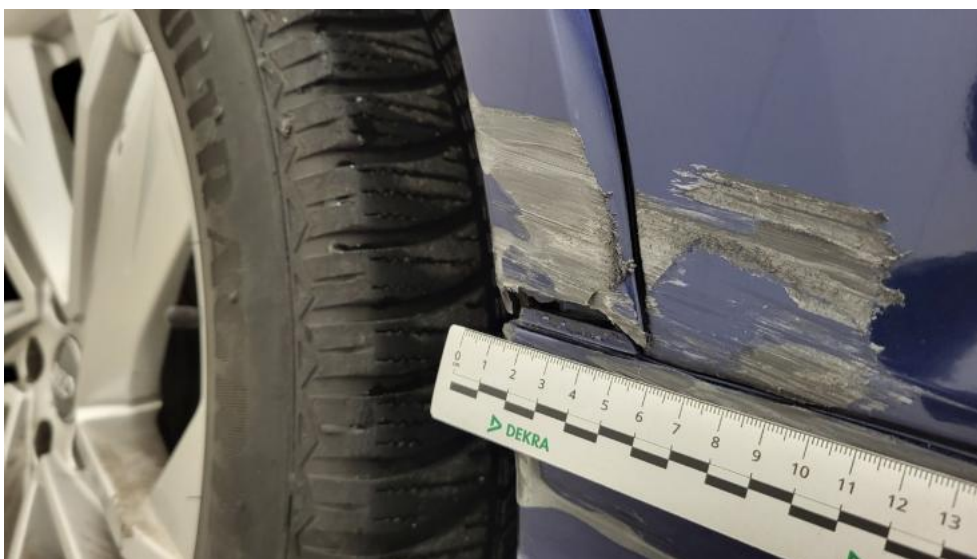
Photo 79.

Listwa krawędzi błotnika tyl L - Pęknięcie/rozerwanie 1

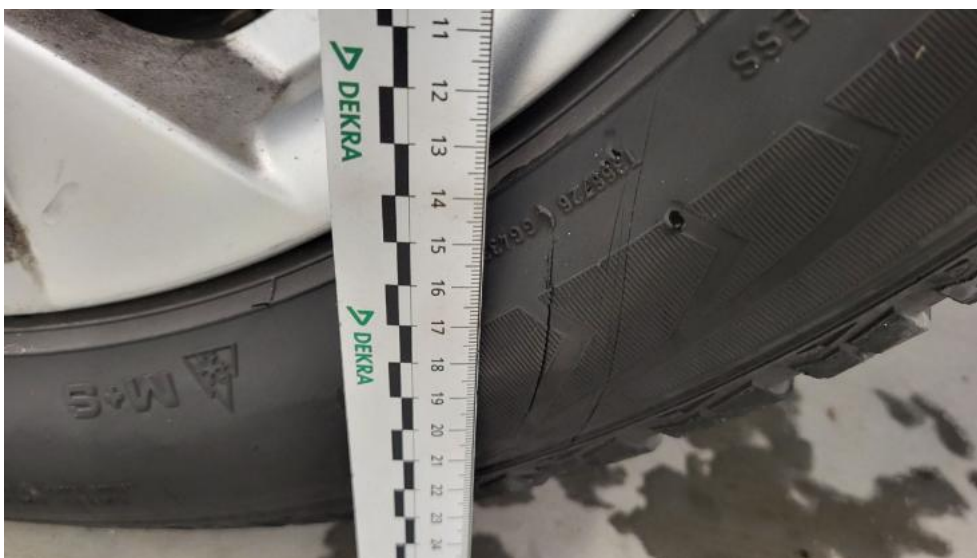
Photo 80.

Opona tylna L - Pęknięcie/rozerwanie 1

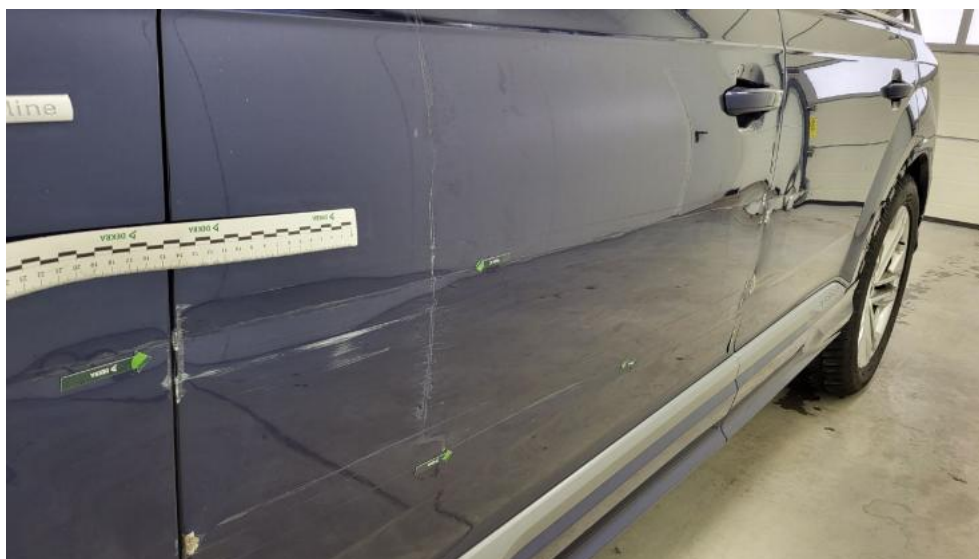
Photo 81.
Drzwi przed L - Wgniecenie/odkształcenie 1

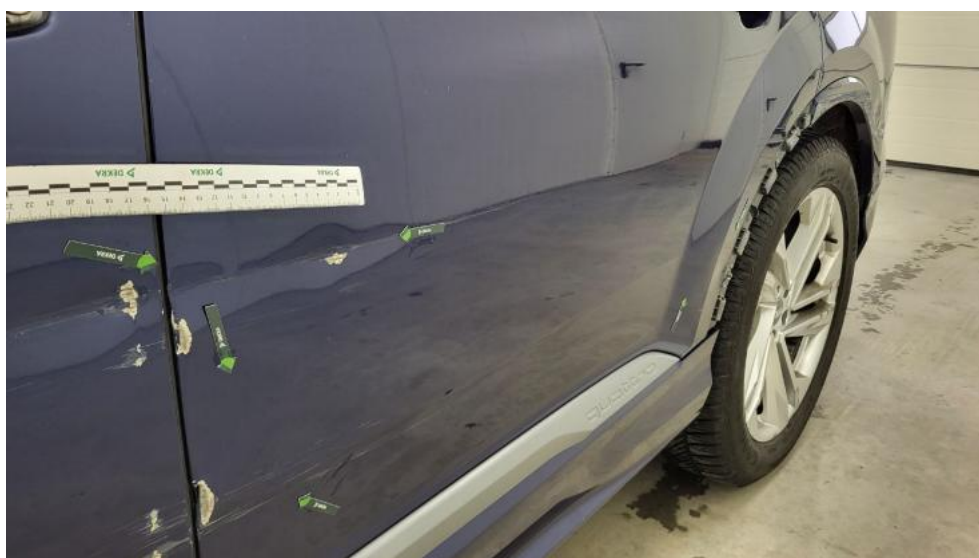
Photo 82.
Drzwi tylne L - Wgniecenie/odkształcenie 1

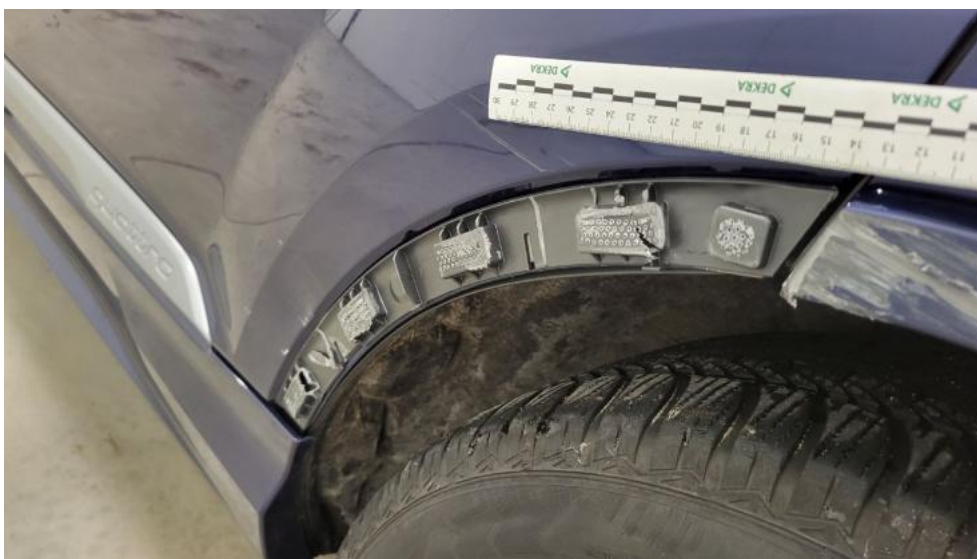
Photo 83.
Listwa drzwi tylnych L - Inne 1

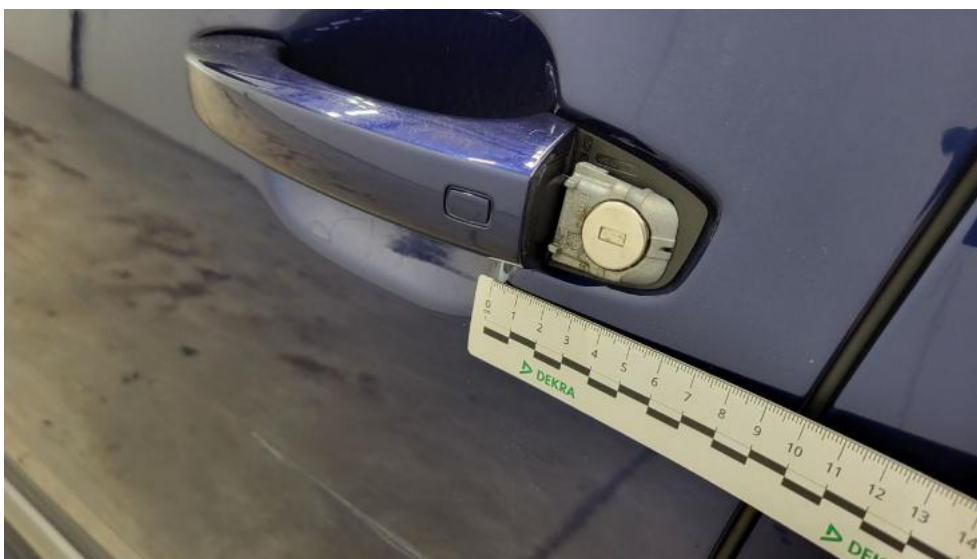
Photo 85.
Zamek drzwi przednich L - Inne 1

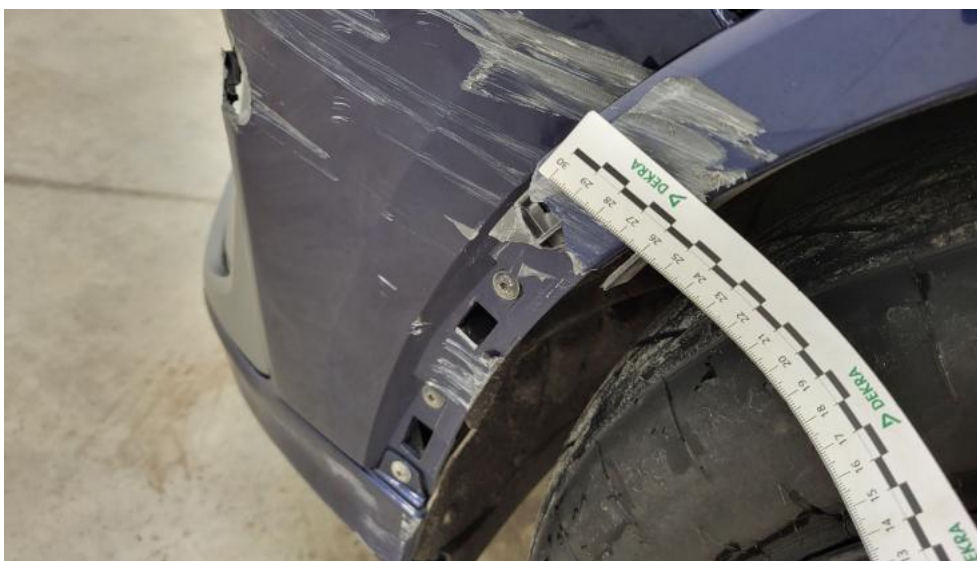
Photo 87.

Listwa błotnika przedniego L - Pęknięcie/rozerwanie 1

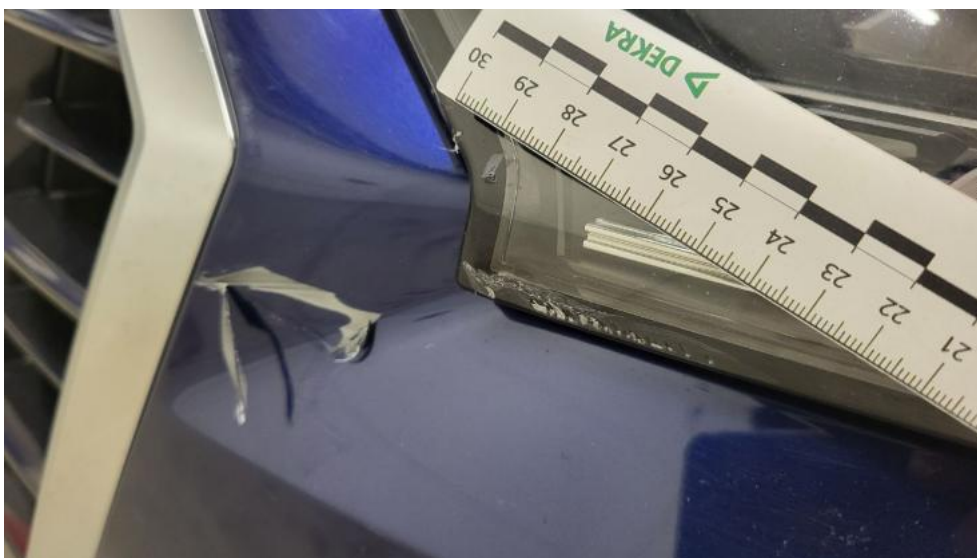
Photo 88.

Reflektor L - Rysa/odprysk 1

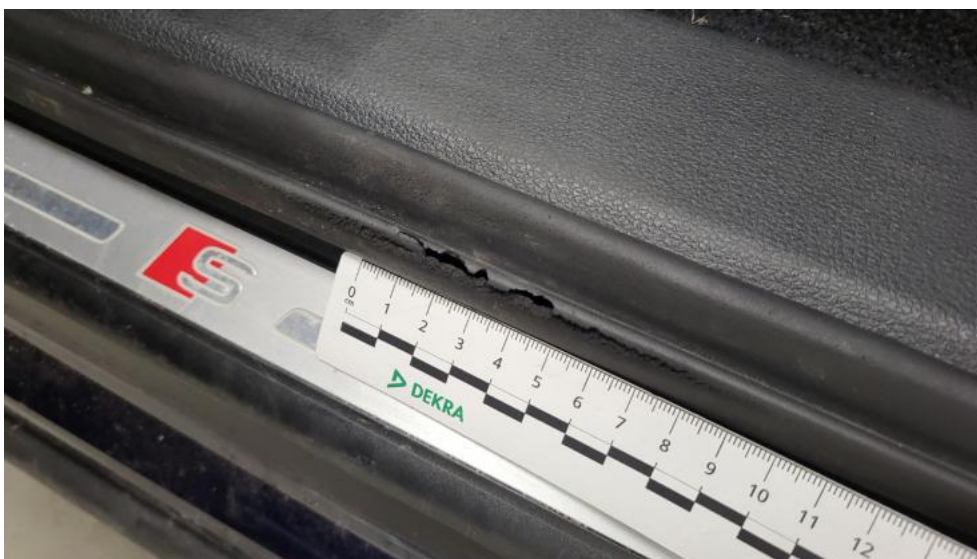
Photo 91.

Uszczelka drzwi przednich L - Pęknięcie/rozerwanie 1

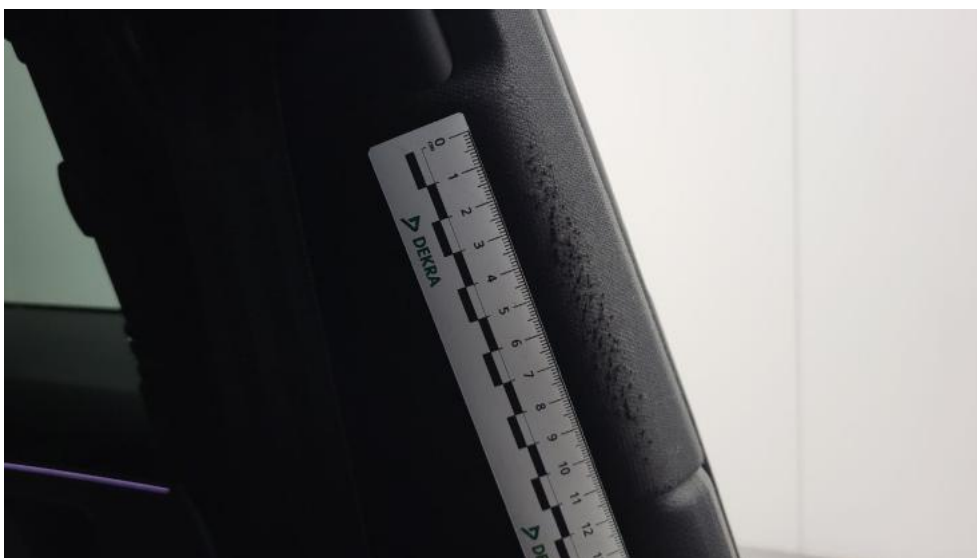
Photo 92.

Wykładzina(y) słupka środkowego L - Inne 1
