DEKRA's commission No. : PKOL(W)/LODZ/11082/25/02/13
 commission/ damage No. : 24/006087
 Date of commission: 13-02-2025

Vehicle data

Description of the technical condition

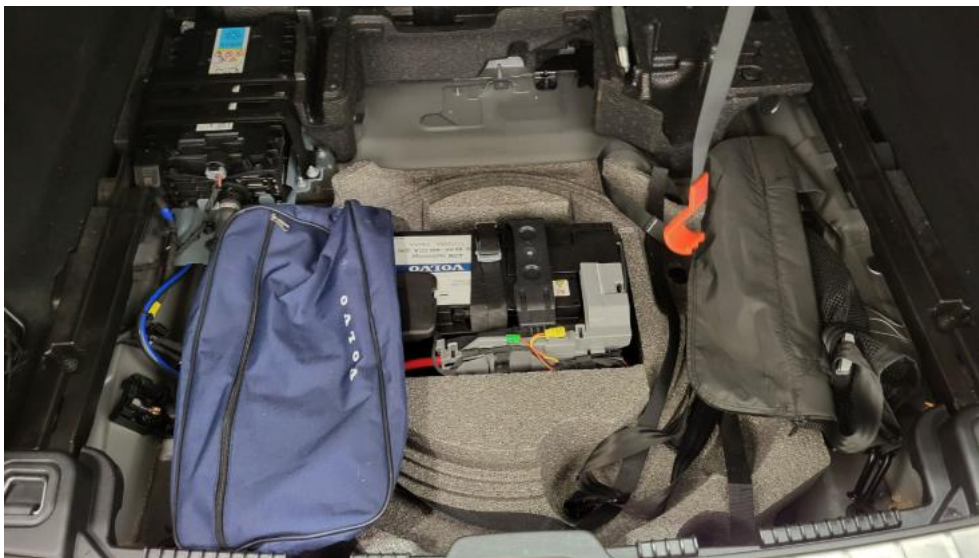
Photo 19.
Koło zapasowe

Rysy na samochodzie. Koło dojazdowe zamontowane na samochodzie. Uszkodzone koło prawy przód w bagażniku. Aktywna kontrolka ciśnienia w kołach. Przekroczenie terminu przeglądu okresowego.

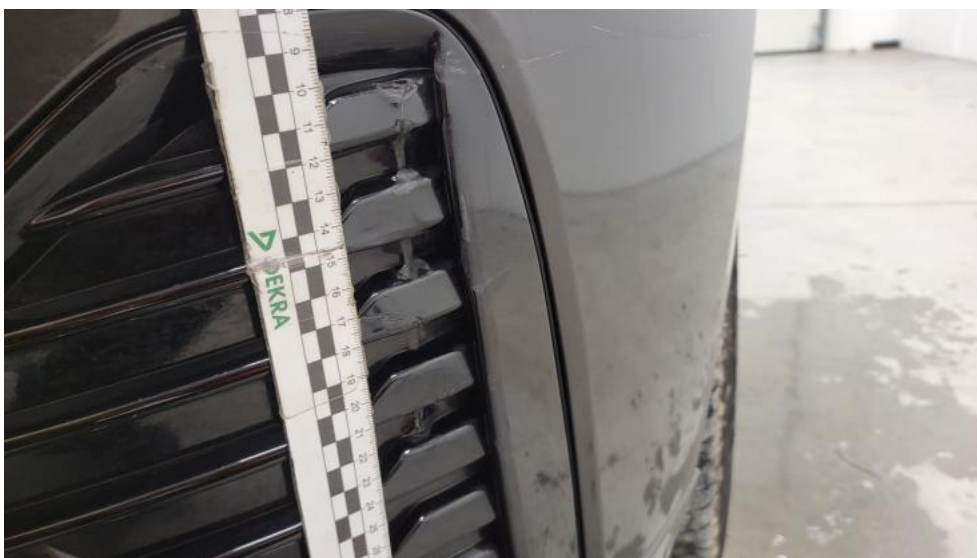
Photo 38.
Kratka/zaślepka halogenu L - Rysa/odprysk 1

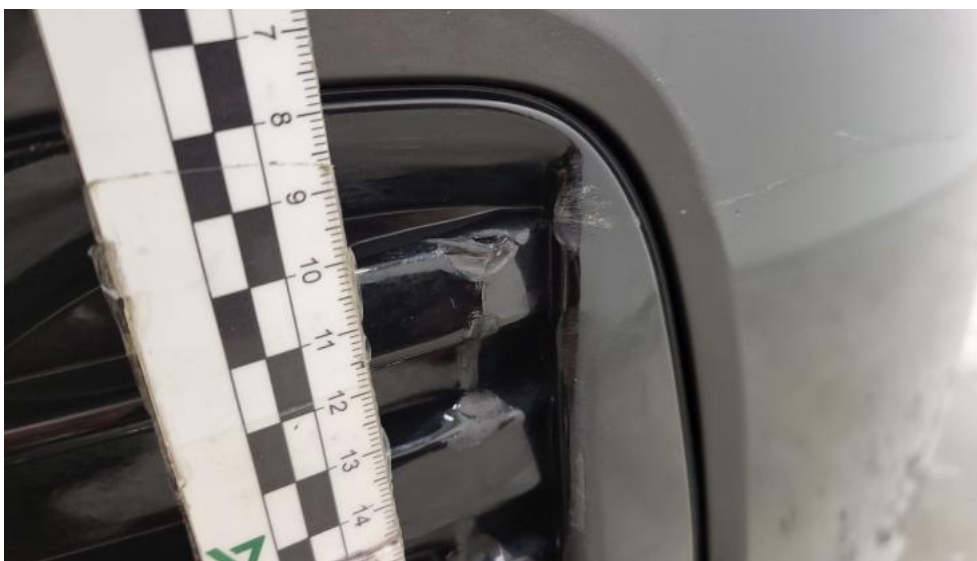
Photo 39.
Kratka/zaślepka halogenu L - Wgniecenie/odkształcenie 1

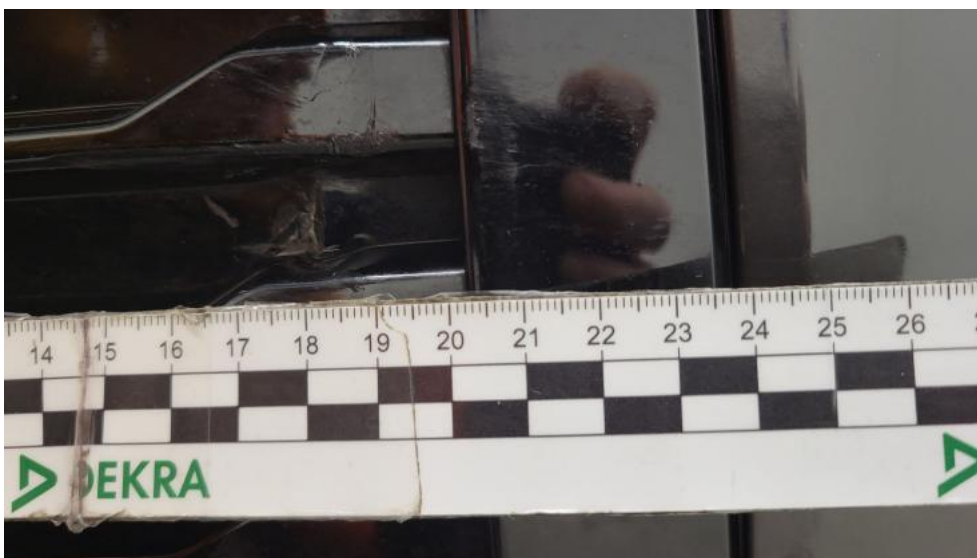
Photo 40.
Kratka/zaślepka halogenu L - Pęknięcie/rozerwanie 1

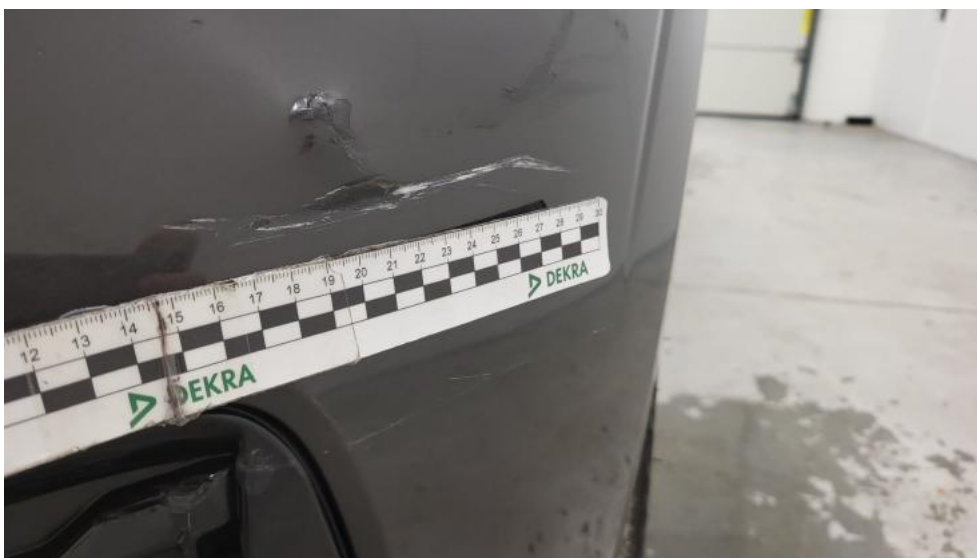
Photo 42.

Zderzak - Rysa/odprysk 1

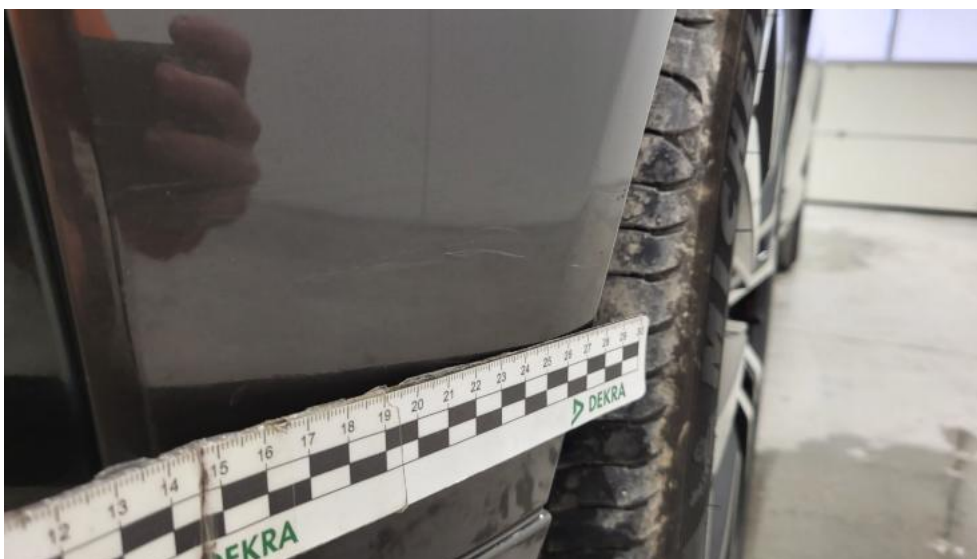
Photo 43.
Zderzak - Rysa/odprysk 2

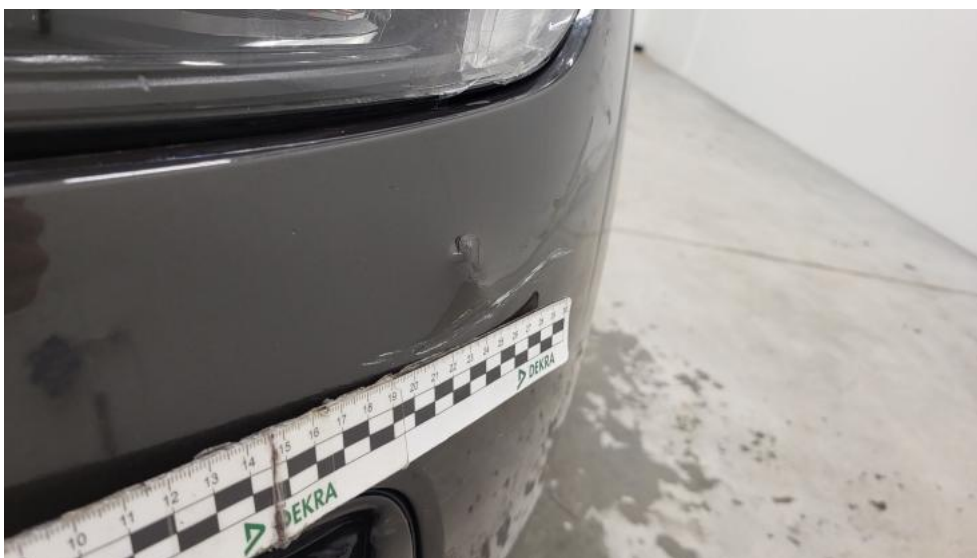
Photo 44.
Zderzak - Wgniecenie/odkształcenie 1

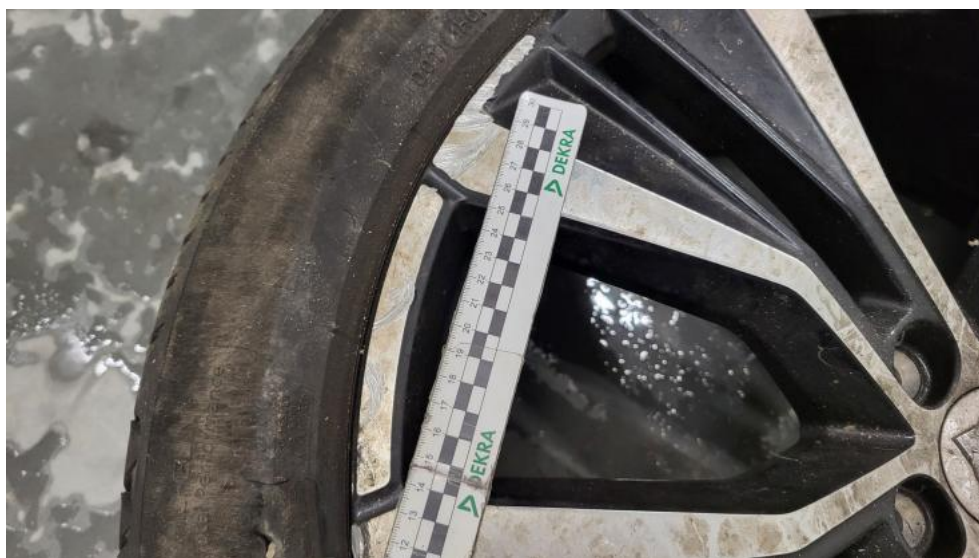
Photo 46.
Felga aluminiowa przednia P - Rysa/odprysk 1

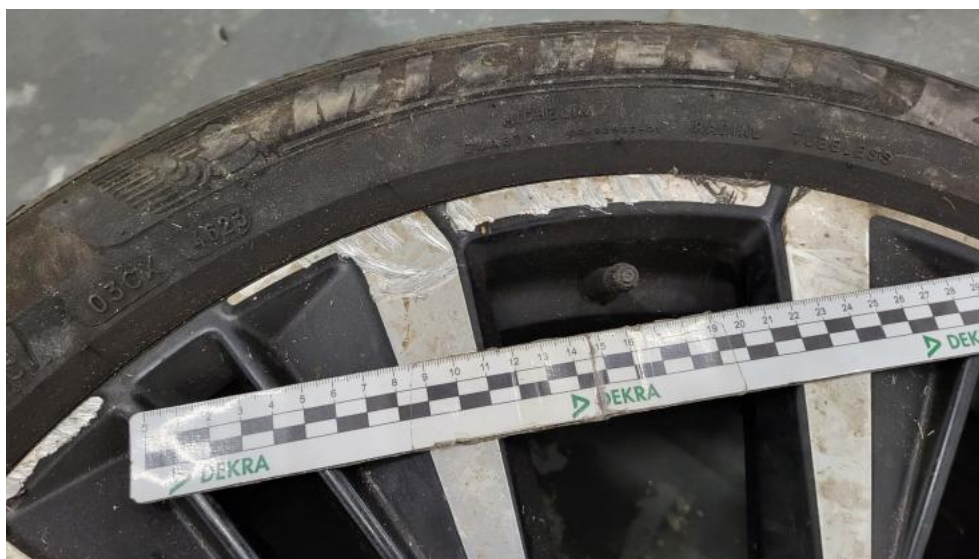
Photo 47.
Felga aluminiowa przednia P - Rysa/odprysk 2

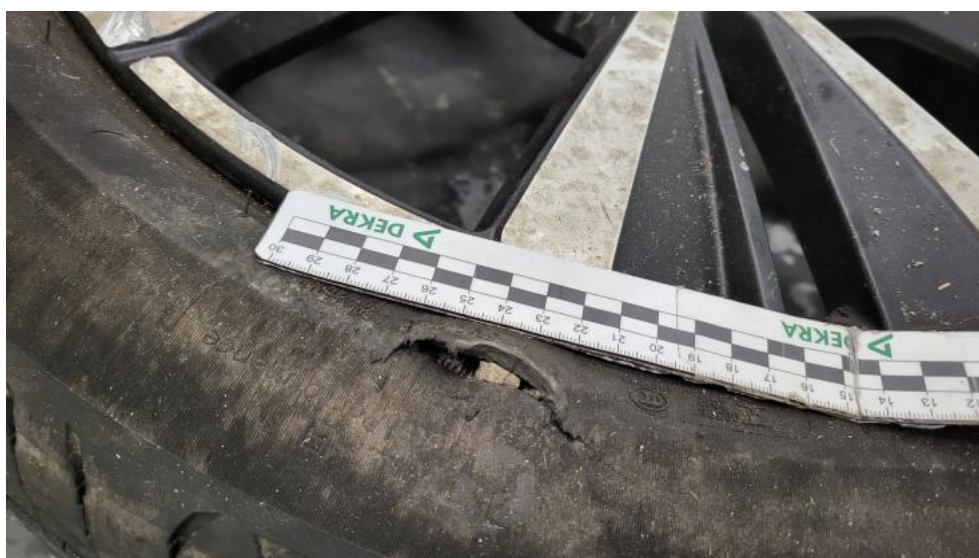
Photo 48.
Opona przednia P - Pęknięcie/rozerwanie 1

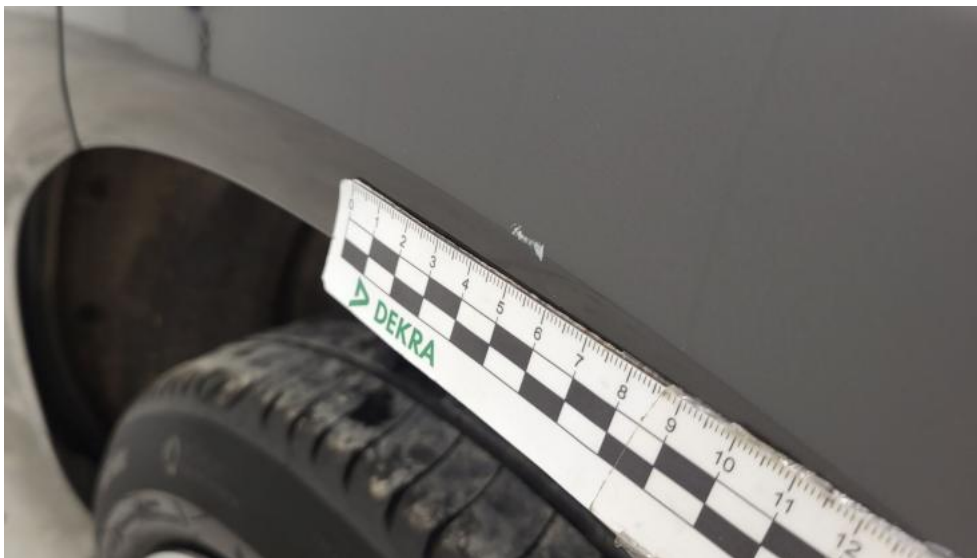
Photo 49.

Błotnik tylny L / Ściana boczna L - Rysa/odprysk 1

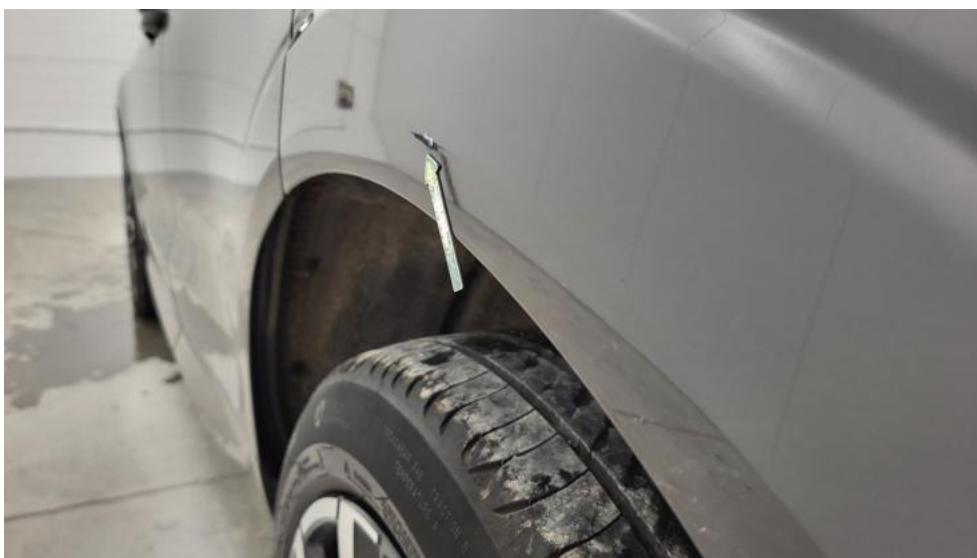
Photo 50.

Błotnik tylny L / Ściana boczna L - Wgniecenie/odkształcenie 1

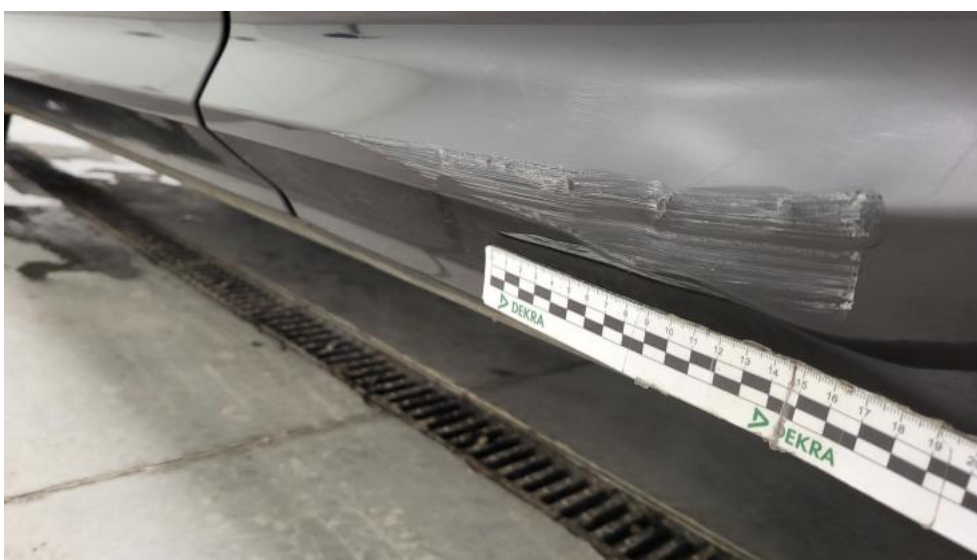
Photo 52.

Listwa drzwi tylnych L - Rysa/odprysk 1

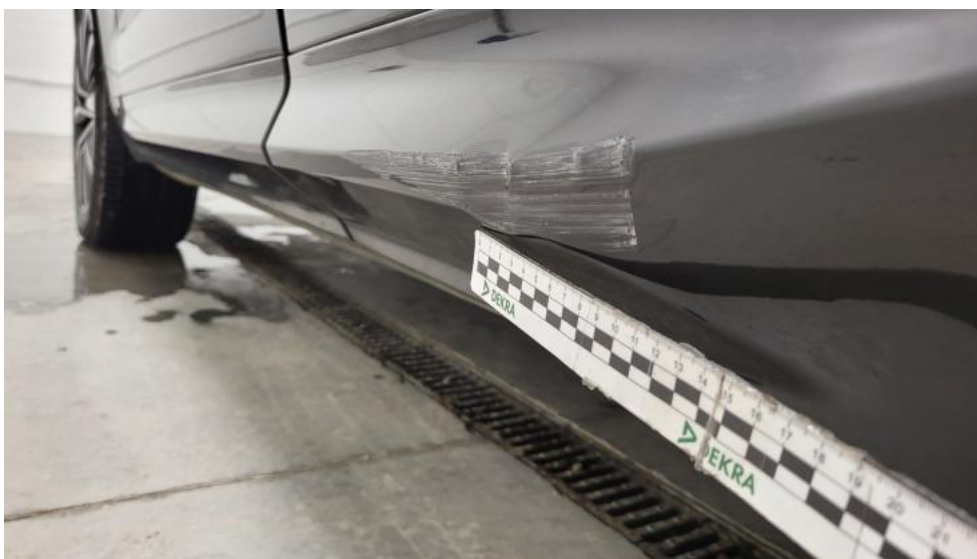
Photo 53.
Listwa drzwi tylnych L - Wgniecenie/odkształcenie 1

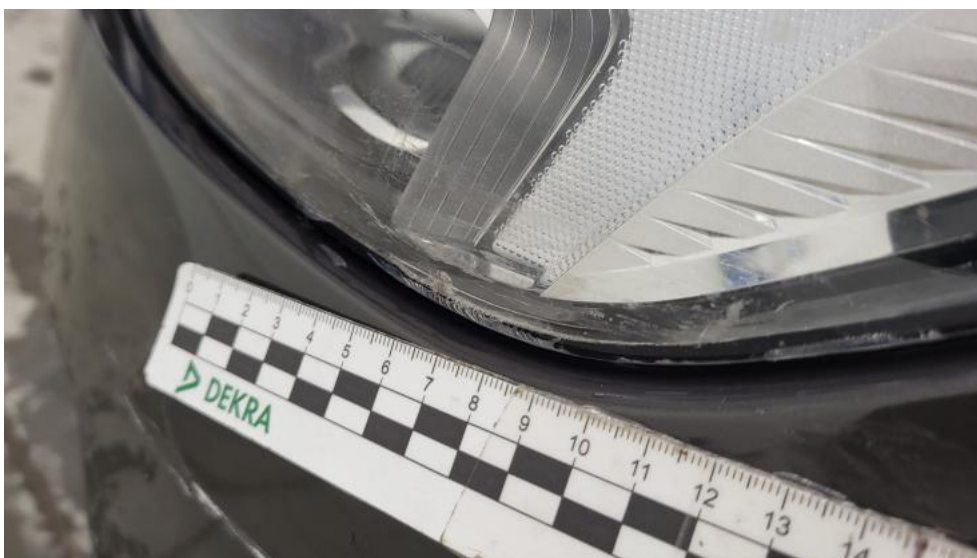
Photo 54.
Reflektor L - Rysa/odprysk 1

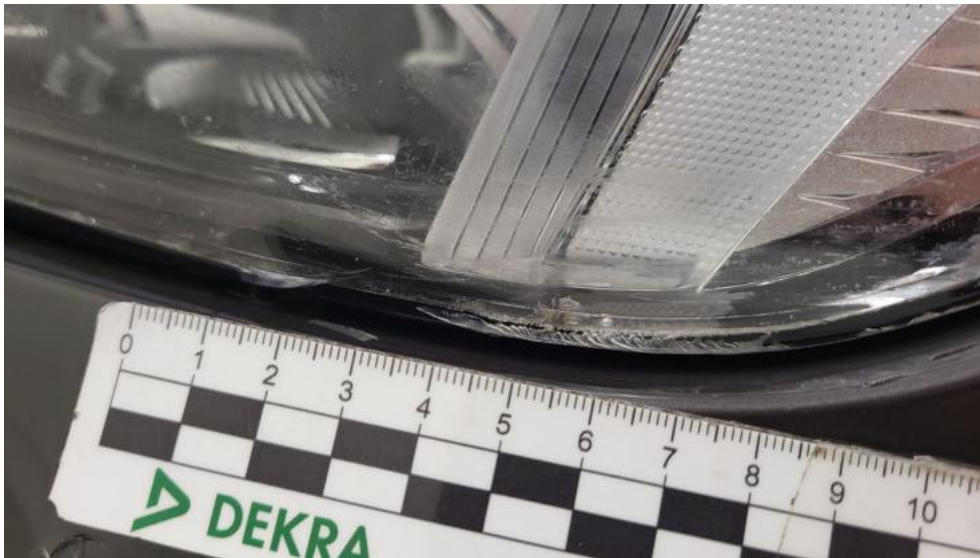
Photo 55.
Reflektor L - Pęknięcie/rozerwanie 1

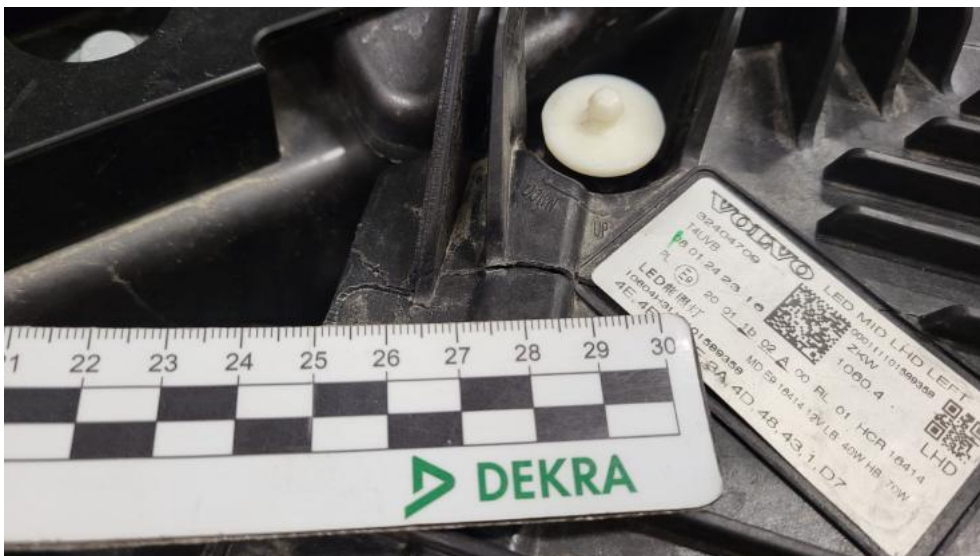
Photo 56.
Reflektor L - Pęknięcie/rozerwanie 2

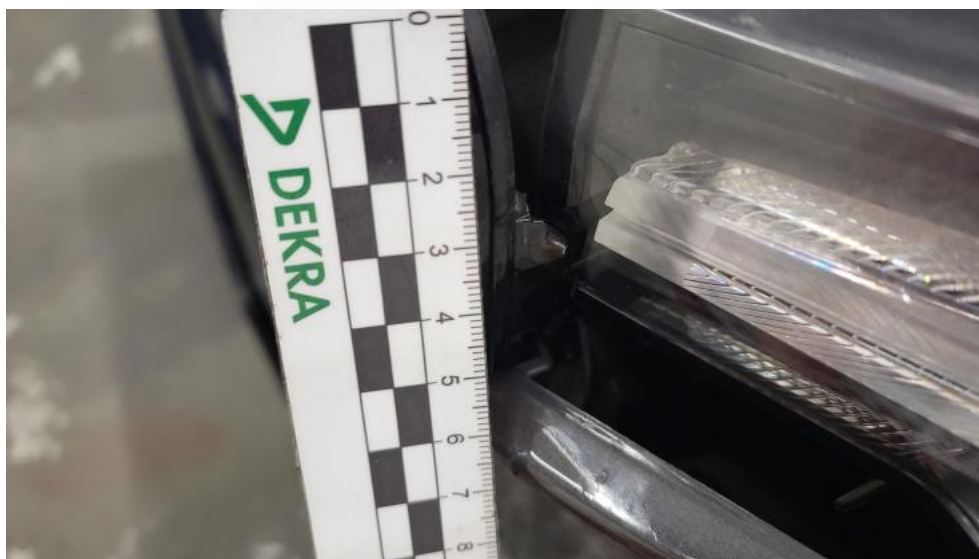
Photo 57.
Reflektor L() - Pęknięcie/rozerwanie 3

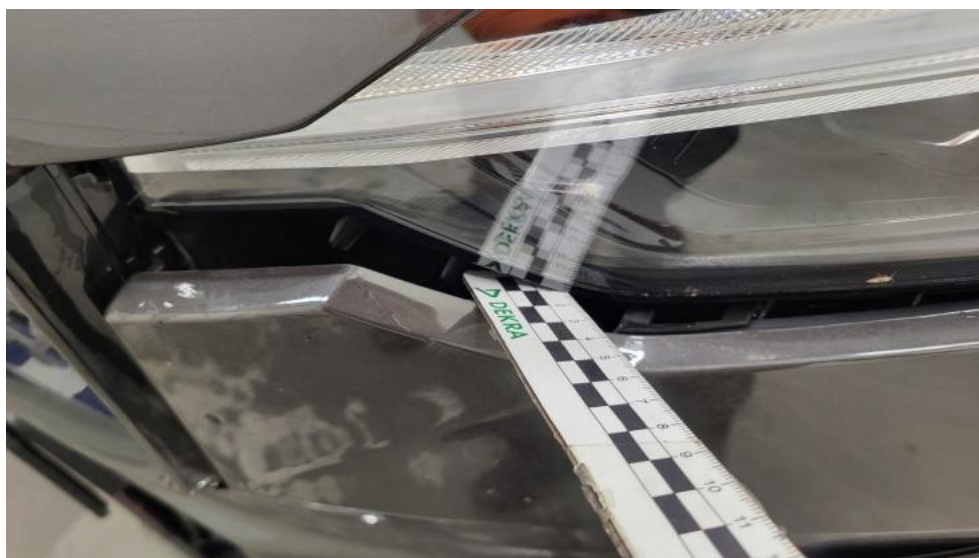
Photo 58.
Reflektor L - Inne 1

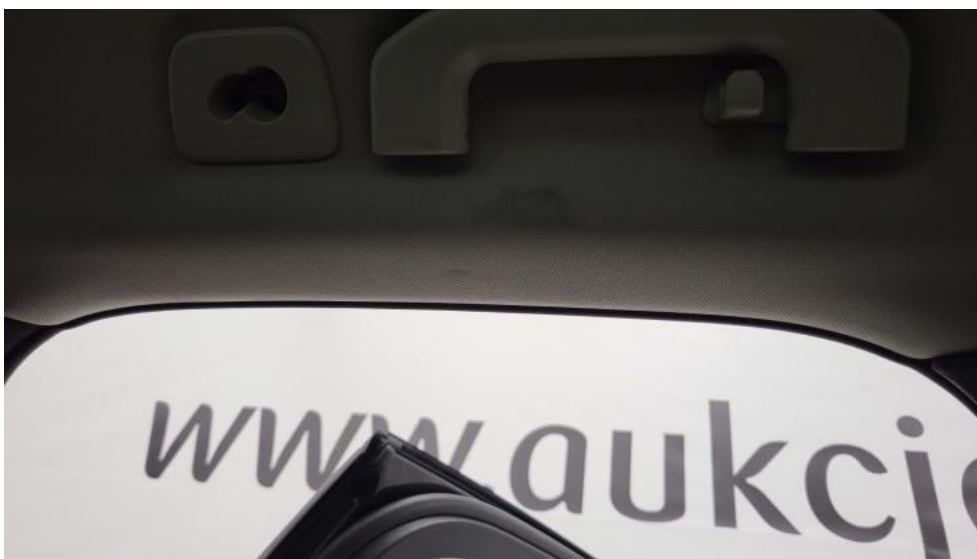
Photo 59.
Podsufitka - Inne 1

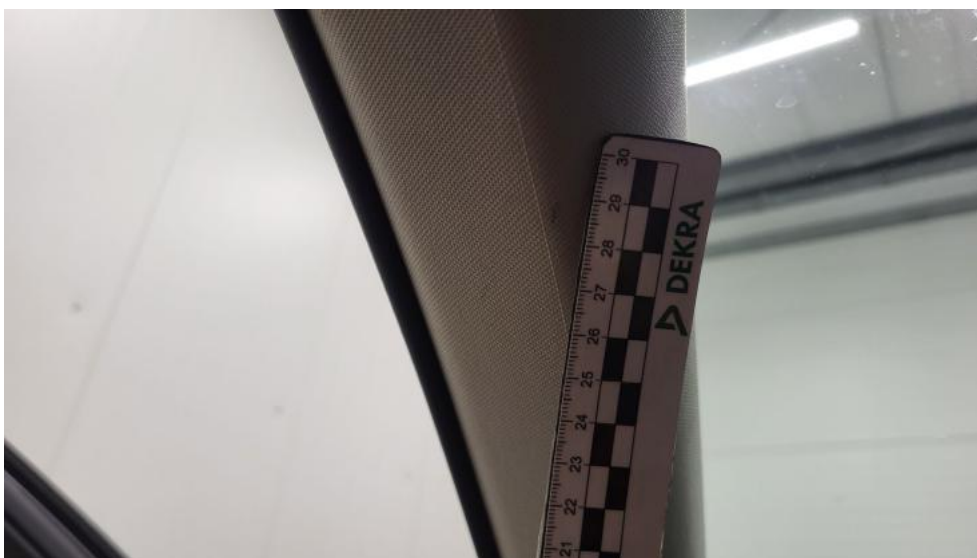
Photo 60.
Wykładzina(y) słupka przedniego L - Inne 1
