DEKRA's commission No. : PKOL(W)/LODZ/100054/24/12/30  
commission/ damage No. : 50598  
Date of commission: 30-12-2024

**Vehicle data**

Group of objects (Eurotax)	jeeps
EC code (Eurotax)	0135296
Manufacturer	LEXUS
Model	UX 18-24
Type / version	UX 250h GPF Prestige AWD
Body type	KOM
Number of doors / seats	5/5
Curb weight [kg]	1629
Gross vehicle weight [kg]	2110
Wheelbase 1/2	2640
Engine type	spark ignition
Pollution reduction system	GPF
Engine marking	hybrydowy
Engine capacity [ccm]	1987
Engine Power [hp/kW]	152/112
Gearbox	automatic
Registration /record No.	WR369AY
VIN / serial number	JTHU95BHX02008729
Date of first registration	24-06-2019
Date of next. tech. test	28-06-2025
Year of manufacture	2019 (year has been verified with the manufacturer's base)
Readout [km]	107 000 (read)
Body color / type of coating	green/double-layered, metallized

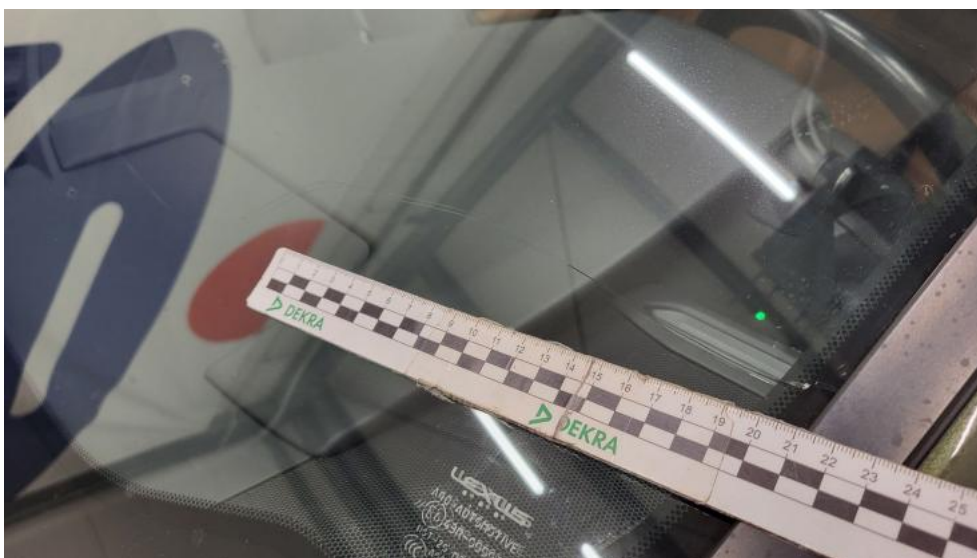
**Photo 42.**  
Szyba czołowa - Pęknięcie/rozerwanie 1

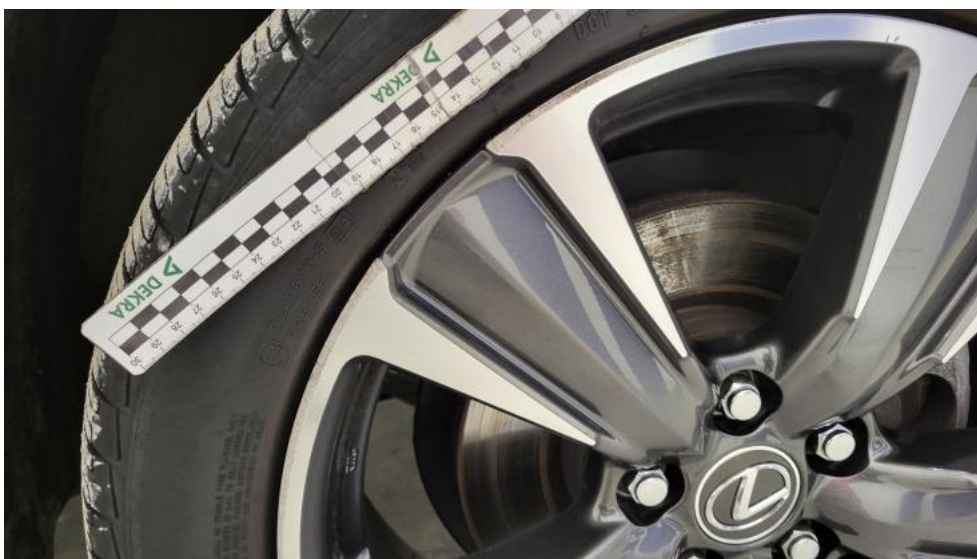
**Photo 43.**  
Felga aluminiowa przednia P - Rysa/odprysk 1

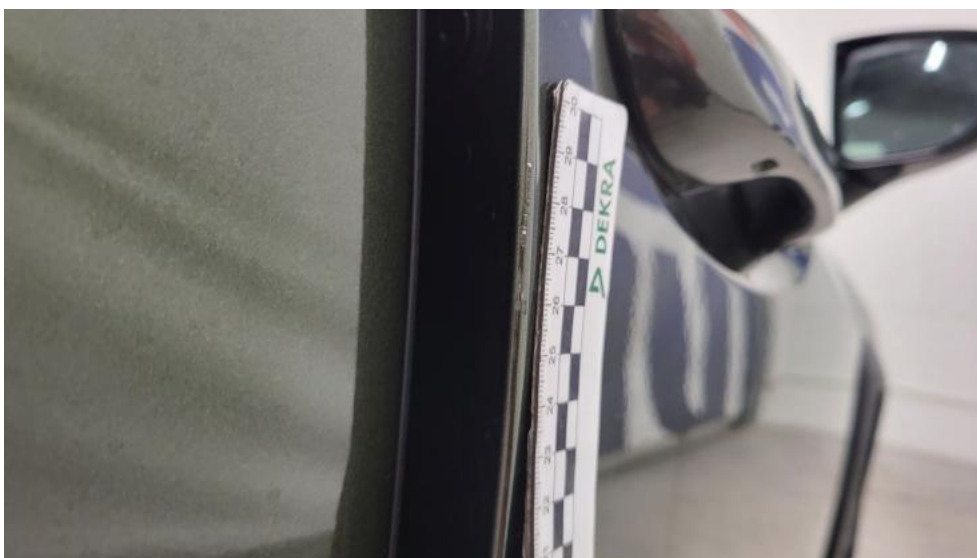
**Photo 44.**  
Drzwi przednie P - Rysa/odprysk 1

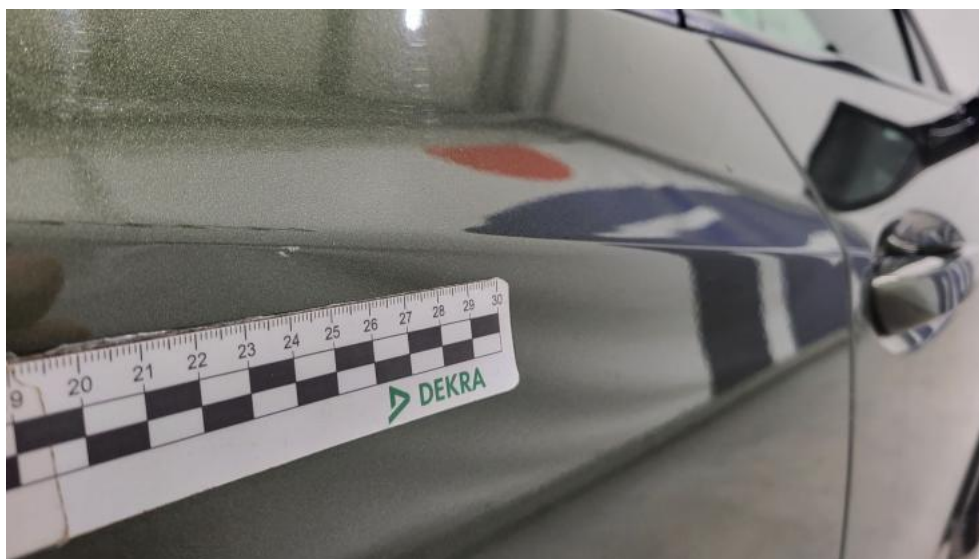
**Photo 47.**  
Drzwi tylne P - Rysa/odprysk 1

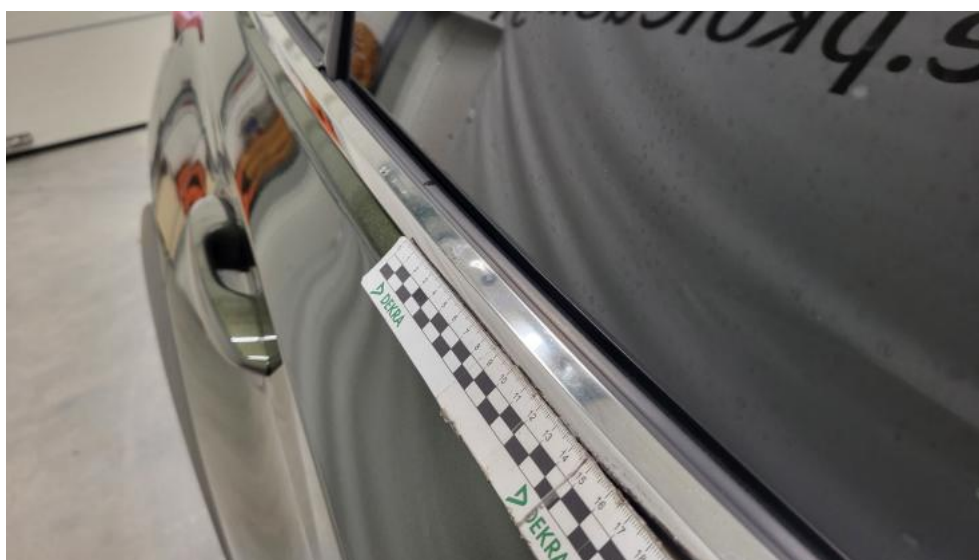
**Photo 48.**  
Listwa drzwi tylnych P - Wgniecenie/odkształcenie 1

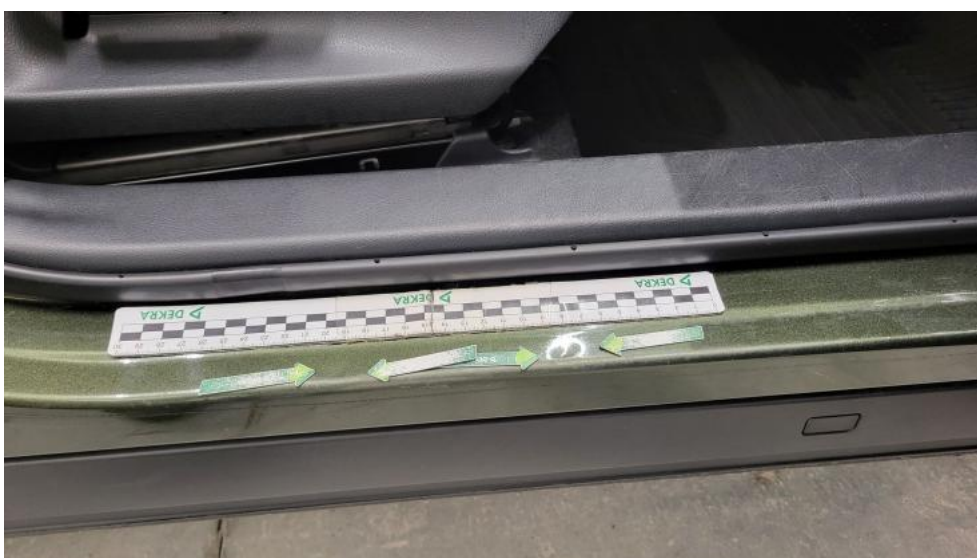
**Photo 50.**  
Próg P - Wgniecenie/odkształcenie 1

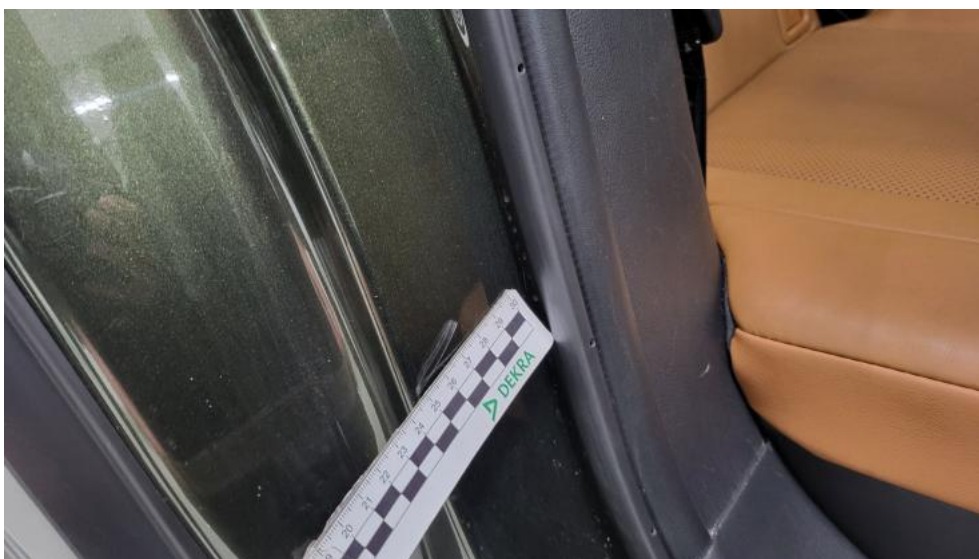
**Photo 51.**

Błotnik tylny P / Ściana boczna P - Rysa/odprysk 1

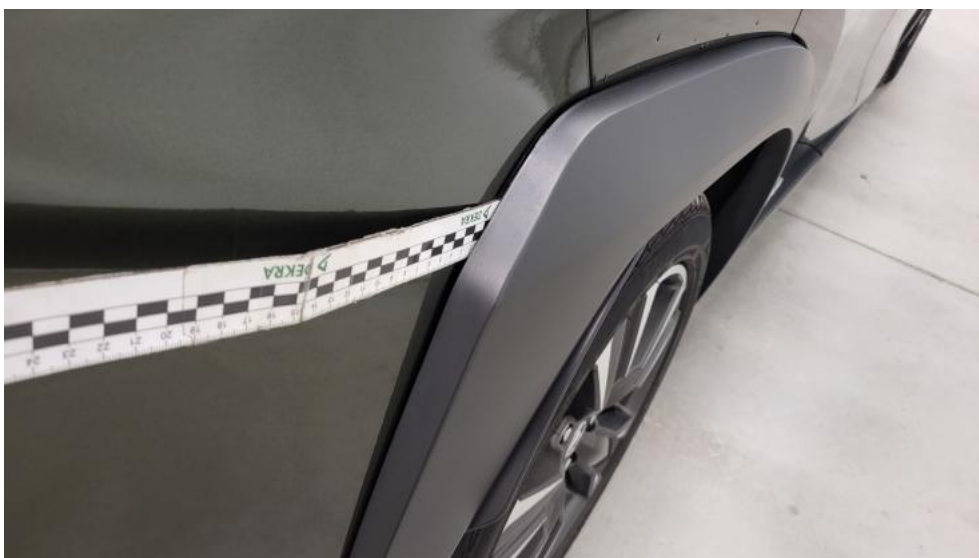
**Photo 52.**

Listwa krawędzi błotnika tyl P - Inne 1

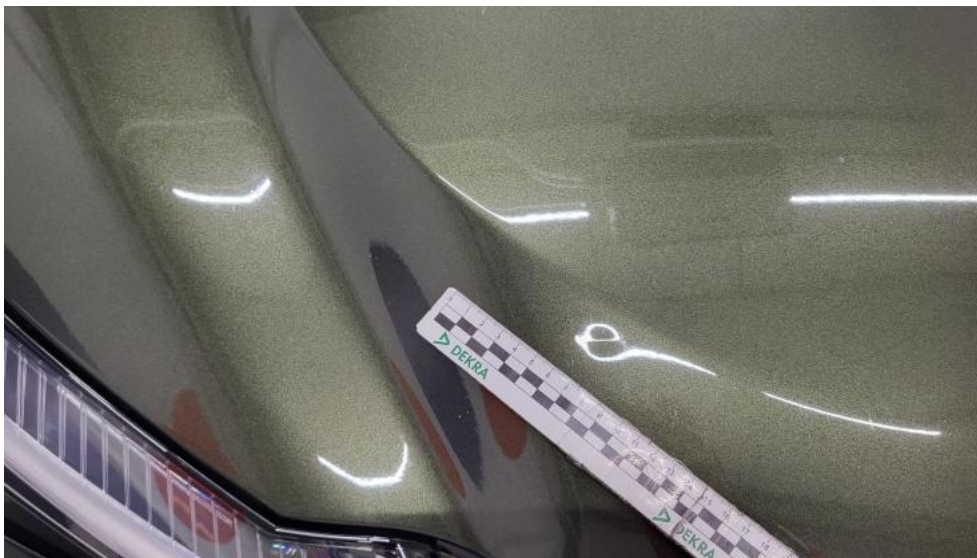
**Photo 53.**  
Pokrywy przód - Wgniecenie/odkształcenie 1

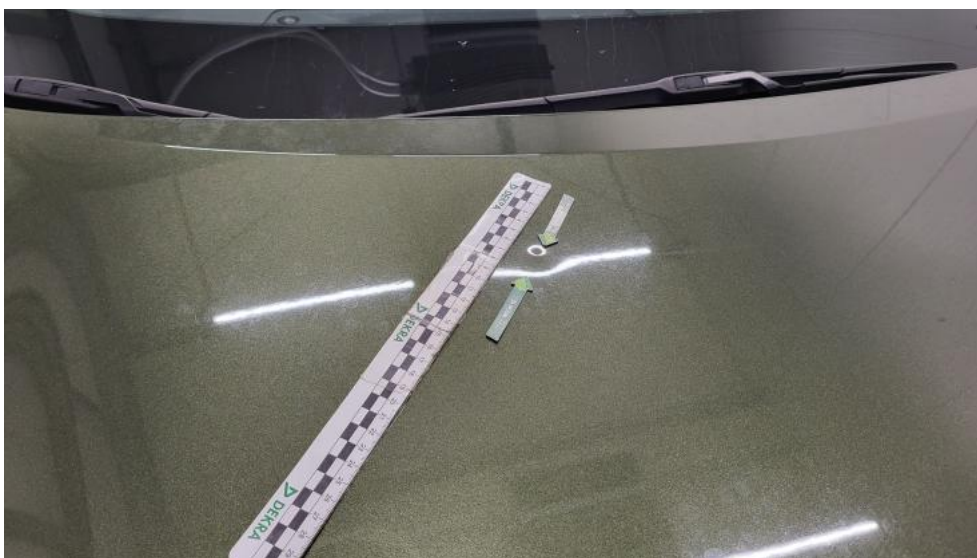
**Photo 54.**  
Pokrywy przód - Wgniecenie/odkształcenie 2

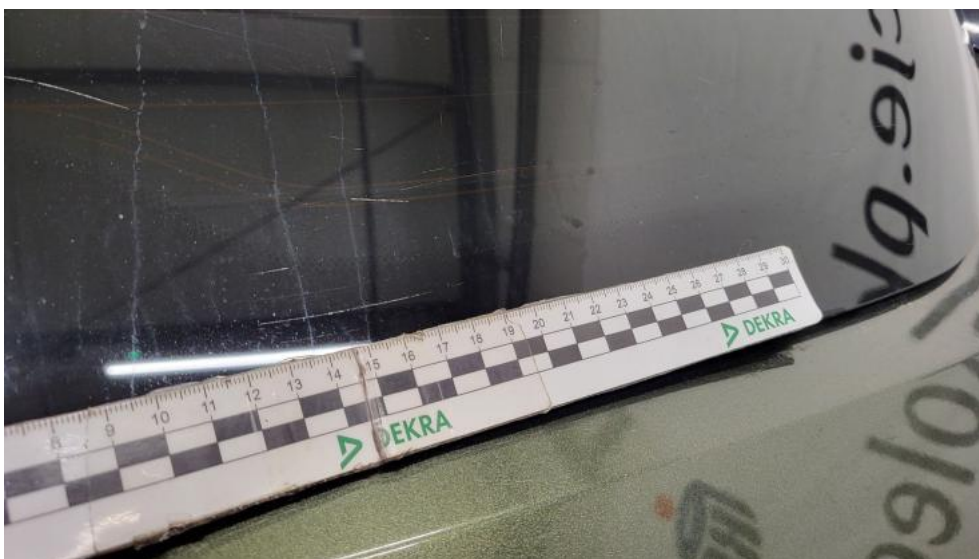
**Photo 55.**  
Szyba tylna - Rysa/odprysk 1

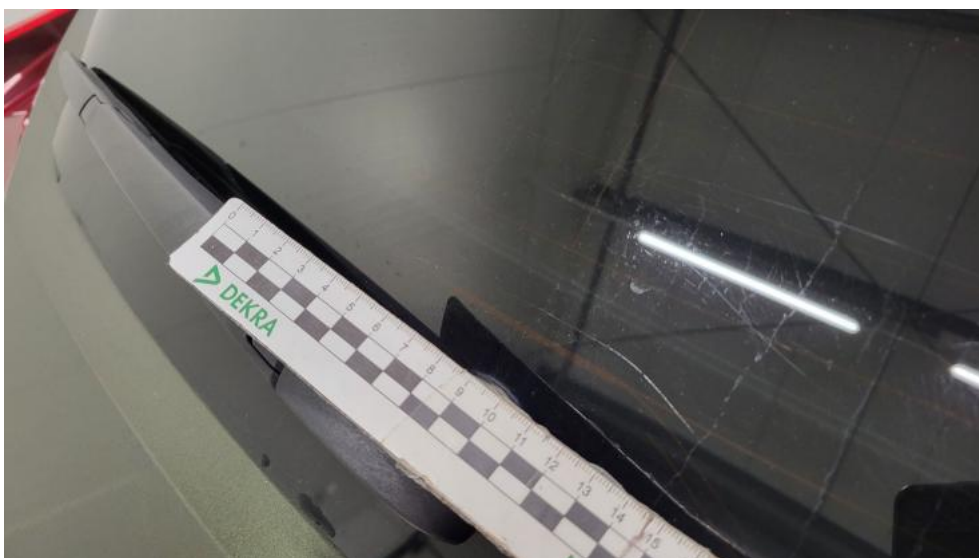
**Photo 56.**  
Szyba tylna - Rysa/odprysk 2

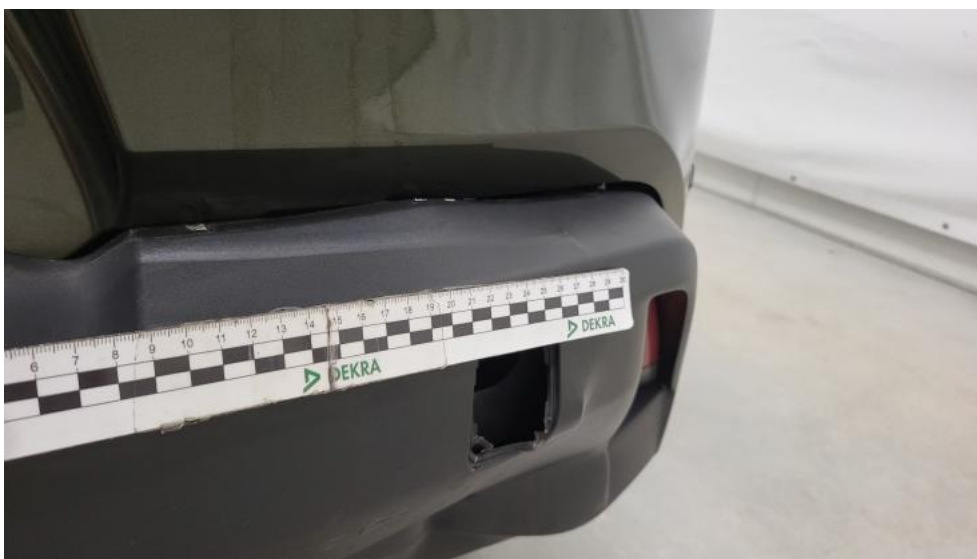
**Photo 59.**

Zderzak tylny cz dolna - Wgniecenie/odkształcenie 1

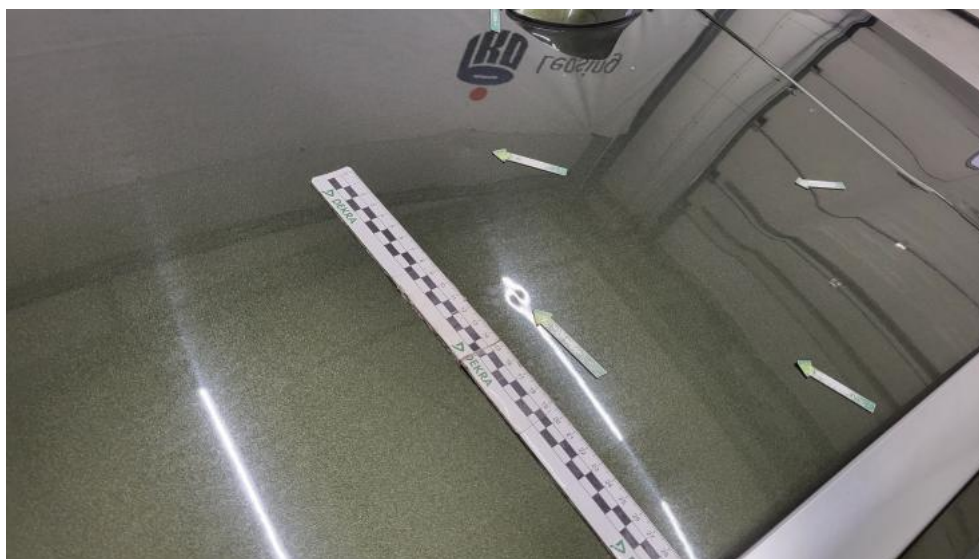
**Photo 65.**  
Dach - Wgniecenie/odkształcenie 2

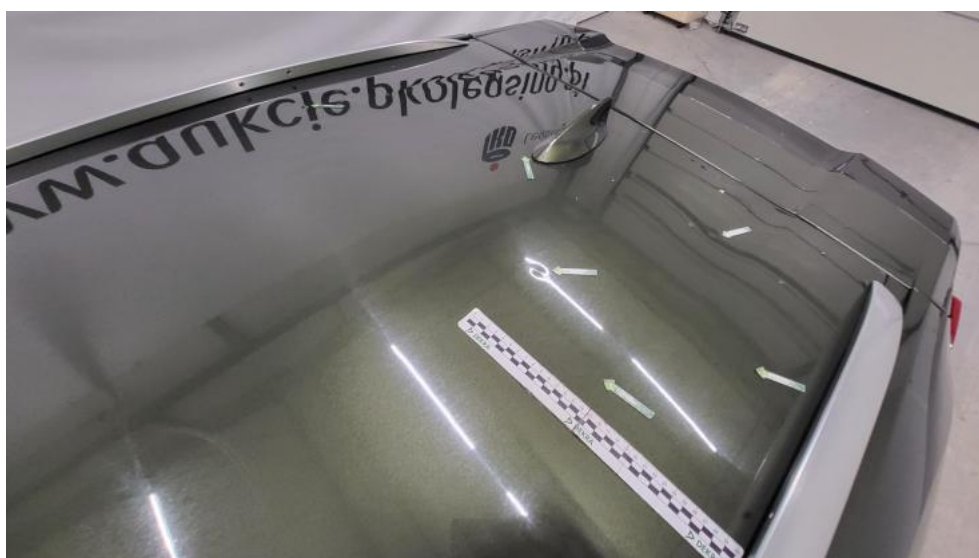
**Photo 66.**  
Dach() - Wgniecenie/odkształcenie 3

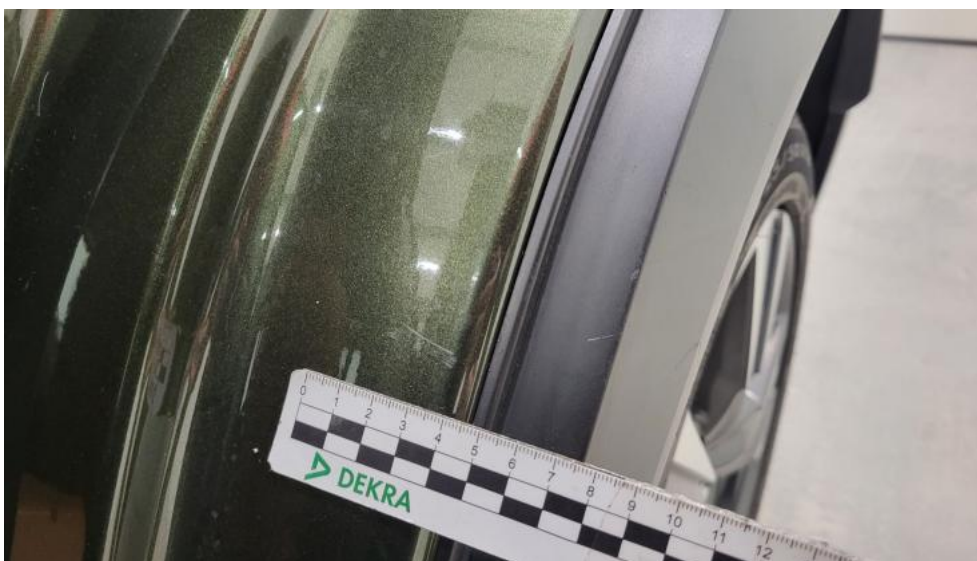
**Photo 67.**  
Błotnik tylny L / Ściana boczna L - Rysa/odprysk 1

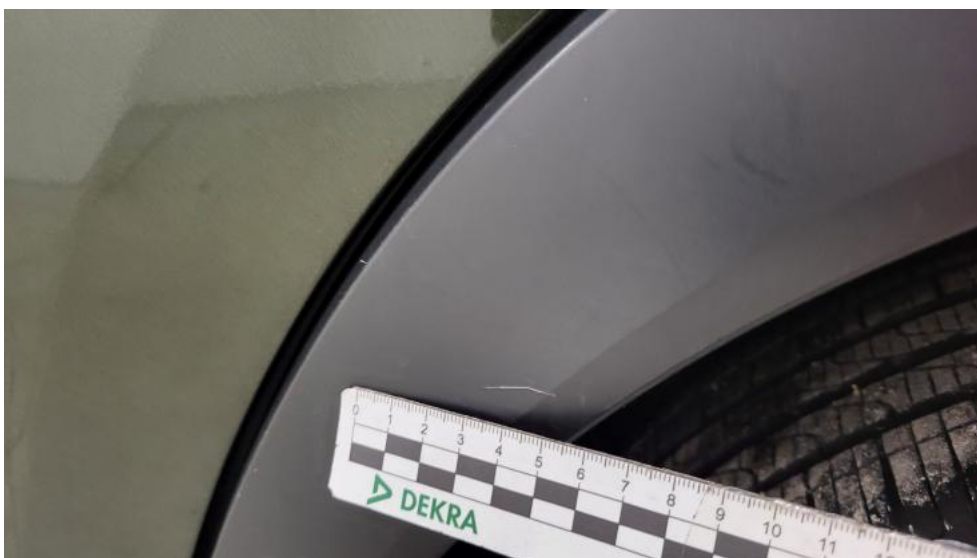
**Photo 68.**  
Listwa krawędzi błotnika tył L - Rysa/odprysk 1

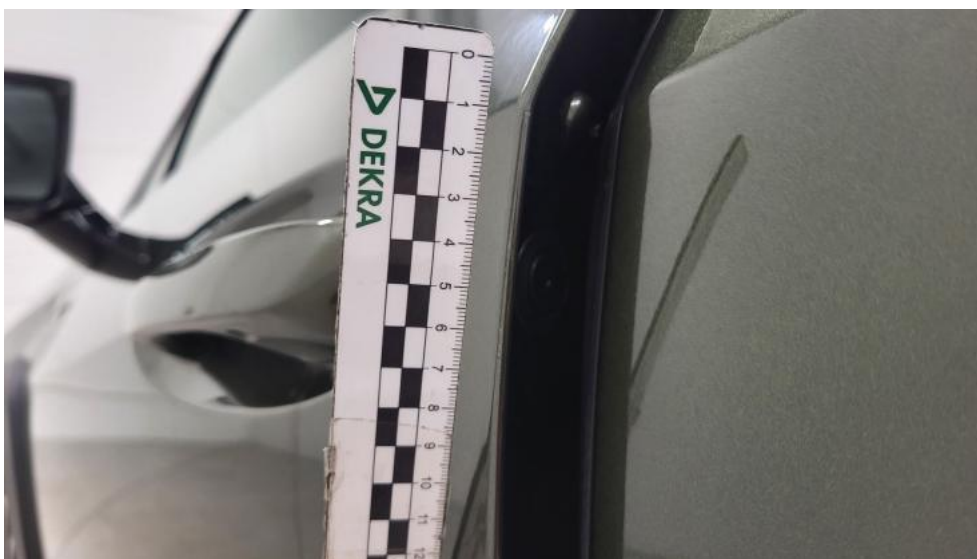
**Photo 69.**

Drzwi przed L - Rysa/odprysk 1

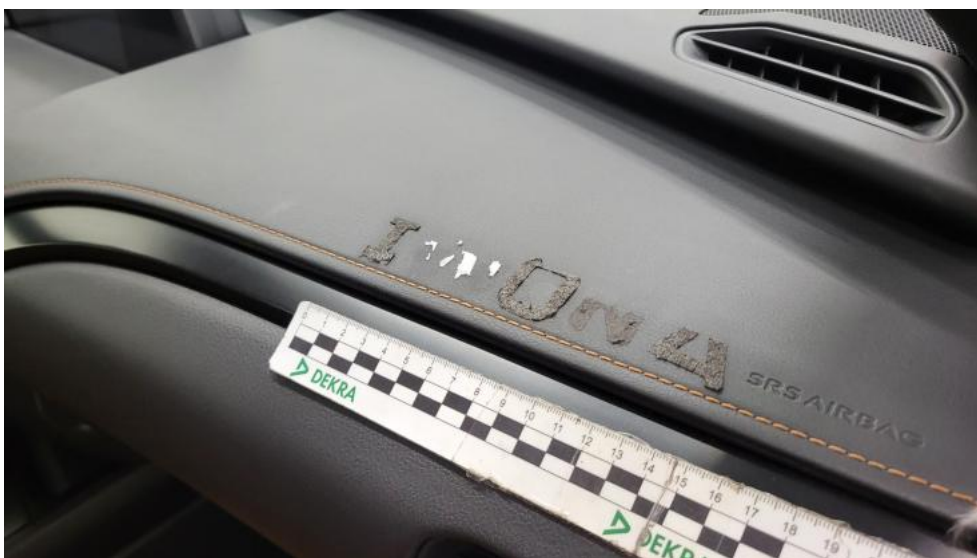
**Photo 72.**  
Deska rozdzielcza - Inne 1

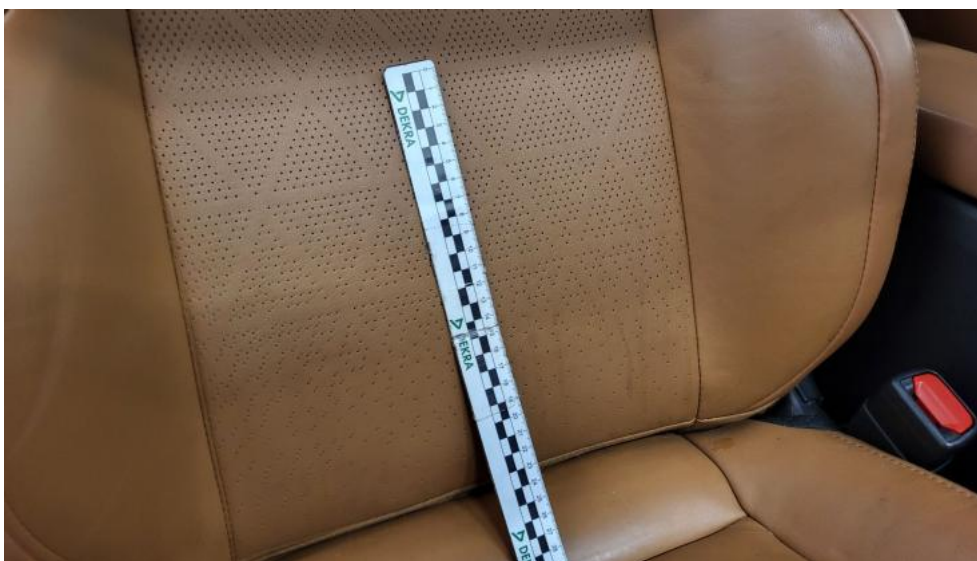
**Photo 75.**  
Fotel prz. praw. - Inne 2

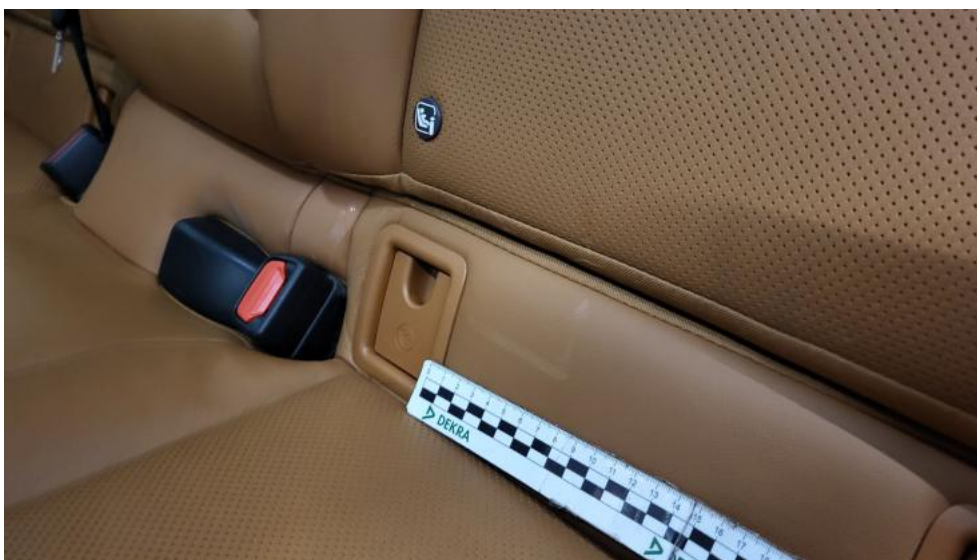
**Photo 76.**  
Kanapa tyl. - Inne 1

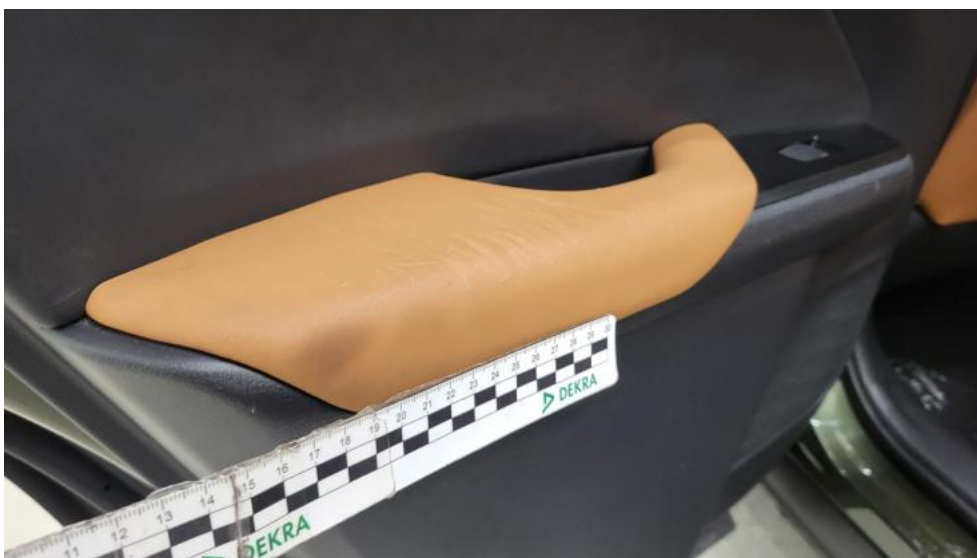
**Photo 78.**  
Uchwyt drzwi tyl L - Inne 1
