DEKRA's commission No. : PKOL(W)/LODZ/86012/24/11/07  
commission/ damage No. : 22/032371  
Date of commission: 07-11-2024

**DEKRA Poland - Headquarters**  
02-673 Warszawa, ul. Konstruktorska 12A

**Vehicle data**

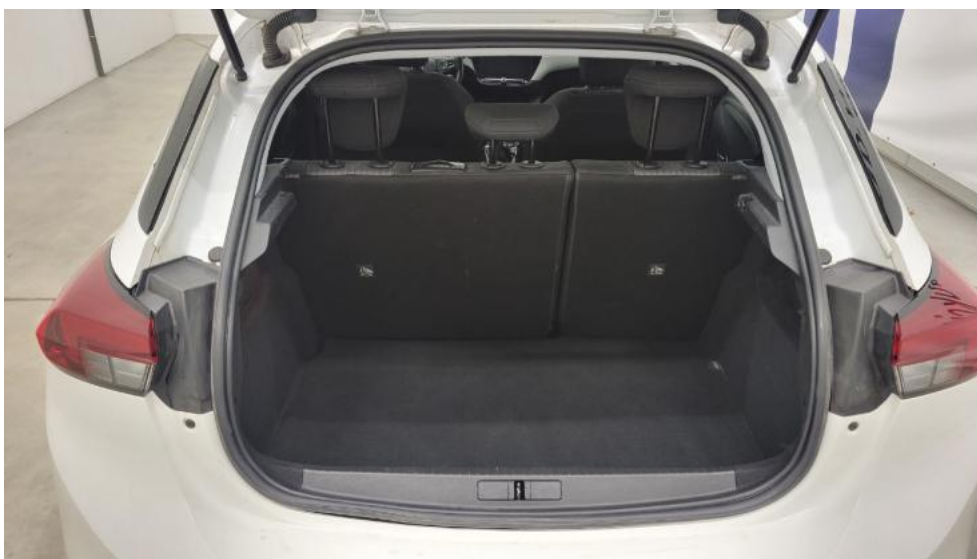
Dostarczono ksero pozwolenia czasowego. Brak półki w bagażniku. Rysy na samochodzie.

**Photo 19.**  
Bagażnik

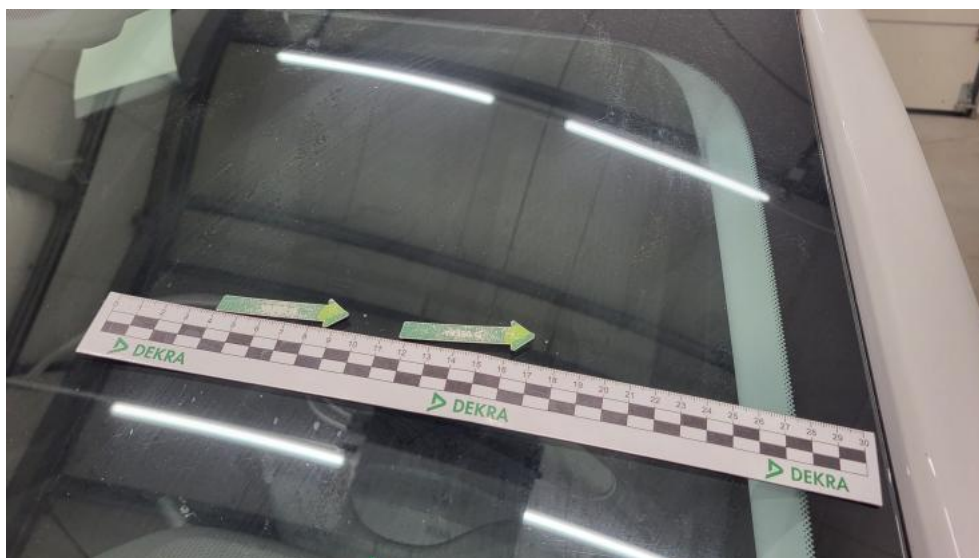
**Photo 42.**  
Szyba czołowa - Rysa/odprysk 1

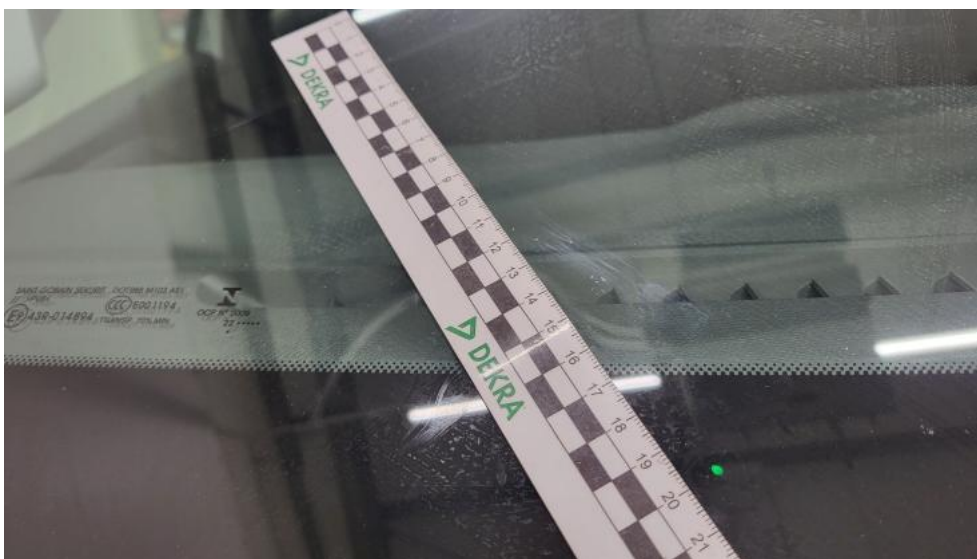
**Photo 43.**

Szyba czołowa - Rysa/odprysk 2

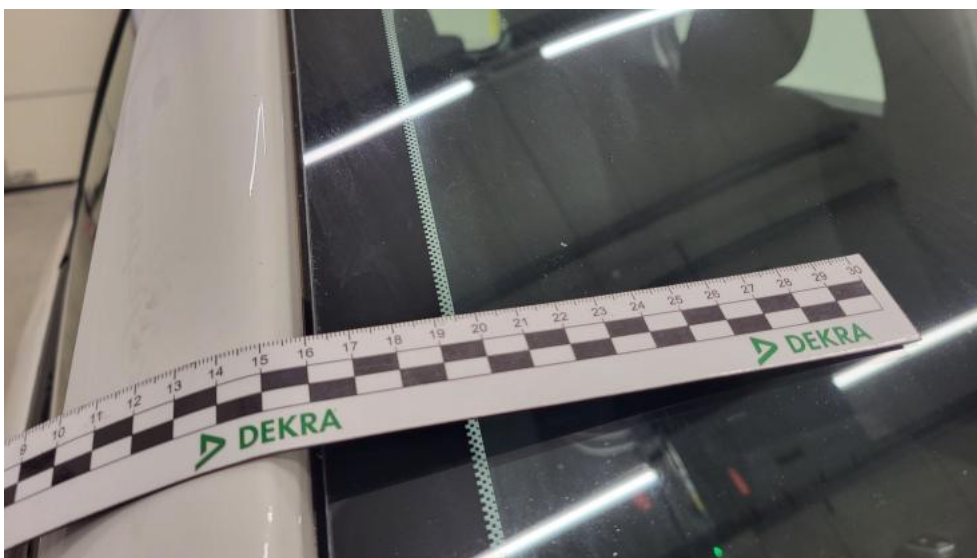
**Photo 44.**

Szyba czołowa() - Rysa/odprysk 3

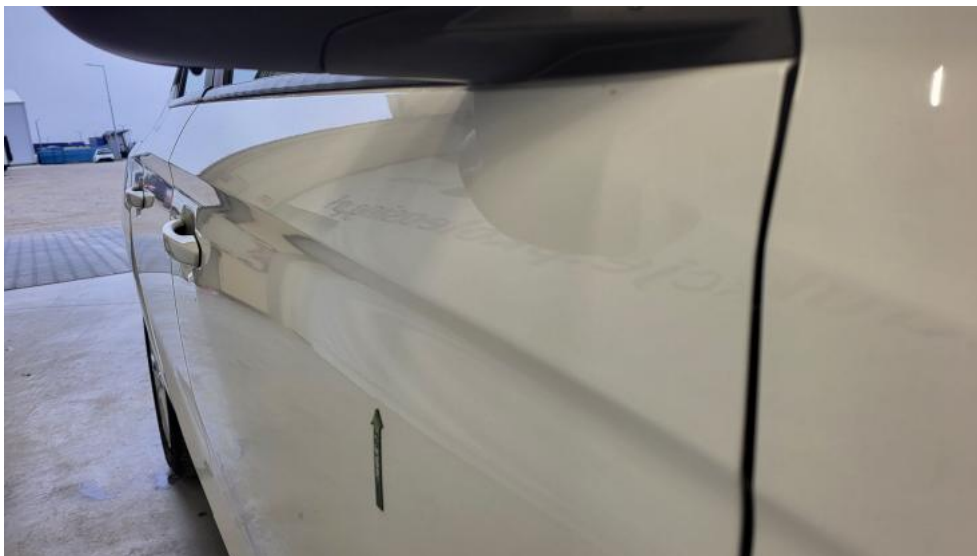
**Photo 49.**  
Drzwi przednie P - Wgniecenie/odkształcenie 1

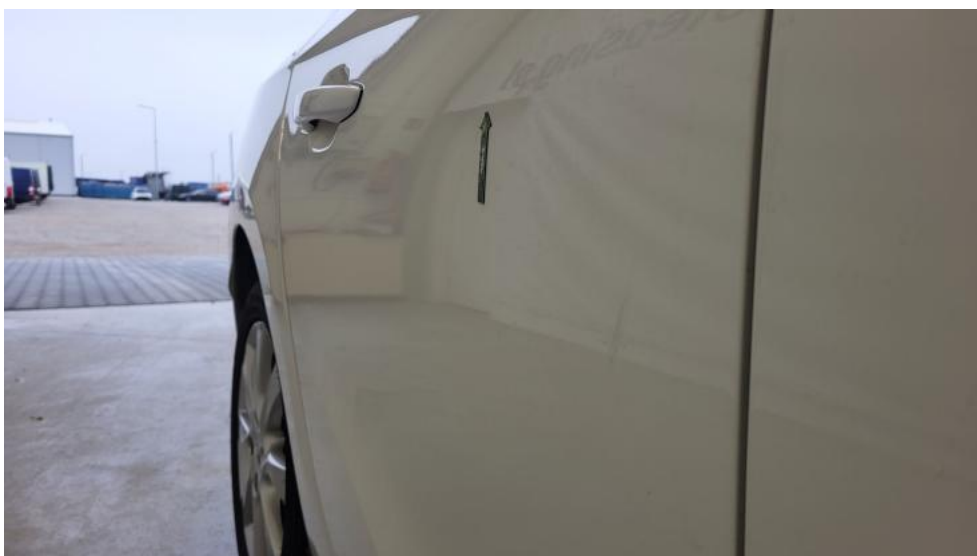
**Photo 50.**  
Drzwi tylne P - Wgniecenie/odkształcenie 1

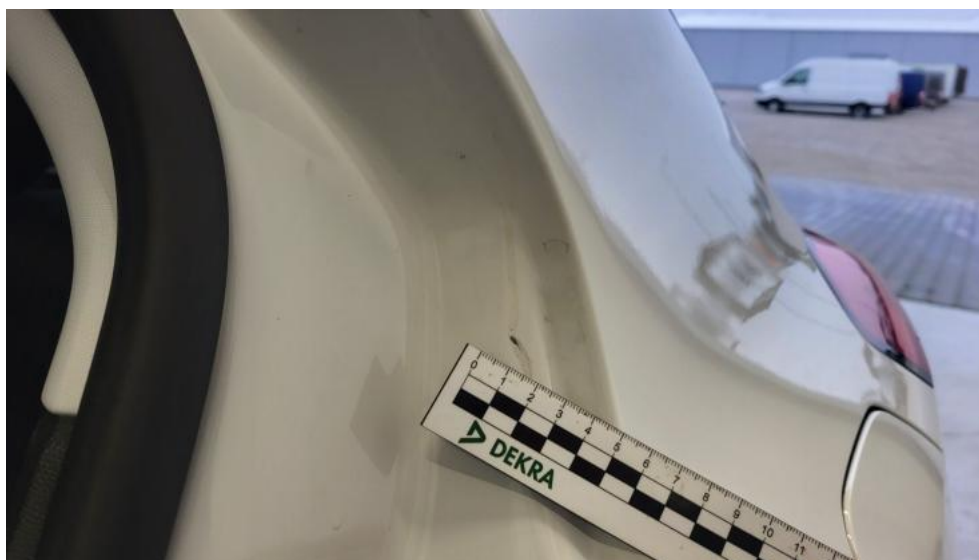
**Photo 52.**

Błotnik tylny L / Ściana boczna L - Rysa/odprysk 2

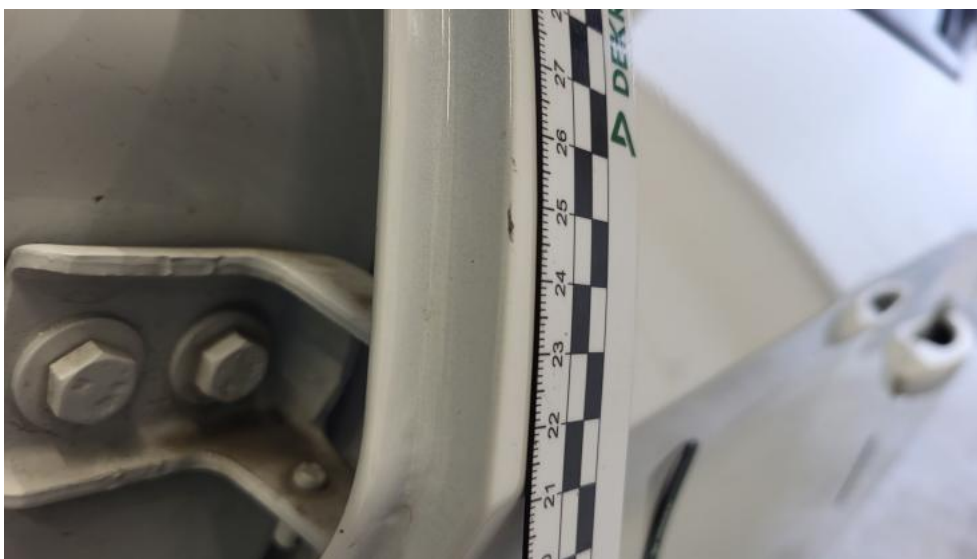
**Photo 55.**

Drzwi tylne L - Rysa/odprysk 1

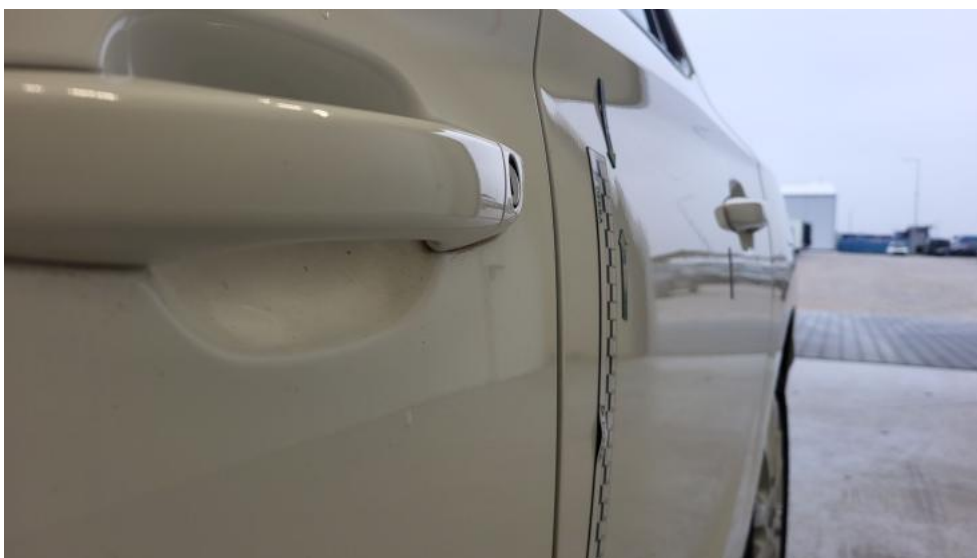
**Photo 56.**

Drzwi tylne L - Wgniecenie/odkształcenie 1

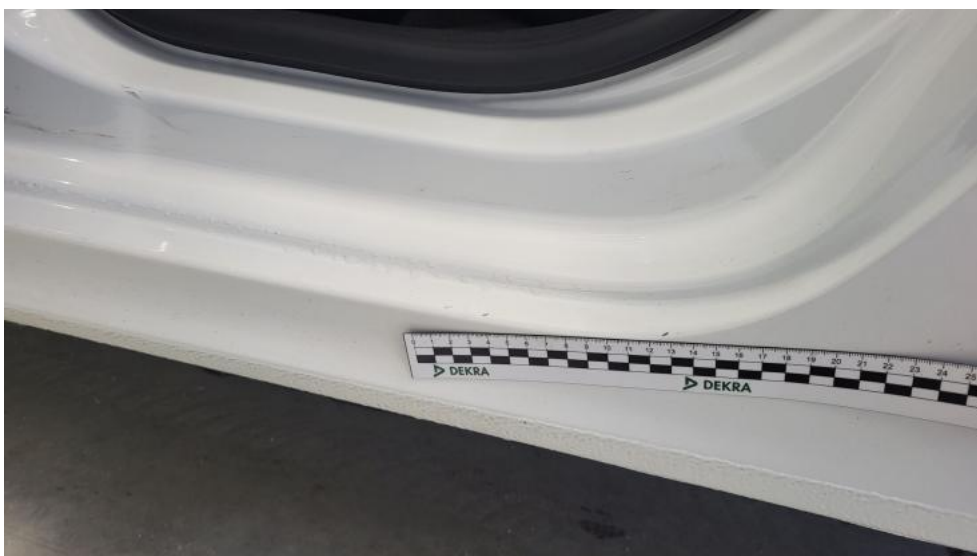
**Photo 58.**  
Próg L - Rysa/odprysk 1

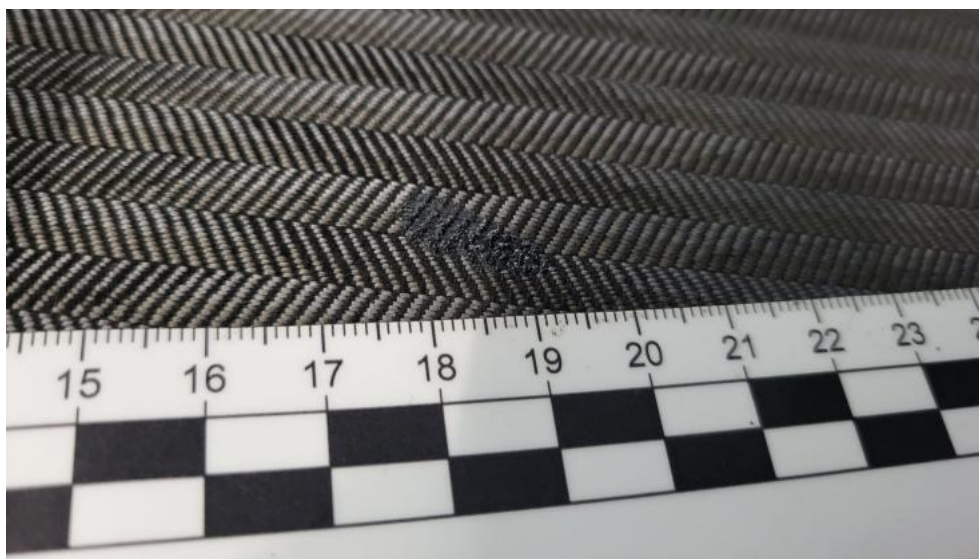
**Photo 61.**  
Fotel prz. lew. - Inne 1

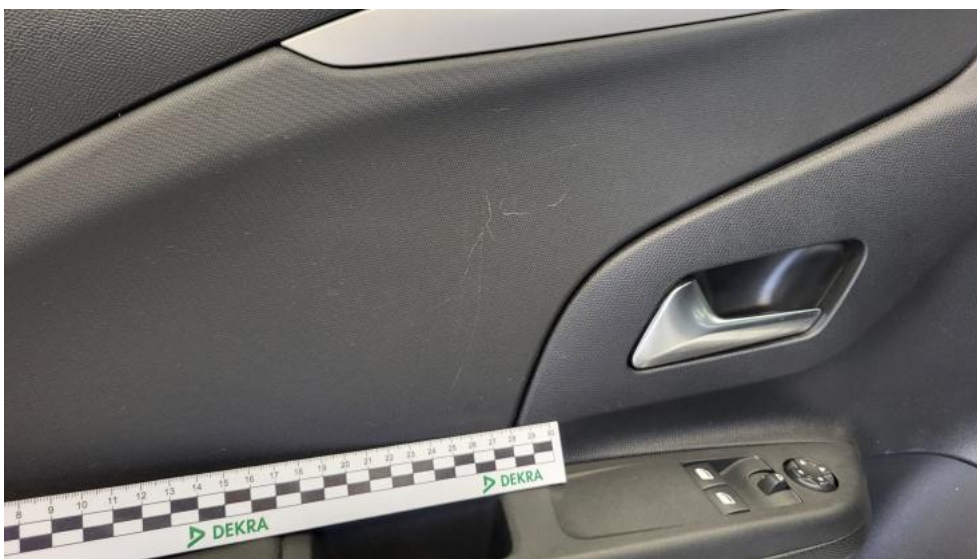
**Photo 63.**  
Tapicerka drzwi przednich L - Rysa/odprysk 1

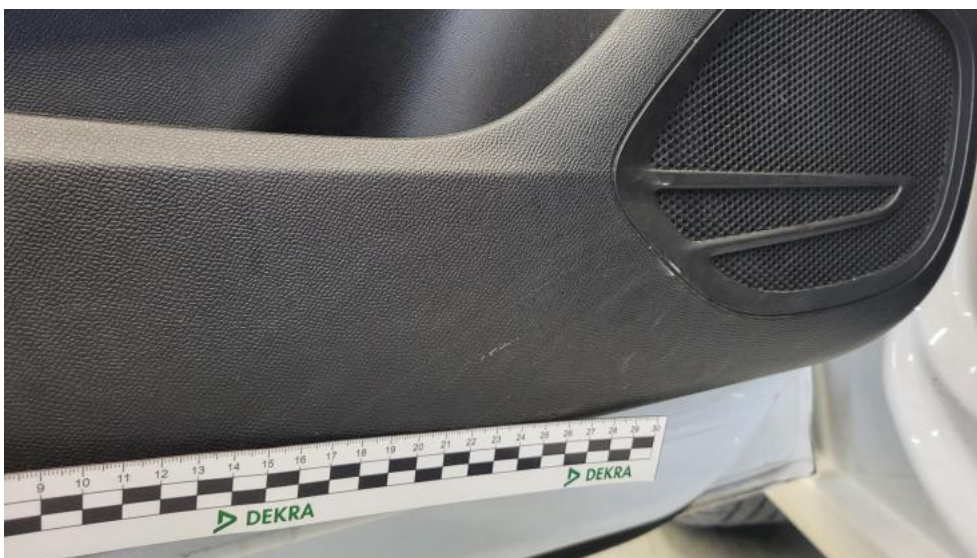
**Photo 64.**  
Tapicerka drzwi przednich L - Rysa/odprysk 2

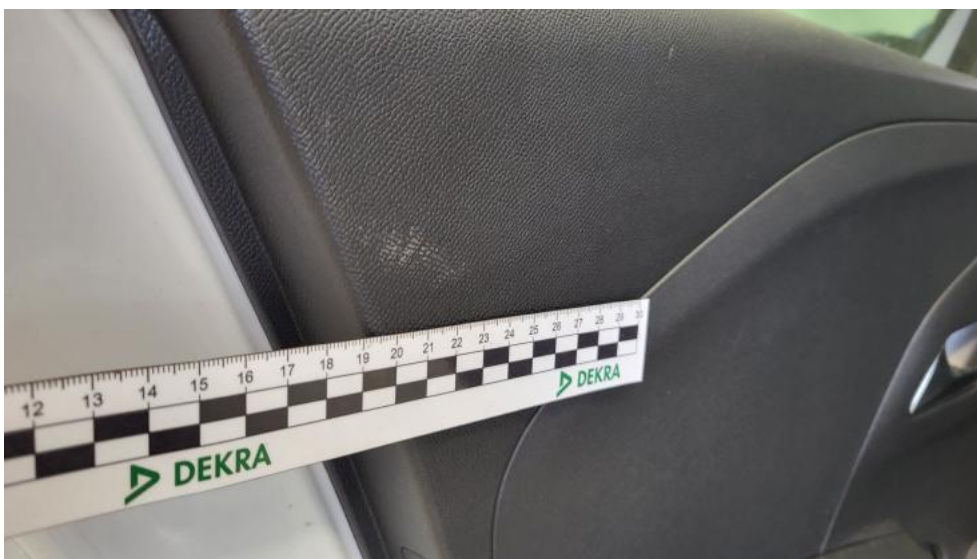
**Photo 65.**  
Tapicerka drzwi tylnych L - Rysa/odprysk 1

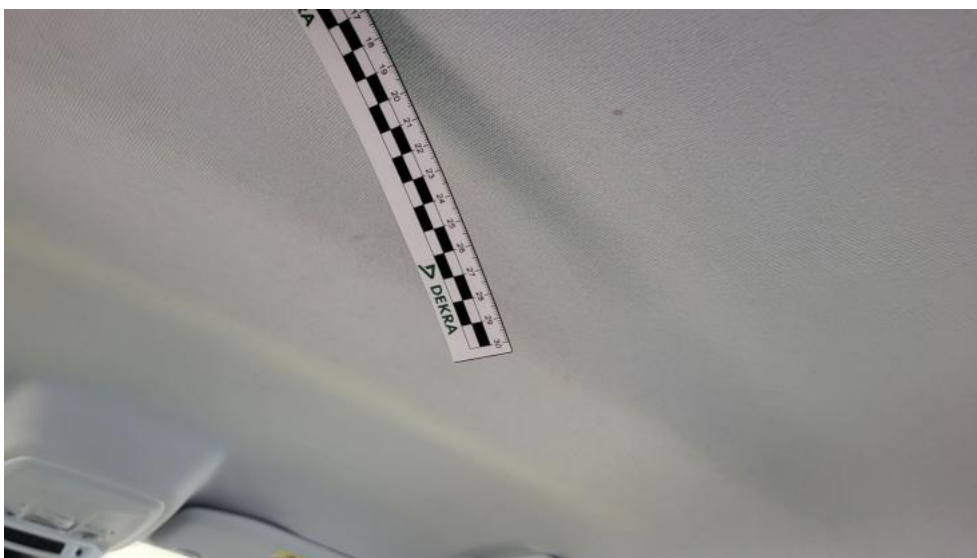
**Photo 66.**  
Podsufitka - Inne 1
