DEKRA's commission No. : PKOL(W)/LODZ/72770/24/09/20
 commission/ damage No. : 00481/LF/23
 Date of commission: 20-09-2024

Vehicle data

| Manufacturer | TOYOTA |
| Model | Corolla Sedan 18-22 |

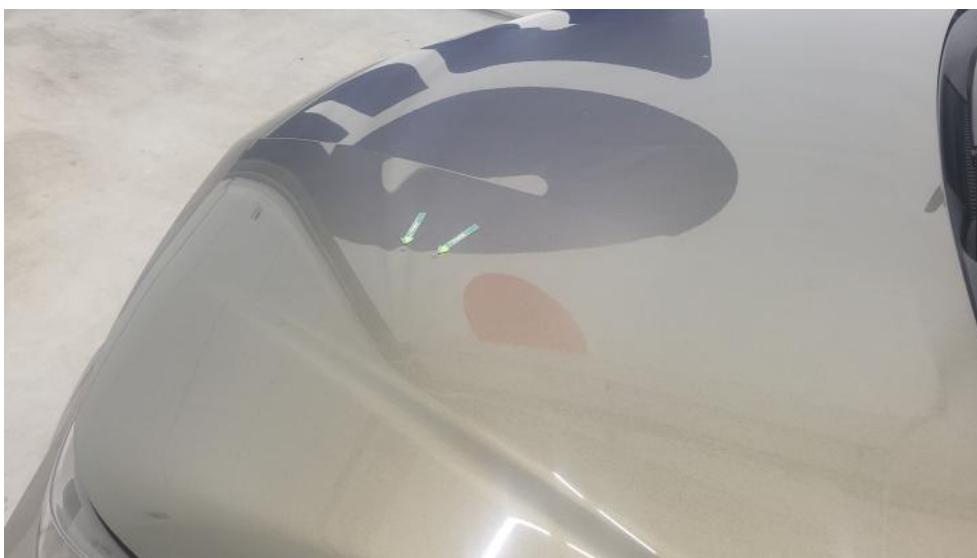
Photo 38.
Pokrywa komory silnika - Wgniecenie/odkształcenie 1

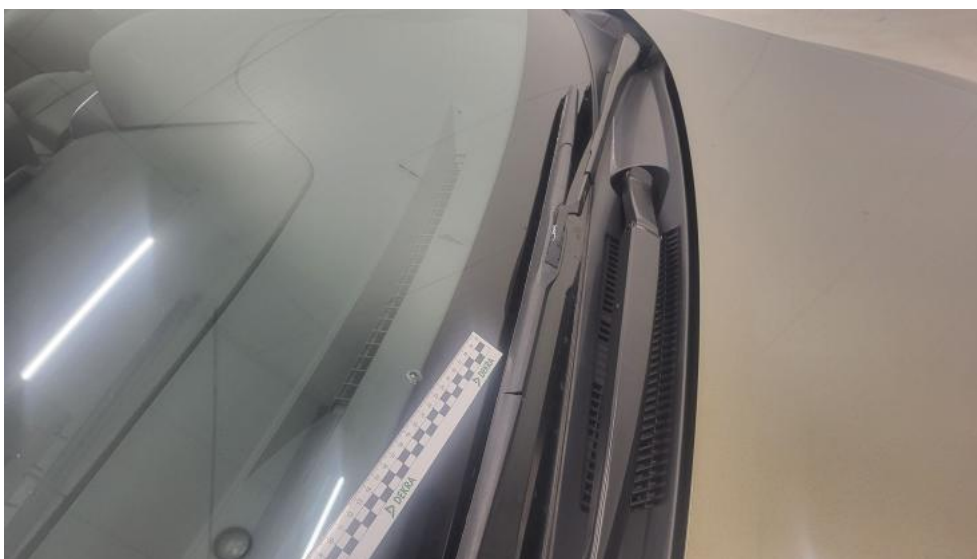
Photo 39.
Szyba czołowa - Pęknięcie/rozerwanie 1

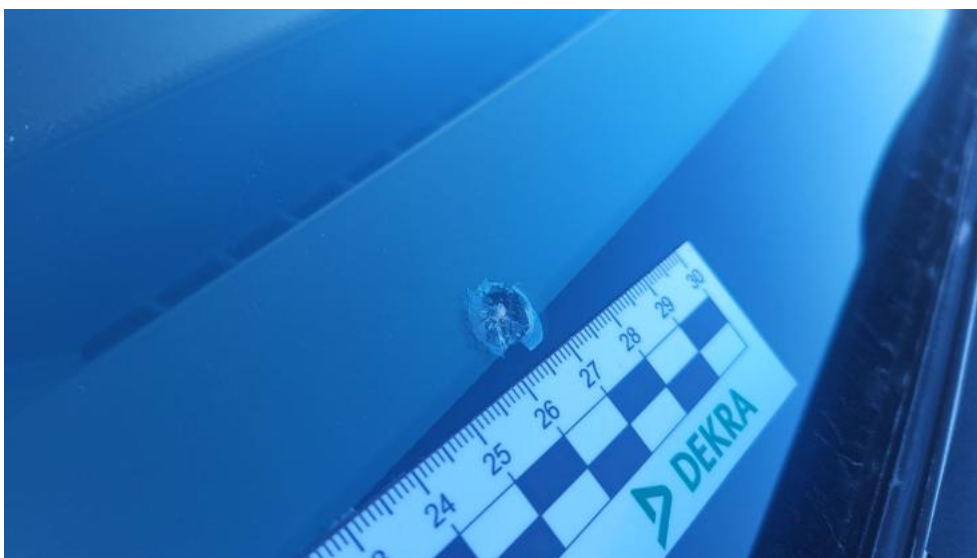
Photo 40.
Szyba czołowa - Pęknięcie/rozerwanie 2

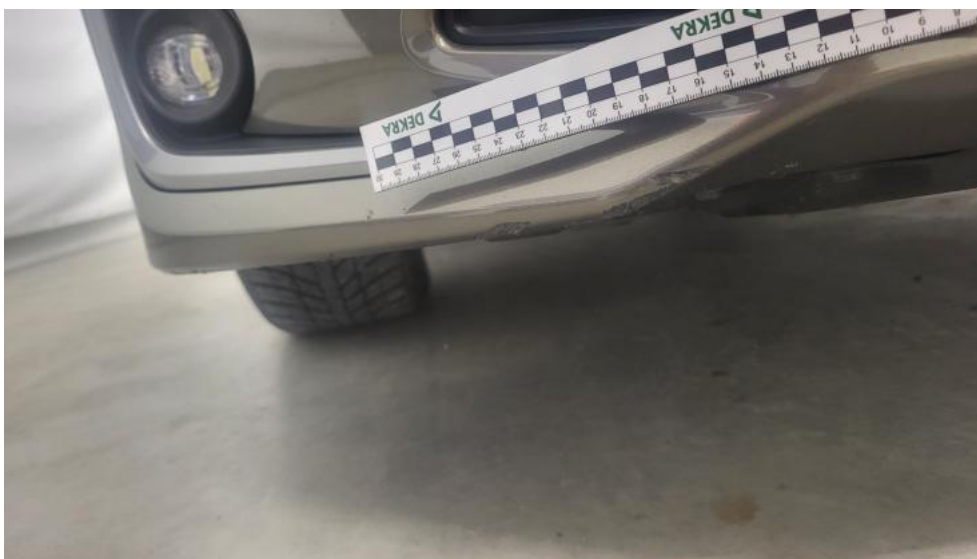
Photo 41.
Zderzak - Rysa/odprysk 1

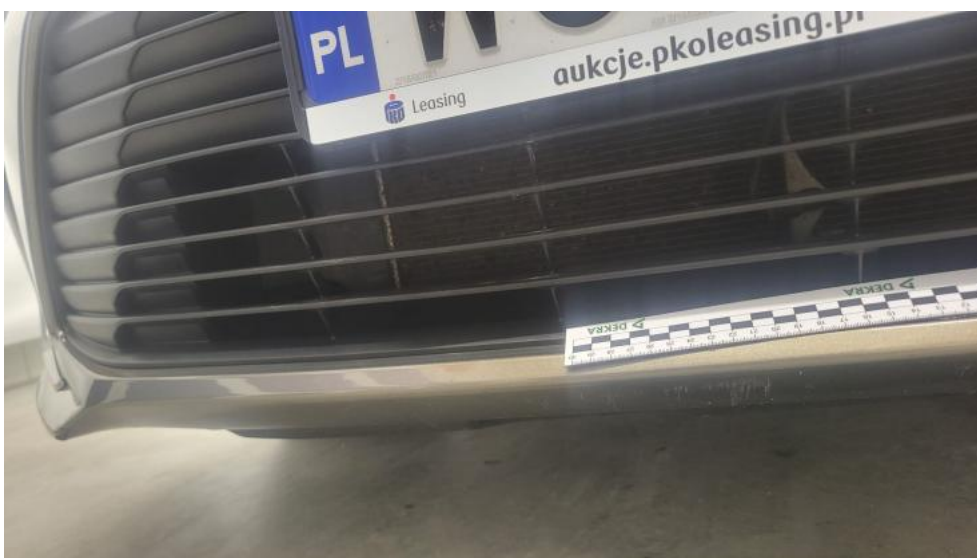
Photo 42.
Zderzak - Rysa/odprysk 2

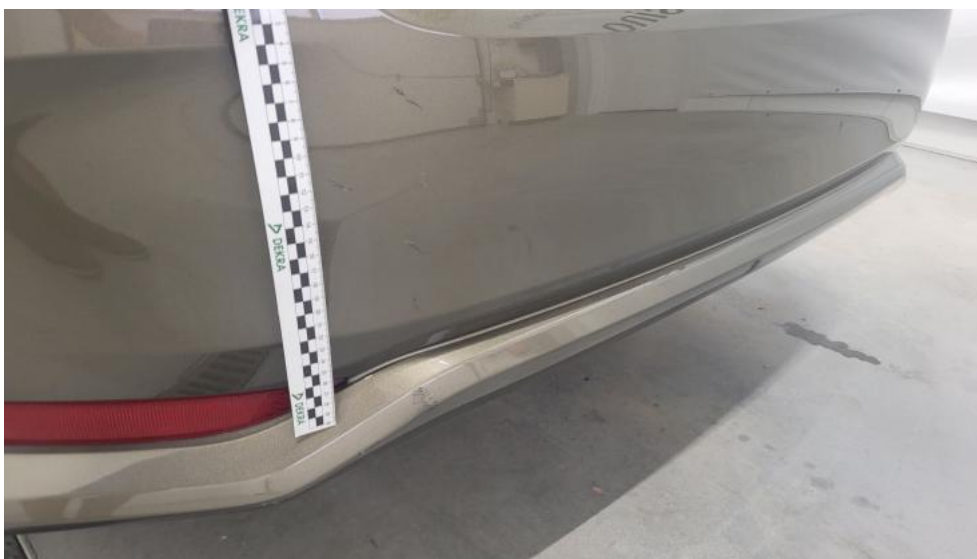
Photo 43.
Zderzak tylny - Rysa/odprysk 1

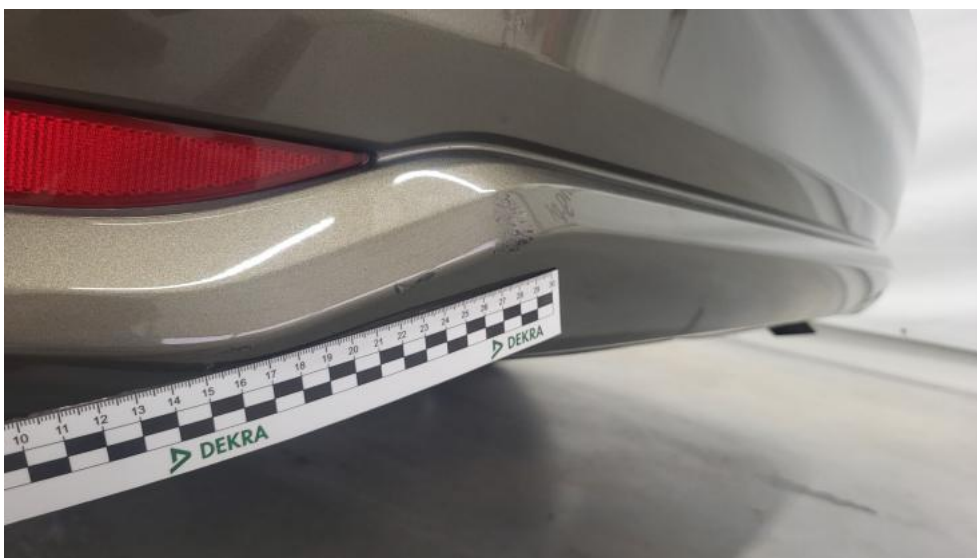
Photo 44.
Zderzak tylny - Rysa/odprysk 2

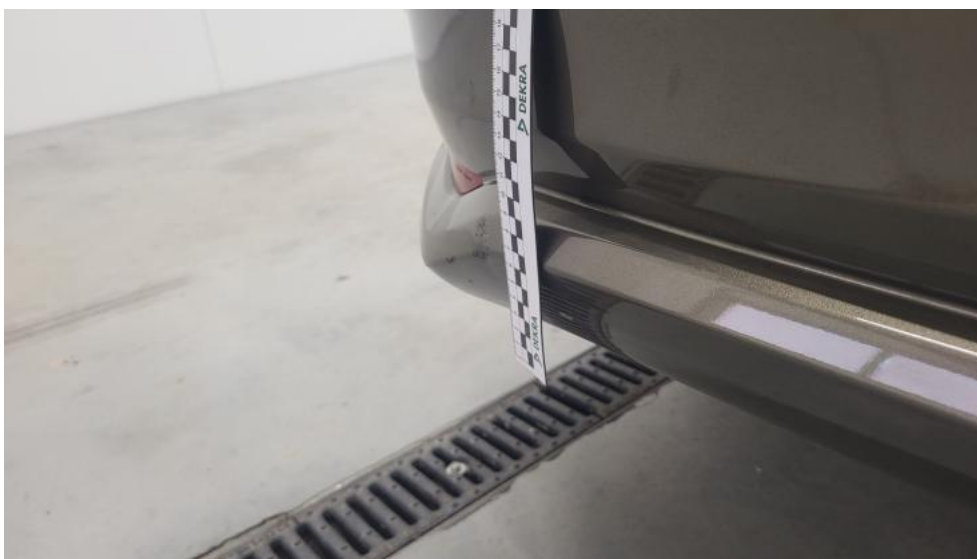
Photo 45.
Zderzak tylny - Wgniecenie/odkształcenie 1

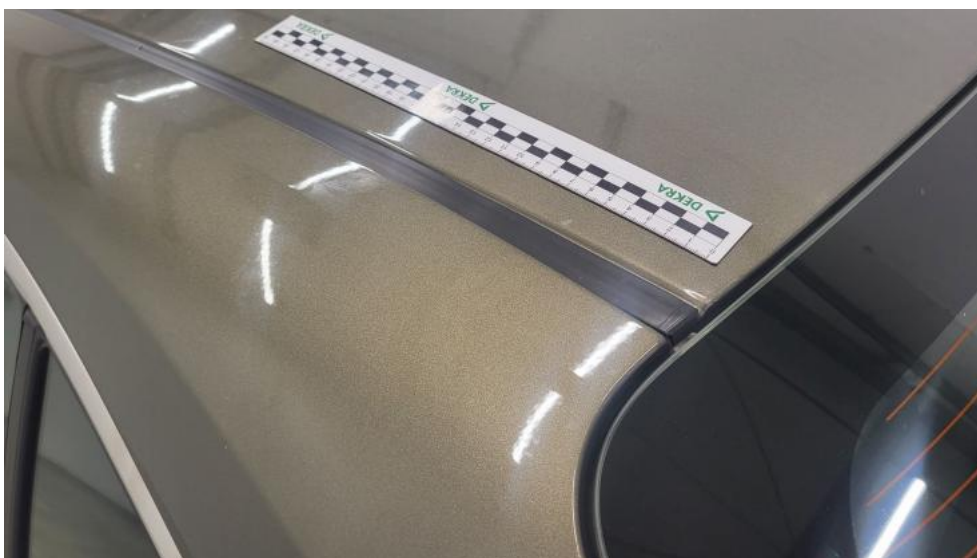
Photo 46.
Dach - Rysa/odprysk 1

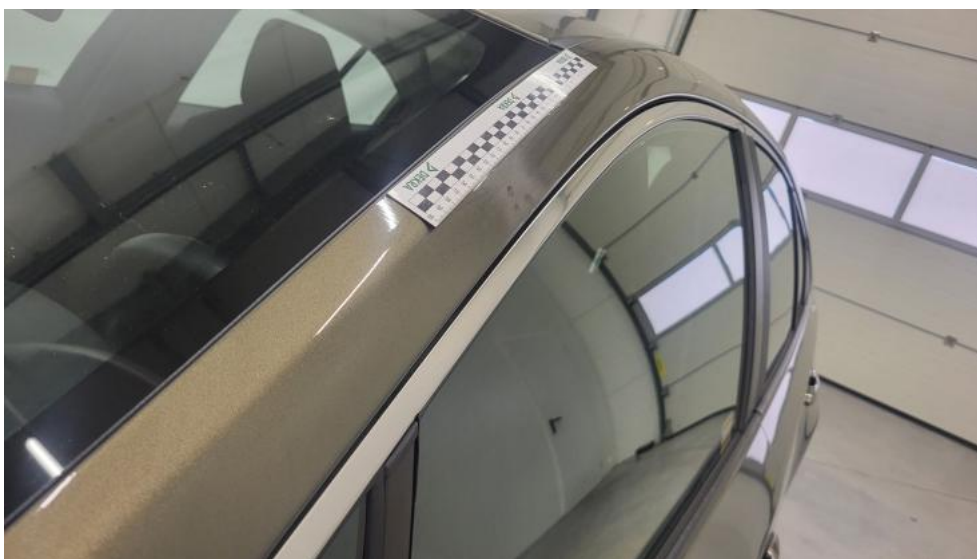
Photo 47.
Stupek przedni L - Inne 1

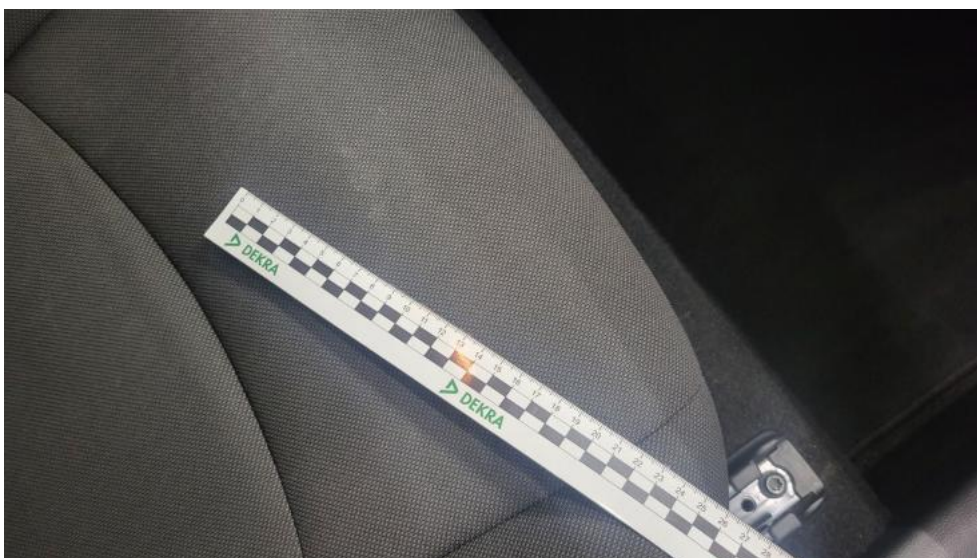
Photo 48.
Fotel prz. praw. - Inne 1

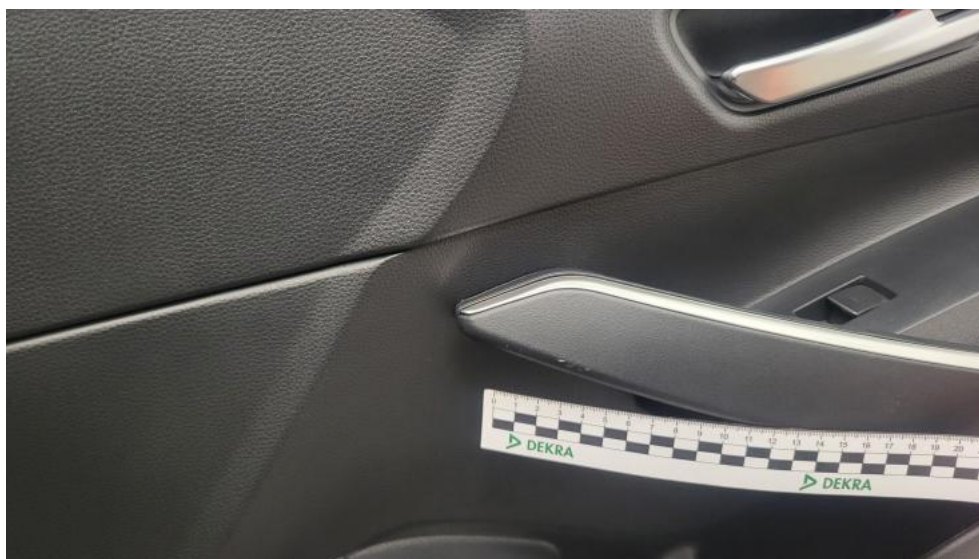
Photo 49.

Uchwyt drzwi prze P - Rysa/odprysk 1
