DEKRA's commission No. : PKOL(W)/LODZ/19354/25/03/17  
commission/ damage No. : Futura  
Date of commission: 17-03-2025

**Client :**

| Manufacturer | AUDI |
| Type / version | A8 L 60 TFSI mHEV Quattro Tiptr. |

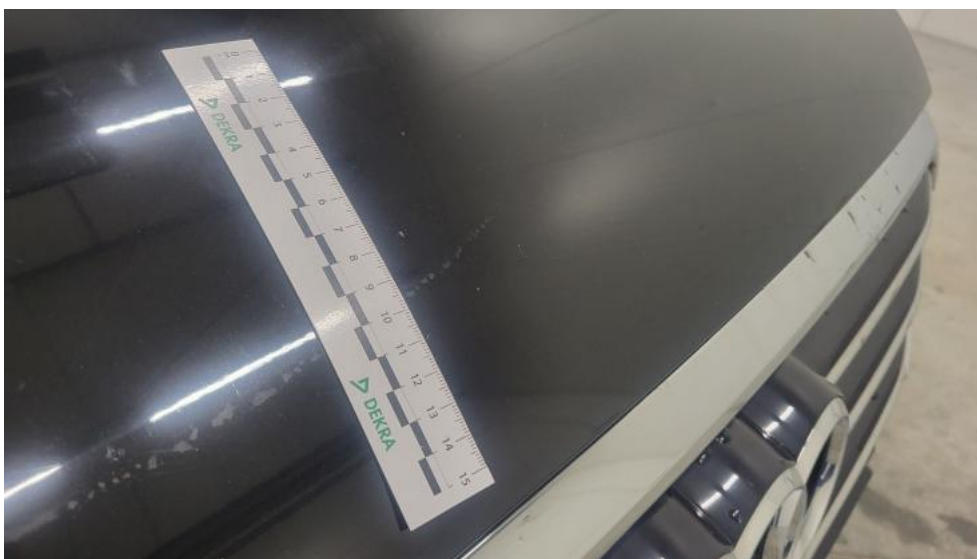
**Photo 43.**

Pokrywa komory silnika - Rysa/odprysk 1

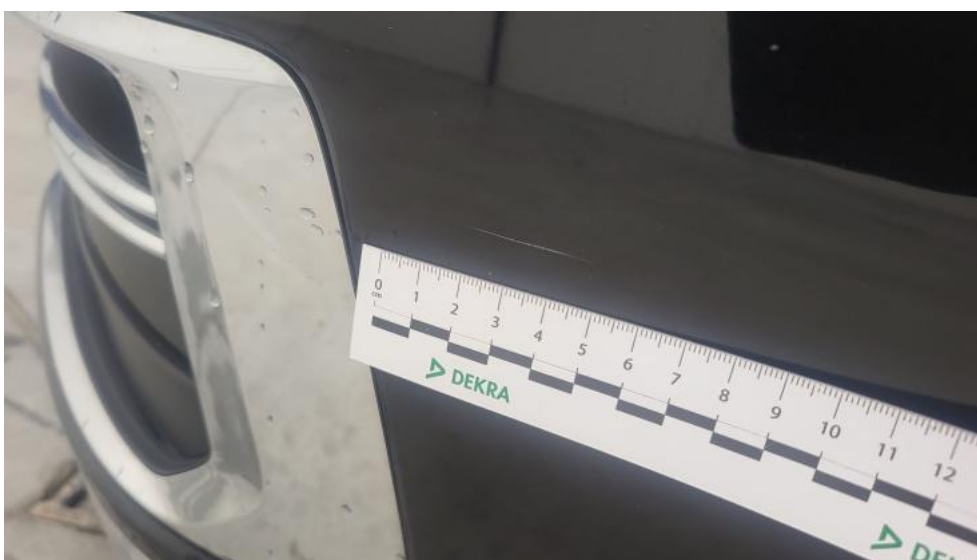
**Photo 44.**

Zderzak - Rysa/odprysk 1

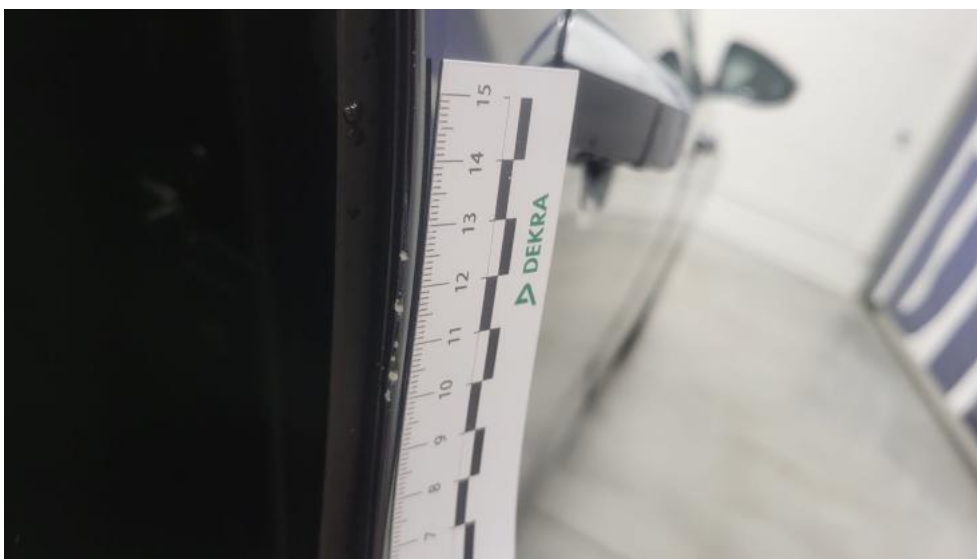
**Photo 45.**

Drzwi tylne P - Rysa/odprysk 1

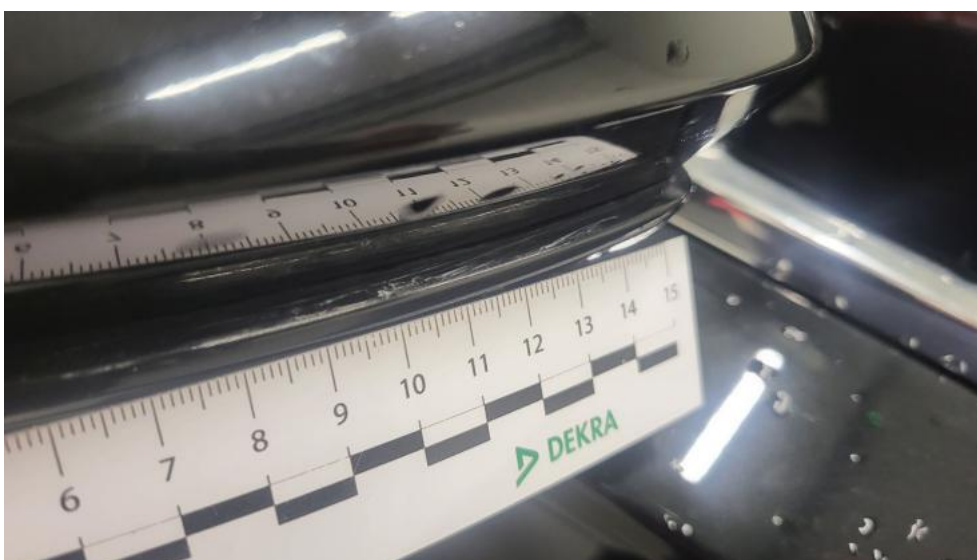
**Photo 46.**

Lusterko zew P - Rysa/odprysk 1

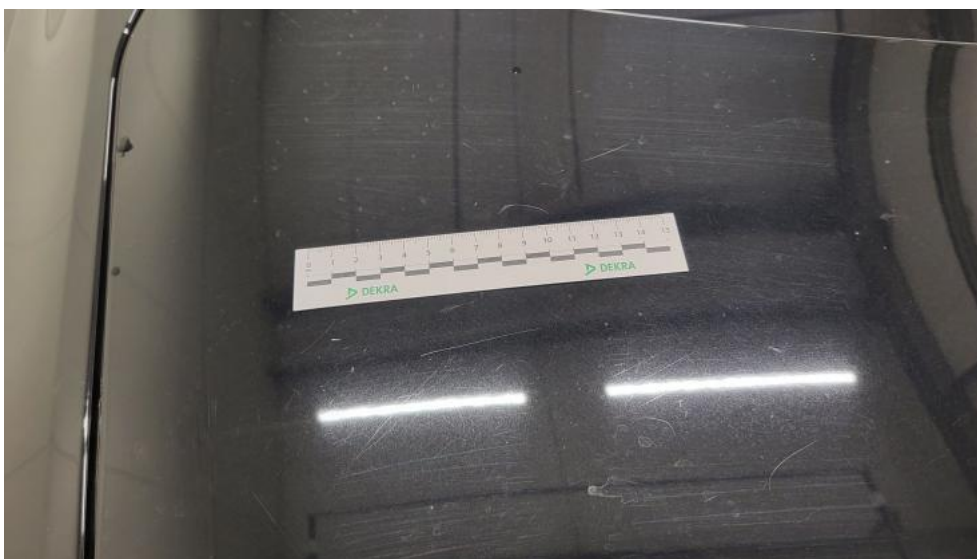
**Photo 47.**

Pokrywy bagażnika - Rysa/odprysk 1

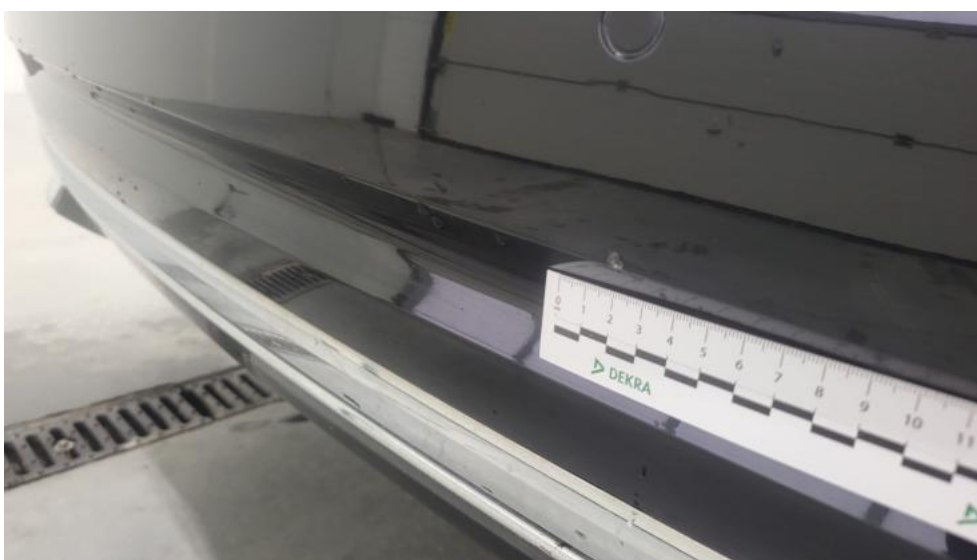
**Photo 48.**

Zderzak tylny - Rysa/odprysk 1

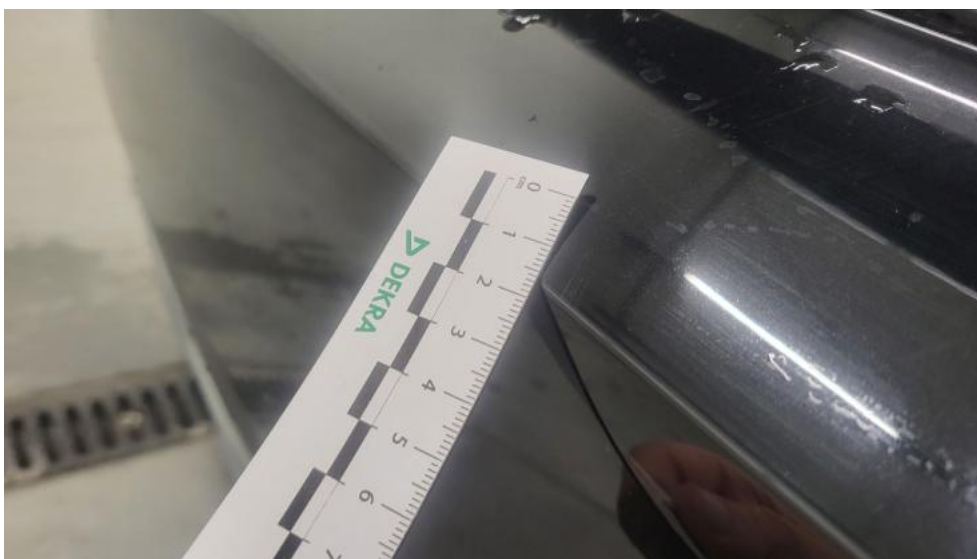
**Photo 49.**

Zderzak tylny - Rysa/odprysk 2

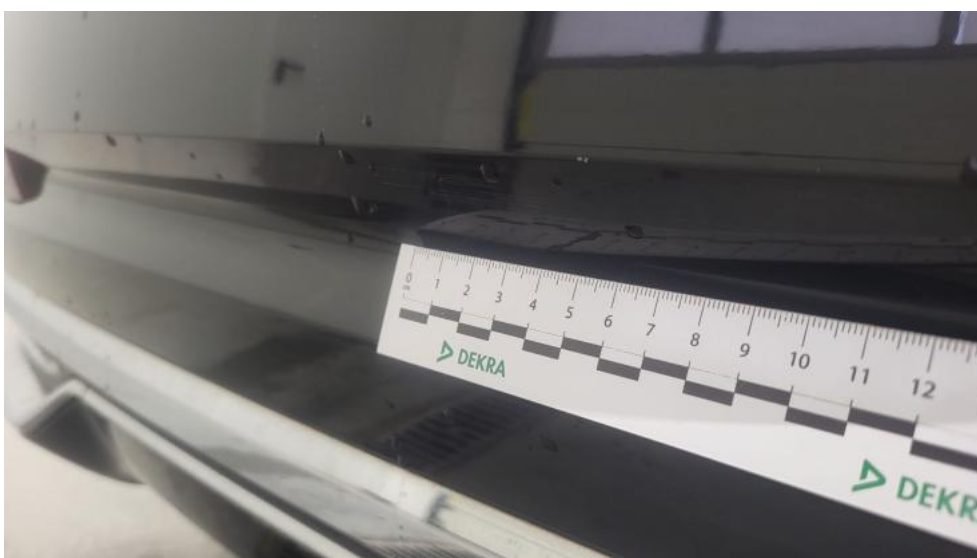
**Photo 50.**

Zderzak tylny() - Rysa/odprysk 3

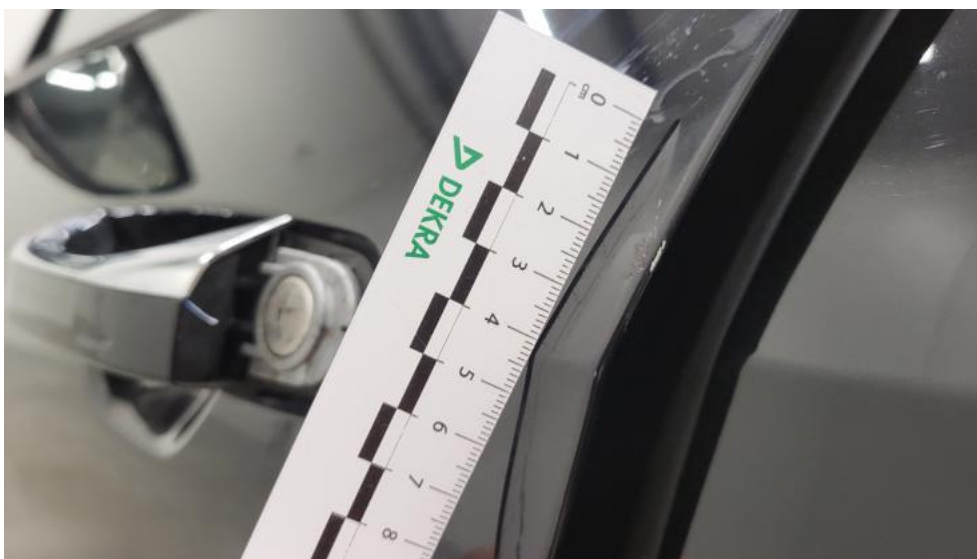
**Photo 51.**

Drzwi przed L - Rysa/odprysk 1

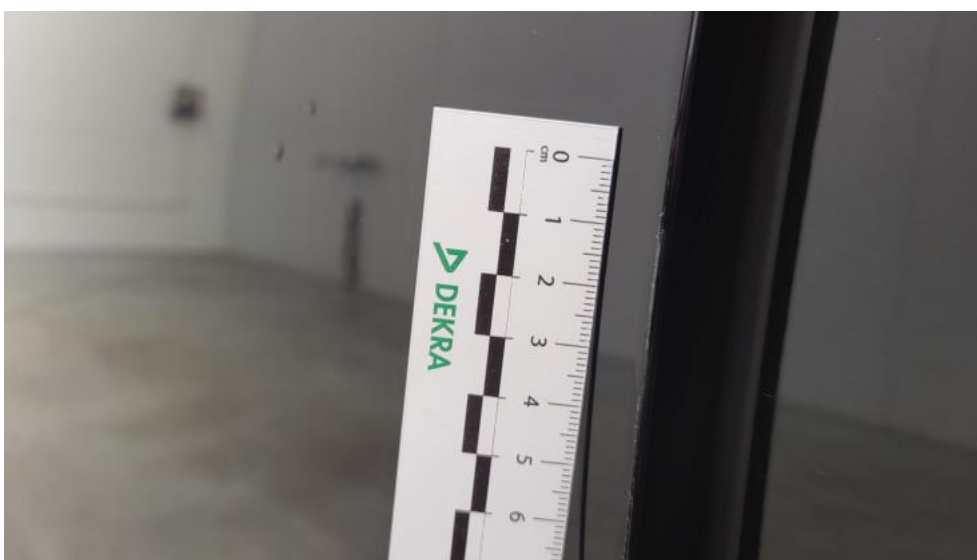
**Photo 52.**

Drzwi przed L - Rysa/odprysk 2

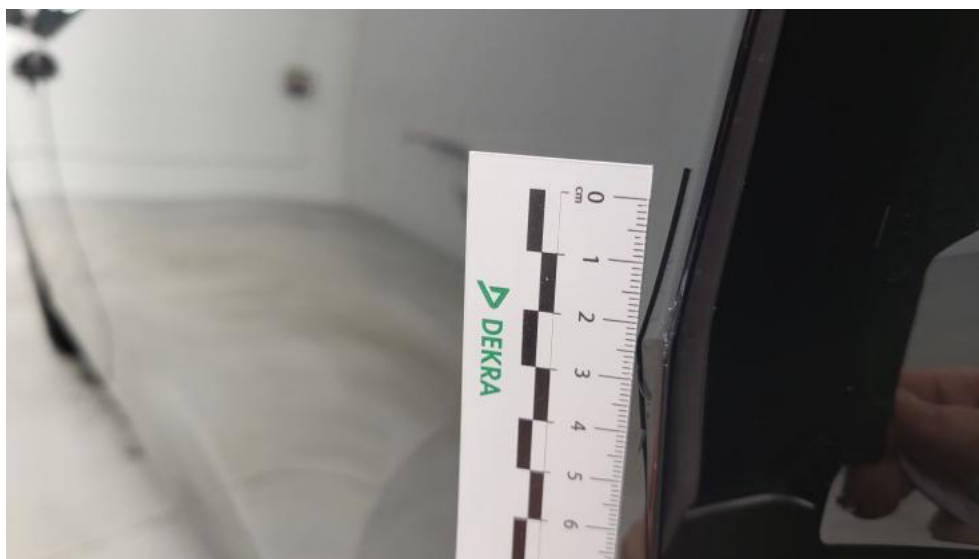
**Photo 53.**

Drzwi tylne L - Rysa/odprysk 1

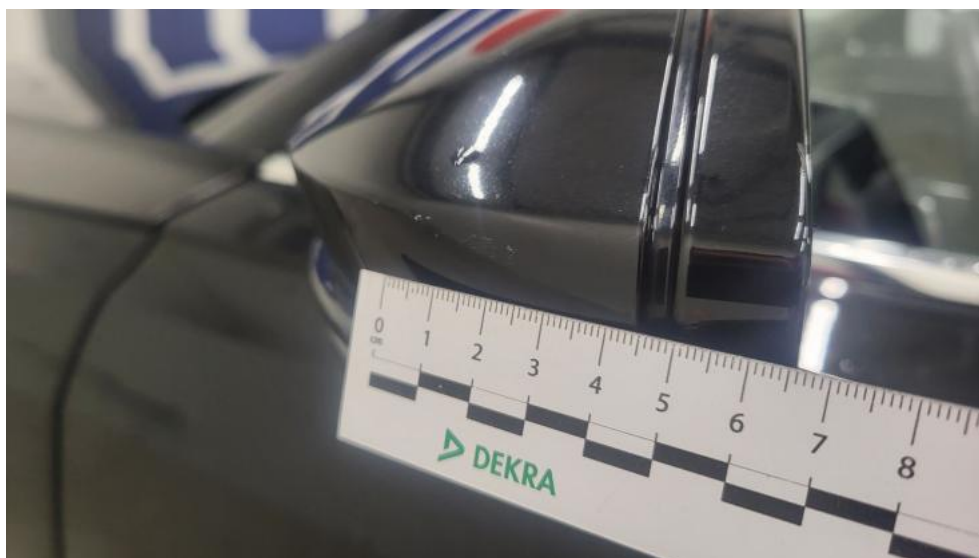
**Photo 54.**

Lusterko zew L - Rysa/odprysk 1

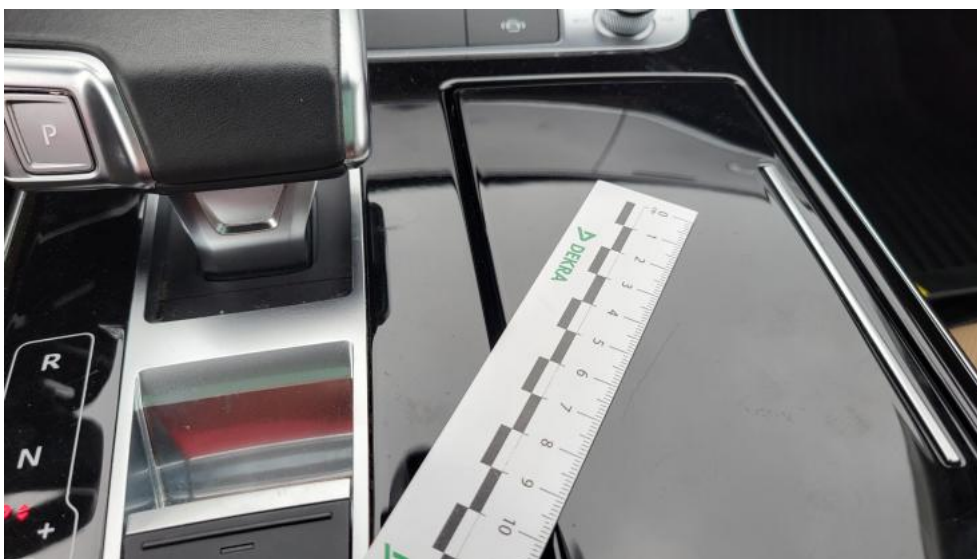
**Photo 55.**

Konsola tunelu śr. - Rysa/odprysk 1

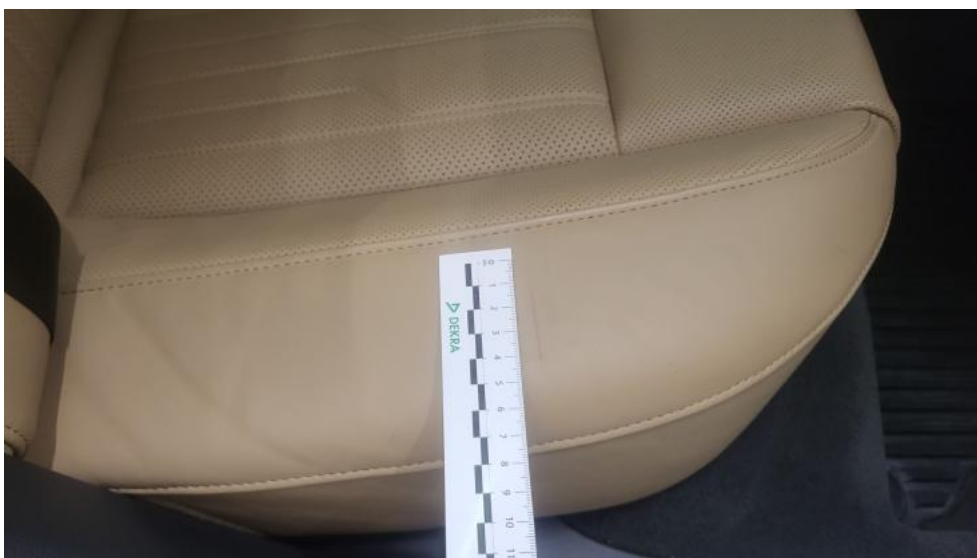
**Photo 56.**

Kanapa tyl. - Inne 1
