DEKRA's commission No. : PKOL(W)/LODZ/19375/25/03/17  
commission/ damage No. : Futura  
Date of commission: 17-03-2025

PKO Leasing SA  
Świętokrzyska 36  
00-116 Warszawa

Group of objects (Eurotax)	cars
EC code (Eurotax)	0137057
Manufacturer	FORD
Model	Mondeo Kombi 19-21
Type / version	Mondeo 2.0 EcoBlue Titanium AWD aut
Body type	KOM
Number of doors / seats	5/5
Curb weight [kg]	1797
Gross vehicle weight [kg]	2365
Wheelbase 1/2	2850
Engine type	Automatic ignition
Supercompression	turbocompressor with intercooler
Pollution reduction system	KSC
Emission standard	EURO 6
Engine capacity [ccm]	1997
Engine Power [hp/kW]	190/140
Gearbox	automatic 8- gear
Registration /record No.	WD2087N
VIN / serial number	WF0FXXWPCFKU82228
Date of first registration	11-12-2019
Date of next. tech. test	27-11-2025
Year of manufacture	2019 (year has been verified with the manufacturer's base)
Readout [km]	123 600 (read)
Body color / type of coating	black/2-warstwowy uni

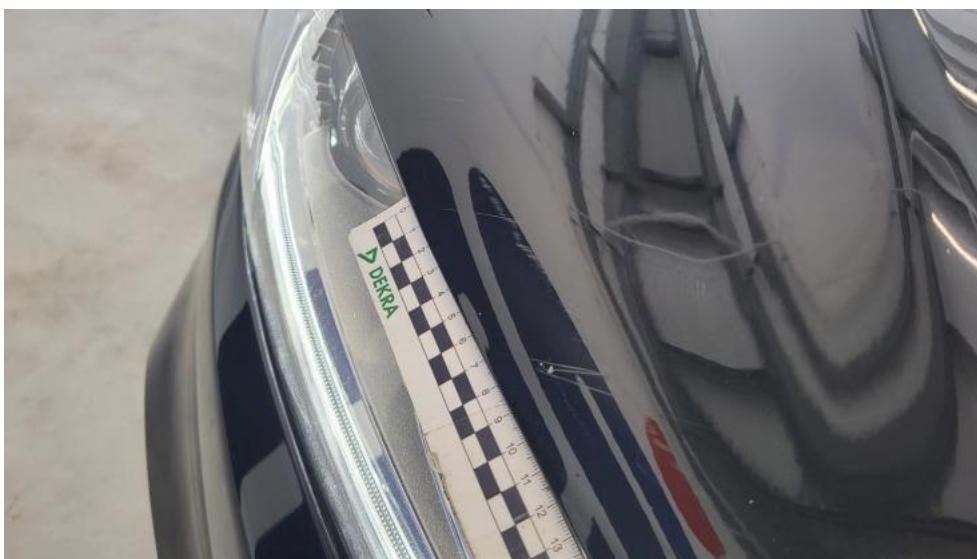
**Photo 39.**  
Pokrywa komory silnika - Rysa/odprysk 1

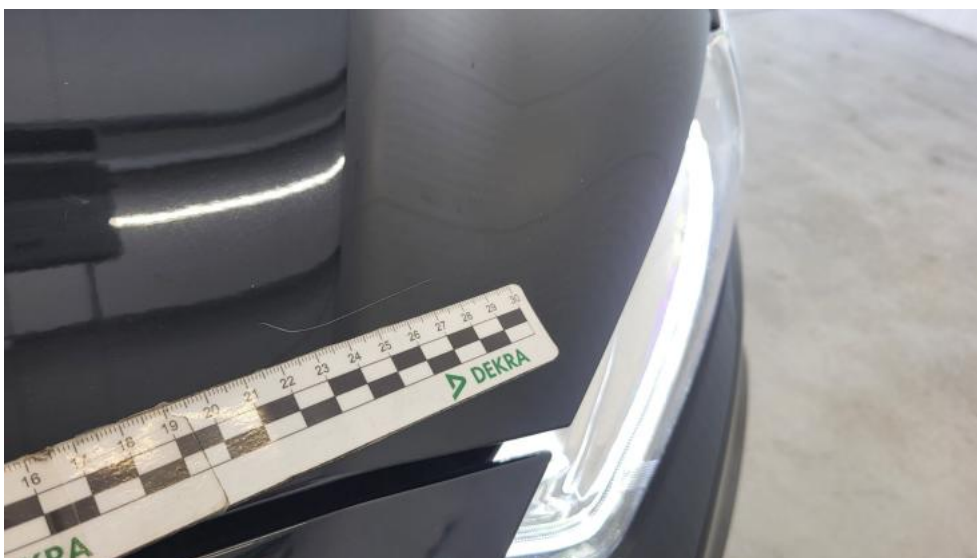
**Photo 40.**  
Pokrywa komory silnika - Rysa/odprysk 2

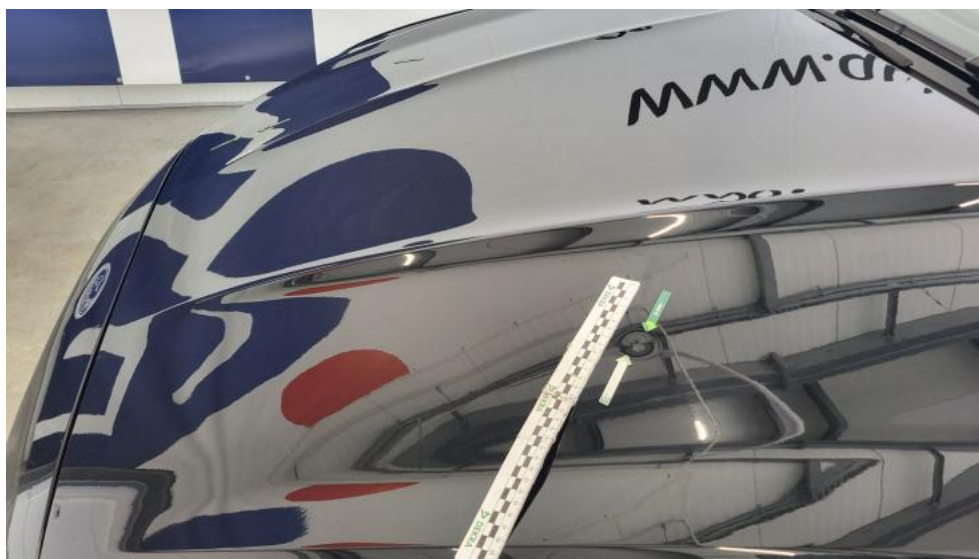
**Photo 41.**  
Pokrywa komory silnika - Wgniecenie/odkształcenie 1

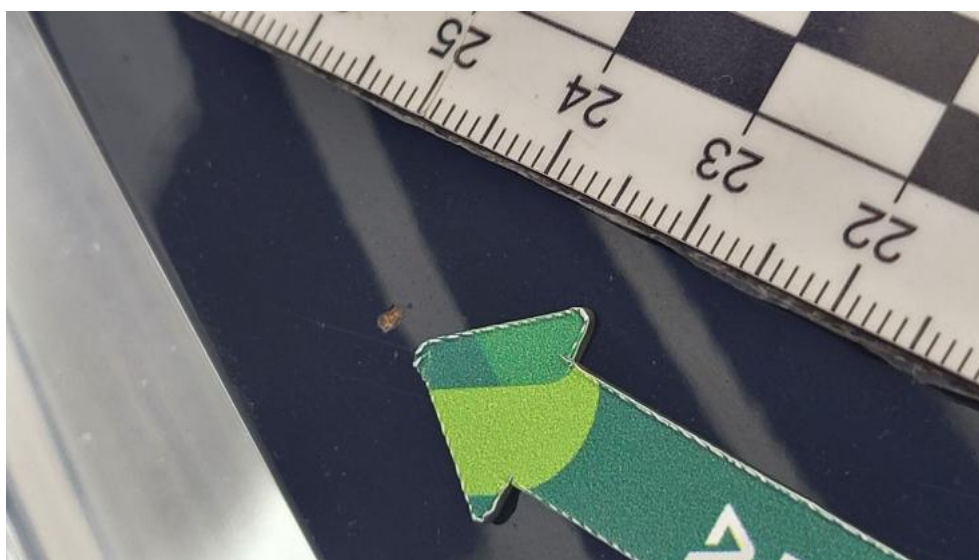
**Photo 42.**  
Pokrywa komory silnika - Inne 1

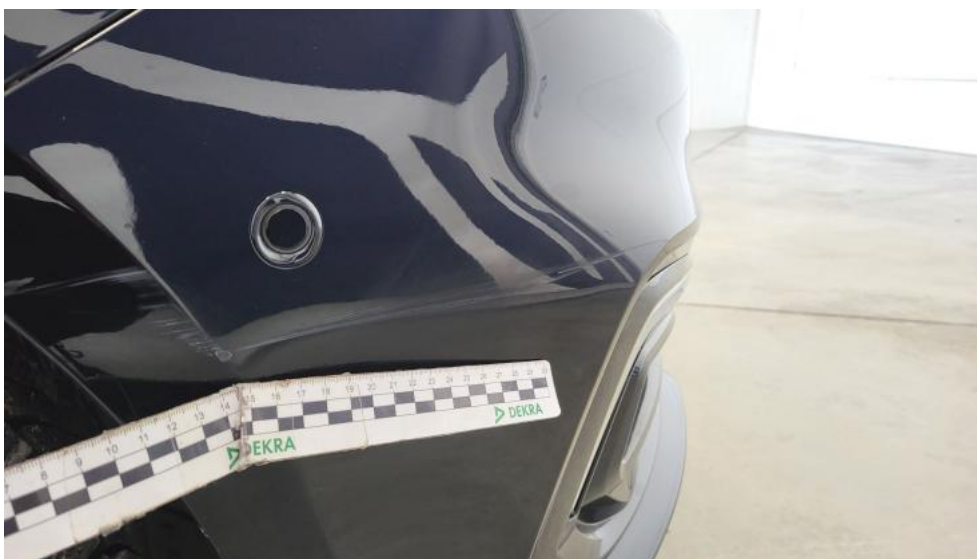
**Photo 43.**  
Zderzak - Rysa/odprysk 1

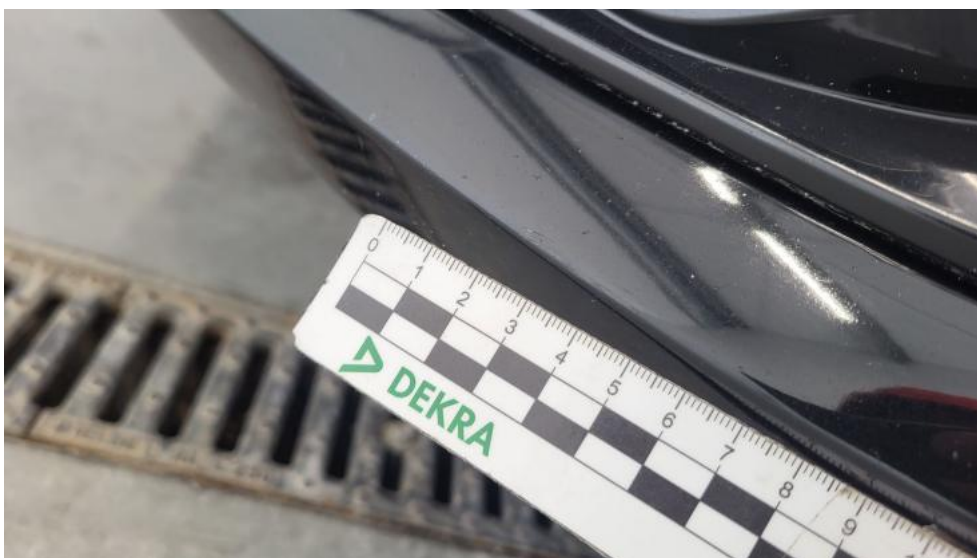
**Photo 44.**  
Zderzak - Rysa/odprysk 2

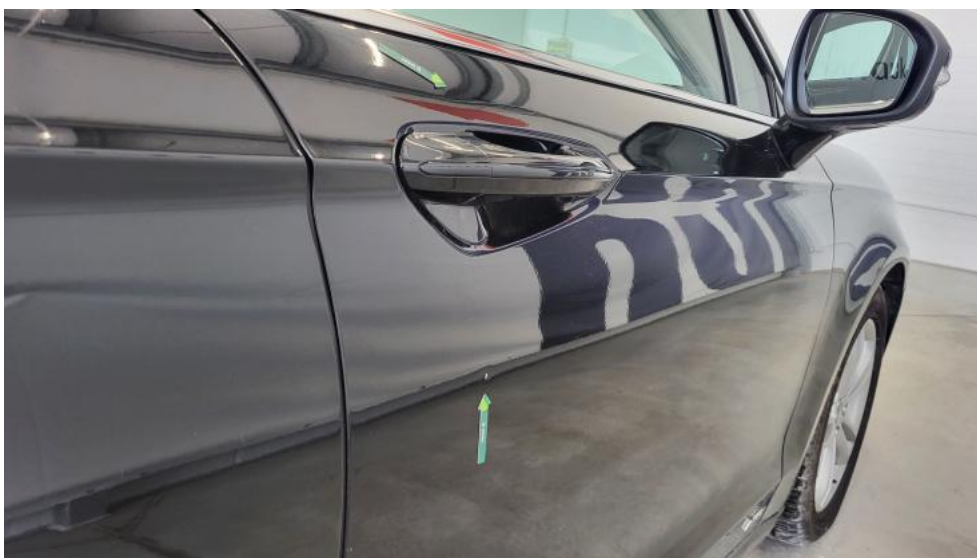
**Photo 46.**

Drzwi przednie P - Wgniecenie/odkształcenie 1

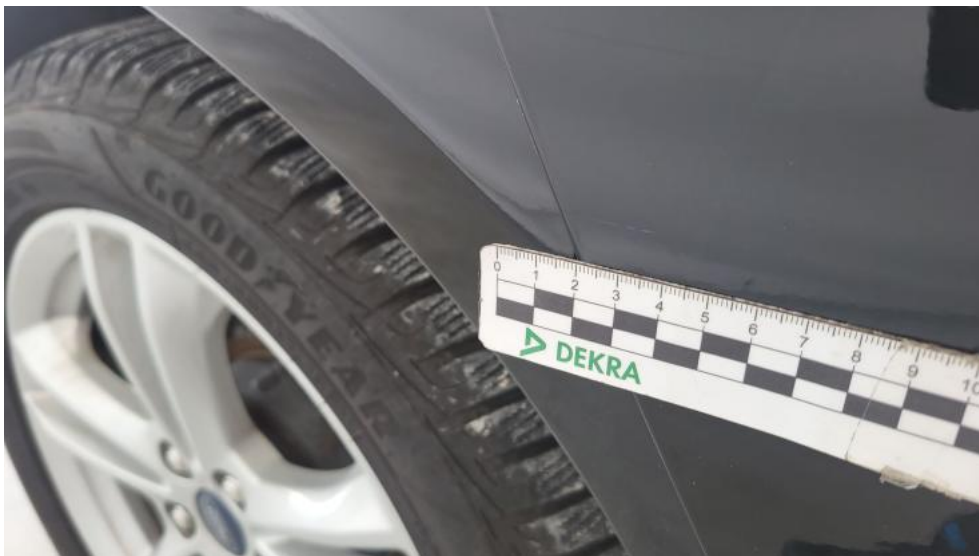
**Photo 47.**

Drzwi tylne P - Rysa/odprysk 1

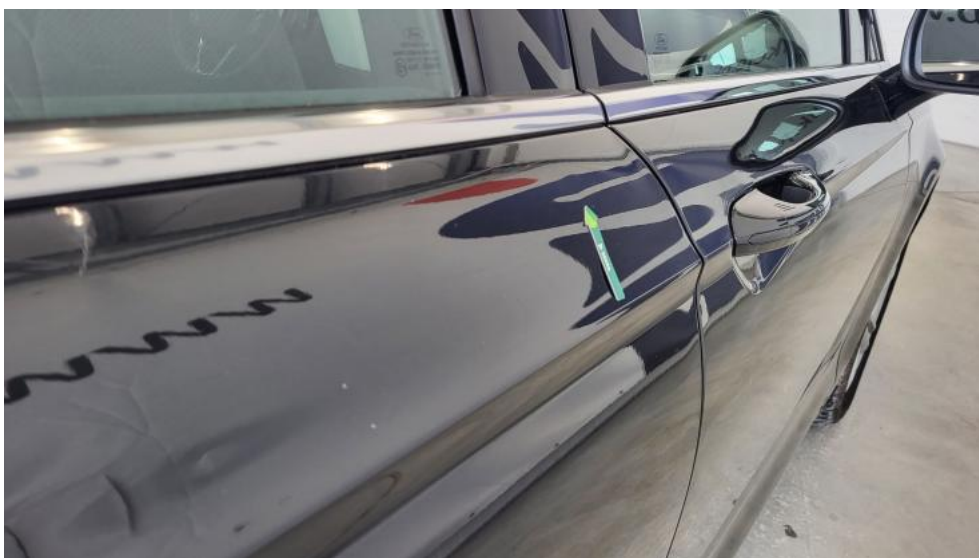
**Photo 48.**

Drzwi tylne P - Wgniecenie/odkształcenie 1

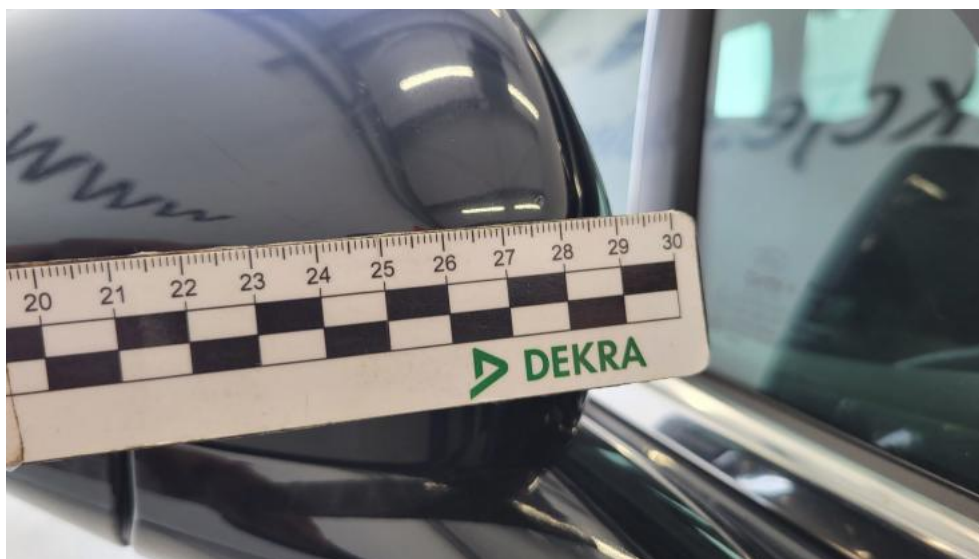
**Photo 49.**

Lusterko zew P - Rysa/odprysk 1

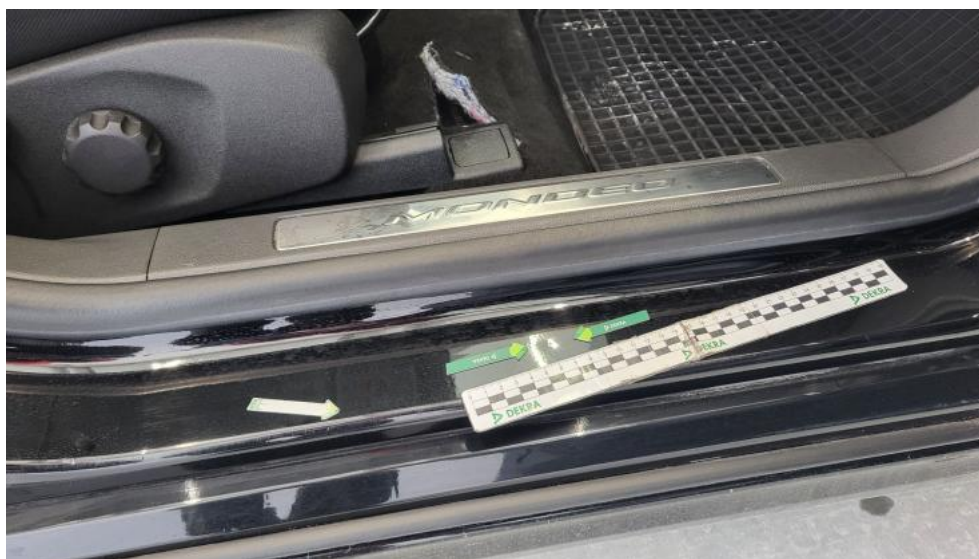
**Photo 51.**  
Próg P - Wgniecenie/odkształcenie 1

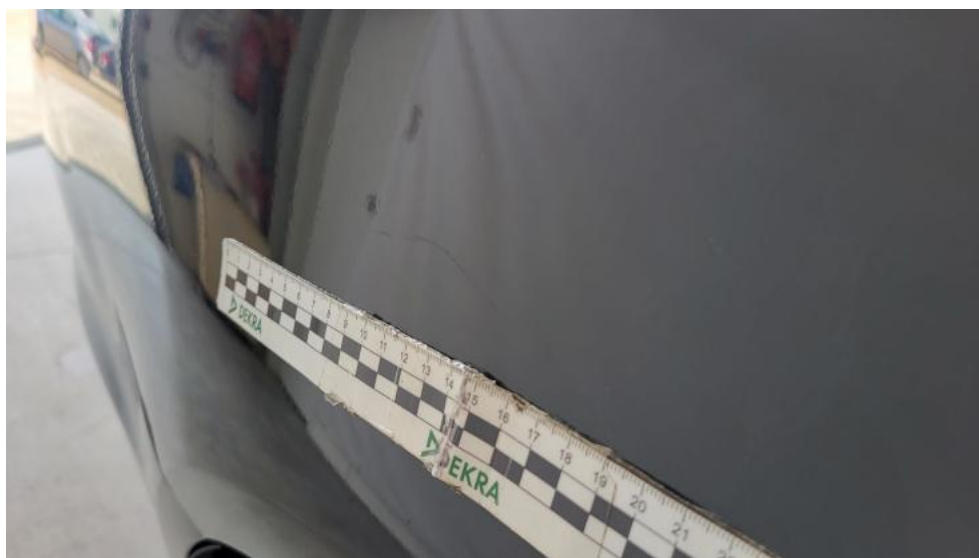
**Photo 52.**  
Błotnik tylny P / Ściana boczna P - Rysa/odprysk 1

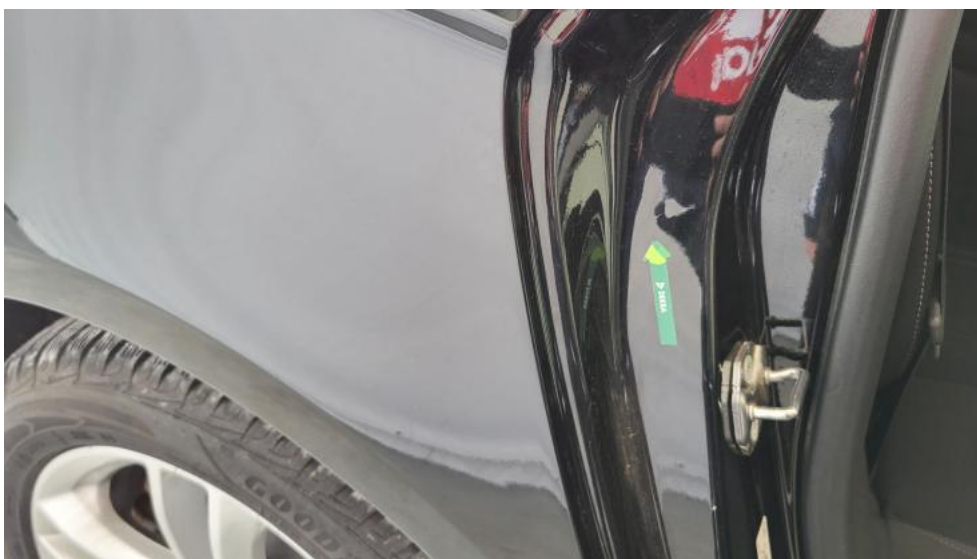
**Photo 53.**  
Błotnik tylny P / Ściana boczna P - Wgniecenie/odkształcenie 1

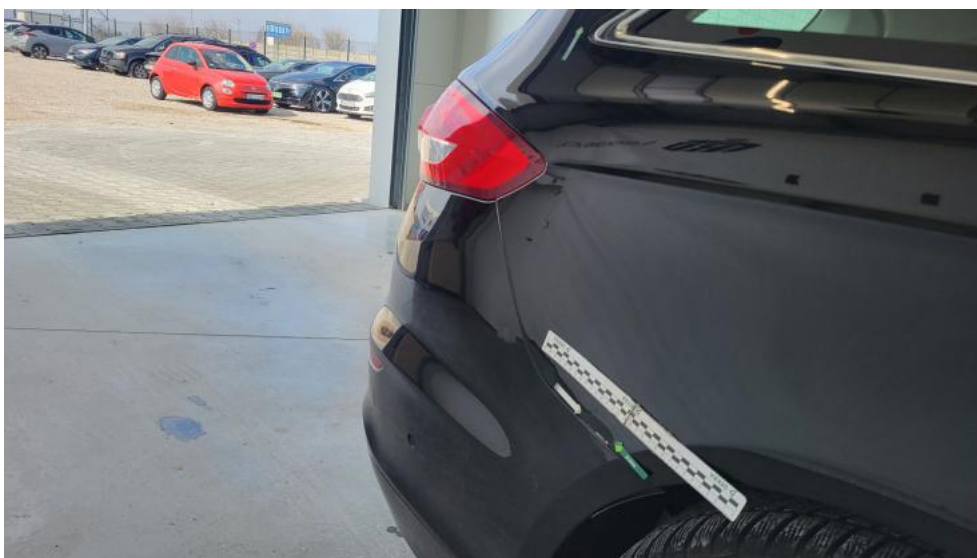
**Photo 54.**  
Błotnik tylny P / Ściana boczna P - Wgniecenie/odkształcenie 2

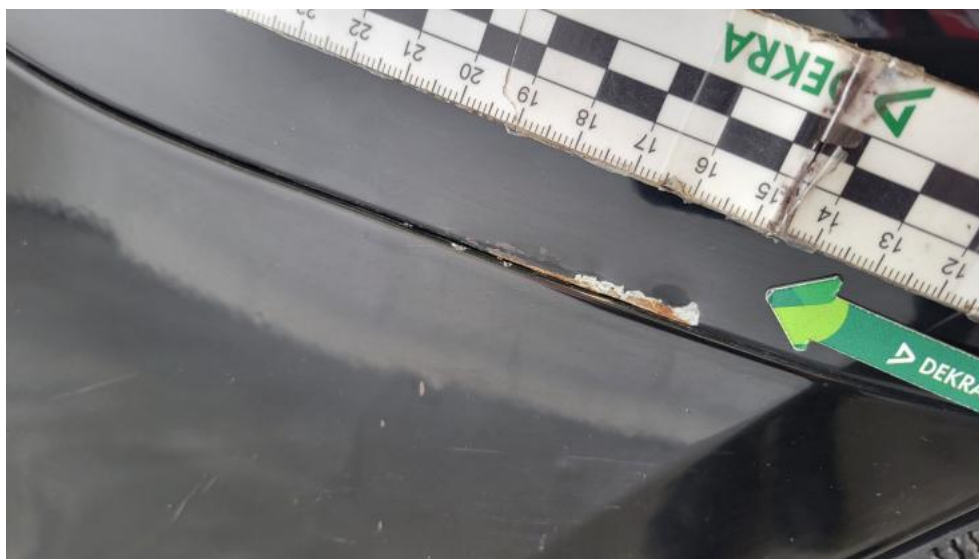
**Photo 55.**  
Błotnik tylny P / Ściana boczna P - Inne 1

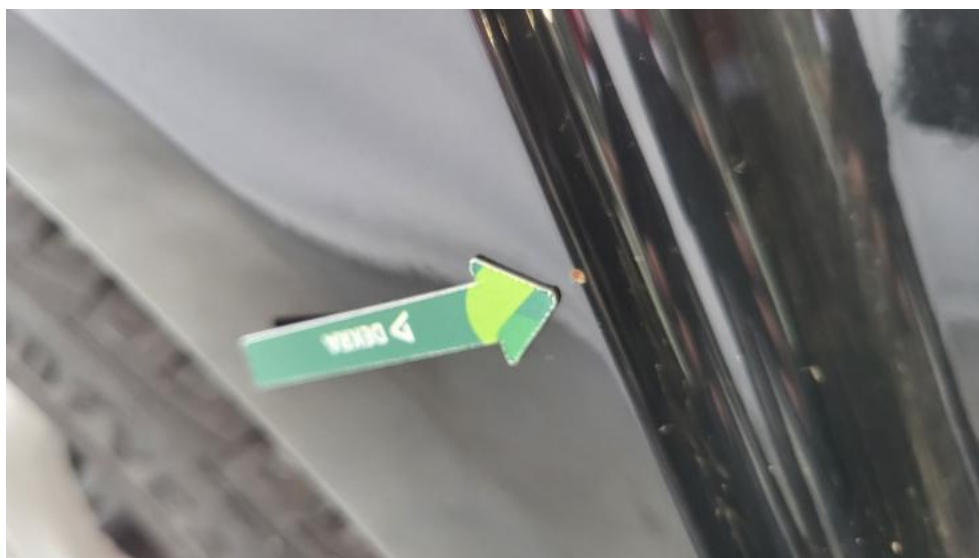
**Photo 56.**  
Błotnik tylny P / Ściana boczna P - Inne 2

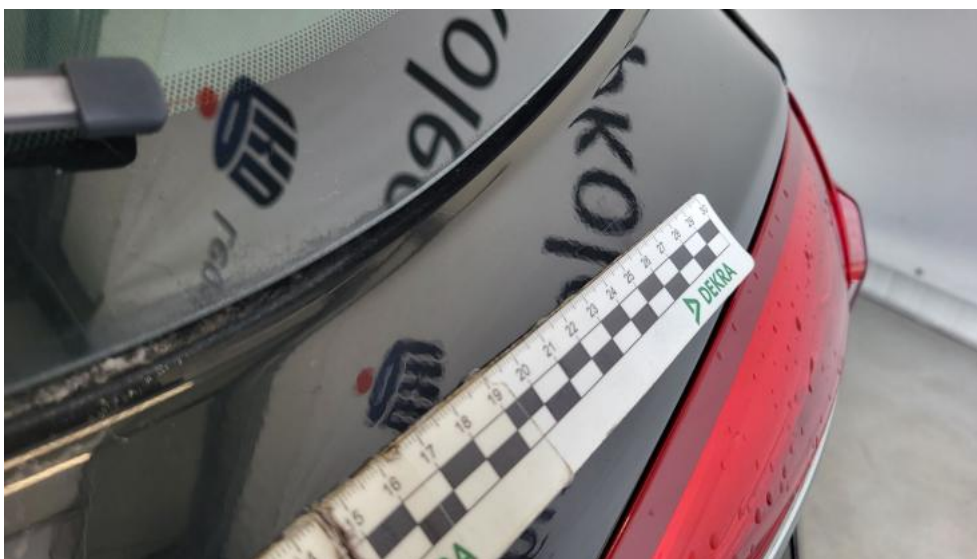
**Photo 57.**  
Pokrywy bagażnika - Rysa/odprysk 1

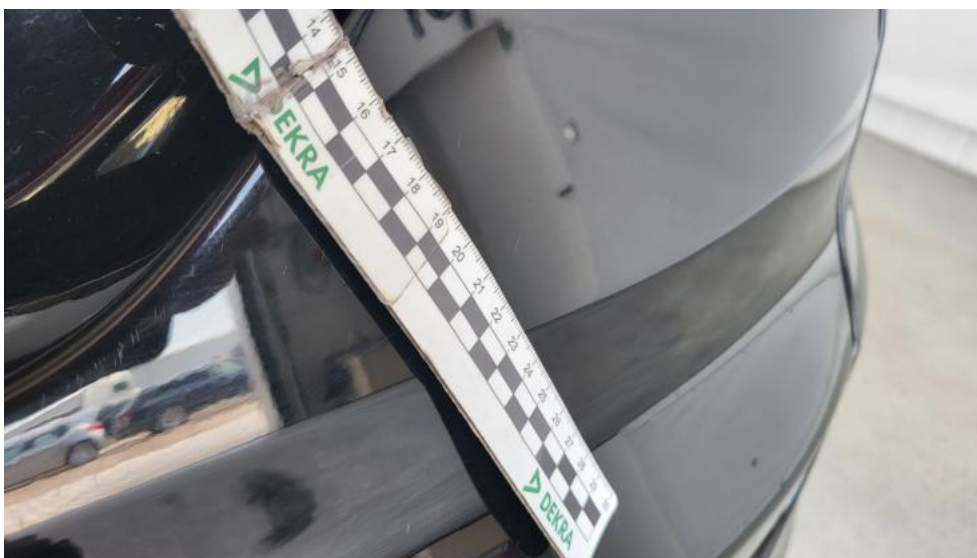
**Photo 58.**  
Pokrywy bagażnika - Rysa/odprysk 2

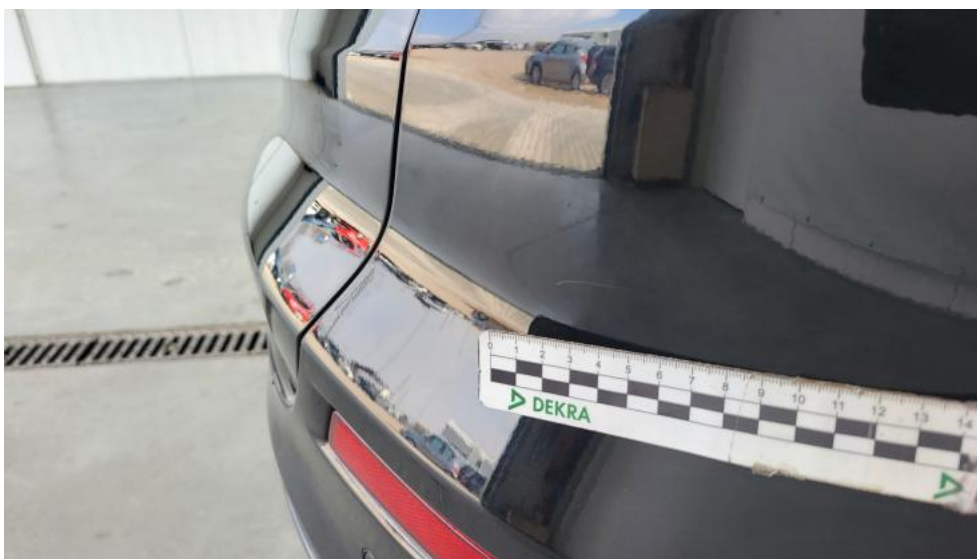
**Photo 59.**  
Zderzak tylny - Rysa/odprysk 1

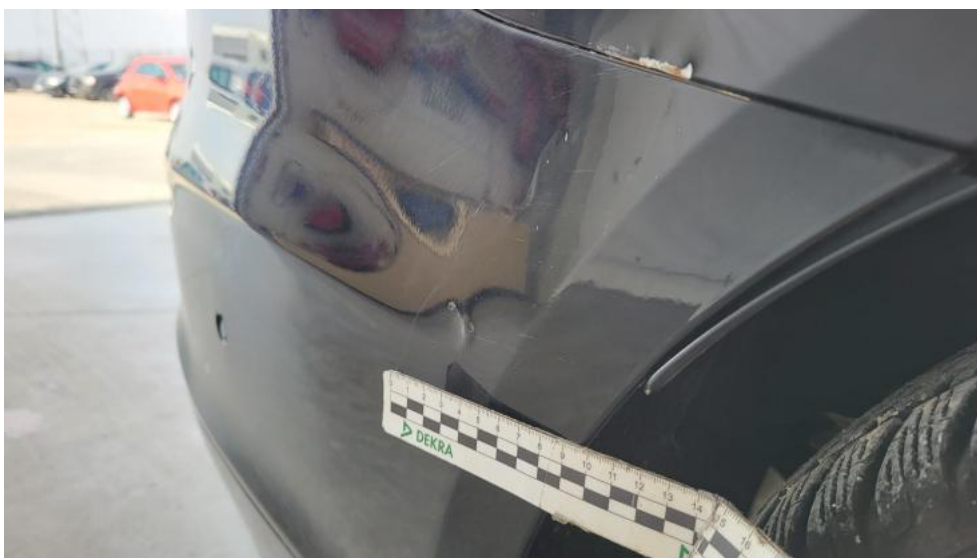
**Photo 60.**  
Zderzak tylny - Wgniecenie/odkształcenie 1

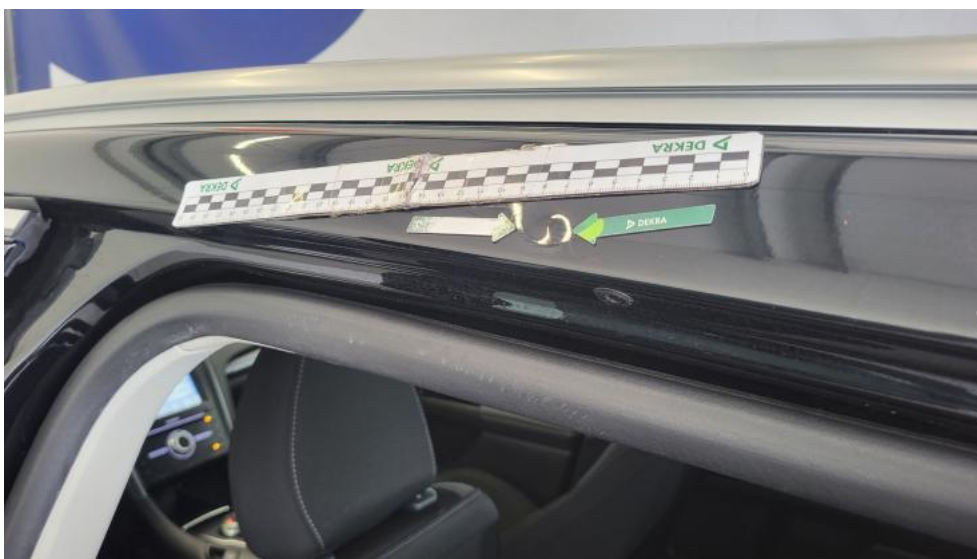
**Photo 61.**  
Błotnik tylny L / Ściana boczna L - Wgniecenie/odkształcenie 1

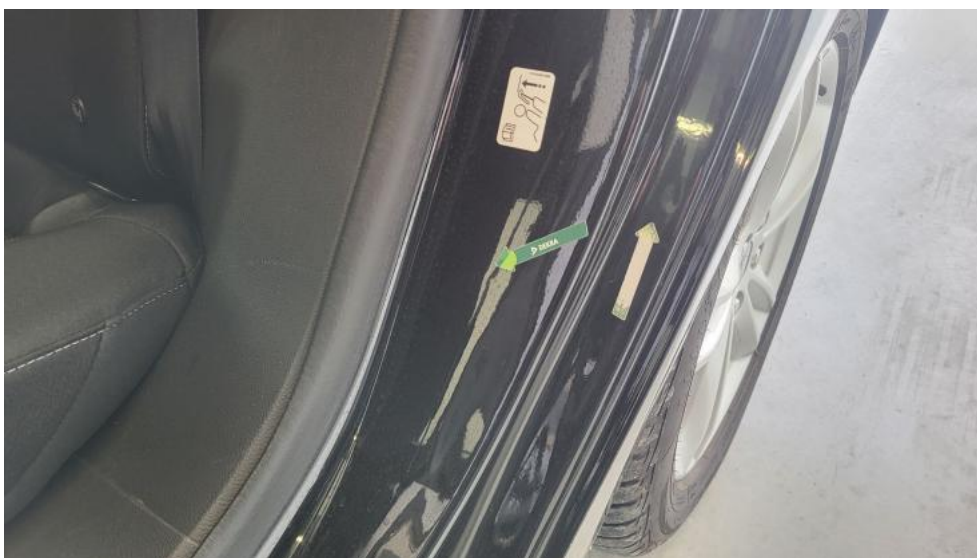
**Photo 62.**  
Błotnik tylny L / Ściana boczna L - Wgniecenie/odkształcenie 2

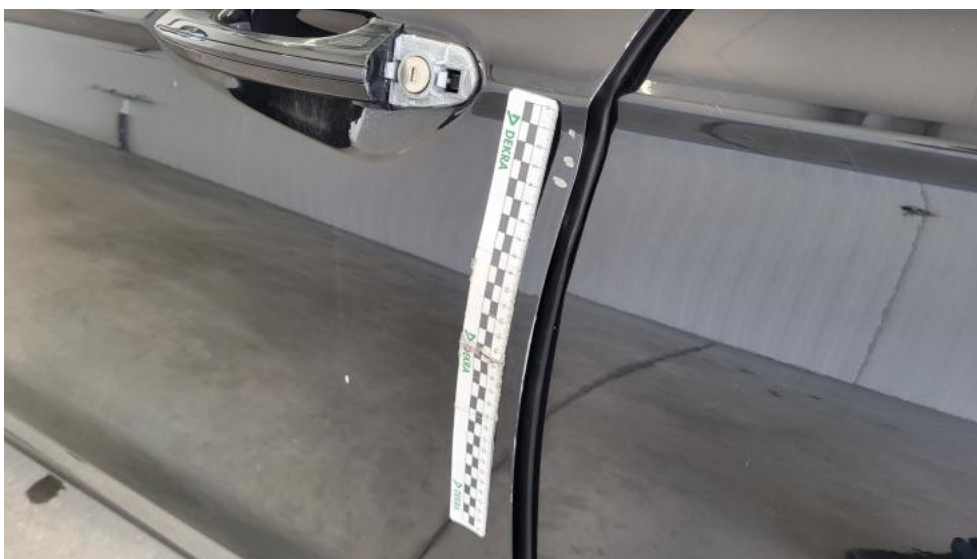
**Photo 63.**

Drzwi przed L - Rysa/odprysk 1

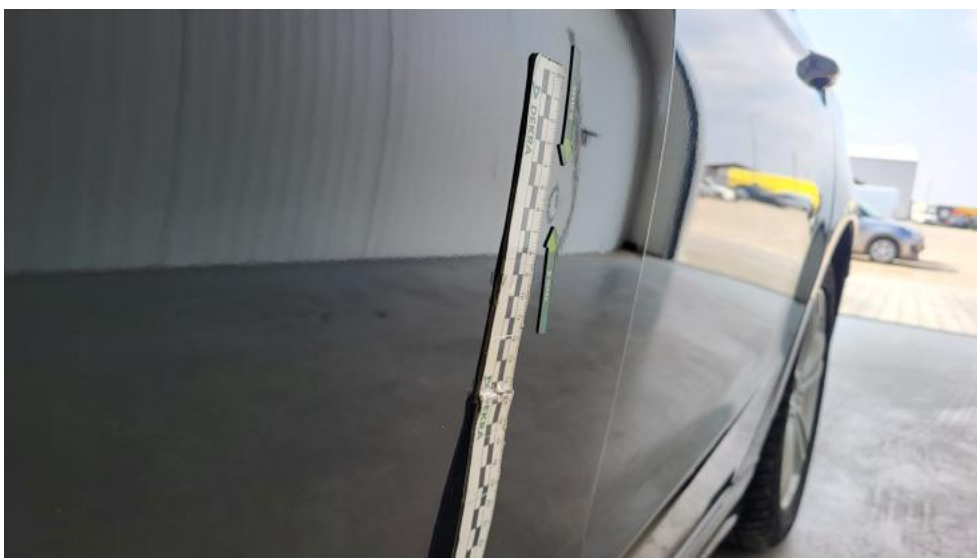
**Photo 64.**

Drzwi przed L - Wgniecenie/odkształcenie 1

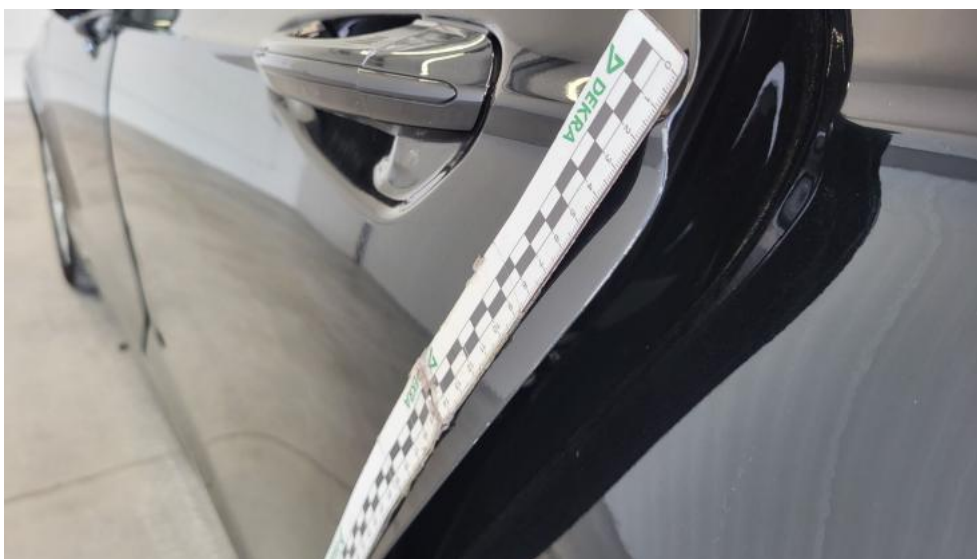
**Photo 65.**

Drzwi tylne L - Rysa/odprysk 1

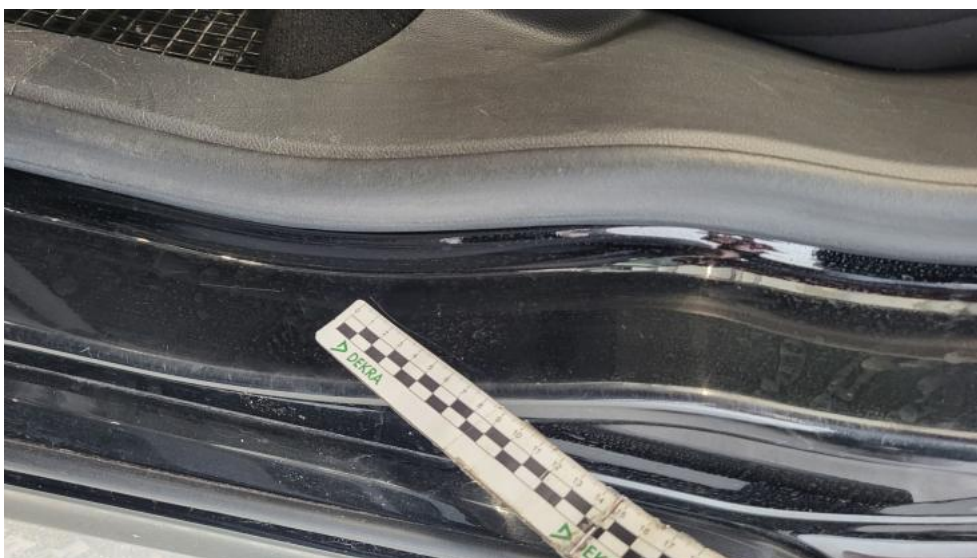
**Photo 66.**

Próg L - Rysa/odprysk 1

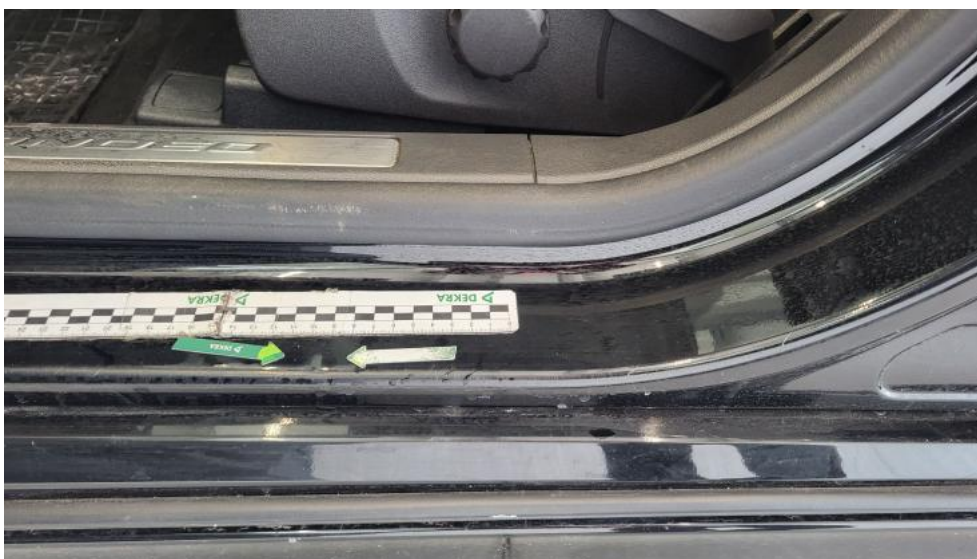
**Photo 67.**  
Próg L - Wgniecenie/odkształcenie 1

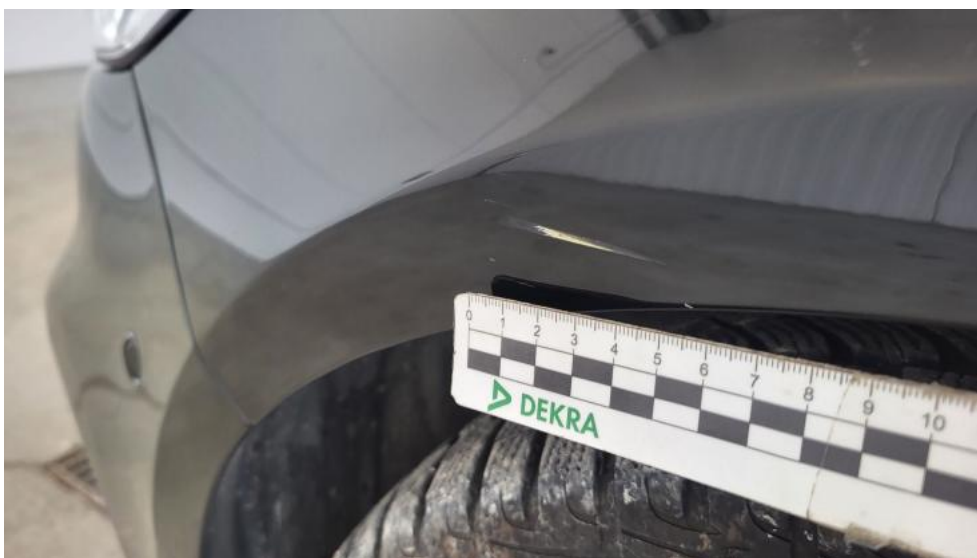
**Photo 68.**  
Błotnik przedni L - Rysa/odprysk 1

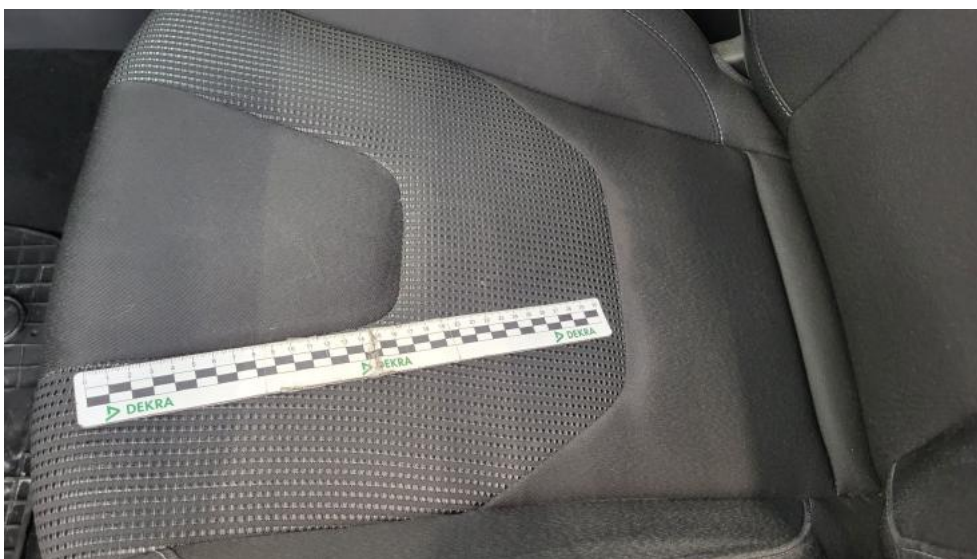
**Photo 69.**  
Fotel prz. lew. - Inne 1

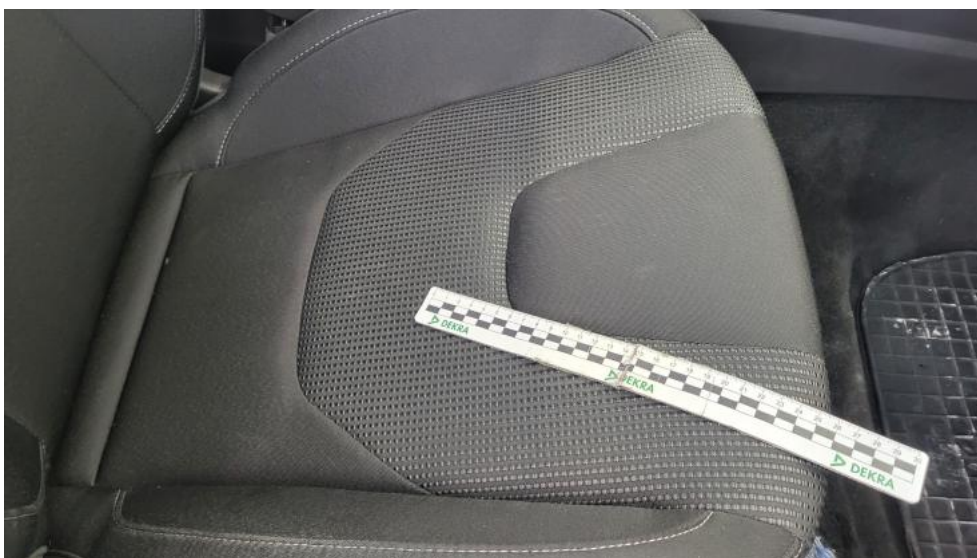
**Photo 70.**  
Fotel prz. praw. - Inne 1

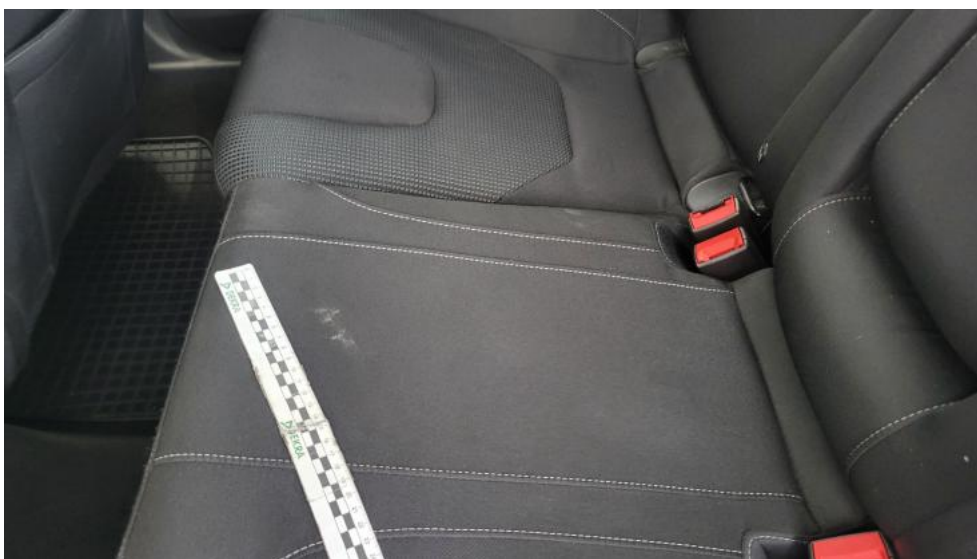
**Photo 71.**  
Kanapa tyl. - Inne 1
