DEKRA's commission No. : PKOL(W)/LODZ/02762/26/01/13  
commission/ damage No. : 21/011404  
Date of commission: 13-01-2026

| Manufacturer | PORSCHE |
| Model | 718 Cayman [982] 16- |
| VIN / serial number | WP0ZZZ98ZNS250876 |

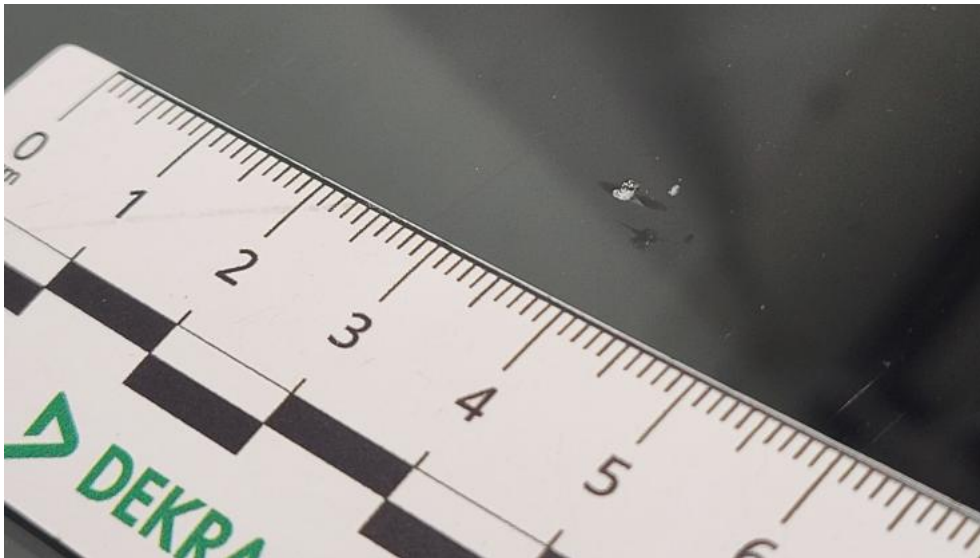
**Photo 43.**

Dostarczono ksero pozwolenia czasowego. Informacja wymagana wymiana okładzin hamulcowych. Pojazd oklejony folią, pomiar lakieru wykonany na folii elementy: pokrywa przednia, dach, słupek przedni lewy/prawy, błotnik przedni prawy. Rysy na samochodzie. Odpryski na szybie czołowej. Lusterka i lampy tylne oklejone folią. Widoczne wady lakiernicze.

Szyba czołowa - Pęknięcie/rozerwanie 1

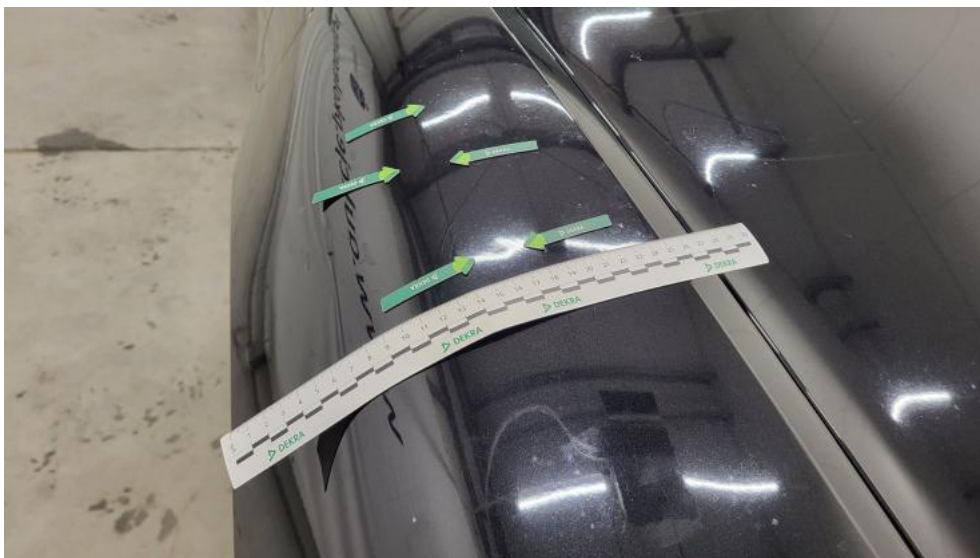
**Photo 44.**

Blotnik przedni P - Wgniecenie/odkształcenie 1

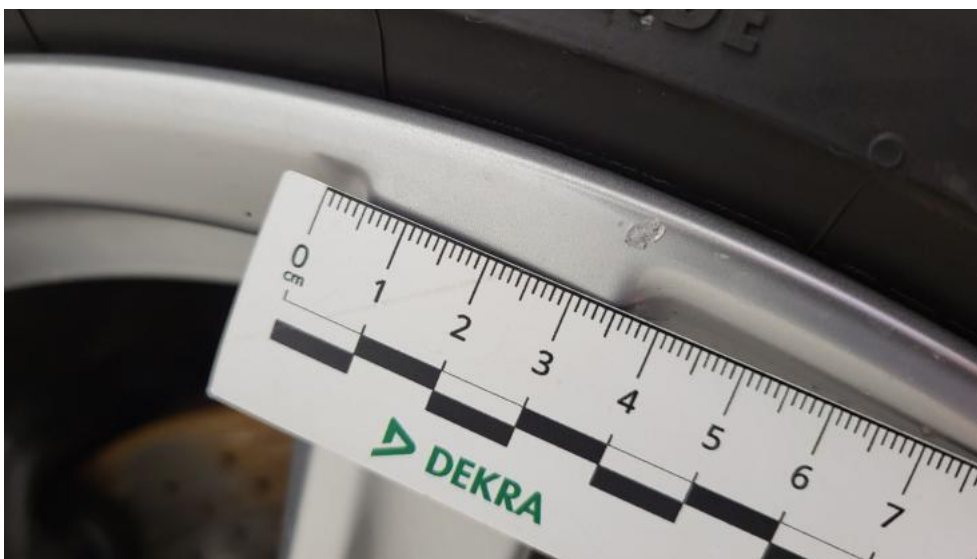
**Photo 45.**

Felga aluminiowa przednia P - Rysa/odprysk 1

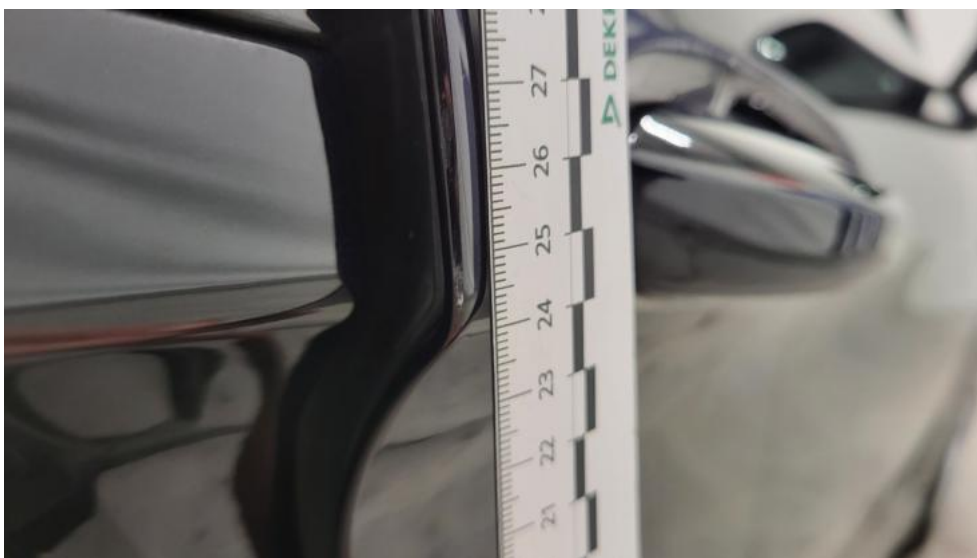
**Photo 46.**

Drzwi przednie P - Rysa/odprysk 1

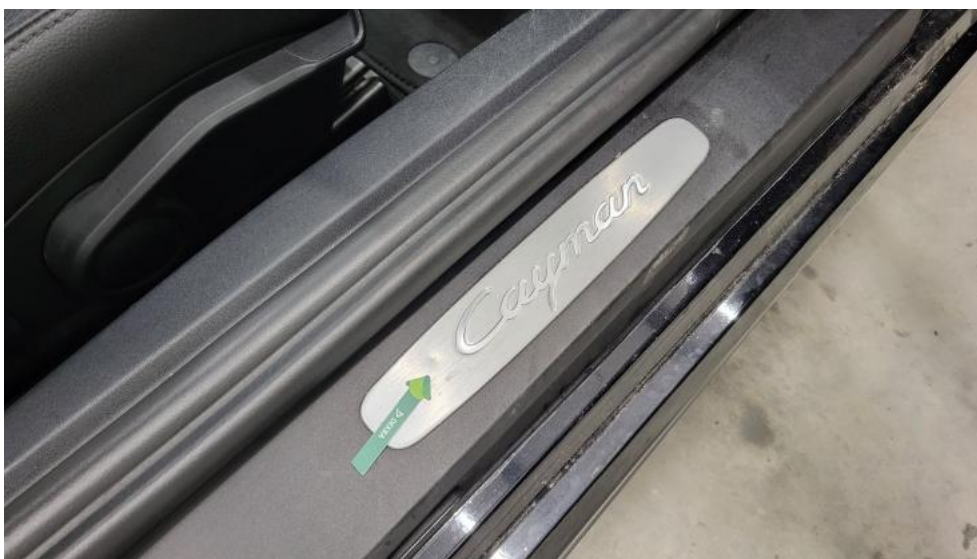
**Photo 47.**

Próg P - Wgniecenie/odkształcenie 1

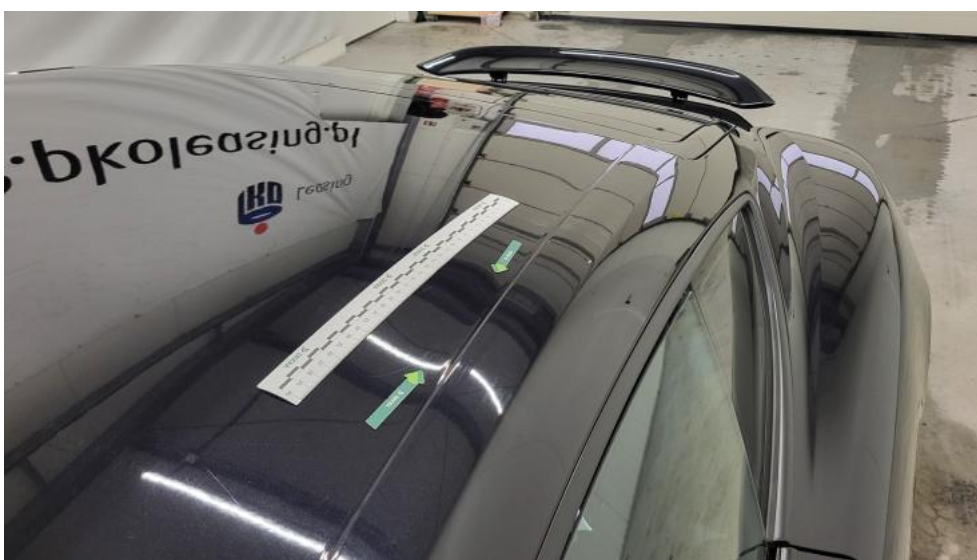
**Photo 48.**

Dach - Wgniecenie/odkształcenie 1

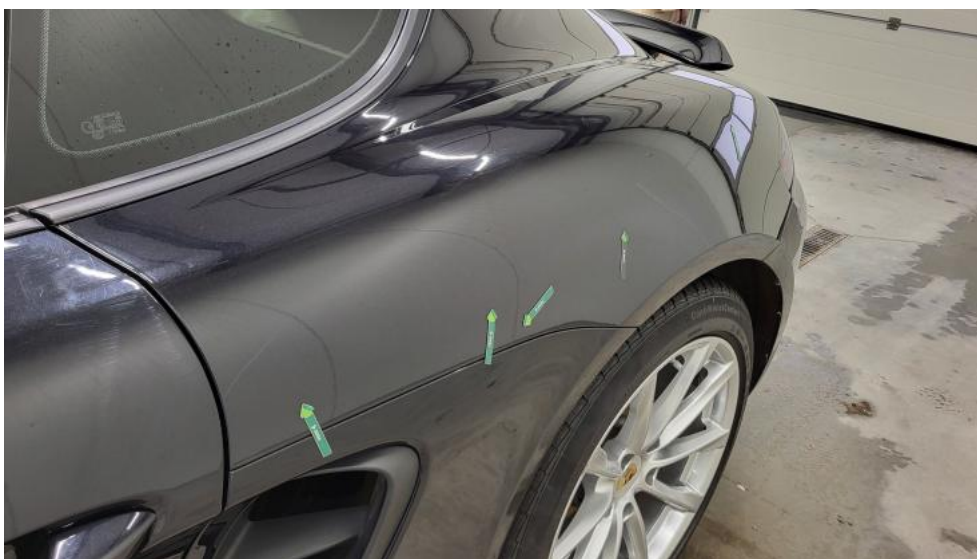
**Photo 49.**

Błotnik tylny L / Ściana boczna L - Wgniecenie/odkształcenie 1

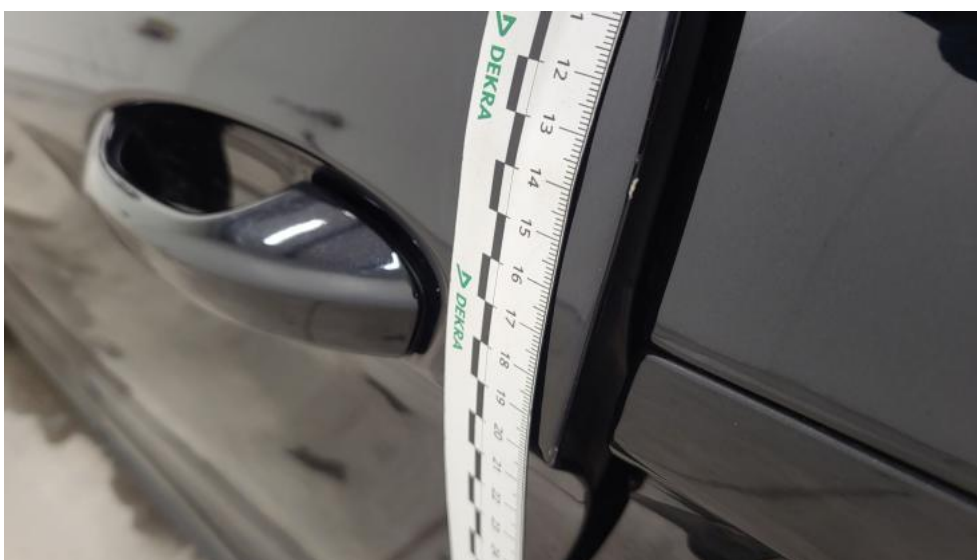
**Photo 50.**

Drzwi przed L - Rysa/odprysk 1

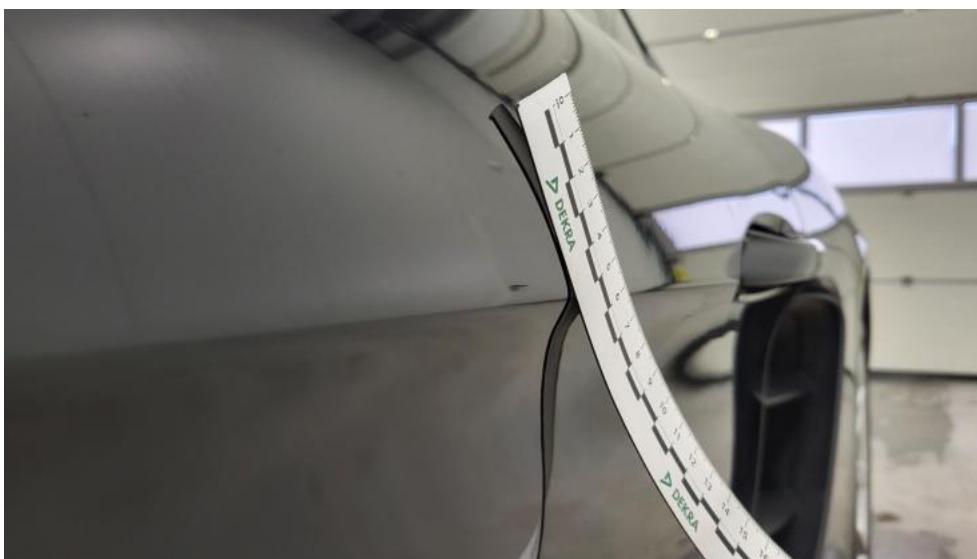
**Photo 51.**

Drzwi przed L - Wgniecenie/odkształcenie 1

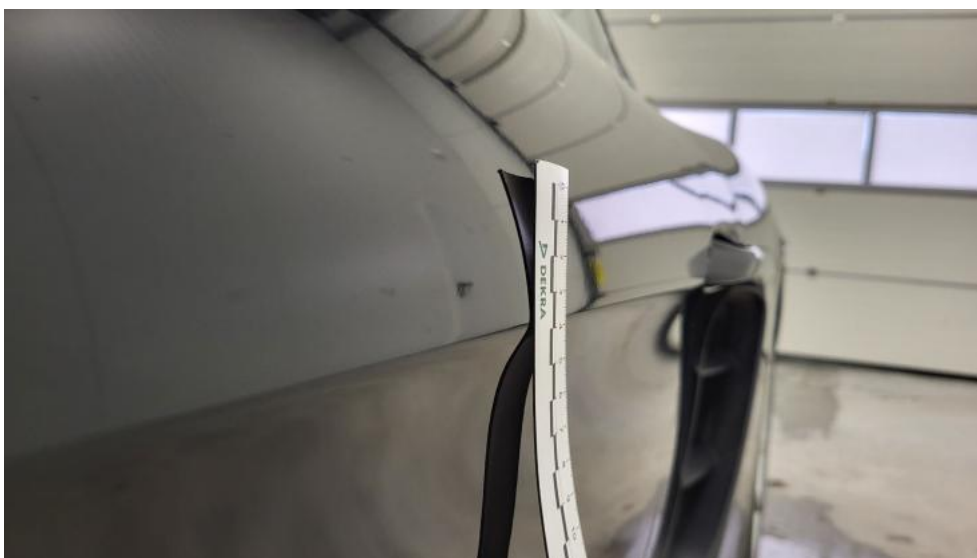
**Photo 52.**

Drzwi przed L - Wgniecenie/odkształcenie 2

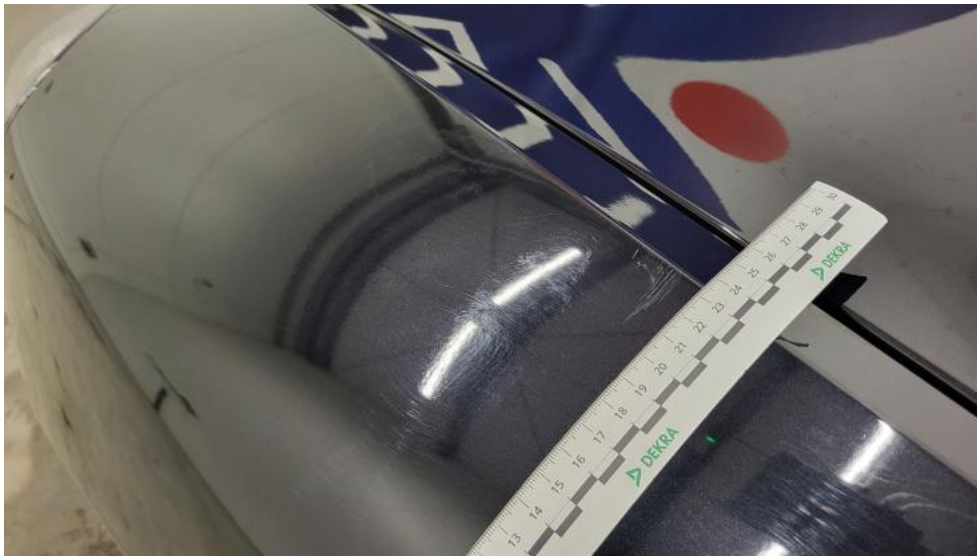
**Photo 53.**

Błotnik przedni L - Rysa/odprysk 1

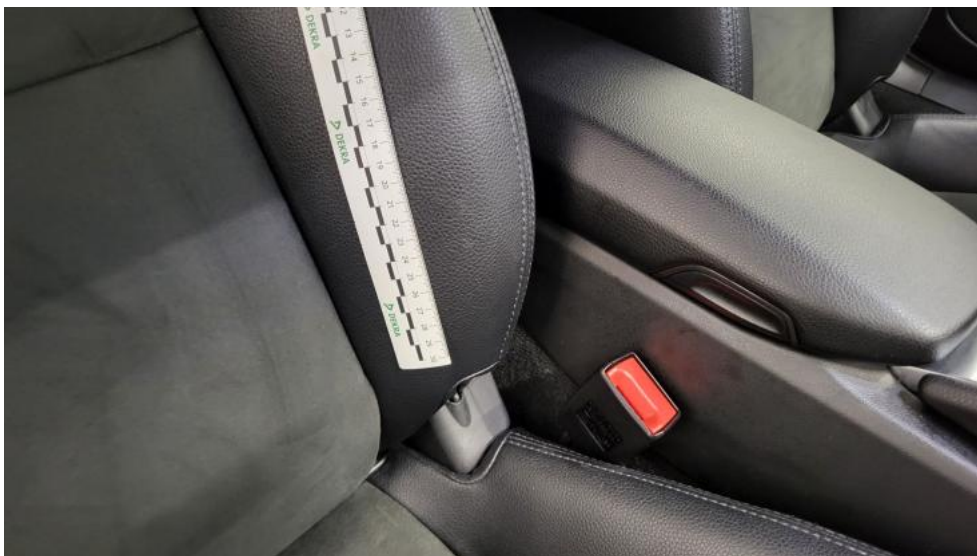
**Photo 54.**

Fotel prz. praw. - Inne 1

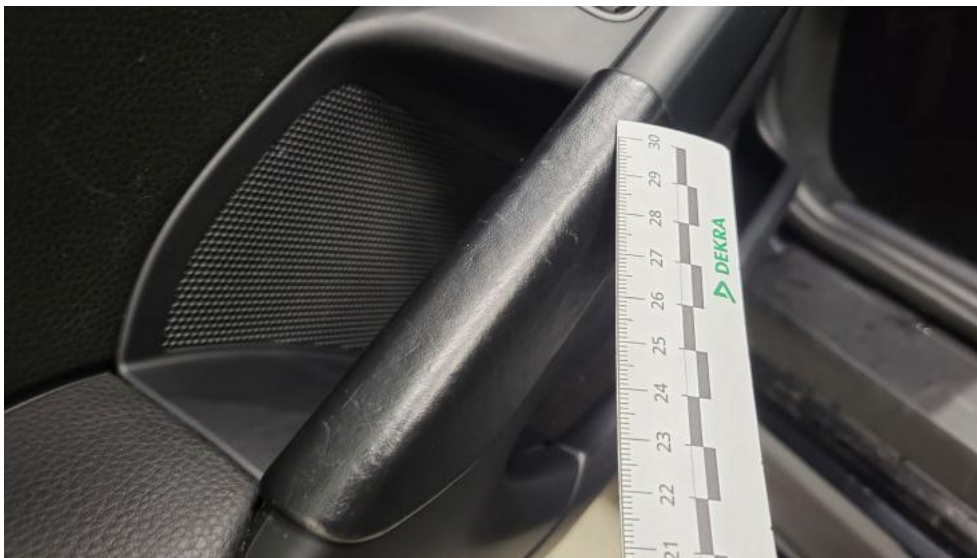
**Photo 55.**

Uchwyt drzwi prze L - Rysa/odprysk 1
