DEKRA's commission No. : PKOL(W)/LODZ/16793/26/02/24
commission/ damage No. : 21/059163
Date of commission: 24-02-2026

Vehicle data

Description of the technical condition

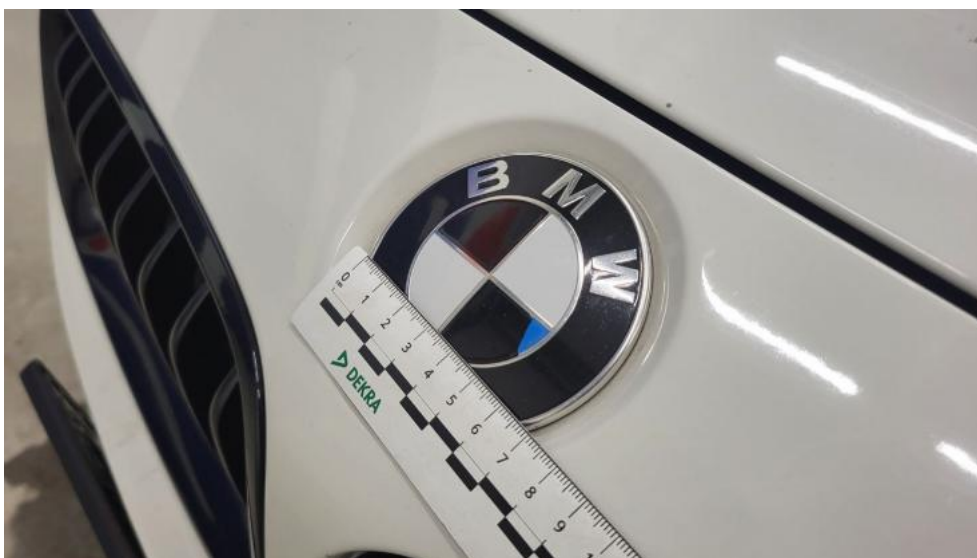
Photo 42.
Emblemat - Inne 1

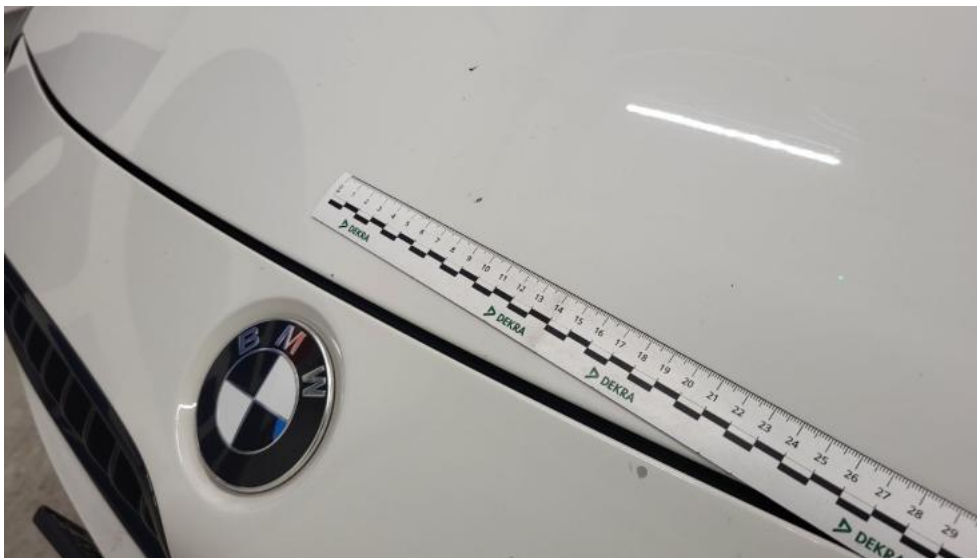
Photo 43.
Pokrywa komory silnika - Rysa/odprysk 1

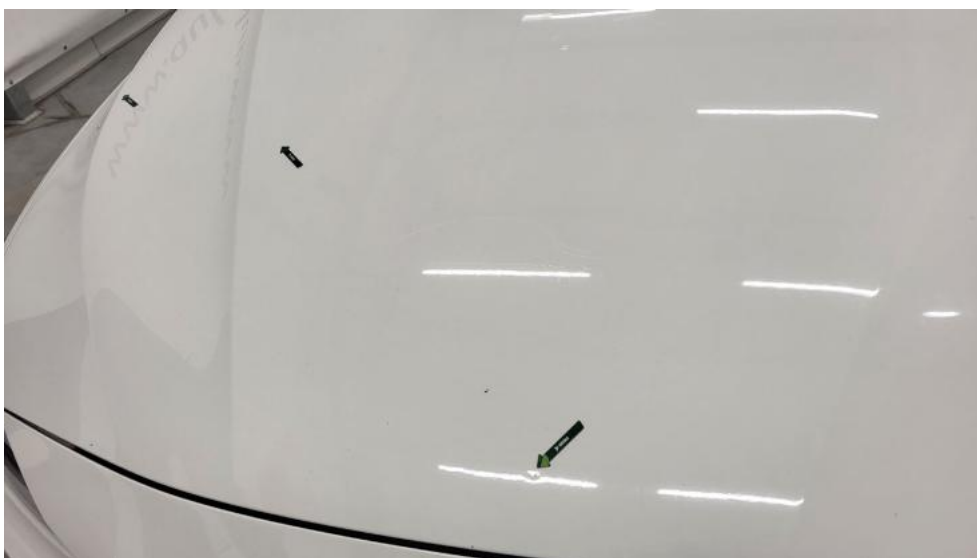
Photo 44.
Pokrywa komory silnika - Wgniecenie/odkształcenie 1

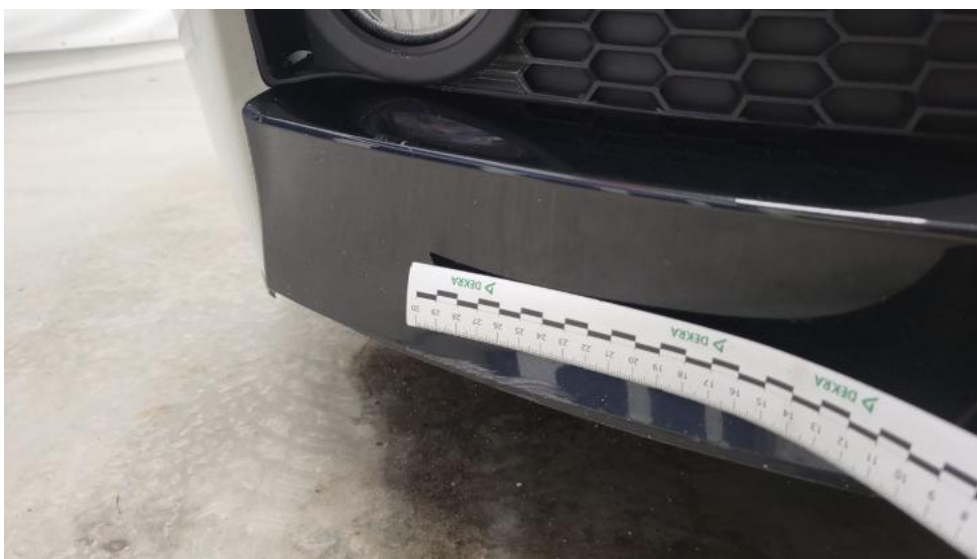
Photo 45.

Spoiler zderzaka przedniego - Rysa/odprysk 1

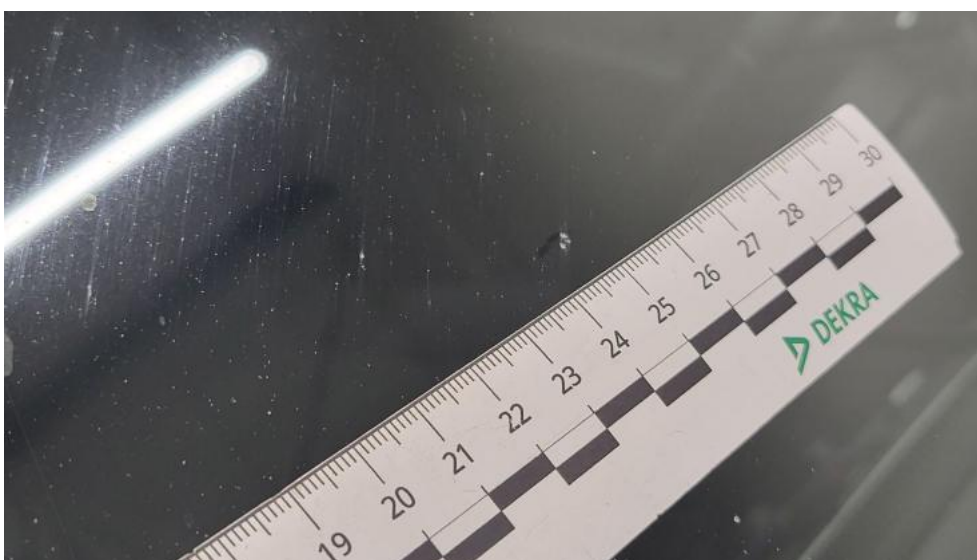
Photo 48.

Informacja w dowodzie rejestracyjnym wtórnik tablicy rejestracyjnej. Brak aktualnych badań technicznych. Aktywna kontrolka silnika. Głośna praca układu hamulcowego podczas hamowania. Głośna praca układu wydechowego, do weryfikacji serwisowej. Informacja wymień baterie kluczyka. Widoczne wady lakiernicze. Rysy na samochodzie. Odpryski na szybie czołowej. Reflektory i lampy tylne oklejone folią.

Szyba czołowa - Pęknięcie/rozerwanie 1

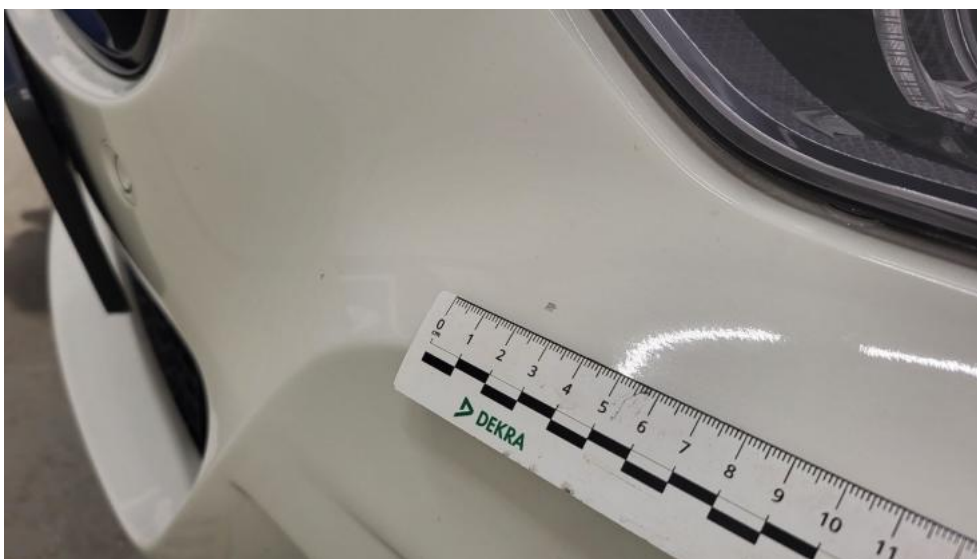
Photo 49.

Zderzak - Rysa/odprysk 1

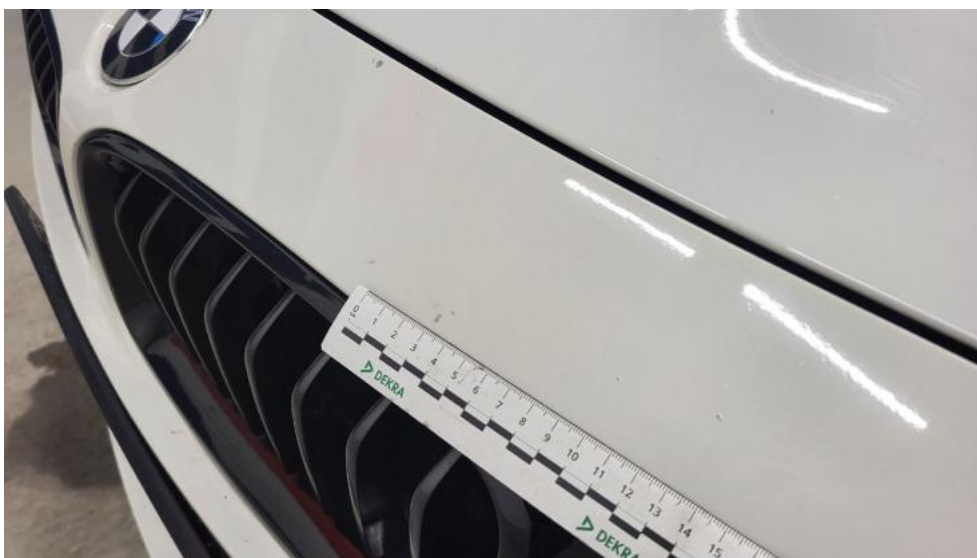
Photo 50.

Zderzak - Rysa/odprysk 2

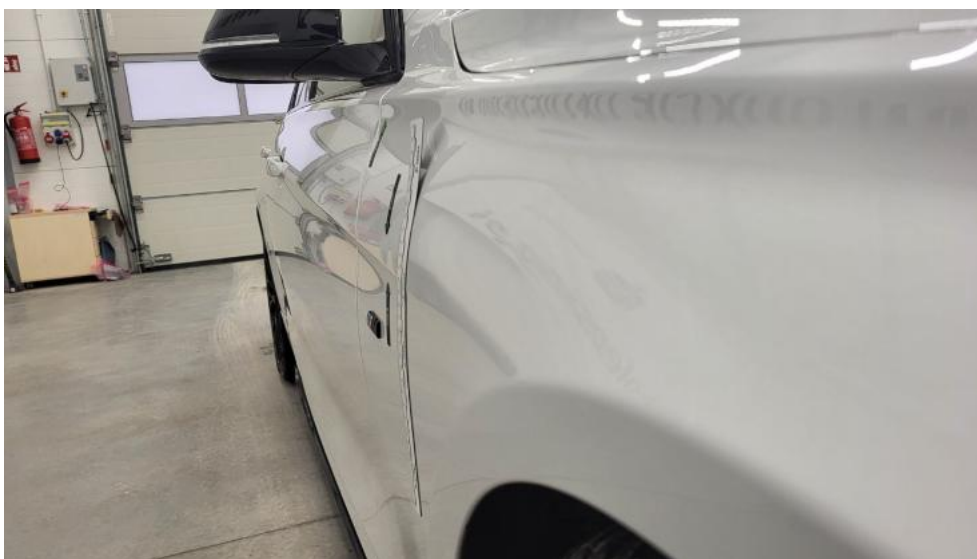
Photo 51.
Błotnik przedni P - Wgniecenie/odkształcenie 1

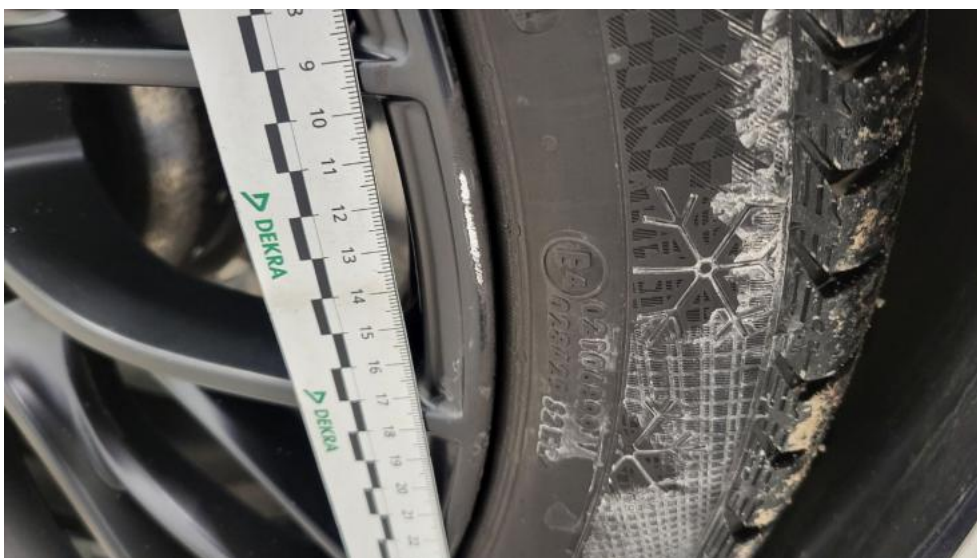
Photo 52.
Felga aluminiowa przednia P - Rysa/odprysk 1

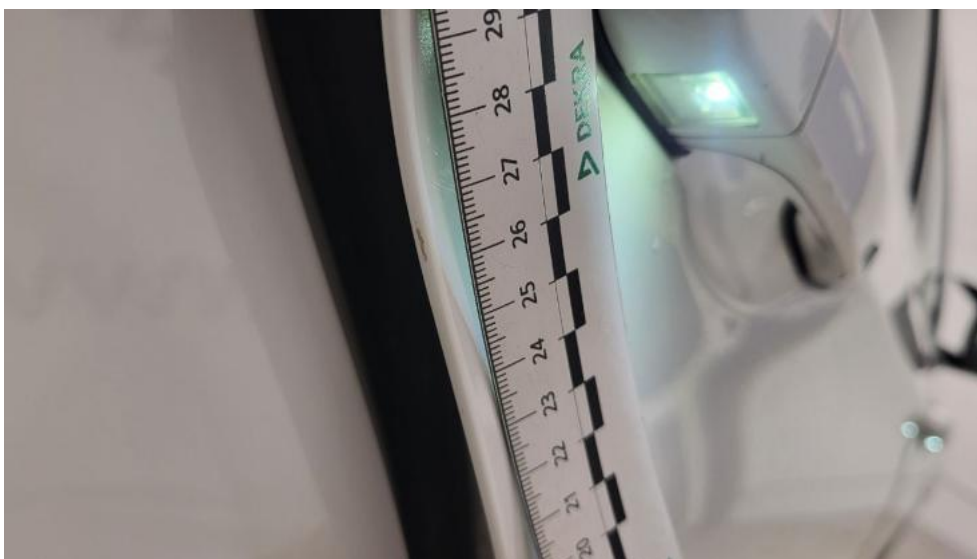
Photo 55.

Drzwi tylne P - Rysa/odprysk 1

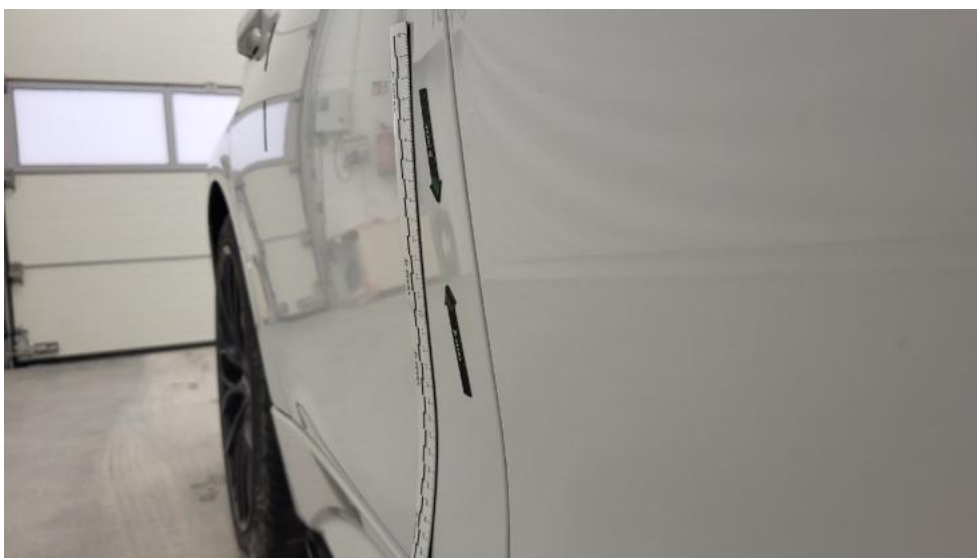
Photo 56.

Drzwi tylne P - Wgniecenie/odkształcenie 1

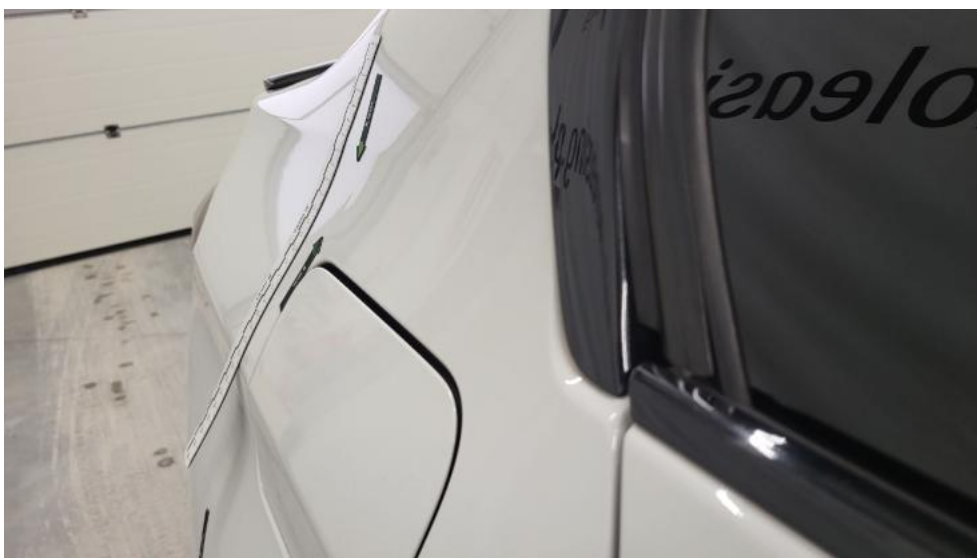
Photo 58.

Błotnik tylny P / Ściana boczna P - Wgniecenie/odkształcenie 1

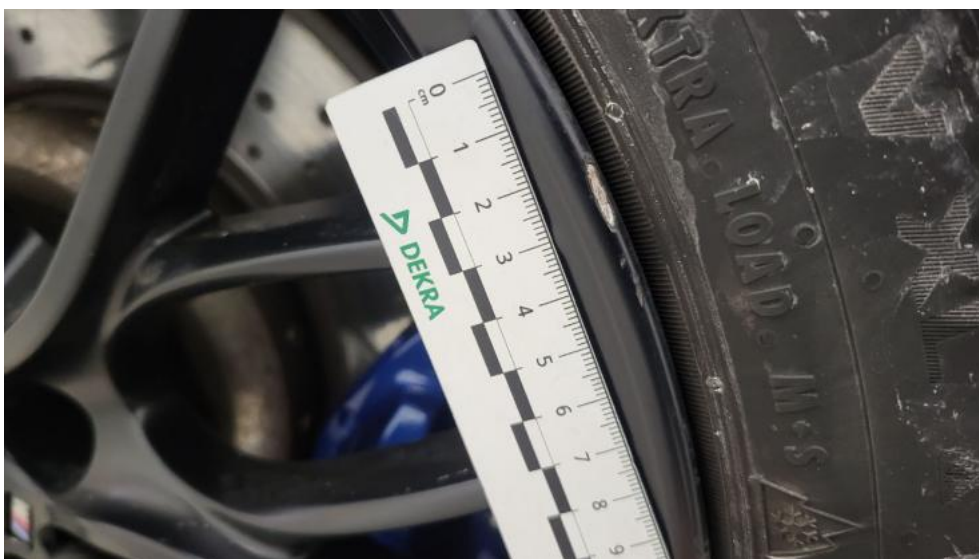
Photo 59.
Felga aluminiowa tylna P - Rysa/odprysk 1

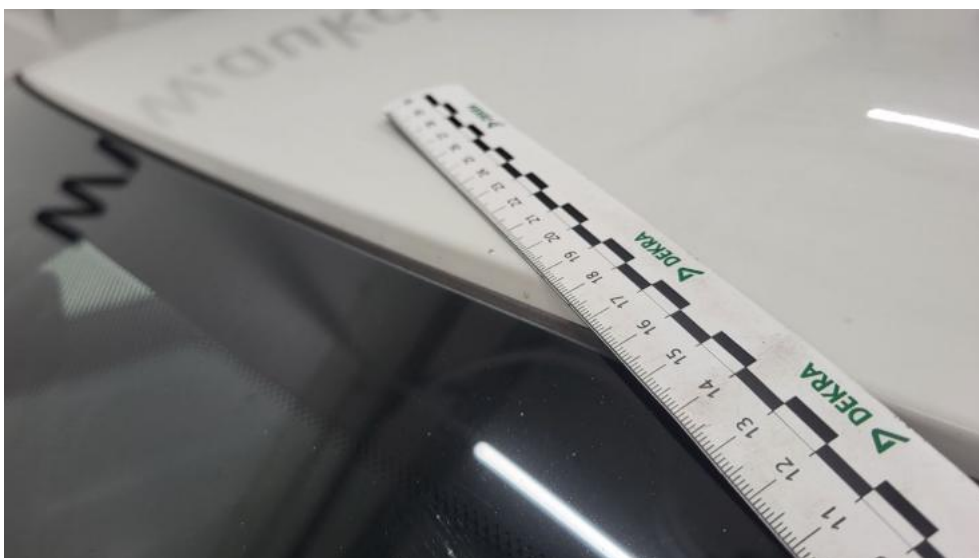
Photo 60.
Dach - Rysa/odprysk 1

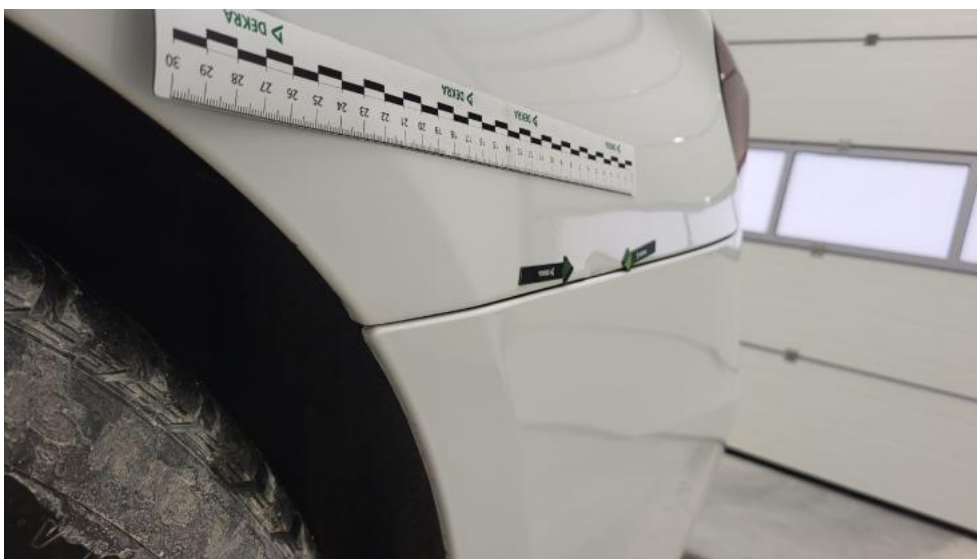
Photo 63.
Błotnik tylny L / Ściana boczna L - Wgniecenie/odkształcenie 2

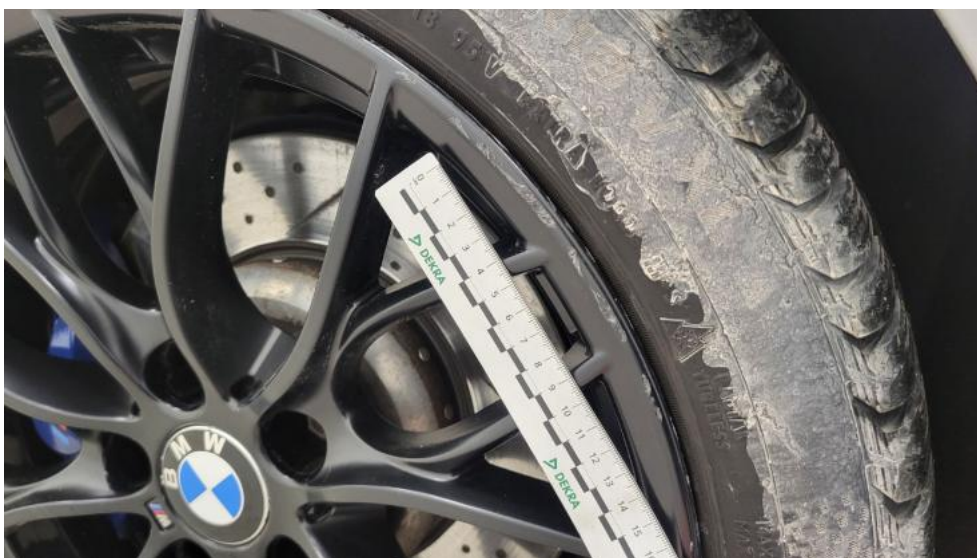
Photo 64.
Felga aluminiowa tylna L - Rysa/odprysk 1

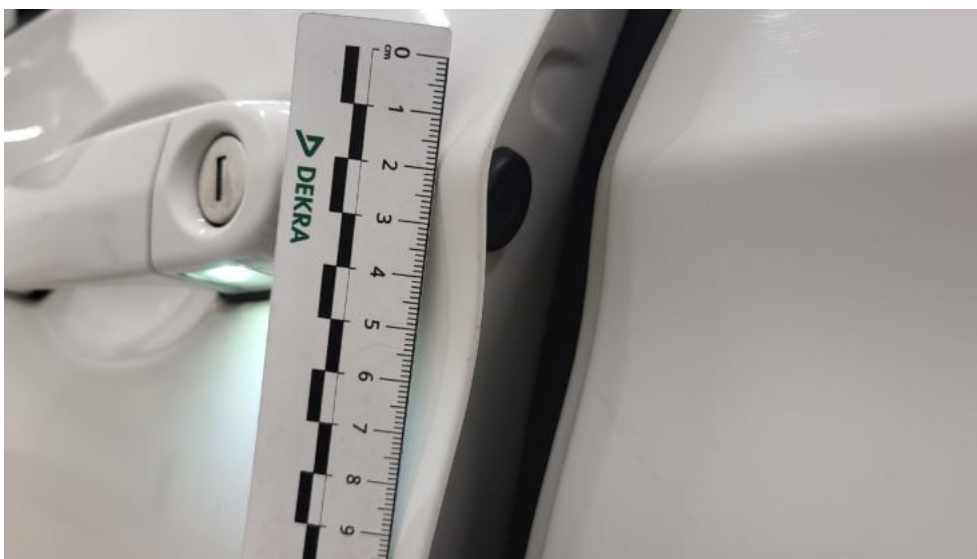
Photo 65.

Drzwi przed L - Rysa/odprysk 1

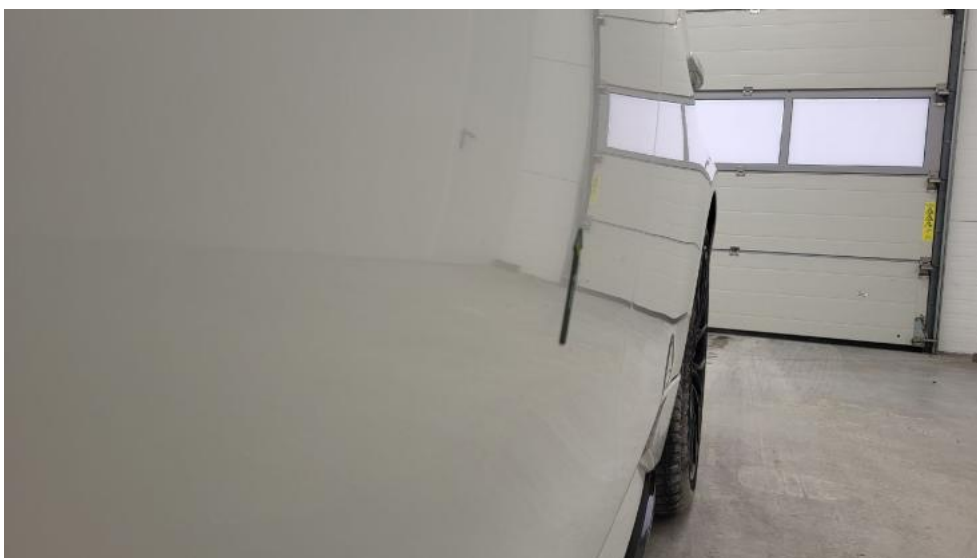
Photo 66.

Drzwi przed L - Wgniecenie/odkształcenie 1

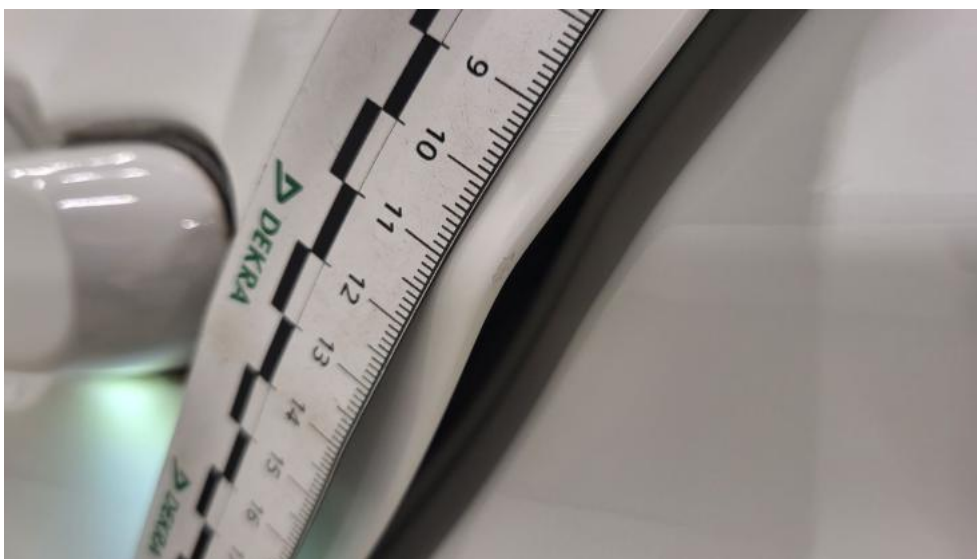
Photo 67.
Drzwi tylne L - Rysa/odprysk 1

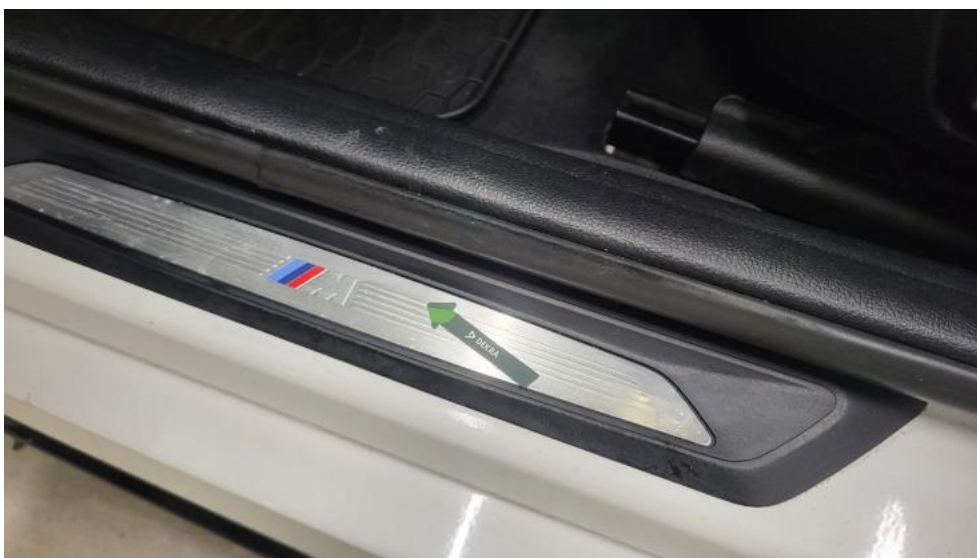
Photo 68.
Próg L - Wgniecenie/odkształcenie 1

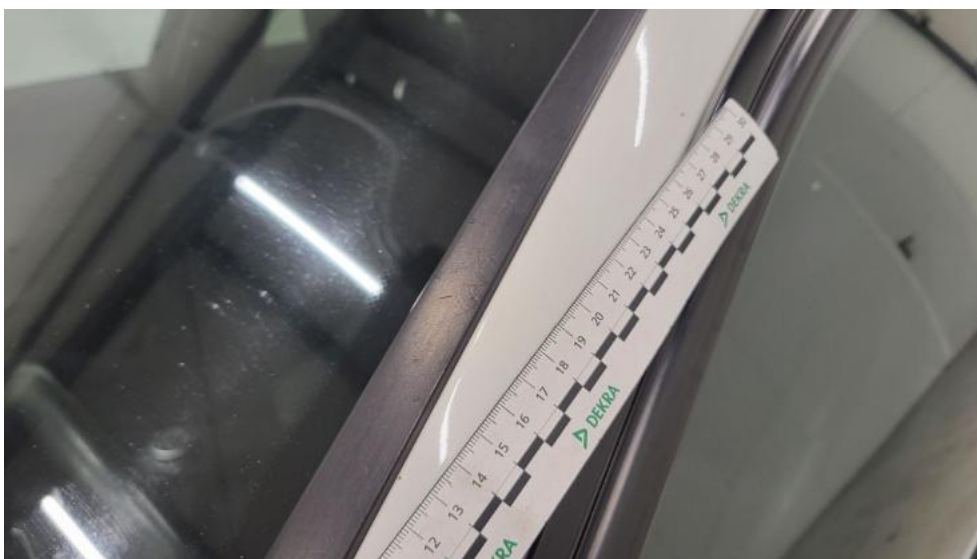
Photo 69.
Słupek przedni L - Rysa/odprysk 1

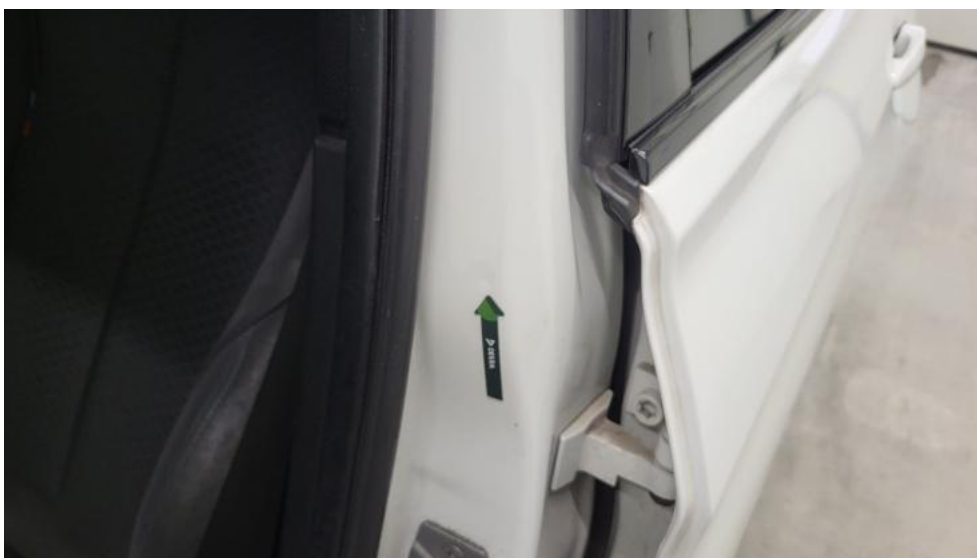
Photo 70.
Słupek środkowy L - Wgniecenie/odkształcenie 1

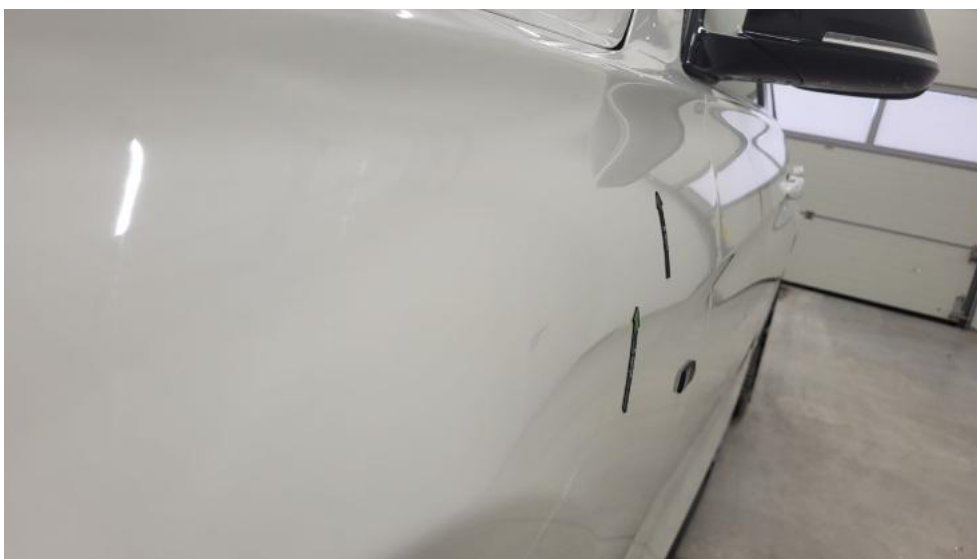
Photo 71.

Błotnik przedni L - Wgniecenie/odkształcenie 1

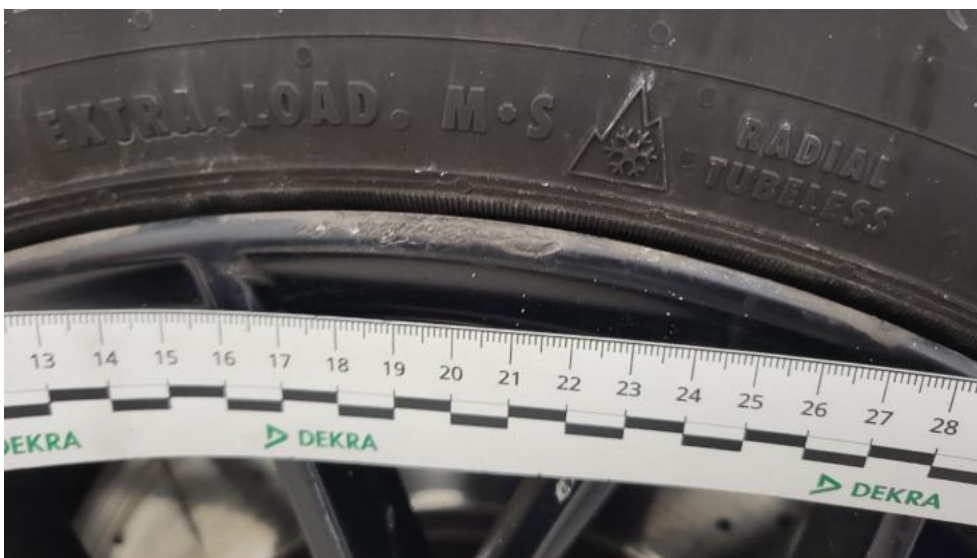
Photo 72.

Felga Aluminiowa przednia L - Rysa/odprysk 1

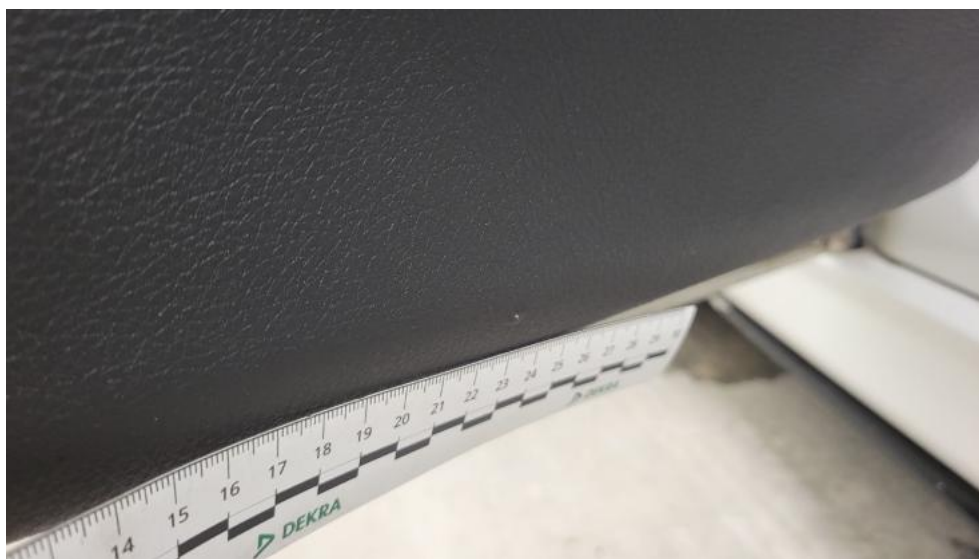
Photo 77.

Tapicerka drzwi przednich L - Wgniecenie/odkształcenie 1

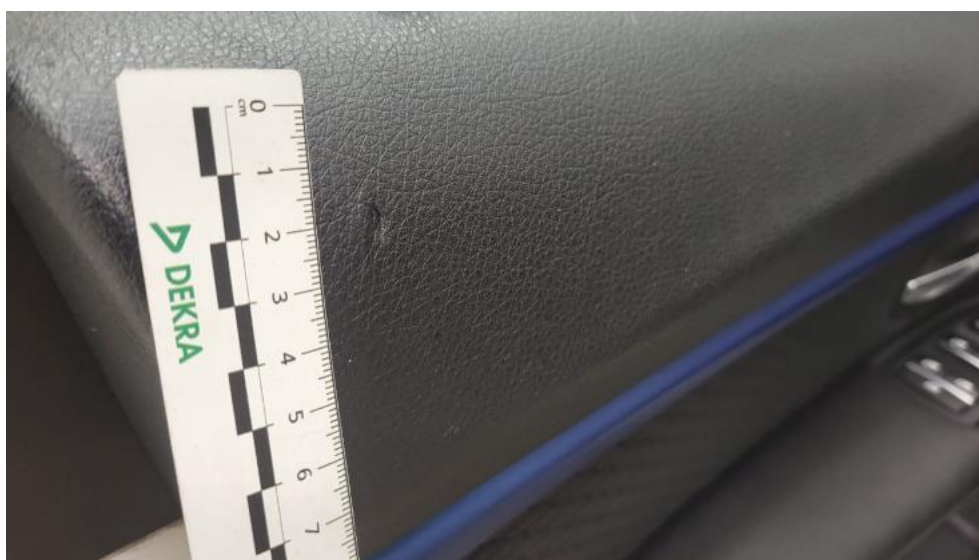
Photo 78.

Tapicerka drzwi przednich L - Pęknięcie/rozerwanie 1

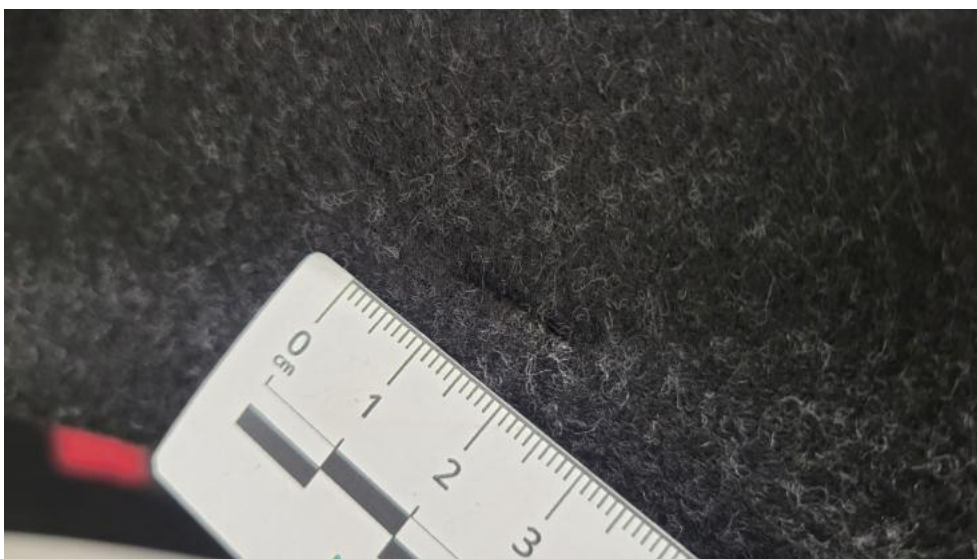
Photo 81.

Wykładzina pokrywy tylnej - Pęknięcie/rozerwanie 1
