DEKRA's commission No. : PKOL(W)/LODZ/39987/26/05/07
 commission/ damage No. : 24/043425
 Date of commission: 07-05-2026

Vehicle data

Group of objects (Eurotax)	cars
EC code (Eurotax)	0135214
Manufacturer	SEAT
Model	Arona 17-21
Type / version	Arona 1.0 TSI GPF FR S&S DSG
Body type	hatchback
Number of doors / seats	5/5
Curb weight [kg]	1162
Gross vehicle weight [kg]	1630
Wheelbase 1/2	2566
Engine type	spark ignition
Pollution reduction system	GPF
Engine capacity [ccm]	999
Engine Power [hp/kW]	115/85
Gearbox	automatic
Registration /record No.	SG583EA
VIN / serial number	VSSZZZKJZMR034421
Date of first registration	08-12-2020
Date of next. tech. test	11-12-2026
Year of manufacture	2020 (year has been verified with the manufacturer's base)
Readout [km]	127 417 (read)
Body color / type of coating	white/UNI

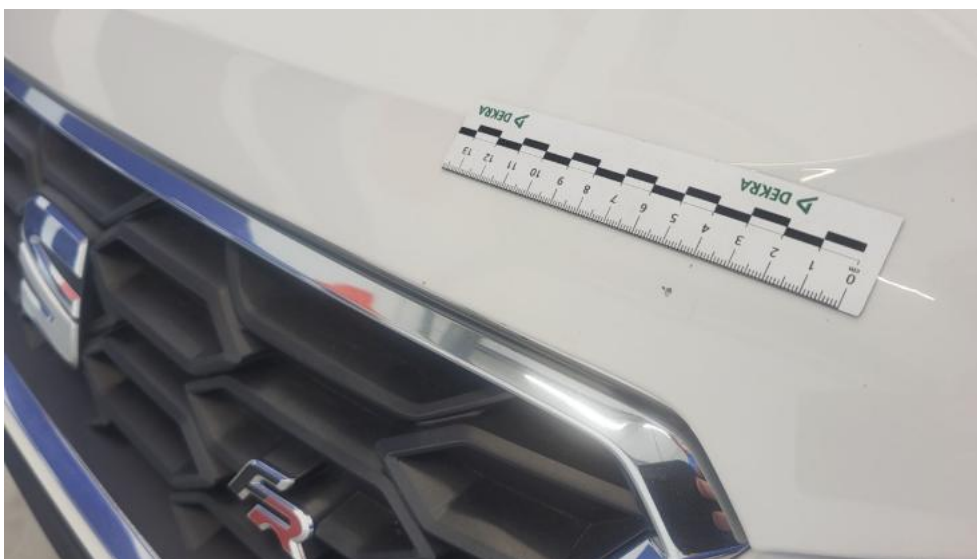
Photo 39.
Pokrywa komory silnika - Rysa/odprysk 1

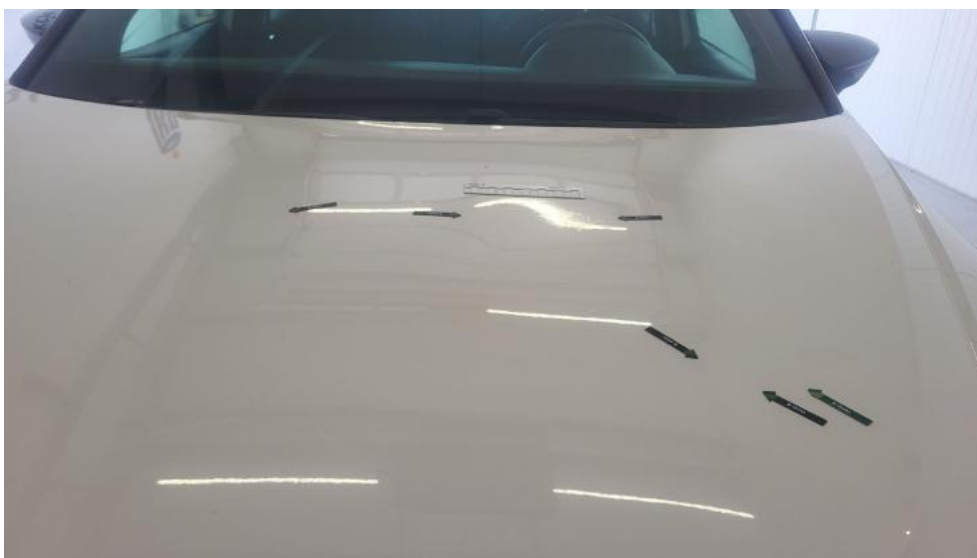
Photo 40.
Pokrywa komory silnika - Wgniecenie/odkształcenie 1

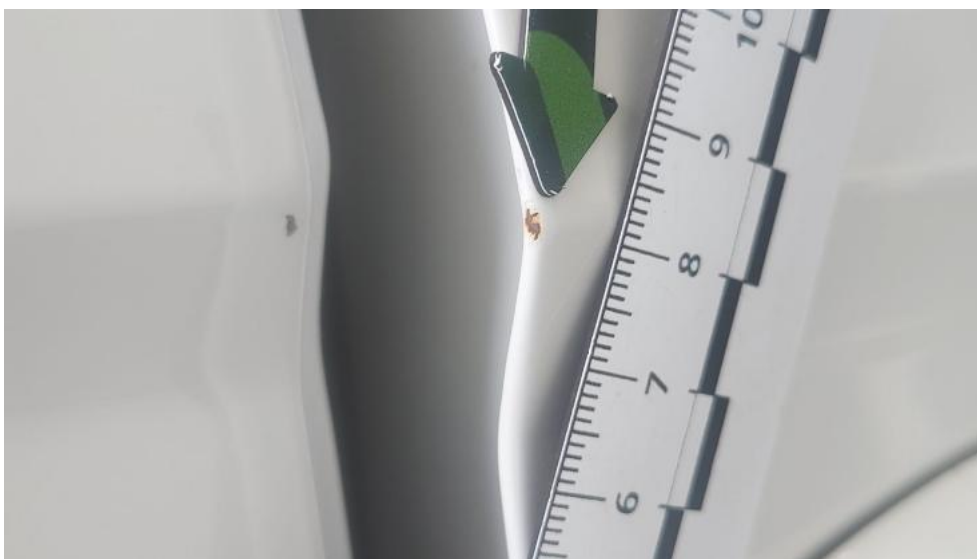
Photo 45.

Drzwi przednie P - Inne 1

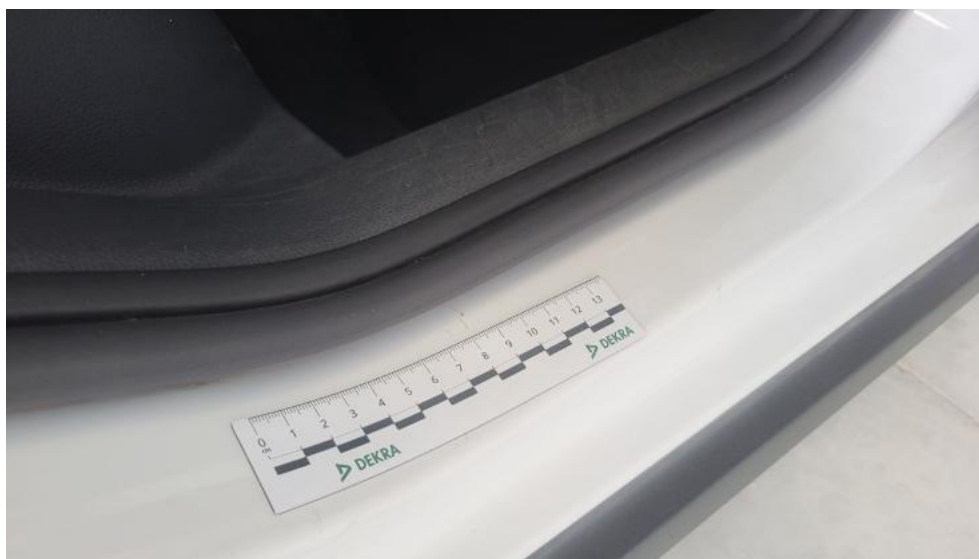
Photo 47.
Próg P - Rysa/odprysk 1

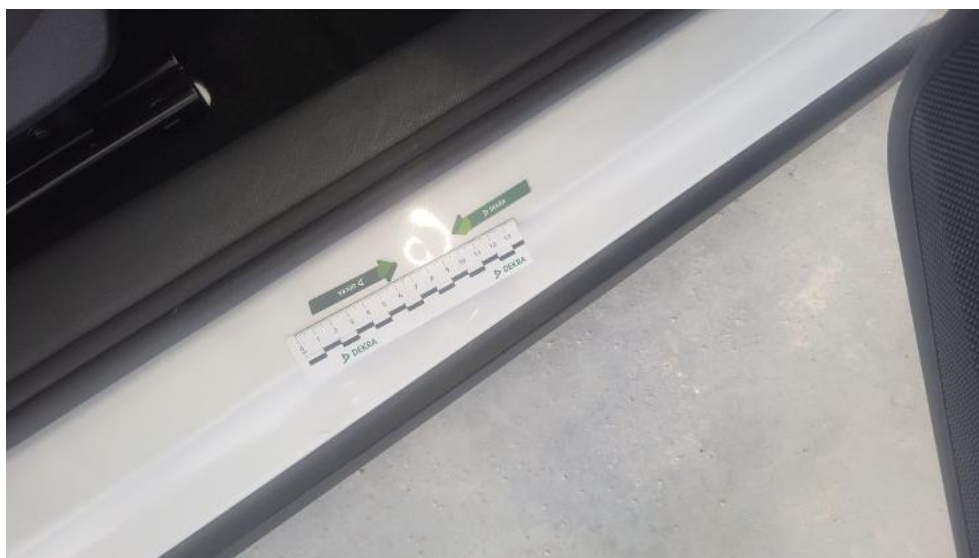
Photo 48.
Próg P - Wgniecenie/odkształcenie 1

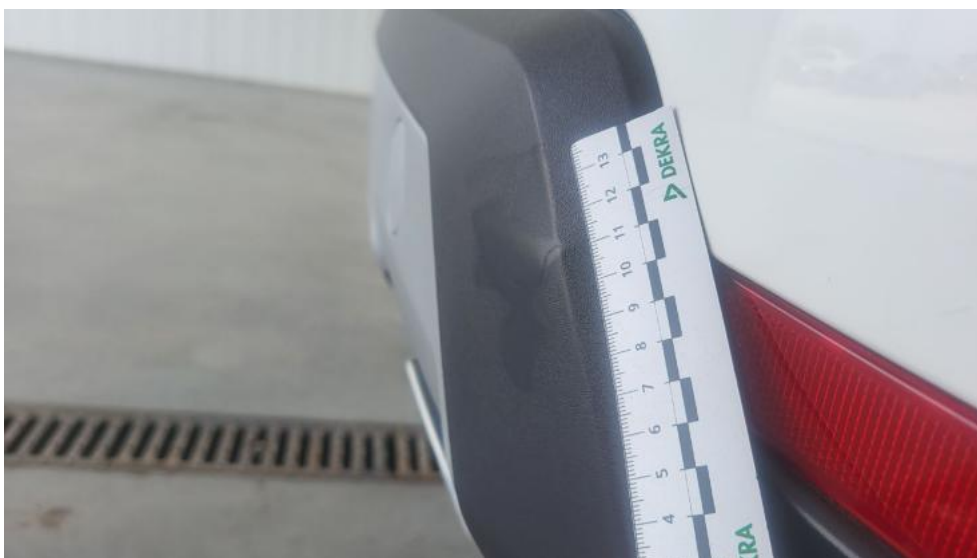
Photo 54.
Zderzak tylny cz dolna - Wgniecenie/odkształcenie 1

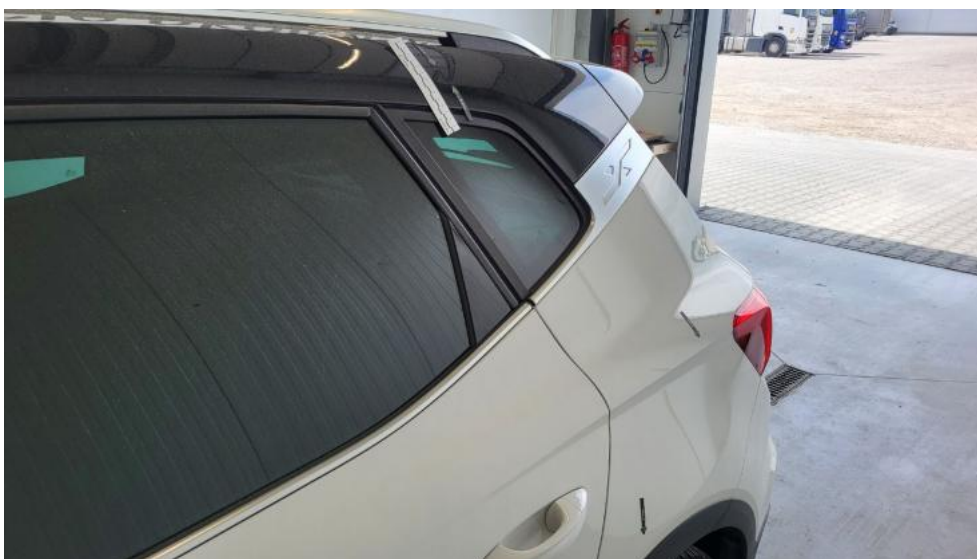
Photo 55.
Błotnik tylny L / Ściana boczna L - Wgniecenie/odkształcenie 1

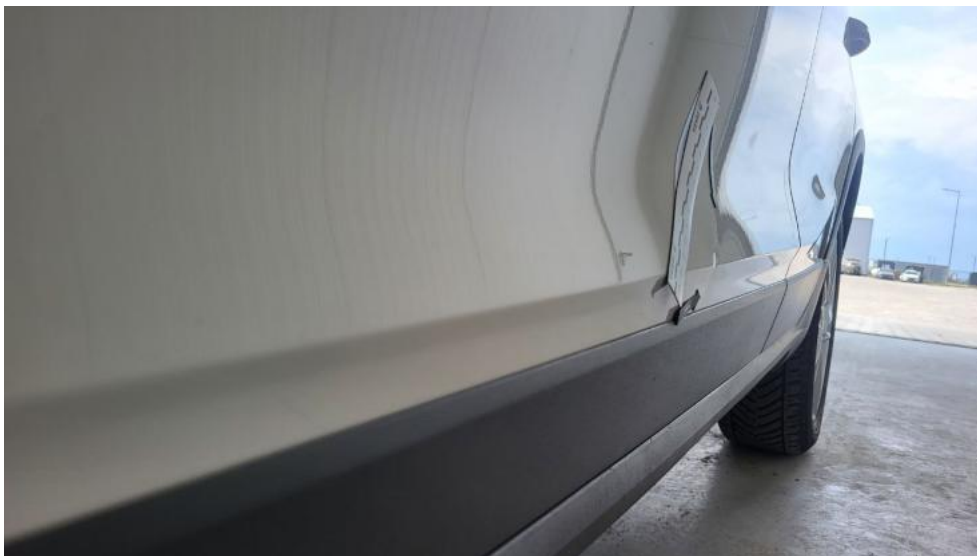
Photo 57.
Drzwi przed L - Wgniecenie/odkształcenie 1

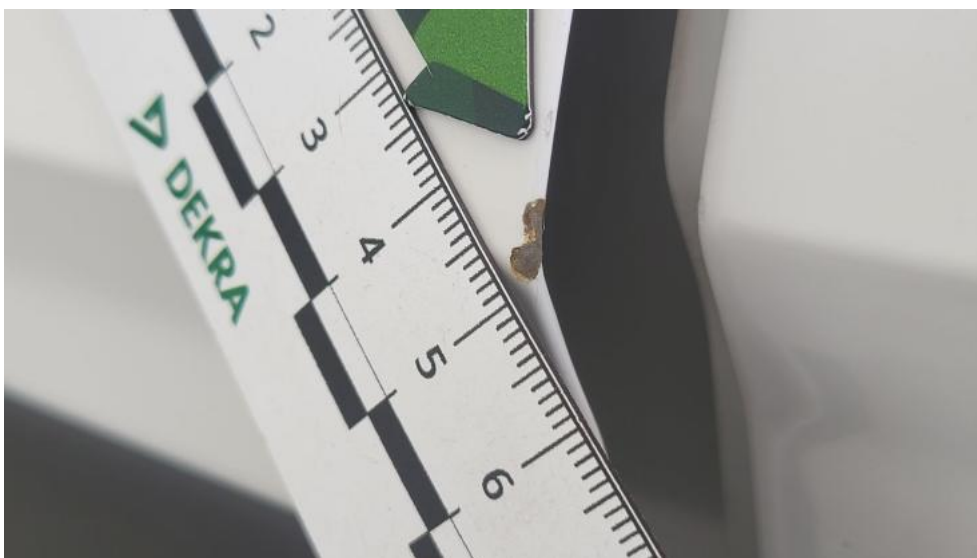
Photo 58.
Drzwi przed L - Inne 1

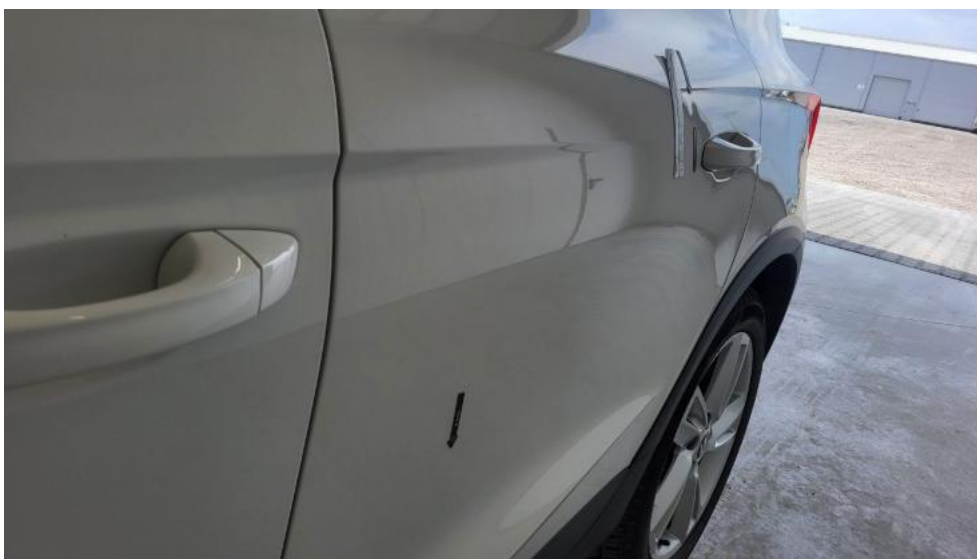
Photo 59.
Drzwi tylne L - Wgniecenie/odkształcenie 1

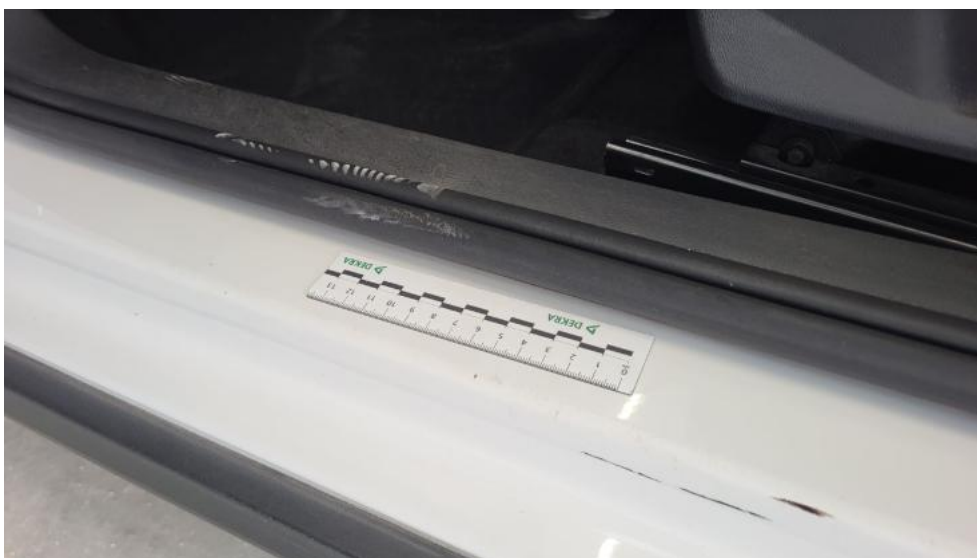
Photo 60.
Próg L - Rysa/odprysk 1

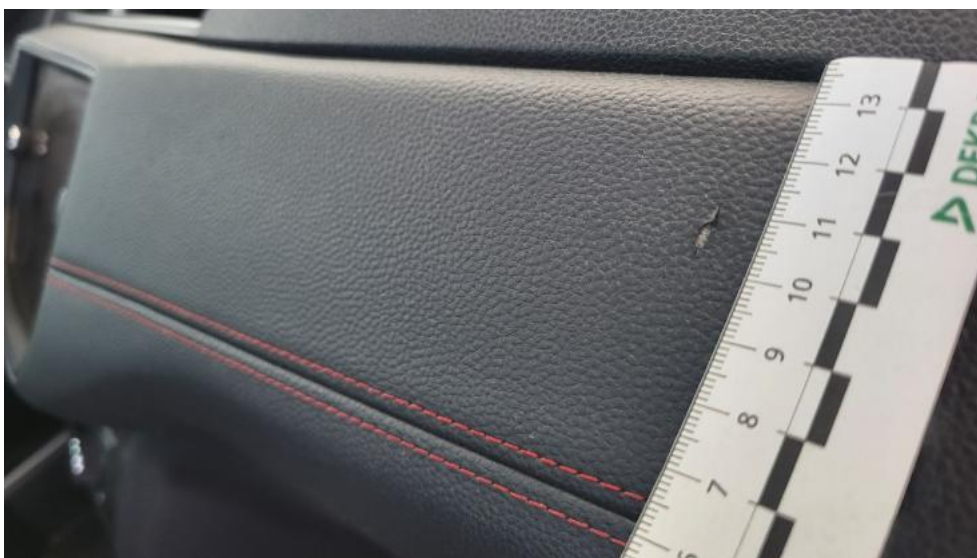
Photo 62.
Deska rozdzielcza - Pęknięcie/rozerwanie 1

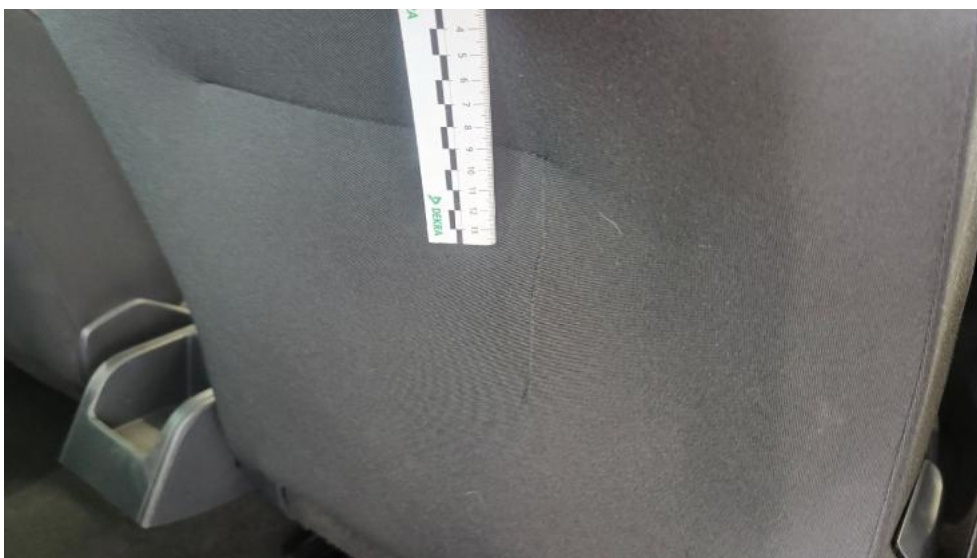
Photo 66.
Fotel prz. praw. - Inne 1

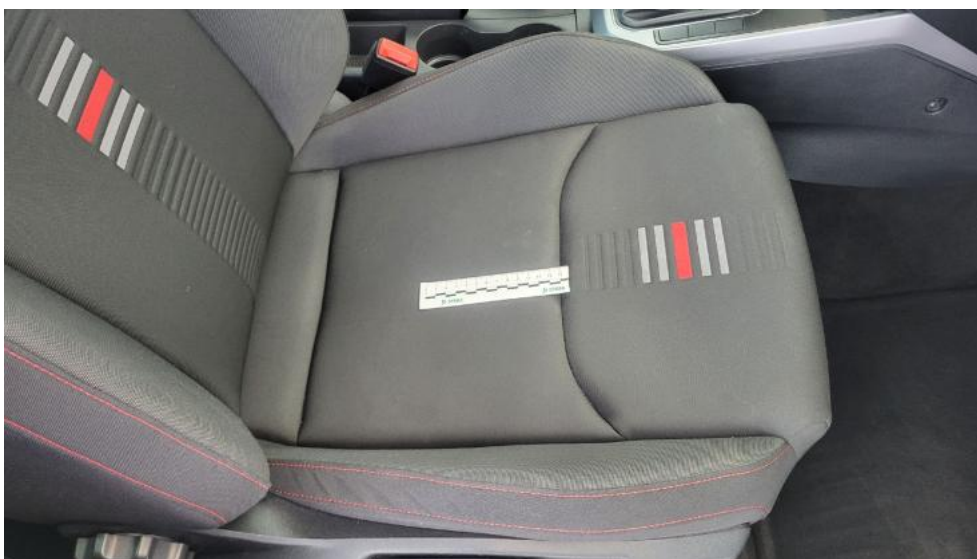
Photo 67.
Fotel prz. praw. - Inne 2

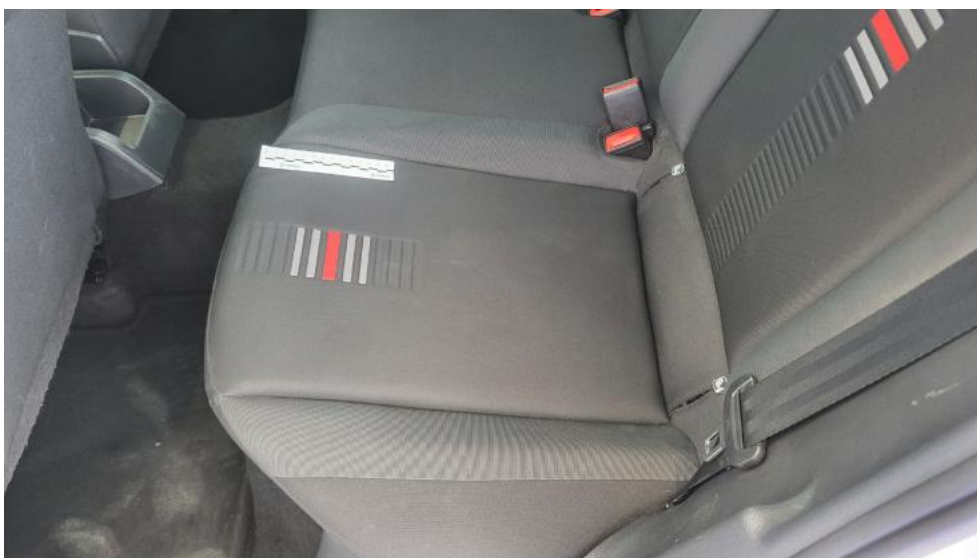
Photo 68.
Kanapa tyl. - Inne 1
