DEKRA's commission No. : PKOL(W)/LODZ/55150/25/07/28  
commission/ damage No. : 22/032797  
Date of commission: 28-07-2025

**DEKRA Poland - Headquarters**  
02-673 Warszawa, ul. Konstruktorska 12A

| Manufacturer | HYUNDAI |
| Type / version | Ioniq 5 73kWh Executive 4WD |

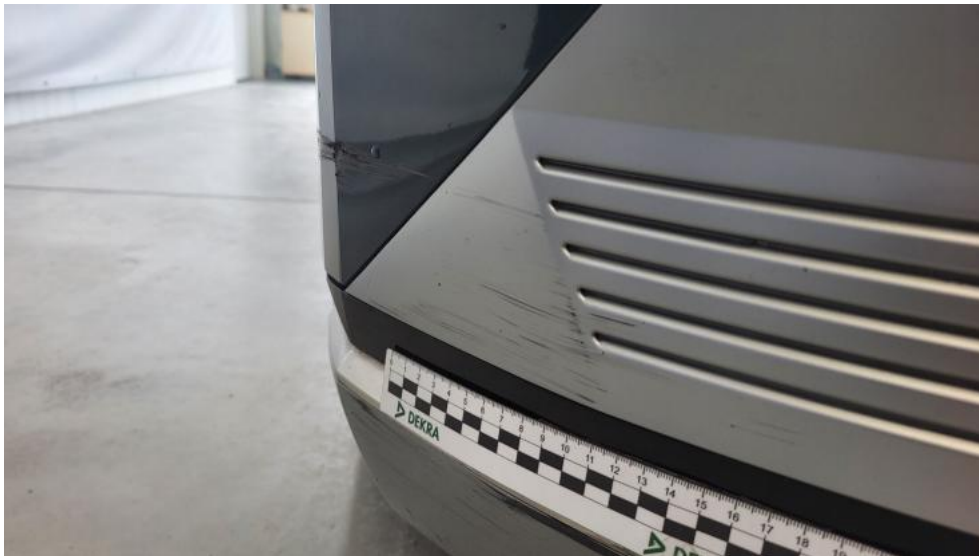
**Photo 47.**

Listwa śr zderzaka przedniego - Rysa/odprysk 1

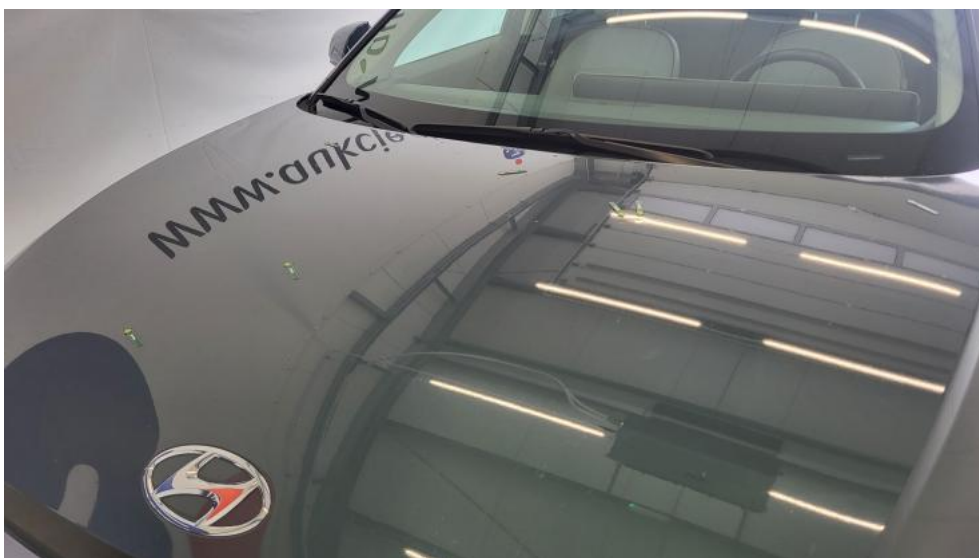
**Photo 48.**

Pokrywa komory silnika - Wgniecenie/odkształcenie 1

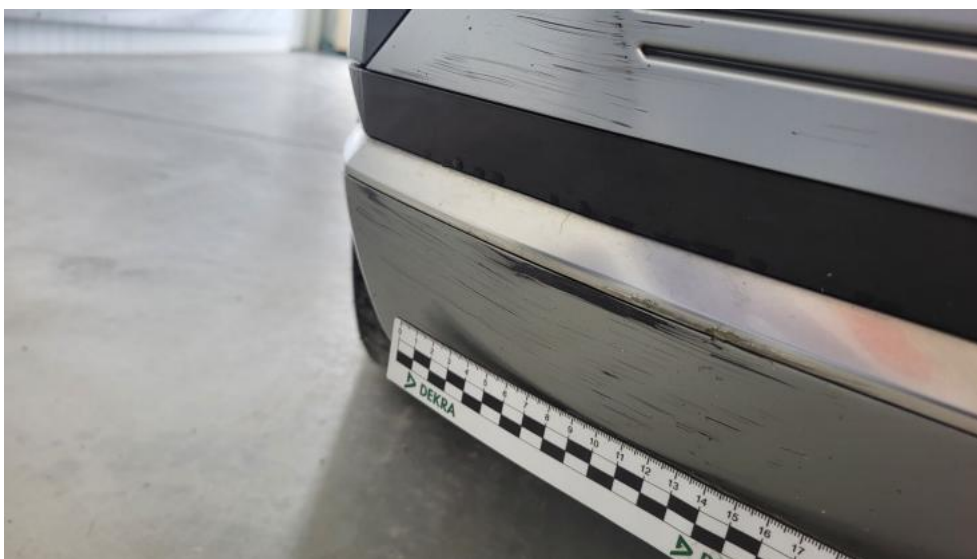
**Photo 49.**

Spoiler zderzaka przedniego - Rysa/odprysk 1

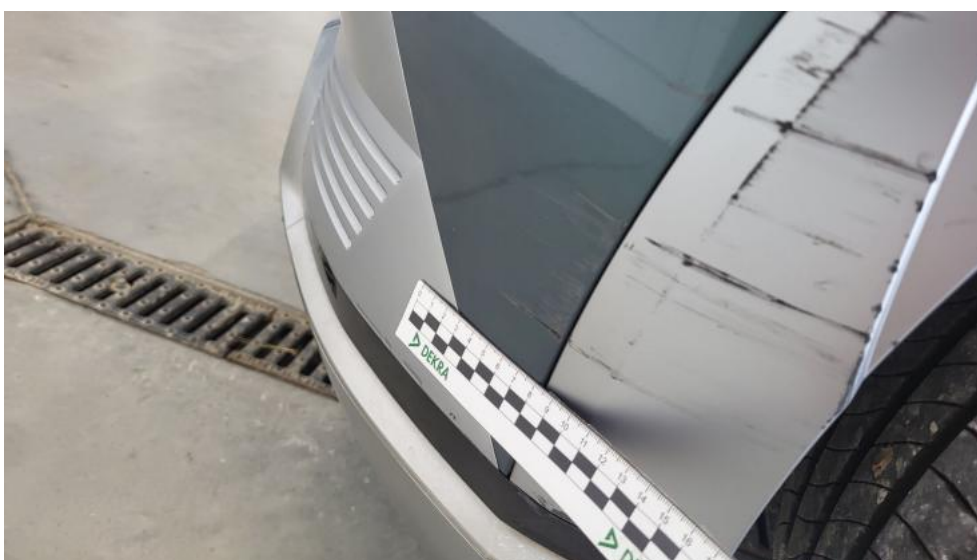
**Photo 50.**

Zderzak - Rysa/odprysk 1

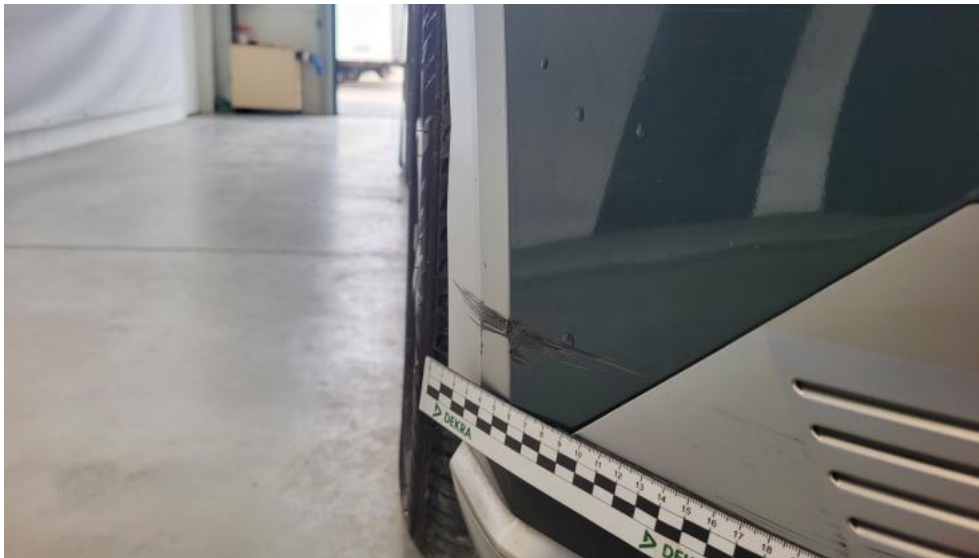
**Photo 51.**

Zderzak - Rysa/odprysk 2

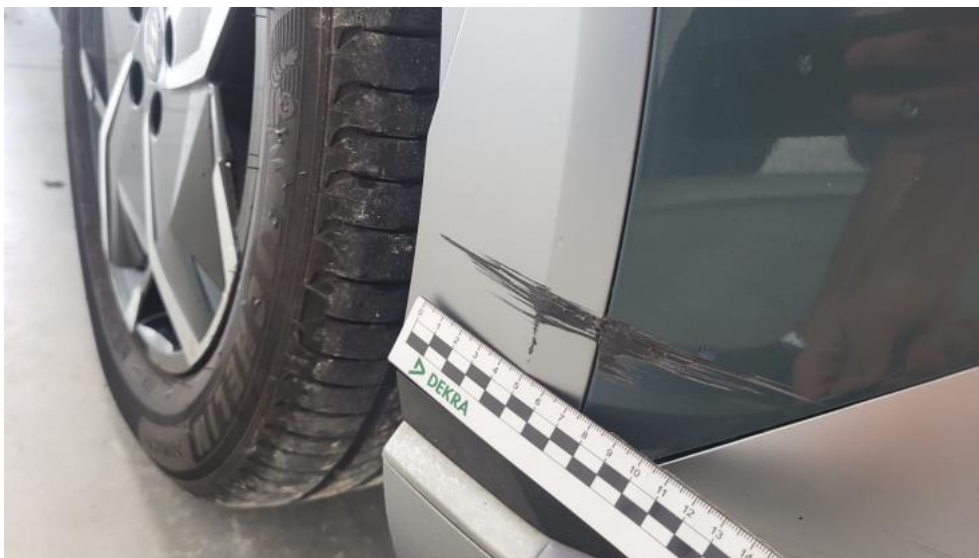
**Photo 52.**

Listwa błotnika przedniego P - Rysa/odprysk 1

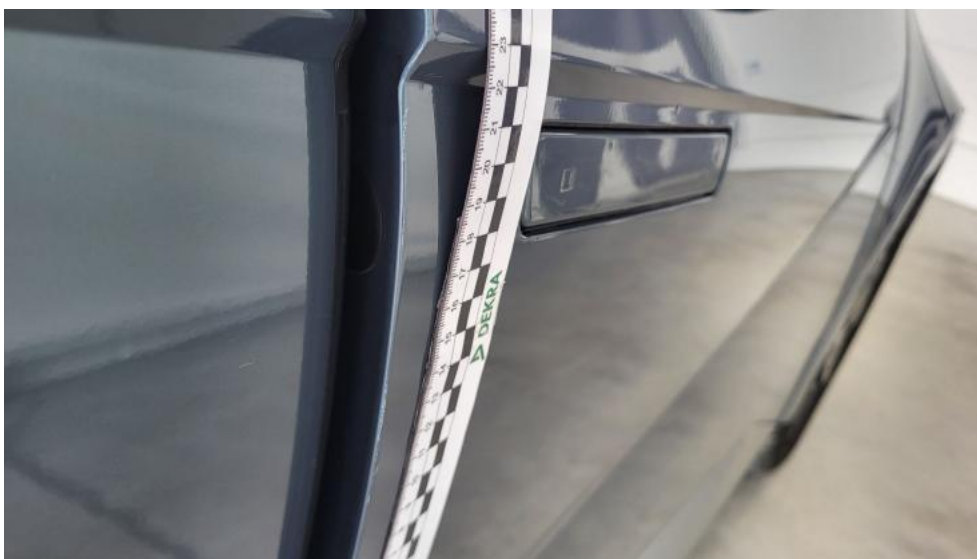
**Photo 53.**

Drzwi przednie P - Rysa/odprysk 1

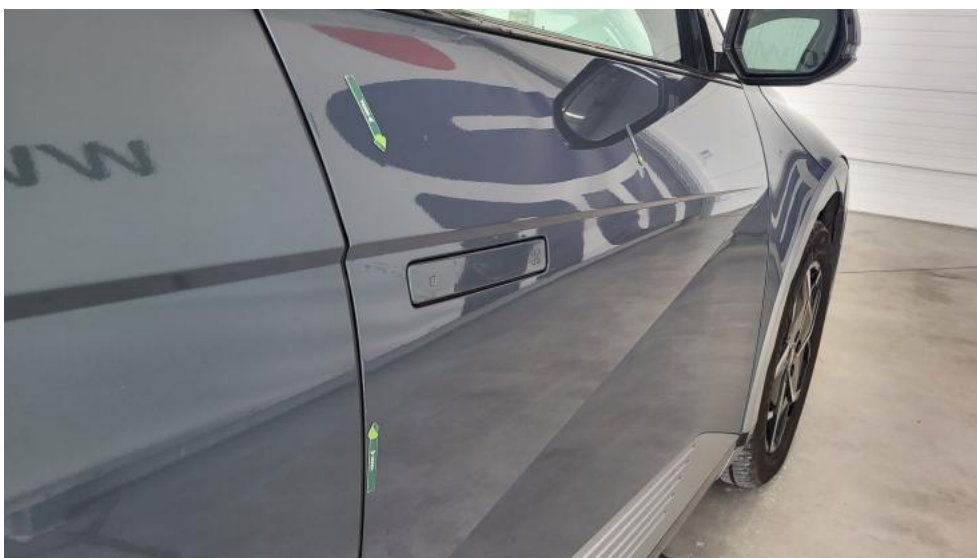
**Photo 54.**

Drzwi przednie P - Wgniecenie/odkształcenie 1

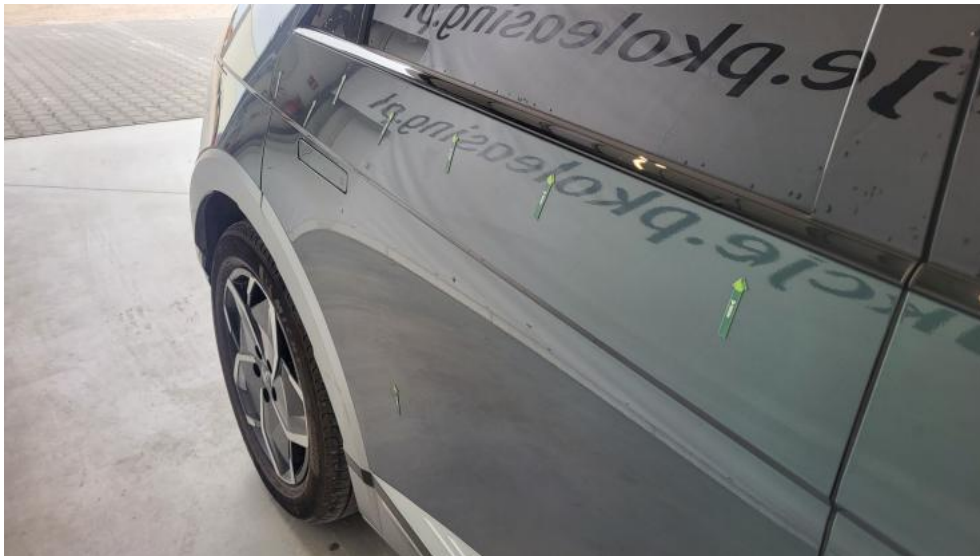
**Photo 55.**

Drzwi tylne P - Wgniecenie/odkształcenie 1

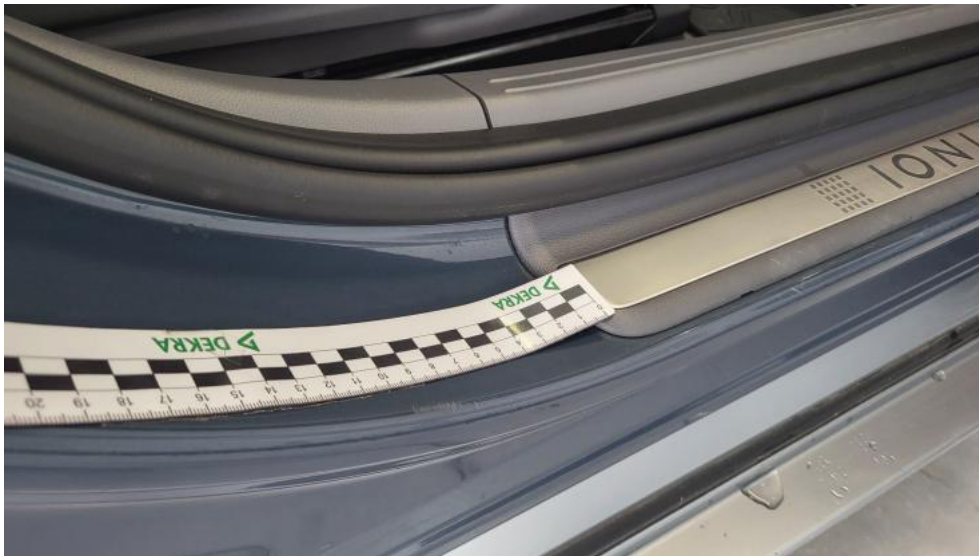
**Photo 57.**

Próg P - Rysa/odprysk 1

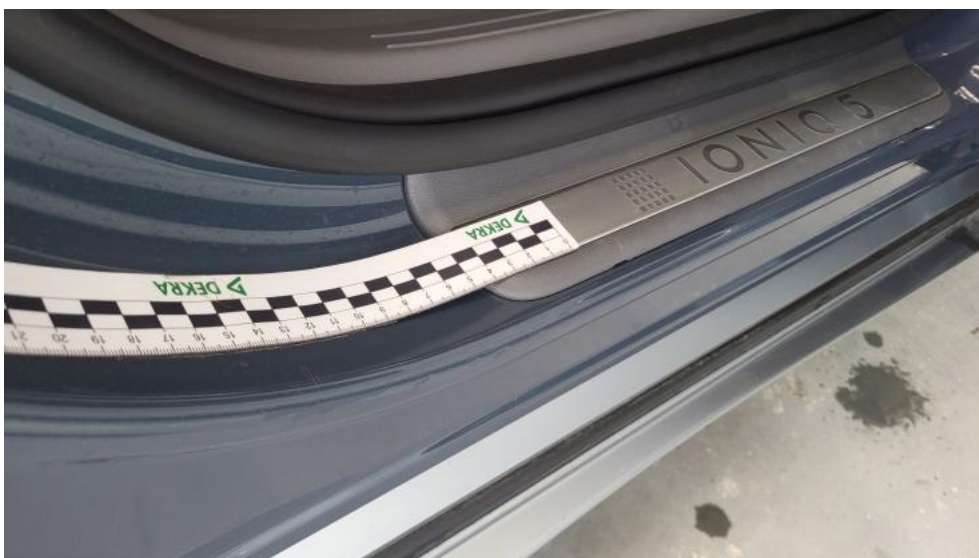
**Photo 58.**

Próg P - Rysa/odprysk 2

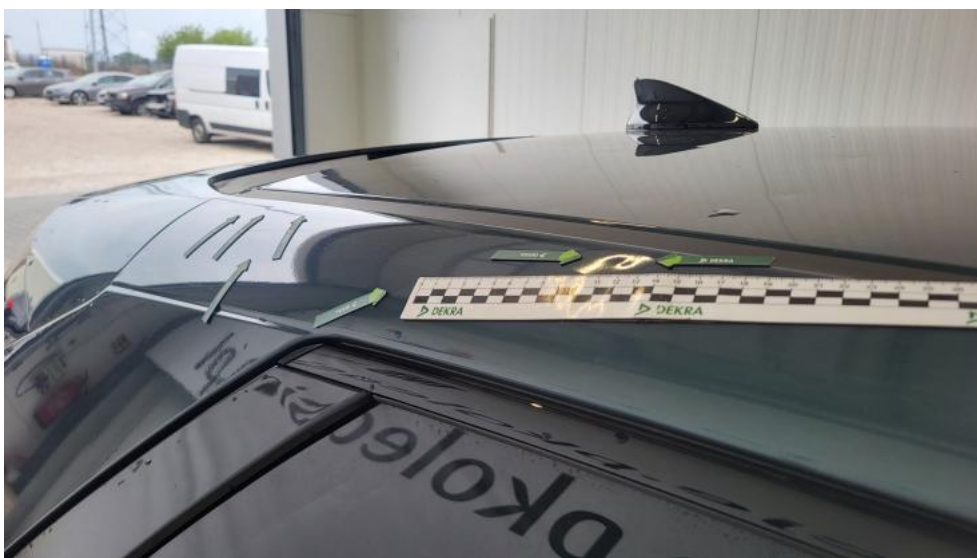
**Photo 60.**

Łotnik tylny P / Ściana boczna P - Wgniecenie/odkształcenie 1

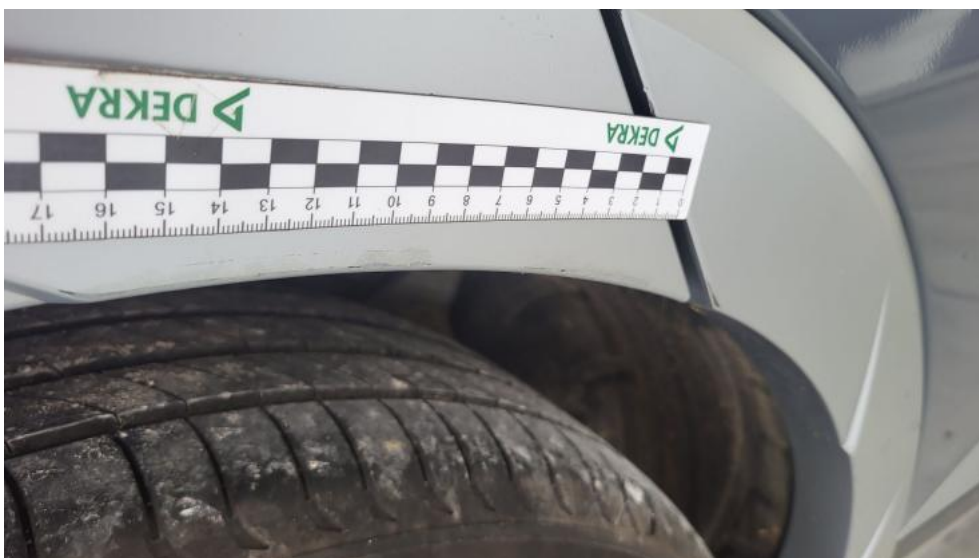
**Photo 62.**

Ścianka tylna P - Rysa/odprysk 1

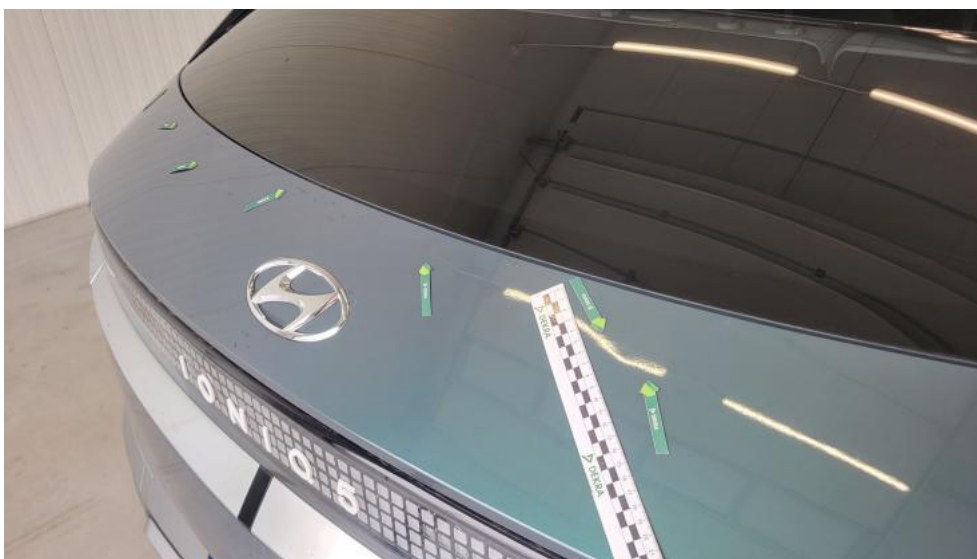
**Photo 63.**

Pokrywy bagażnika - Wgniecenie/odkształcenie 1

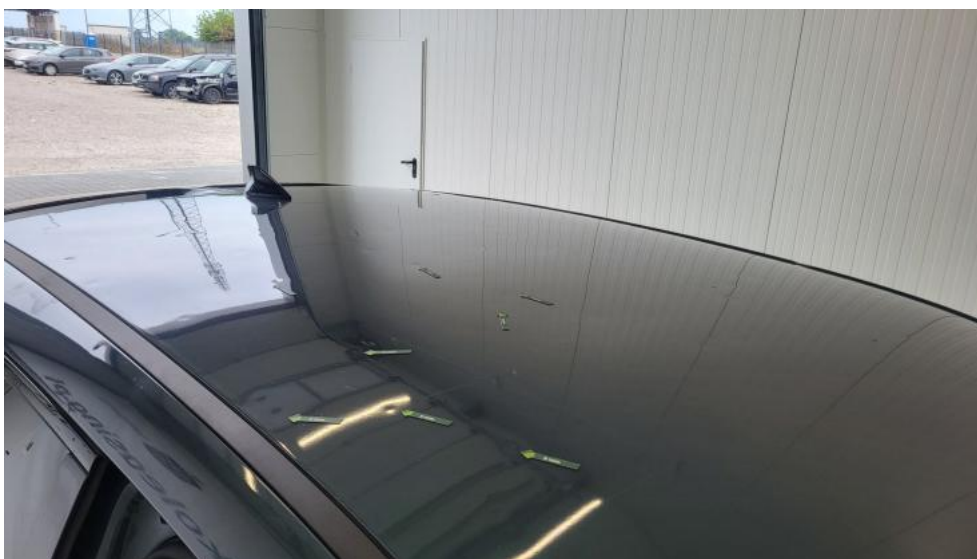
**Photo 65.**

Dach - Wgniecenie/odkształcenie 1

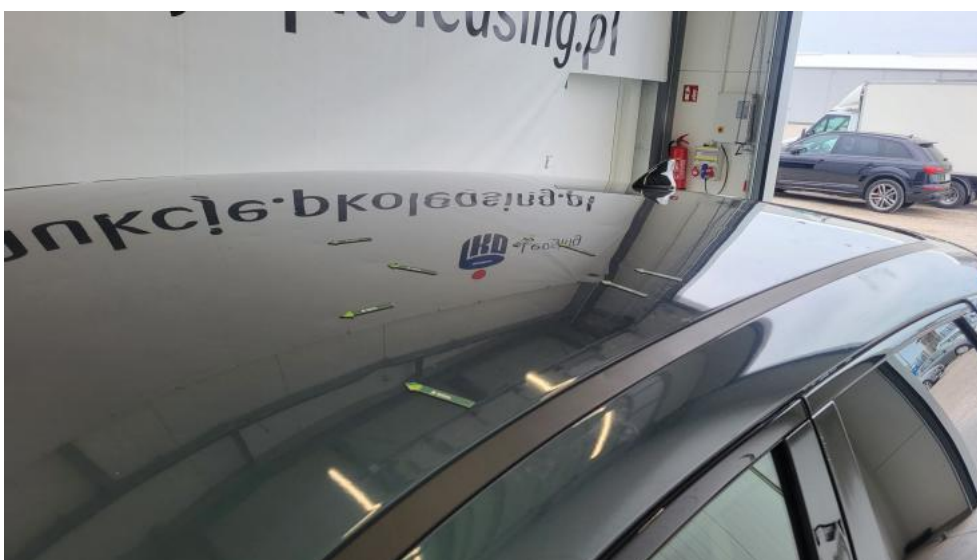
**Photo 66.**

Dach - Wgniecenie/odkształcenie 2

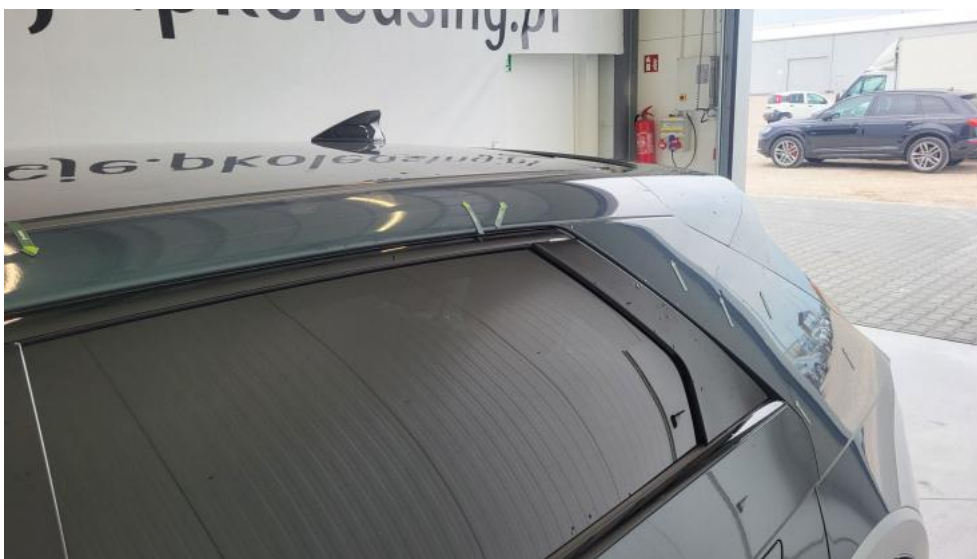
**Photo 69.**

Błotnik tylny L / Ściana boczna L - Wgniecenie/odkształcenie 2

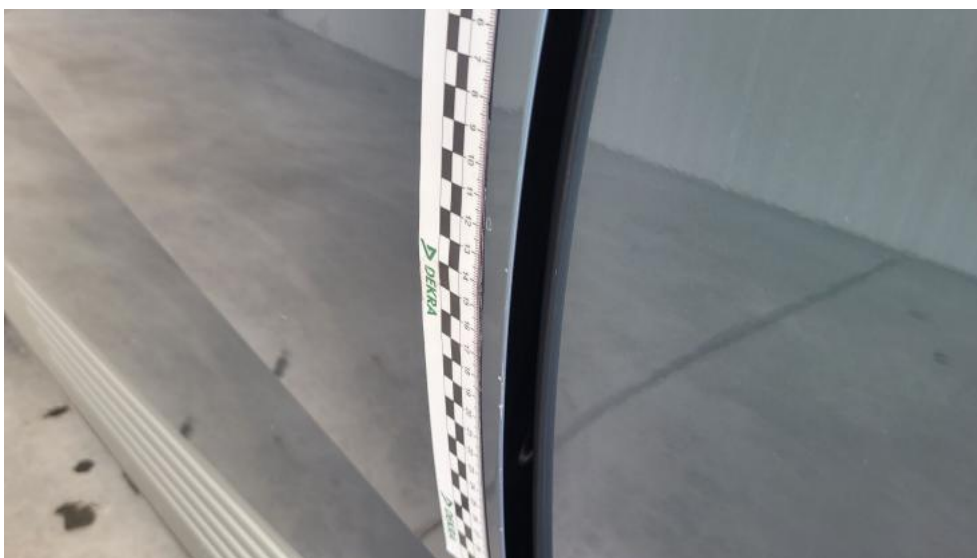
**Photo 70.**

Drzwi przed L - Rysa/odprysk 1

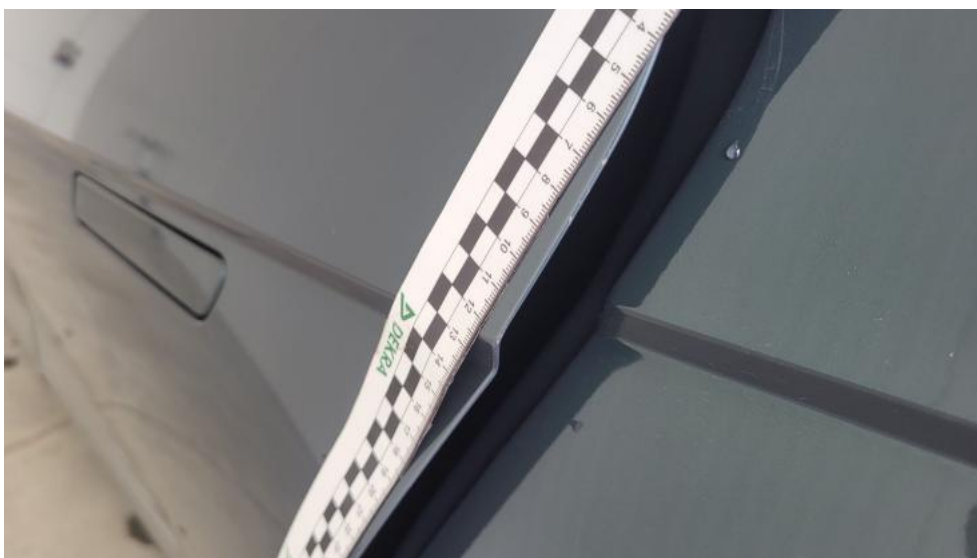
**Photo 72.**

Drzwi tylne L - Rysa/odprysk 1

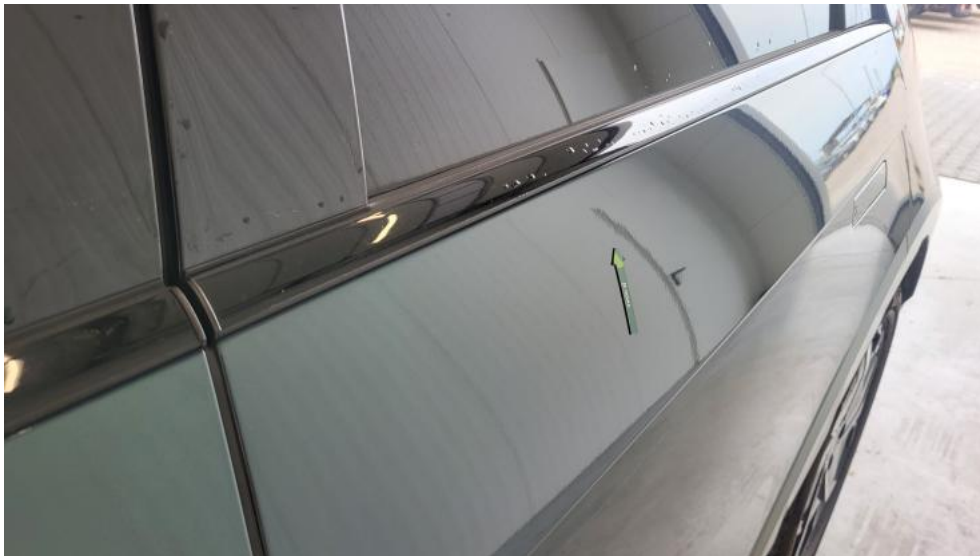
**Photo 73.**

Drzwi tylne L - Wgniecenie/odkształcenie 1

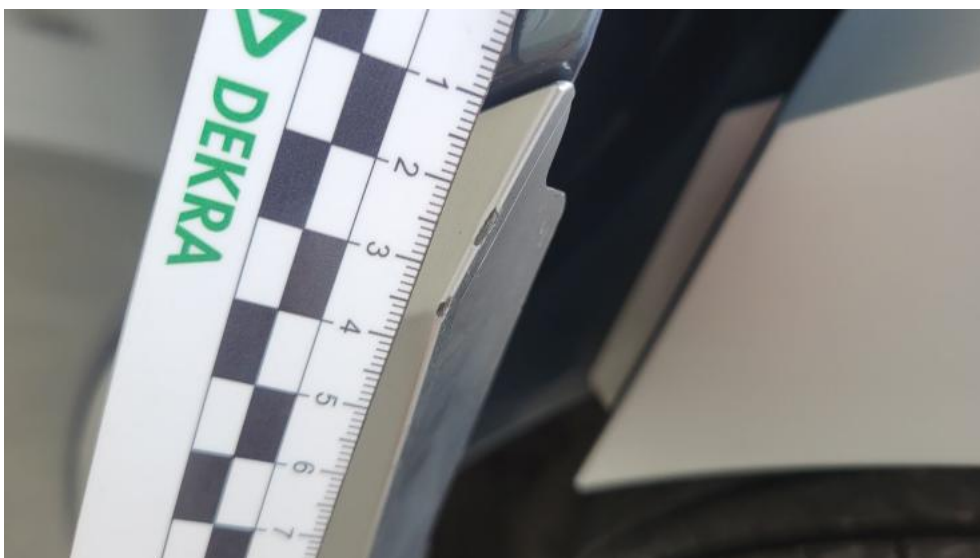
**Photo 74.**

Listwa drzwi tylnych L - Rysa/odprysk 1

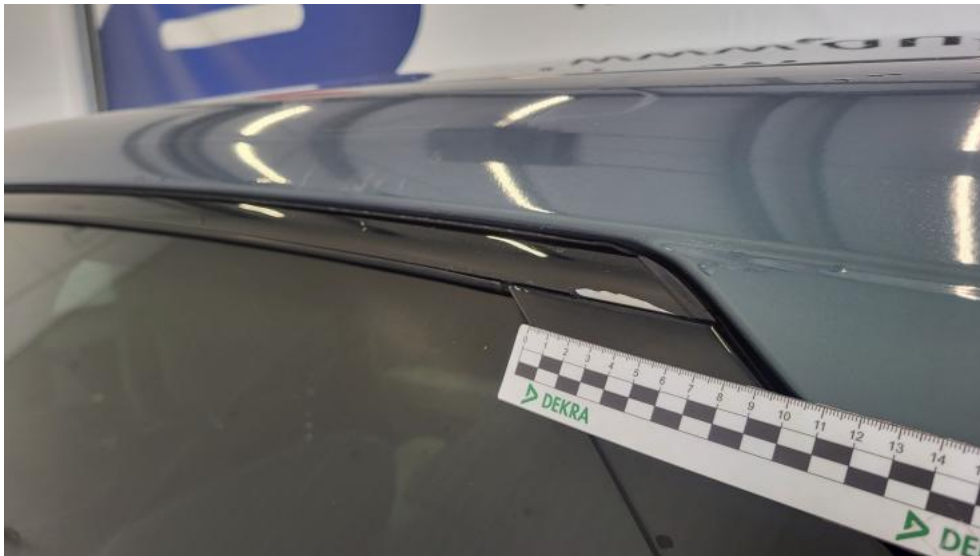
**Photo 75.**

Listwa drzwi tylnych L - Rysa/odprysk 2

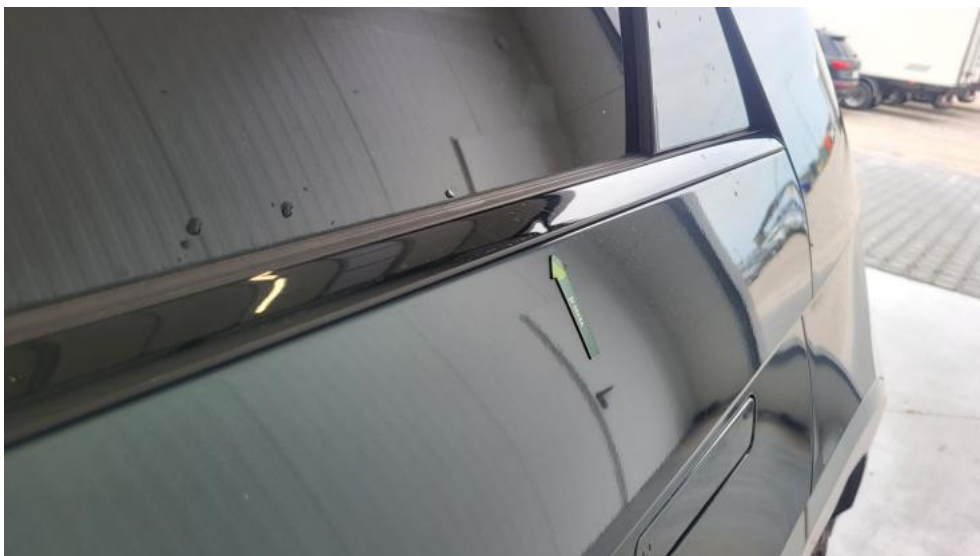
**Photo 76.**

Listwa drzwi tylnych L - Wgniecenie/odkształcenie 1

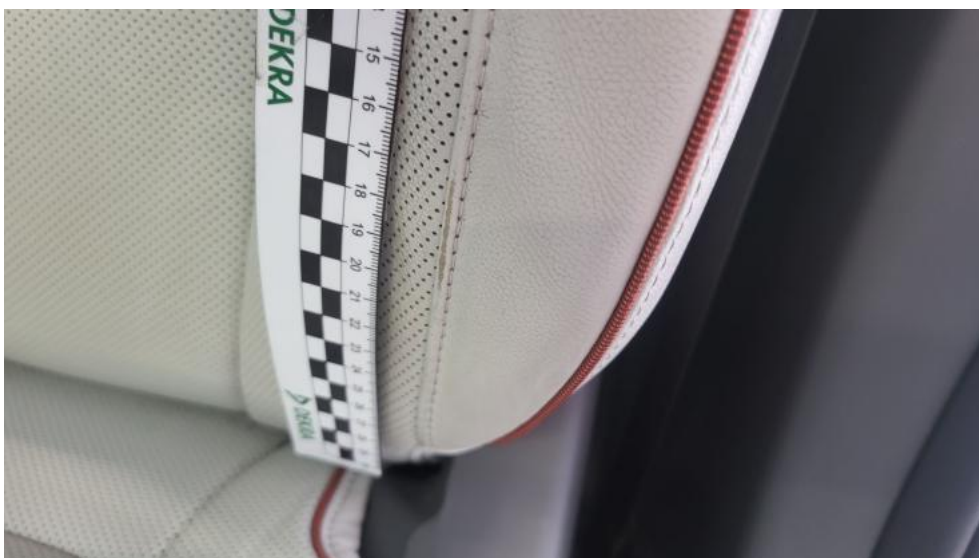
**Photo 80.**

Fotel prz. lew. - Inne 1

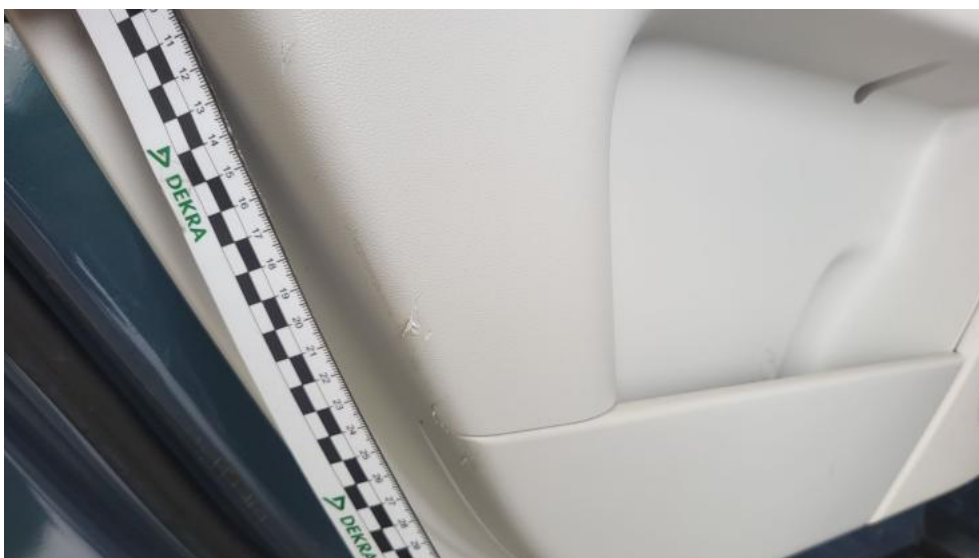
**Photo 82.**

Tapicerka drzwi tylnych L - Pęknięcie/rozerwanie 2

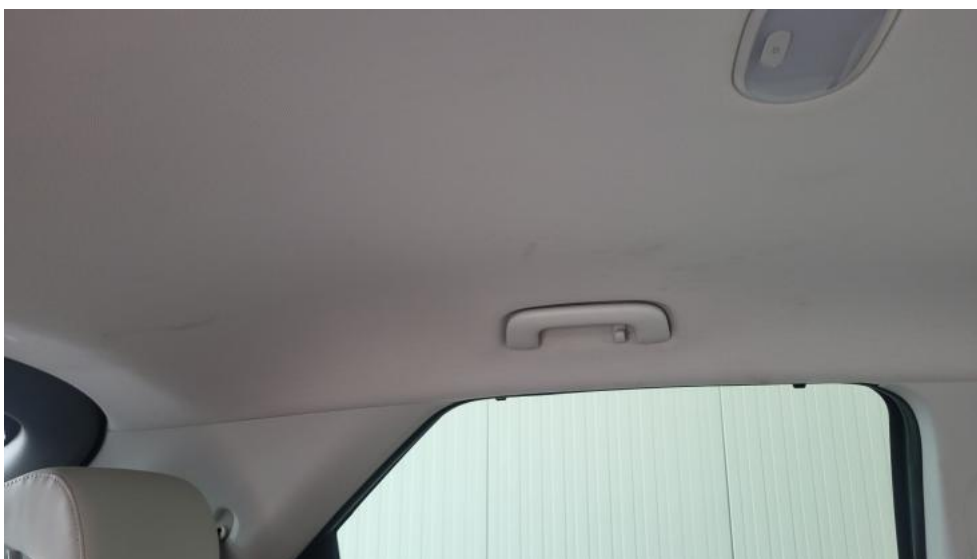
**Photo 83.**

Podsufitka - Inne 1

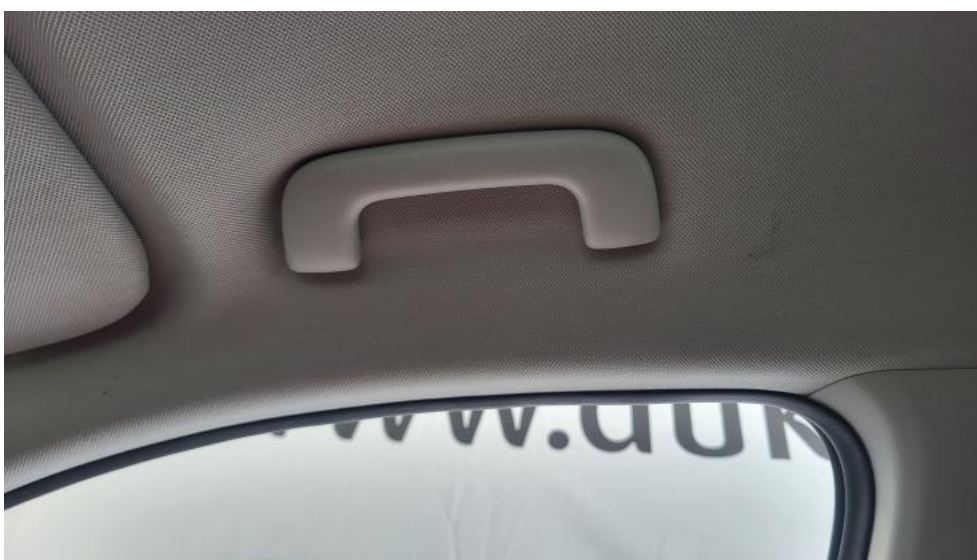
**Photo 84.**

Podsufitka - Inne 2
