DEKRA's commission No. : PKOL(W)/LODZ/72289/25/09/24  
commission/ damage No. : 20/042657  
Date of commission: 24-09-2025

PKO Leasing SA  
Świętokrzyska 36  
00-116 Warszawa

| Model | Sorento 15-18 |
| Type / version | Sorento 2.0 CRDI Business Line Plus aut |

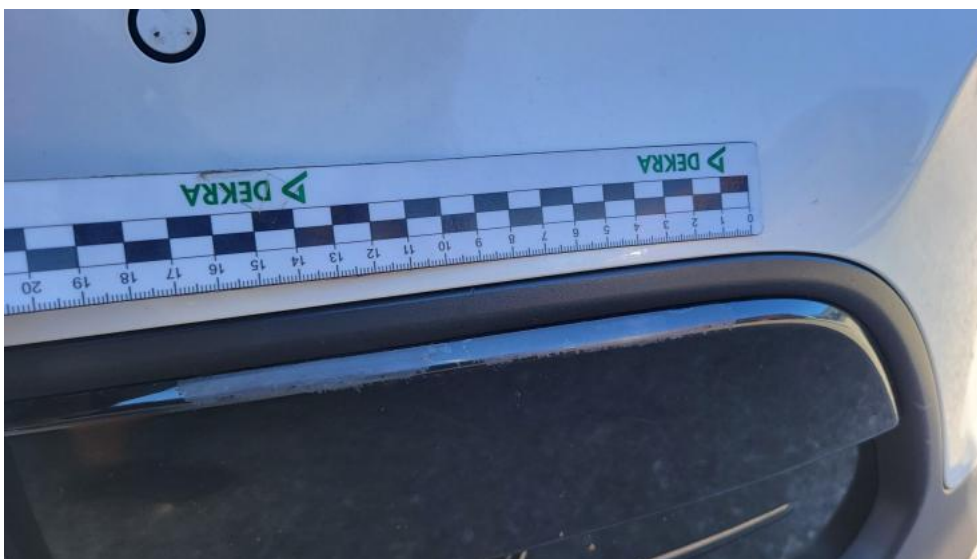
**Photo 45.**

Listwa śr zderzaka przedniego - Inne 1

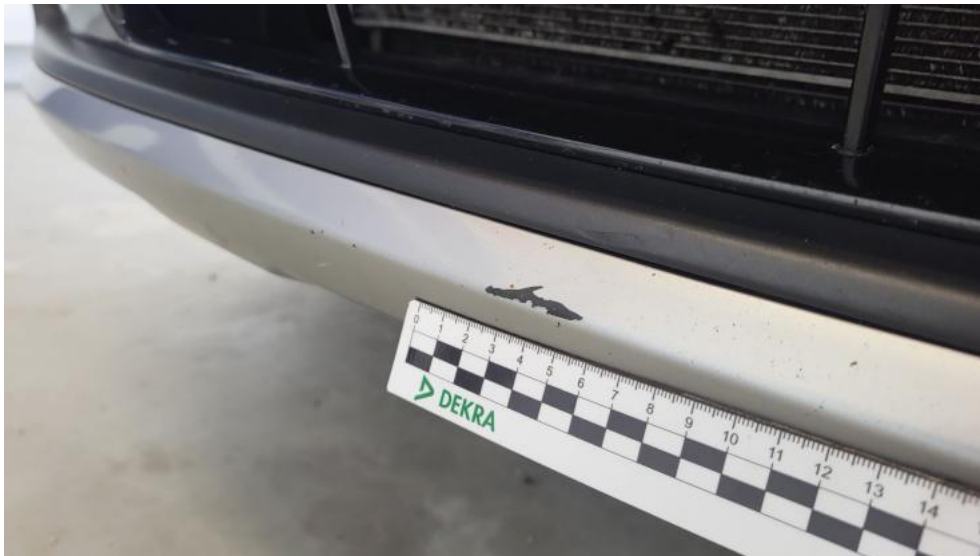
**Photo 49.**

Spoiler zderzaka przedniego - Rysa/odprysk 1

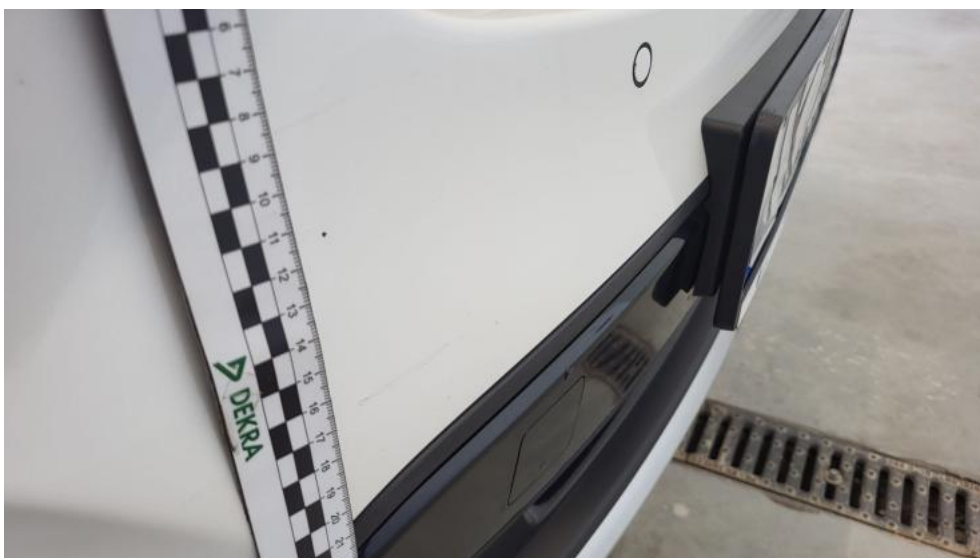
**Photo 50.**

Zderzak przedni cz dolna - Rysa/odprysk 1

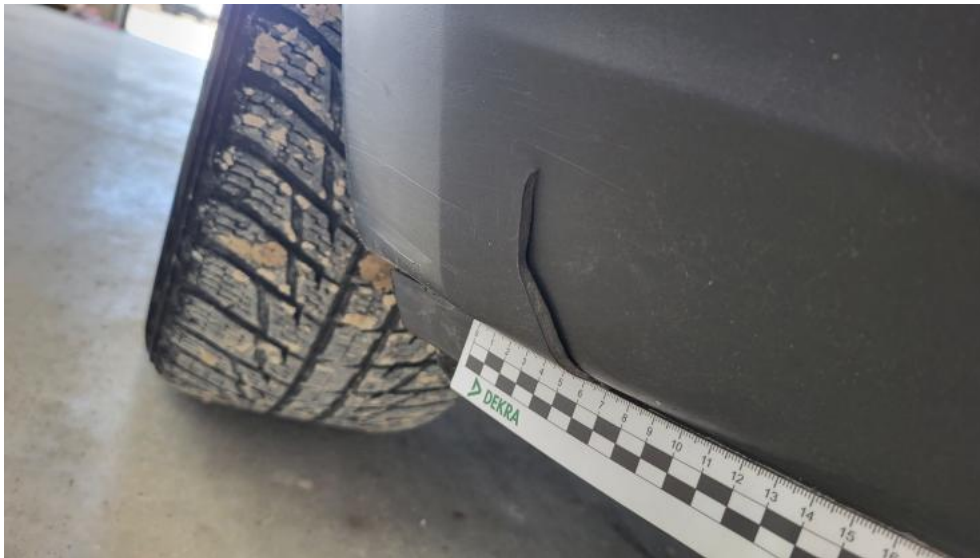
**Photo 51.**

Zderzak przedni cz dolna - Pęknięcie/rozerwanie 1

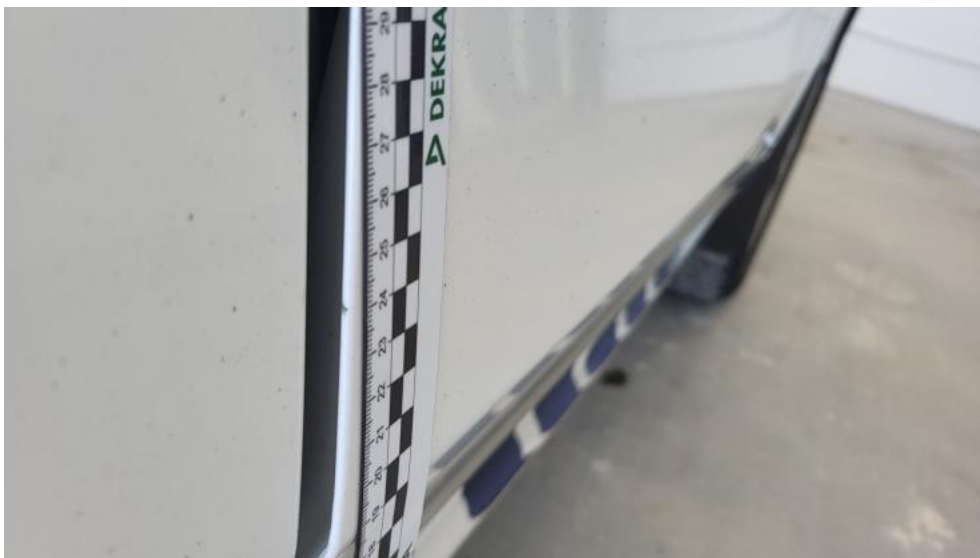
**Photo 52.**

Drzwi przednie P - Rysa/odprysk 1

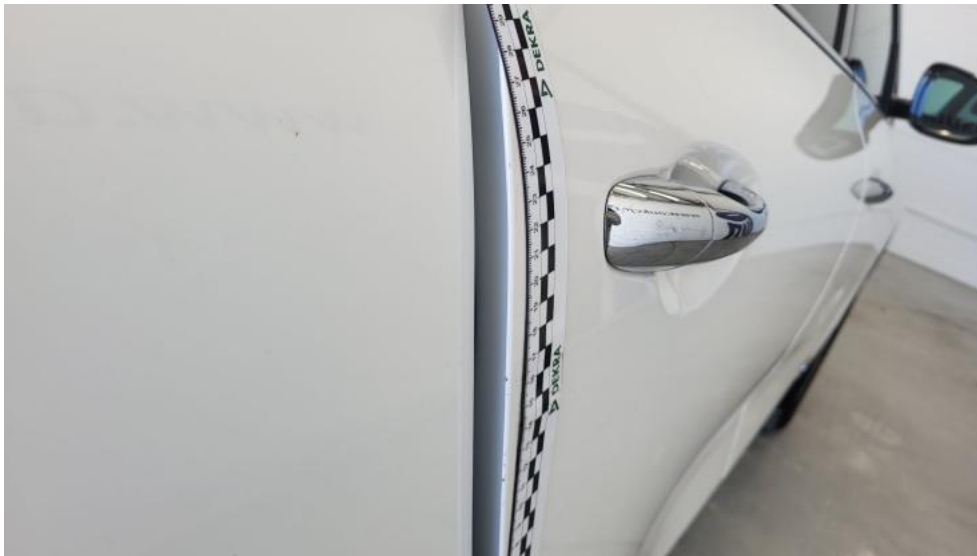
**Photo 53.**

Drzwi tylne P - Rysa/odprysk 1

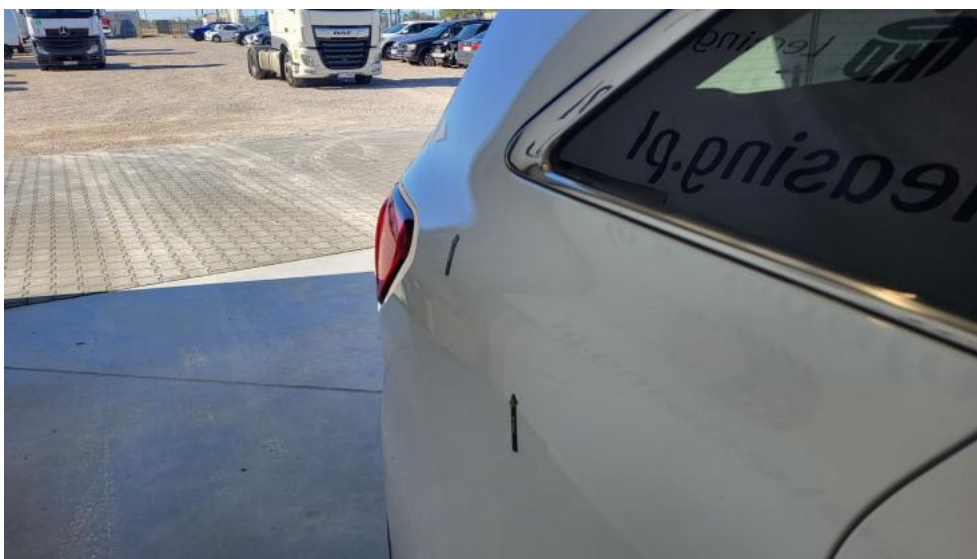
**Photo 55.**

Błotnik tylny P / Ściana boczna P - Wgniecenie/odkształcenie 1

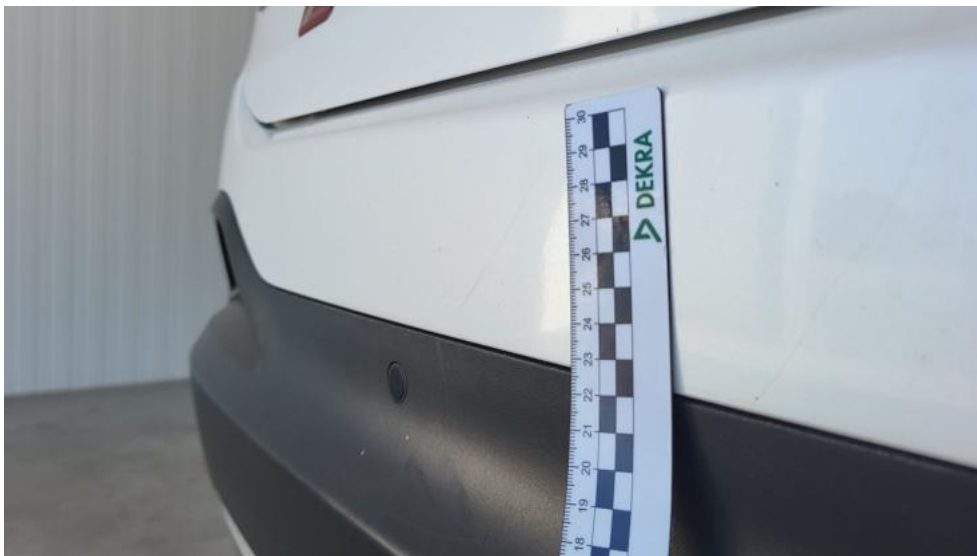
**Photo 57.**

Zderzak tylny - Wgniecenie/odkształcenie 1

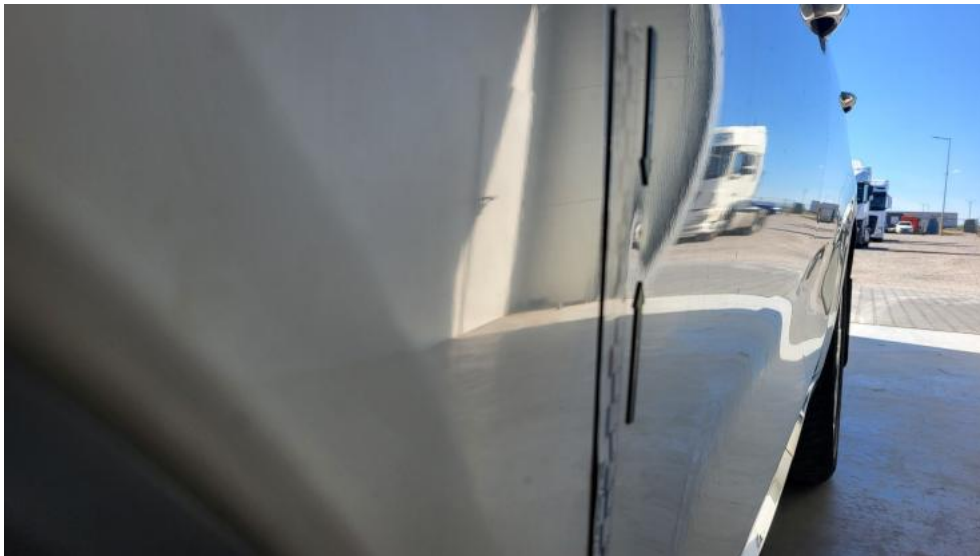
**Photo 59.**

Drzwi przed L - Wgniecenie/odkształcenie 1

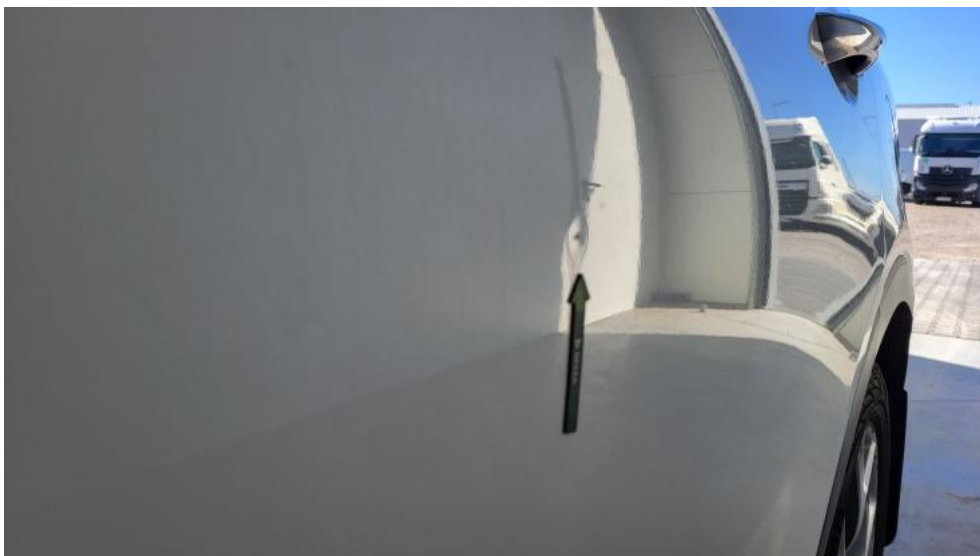
**Photo 60.**

Drzwi tylne L - Wgniecenie/odkształcenie 1

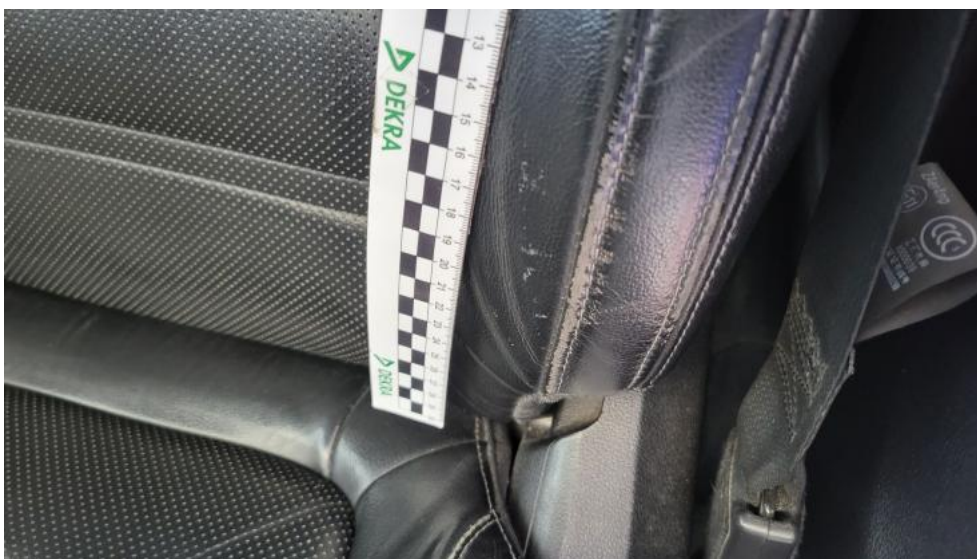
**Photo 63.**

Fotel prz. lew. - Inne 1

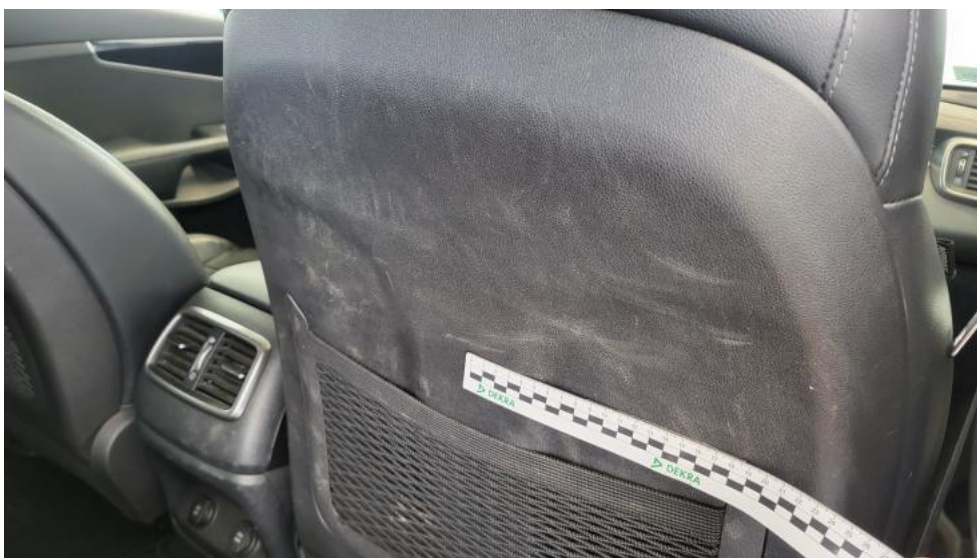
**Photo 64.**

Fotel prz. praw. - Inne 1
