DEKRA's commission No. : PKOL(W)/LODZ/89683/25/11/19  
commission/ damage No. : 20/043709  
Date of commission: 19-11-2025

| Manufacturer | AUDI |
| Type / version | A4 2.0 TDI S tronic |
| Registration /record No. | WZ095CA |

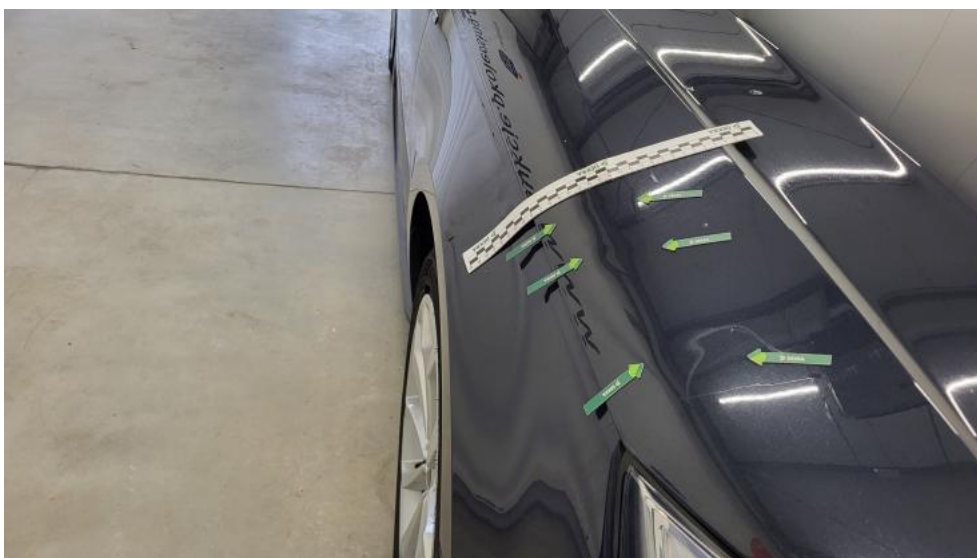
**Photo 38.**

Pokrywa komory silnika - Wgniecenie/odkształcenie 2

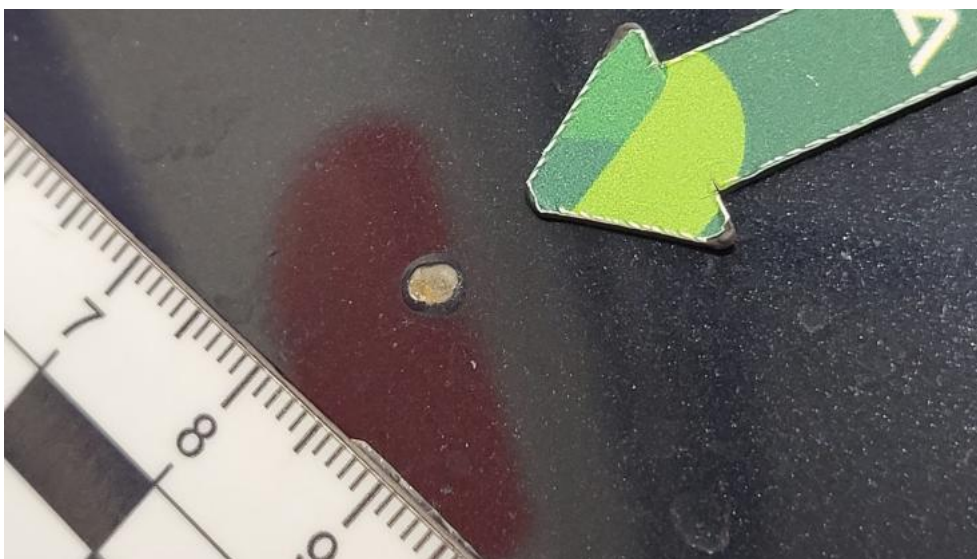
**Photo 39.**

Pokrywa komory silnika - Inne 1

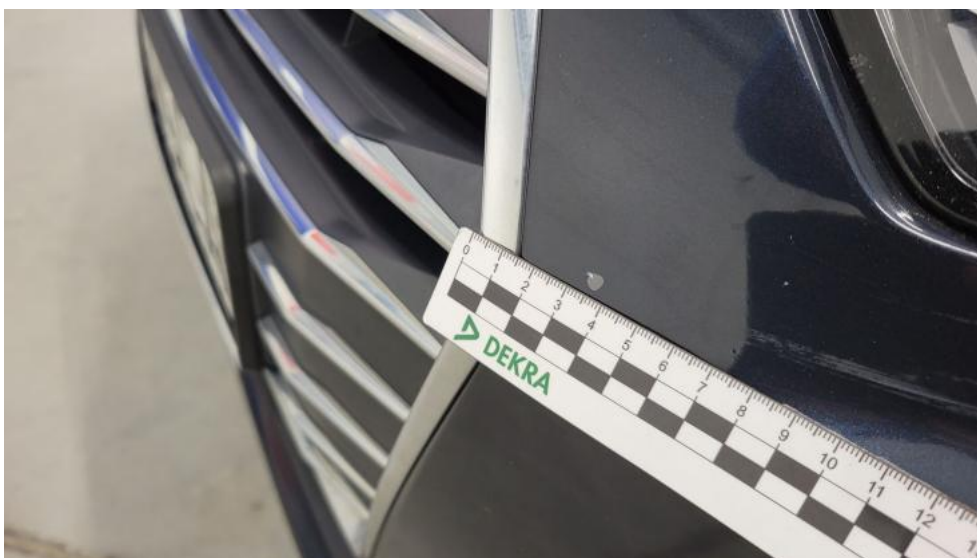
**Photo 40.**

Zderzak - Rysa/odprysk 1

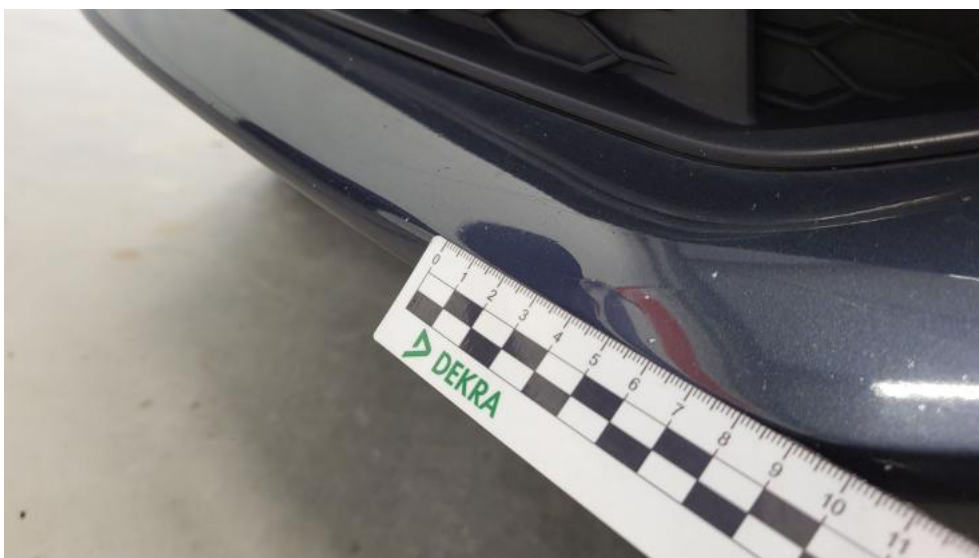
**Photo 42.**

Zderzak - Pęknięcie/rozerwanie 1

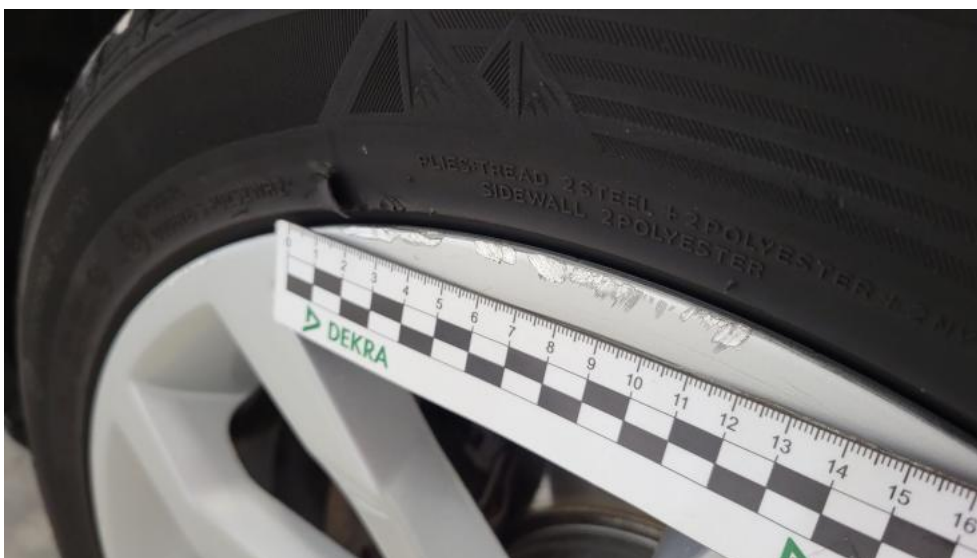
**Photo 44.**

Felga aluminiowa przednia P - Rysa/odprysk 1

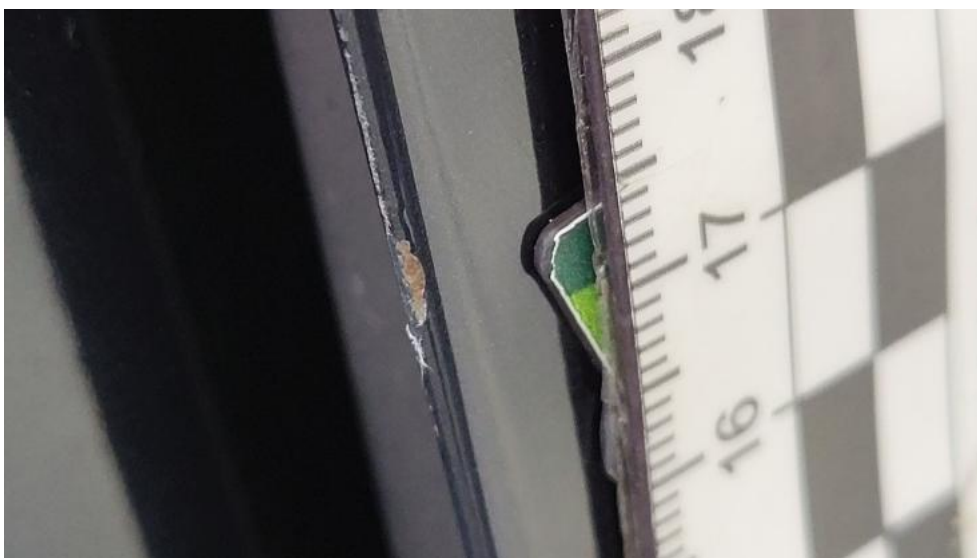
**Photo 50.**

Drzwi tylne P - Inne 1

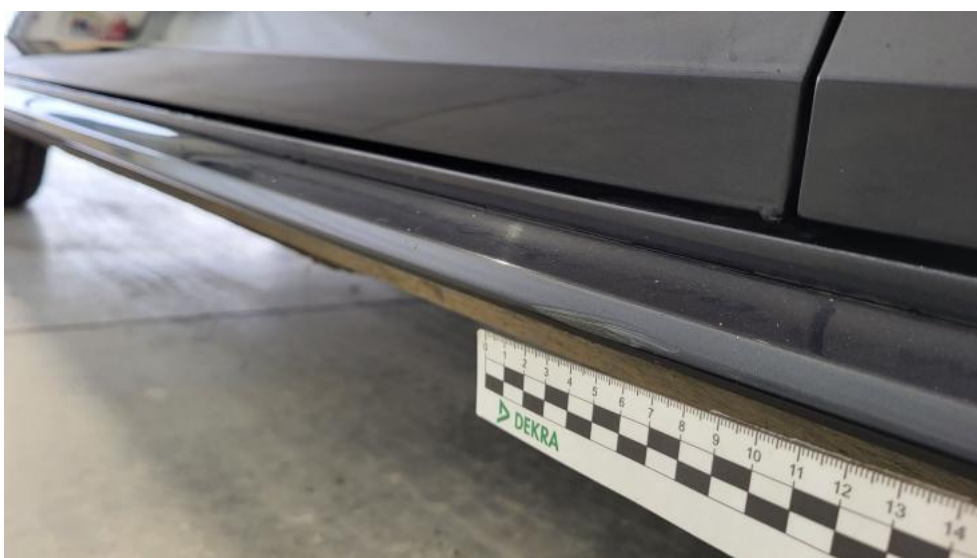
**Photo 52.**

Próg P - Rysa/odprysk 1

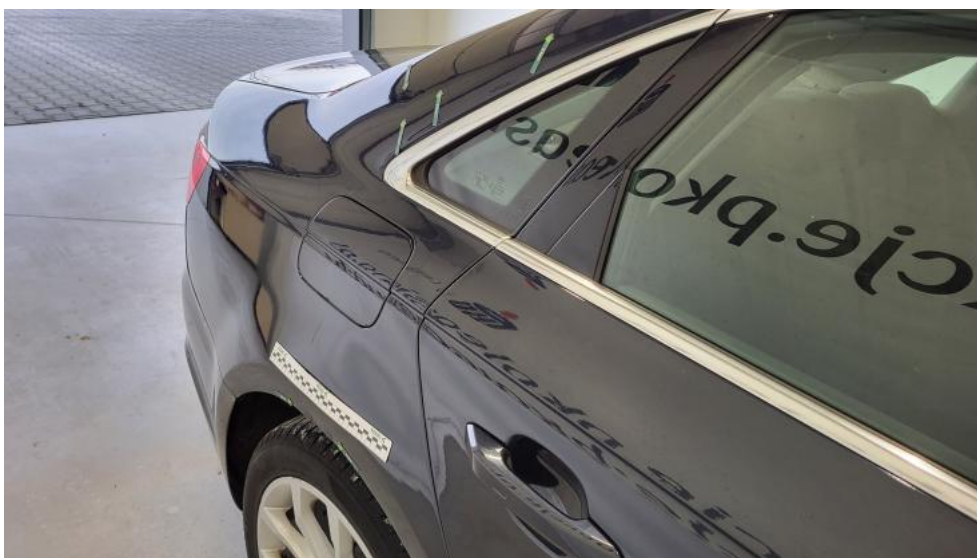
**Photo 56.**

Ścianka tylna P / Ścianka boczna P - Wgniecenie/odkształcenie 1

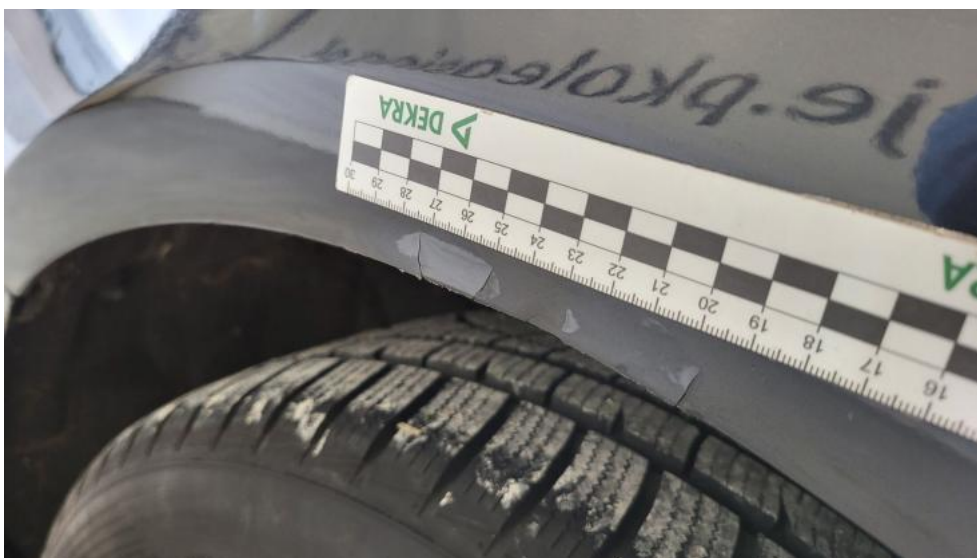
**Photo 58.**

Łotnik tylny P / Ściana boczna P - Pęknięcie/rozerwanie 2

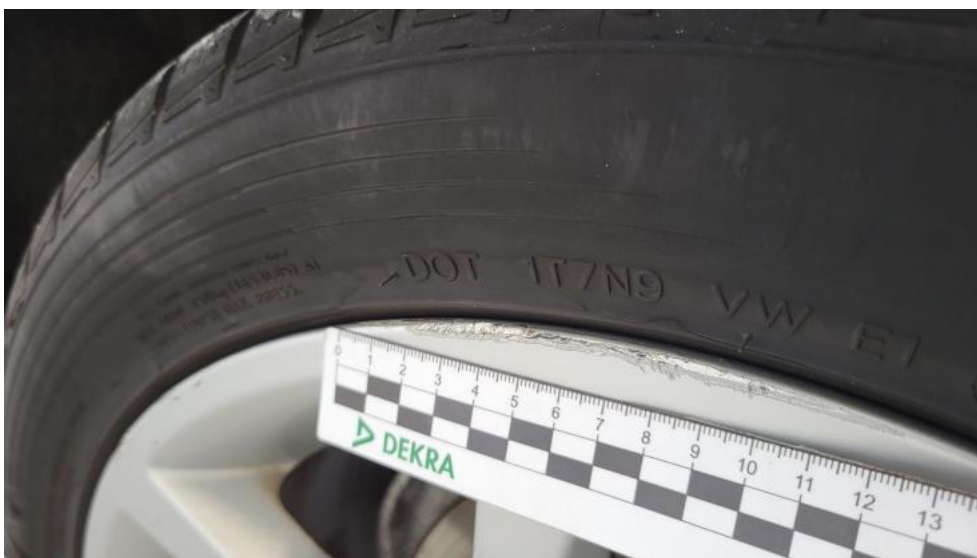
**Photo 60.**

Felga aluminiowa tylna P - Rysa/odprysk 1

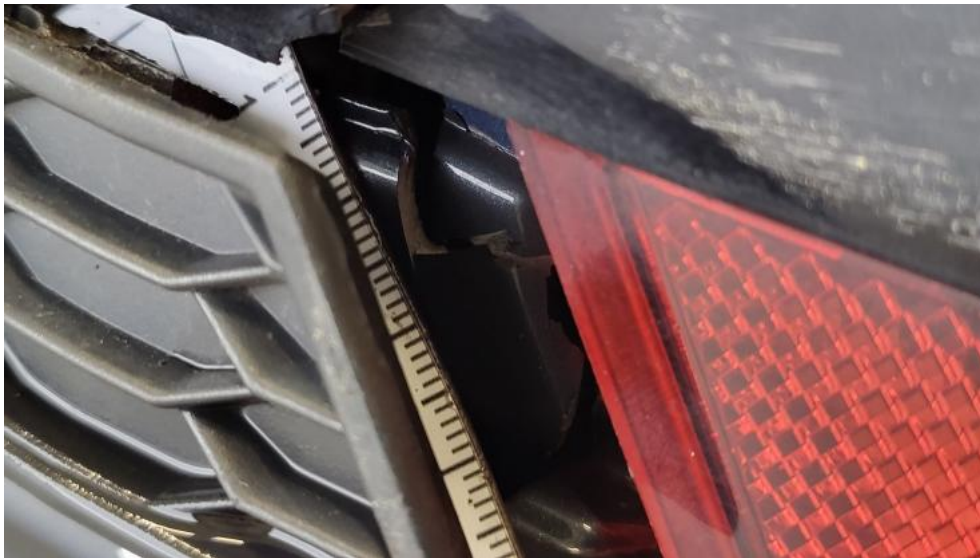
**Photo 61.**

Listwa śr zderzaka tylnego - Pęknięcie/rozerwanie 1

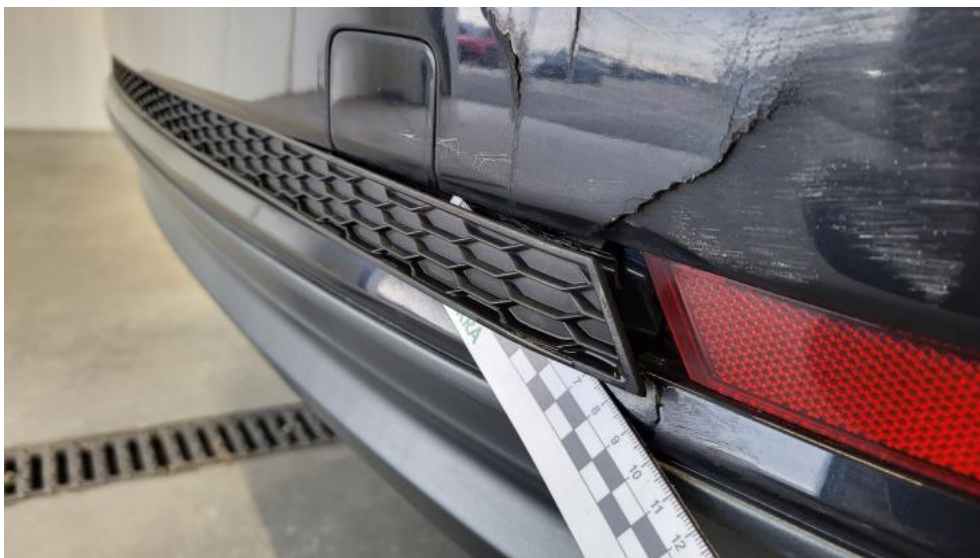
**Photo 62.**

Listwa śr zderzaka tylnego - Inne 1

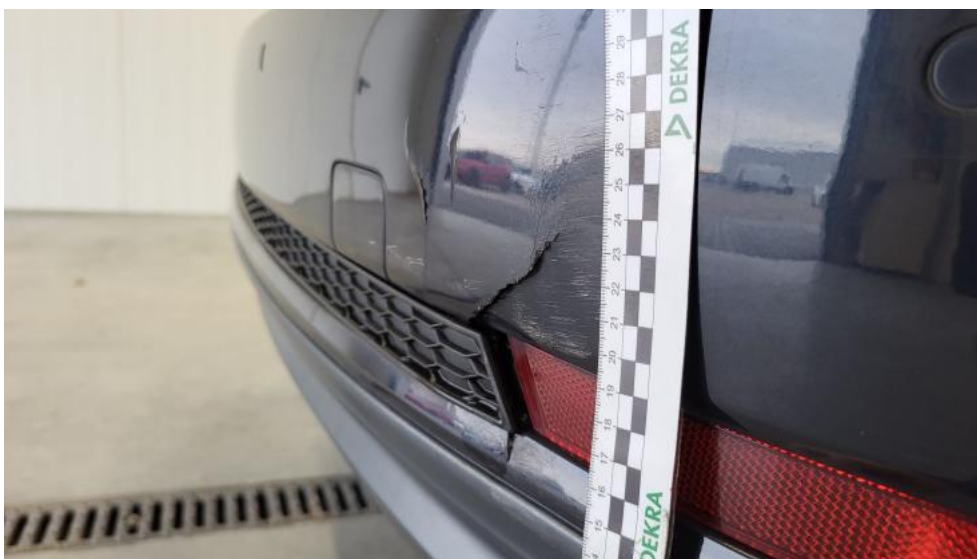
**Photo 67.**

Zderzak tylny - Pęknięcie/rozerwanie 1

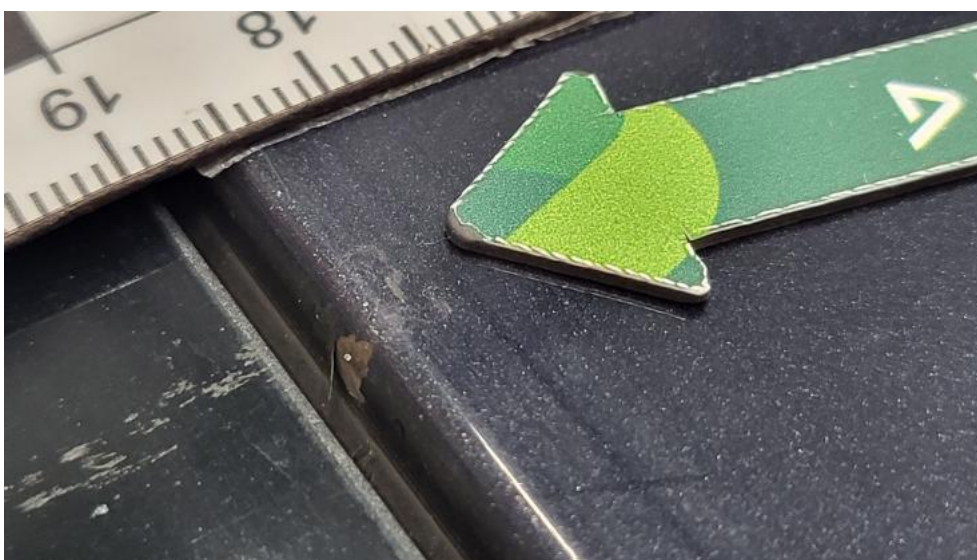
**Photo 70.**

Dach - Inne 1

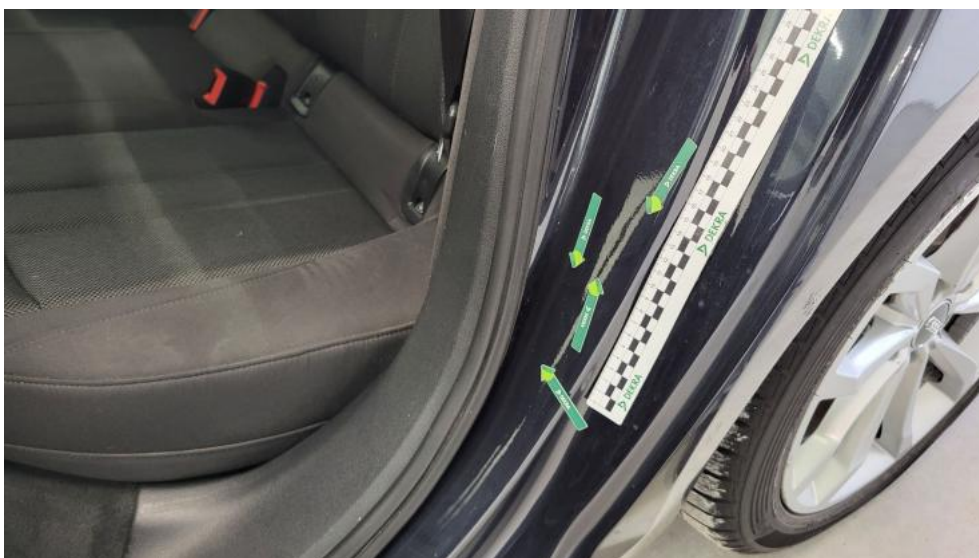
**Photo 74.**

Błotnik tylny L / Ściana boczna L() - Wgniecenie/odkształcenie 3

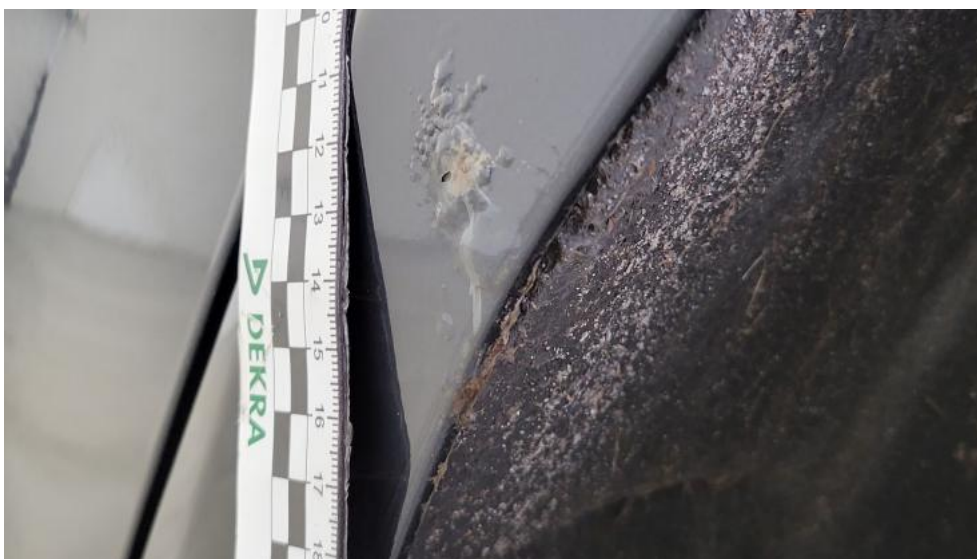
**Photo 75.**

Błotnik tylny L / Ściana boczna L - Inne 1

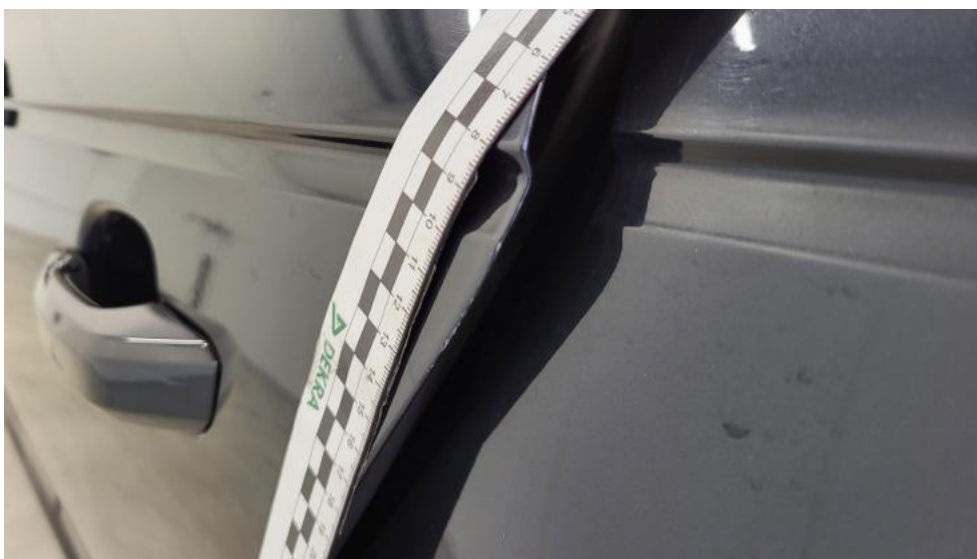
**Photo 79.**

Drzwi tylne L - Rysa/odprysk 1

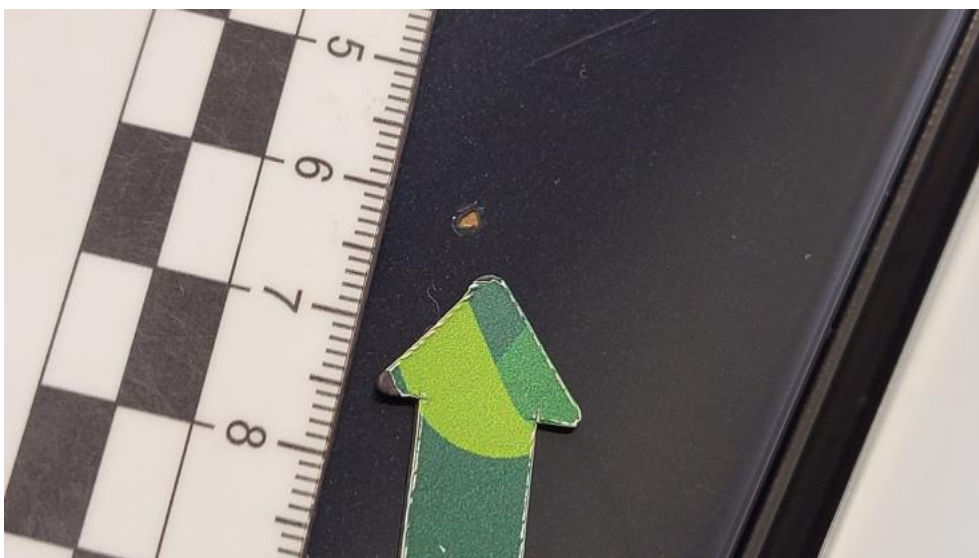
**Photo 84.**

Słupek przedni L - Inne 1

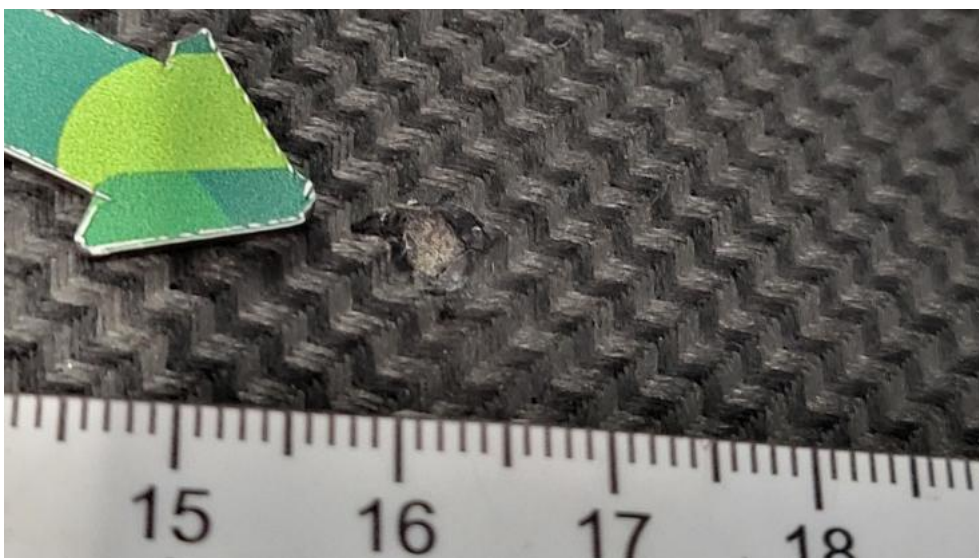
**Photo 90.**

Fotel prz. lew. - Inne 1

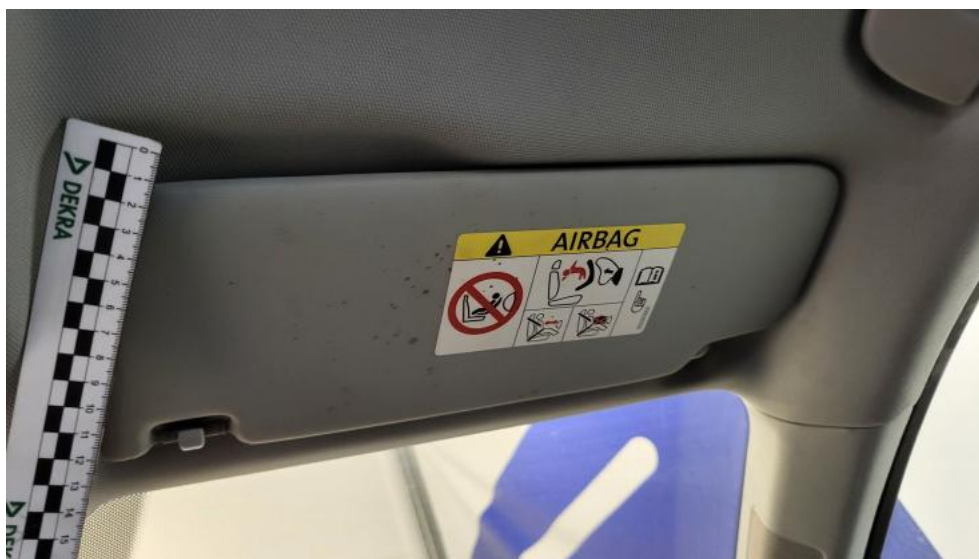
**Photo 91.**

Oslony fotela prz. P - Inne 1

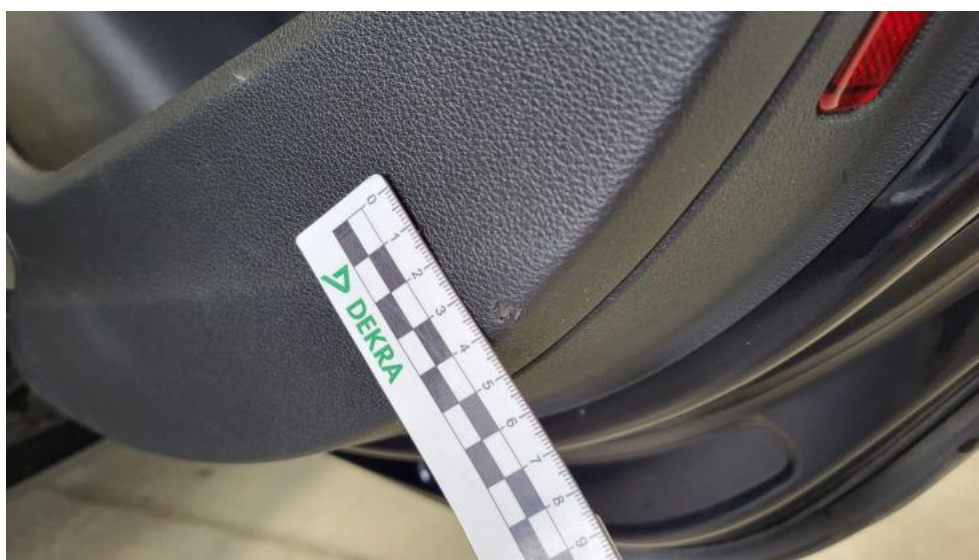
**Photo 92.**

Tapicerka drzwi tylnych P - Pęknięcie/rozerwanie 1
