DEKRA's commission No. : PKOL(W)/LODZ/03290/26/01/15  
commission/ damage No. : 21/026055  
Date of commission: 15-01-2026

| Manufacturer | BMW |
| Type / version | X5 xDrive45e sport-aut |
| Registration /record No. | FZ3633P |

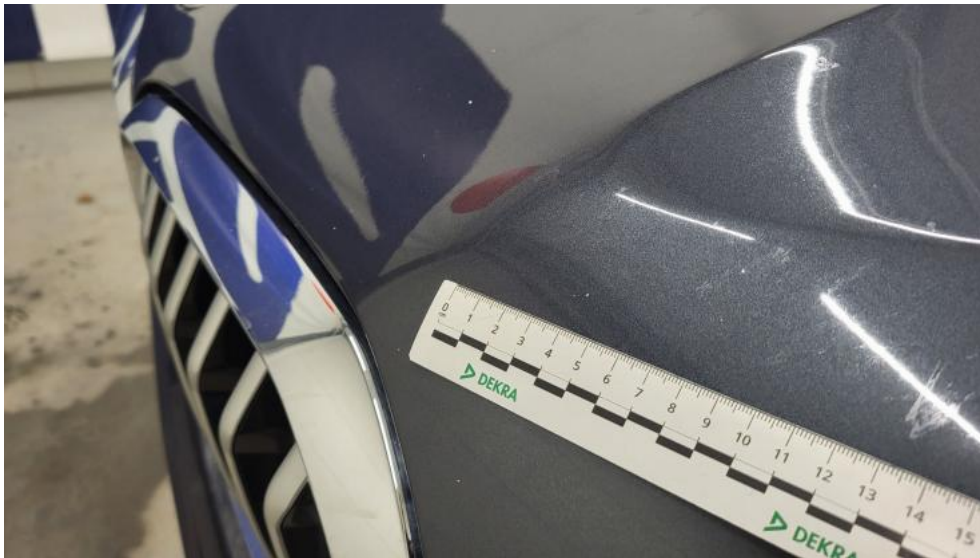
**Photo 41.**

Pokrywa komory silnika - Rysa/odprysk 1

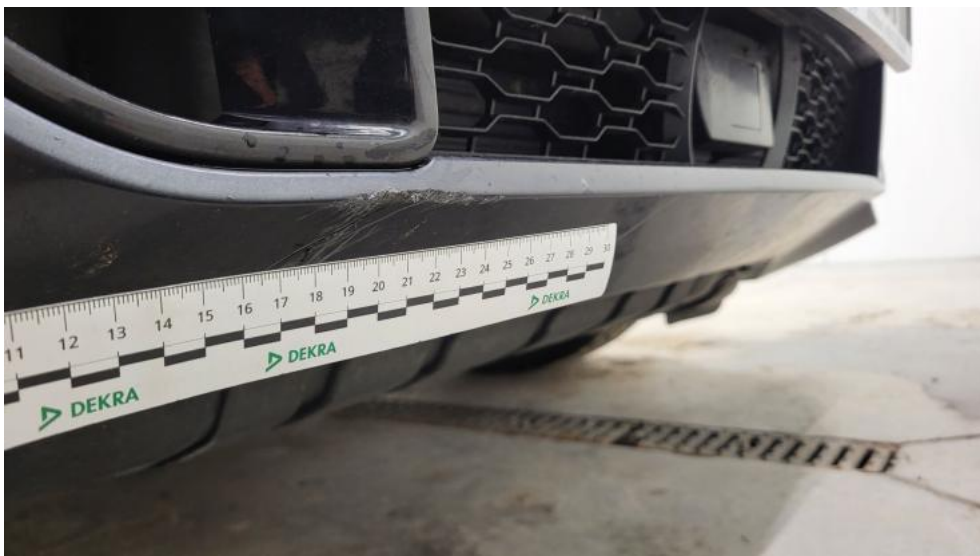
**Photo 42.**

Zderzak - Rysa/odprysk 1

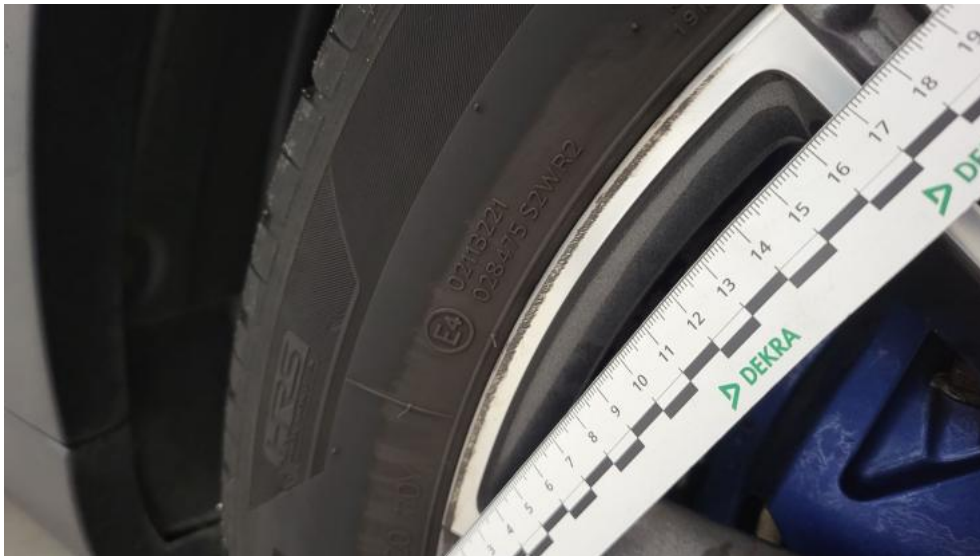
**Photo 43.**

Felga aluminiowa przednia P - Rysa/odprysk 1

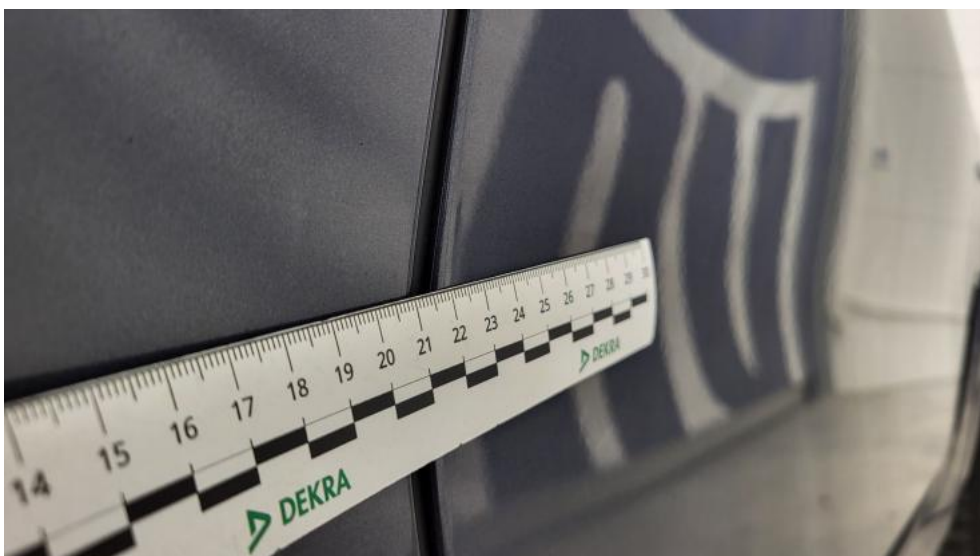
**Photo 44.**

Drzwi przednie P - Wgniecenie/odkształcenie 1

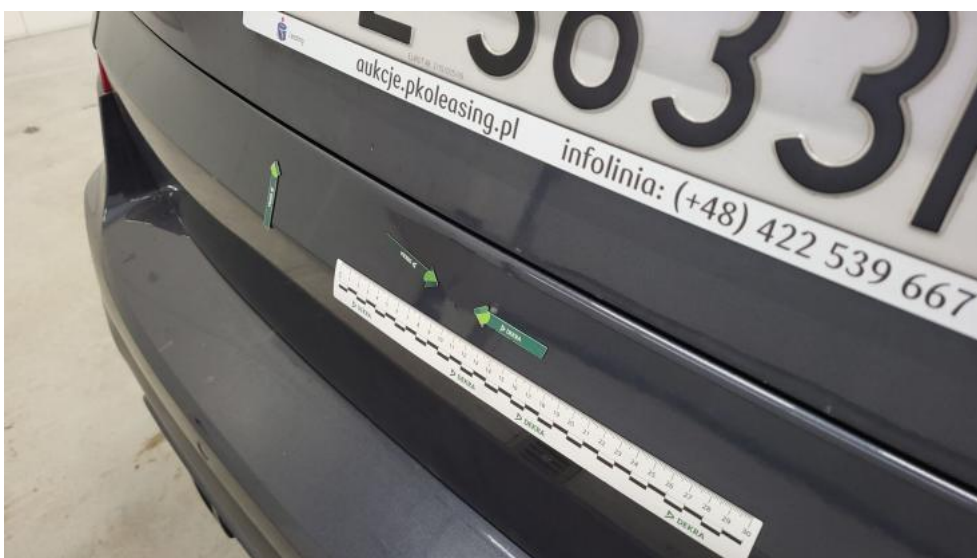
**Photo 50.**

Pokrywy bagażnika - Wgniecenie/odkształcenie 1

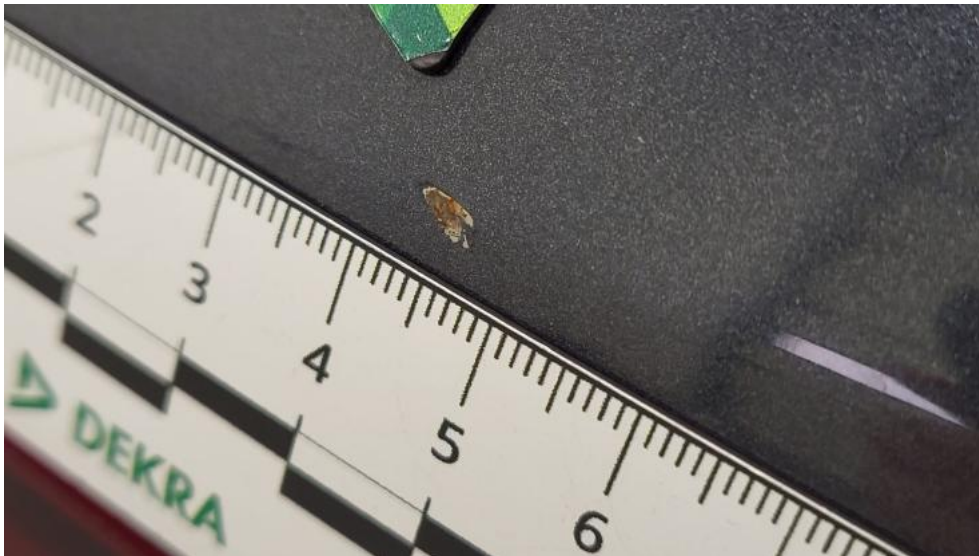
**Photo 51.**

Pokrywy bagażnika - Inne 1

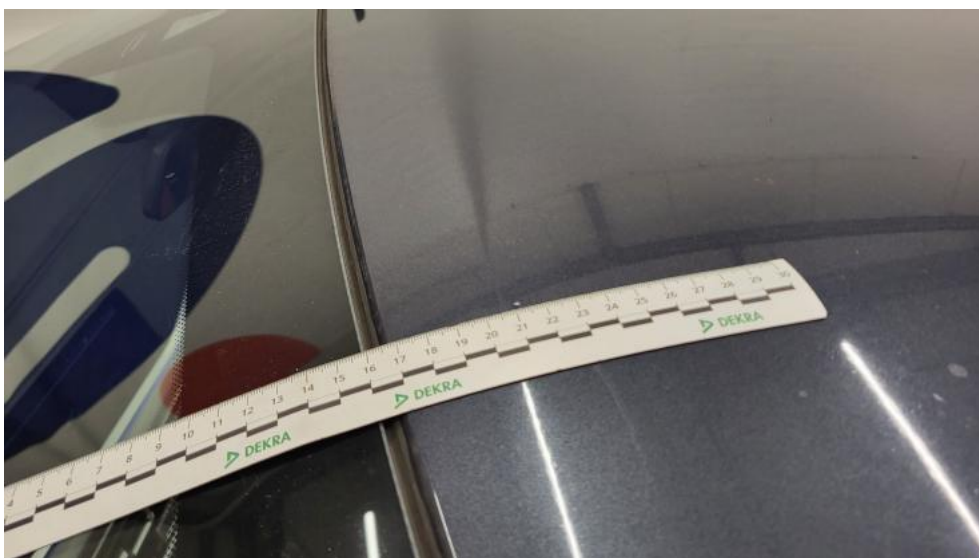
**Photo 52.**

Dach - Rysa/odprysk 1

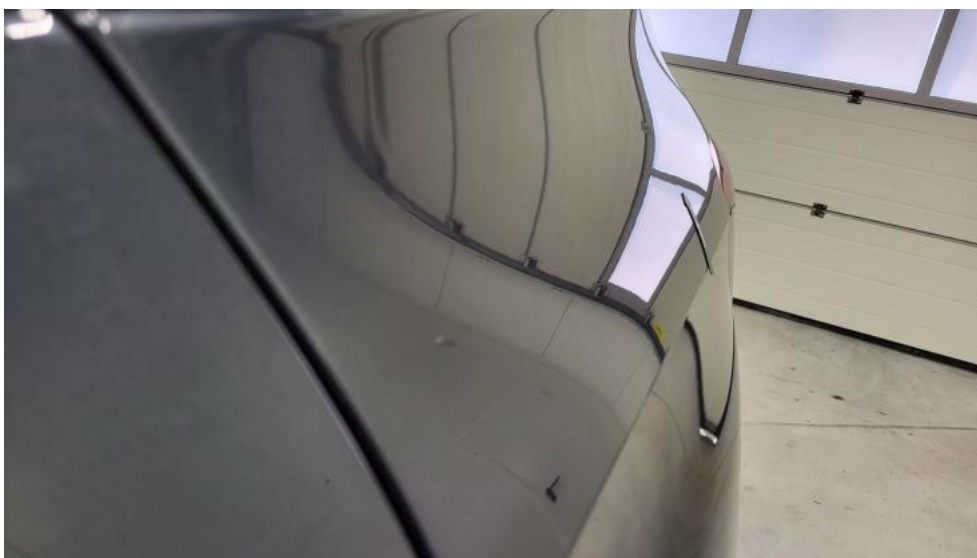
**Photo 54.**

Błotnik tylny L / Ściana boczna L - Wgniecenie/odkształcenie 1

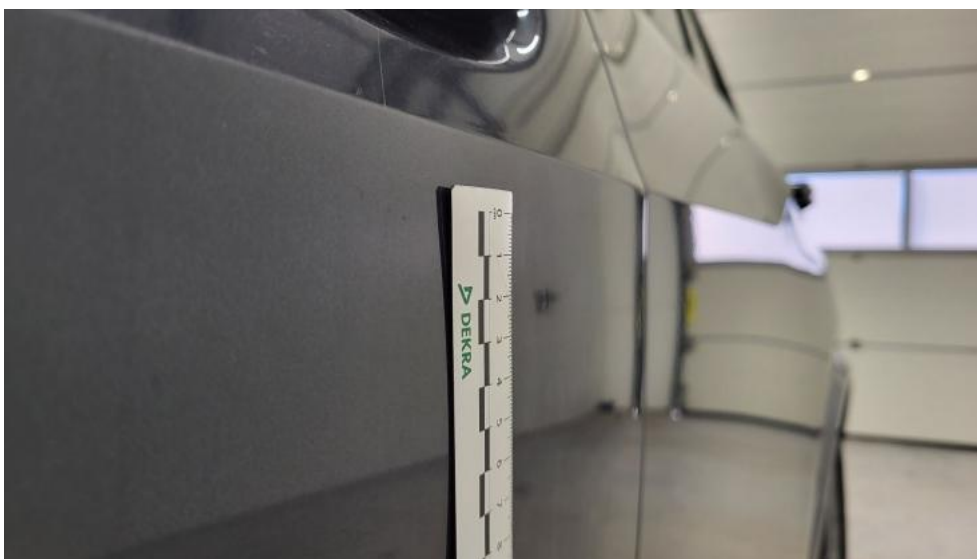
**Photo 59.**

Drzwi przed L - Wgniecenie/odkształcenie 1

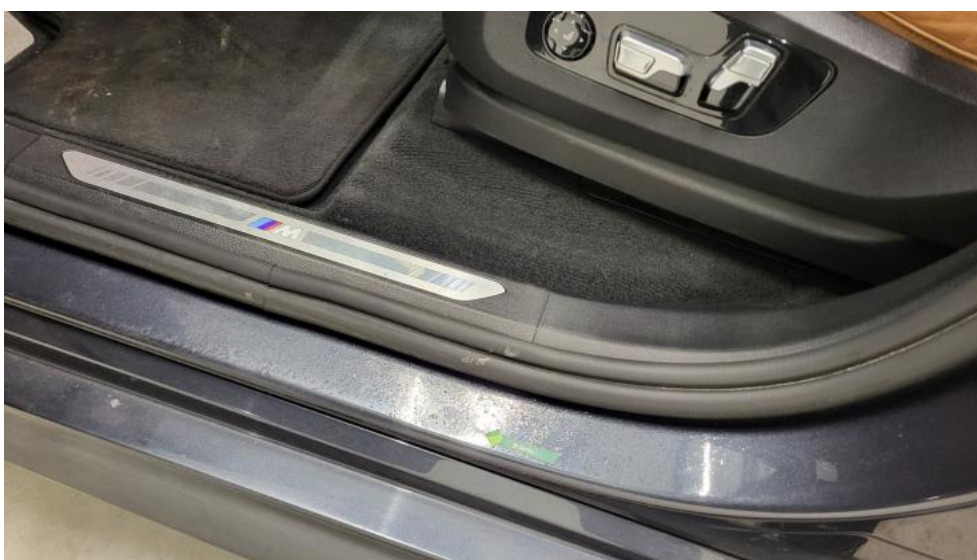
**Photo 60.**

Próg L - Wgniecenie/odkształcenie 1

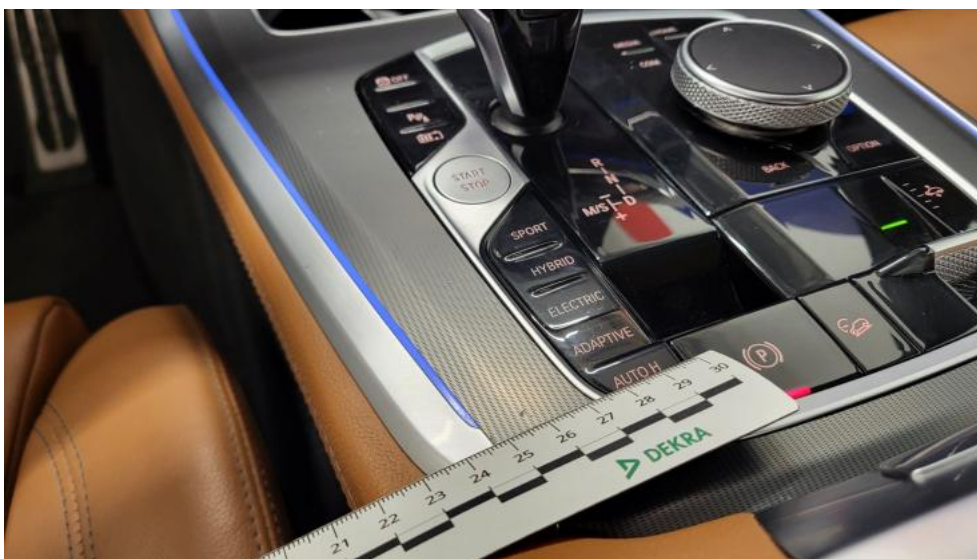
**Photo 61.**

Konsola tunelu śr. - Rysa/odprysk 1

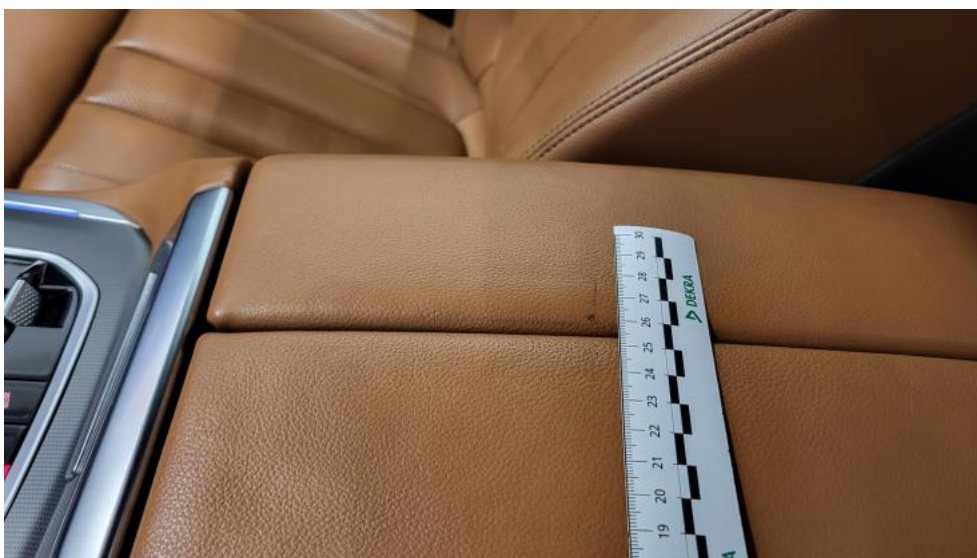
**Photo 62.**

Podłokietnik środkowy przedni - Rysa/odprysk 1

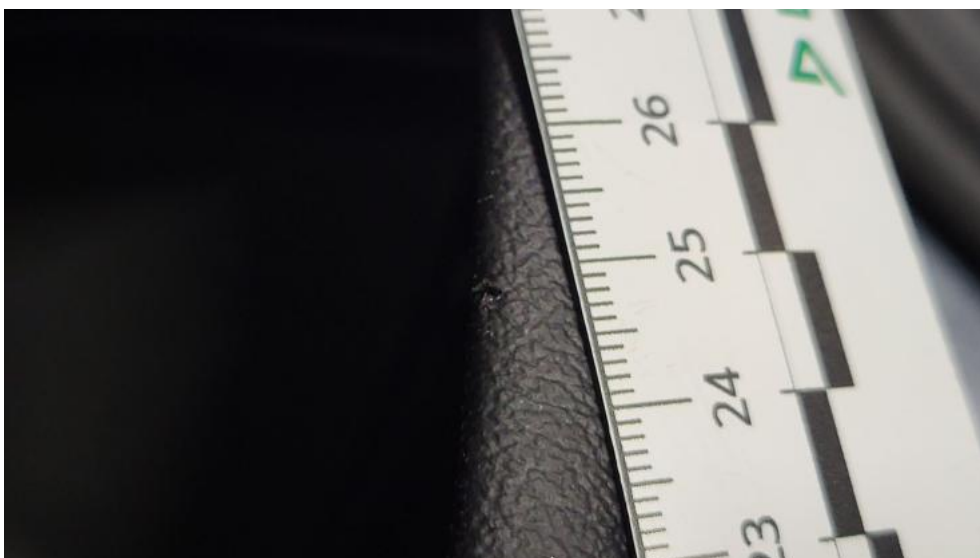
**Photo 64.**

Tapicerka drzwi przednich L - Pęknięcie/rozerwanie 1
