DEKRA's commission No. : PKOL(W)/LODZ/95148/25/12/04  
commission/ damage No. : 22/017051  
Date of commission: 04-12-2025

**DEKRA Poland - Headquarters**  
02-673 Warszawa, ul. Konstruktorska 12A

| Manufacturer | AUDI |
| Model | A6 Avant [C8] 18-23 |

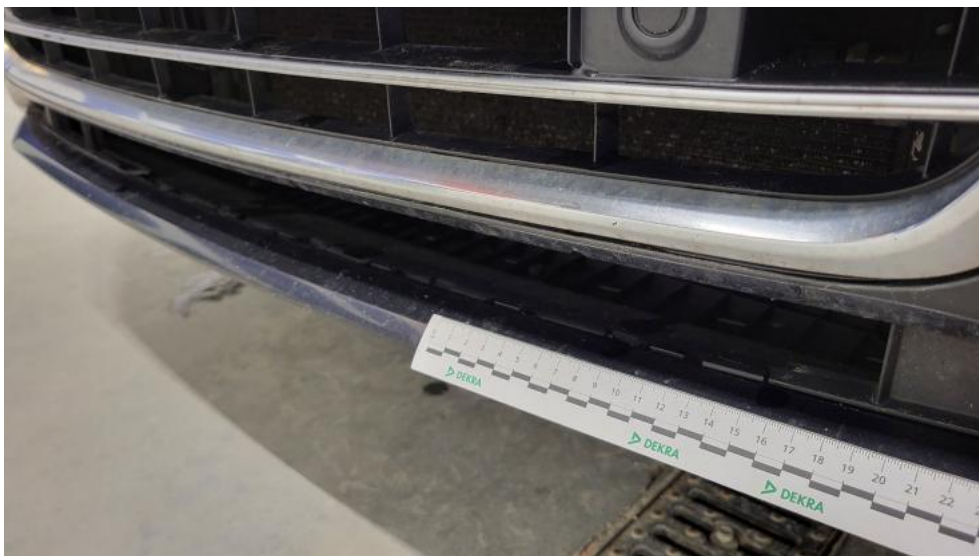
**Photo 40.**

Krata zderzaka prz. - Pęknięcie/rozerwanie 1

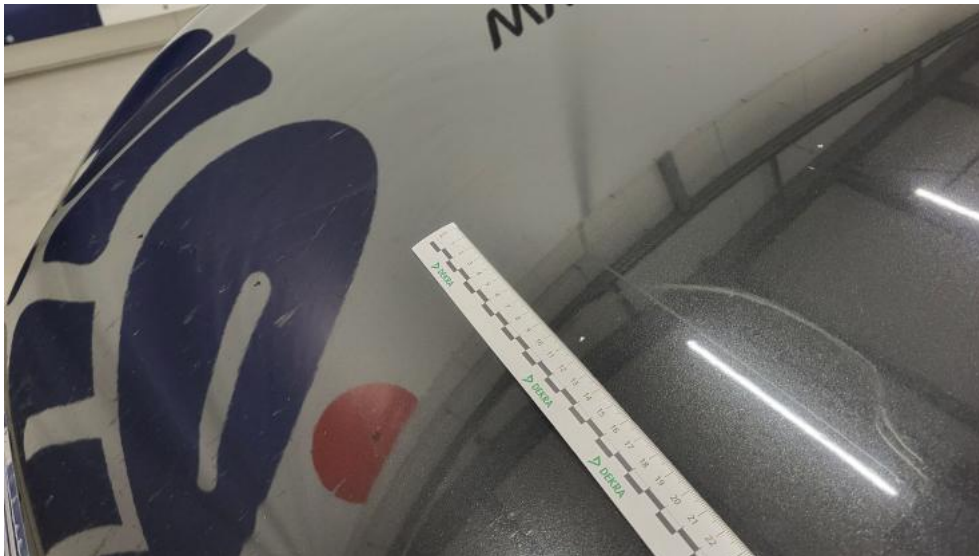
**Photo 41.**

Pokrywa komory silnika - Rysa/odprysk 1

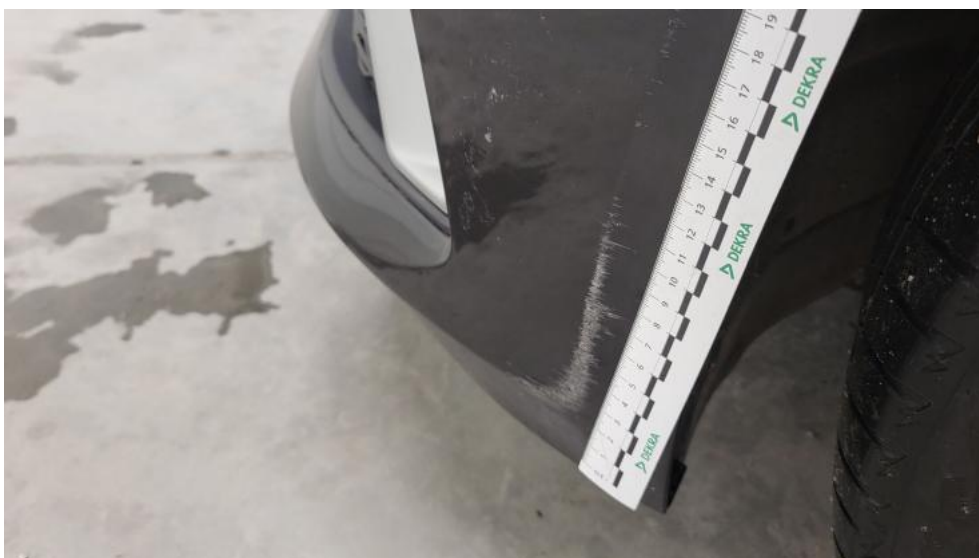
**Photo 42.**

Zderzak - Rysa/odprysk 1

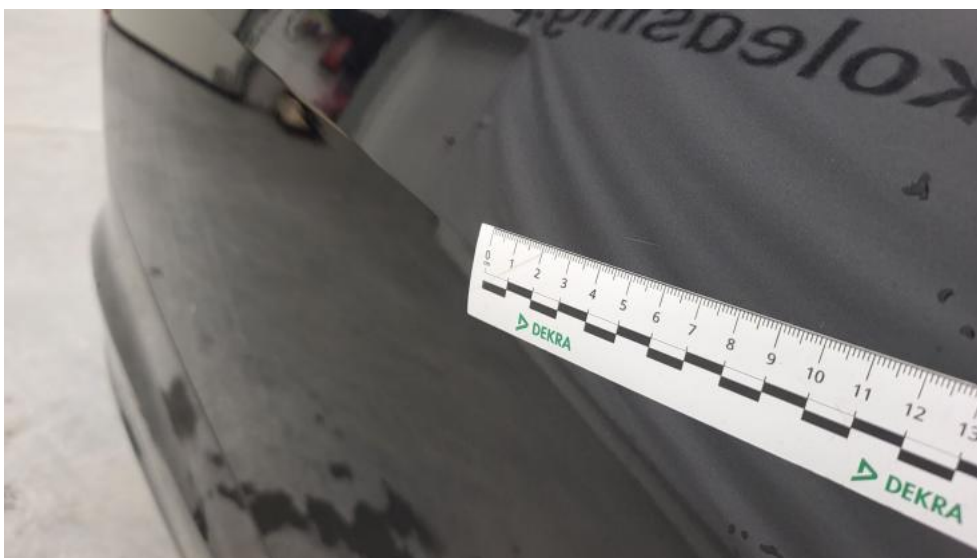
**Photo 44.**

Błotnik tylny P / Ściana boczna P - Rysa/odprysk 1

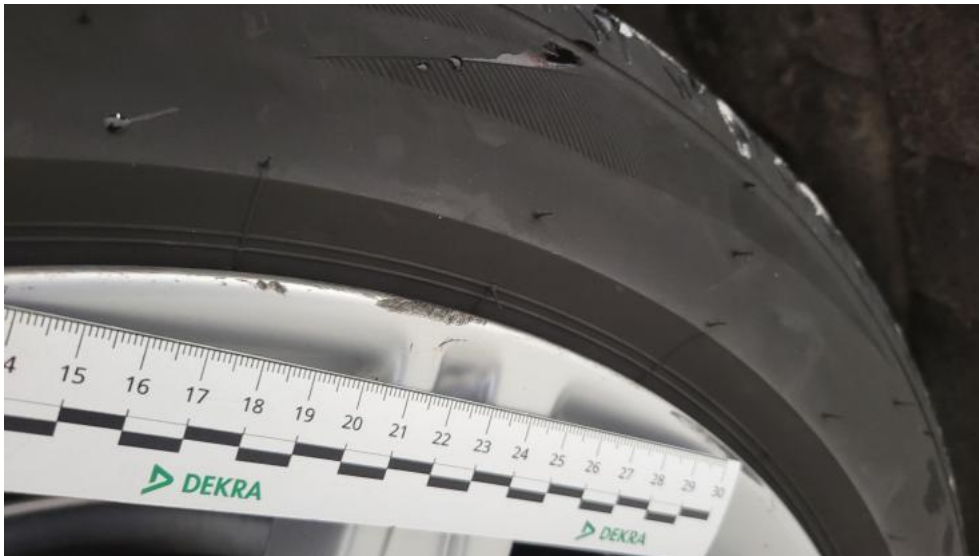
**Photo 45.**

Felga aluminiowa tylna P - Rysa/odprysk 1

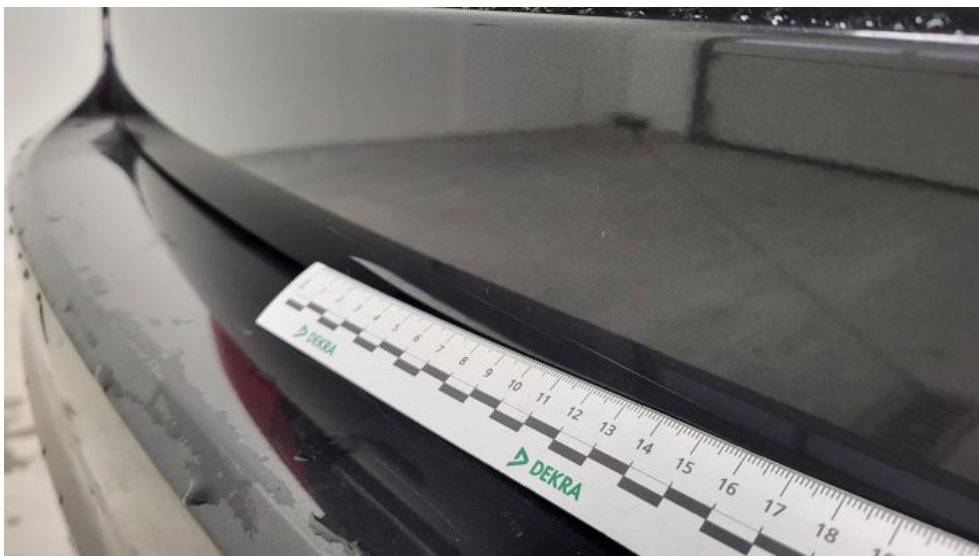
**Photo 46.**

Pokrywy bagażnika - Rysa/odprysk 1

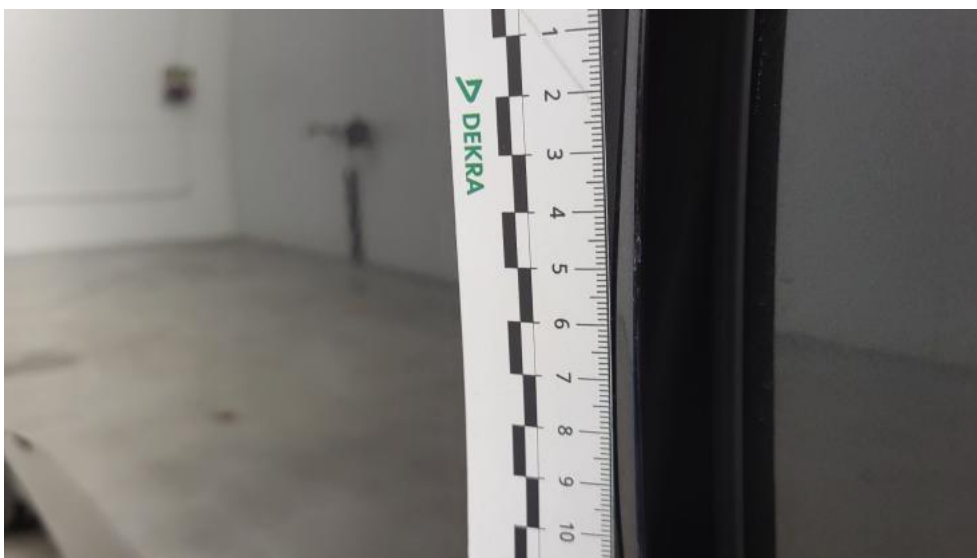
**Photo 50.**

Drzwi przed L - Rysa/odprysk 1

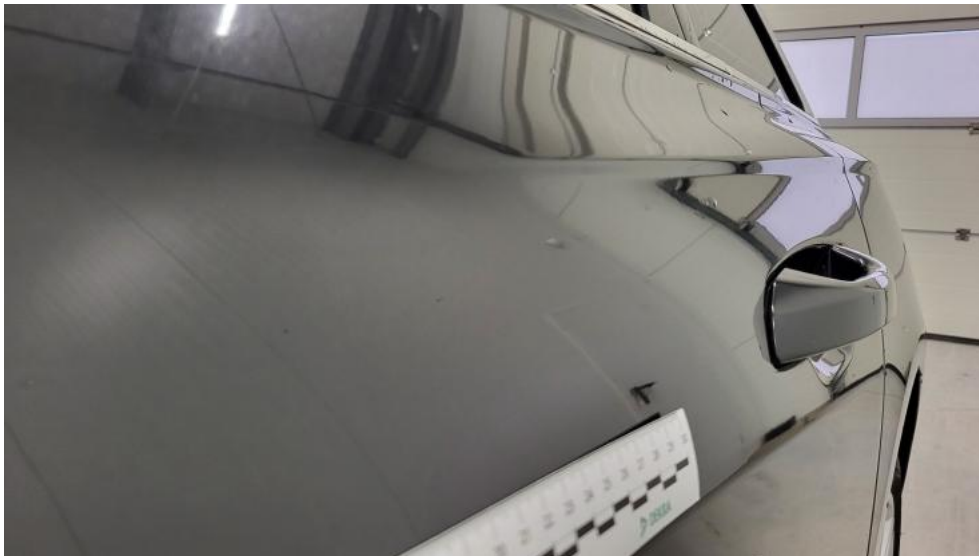
**Photo 53.**

Drzwi tylne L - Wgniecenie/odkształcenie 1

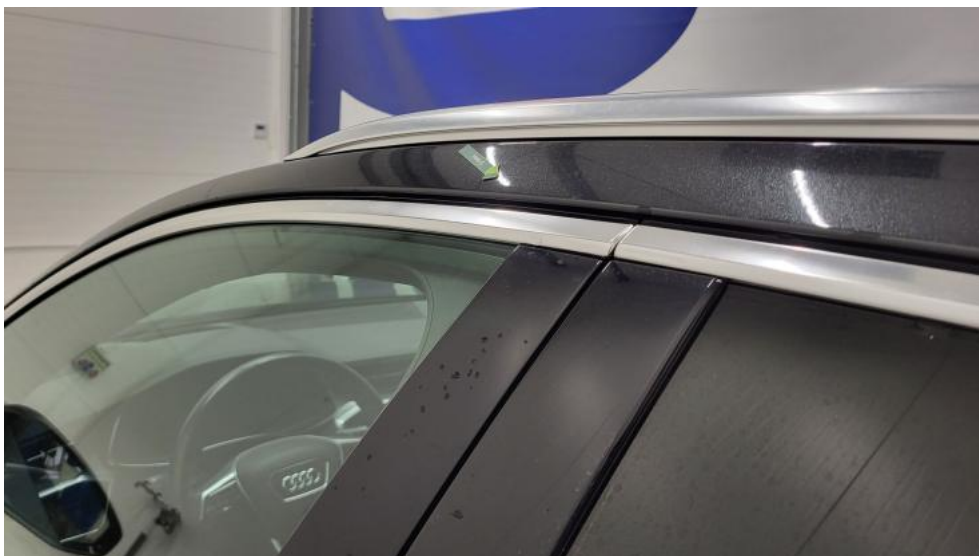
**Photo 54.**

Słupek przedni L - Wgniecenie/odkształcenie 1

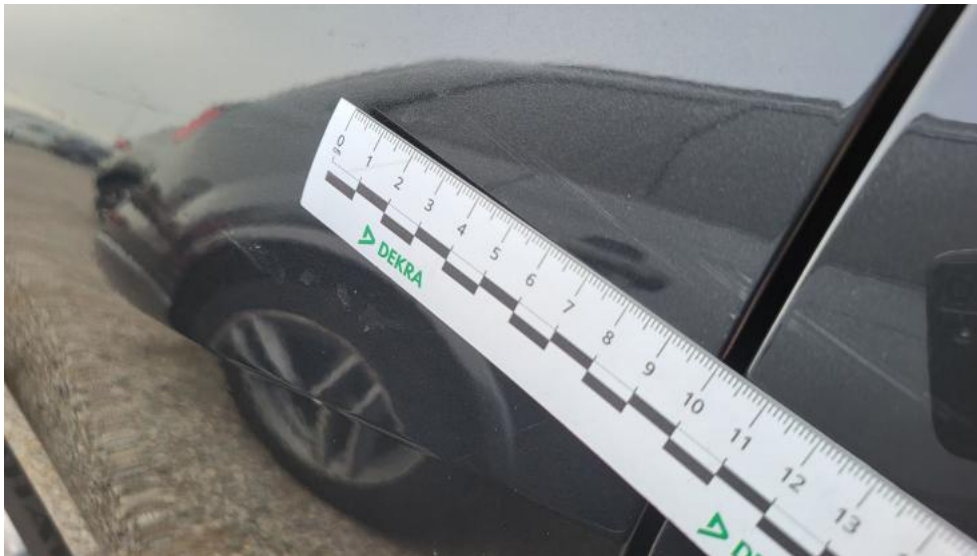
**Photo 55.**

Błotnik przedni L - Rysa/odprysk 1

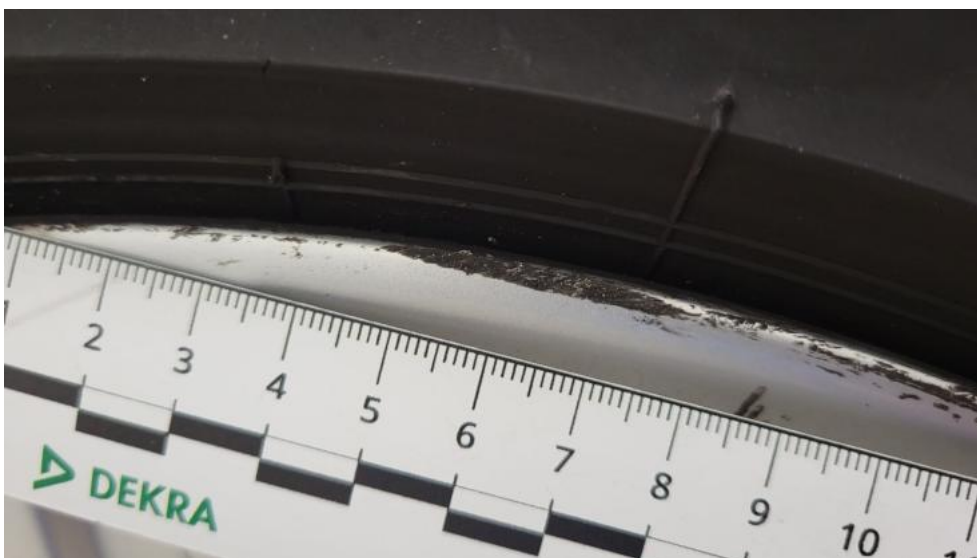
**Photo 56.**

Felga Aluminiowa przednia L - Rysa/odprysk 1
