DEKRA's commission No. : PKOL(W)/LODZ/81171/24/10/21  
commission/ damage No. : 23/016884  
Date of commission: 21-10-2024

Group of objects (Eurotax)	cars
EC code (Eurotax)	0047626
Manufacturer	CHEVROLET
Model	Corvette
Type	Corvette 6.2 Z51 Stingray
Body type	CPE
Number of doors / seats	2/2
Curb weight [kg]	1730
Gross vehicle weight [kg]	1980
Wheelbase 1/2	0
Engine type	spark ignition
Pollution reduction system	three-way catalytic converter
Engine capacity [ccm]	6162
Engine Power [hp/kW]	481/354
Gearbox	automatic 8- gear
Registration /record No.	DW1VU30
VIN / serial number	1G1Y92D47P5113337
Date of first registration	22-11-2022
Date of next. tech. test	13-06-2025
Year of manufacture	2022
Readout [km]	6 002 (read)
Body color / type of coating	white/METALIK

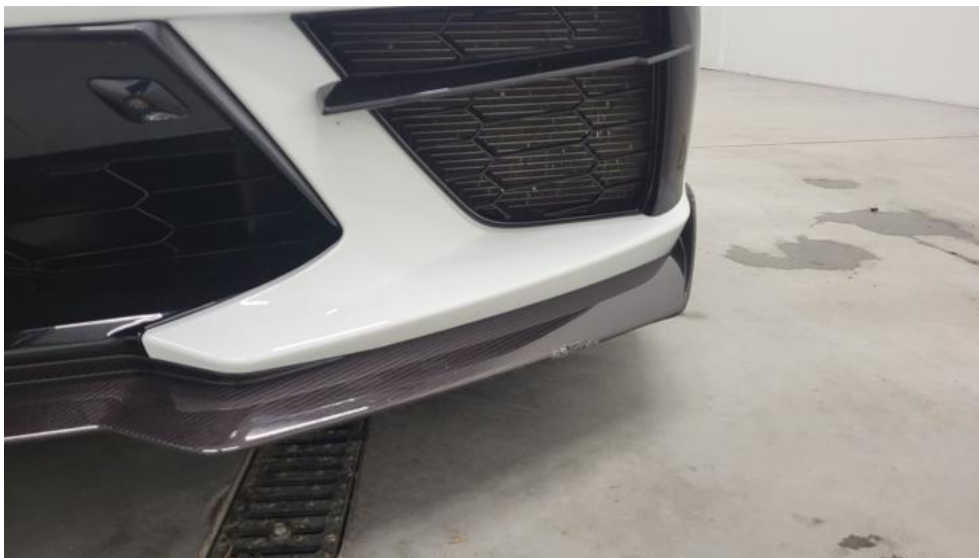
**Photo 71.**  
Spoiler zderzaka przedniego - zdjęcie poglądowe 1

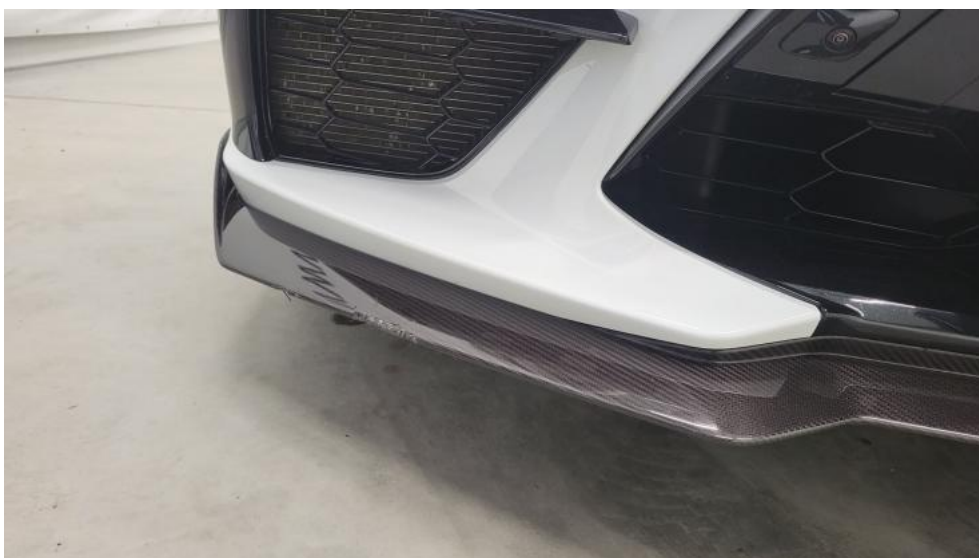
**Photo 72.**  
Spoiler zderzaka przedniego - zdjęcie poglądowe 2

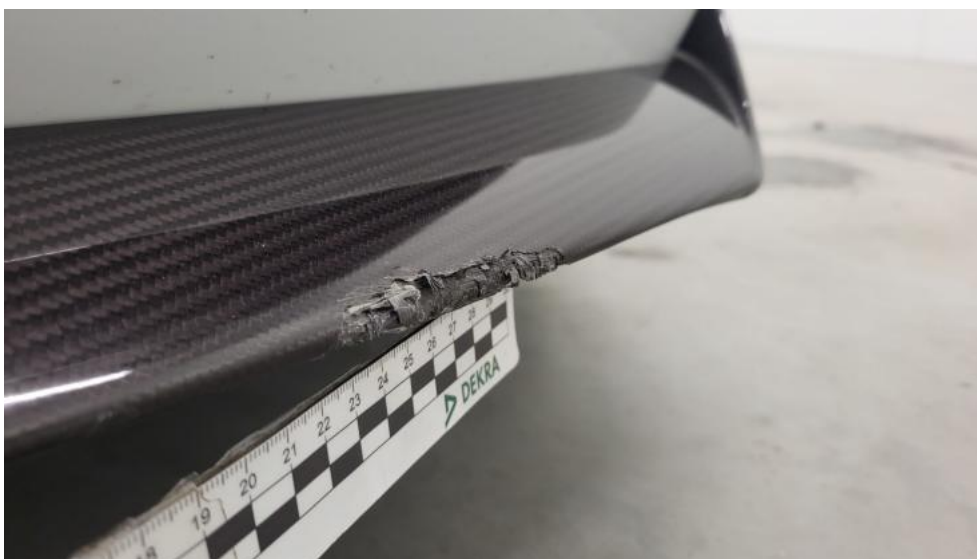
**Photo 73.**

Spoiler zderzaka przedniego - Pęknięcie/rozerwanie 1

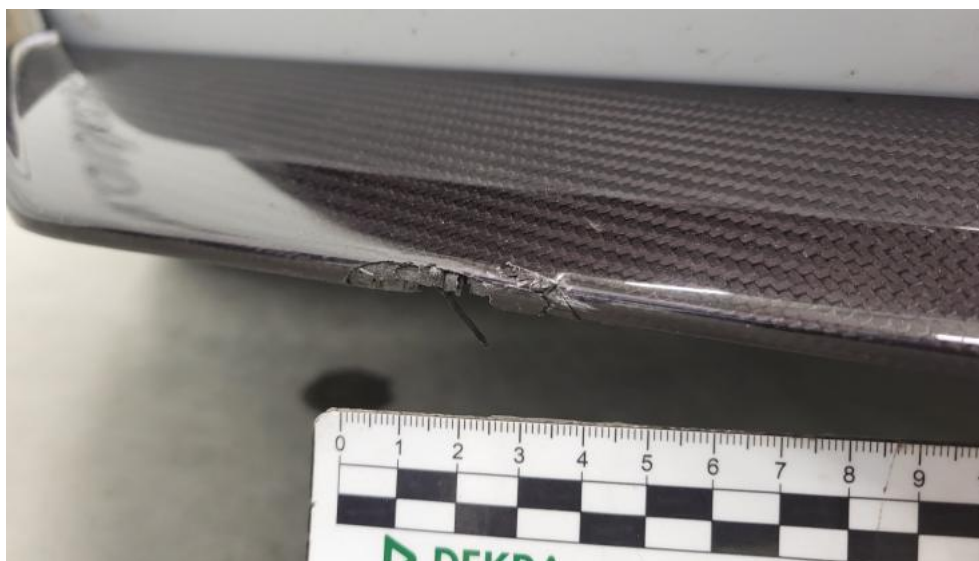
**Photo 75.**  
Spoiler zderzaka przedniego() - Pęknięcie/rozerwanie 3

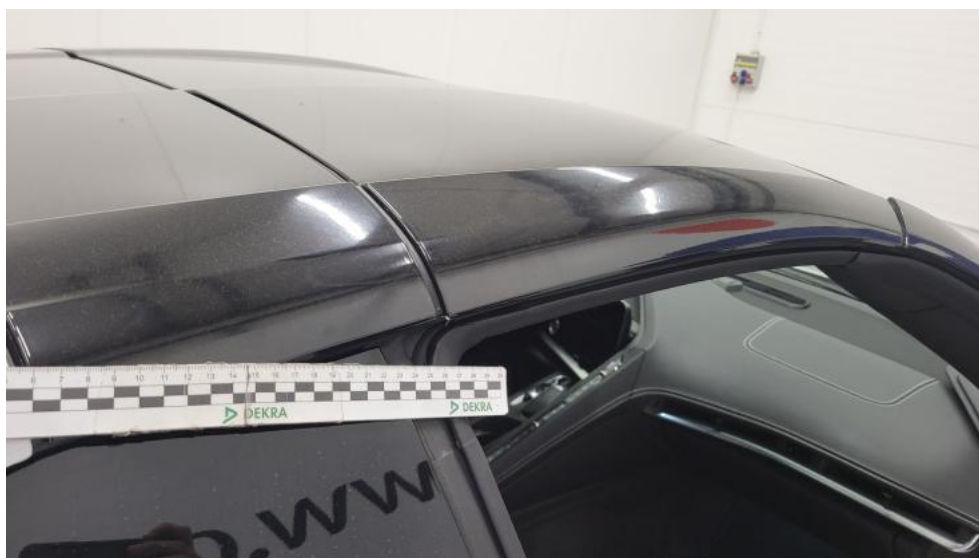
**Photo 76.**  
Dach - zdjęcie poglądowe 1

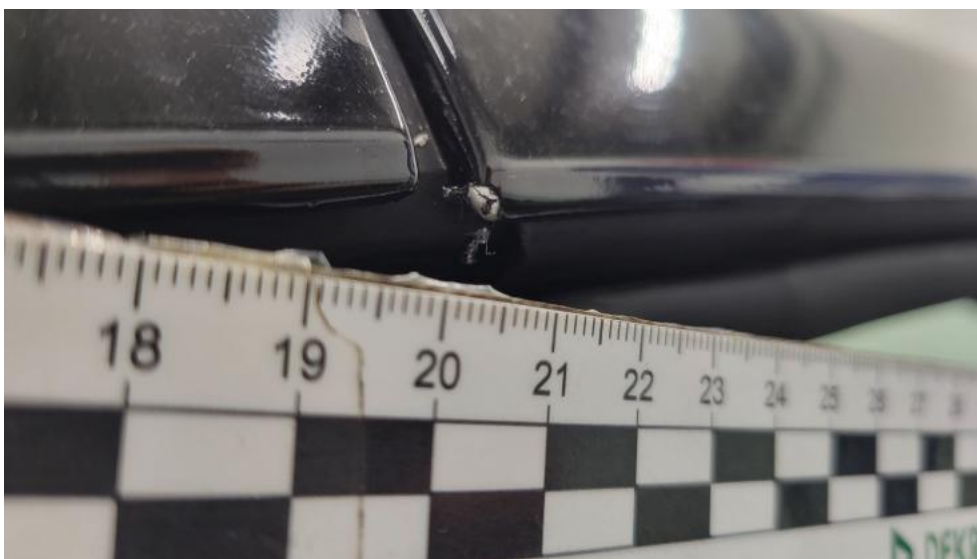
Dostarczono ksero pozwolenia czasowego. Aktywna kontrolka silnika. Rysy na samochodzie.

**Photo 77.**  
Dach - Rysa/odprysk 1

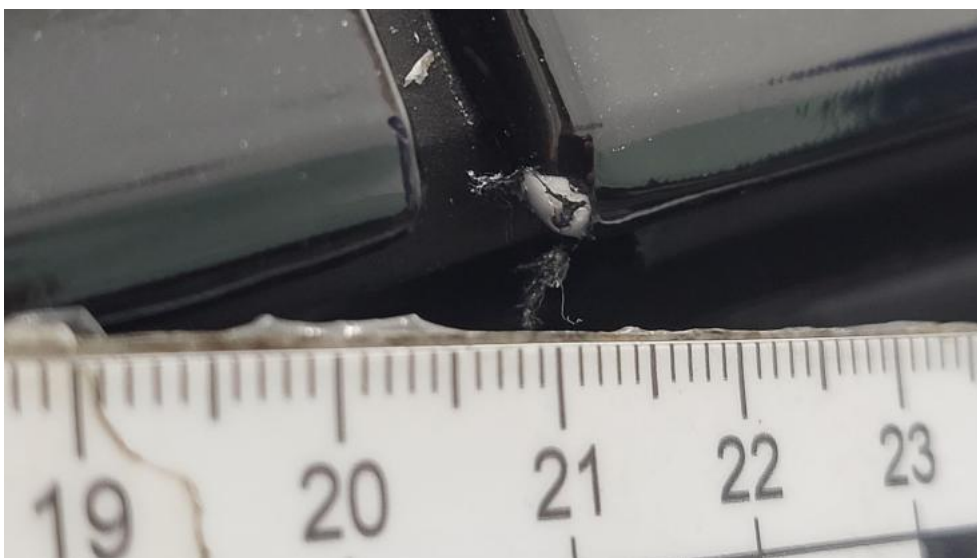
**Photo 78.**  
Dach - Rysa/odprysk 2
