DEKRA's commission No. : PKOL(W)/LODZ/56134/24/07/23  
commission/ damage No. : 23/012365  
Date of commission: 23-07-2024

**DEKRA Poland - Headquarters**  
02-673 Warszawa, ul. Konstruktorska 12A

**Client :**  
PKO Leasing Finance  
PKO Leasing SA  
Al. Śmigłego-Rydza 20  
93-281 Łódź

| Model | X5 [G05] 18-23 |

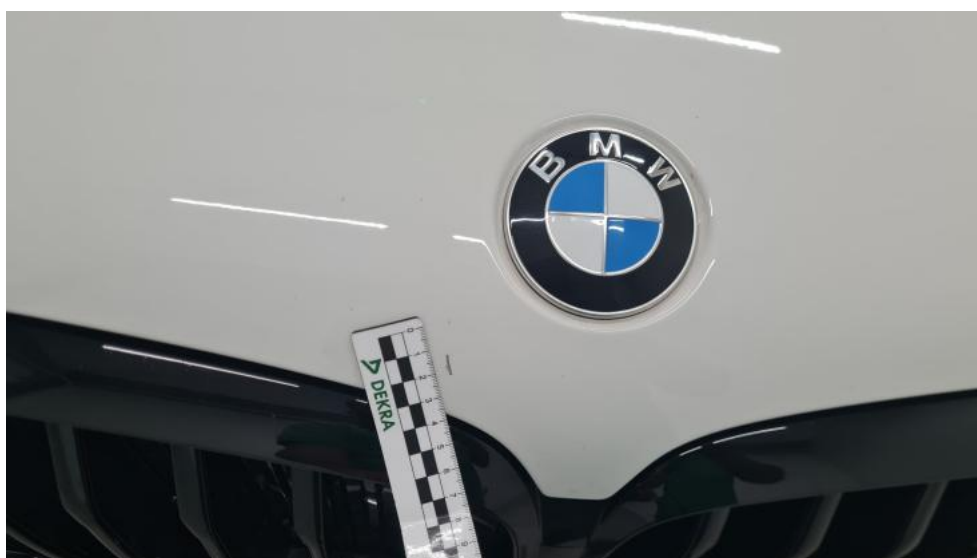
**Photo 36.**

Pokrywa komory silnika - Rysa/odprysk 1

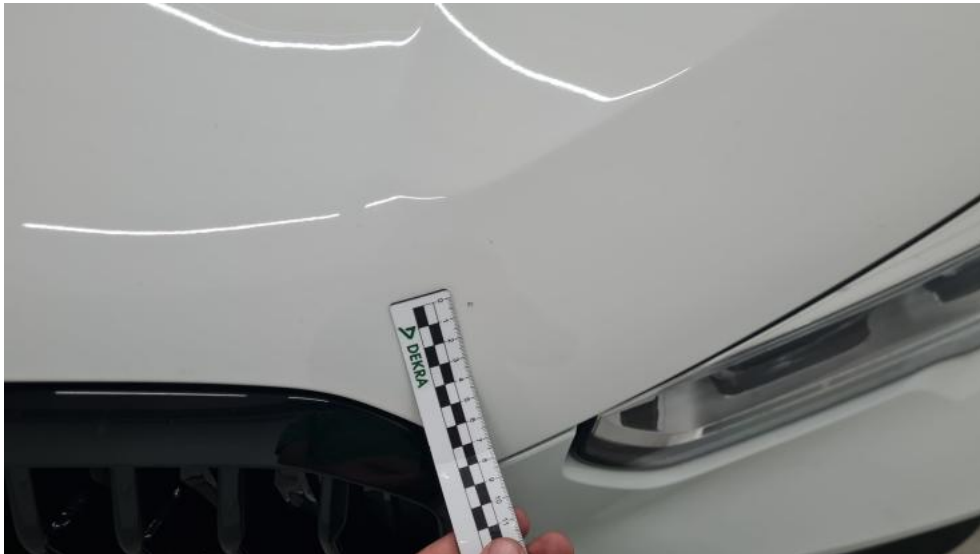
**Photo 37.**

Pokrywa komory silnika - Rysa/odprysk 2

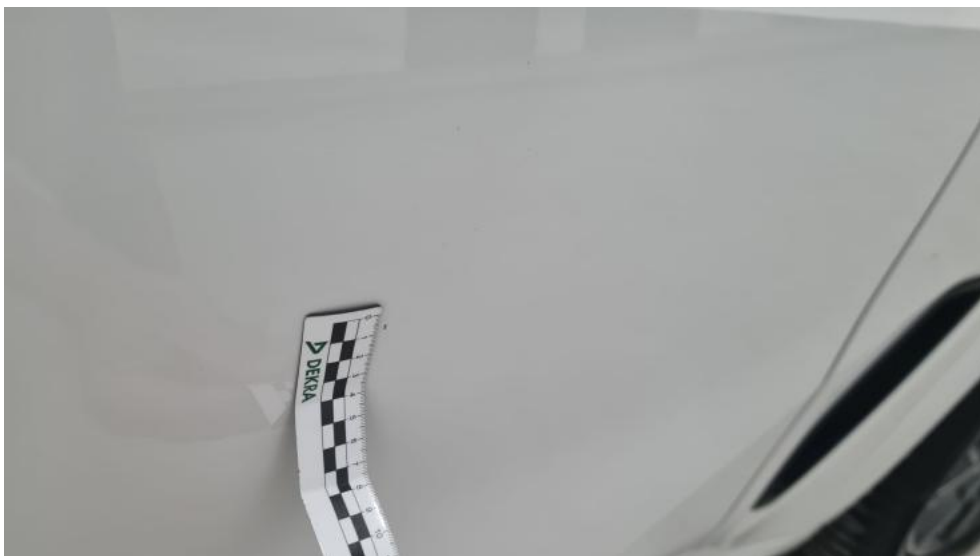
**Photo 38.**

Drzwi przednie P - Rysa/odprysk 1

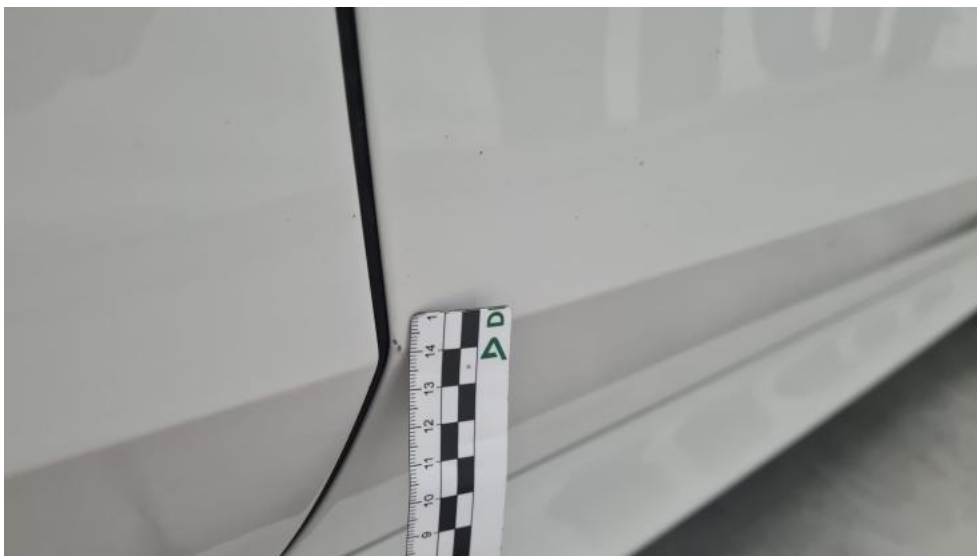
**Photo 39.**

Drzwi przednie P - Rysa/odprysk 2

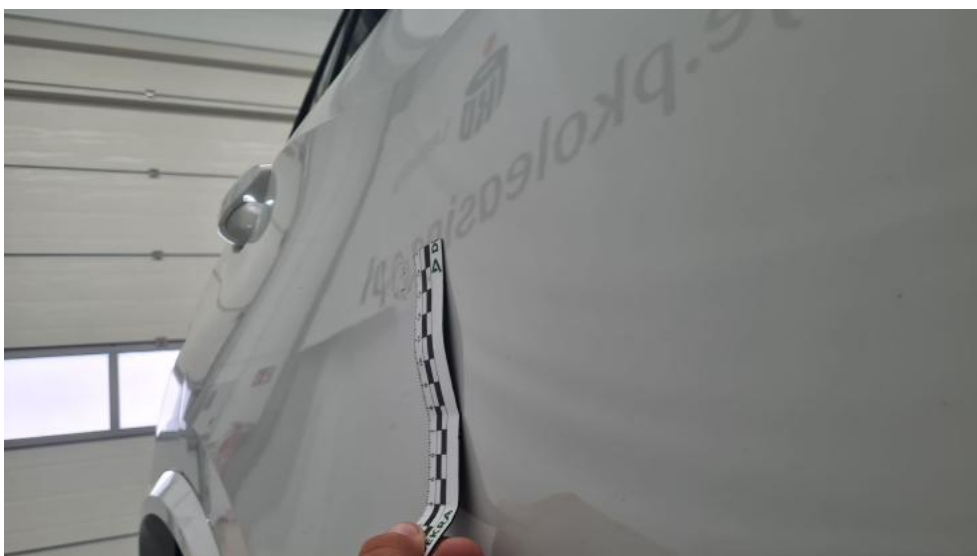
**Photo 40.**

Drzwi tylne P - Wgniecenie/odkształcenie 1

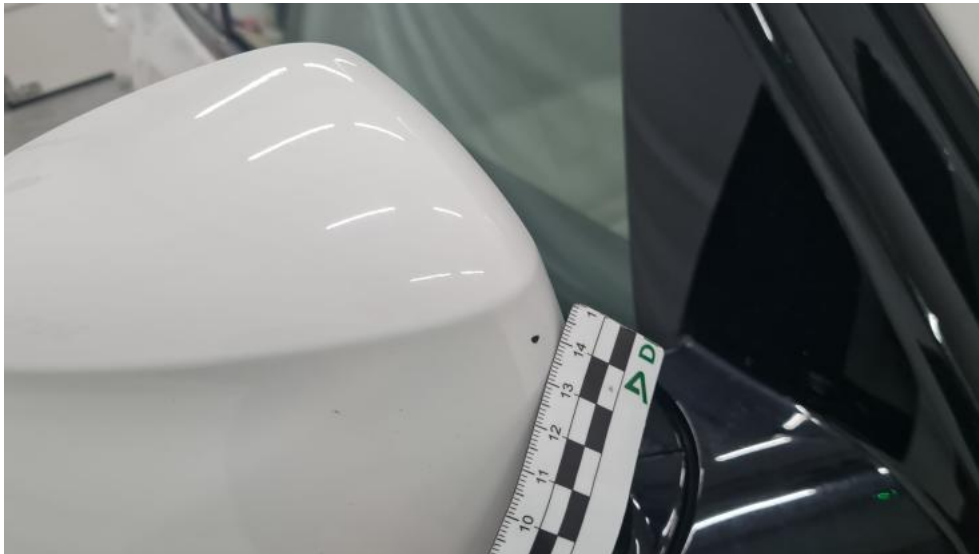
**Photo 41.**

Lusterko zew P - Rysa/odprysk 1

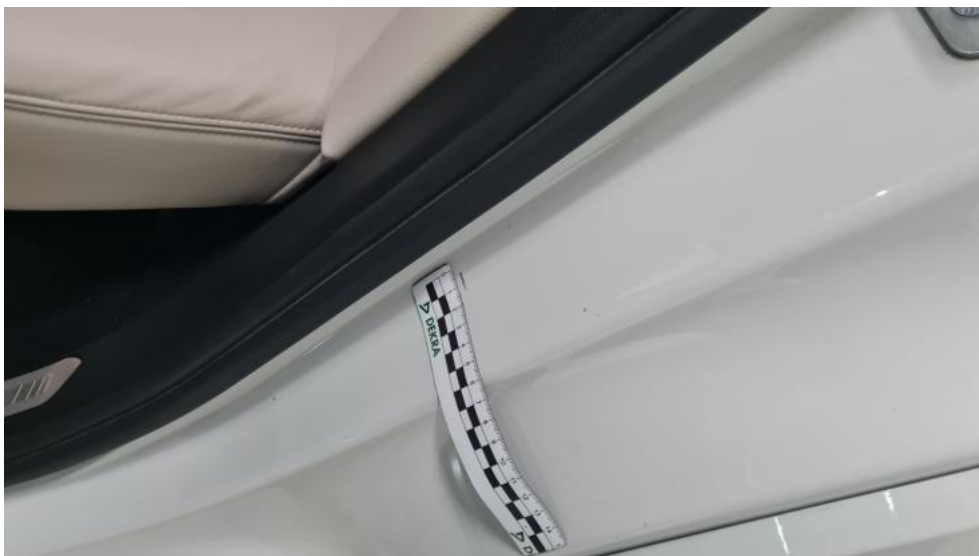
**Photo 42.**

Łotnik tylny L / Ściana boczna L - Rysa/odprysk 1

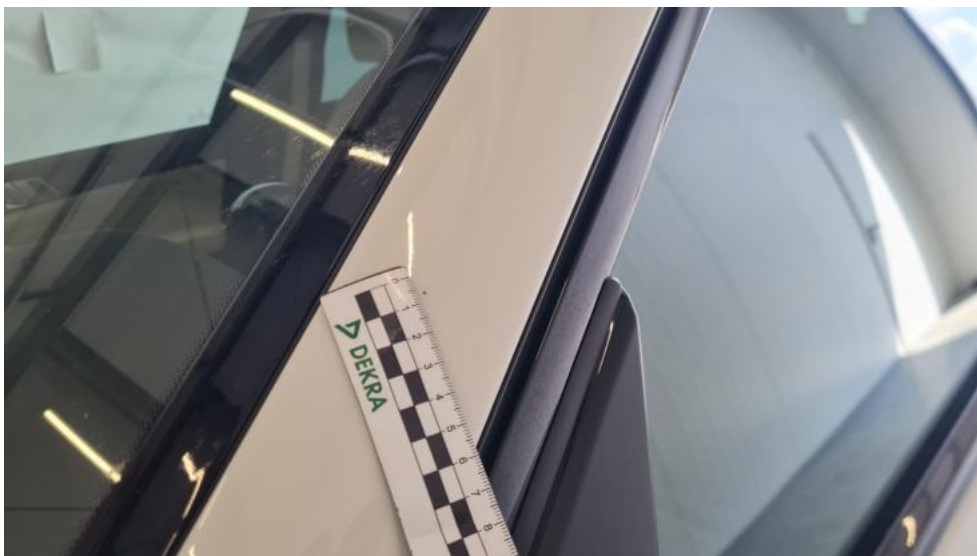
**Photo 43.**

Stupek przedni L - Rysa/odprysk 1
