DEKRA's commission No. : PKOL(W)/LODZ/95545/26/10/12  
commission/ damage No. : 21/044246  
Date of commission: 12-10-2026

**DEKRA Poland - Headquarters**  
02-673 Warszawa, ul. Konstruktorska 12A

| Model | X7 [G07] 18-22 |
| Registration /record No. | LU343MM |

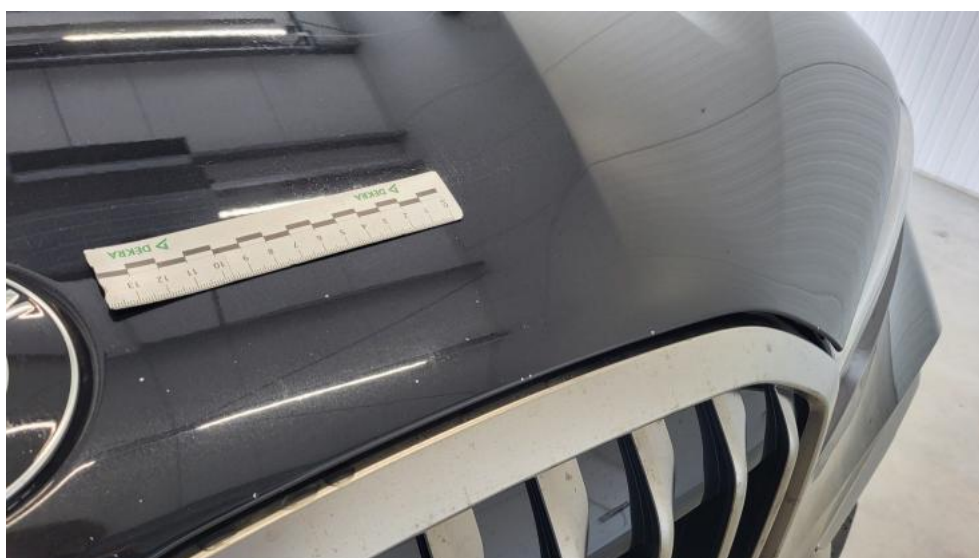
**Photo 50.**

Pokrywa komory silnika - Rysa/odprysk 1

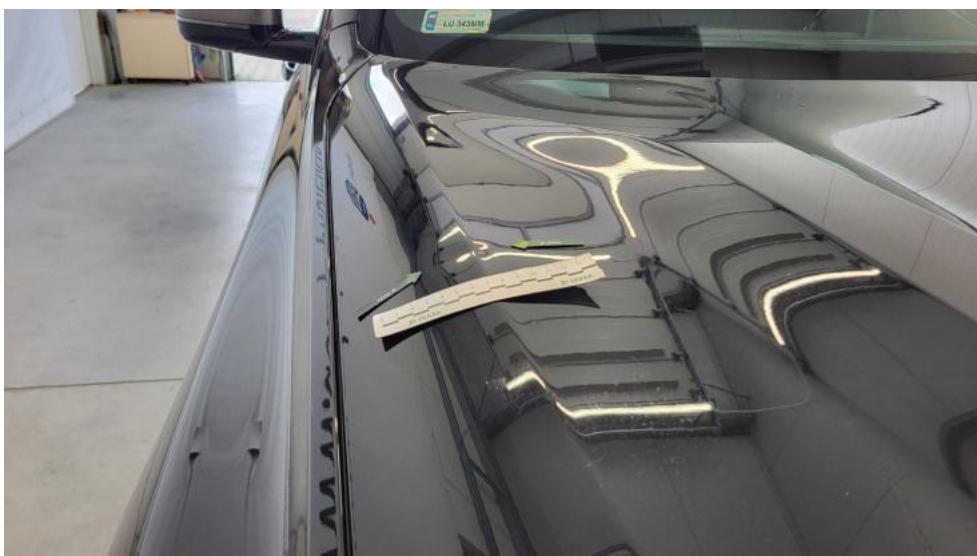
**Photo 52.**

Pokrywa komory silnika - Wgniecenie/odkształcenie 1

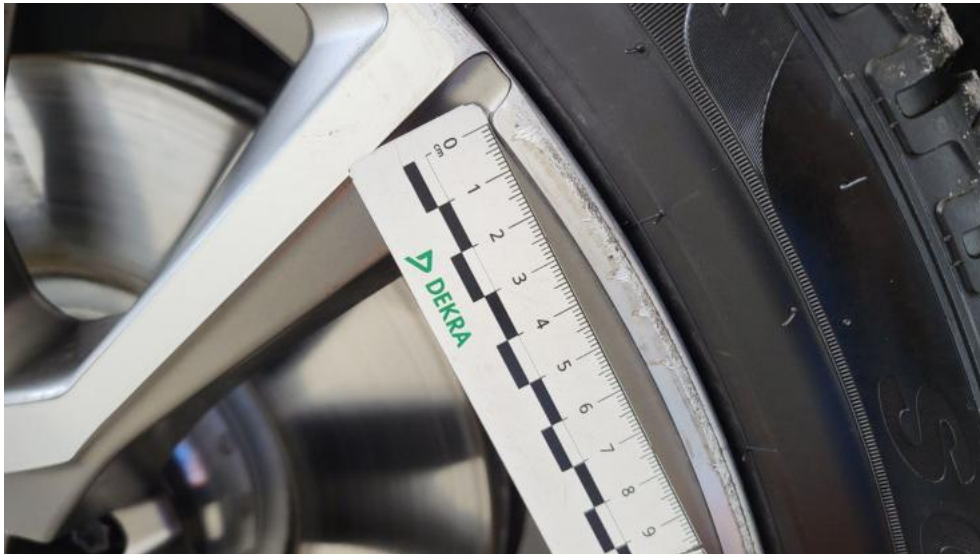
**Photo 55.**

Felga aluminiowa przednia P - Rysa/odprysk 1

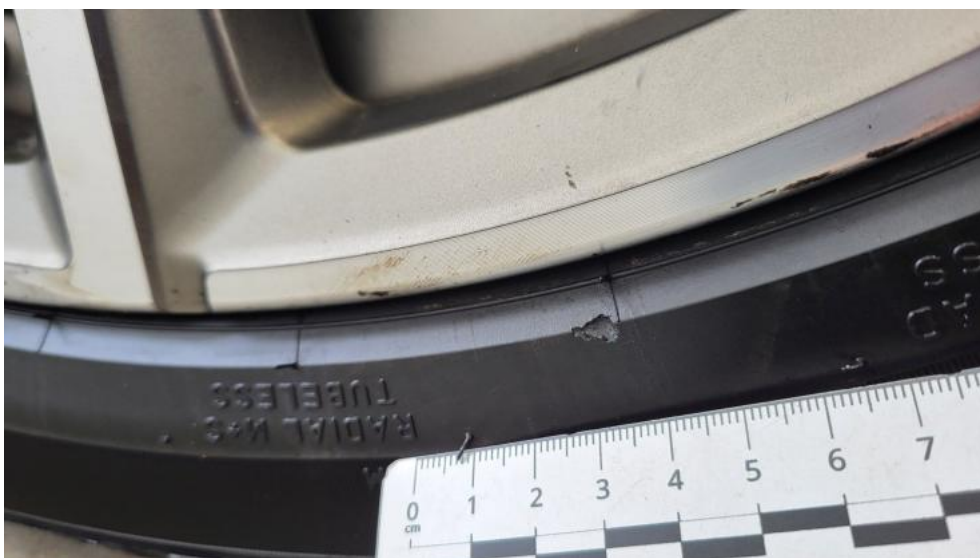
**Photo 56.**

Opona przednia P - Pęknięcie/rozerwanie 1

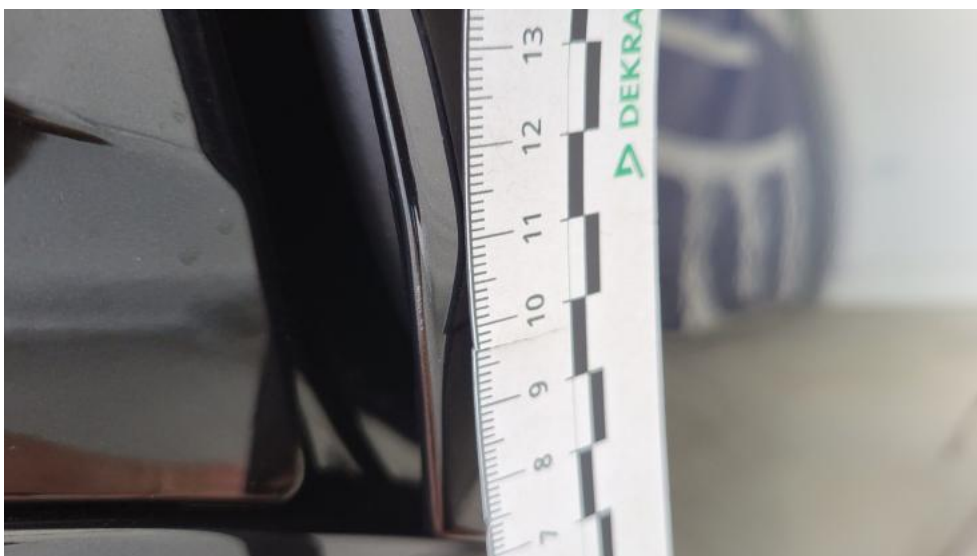
**Photo 58.**

Drzwi tylne P - Rysa/odprysk 1

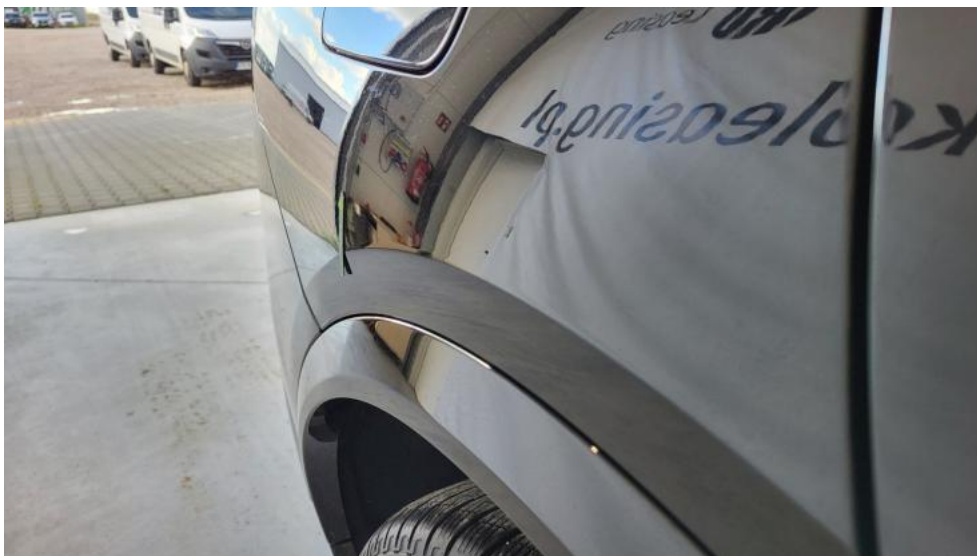
**Photo 59.**

Błotnik tylny P / Ściana boczna P - Wgniecenie/odkształcenie 1

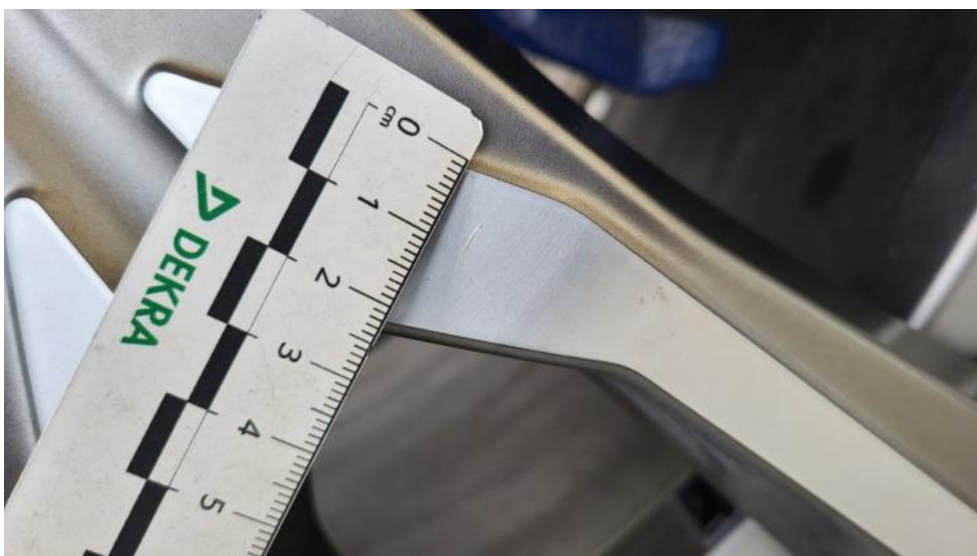
**Photo 60.**

Felga aluminiowa tylna P - Rysa/odprysk 1

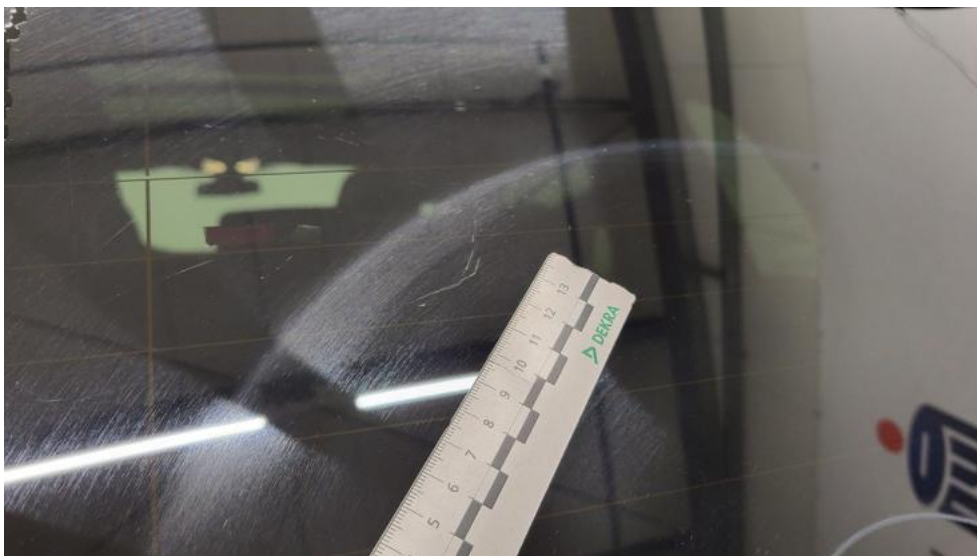
**Photo 65.**

Szyba tylna - Rysa/odprysk 1

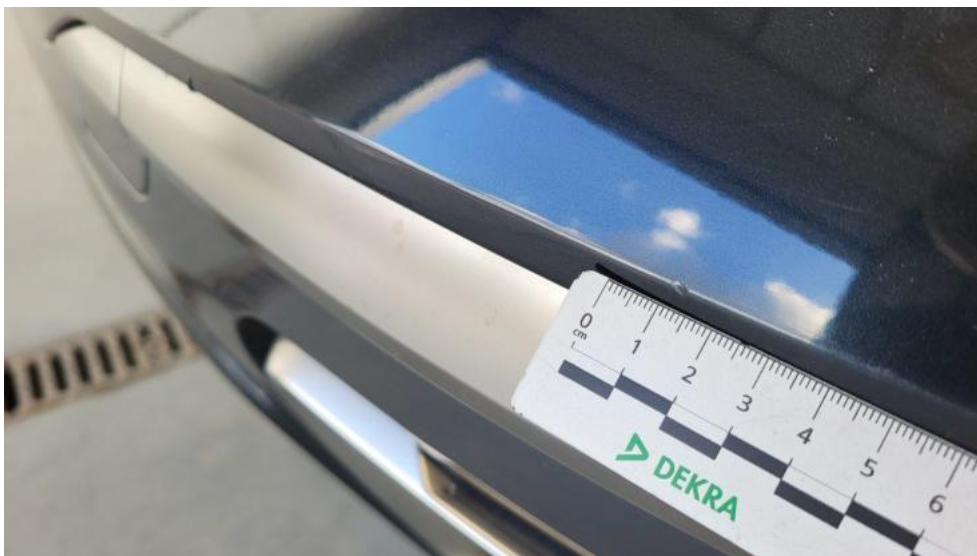
**Photo 67.**

Zderzak tylny - Rysa/odprysk 2

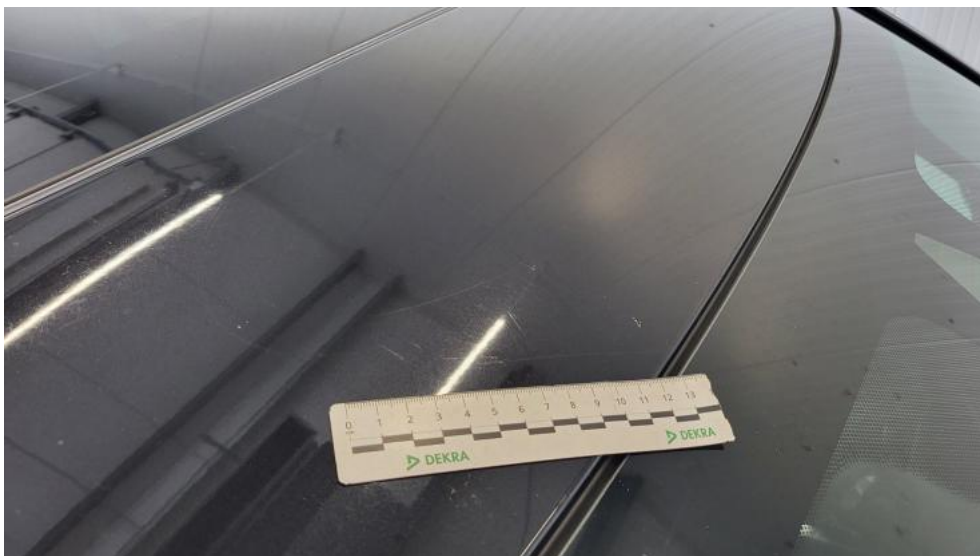
**Photo 70.**

Dach - Rysa/odprysk 1

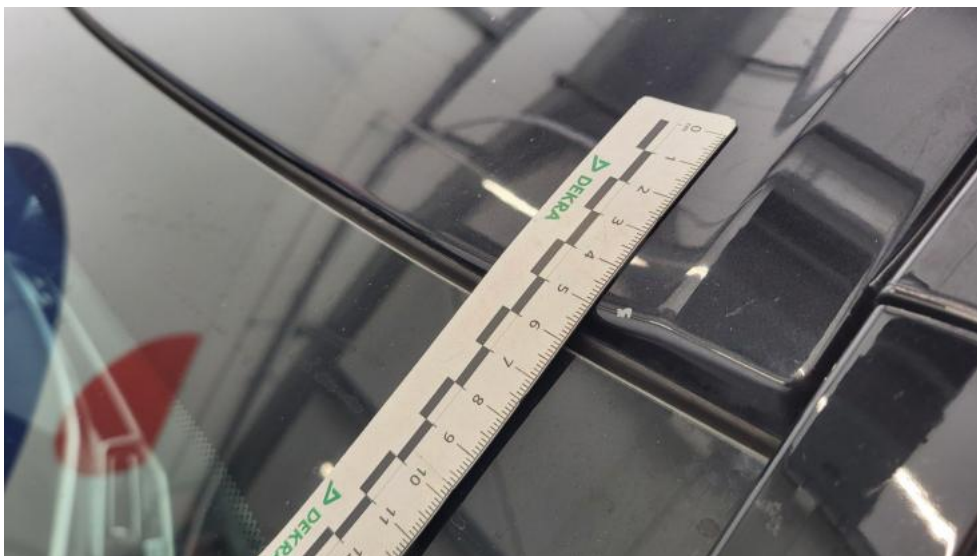
**Photo 71.**

Dach - Rysa/odprysk 2

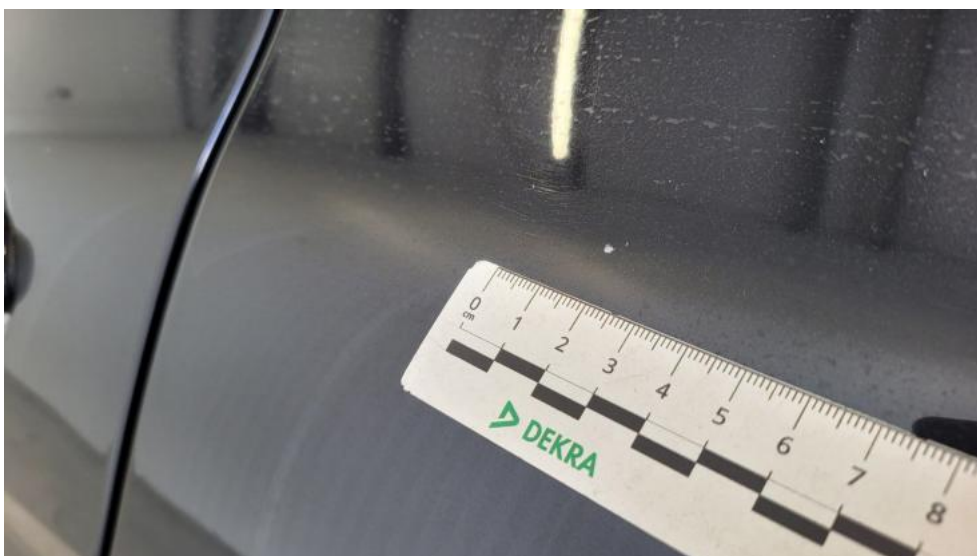
**Photo 72.**

Błotnik tylny L / Ściana boczna L - Rysa/odprysk 1

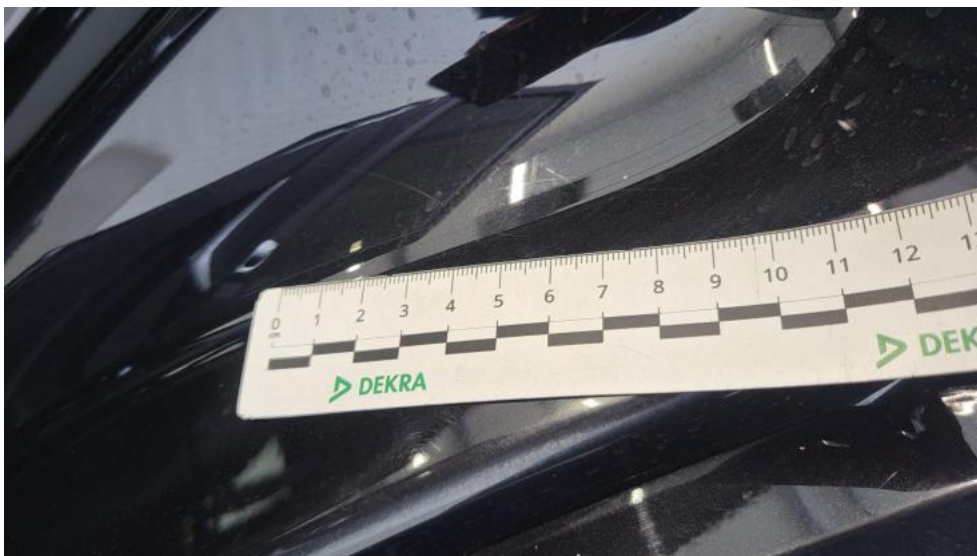
**Photo 73.**

Błotnik tylny L / Ściana boczna L - Rysa/odprysk 2

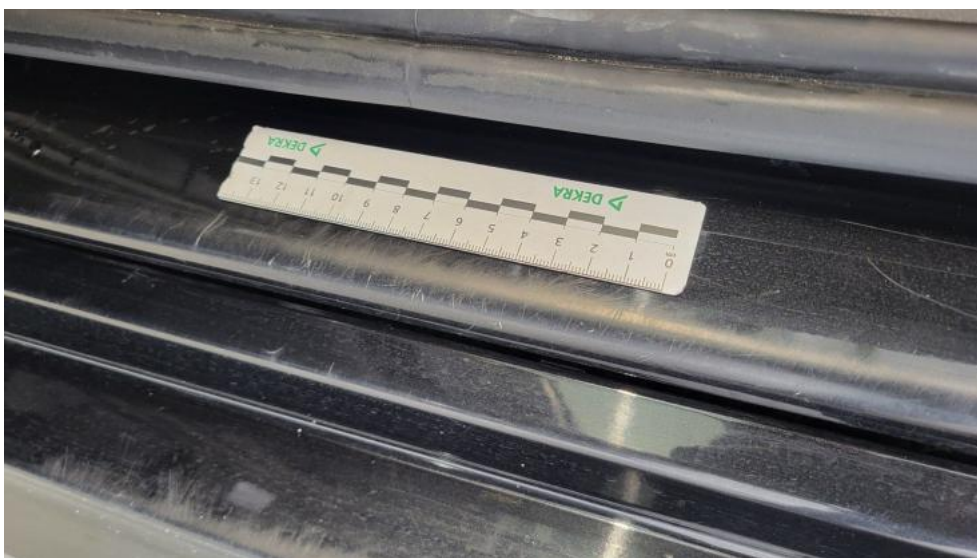
**Photo 84.**

| No. of controlled item | Controlled item | Measured range of thickness of the lacquer coat [ $\mu\text{m}$ ] |
|---|---|---|
| 15 | Right side sill | 150 - 500 |

Próg L - Rysa/odprysk 1

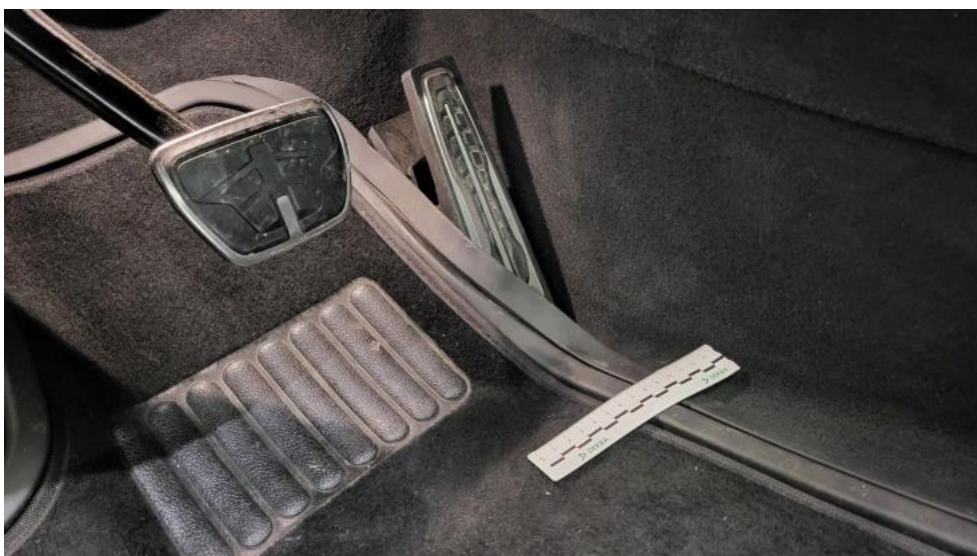
**Photo 100.**

Dywanik prze L - Inne 1
