DEKRA's commission No. : PKOL(W)/LODZ/33586/26/04/16
 commission/ damage No. : PS25/02325
 Date of commission: 16-04-2026

Vehicle data

Description of the technical condition

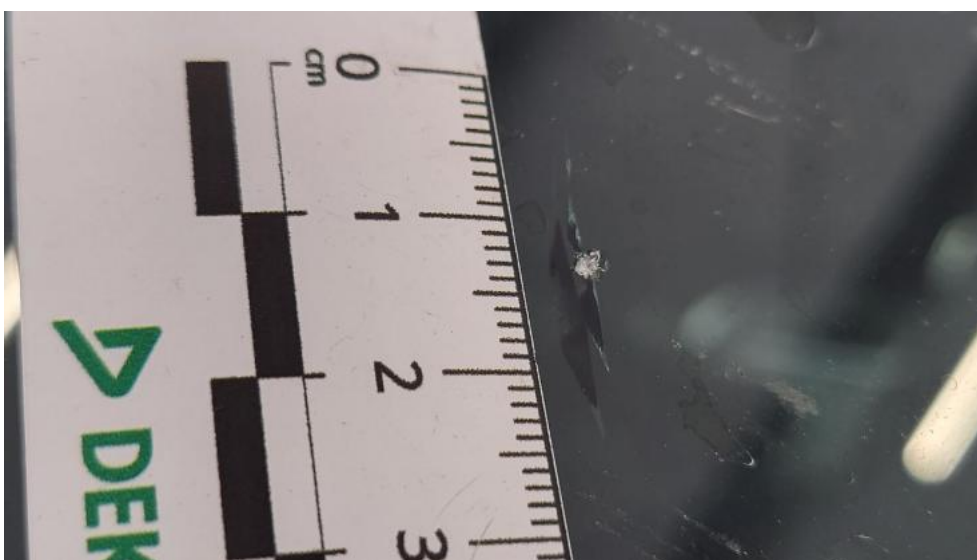
Item name	Description of item	Damage type	Location / Size	Comments
Glass	front	broken		
Bumper	front	loss/chipping) of the lacquer coating

Photo 38.
Szyba czołowa - Pęknięcie/rozerwanie 1

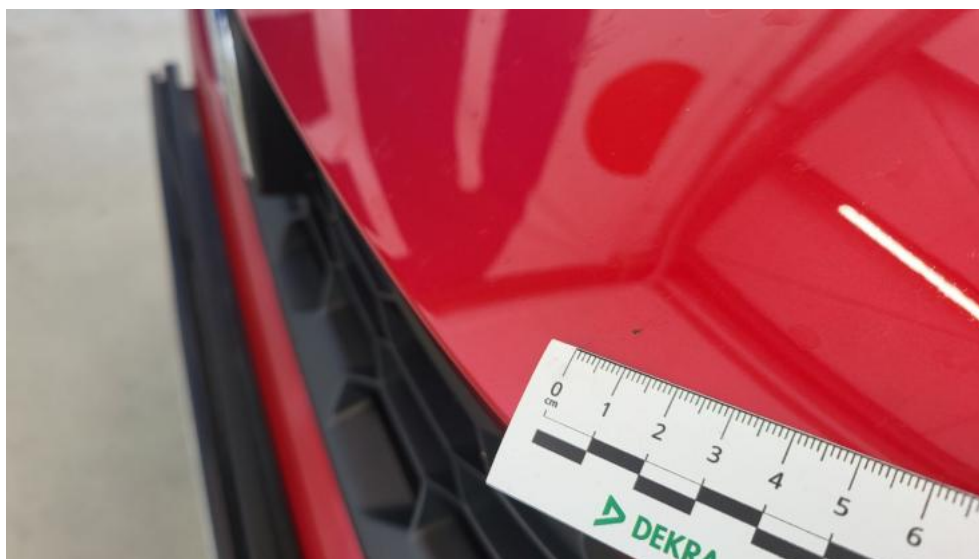
Photo 39.
Zderzak - Rysa/odprysk 1

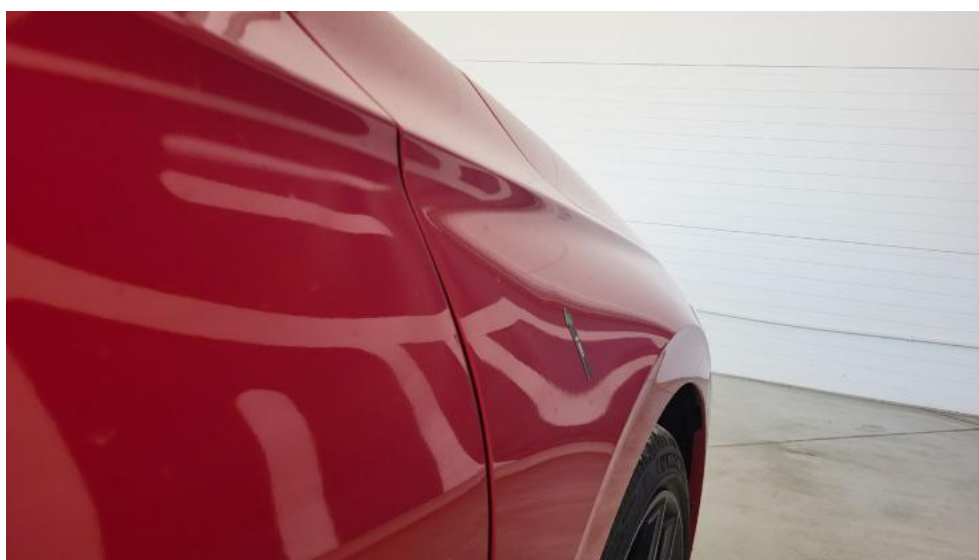
Item name	Description of item	Damage type	Location / Size	Comments
Engine bonnet		loss/chipping) of the lacquer coating	in the right part	
Fender	front r.	wgniecenie/nia	in the rear part	
Door	rear r.	loss/chipping) of the lacquer coating	on the edge	
Door	front l.	loss/chipping) of the lacquer coating	on the edge	
Door	rear l.	loss/chipping) of the lacquer coating	on the edge

Photo 40.
Błotnik przedni P - Wgniecenie/odkształcenie 1

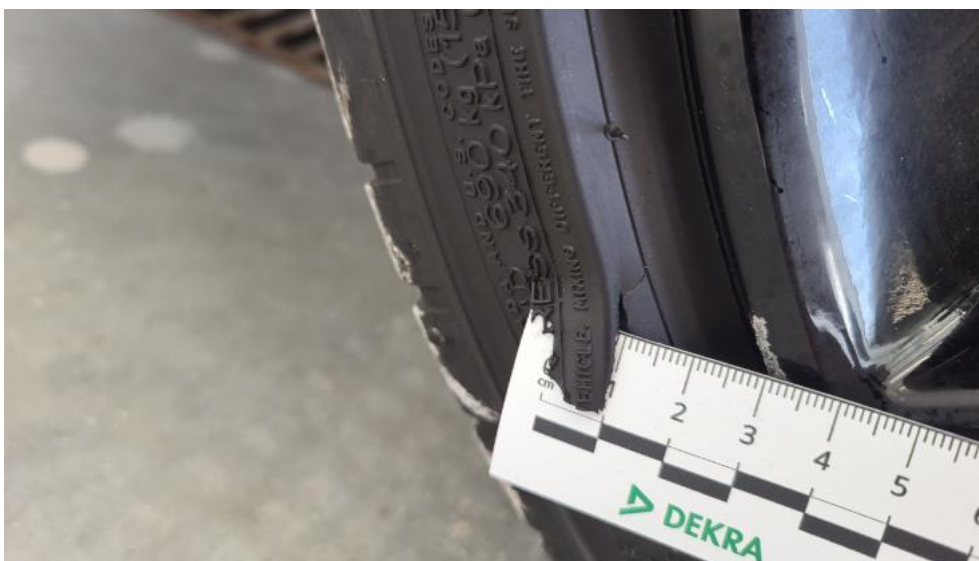
Wheel disc	front r.	scratch		
Wheel tire	front r.	torn		
Wheel disc	front l.	scratch	on the edge	
Wheel tire	front l.	torn

Photo 47.
Opona przednia L - Pęknięcie/rozerwanie 1

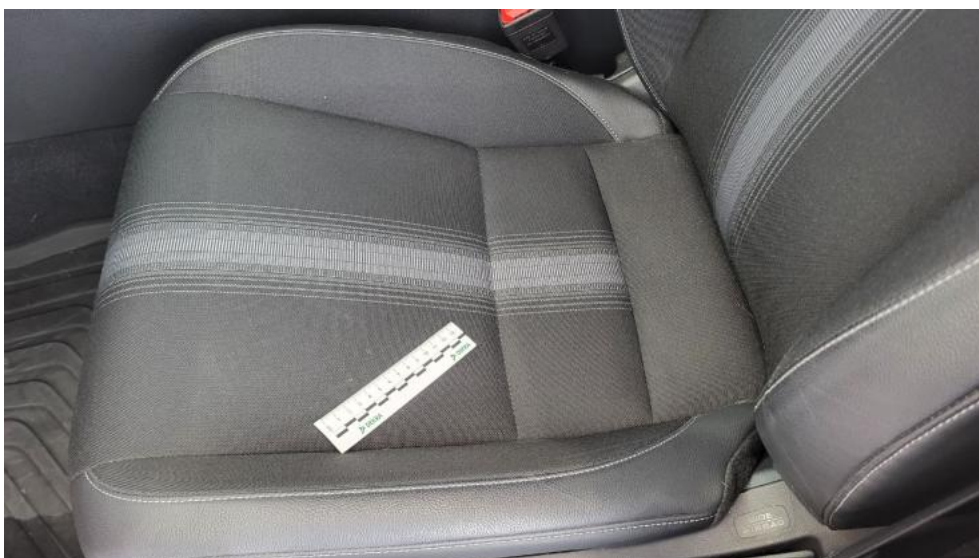
Photo 48.
Fotel prz. lew. - Inne 1
