DEKRA's commission No. : PKOL(W)/LODZ/11928/26/02/13
 commission/ damage No. : 25/006097
 Date of commission: 13-02-2026

PKO Leasing SA
 Świętokrzyska 36
 00-116 Warszawa

Group of objects (Eurotax)	cars
EC code (Eurotax)	0155120
Manufacturer	BMW
Model	Seria 8 Gran Coupe [G16] 22-25
Type / version	840d xDrive mHEV
Body type	sedan
Number of doors / seats	4/5
Curb weight [kg]	2070
Gross vehicle weight [kg]	2600
Wheelbase 1/2	3023
Engine type	Automatic ignition
Pollution reduction system	KSC
Engine capacity [ccm]	2993
Engine Power [hp/kW]	340/250
Gearbox	automatic
Registration /record No.	WY800CR
VIN / serial number	WBAGW010X0CL64188
Date of first registration	16-12-2022
Date of next. tech. test	16-12-2027
Year of manufacture	2022 (year has been verified with the manufacturer's base)
Readout [km]	53 321 (read)
Body color / type of coating	brązowy/double-layered, metallized

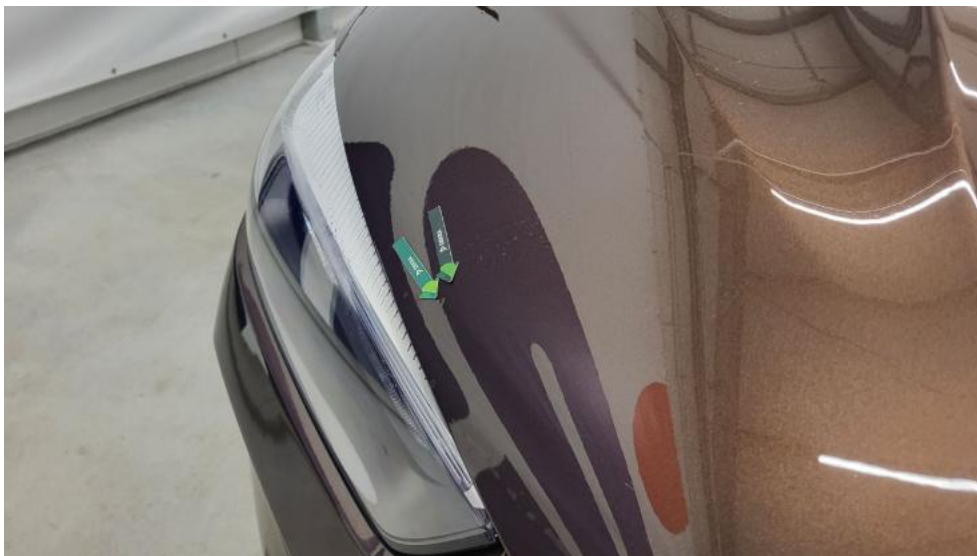
Photo 45.

Pokrywa komory silnika - Wgniecenie/odkształcenie 1

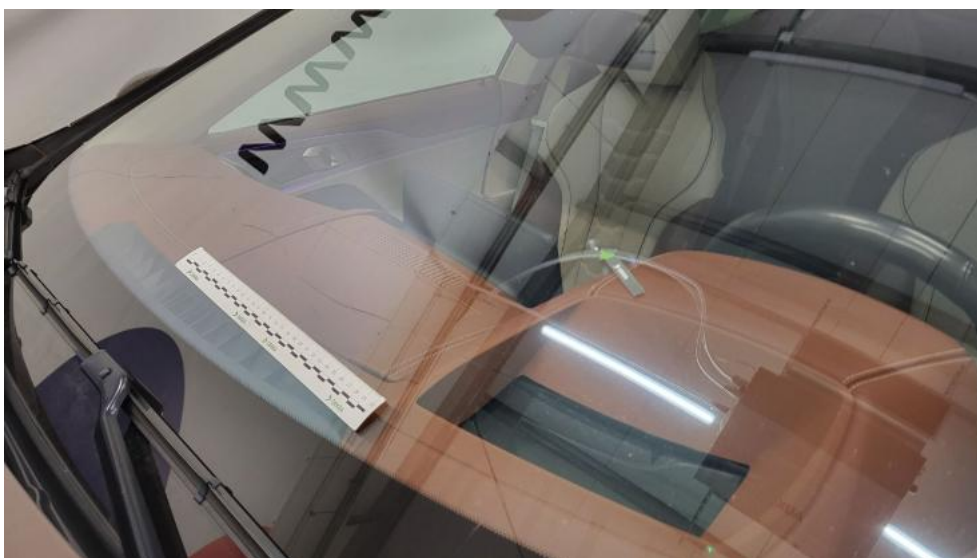
Photo 46.

Szyba czołowa - Pęknięcie/rozerwanie 1

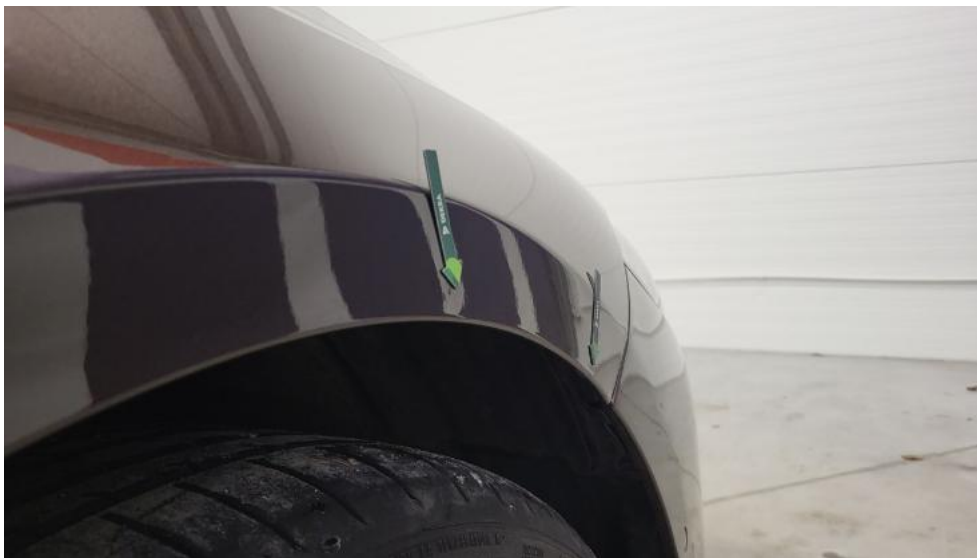
Photo 47.
Błotnik przedni P - Wgniecenie/odkształcenie 1

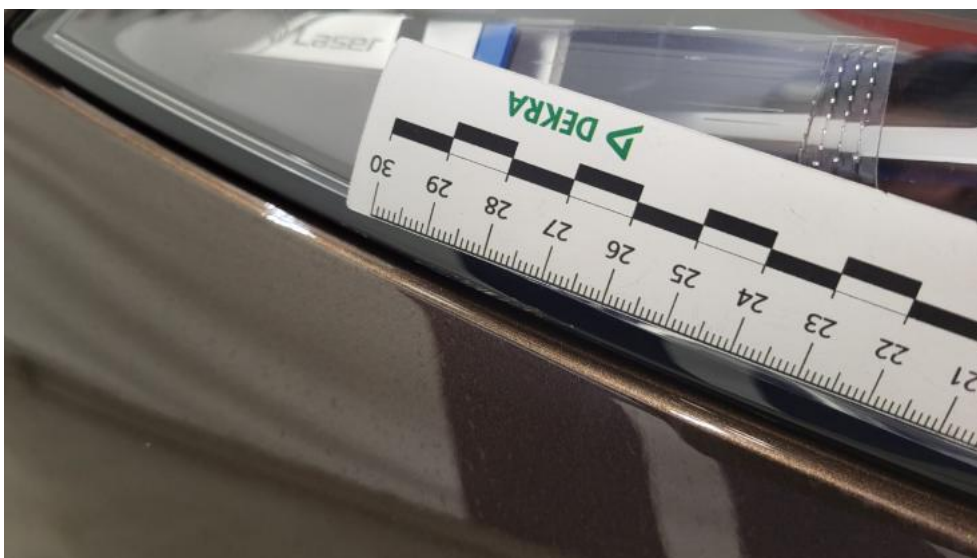
Photo 48.
Reflektor P - Rysa/odprysk 1

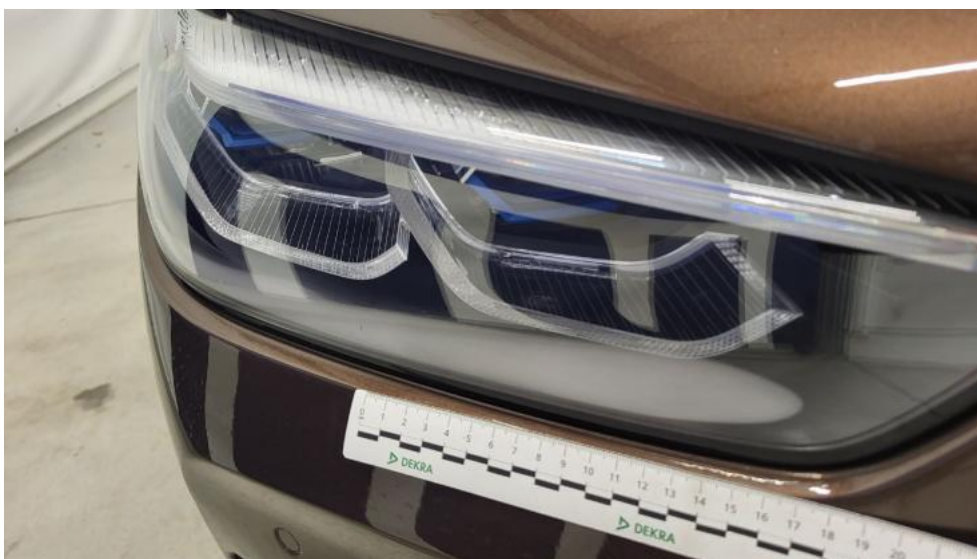
Photo 49.
Reflektor P - Inne 1

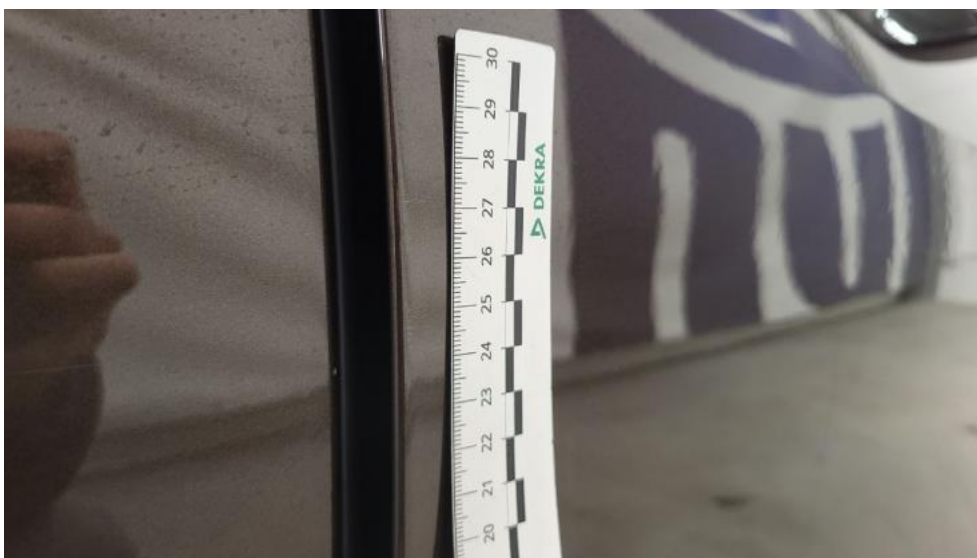
Photo 50.
Drzwi przednie P - Rysa/odprysk 1

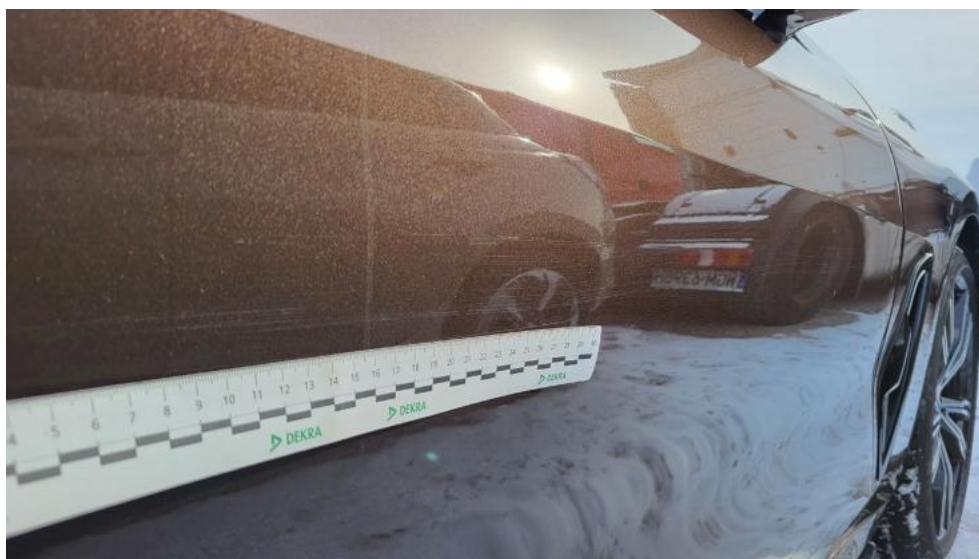
Photo 51.
Drzwi przednie P - Rysa/odprysk 2

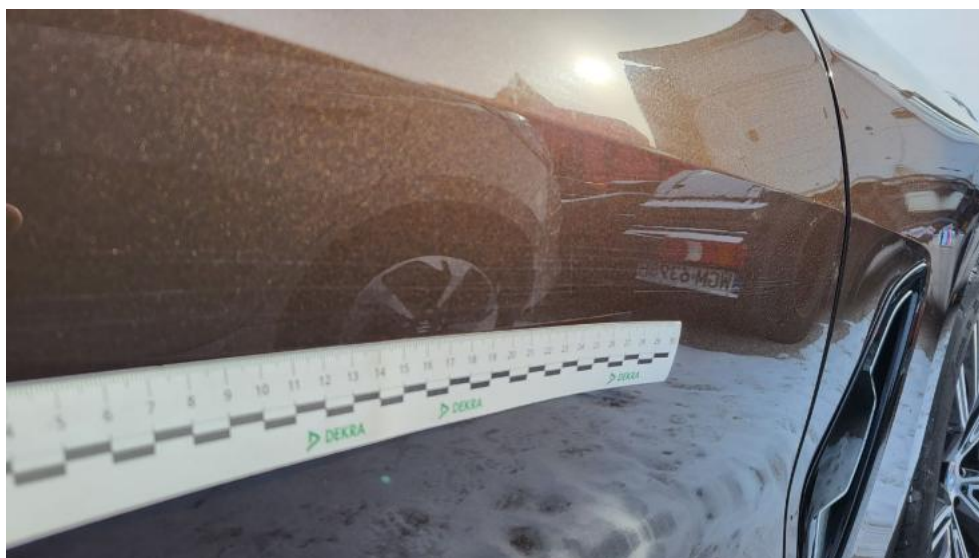
Photo 52.
Drzwi przednie P() - Rysa/odprysk 3

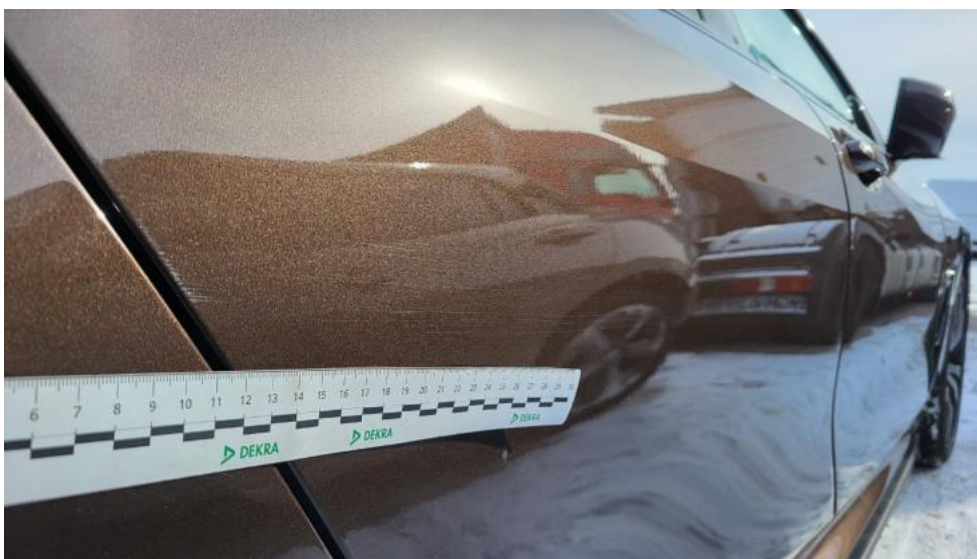
Photo 53.
Drzwi tylne P - Rysa/odprysk 1

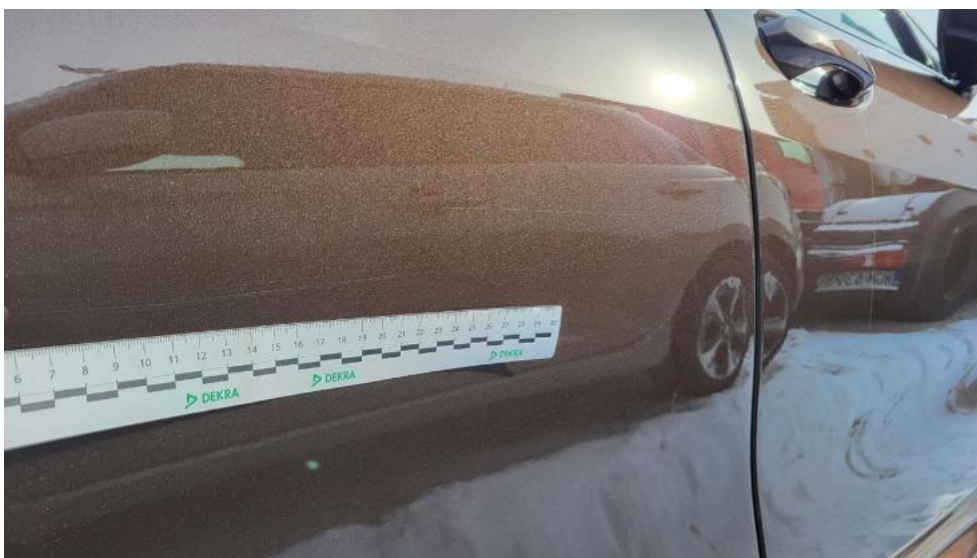
Photo 54.
Drzwi tylne P - Rysa/odprysk 2

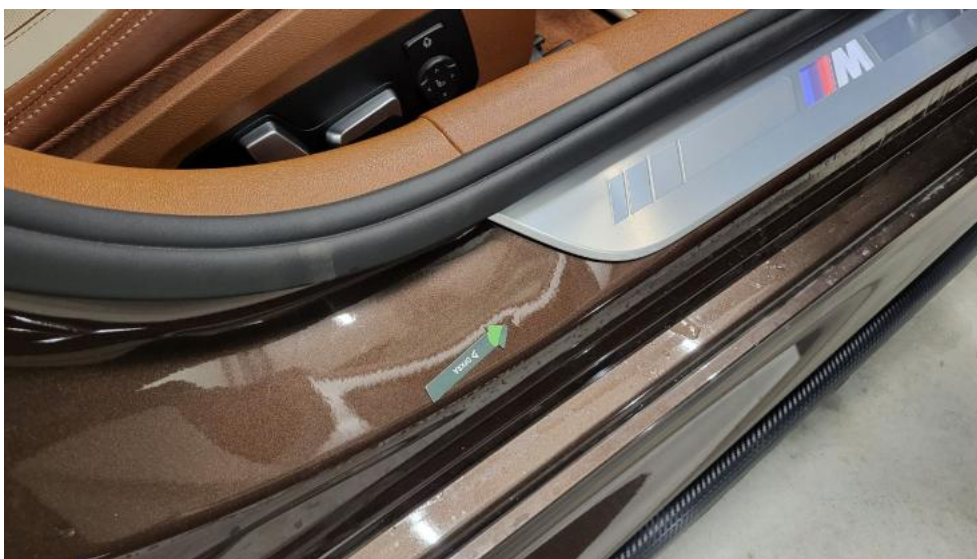
Photo 55.
Próg P - Wgniecenie/odkształcenie 1

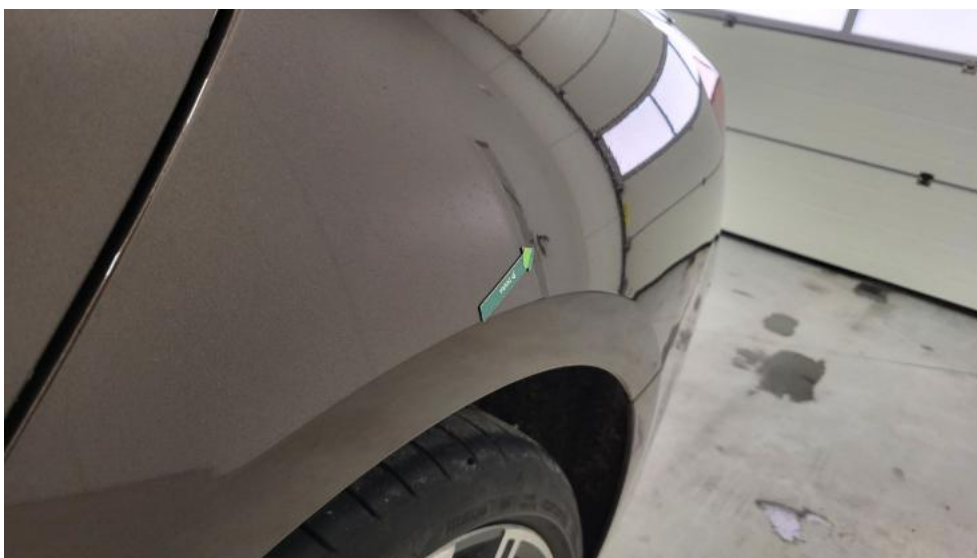
Photo 56.
Błotnik tylny L / Ściana boczna L - Wgniecenie/odkształcenie 1

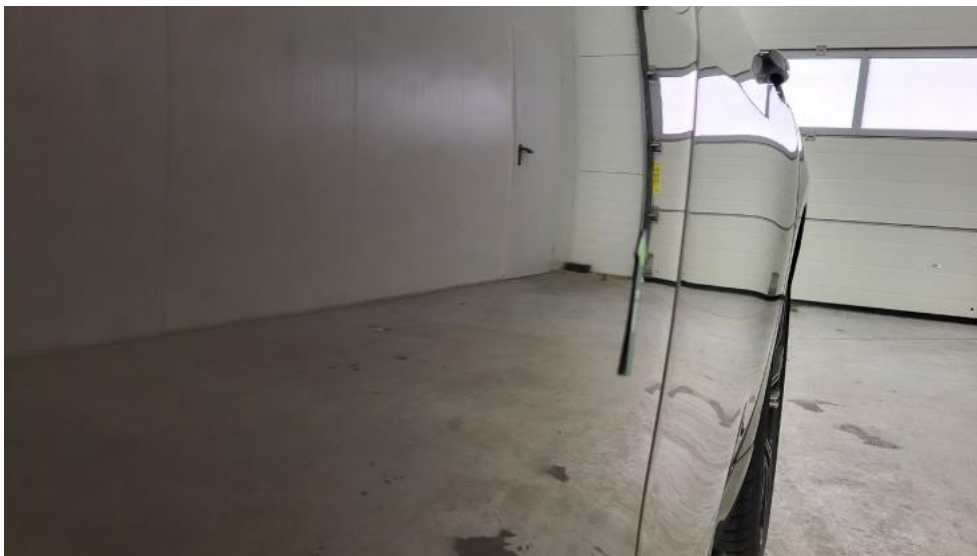
Photo 57.
Drzwi przed L - Wgniecenie/odkształcenie 1

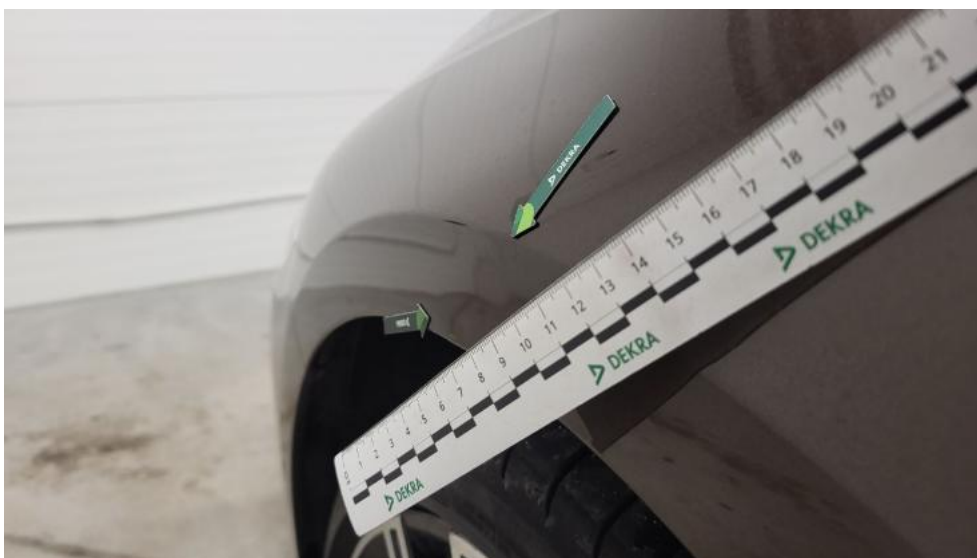
Photo 58.
Błotnik przedni L - Wgniecenie/odkształcenie 1

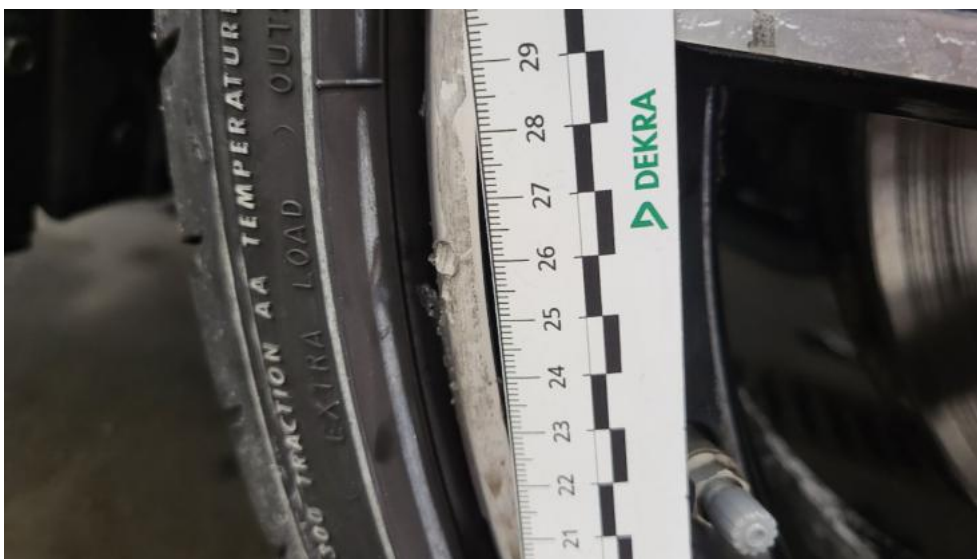
Photo 59.
Felga Aluminiowa przednia L - Rysa/odprysk 1

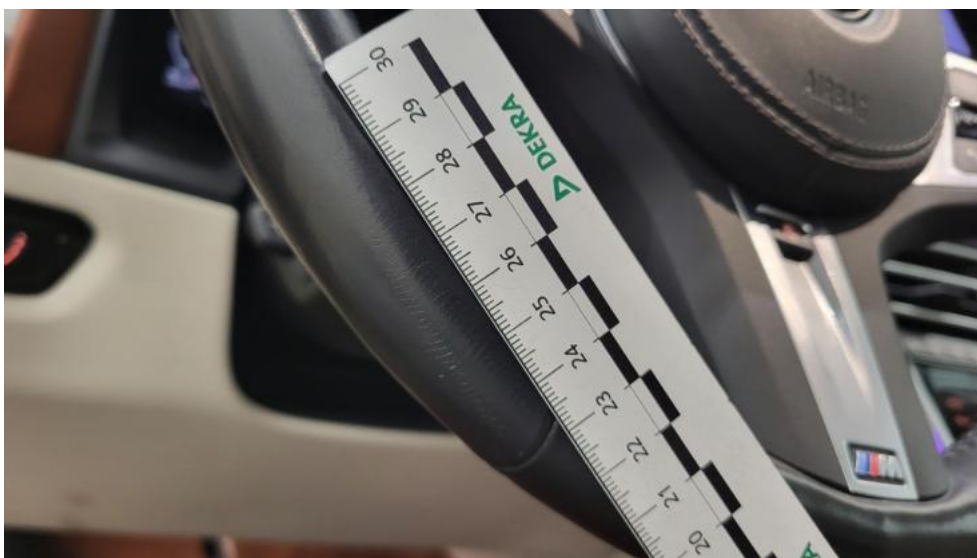
Photo 60.
Koło kierownicy - Rysa/odprysk 1

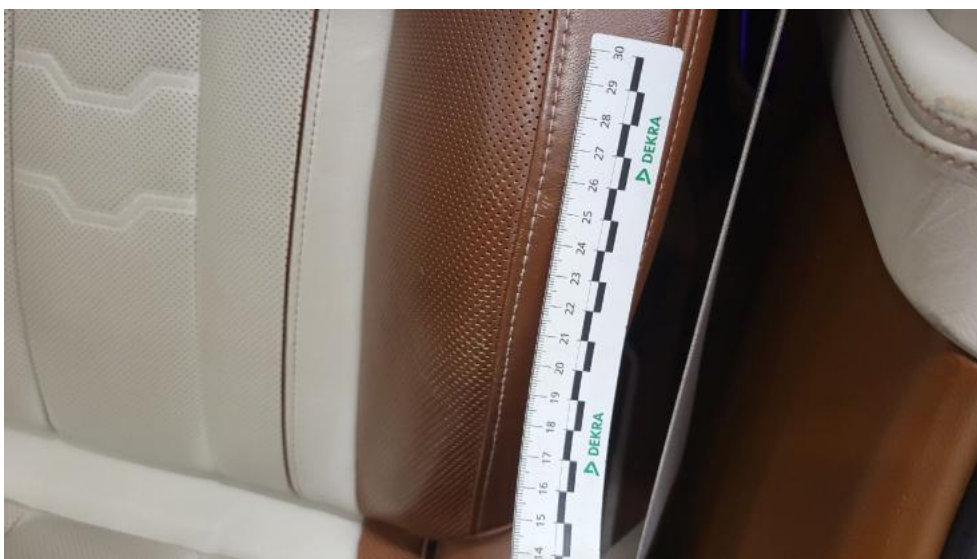
Photo 61.

Fotel prz. lew. - Rysa/odprysk 1

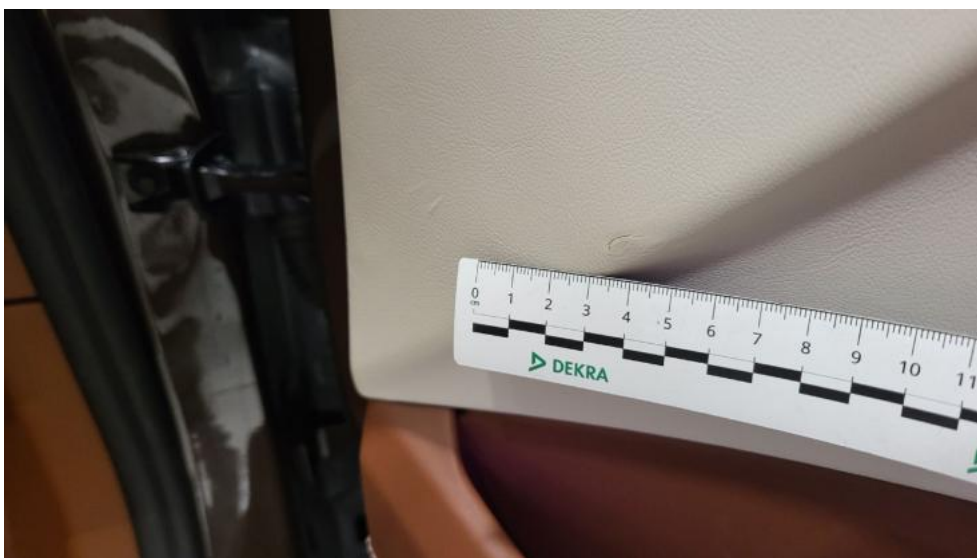
Photo 62.

Tapicerka drzwi przednich P - Pęknięcie/rozerwanie 1

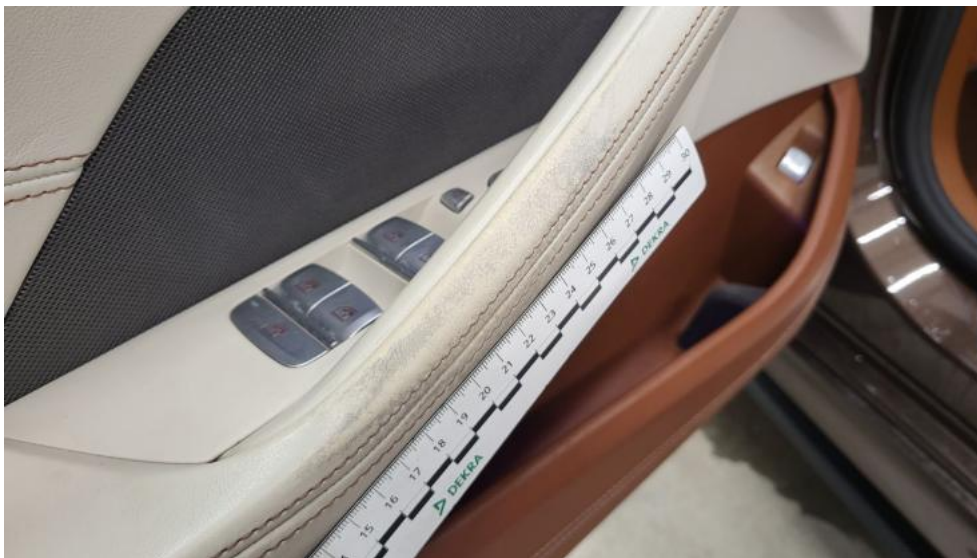
Photo 63.

Uchwyt drzwi prze L - Inne 1
