DEKRA's commission No. : PKOL(W)/LODZ/27279/26/03/26
commission/ damage No. : 21/020852
Date of commission: 26-03-2026

PKO Leasing SA
Świętokrzyska 36
00-116 Warszawa

Vehicle data

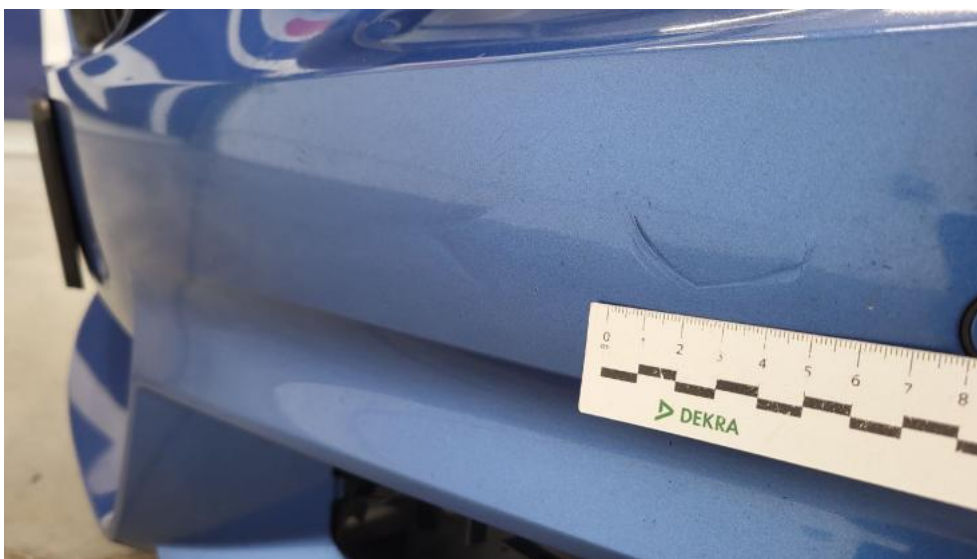
Photo 47.
Zderzak() - Wgniecenie/odkształcenie 3

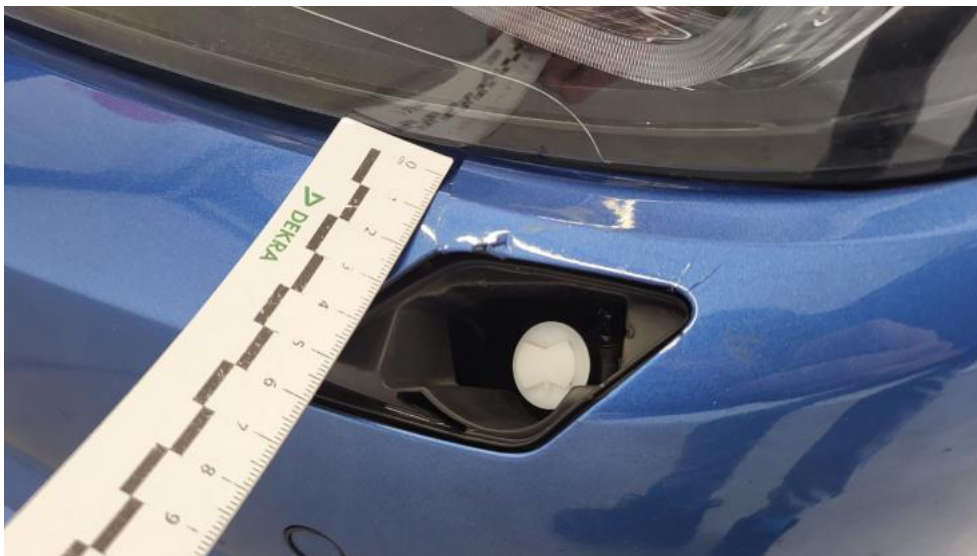
Photo 49.
Zderzak - Pęknięcie/rozerwanie 2

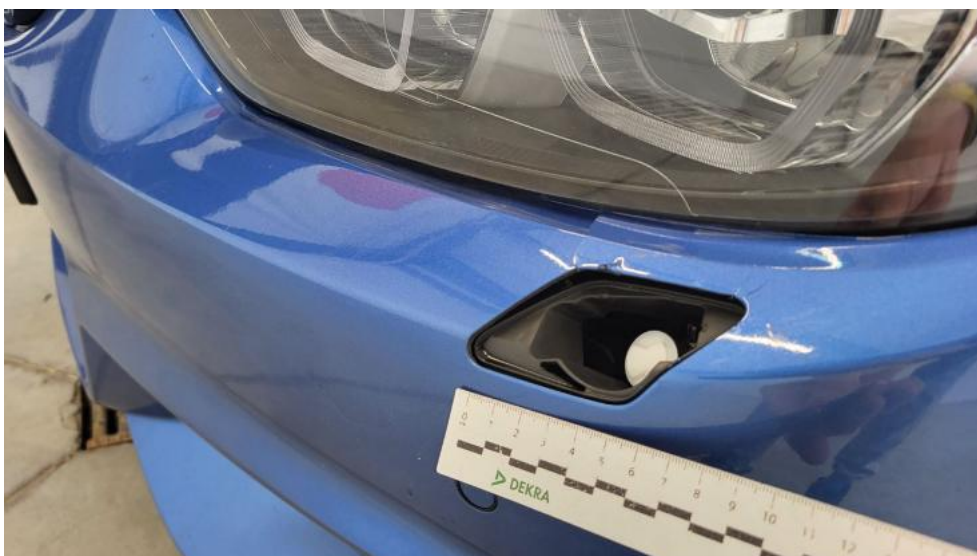
Photo 50.
Zderzak - Inne 1

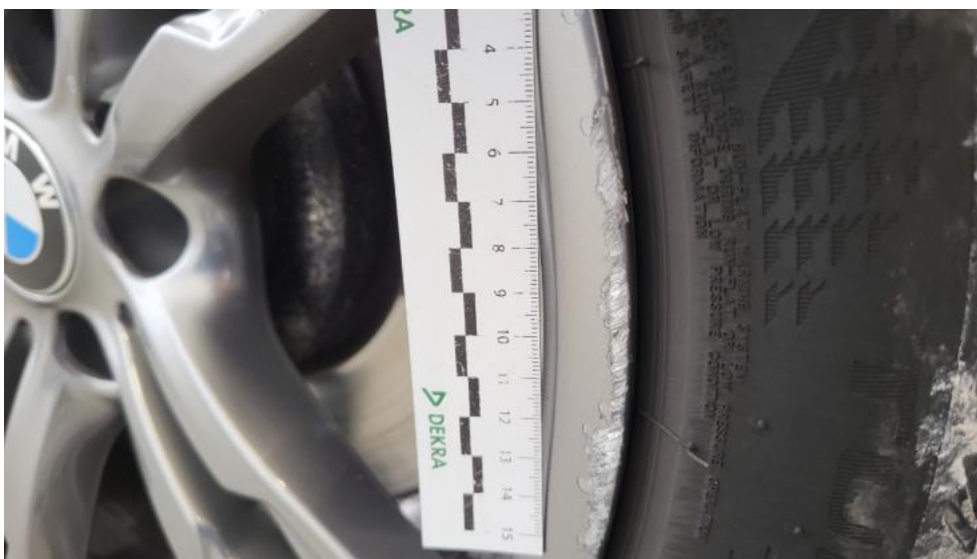
Photo 51.
Felga aluminiowa przednia P - Rysa/odprysk 1

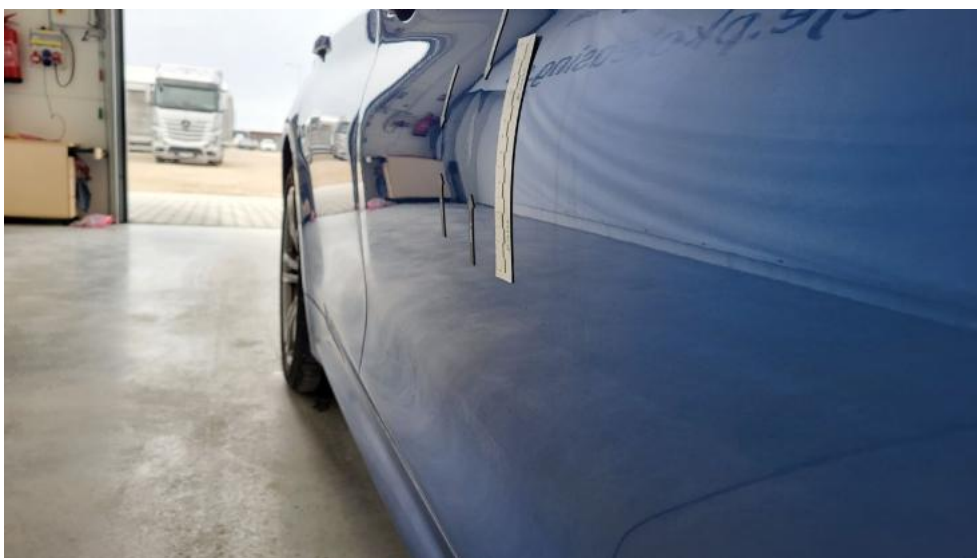
Photo 52.
Drzwi przednie P - Wgniecenie/odkształcenie 1

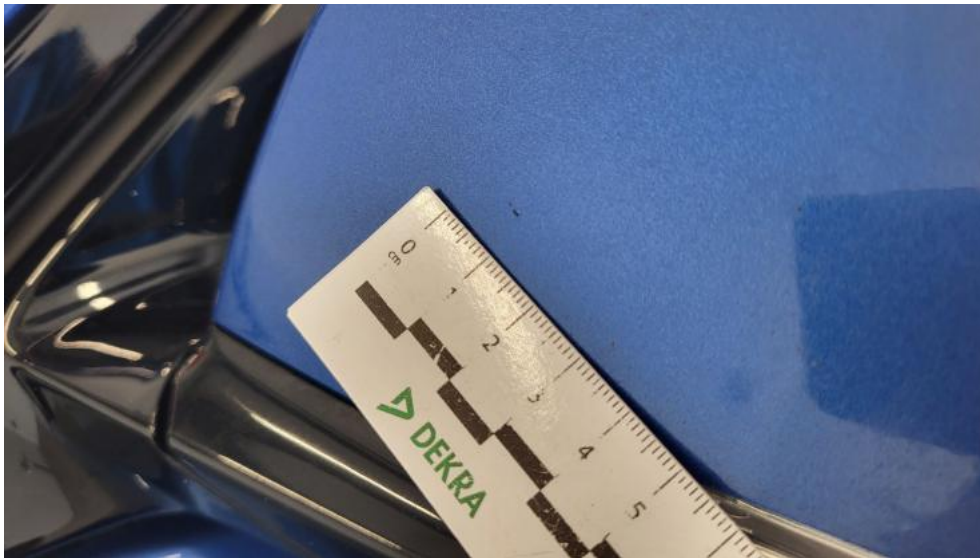
Photo 57.
Lusterko zew L - Rysa/odprysk 1

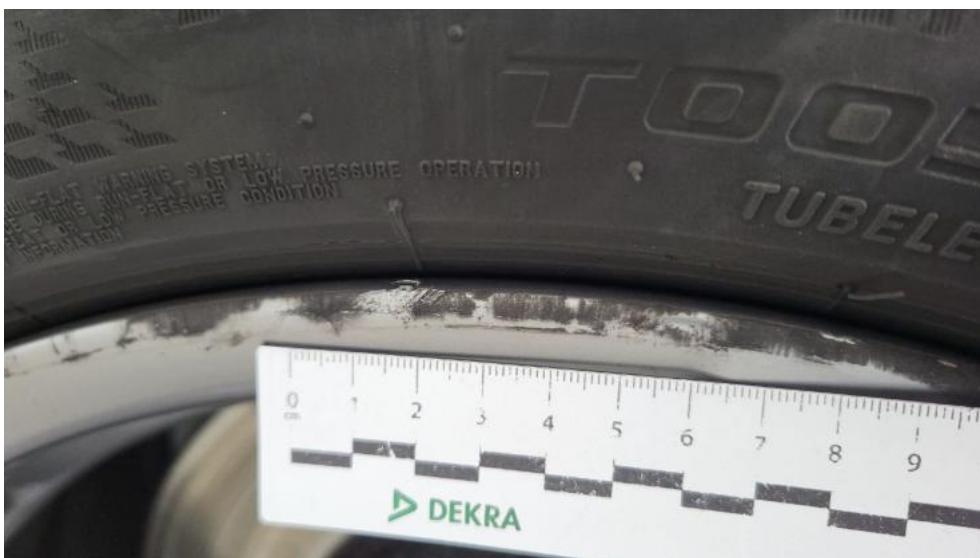
Photo 58.
Felga Aluminiowa przednia L - Rysa/odprysk 1

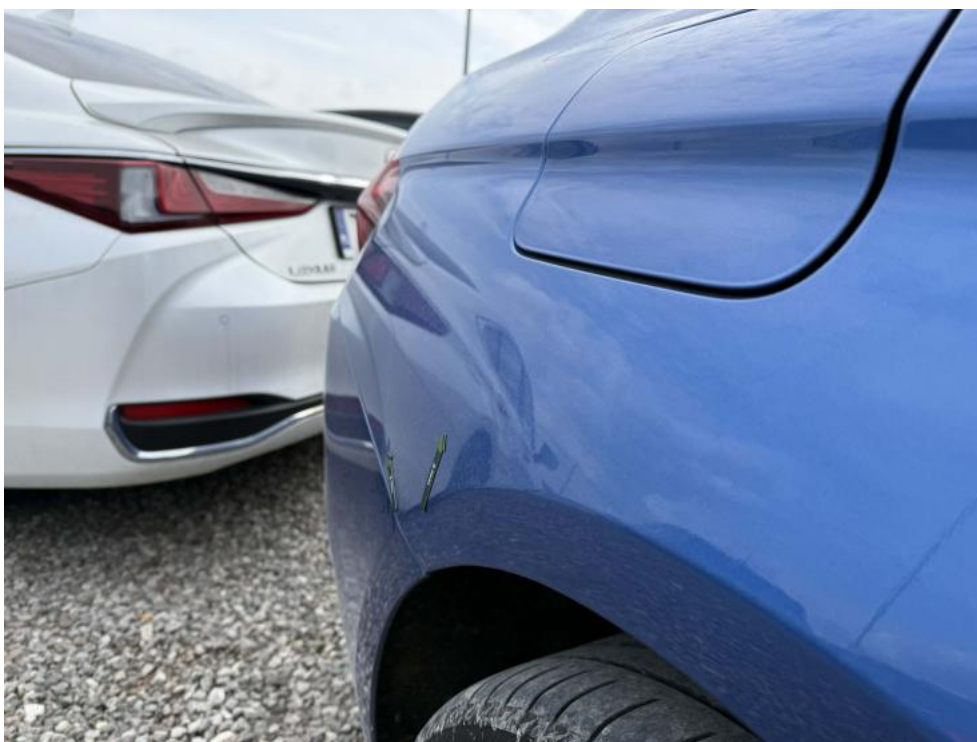
Photo 60.

Błotnik prawy tył - wgniecenie

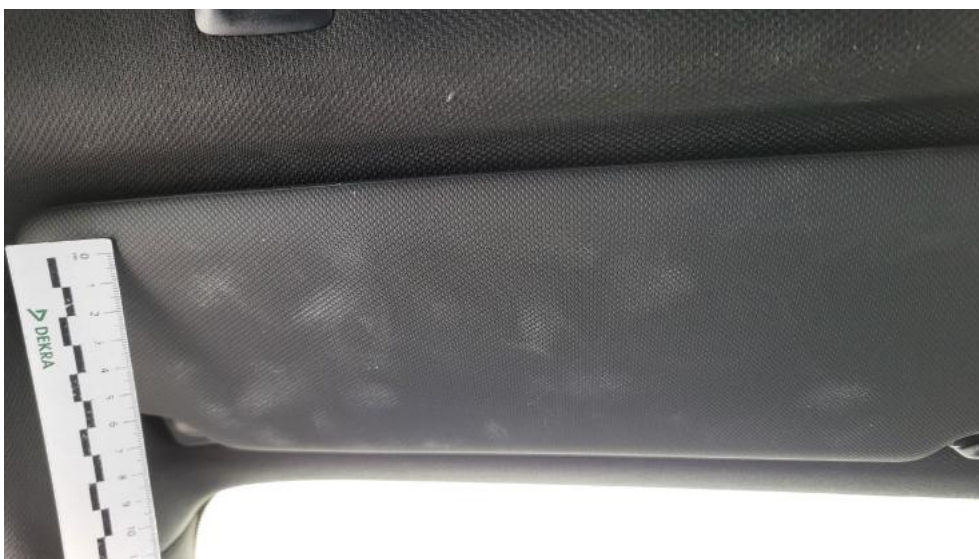
Photo 61.

Osłona p/słoneczna lewa - Inne 1

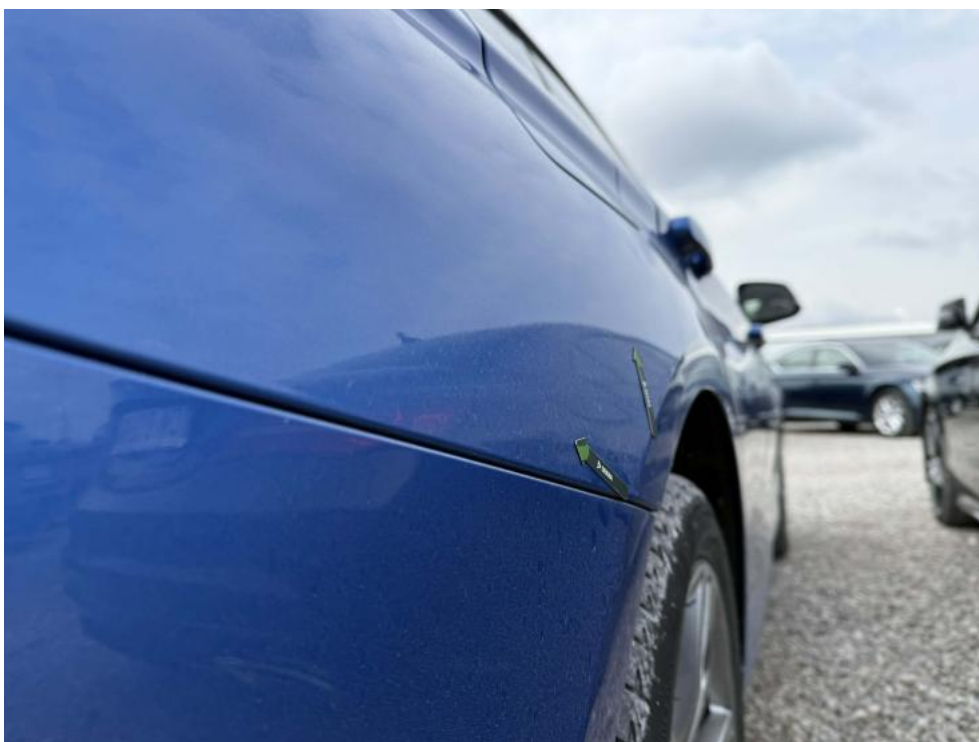
Photo 62.

Błotnik prawy tył - wgniecenie
