DEKRA's commission No. : PKOL(W)/LODZ/29122/26/04/01
commission/ damage No. : 23/007802
Date of commission: 01-04-2026

Vehicle data

Group of objects (Eurotax)	cars
EC code (Eurotax)	0154158
Manufacturer	AUDI
Model	A8 [4N] 21-
Type / version	A8 50 TDI mHEV Quattro Tiptr.
Body type	sedan
Number of doors / seats	4/5
Curb weight [kg]	2160
Gross vehicle weight [kg]	2710
Wheelbase 1/2	2998
Engine type	Automatic ignition
Pollution reduction system	KSC
Engine capacity [ccm]	2967
Engine Power [hp/kW]	286/210
Gearbox	automatic
Registration /record No.	GA874KG
VIN / serial number	WAUZZZF82NN000894
Date of first registration	27-06-2022
Date of next. tech. test	24-02-2027
Year of manufacture	2022
Readout [km]	174 060 (read)
Body color / type of coating	black/double-layered, metallized

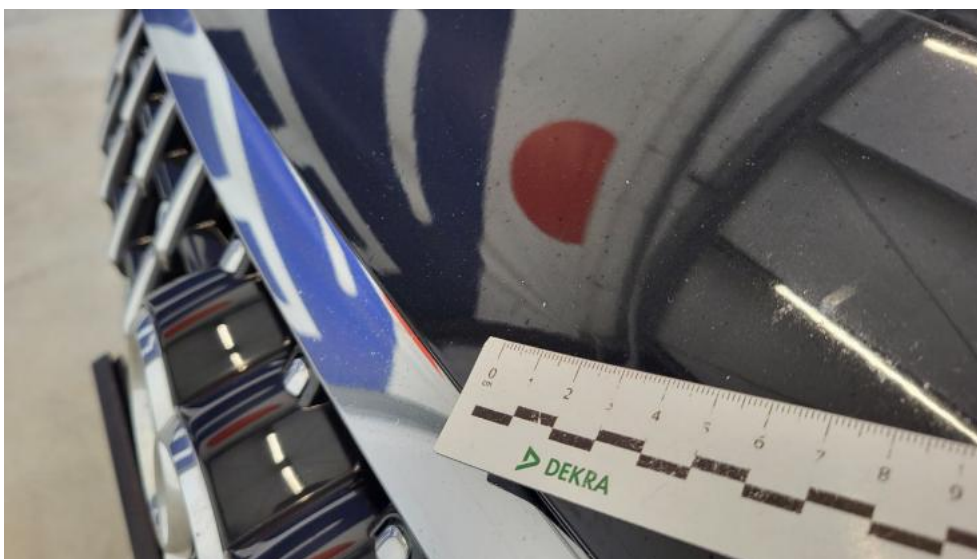
Photo 49.
Pokrywa komory silnika - Rysa/odprysk 1

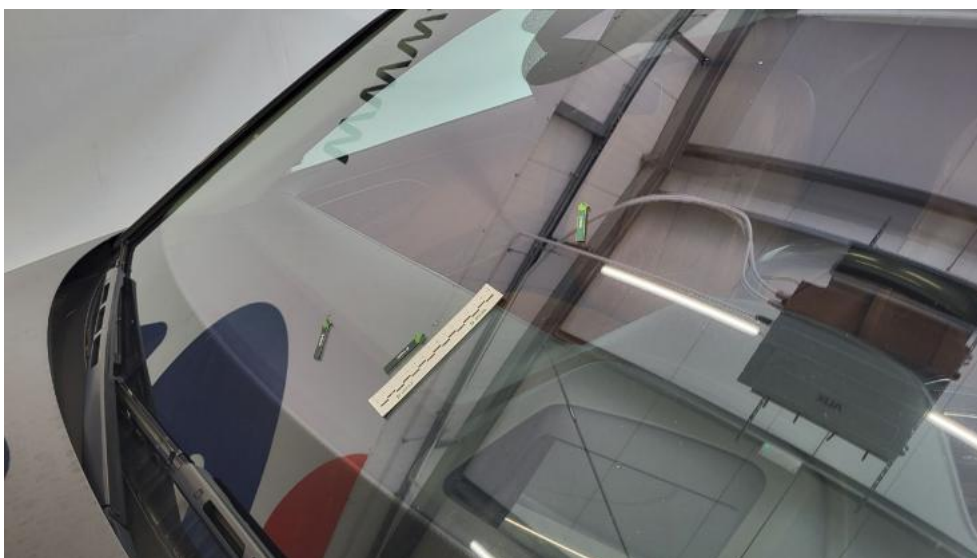
Photo 50.
Szyba czołowa - zdjęcie poglądowe 1

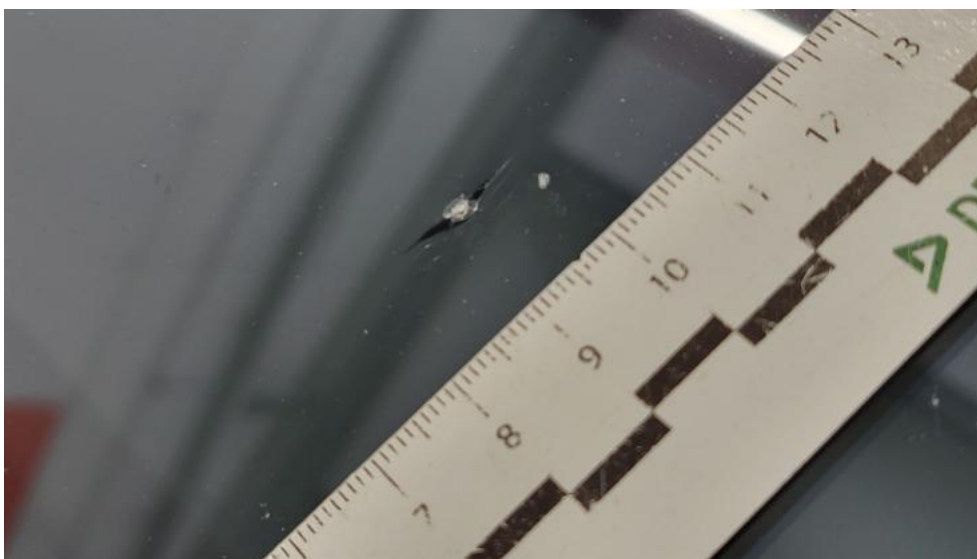
Photo 51.
Szyba czołowa - Pęknięcie/rozerwanie 1

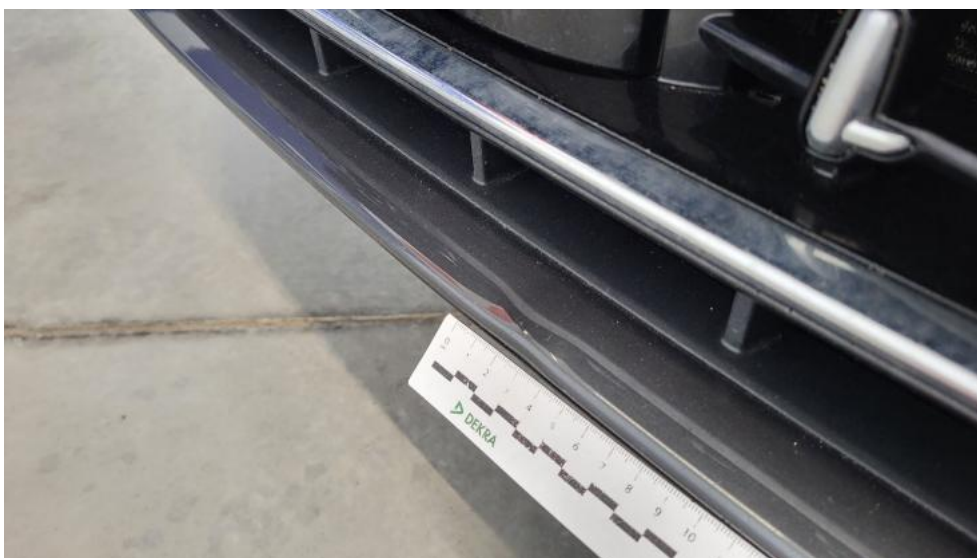
Photo 52.
Zderzak - Wgniecenie/odkształcenie 1

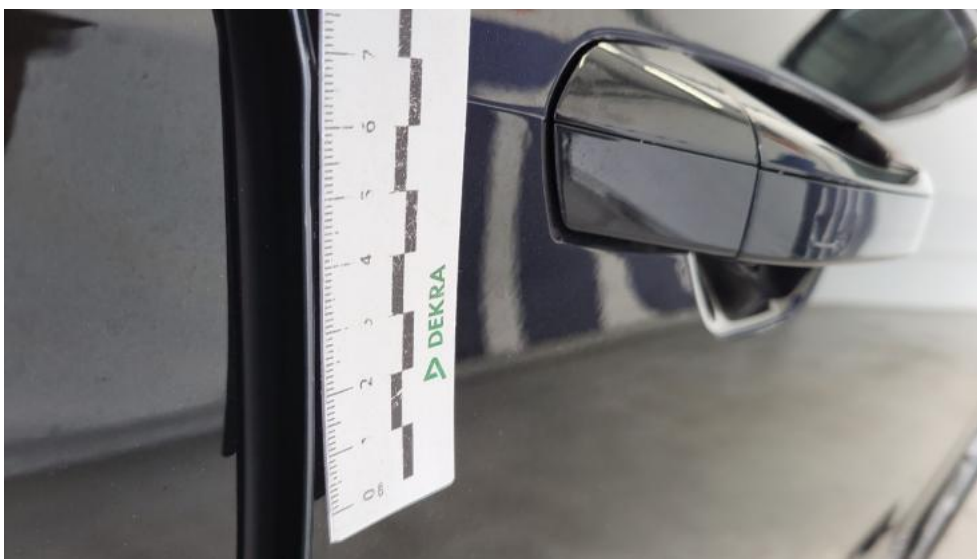
Photo 55.

Drzwi przednie P - Rysa/odprysk 1

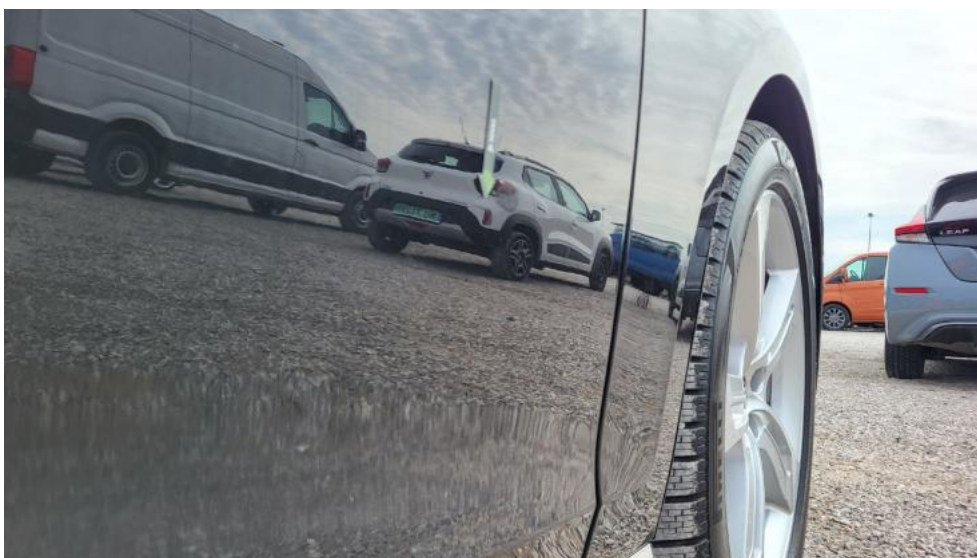
Photo 56.

Drzwi przednie P - Wgniecenie/odkształcenie 1

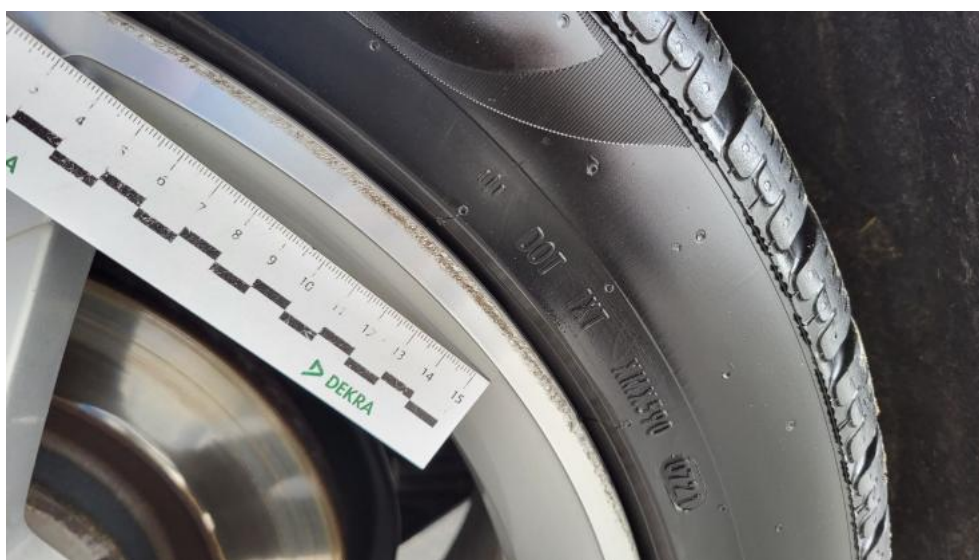
Photo 64.
Felga aluminiowa tylna L - Rysa/odprysk 1

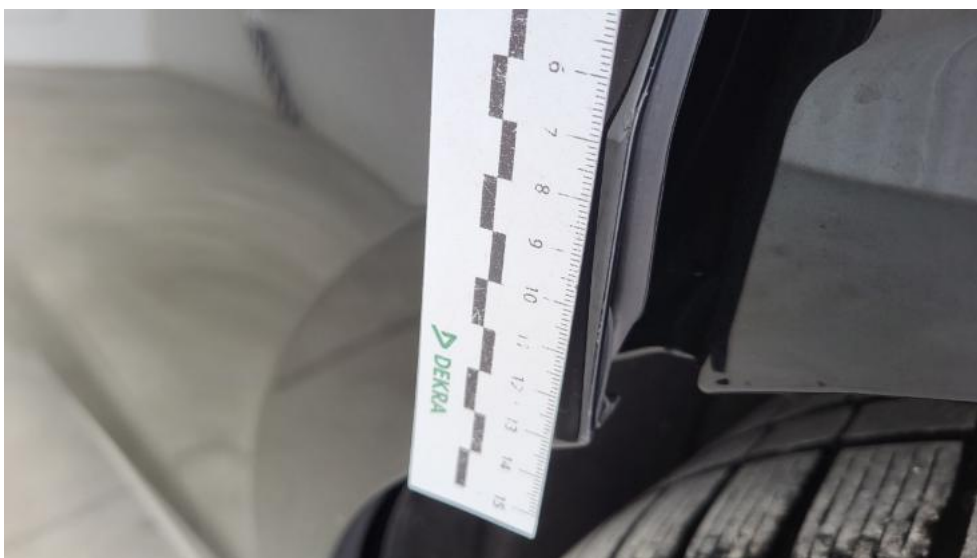
Photo 66.

Drzwi tylne L - Rysa/odprysk 1

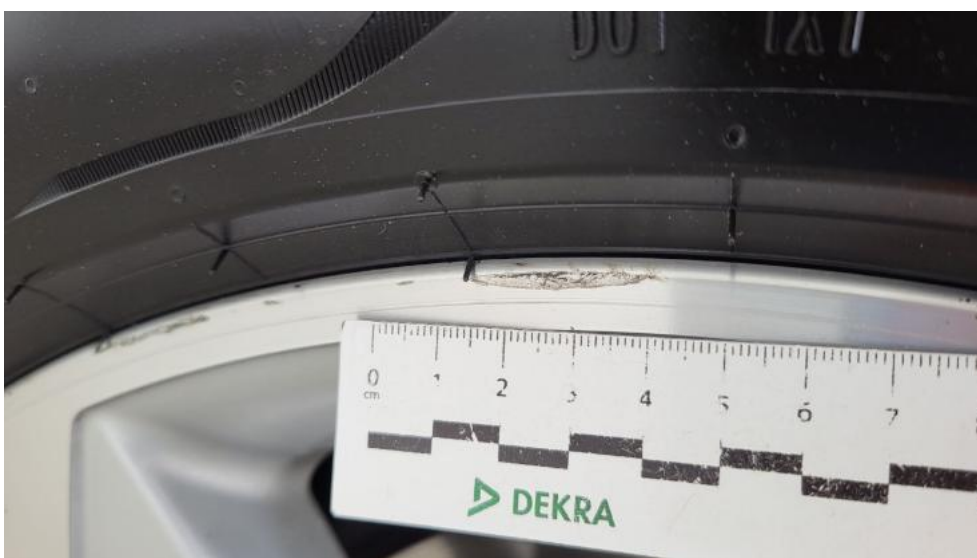
Photo 68.
Felga Aluminiowa przednia L - Rysa/odprysk 1

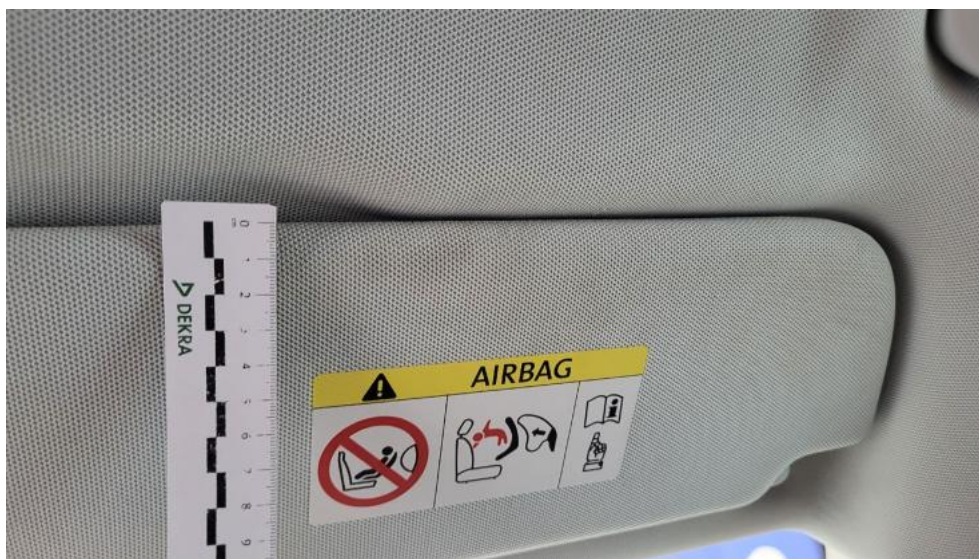
Photo 73.

Osłona p/słoneczna prawa - Inne 1

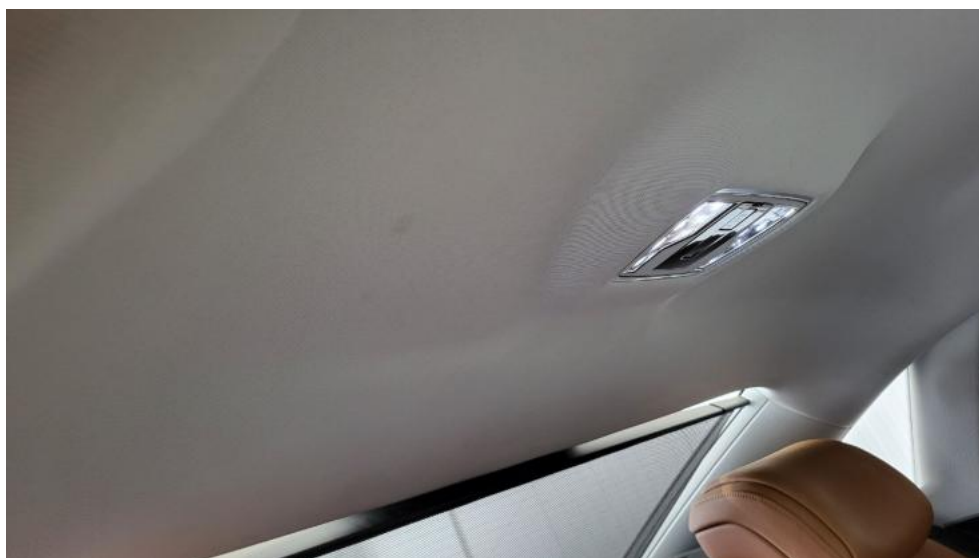
Photo 74.

Podsufitka - Inne 1
