DEKRA's commission No. : PKOL(W)/LODZ/18930/25/03/14  
commission/ damage No. : 23/038597  
Date of commission: 14-03-2025

| Manufacturer | MERCEDES-BENZ |
| Type / version | EQC 400 4-Matic |
| VIN / serial number | W1K2938901F009323 |

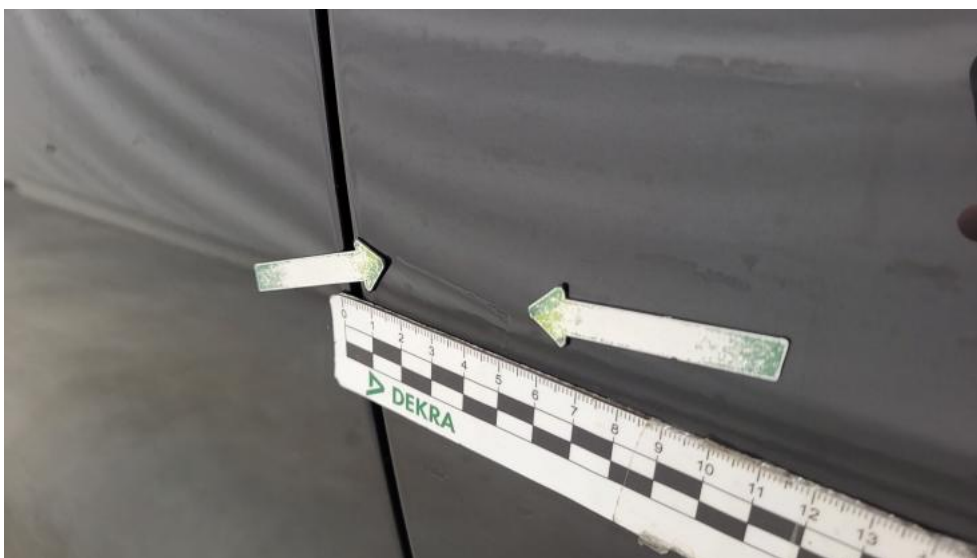
**Photo 46.**

Drzwi przednie P - Wgniecenie/odkształcenie 2

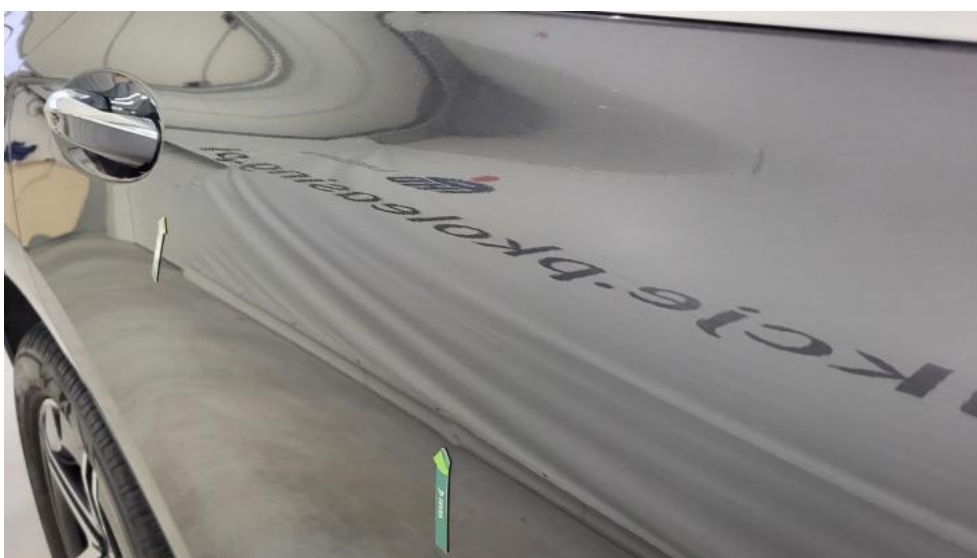
**Photo 48.**

Drzwi tylne P - Wgniecenie/odkształcenie 1

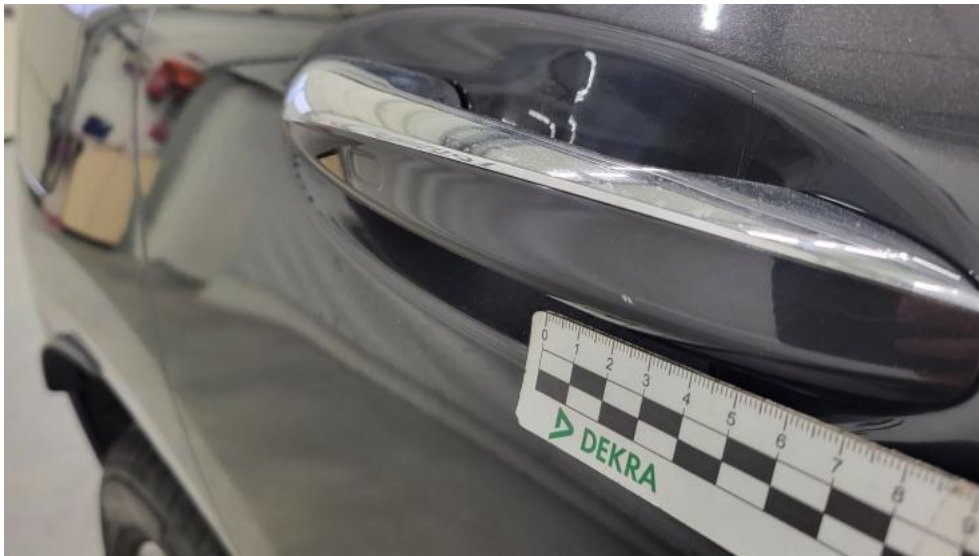
**Photo 49.**

Klamka drzwi tyl P - Rysa/odprysk 1

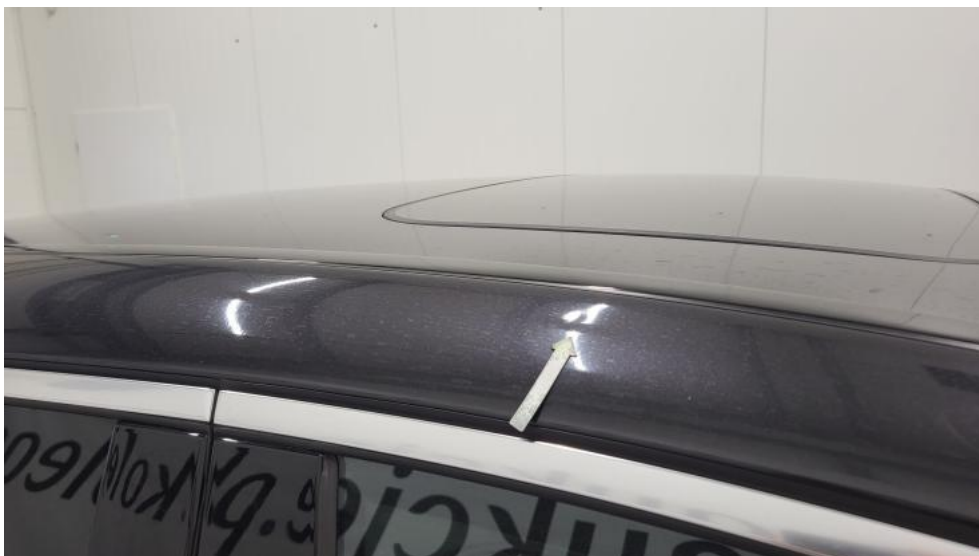
**Photo 50.**

Słupek przedni P - Wgniecenie/odkształcenie 1

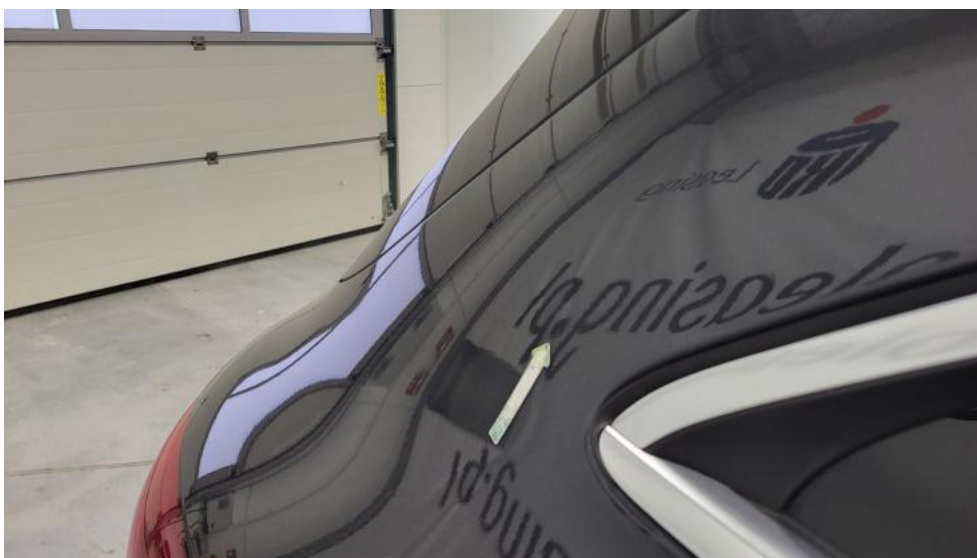
**Photo 52.**

Błotnik tylny P / Ściana boczna P - Wgniecenie/odkształcenie 1

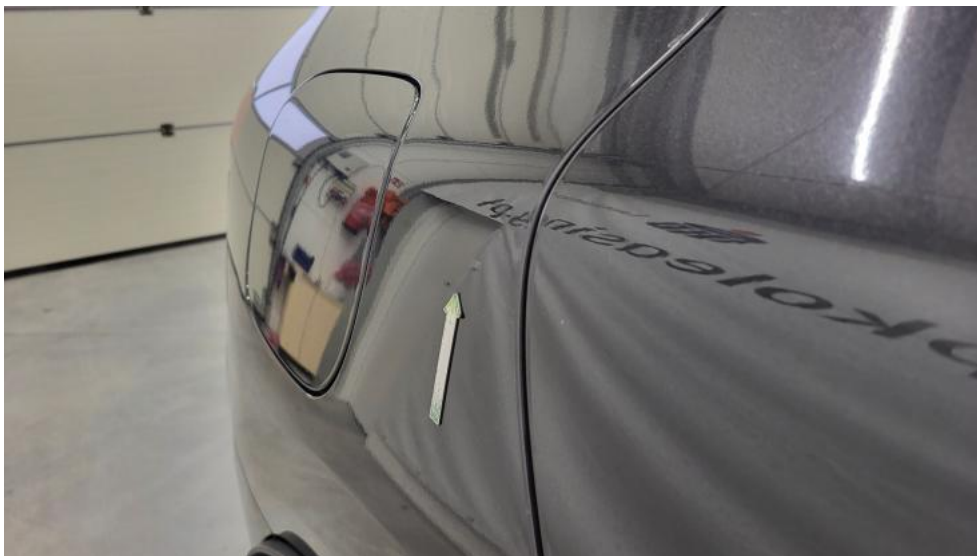
**Photo 53.**

Błotnik tylny P / Ściana boczna P - Wgniecenie/odkształcenie 2

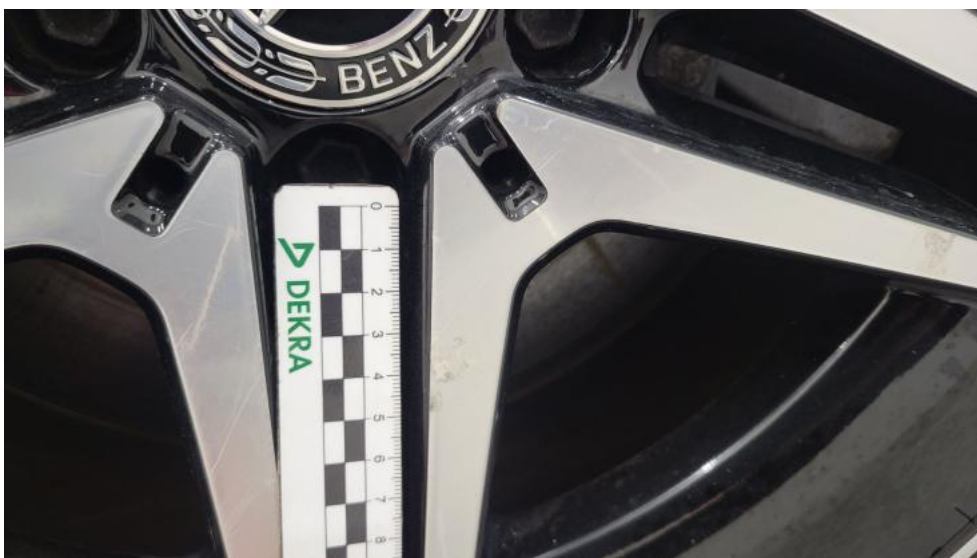
**Photo 54.**

Felga aluminiowa tylna L - Rysa/odprysk 1

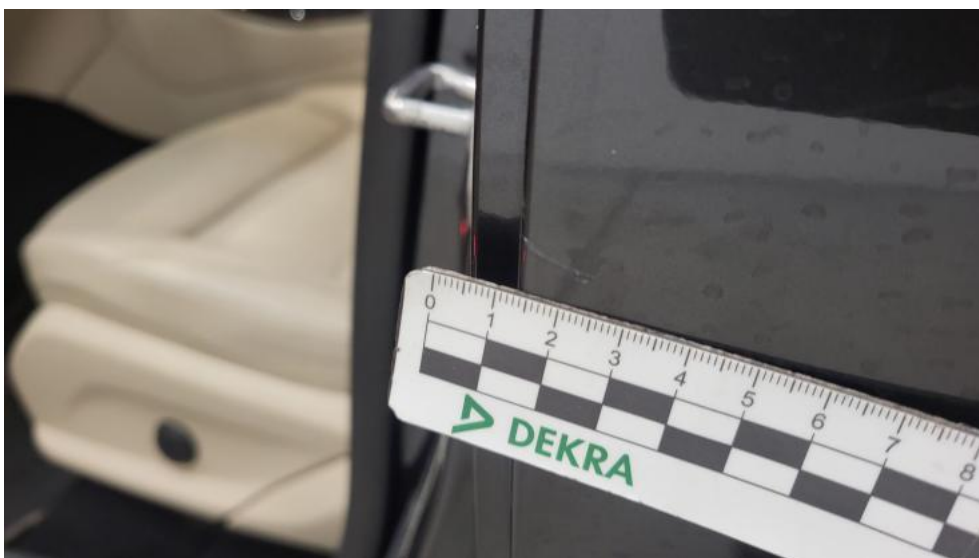
**Photo 58.**

Drzwi tylne L - Rysa/odprysk 1

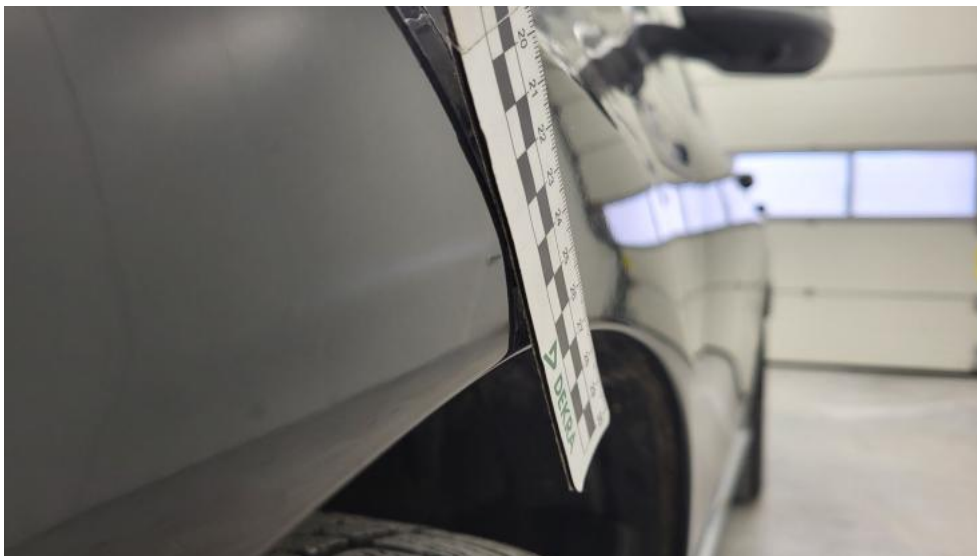
**Photo 63.**

Błotnik przedni L - Wgniecenie/odkształcenie 1

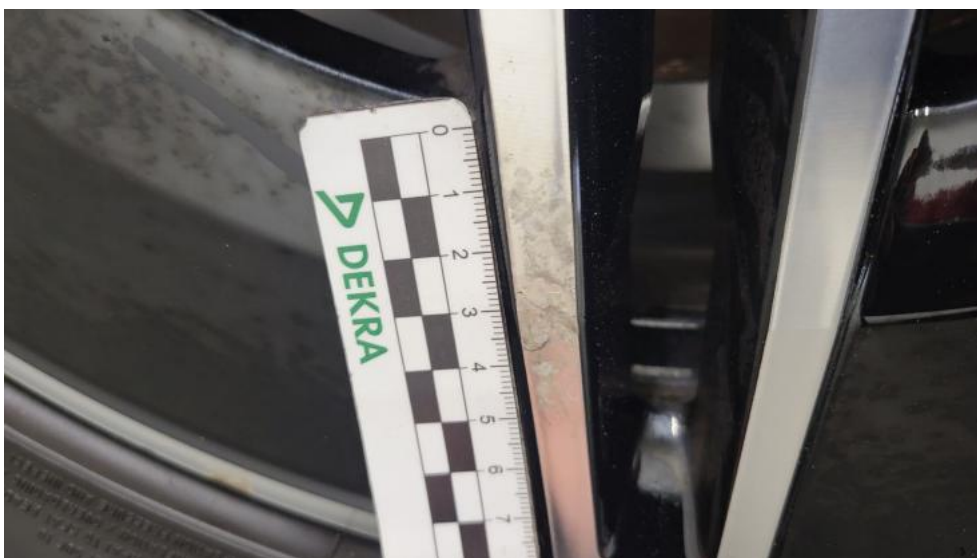
**Photo 64.**

Felga Aluminiowa przednia L - Rysa/odprysk 1

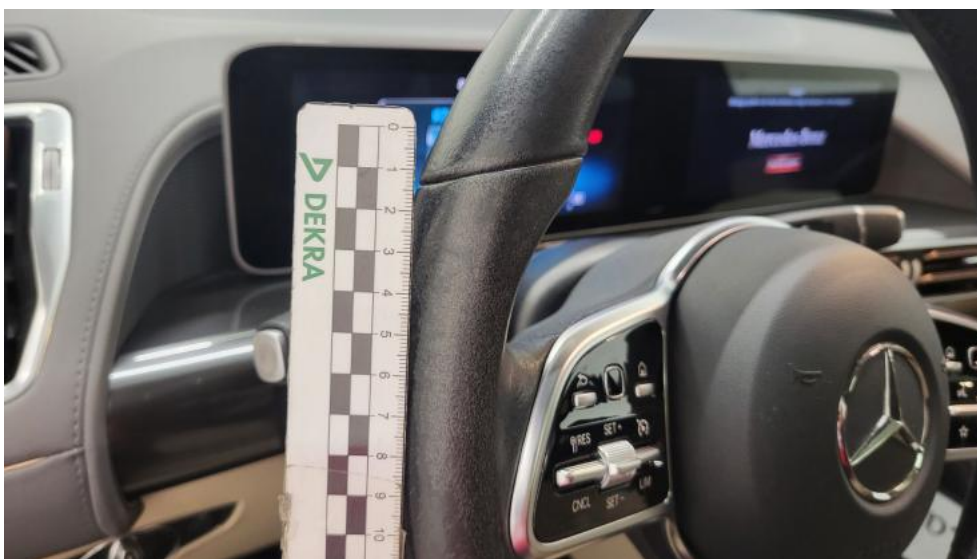
**Photo 65.**

Koło kierownicy - Inne 1

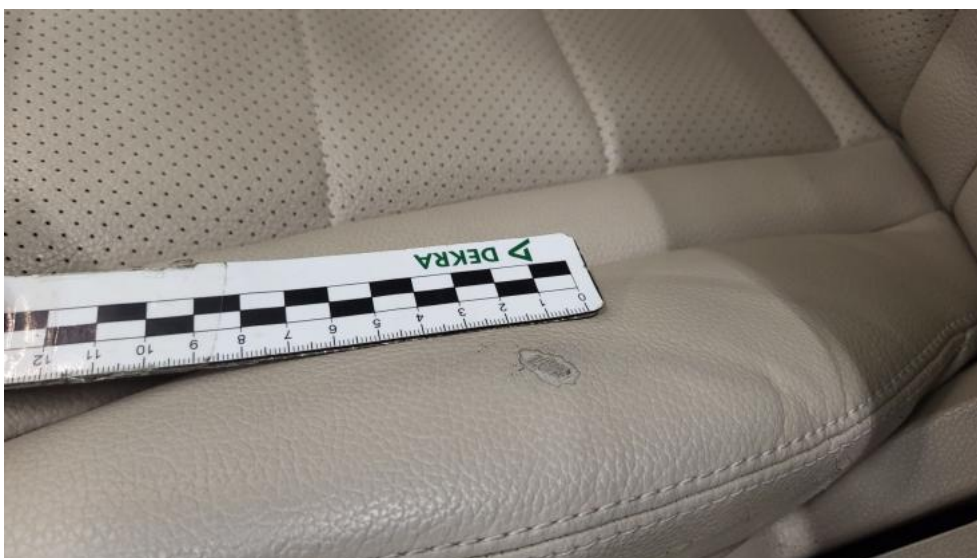
**Photo 66.**

Fotel prz. lew. - Pęknięcie/rozerwanie 1

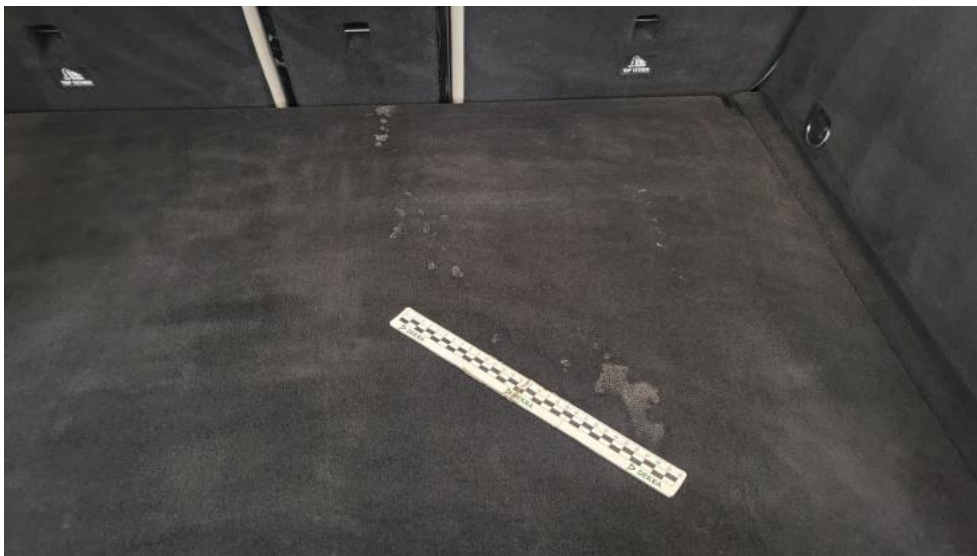
**Photo 67.**

Wykładzina podłogi bagażnika - Inne 1
